GLASS OR CERAMIC SPHERICAL-SHELL  
WINDOW ASSEMBLY FOR 20,000-PSI  
OPERATIONAL PRESSURE

Jerry D. Stachiw

Naval Undersea Center  
San Diego, California

May 1974

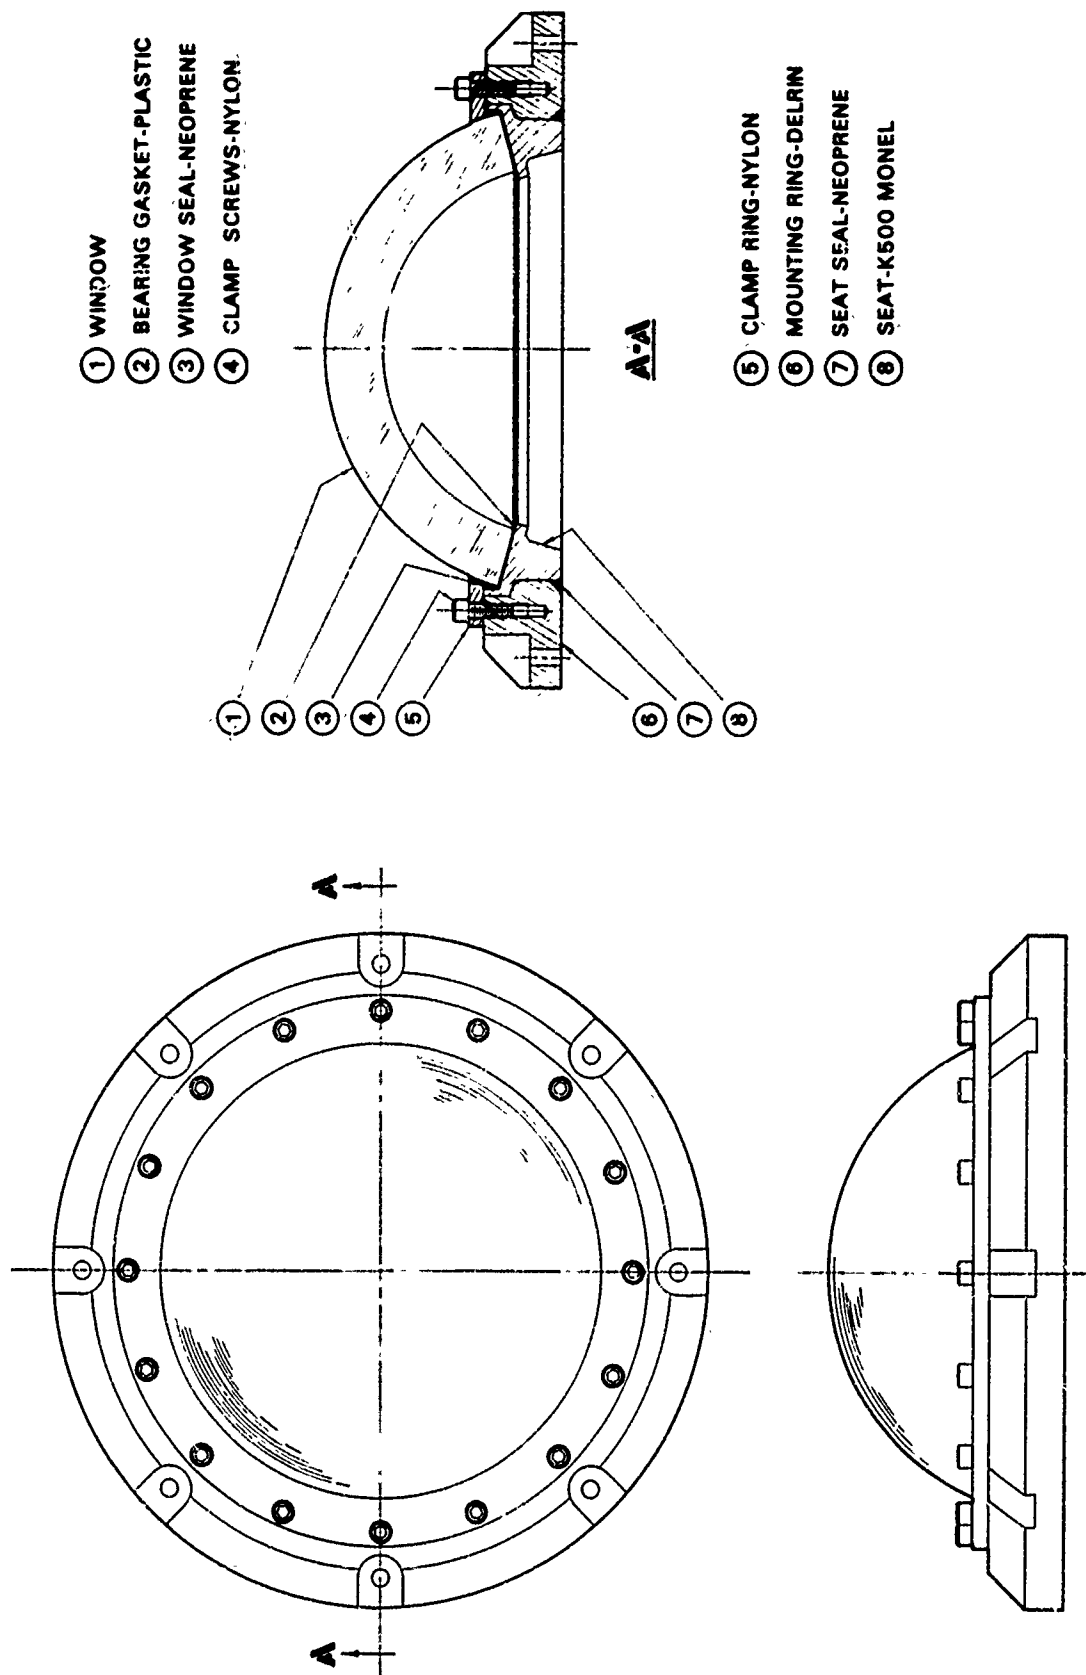
Figure 1. NUC spherical-shell window-flange assembly with 150-degree included spherical angle for service to 20,000-psi hydrostatic pressure.

To make the assembly a self-contained structural subsystem (Appendix A), the window was designed to rest on a flange and be retained by rings that do not form a part of the hull structure (figure 1). Since the flange mounting-ring that bolts to the hull is not rigidly attached to the flange, the latter is free to contract radially under the influence of hydrostatic pressure. The sliding friction between the flange and the hull imposes some restraint on the flange; but this is minor and, in addition, the frictional constraint between two flat surfaces does not readily transmit bending moments from the hull to the flange. The mounting ring also, although bolted to the hull, is not subjected to high stresses by the hull because it is made of DELRIN plastic with a significantly lower modulus of elasticity than that of a typical metallic hull.

The clamp ring for holding the window in the flange and the mounting ring for the attachment of the flange to the hull were made from Nylon and Delrin, respectively. Plastics were chosen for this application because of their compliance to hull deformation and superior corrosion resistance (figure 1).

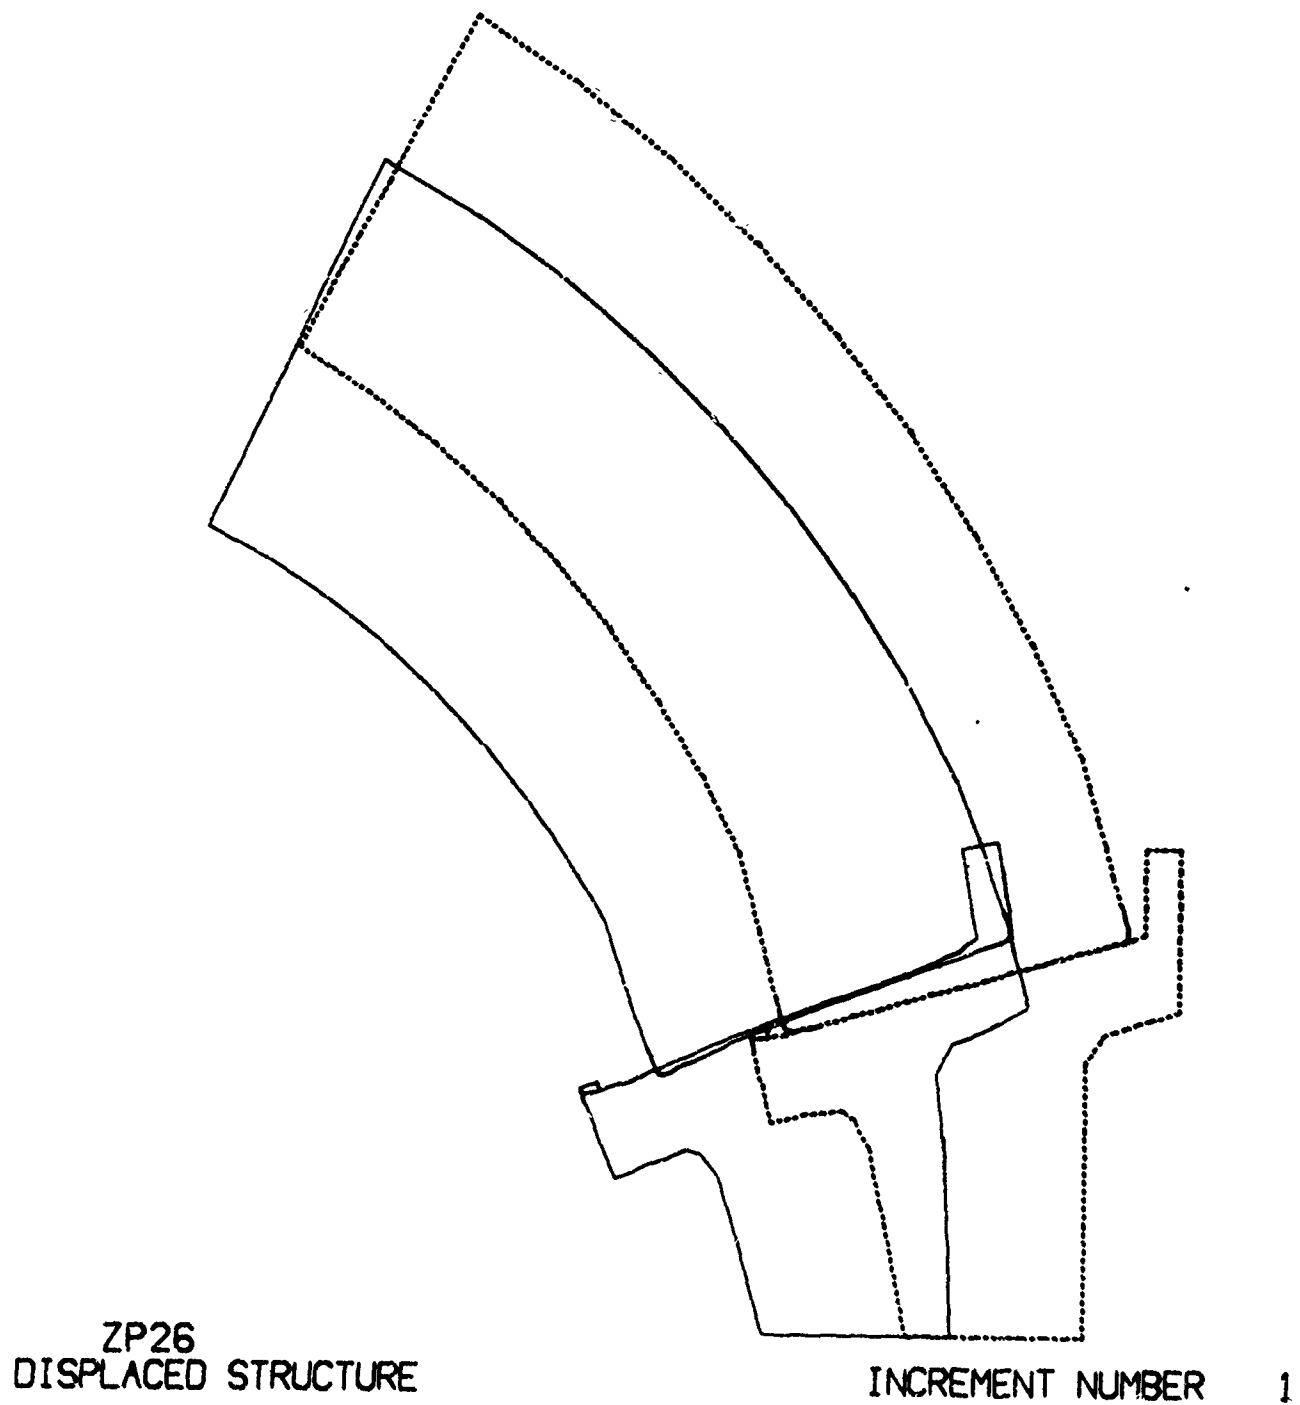
Figure 2. Finite element stress analysis of the NUC window-flange assembly subjected to external hydrostatic pressure; a glass window was supported by a Monel K-500 flange on an epoxy-coated PRD-49 cloth gasket. (sheet 2 of 10)

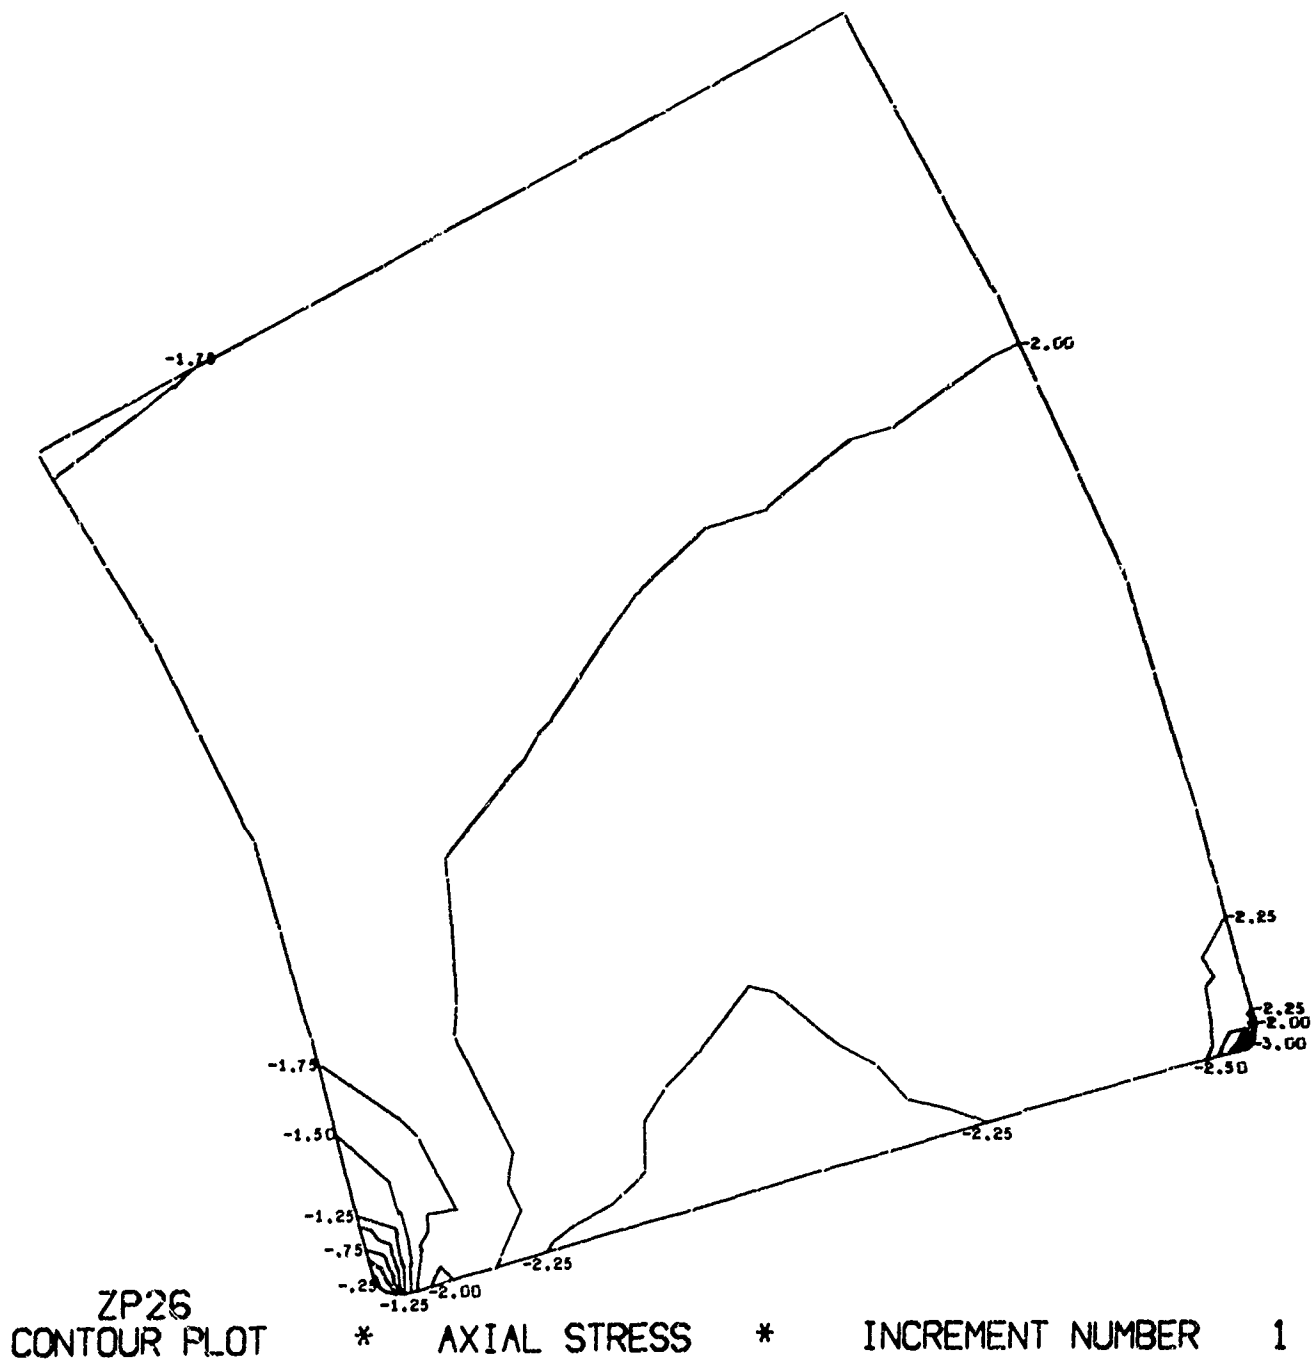
Figure 2. Finite element stress analysis of the NUC window-flange assembly subjected to external hydrostatic pressure; a glass window was supported by a Monel K-509 flange on an epoxy-coated PRD-49 cloth gasket. (sheet 8 of 10)

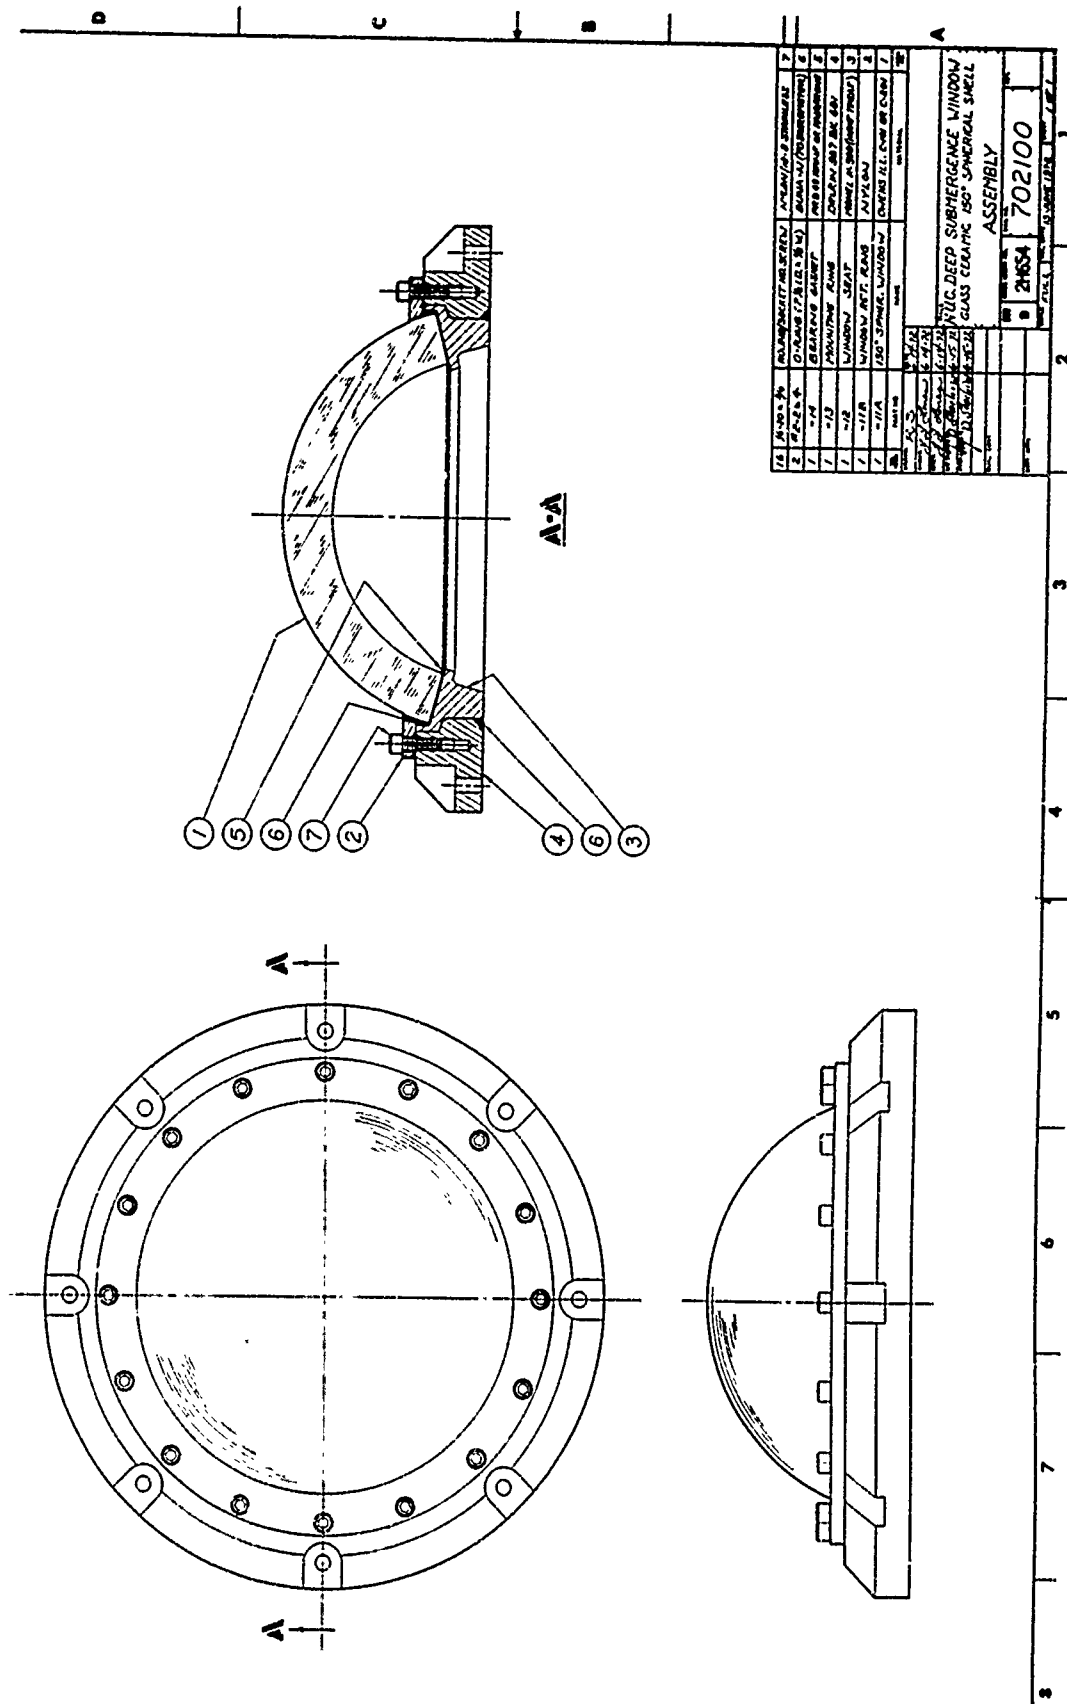
Figure A.11. Scale drawing of the window-flange subsystem.

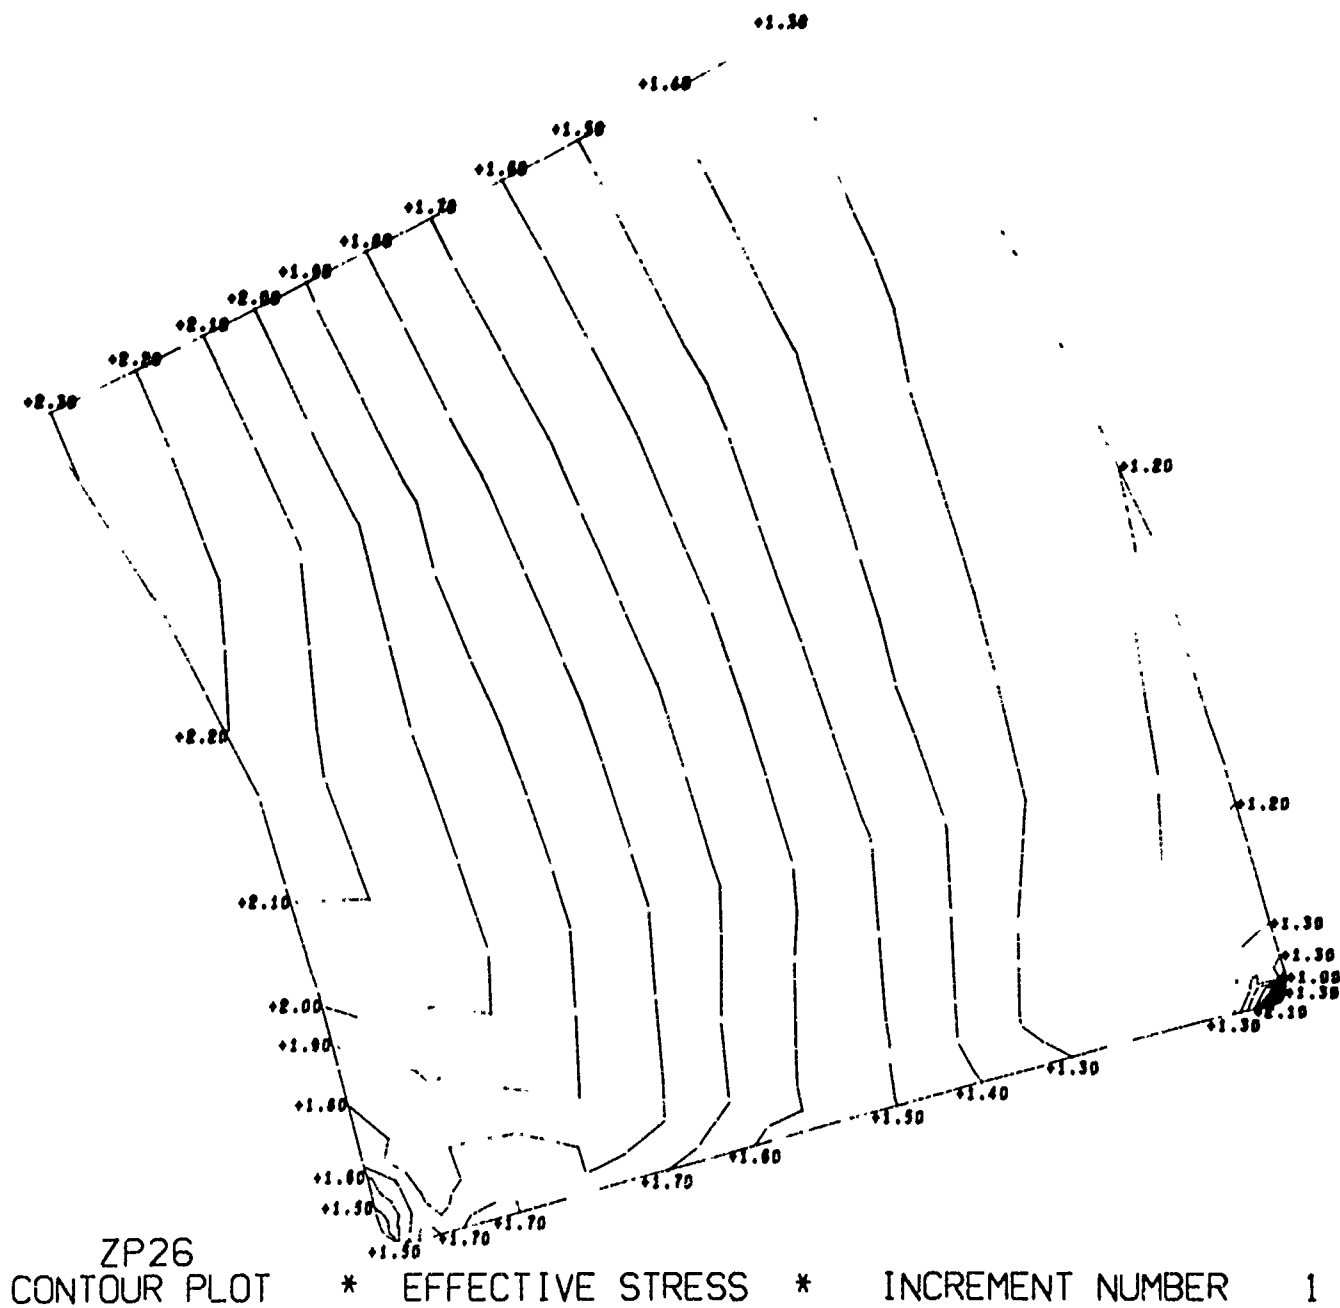
Figure B.5. Magnitude and distribution of stresses in window-flange assembly Configuration A utilizing a steel flange, fiber-reinforced-epoxy gasket, and glass ceramic window (problem 102). (sheet 2 of 7)

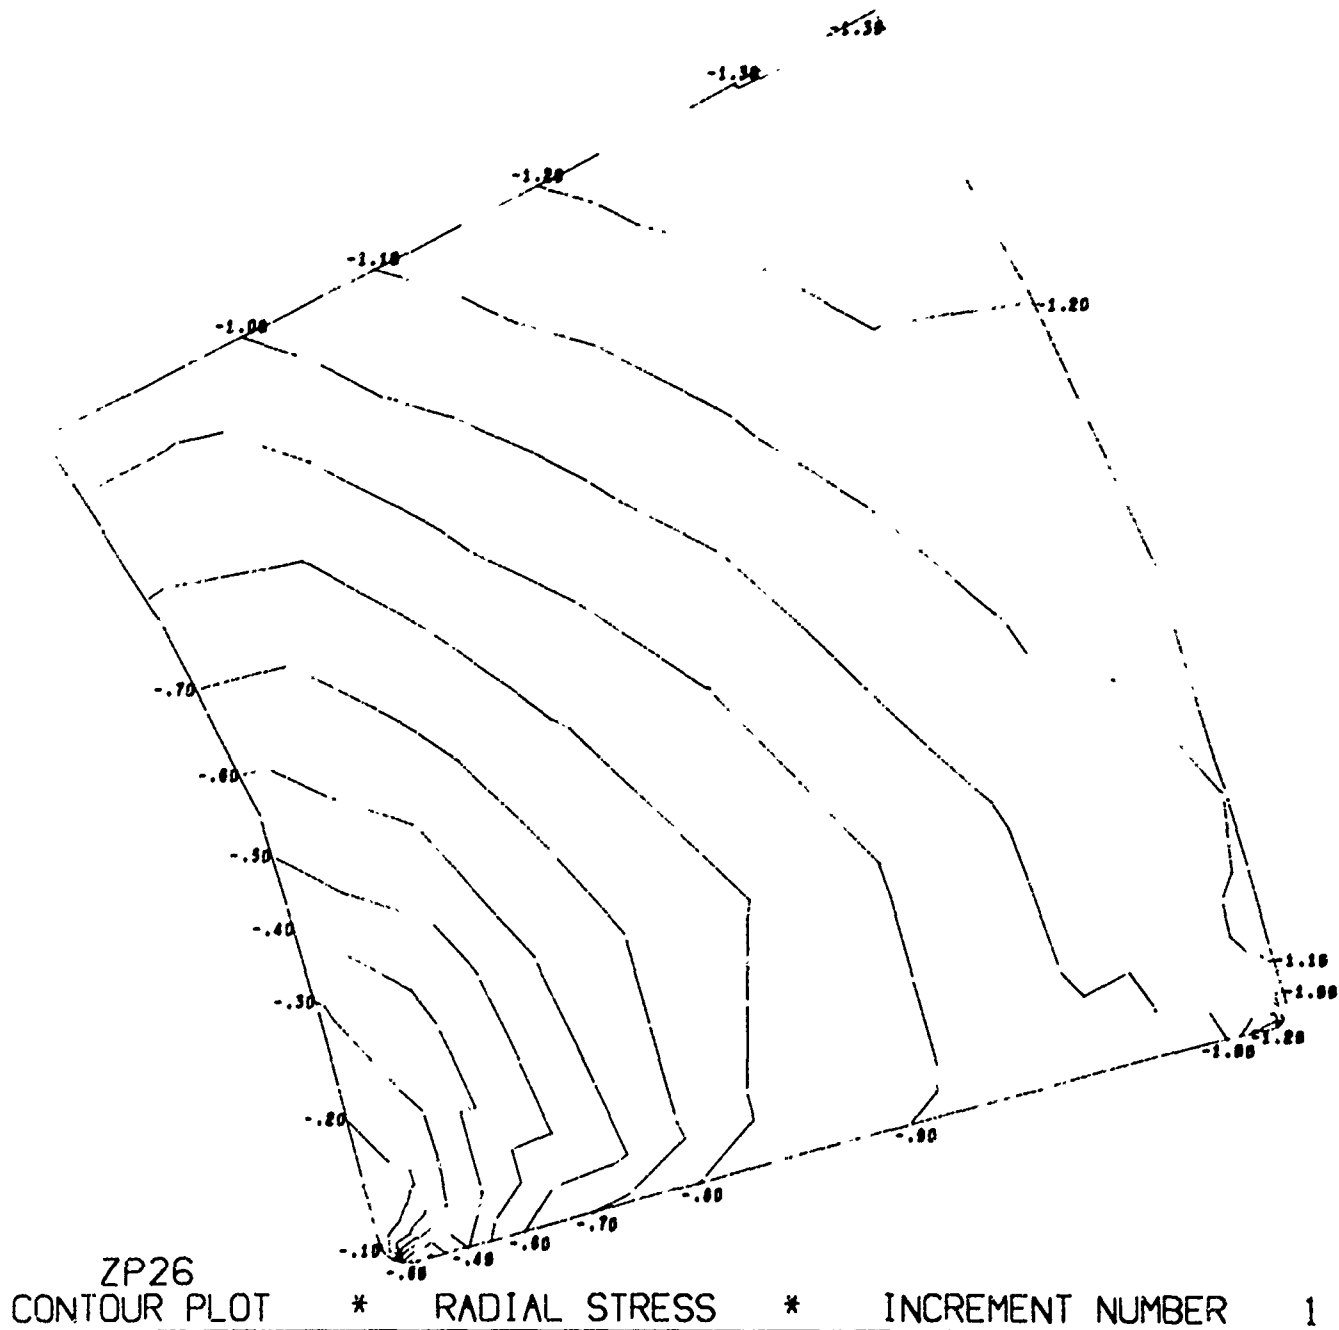
Figure B.5. Magnitude and distribution of stresses in window-flange assembly Configuration A utilizing a steel flange, fiber-reinforced-epoxy gasket, and glass ceramic window (problem 102). (sheet 6 of 7)

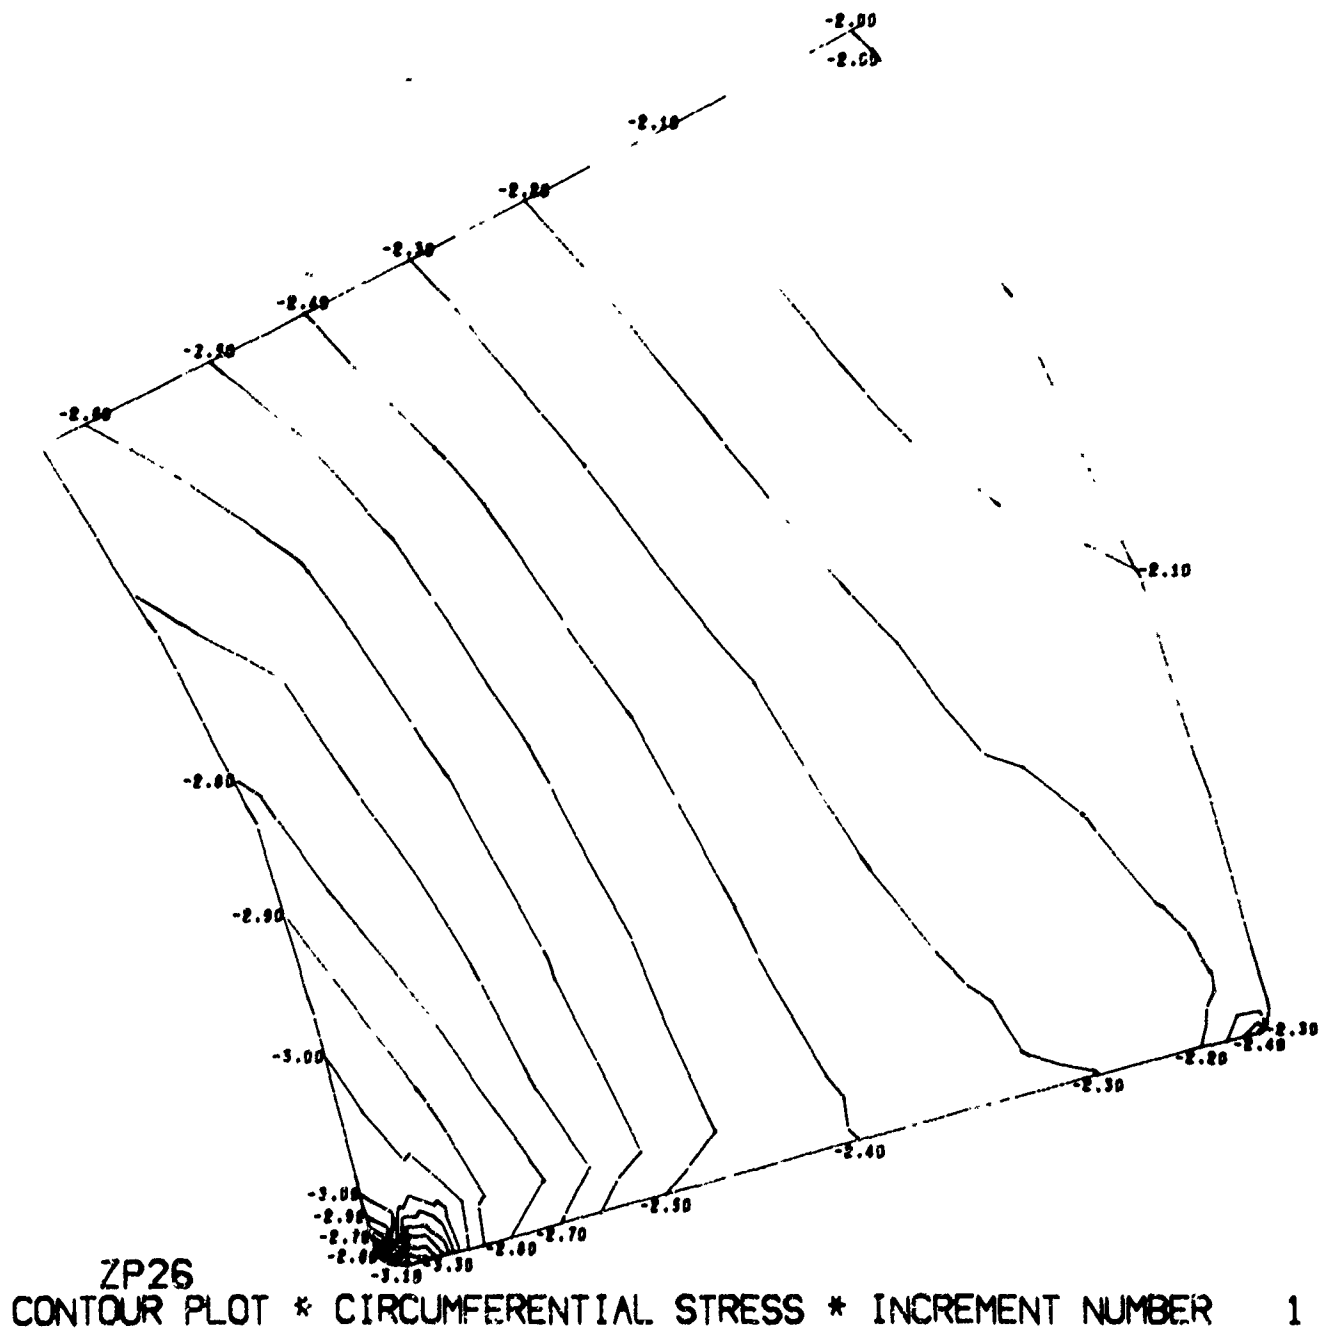
Figure B.8. Magnitude and distribution of stresses in window-flange assembly Configuration B, utilizing a glass-reinforced-plastic flange and glass ceramic window (problem 204). (sheet 4 of 8)

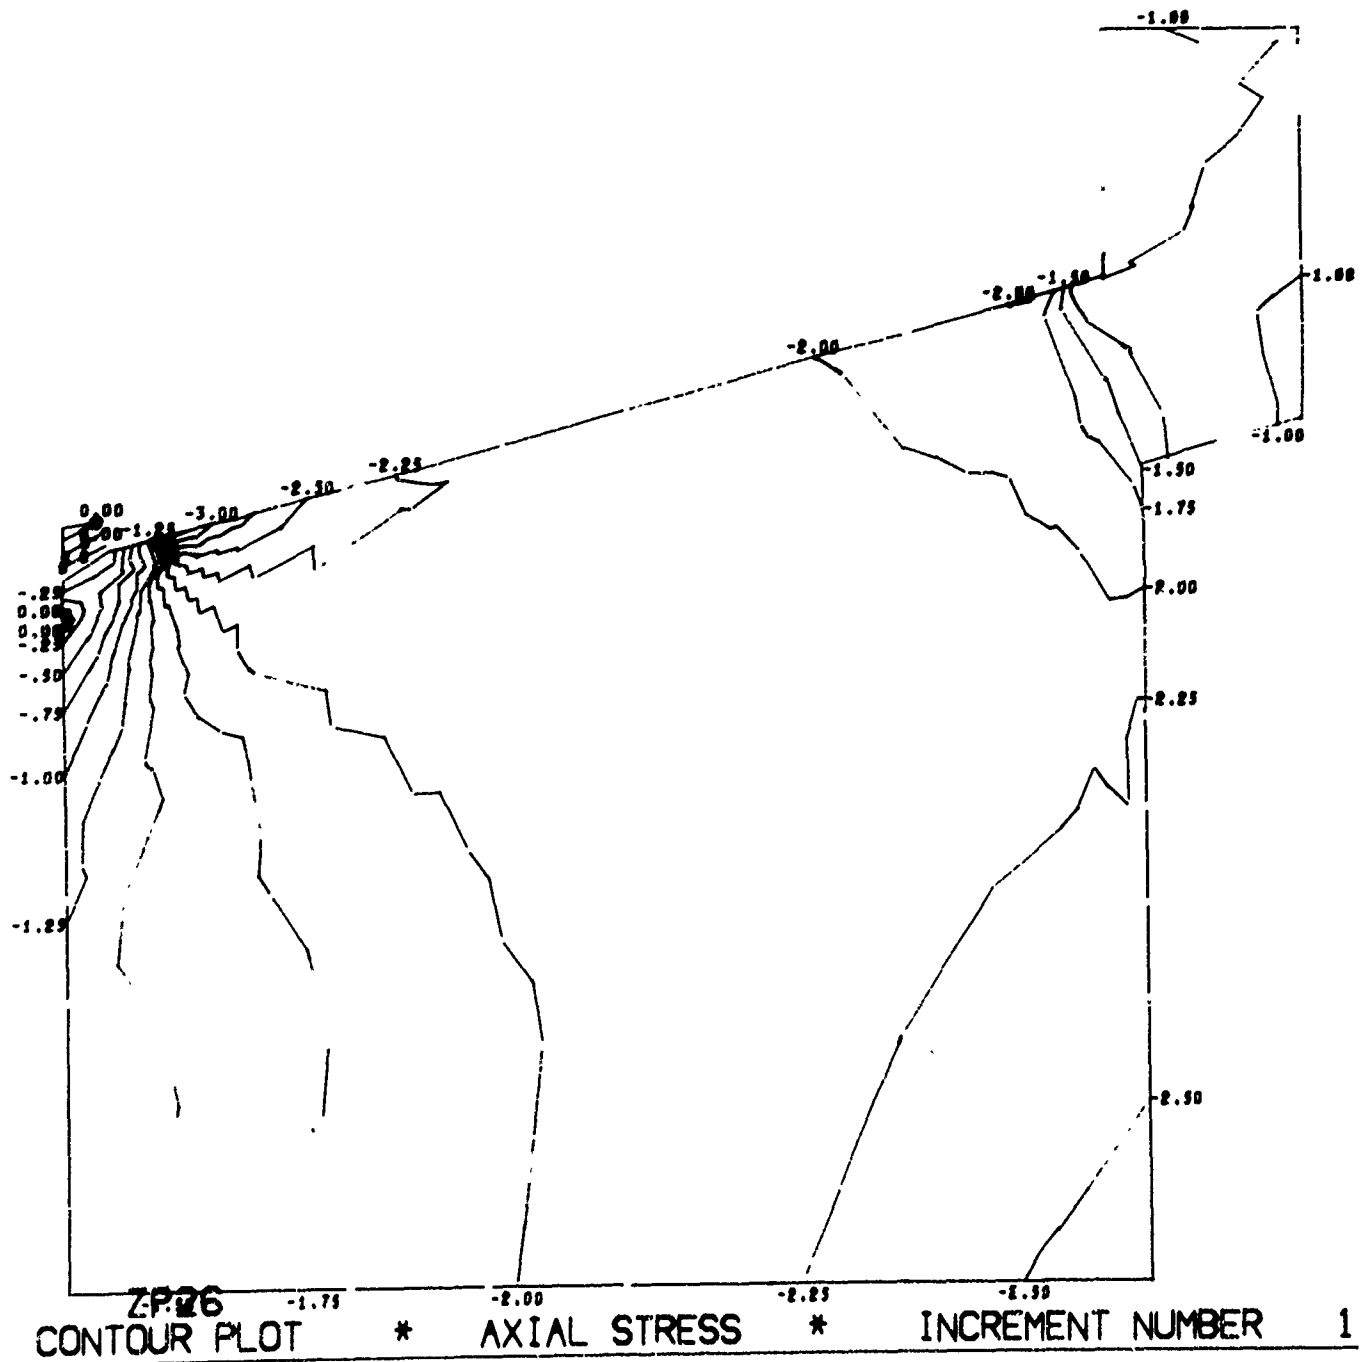
Figure B.9. Magnitude and distribution of stress in window-flange assembly Configuration B utilizing an aluminum flange, fiber-reinforced-epoxy gasket, and glass ceramic window (problem 203). (sheet 2 of 8)

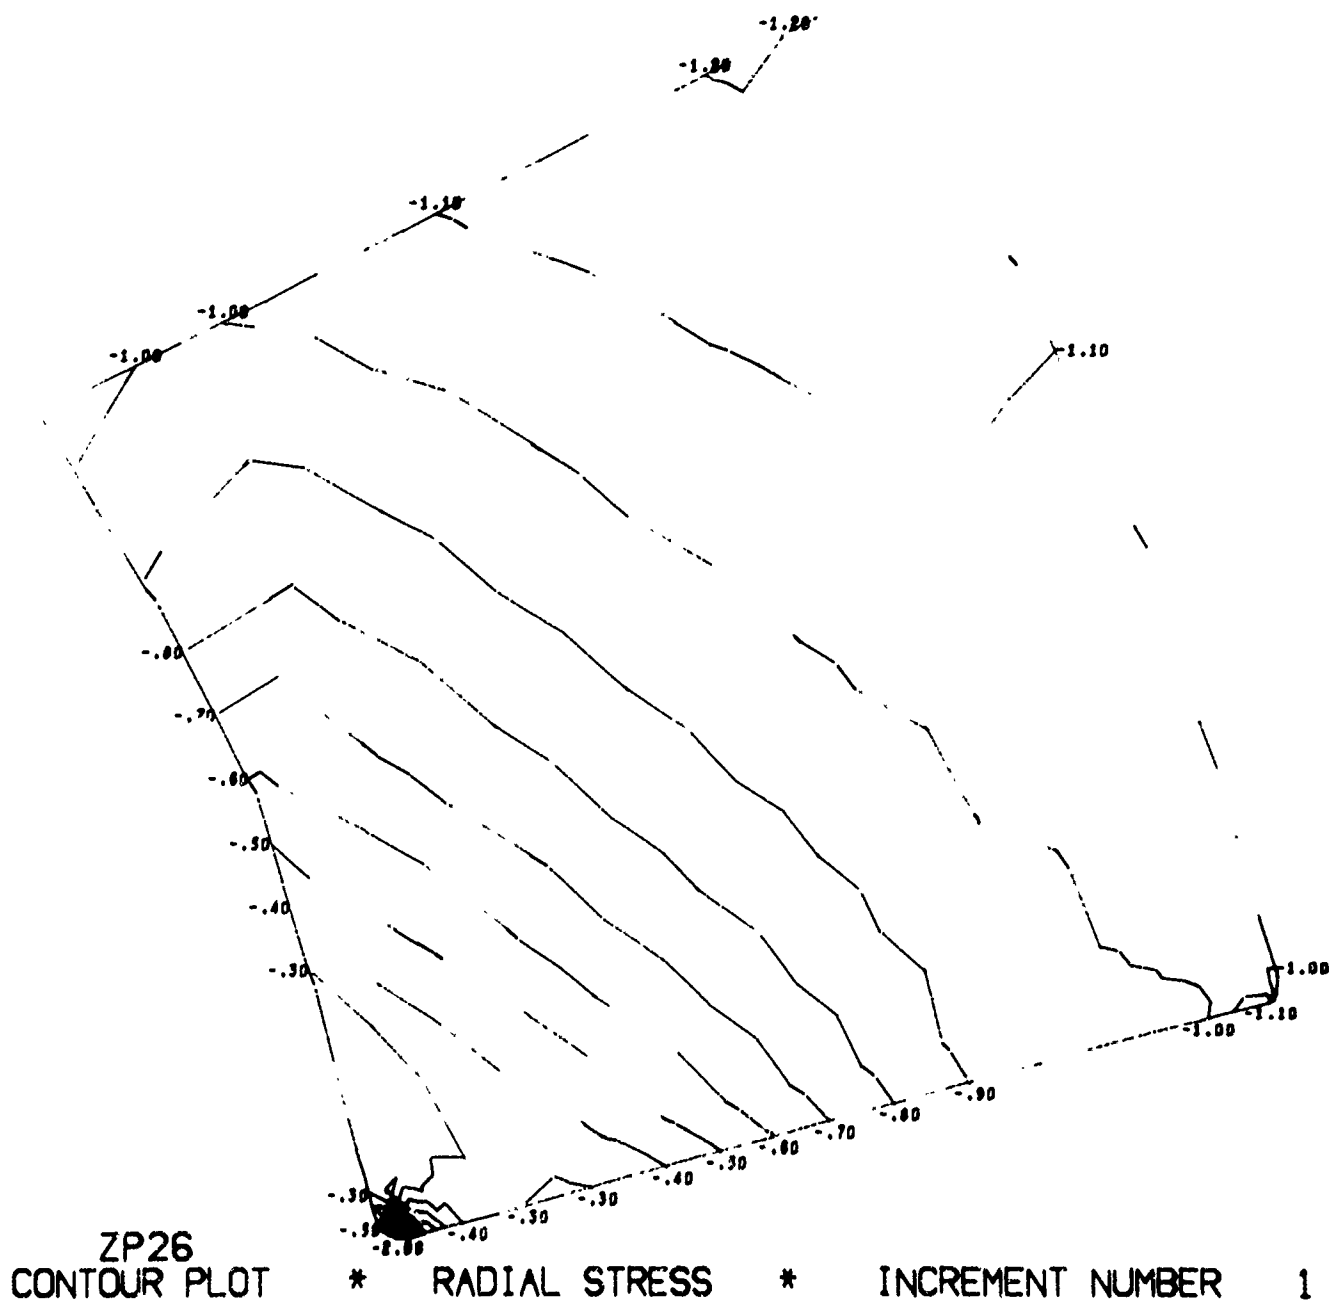
Figure B.9. Magnitude and distribution of stress in window-flange assembly Configuration B utilizing an aluminum flange, fiber-reinforced-epoxy gasket, and glass ceramic window (problem 203). (sheet 3 of 8)

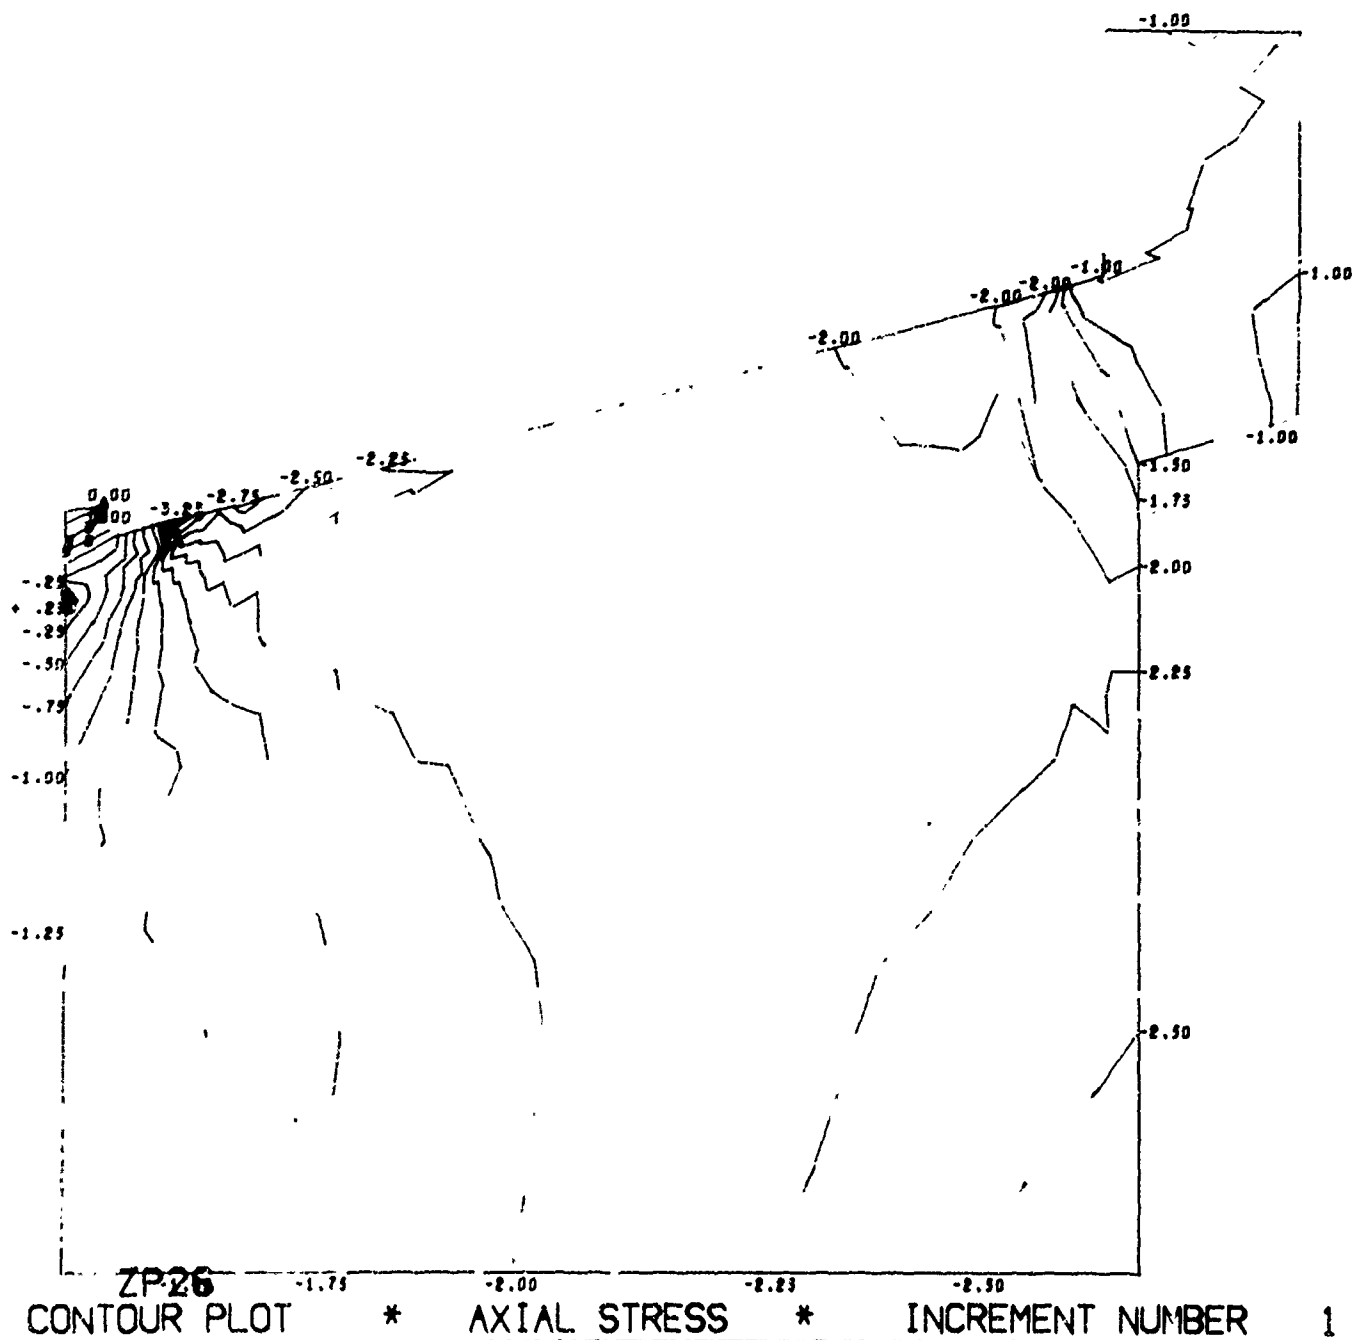
Figure B.10. Magnitude and distribution of stress in window-flange assembly Configuration B utilizing a titanium flange, fiber-reinforced-epoxy gasket, and glass ceramic window (problem 202). (sheet 2 of 8)

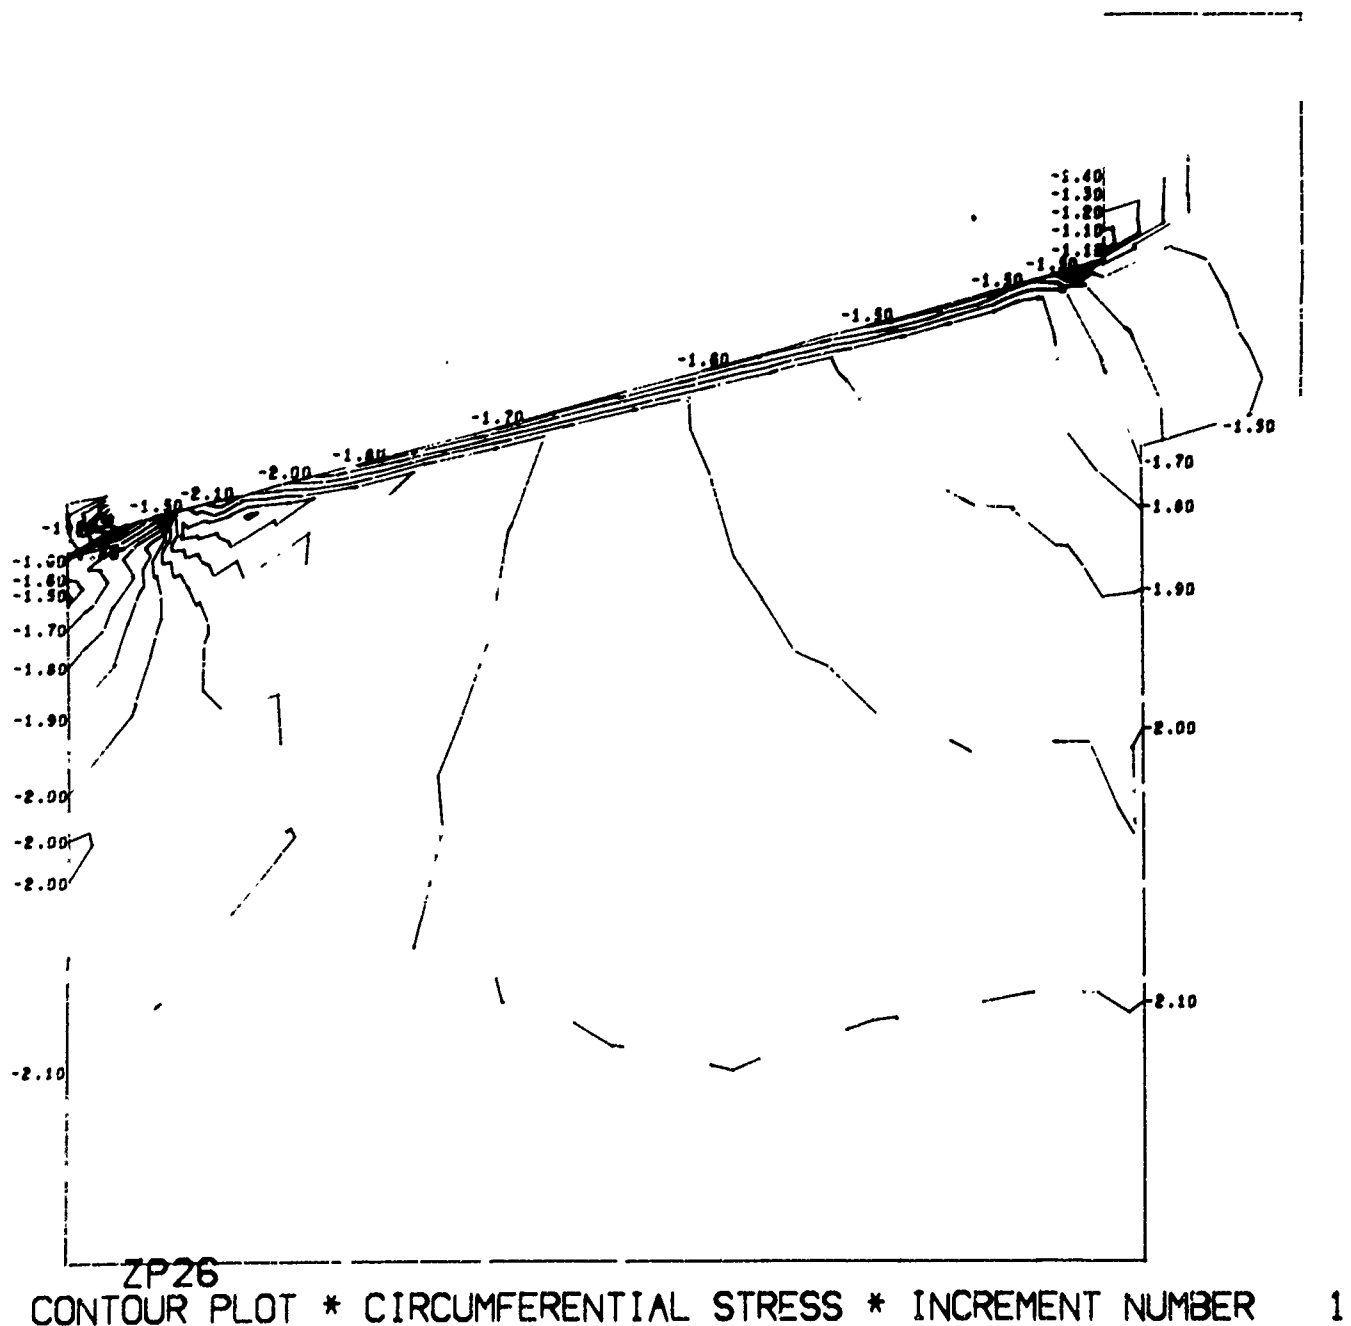
Figure B.10. Magnitude and distribution of stress in window-flange assembly Configuration B utilizing a titanium flange, fiber-reinforced-epoxy gasket, and glass ceramic window (problem 202). (sheet 6 of 8)

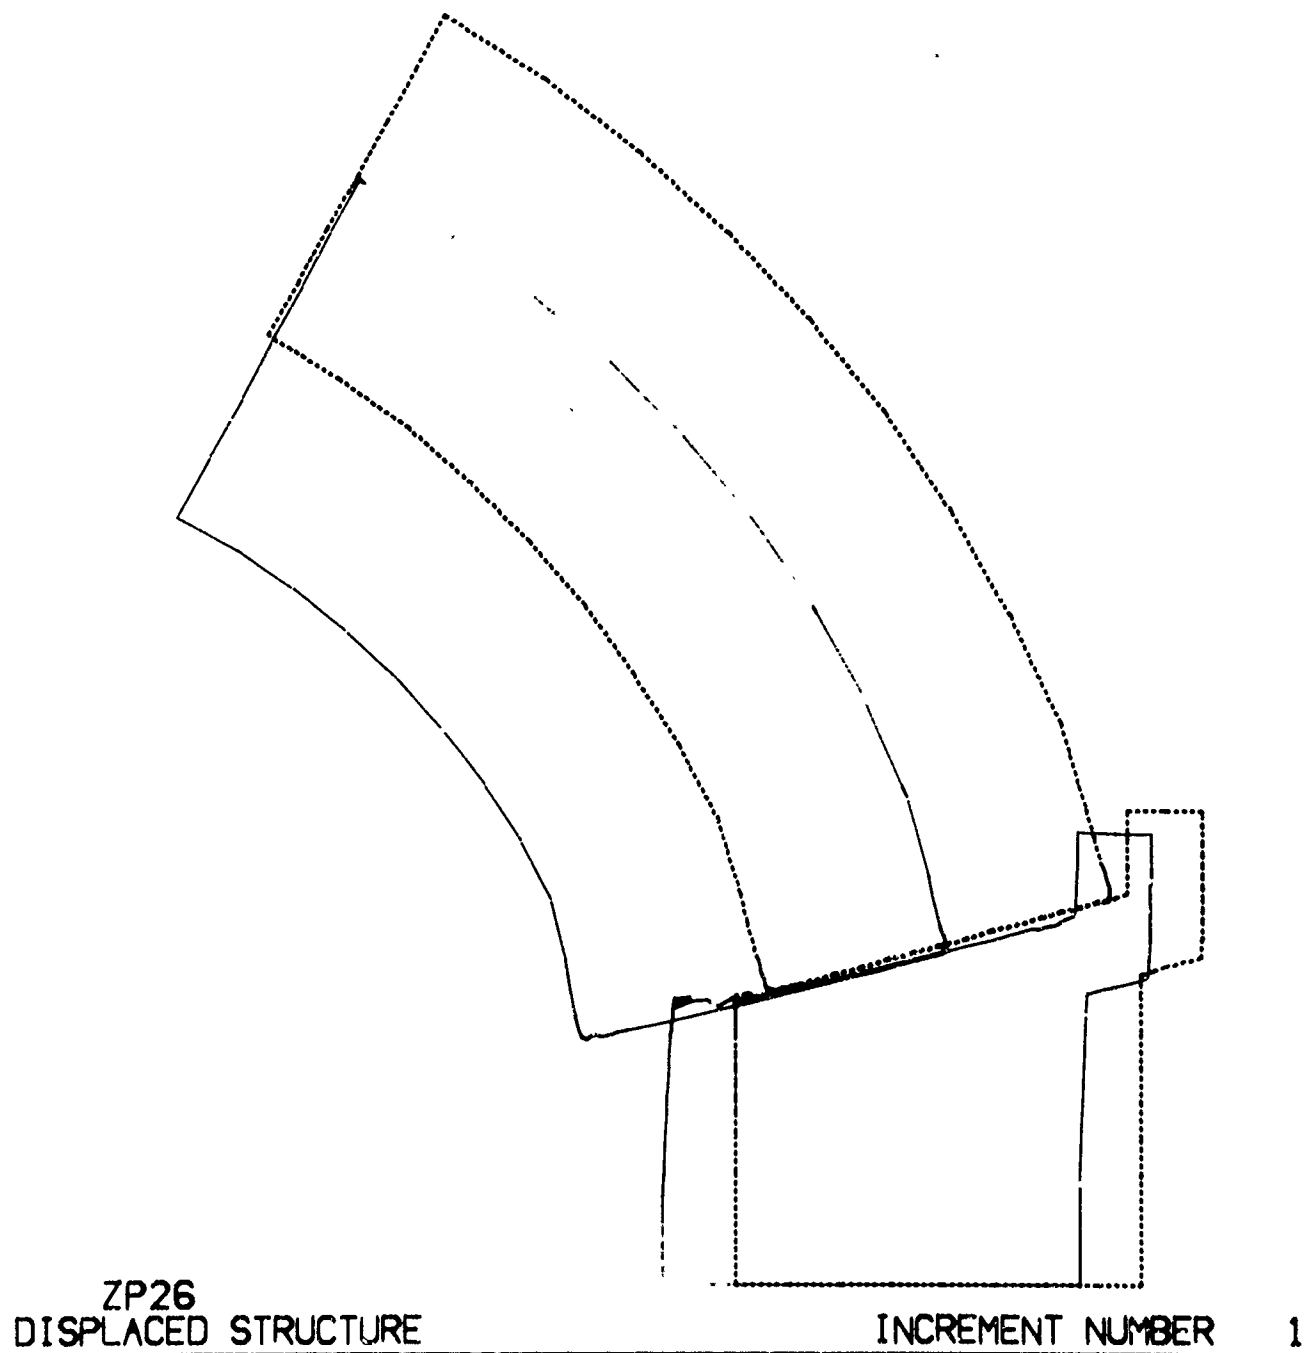
Figure B.11. Radial displacements of window and flange in Configuration B under external hydrostatic loading: problem 201, ceramic on steel.
