GLASS OR CERAMIC SPHERICAL-SHELL  
WINDOW ASSEMBLY FOR 20,000-PSI  
OPERATIONAL PRESSURE

Jerry D. Stachiw

Naval Undersea Center  
San Diego, California

May 1974

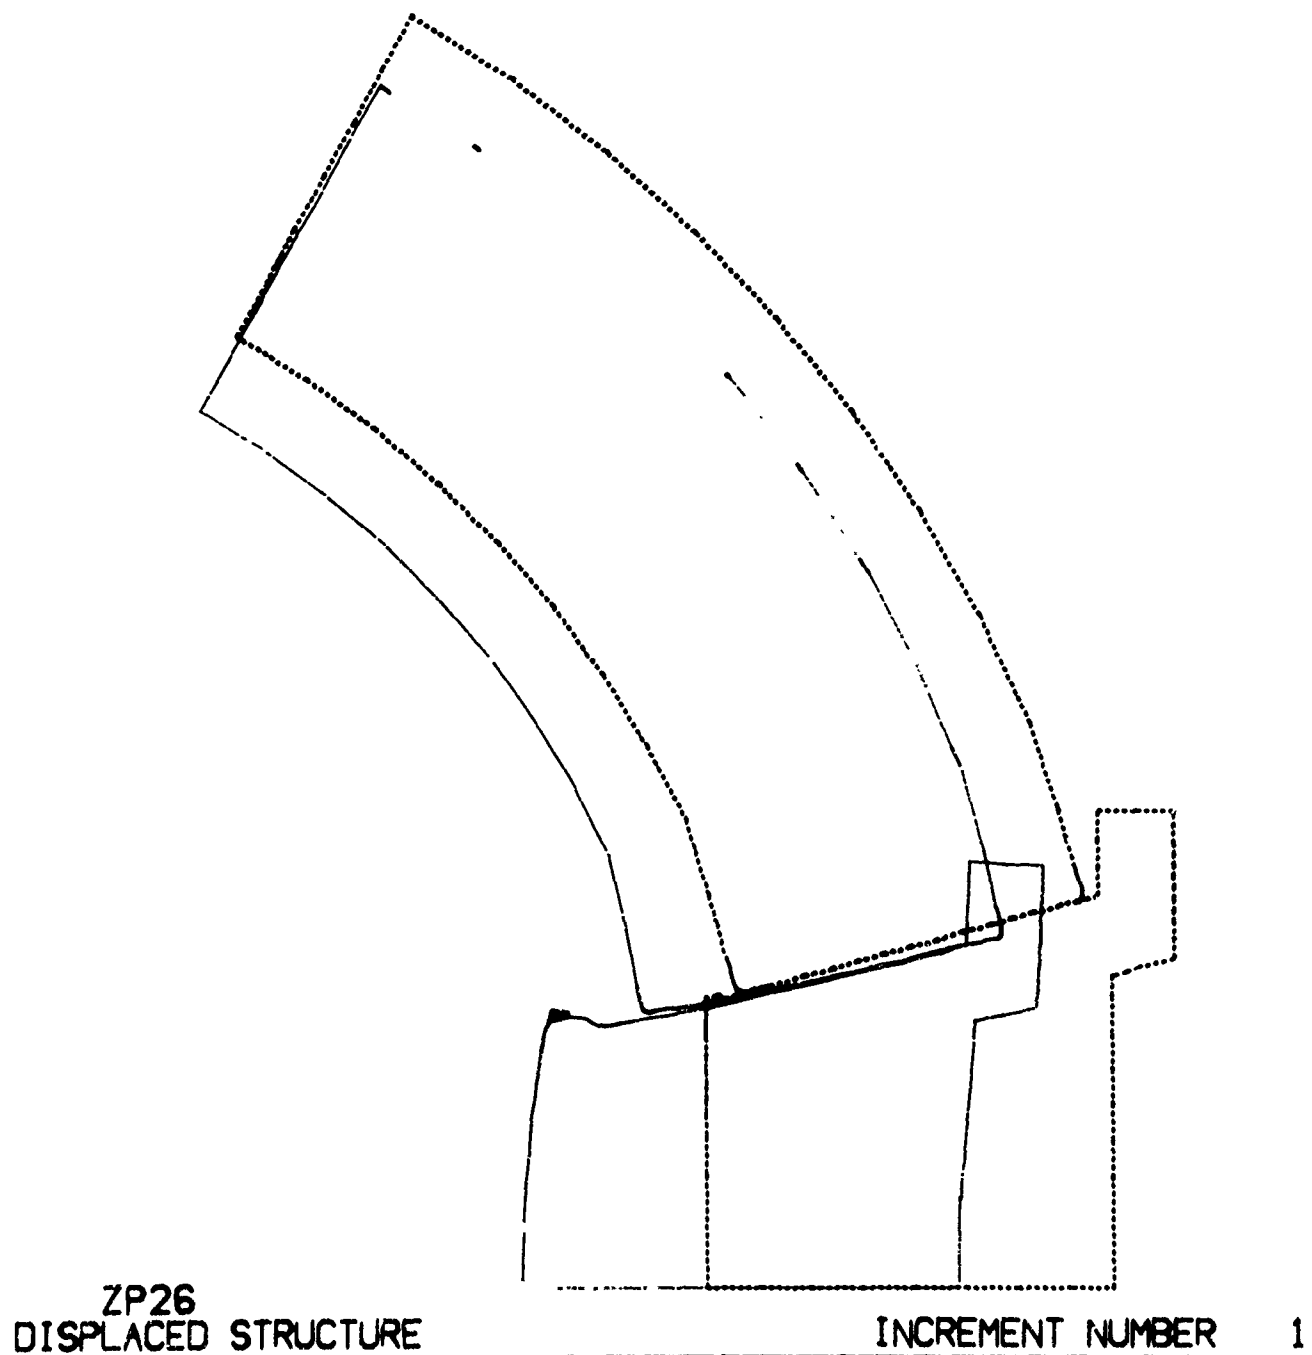
Figure B.11. Radial displacements of window and flange in Configuration B under external hydrostatic loading: problem 204, ceramic on glass-reinforced plastic.

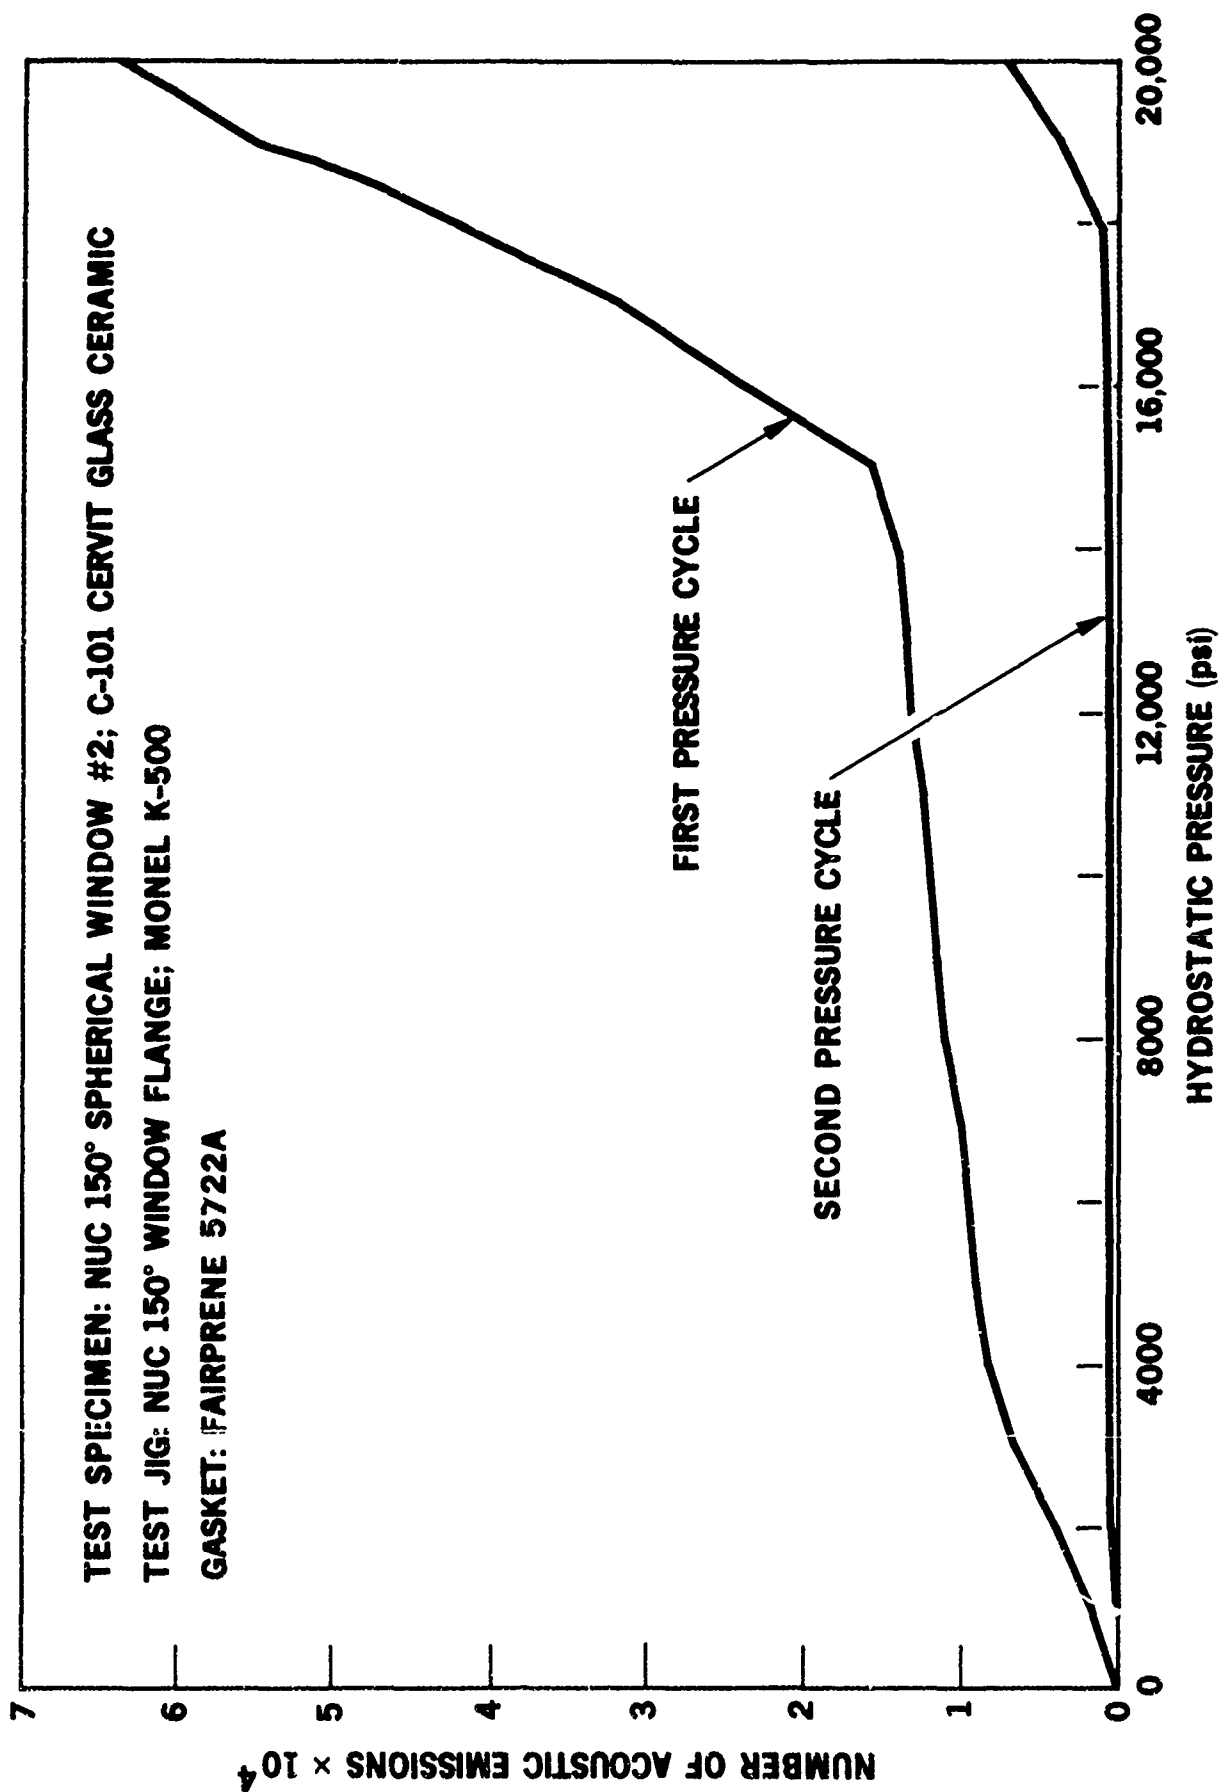
Figure D.1. Cumulative number of acoustic emissions generated by a C-101 glass ceramic, spherical window in NUC 150-degree conical flange seat when subjected to succeeding pressurizations from 0 to 20,000 psi.

Acoustic emissions (Appendix D) recorded during several pressurizations of Cer-Vit C-101 and SSC-201 windows to a pressure of 20,000 psi indicate that C-101 ceramic is a good acoustic emitter while SSC-201 glass is a very poor one.

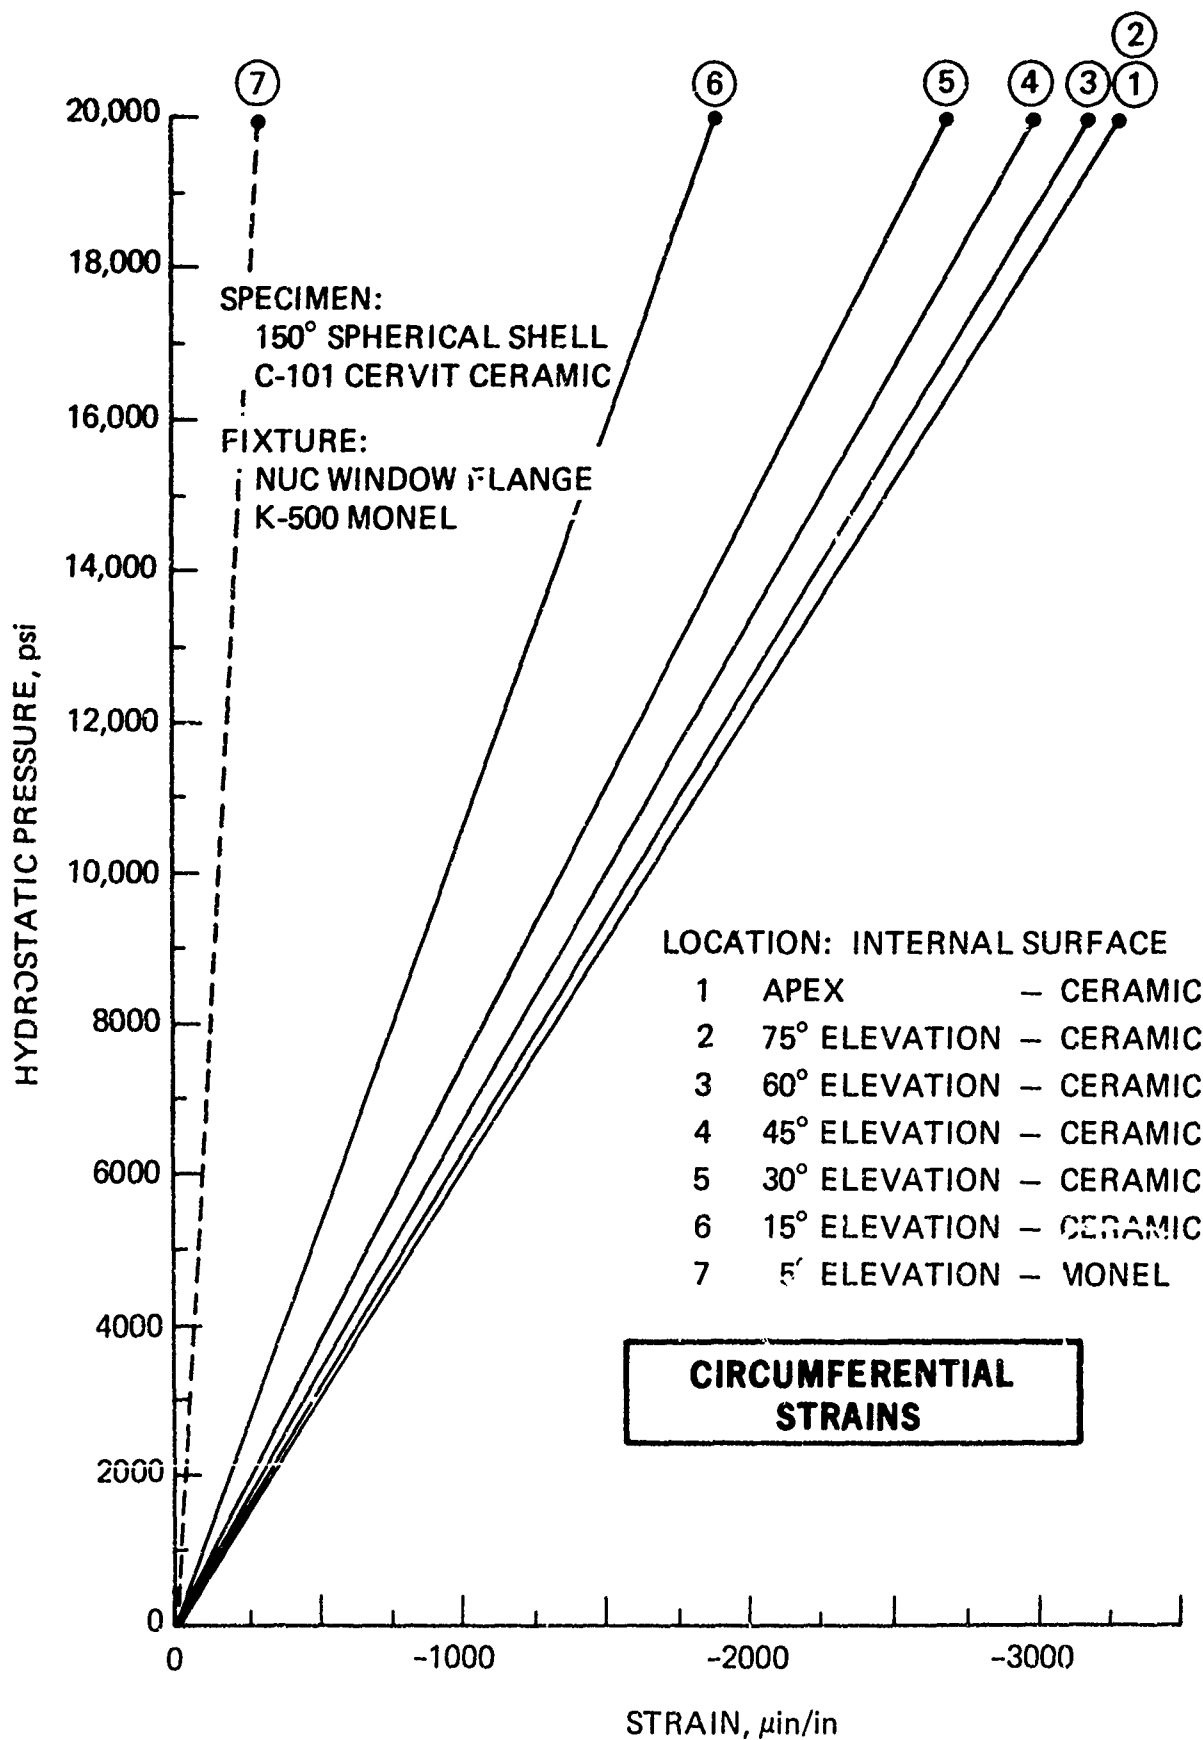
Figure E.1. Comparison of circumferential strains in Cer-Vit C-101 window and Monel K-500 flange.

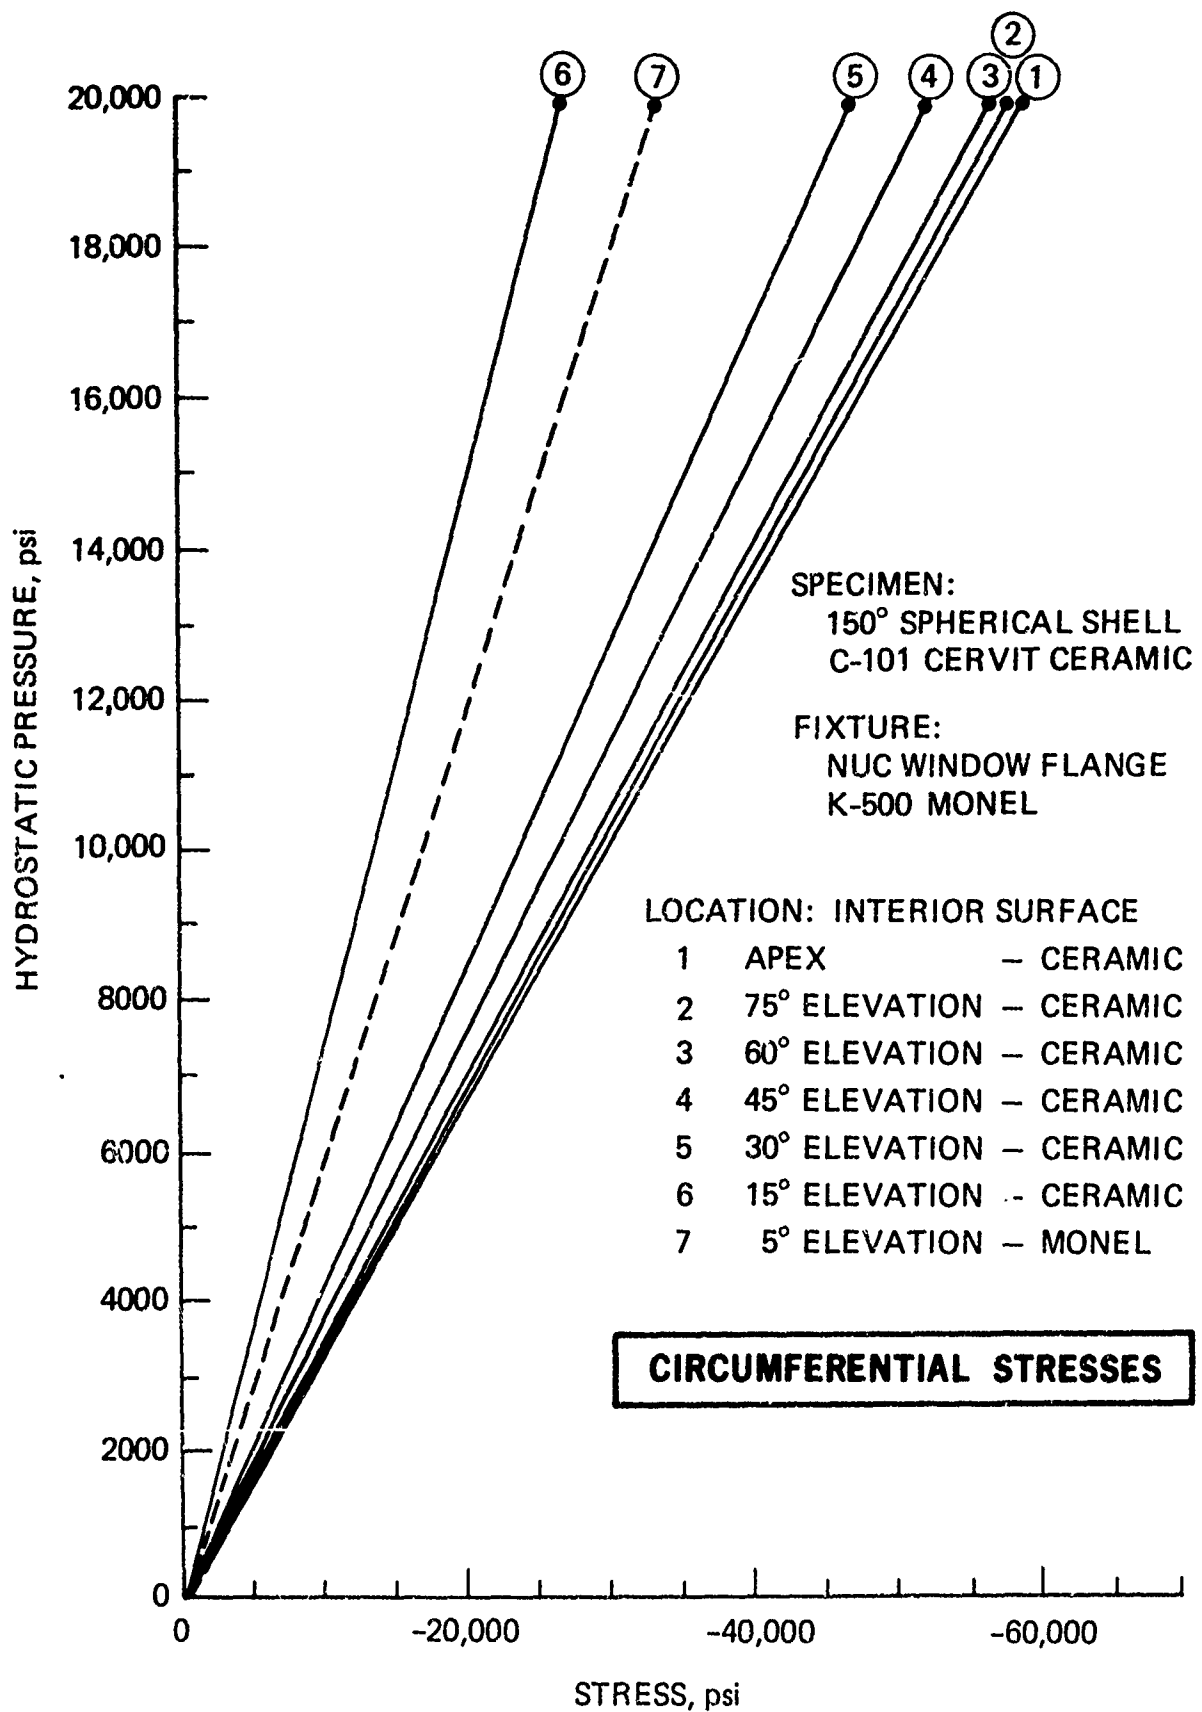
Figure E.3. Experimentally generated stresses in Cer-Vit C-101 window and Monel K-500 flange.

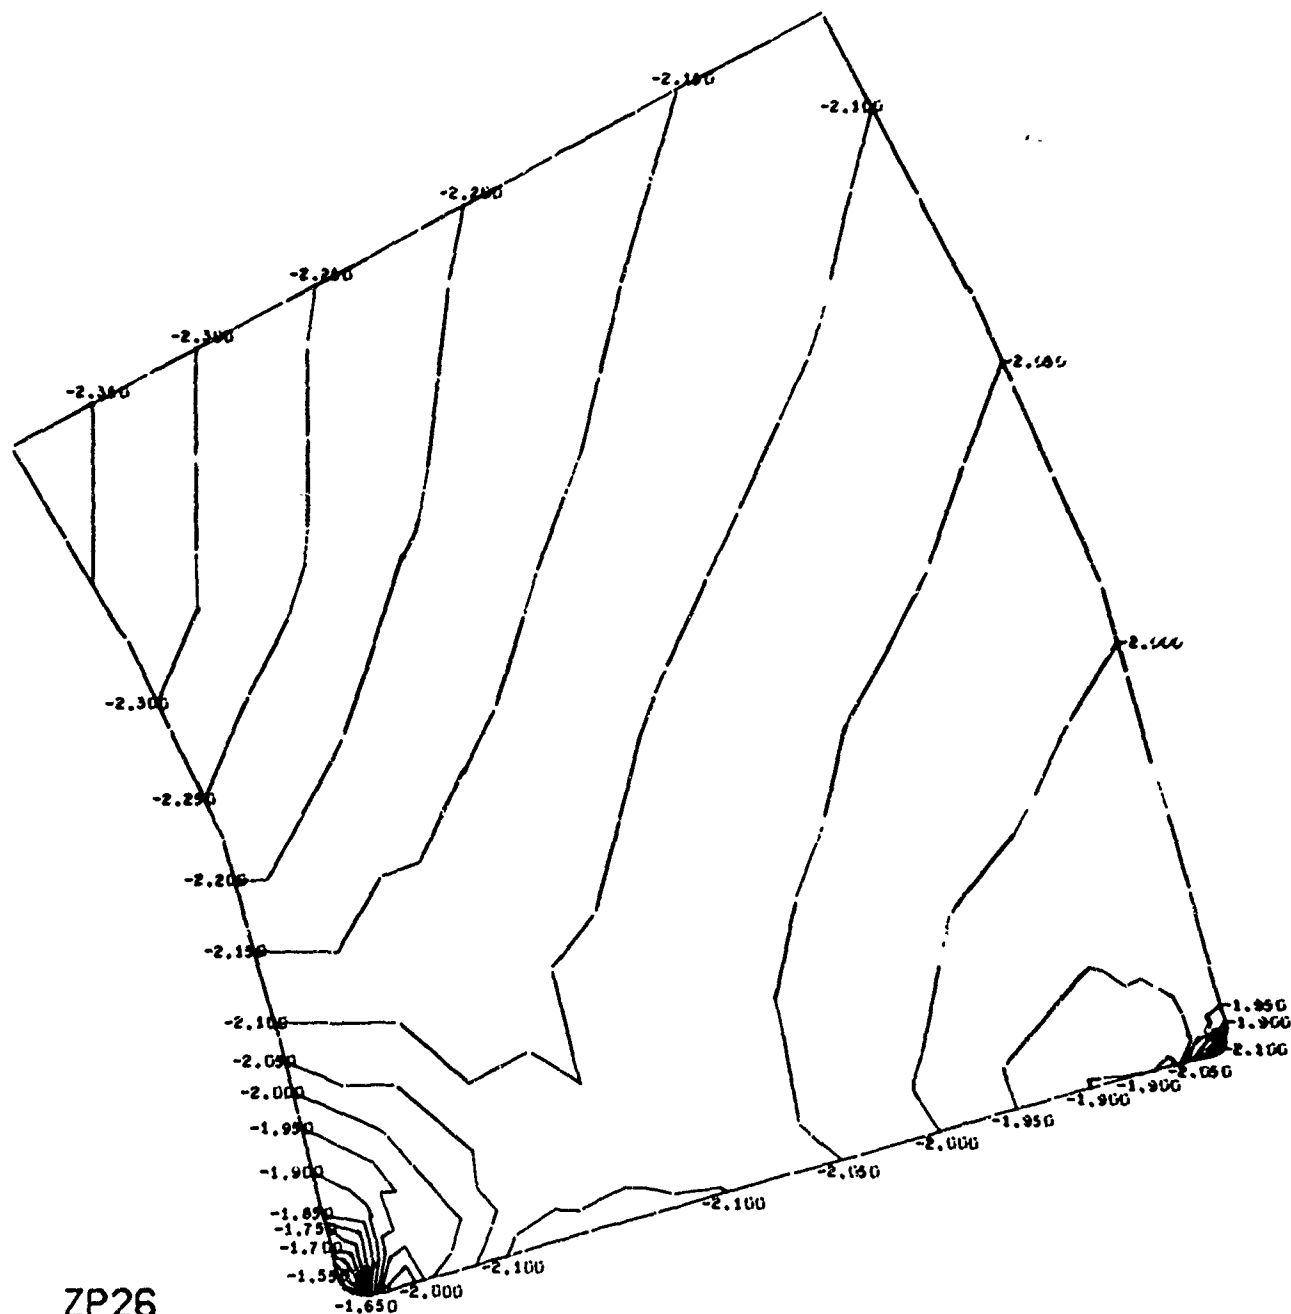
Figure E.5. Calculated circumferential stresses in Cer-Vit C-101 window and Monel K-500 flange. (sheet 2 of 2)

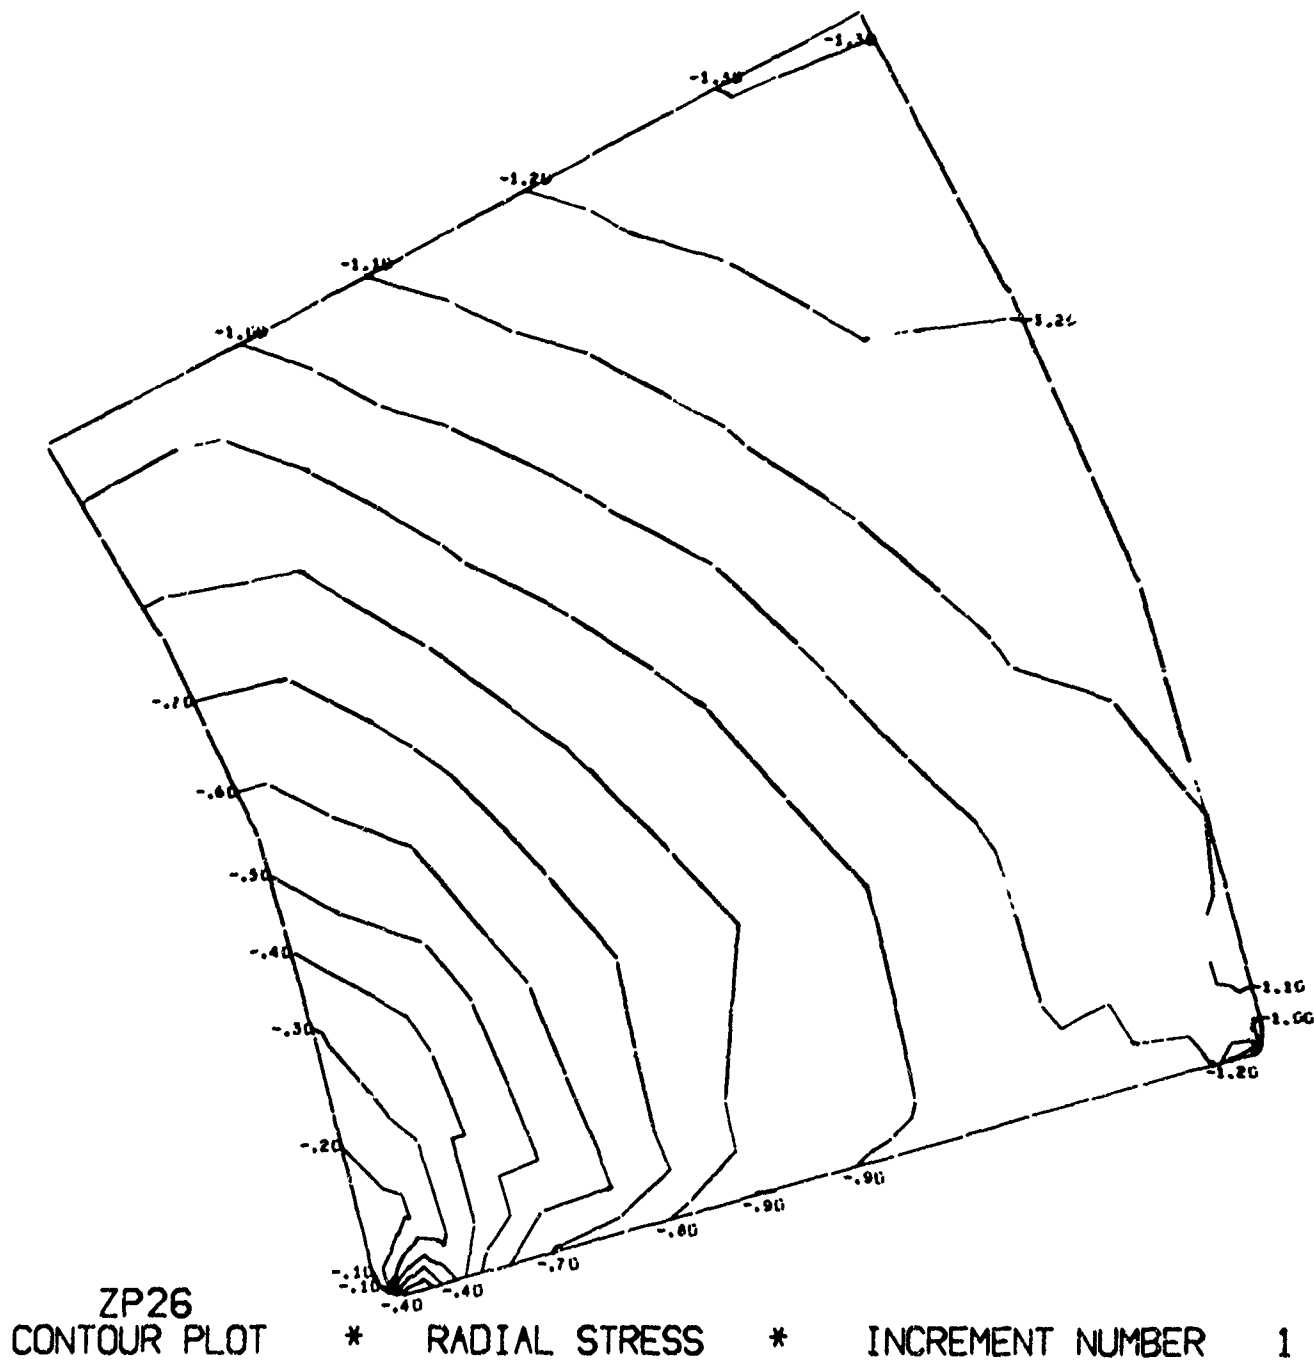
Figure E.7. Calculated radial stresses in Cer-Vit C-101 window and Monel K-500 flange. (sheet 2 of 2)

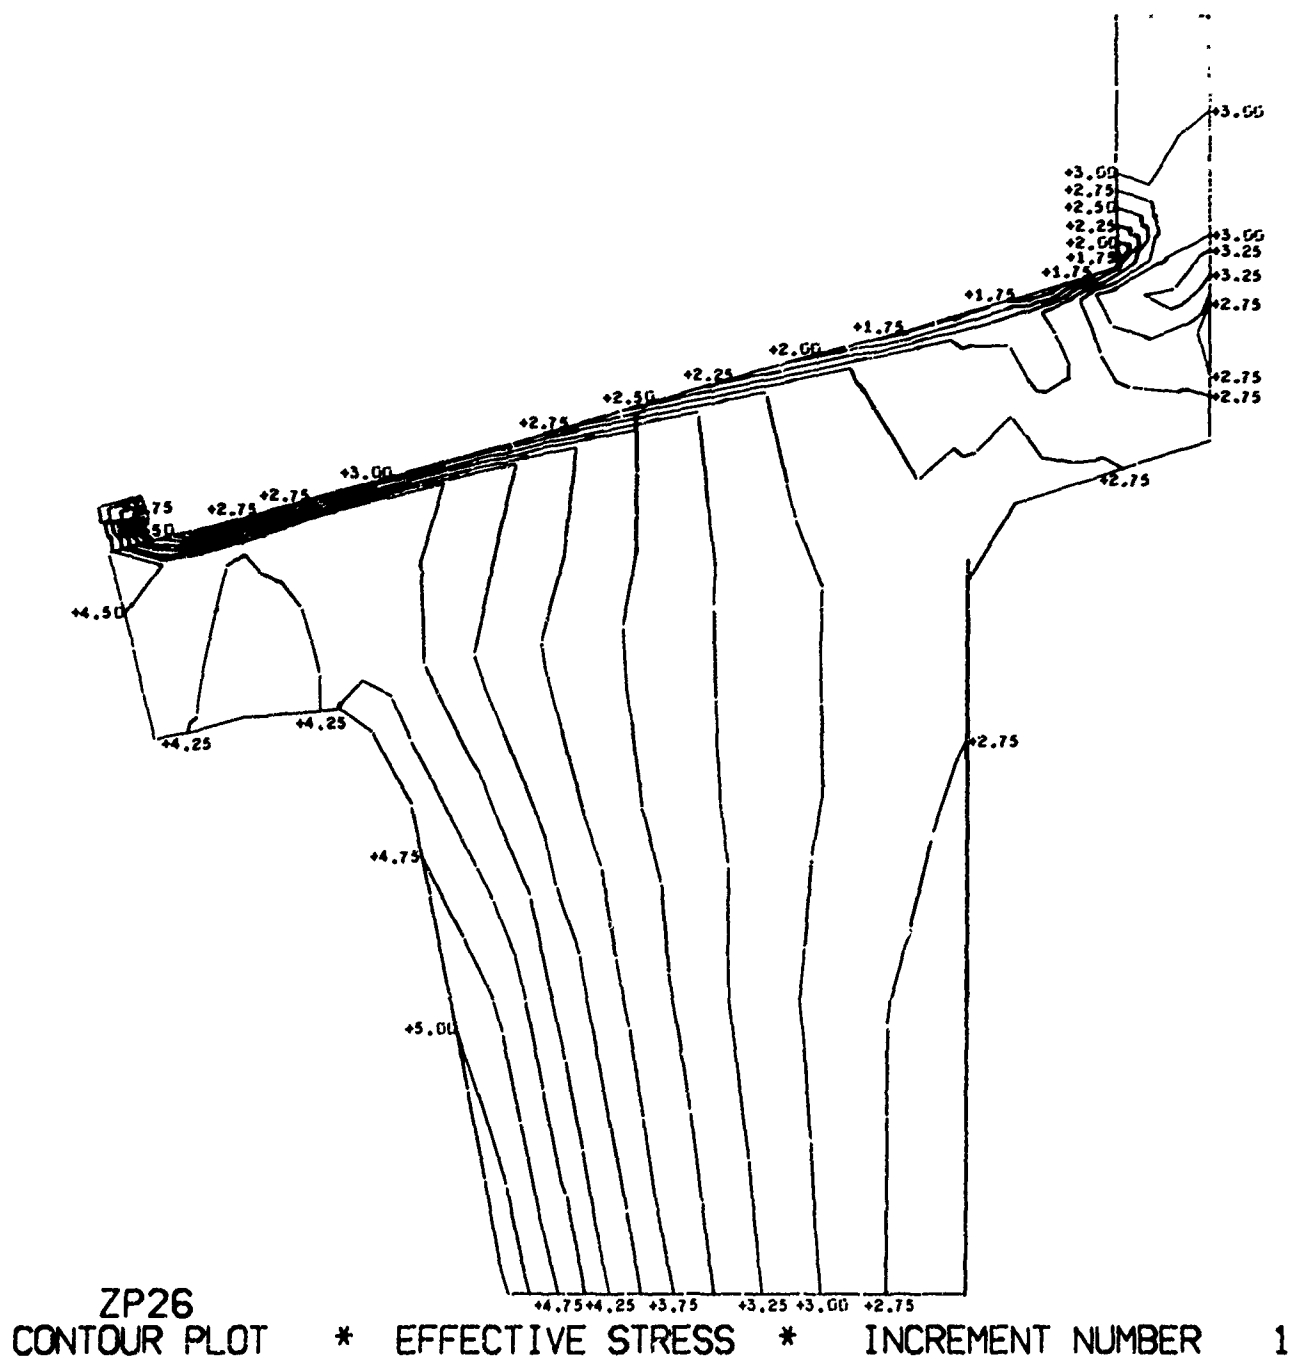
Figure E.8. Calculated effective stresses in Cer-Vit C-101 window and Monel K-500 flange. (sheet 1 of 2)
