THE APPLICABILITY OF A  
FRACTURE MECHANICS-NONDESTRUCTIVE TESTING DESIGN CRITERION

P. F. Packman, H. S. Pearson,  
J. S. Owens, and G. B. Marchese

Lockheed-Georgia Company

TECHNICAL REPORT AFML-TR-68-32

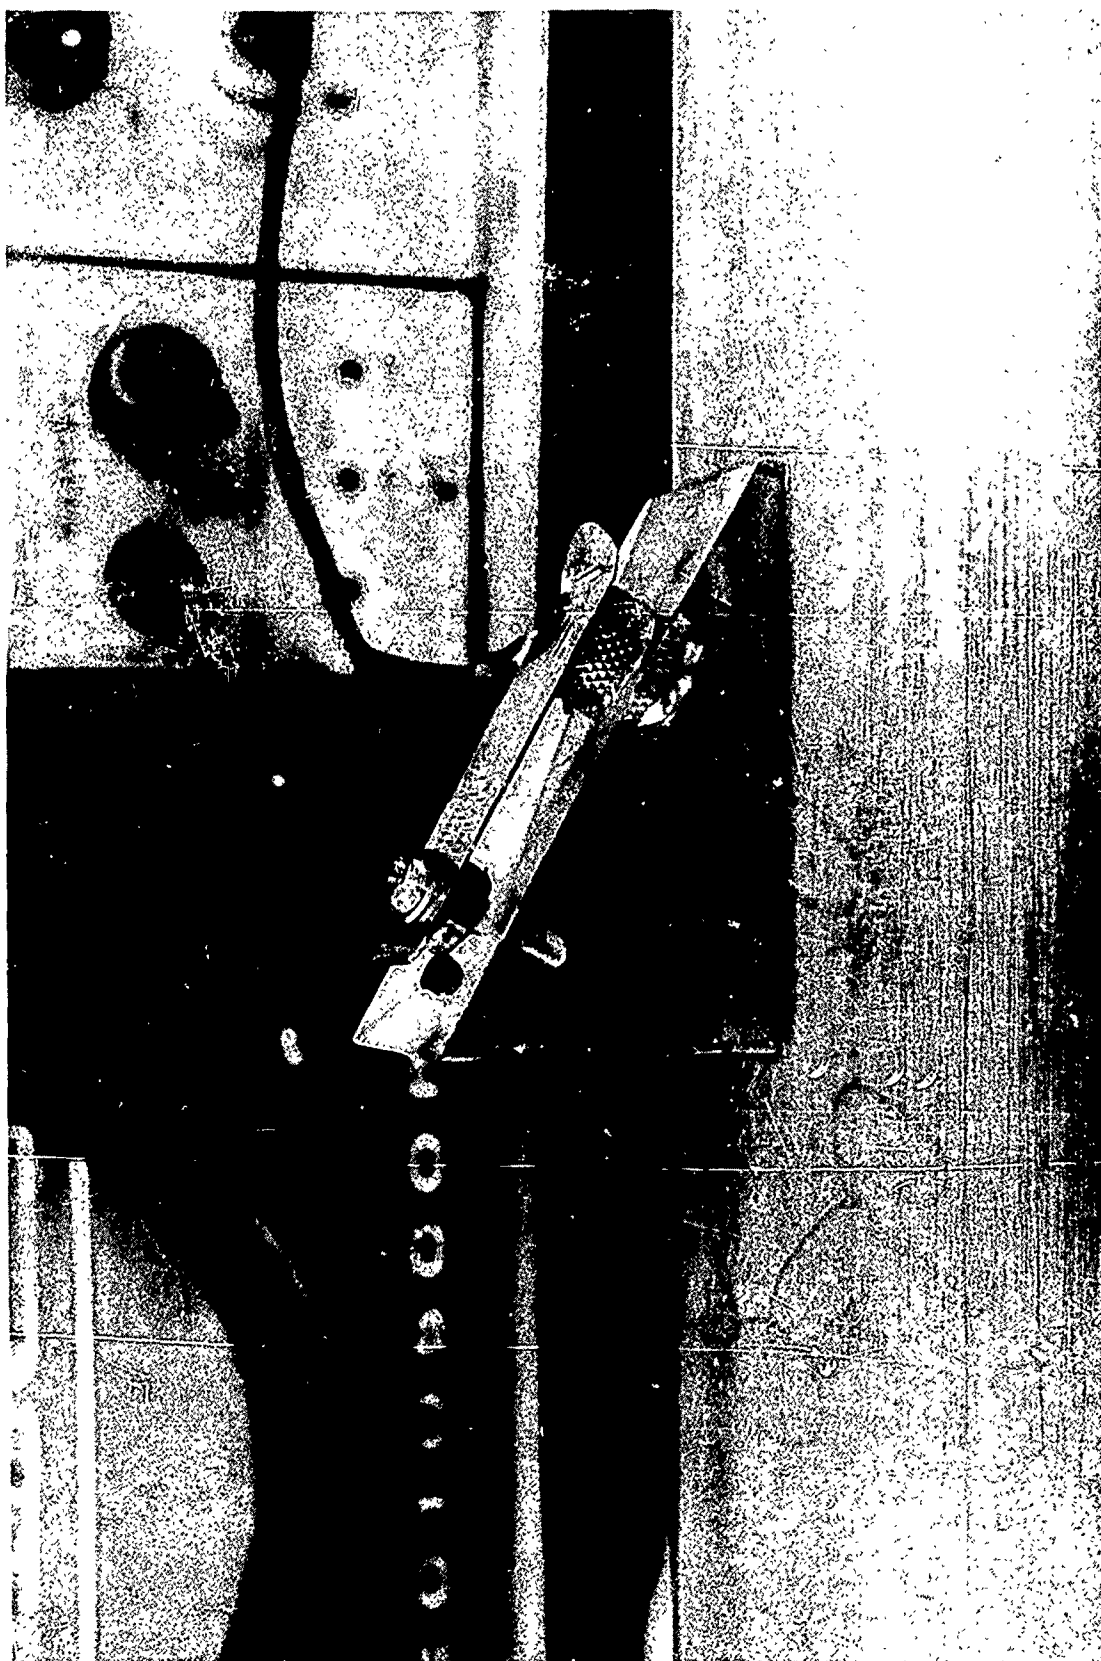
FIGURE 48 LUCITE TRANSDUCER SHOE IN PLACE ON ALUMINUM  
TEST CYLINDERS

The ultrasonic generating and detecting equipment used in this program has consisted of two separate units: The Sperry UM/700 and the UM/715 Reflectoscopes. The latter came into use when the former equipment was repaired. Essentially no difference in the results was obtained for either piece of equipment, but separate calibration curves were needed for each. Figure 49 is a photograph of the UM/715 Reflectoscope and test configuration used in this program.
