ADVANCED TURBINE ENGINE GAS GENERATOR  
CONCEPTUAL STUDIES AND FEASIBILITY  
EXPERIMENTAL TEST PROGRAM  
(UNCLASSIFIED TITLE)

Volume III: Materials Section (Table LXXV)

Frederick G. Groh  
Pratt & Whitney Aircraft Division  
United Aircraft Corporation

TECHNICAL REPORT AFAPL-TR-69-35, VOLUME III  
May 1969

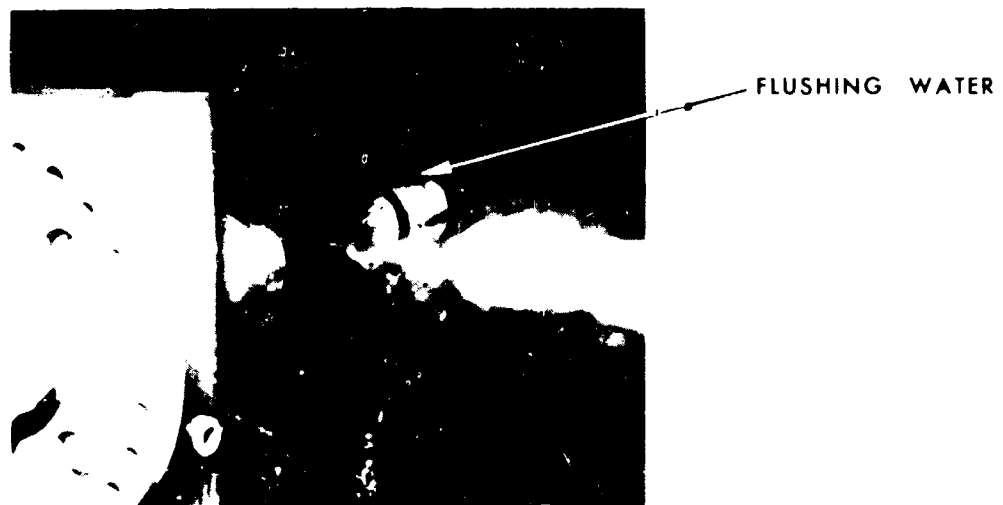
Figure 10 Closeup View of Push-Pull Low-Cycle Fatigue Specimen Being Drilled by ECID Process

(U) The ECID (electrochemical impingement drilling) process is a special application of the electrochemical machining process. In the ECM process, the cathode tube carrying the electrolyte moves through the work piece, and, therefore, the smallest hole that can be produced is limited by the outside diameter of the cathode tube. In the ECID process, this limitation is eliminated by releasing the electrolyte through a jet across a gap of 0.020 to 0.100 inch. The jet is produced by pumping the electrolyte into the nozzle at high pressure. A direct-current power supply is placed across the electrolyte and the work piece, which deplates material from the work piece. A schematic diagram of the equipment used for the process is shown in Figure 7. Figure 8 shows the appearance of the equipment at the start of the program, and Figure 9 shows the appearance of the equipment after modifications were made to permit three-dimensional positioning of the nozzle. A closeup view of a typical specimen being drilled is shown in Figure 10.
