DESIGN, DEVELOPMENT, AND FABRICATION
OF THE
FMU-63/B BOMB FUZE

HONEYWELL INC.

TECHNICAL REPORT AFATL-TR-71-157

DECEMBER 1971

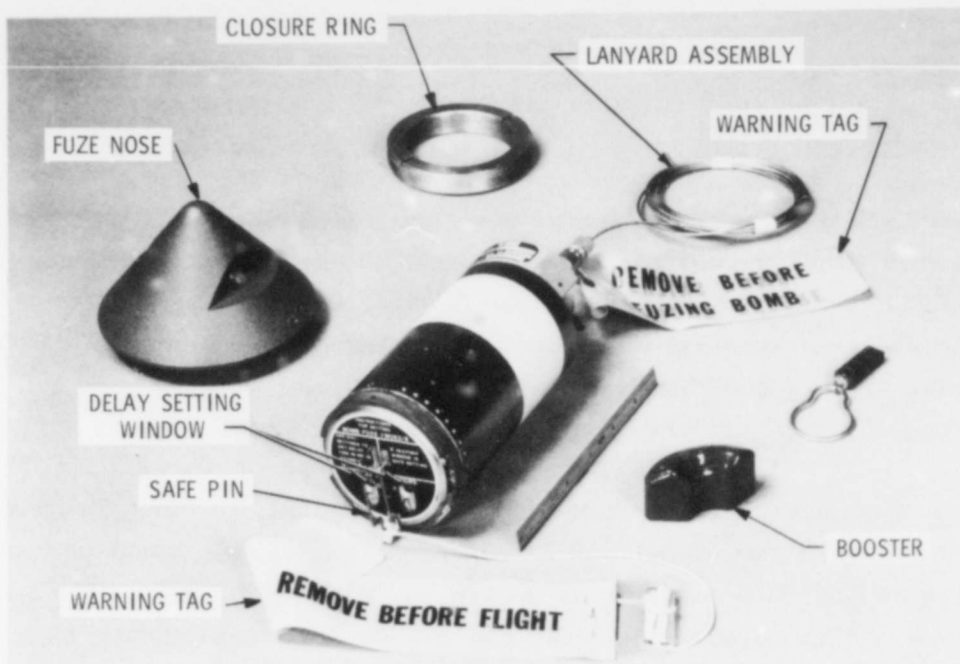
Figure 1. FMU-63/B Bomb Fuze

The selectable delay time is visible in two openings (windows) on the front of the fuze. The red warning tag connected to the handle of the safe pin on the front of the fuze is the safe pin warning flag. The safe pin extends (internally) through the length of the fuze container. When the safe pin is fully inserted, approximately 1/4 inch of the tip can be observed through a viewing window located on the aft end of the container.

a. Nose End

b. BFD End

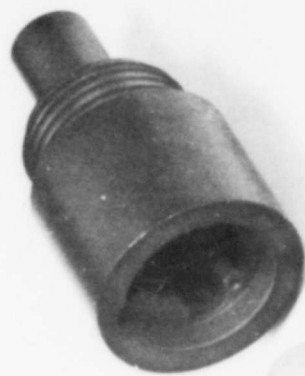
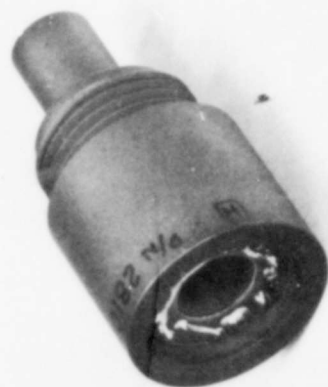
Figure 5. Electrical BFD

ELECTRICAL BFD

PIECE PARTS LESS INITIATOR
