# **Full-Scale Instrumented Evaluations of Multiple Airfield Matting Systems on Soft Soil to Characterize Permanent Deformation**

Final report

Prepared for Headquarters, Air Force Civil Engineer Center  
Tyndall Air Force Base, FL 32403-5319

Under Project Number P2457442

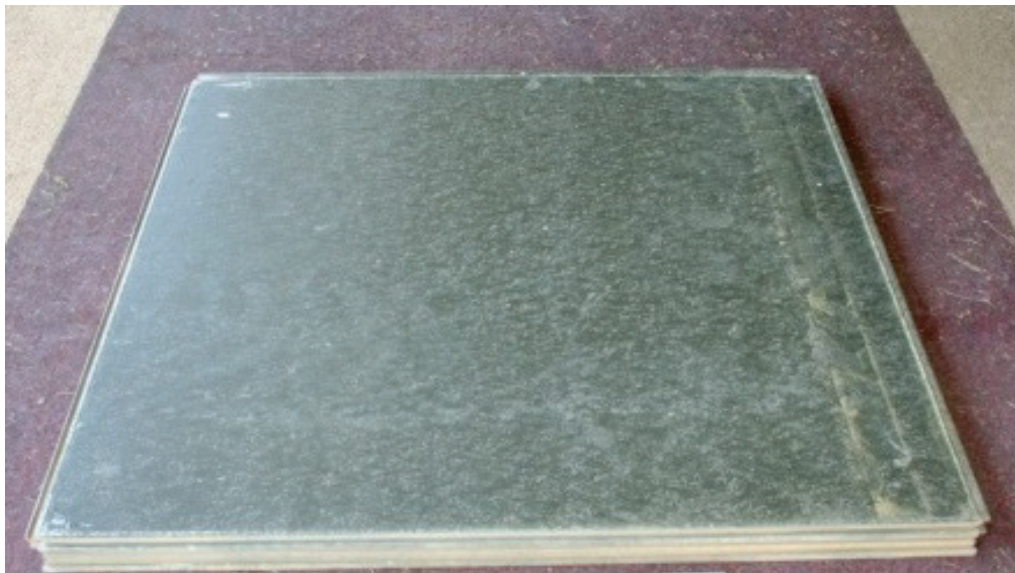
Figure 6. M19 mat panel.

M19 aluminum matting has panels nearly square that consist of a honeycomb core made of 0.125-in. hexagonal cells of aluminum foil. The core is bonded top and bottom to rolled-aluminum sheets by an epoxy adhesive. The edge connectors are welded to the top and bottom sheets and bonded with a potting compound to the core. Panels are joined along two edges by a hinge-type male/female connection. The other two edges consist of overlap/underlap end connectors that are secured by an aluminum locking

bar, much like AM2. The panels are coated with a non-skid material to increase surface friction. M19 mat used for testing was purchased from war reserve material stockpiles, so the history of the purchased mat was unknown. However, the mat was visually inspected and seemed to be in good structural condition. There were no cracked welds, nor was there any deformation. A photograph of an M19 aluminum mat panel is shown in Figure 6.

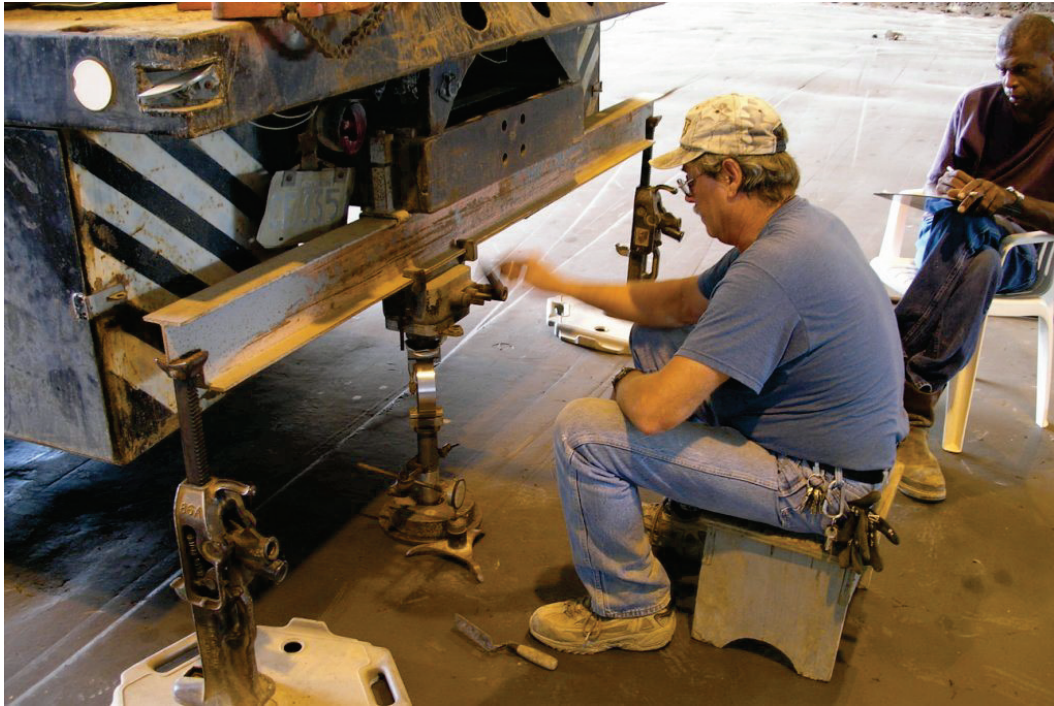
Figure 24. In situ CBR test.

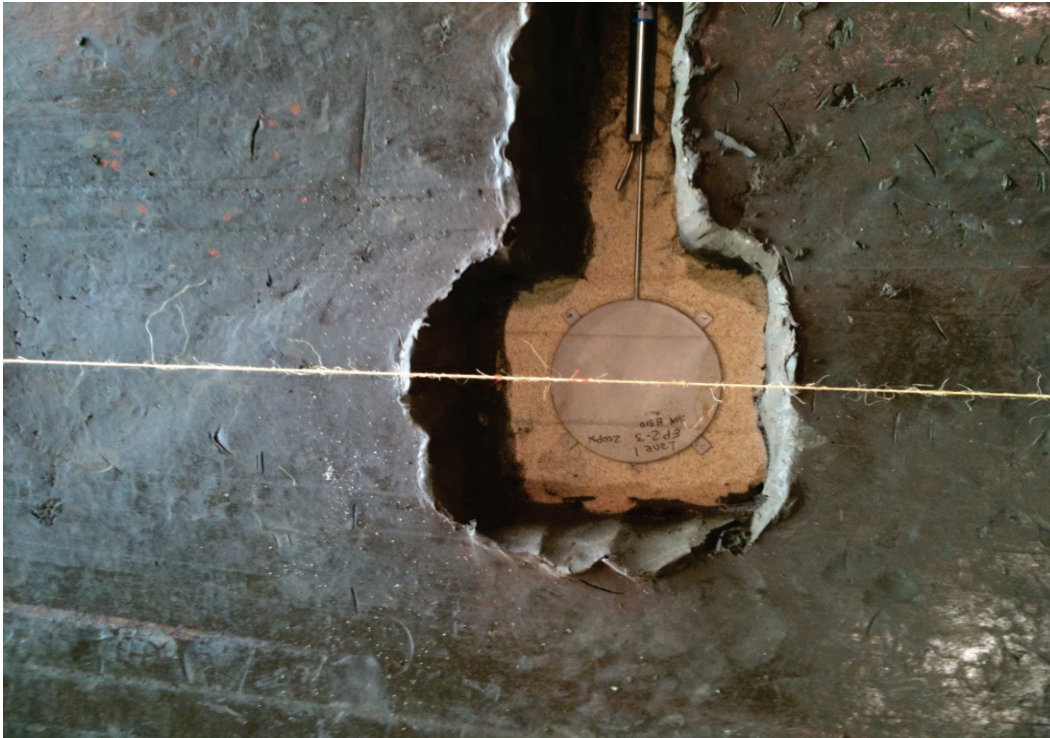
Figure 26. EPC placement during subgrade construction.

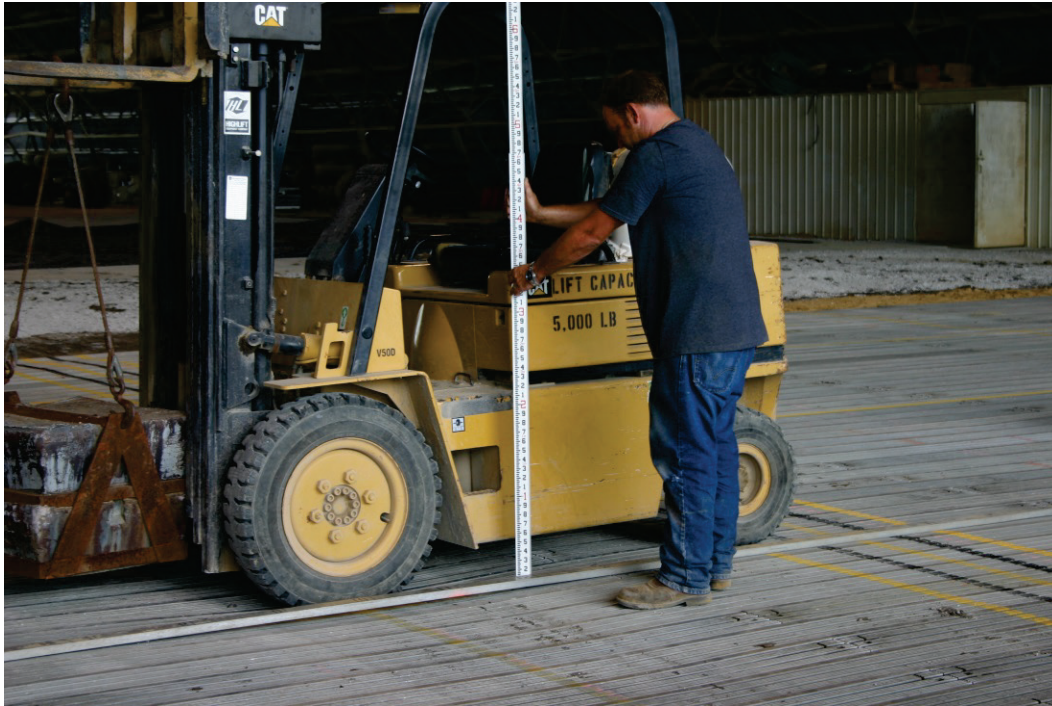
Figure 39. Loaded deflection procedure used to determine  $\delta_{s-2}$ .

An attempt was made to monitor  $\delta_s$  by adding a 6-kip load next to each cross section location with a forklift carrying 4 kips of lead blocks. The forklift was parked adjacent to each cross section, with the front axle located at the centerline (Figure 39). The purpose was to deform the mat panels just enough to contact the subgrade surface without causing elastic deformation of the subgrade. Survey data were then collected at 1-ft intervals along each cross section. This method was designated the “loaded deflection” procedure, according to Rushing and Howard (2015), and the data collected at each cross section were averaged and used to approximate the term  $\delta_{s-2}$ . An example of  $\delta_{s-2}$  determination is shown in Chapter 5.

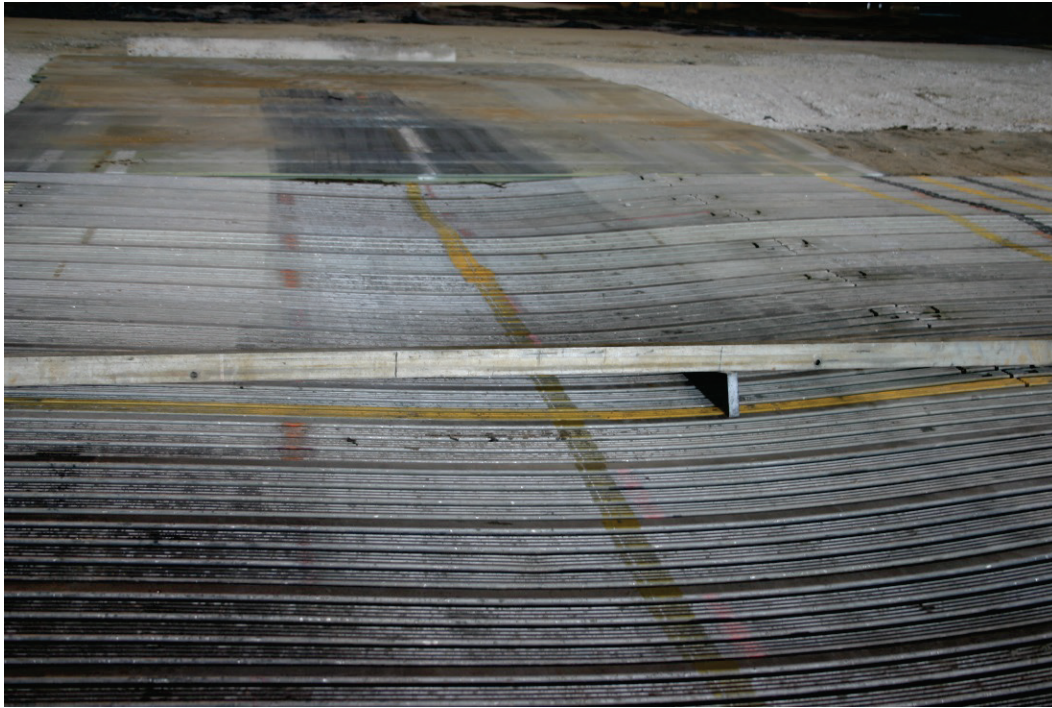
Figure 53. MLC-70 Trackway deformation on mat surface.
