# **EXTENDED LIFE COOLANT TESTING**

**INTERIM REPORT  
TFLRF No. 478**

**U.S. Army TARDEC Fuels and Lubricants Research Facility  
Southwest Research Institute® (SwRI®)  
San Antonio, TX**

**June 2016**

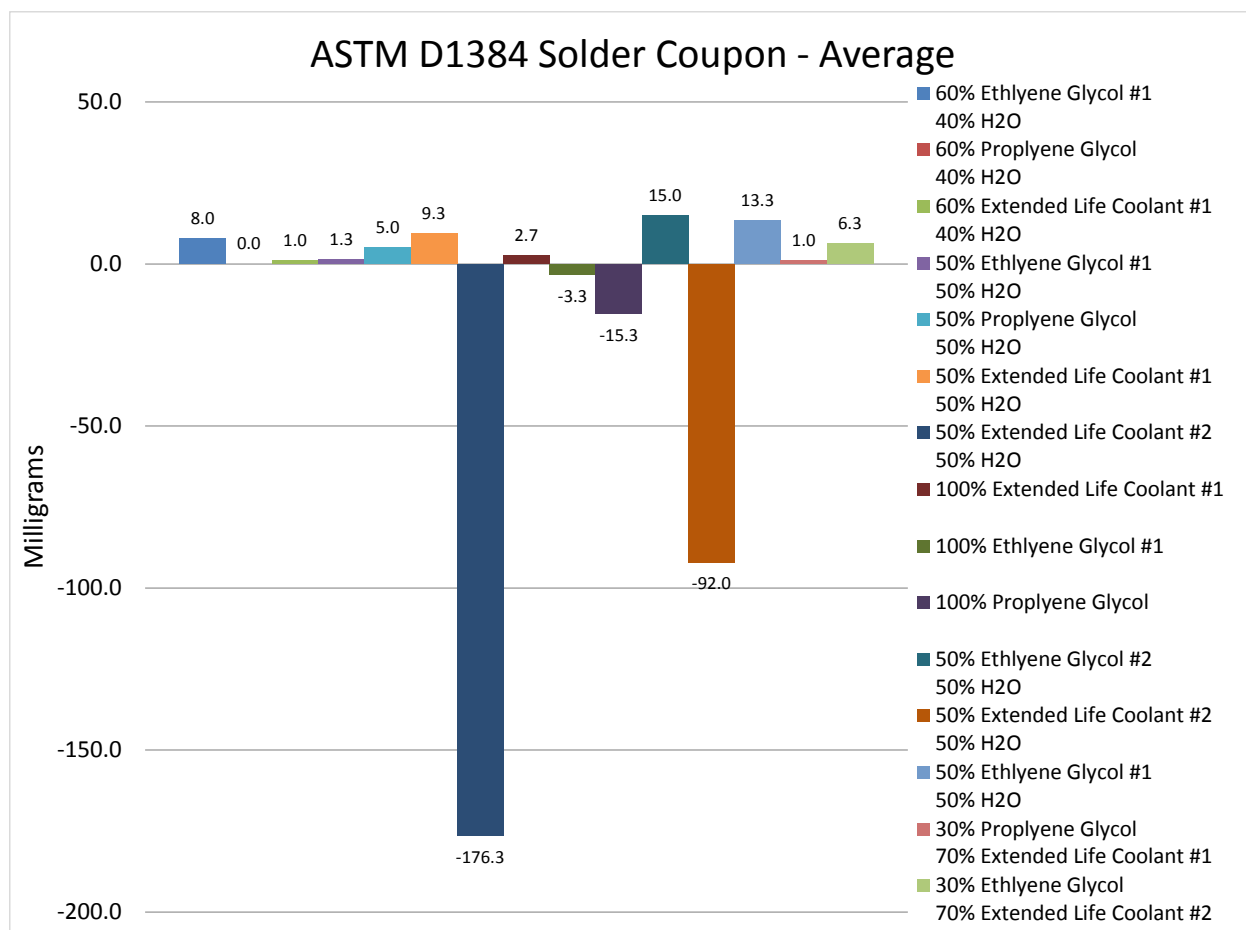
**Figure 1. ASTM D1384 Solder Coupon Mass Loss**

For all of the tests run in the glassware corrosion test, only the solder coupons in the Extended Life Coolant #2 tests showed questionable results. In total, none of the coupons were beyond the proscribed limits for mass loss, but since there is no limit for mass gain, the results are open to interpretation. The two solder coupons with high mass gain (as seen in Figure 1), indicated by a large negative value, were heavily plated with salt at the end of the tests. Some of the salt flaked off during the approved cleaning procedure, and so the values would have been even more negative pre-cleaning. Images of the coupons for those two tests can be seen in Figure 2 and Figure 3.

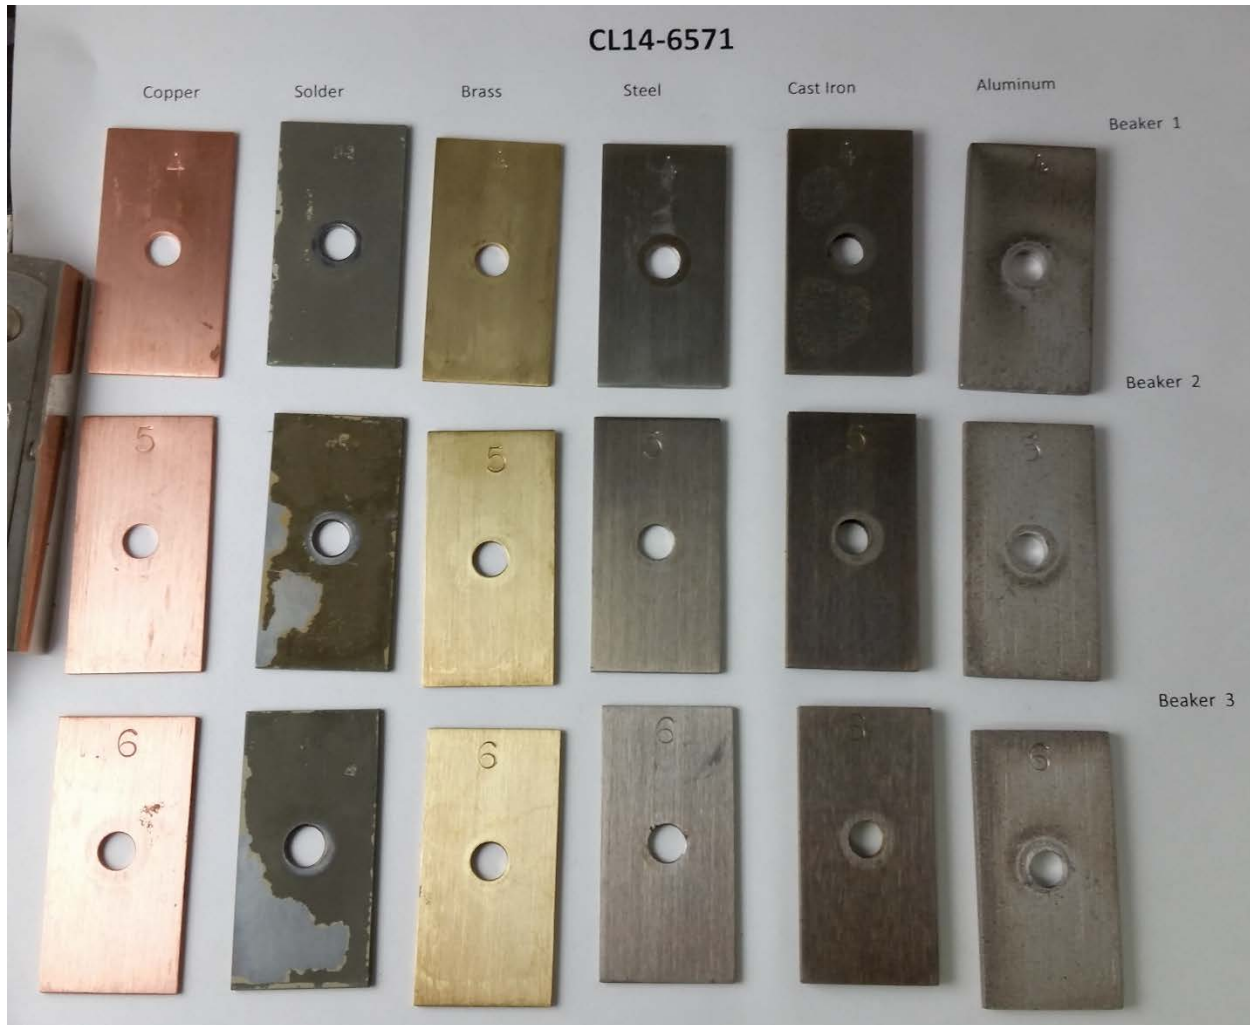
**Figure 2. ASTM D1384 Coupons for Test CL14-6571 Extended Life Coolant #2**

The solder coupons in Figure 2 showed an average weight gain of 176.3 grams. The cleaning process for the solder involved brushing the coupons with a soft bristle brush to remove any loose deposits. Then they were immersed for 5 minutes in a 1% solution of glacial acetic acid. The coupons were then rinsed in deionized water and brushed again. This cleaning procedure, which is outlined in the ASTM D1384 method, removed some of the salt crust that formed, but not all.

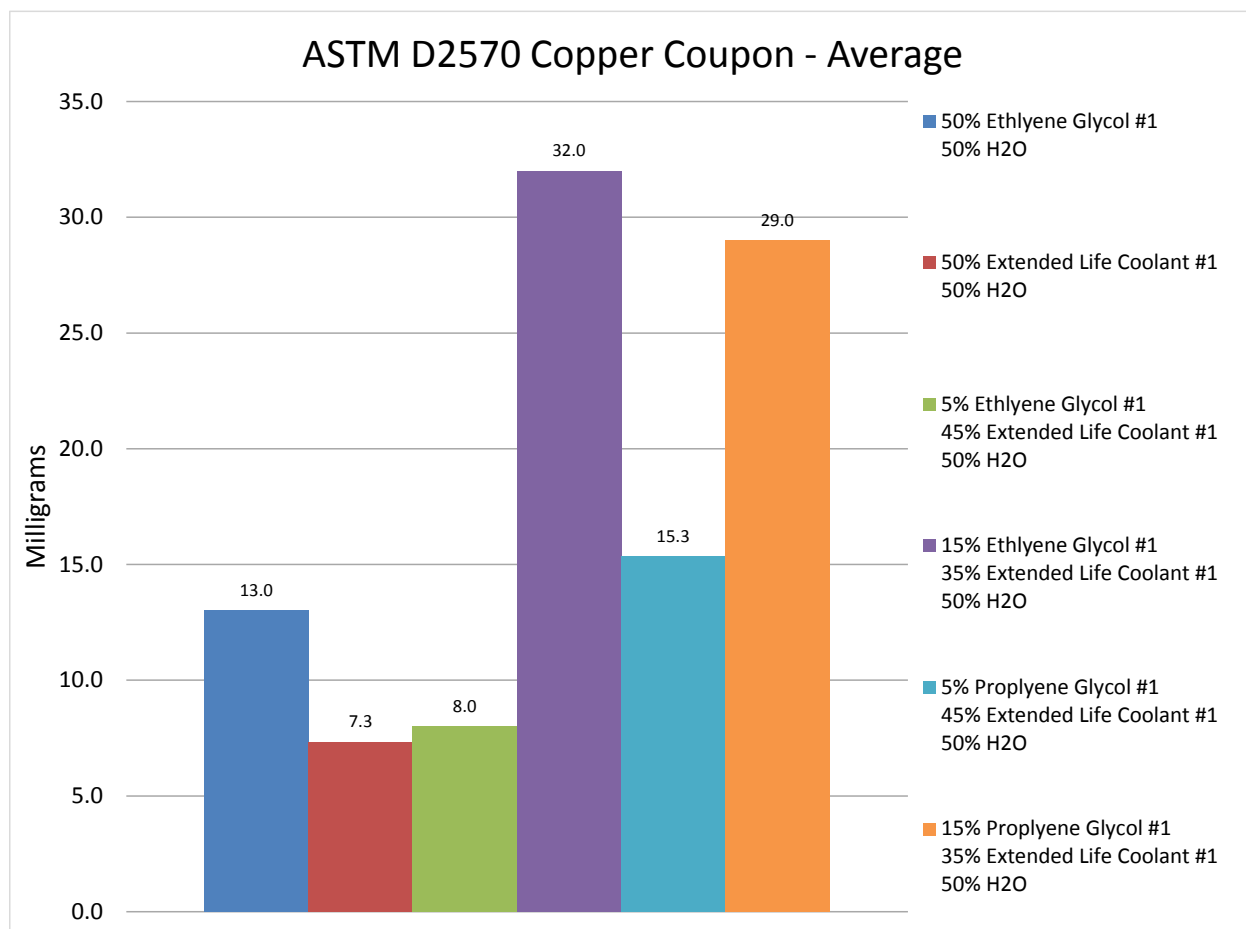
**Figure 4. ASTM D2570 Copper Coupon Mass Loss**

In both of the tests exhibiting higher than allowed copper mass loss, the coolant formulations were a mix of either 15% ethylene or propylene glycol and 35% extended life coolant #1 (ELC1) with a balance of water. At a higher ELC1 content of 45% or 50%, the mass loss results were within acceptable bounds. This may warrant further study at lower ELC1 concentrations in various coolant mixtures as there could be some competitive chemistry at work in the additive packages.

In the simulated service corrosion tests, two of the six tests had copper coupons (as seen in Figure 4) had mass loss higher than the limit of 20 milligrams.

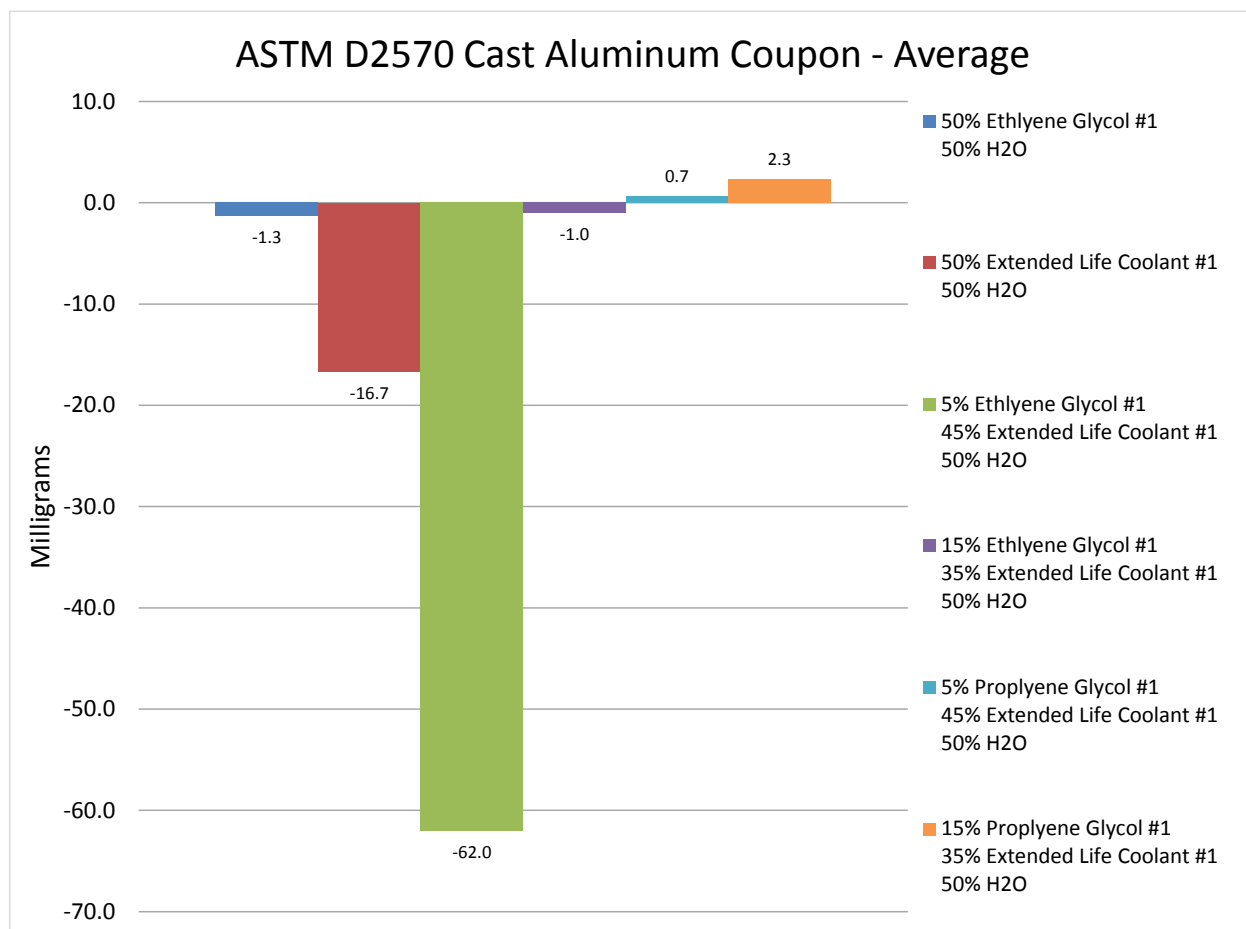
**Figure 5. ASTM D2570 Cast Aluminum Coupon Mass Loss**

The cause of these deposits may be due to a series of pump failures that occurred during the test. Typically pump failures occur due to the design age (1987 Buick Skylark, per the method), but it is uncommon to have more than 1 per test. The procedure for continuing the test is to drain the fluid, replace the pump, put all of the fluid back in and top off if necessary. The first pump failure in the test was an internal bearing rupture, which was only discovered during post-test investigations. This caused some of the bearing grease to be washed out into the coolant system.

There was an issue with mass gain during this testing as well, although the cast aluminum coupons showed the evidence as opposed to the solder coupons mentioned previously. For the third test

which was a mixture of 5% ethylene glycol, 45% ELC1, and 50% water, there was significant material accumulation on the aluminum coupons as seen in Figure 5 and Figure 6.

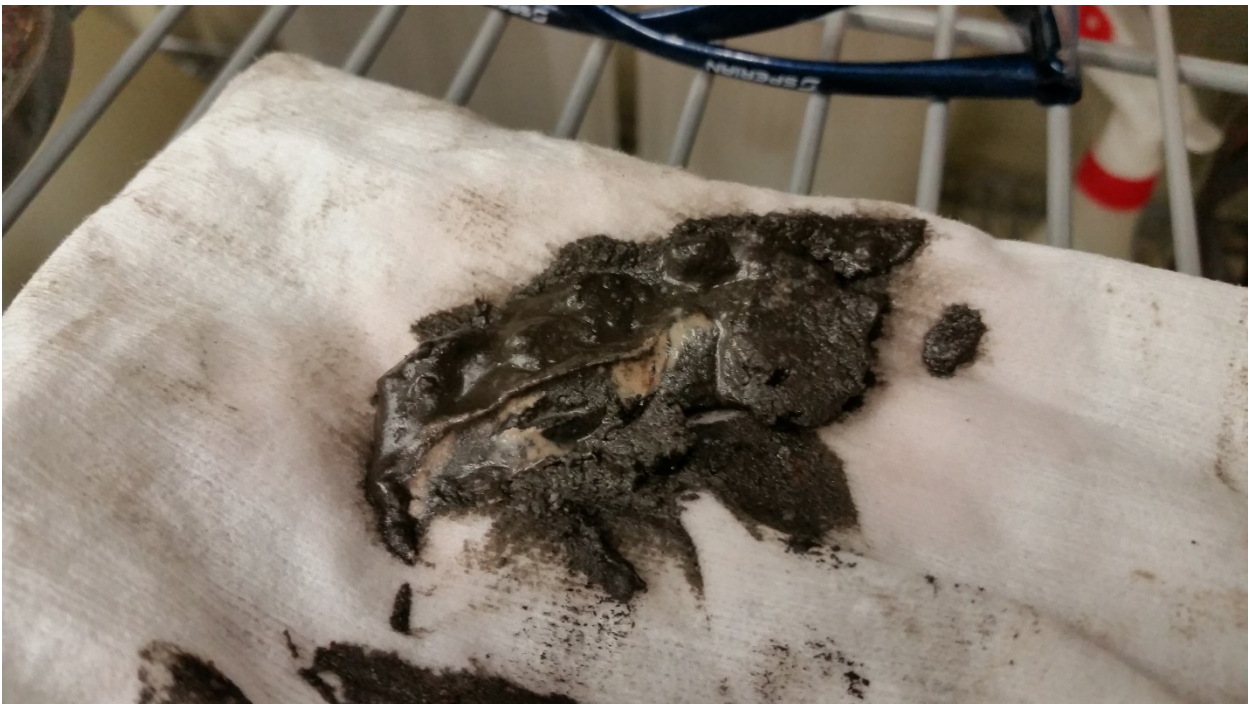
Although no samples were analyzed, pictures were taken of the heavy deposits inside the cast iron vessel and of the 'grease' that was collected from the system, Figure 7 and Figure 8.

**Figure 8. 'Grease' found at bottom of cast iron vessel**

It is possible that there was some chemical reactions occurring between the corrosive water and the grease that was leaked into the system. In terms of corrosion, the third test still passed by not exceeding any of the mass loss limits, but since water pump failures can and do occur in the field, it may be of interest to further investigate the interaction of coolant mixtures and bearing greases typically found in the coolant pumps. This could ensure that the coolant system would not clog up and still be serviceable after replacement of a failed pump.
