# **FINAL REPORT**

## **Demonstrate a Low Biochemical Oxygen Demand Aircraft Deicing Fluid**

**ESTCP Project WP-200905**

**March 2013**

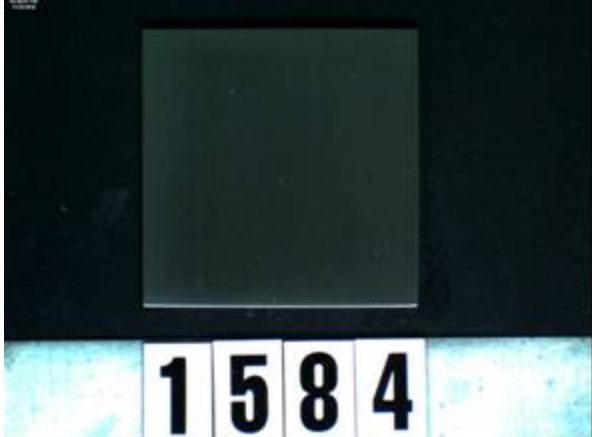
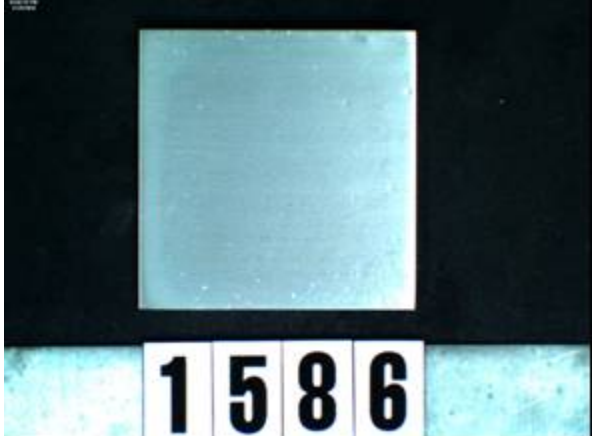
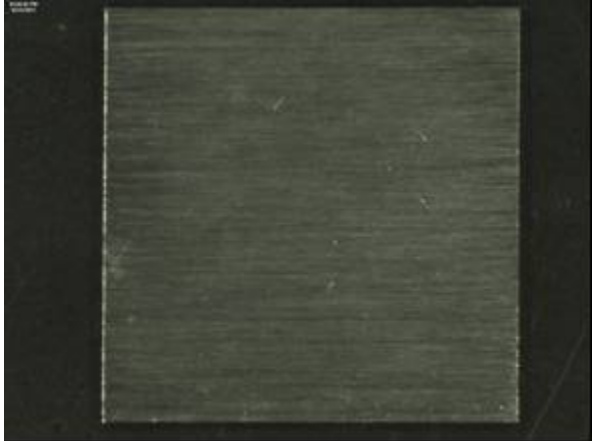
**Table 5. Alternate Immersion Photos – After Exposure**

Test results from Type I Octaflo deicer from a previous testing effort was reviewed and compared to this data. The PG deicer also had little to no effect on these metallic substrate materials.

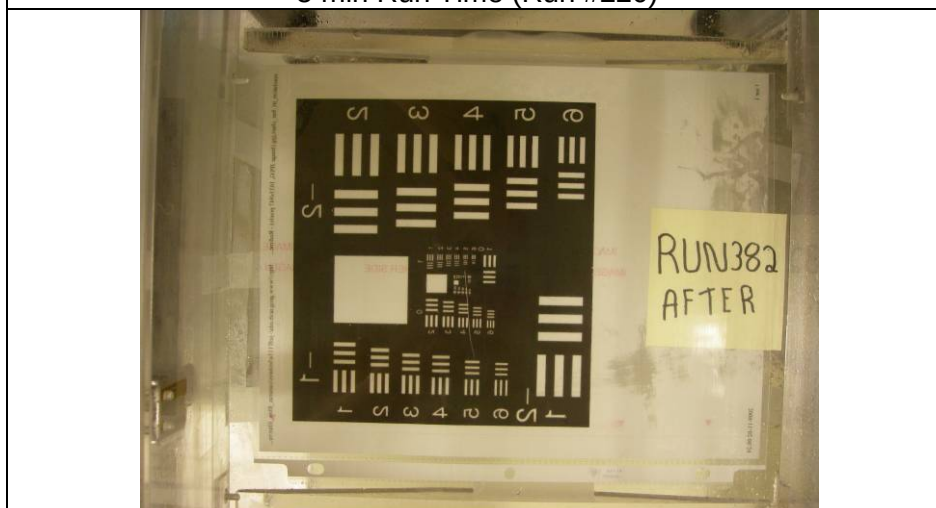
EcoFlo @ 0°C, 0% $\text{H}_2\text{O}$  Reduction, 4mm Initial Fluid Thickness, After 5 min Run Time (Run #382)
