# Preparation Ferrule Design Effect on EndoCrown Fracture Resistance

24 May 2016

Dean, Air Force Postgraduate Dental School

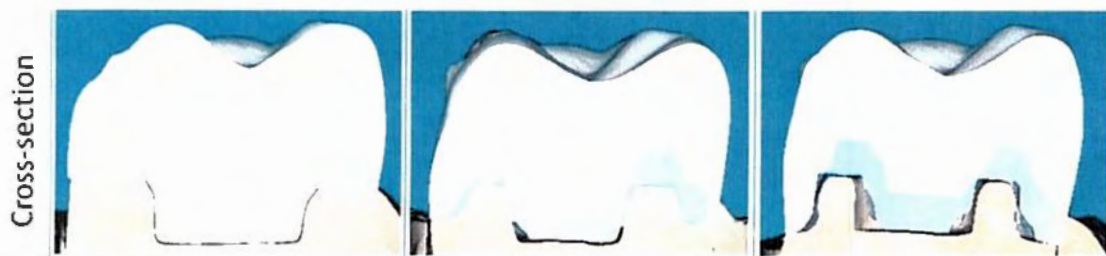
**Figure 15. Cross Section of endocrowns with decreased crown adaption**

A preparation parameter that was observed that may affect restoration performance was the milling limitations in reproducing the intaglio surface of the crown. Accordingly, it was observed that the more complex the preparation, the more complex the restoration design and therefore resulted in decrease crown adaptation with 1mm and 2mm designs with larger cement space (Figure 15). Another preparation parameter was the sometimes tooth structure limitation realized by a ferrule addition in the cervical area. This resulted in some ferrule areas with limited ferrule wall thickness (Figure 16).
