# FINAL REPORT

Automated Aerosol-Sealing of Building Envelopes

ESTCP Project EW-201511

JANUARY 2018

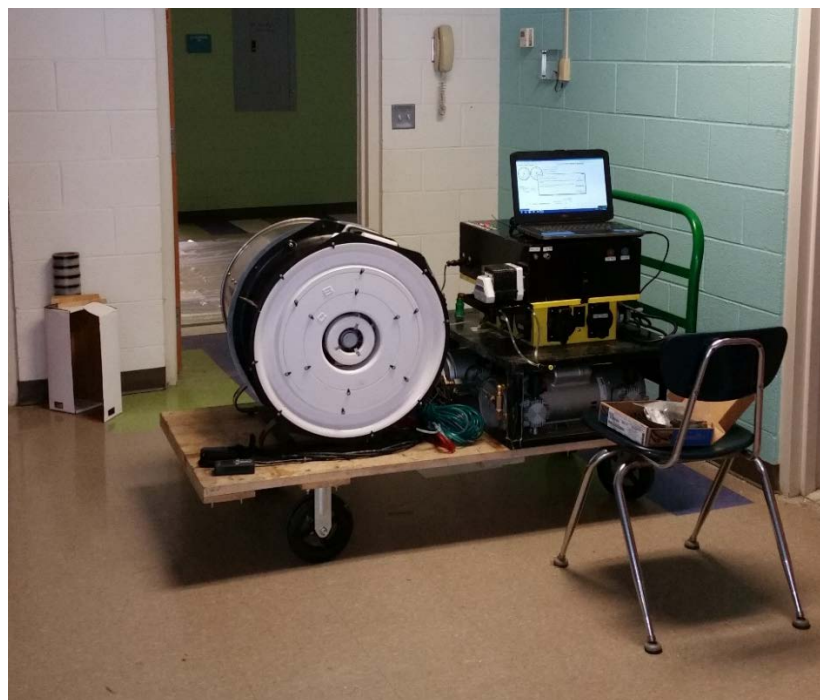
The injection system consists of an air compressor, sealant injection pump, and nozzles. The injection system is controlled to maintain the humidity target during the process in order to promote seal durability while also limiting sealant deposition on the floor. Each injector nozzle is placed strategically around the building to allow for adequate aerosol distribution. Depending on the building geometry, a single nozzle can seal up to 400 square feet of floor area.

**Figure 14: Photo of aerosol sealing equipment setup**

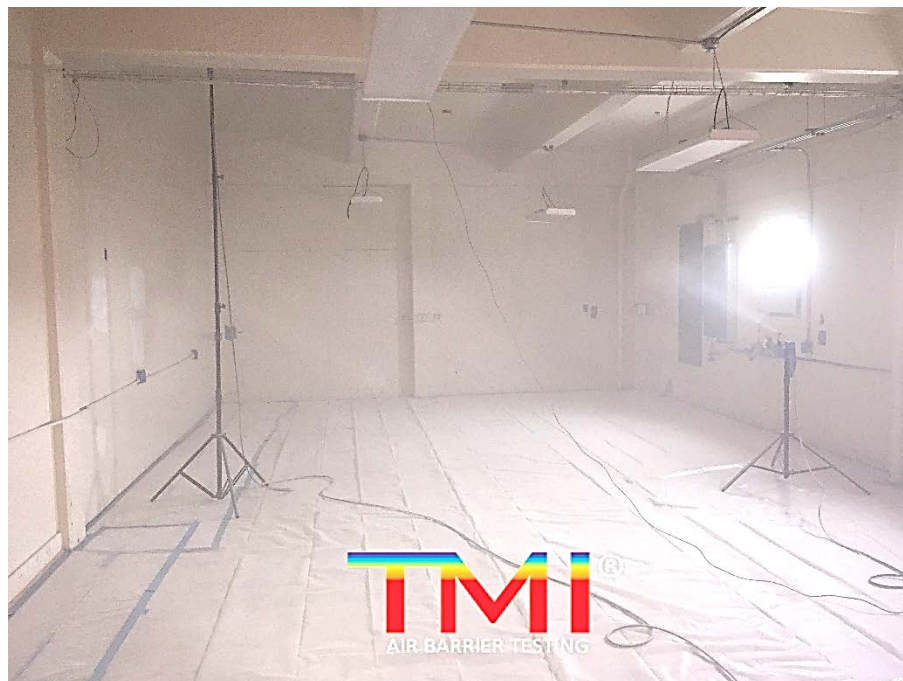
Another demonstration that took place at Quantico was the last demonstration for this project on a small office building. This building was vacant at the time of the aerosol sealing installation but was planned to be re-occupied at a later date requiring that the horizontal surfaces inside the building be protected (Figure 18). The prep work required about 16 person-hours or about one day for a two person crew.

**Figure 18. Building 2177 at Quantico Prepped for Aerosol Envelope Sealing**

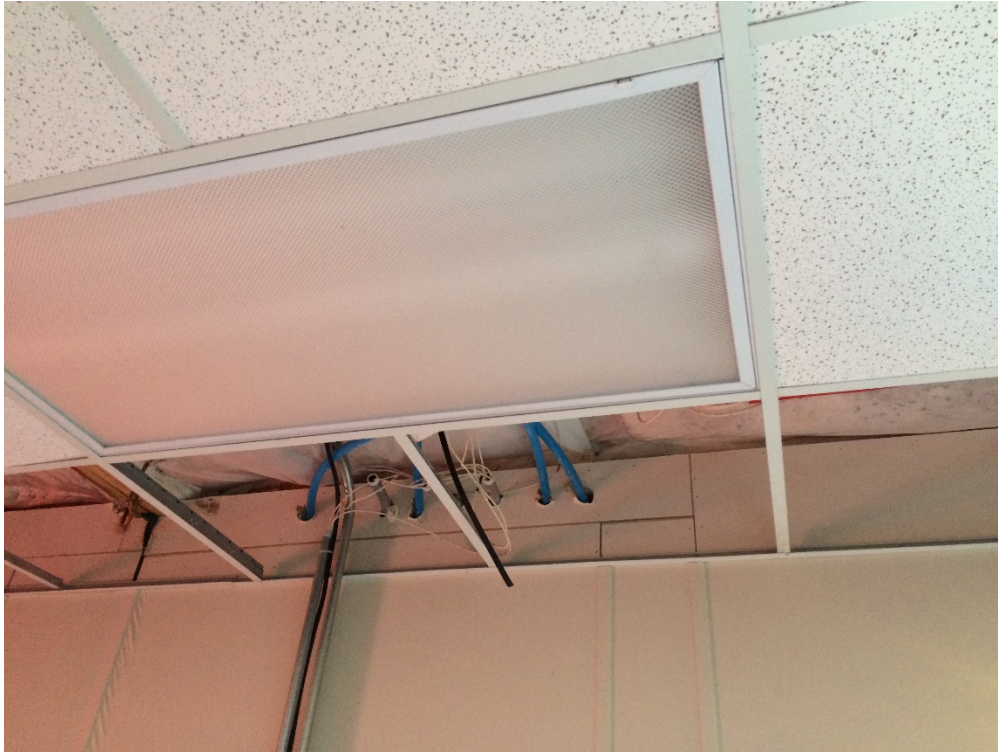
Building A6372 was sealed June 28, 2016. The building was in poor condition with the floor partially collapsed. There also appeared to be retrofits performed to the building to introduce network wiring through large conduits. The holes drilled for these conduits introduced significant leakage that was too large for the aerosol sealing to address (Figure 23). The overall impact of the aerosol sealing demonstration reduced overall building leakage by 44% from 2,643 CFM at 75 Pa to 1,479 CFM at 75 Pa. Figure 24 shows a seal formed at the baseboard of the building.

**Figure 23. Conduits Installed in Building A6372 for Network Wiring**

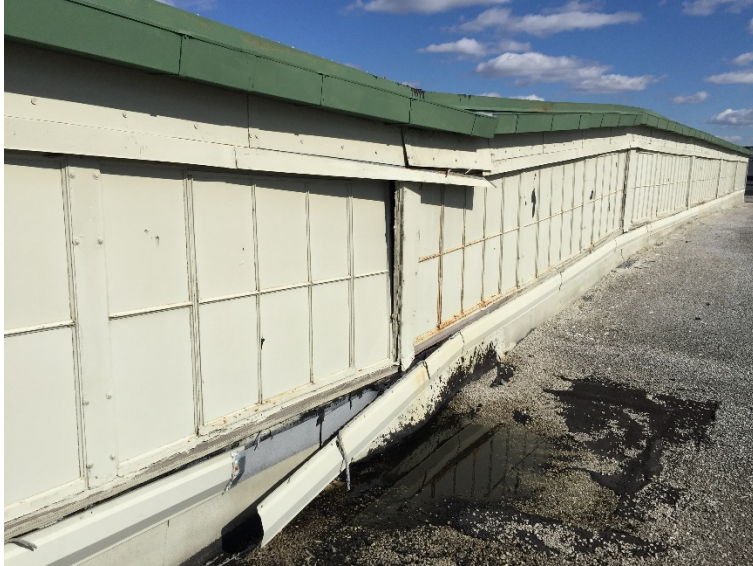
The last demonstration performed at NSA Mechanicsburg was on a relatively small bay of a larger building. Building 408 was a warehouse style construction with high ceilings and significant leakage issues at the roof (Figure 30). Much of this building was occupied including some adjoining spaces to the bay that was sealed.

**Figure 30. Photo of Clerestory on Roof at Building 408 at NSA Mechanicsburg**

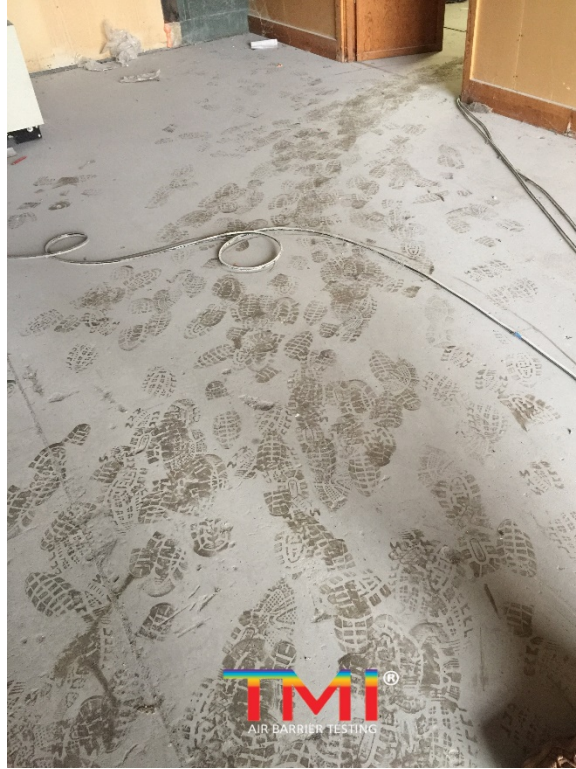
**Figure 46. Photo of Floor Not Prepped at Building 608A at NSA Mechanicsburg**
