## **Demonstration of Dehumidification Technology for a Missile-Storage Facility**

Final Report on Project F11-AR25

Under Project F11-AR25, "Dehumidification of Forward Position Facilities for  
Munitions Storage in Okinawa"

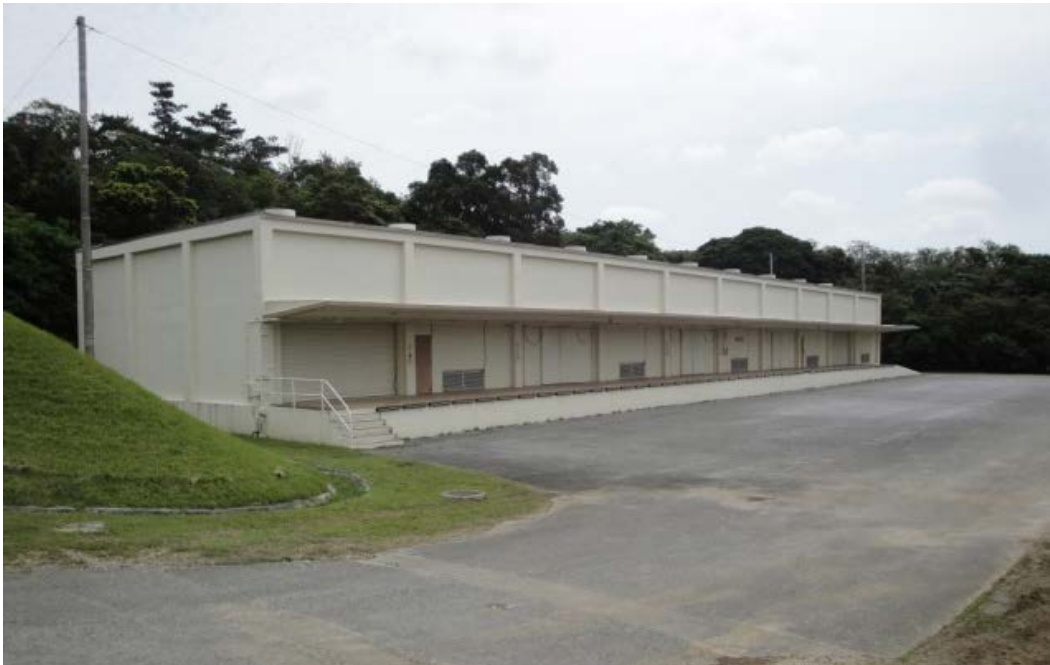
Figure 1. Storage facility used for demonstration/validation project.

The missile-storage facility (MSF) used as the Kadena test location is a conventional concrete-frame, block-infill warehouse (Figure 1). The building has no climate control except for wall vents and wind-driven roof vents. Leaks in the roof allow moisture to infiltrate and aggravate the high-humidity indoor environment.

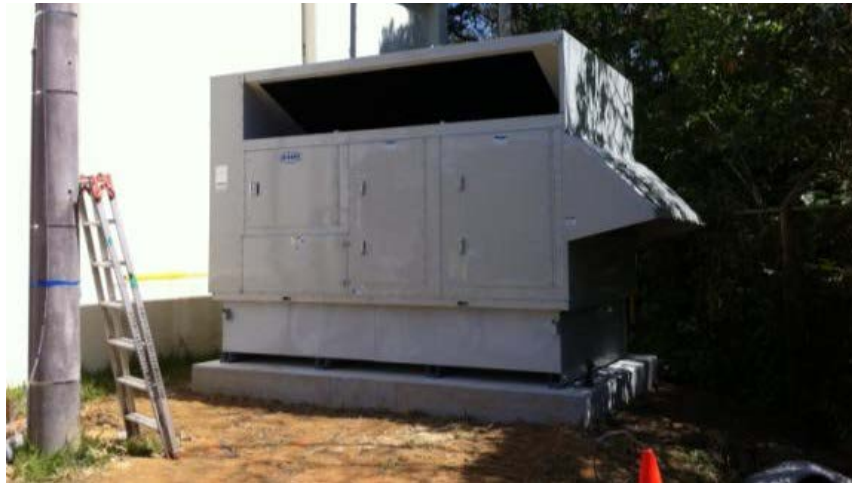
Figure 2. Selected dehumidification unit on concrete pad.

The unit selected for installation was a 9,200 cubic feet per minute (cfm) heating, ventilation, and cooling (HVAC) system manufactured by AAON Heating and Cooling Products (Tulsa, OK), shown in Figure 2. Specifications for the unit are available in Appendix A.

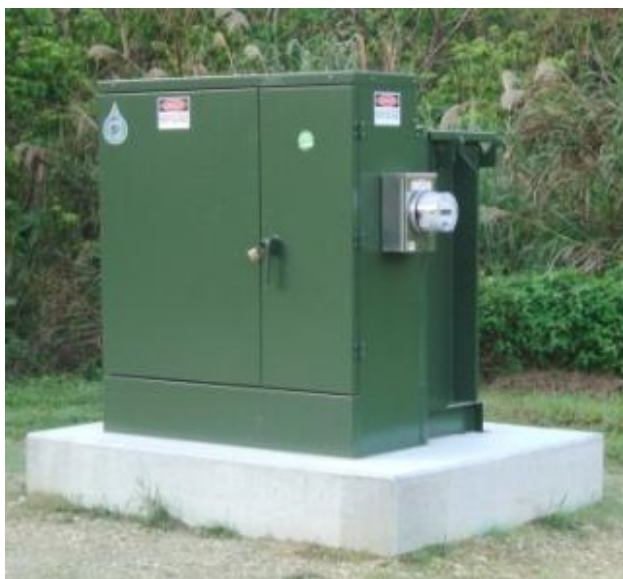
Figure 3. Transformer unit.

System design required that three-phase power be routed to the building from the closest source, which was approximately 330 yards away. This line was extended to a pole across the street from the building. A three-phase 112.5 kilovolt-ampere (KVA), 1300 V Delta 208/120 V wye transformer was mounted to a concrete pad adjacent to the building (Figure 3). A standalone 400A/3/350A fused-disconnect switch junction box was installed between the transformer and the location for the DH unit (Figure 4).

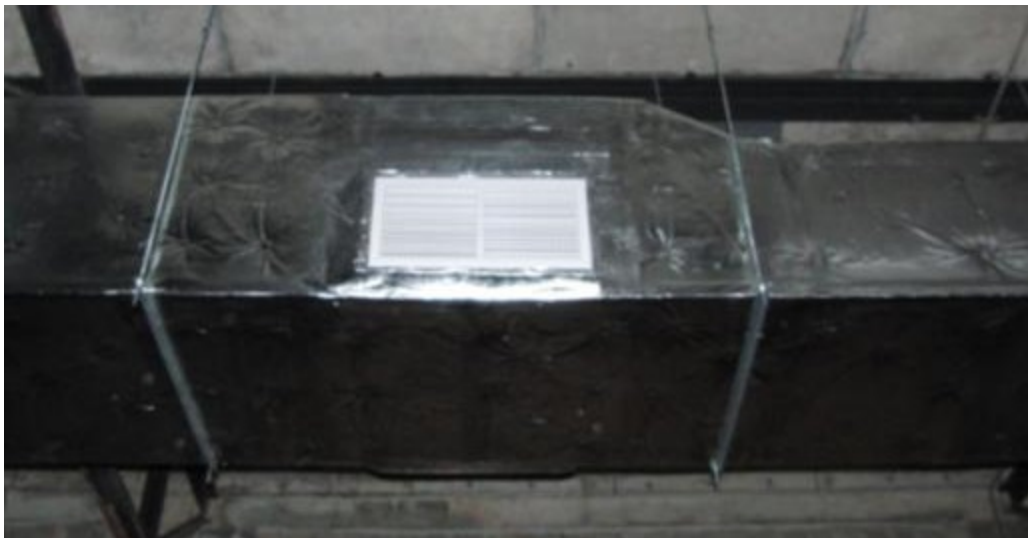
Figure 5. Ducting vent showing left-to-right size transition from larger to smaller.

A 30,000 lb crane was used to lift and place the HVAC curb adapter and HVAC unit onto the concrete pad. Stainless steel ducting measuring 36 x 30 in. was fabricated and installed along the adjacent exterior wall of the MSF. A hole was cut in the block wall to transition the exterior ducting into the interior ducting. The ducting continues into the building at the same size, then progressively reduces in size to 36 x 22 in.; 28 x 22 in.; and 28 x 14 in. throughout the length of the building. Four 24 x 12 in. vents were mounted on each side of the ducting for a total of eight installed vents (Figure 5). Engineering drawings are reproduced in Appendix B.

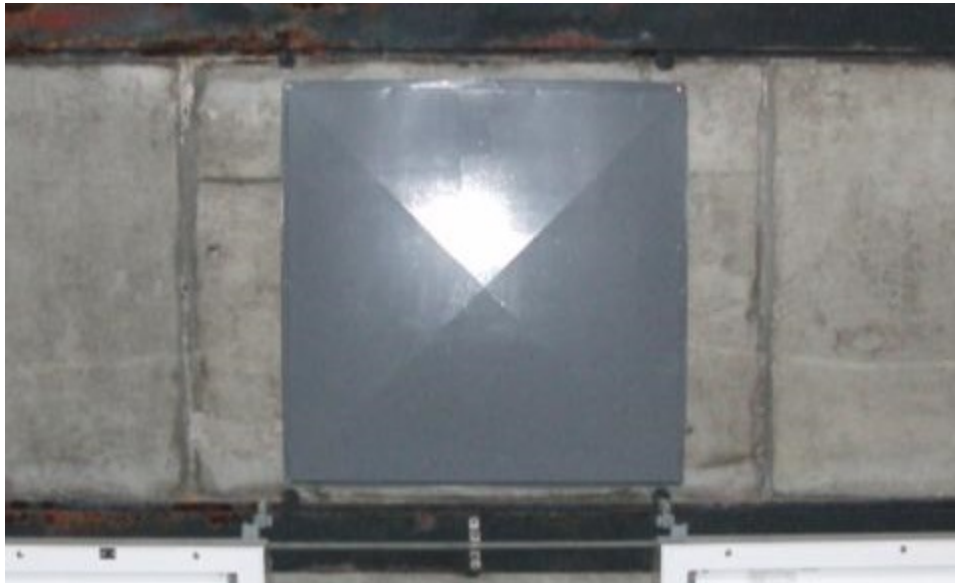
Figure 6. Roof vent cover.

The original building had vents that had to be sealed. Covers shown in Figure 6 and Figure 7 were fabricated of galvanized steel to cover the 20 circular roof vents and 14 wall vents. The covers were painted gray to match the building interior. Foam insulation was installed on the inside of each cover to reduce heat transfer to the interior. The covers were fastened to the walls and ceiling using stainless steel concrete screws. A rubber strip was placed around the edges to seal the covers against the concrete.

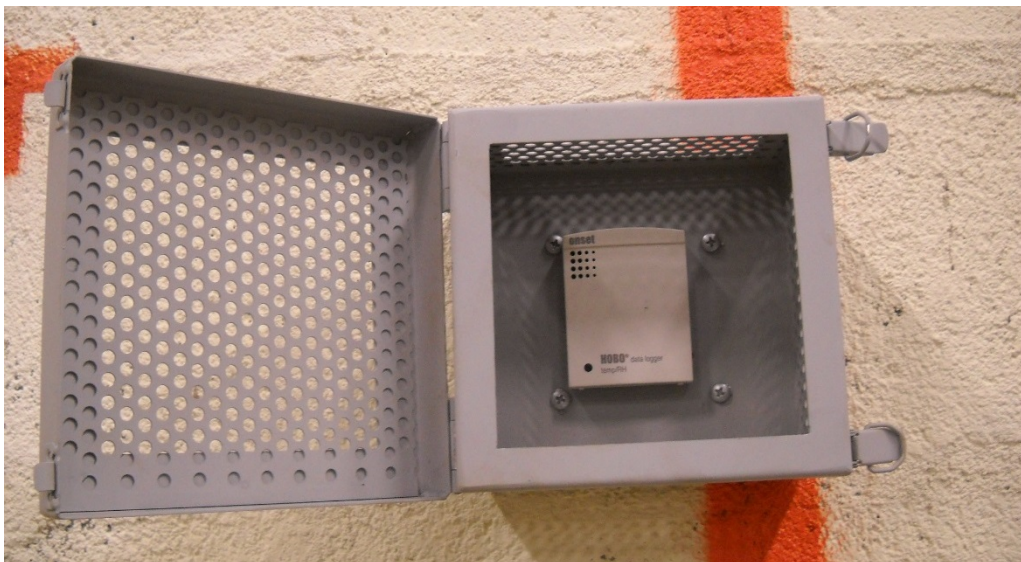
Figure 8. Interior temperature and humidity sensor mounted in protective box.

Two HOBO® temperature and relative humidity sensors (Onset Computer Corporation, Bourne, MA), were each installed in a tamper-proof box. They were mounted on opposite walls—front and rear—inside the facility

(Figure 8). These units logged the data for later downloading to a computer at the end of the monitoring period.
