TEST FILLS FOR ROCK-FILL DAMS

MISCELLANEOUS PAPER S-73-7

Conducted by U. S. Army Engineer Waterways Experiment Station  
Soils and Pavements Laboratory  
Vicksburg, Mississippi

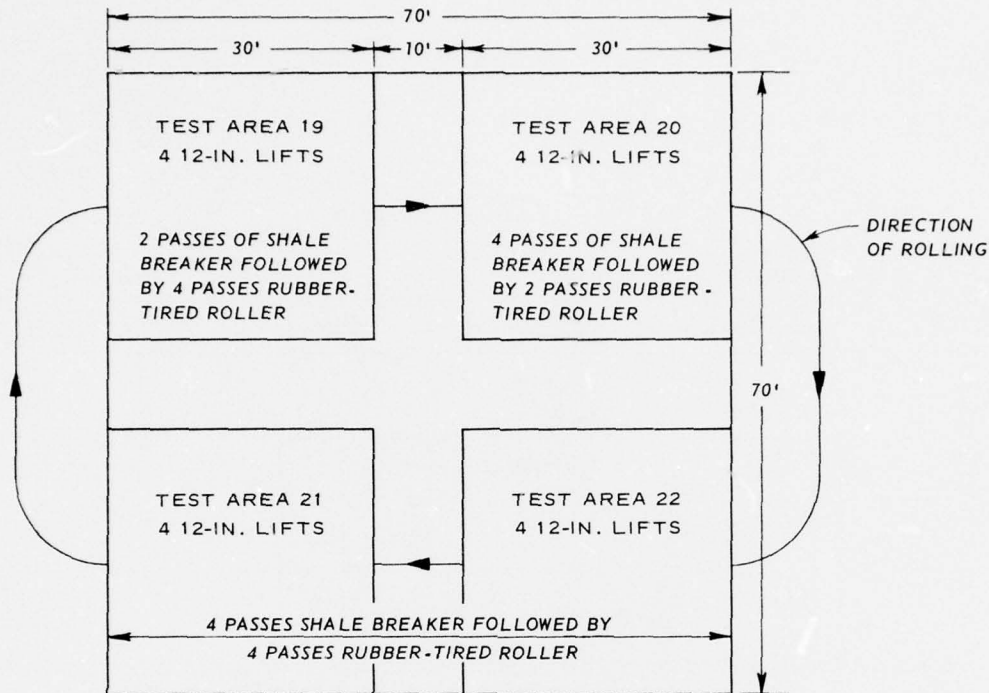
NOTE: ALL LIFT THICKNESSES REFER TO THE LOOSE OR UNCOMPACTED THICKNESS.

1. MATERIAL: PARTLY WEATHERED SHALE
2. COMPACTION EQUIPMENT:
  - A. SHALE BREAKER, FERGUSION-GEBHARD MODEL 22, FULLY BALLASTED WITH CHISELTIPS HAVING A FACE AREA OF 1-1/2 SQ IN. AND A 3750 PSI TIP PRESSURE
  - B. RUBBER-TIRED ROLLER, 50-TON BROS, FULL BALLASTED, FOUR PNEUMATIC TIRES ABREAST AT 90 PSI, 25,000-LB WHEEL LOAD
3. ALL SPREADING OF MATERIAL AND TOWING OF COMPACTION EQUIPMENT WAS WITH AN ALLIS-CHALMERS HD-20 TRACKED BULLDOZER

Fig. 3. Compaction schedule, Zone C, Beltzville test fill

\* Note: Description of equipment is given in figs. 3 and 4.

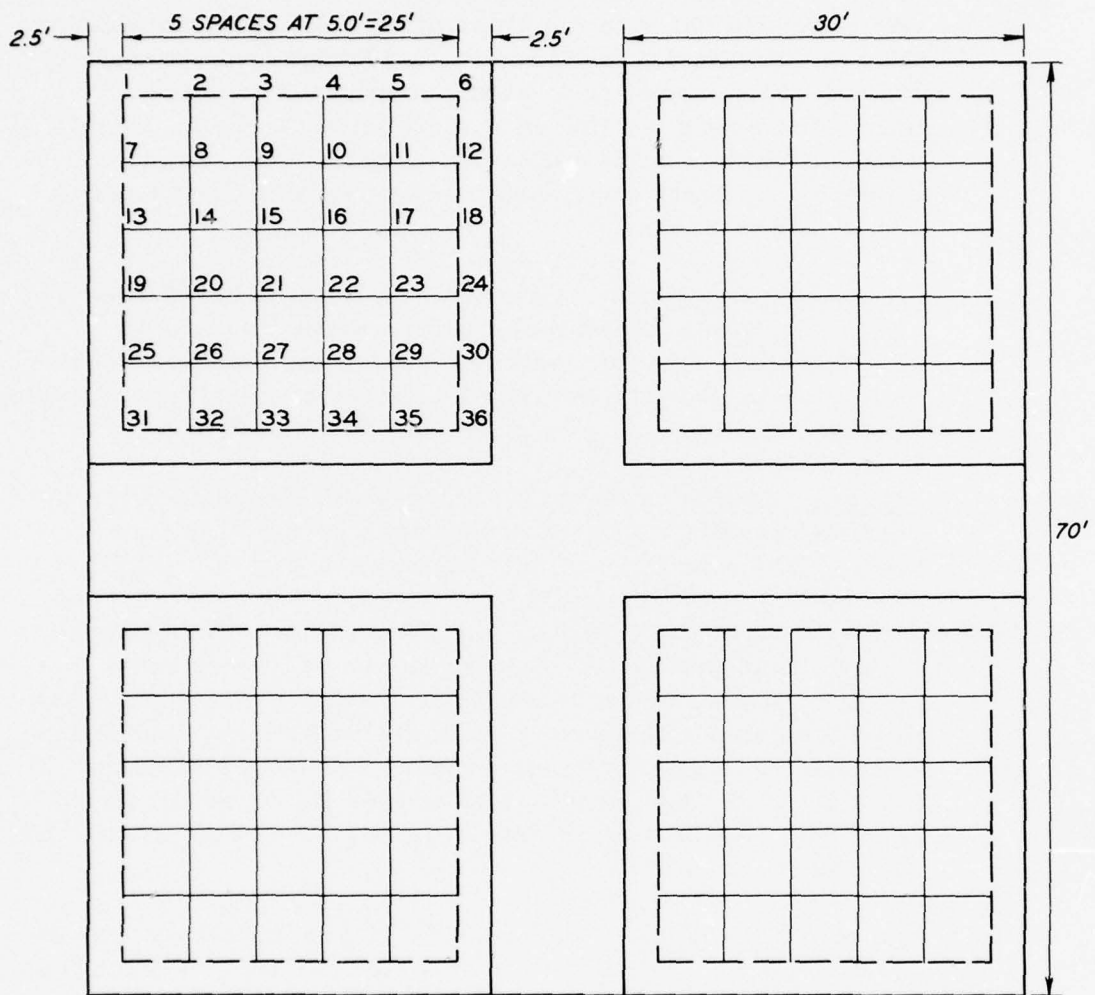
Fig. 5. Typical grid for level readings Beltzville test fill

- c. Settlement measurements. The typical layout used for taking level readings over each test area is shown in fig. 5. Strings with markings at 5-ft centers were stretched from side stakes, and the grid points thus located were sprayed with red paint for identification. Steel plates were placed on the prepared foundation in order to provide a reference elevation before and after test fill operations to ensure that final computed settlements would not include any foundation settlement. Readings taken consisted of initial readings prior to spreading, readings to establish proper lift thickness, and readings after every two passes of the compaction equipment.

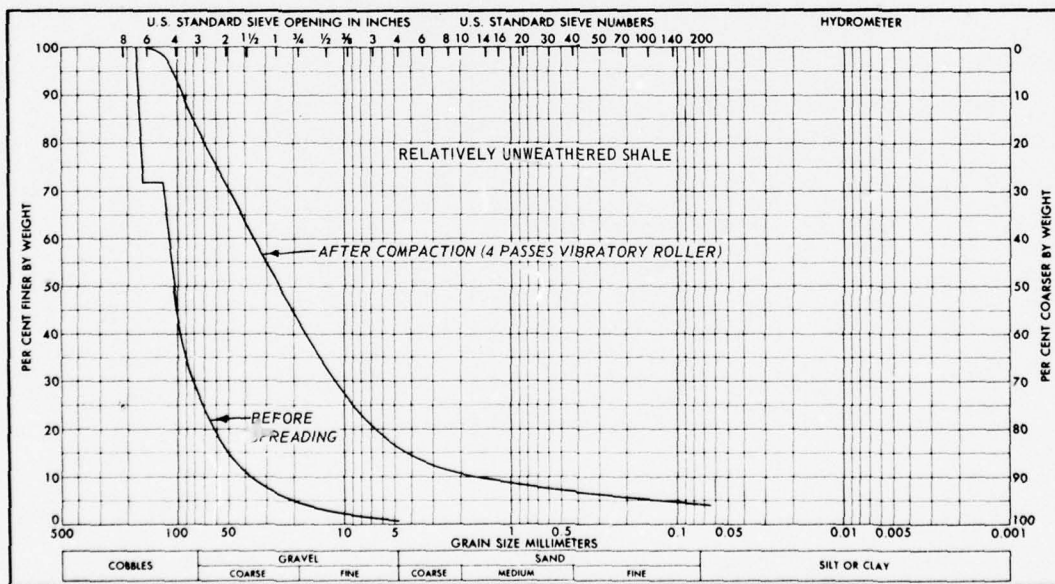
a. TEST ZONE C, AREA 22, LIFT 1

b. TEST ZONE D, AREA 23, LIFT 3

Fig. 7. Before spreading and after compaction gradation curves Test Zones C and D Beltzville test fill

- b. Mechanical analyses. Results of mechanical analyses are shown in figs. 6 and 7. Each plot contains representative gradations of material before spreading and after compaction in order to demonstrate the degradation that occurred due to spreading and compaction. As is evidenced by these data, considerable degradation took place in both the partly weathered shale and the relatively unweathered shale during spreading and compaction. However, the distribution of fines throughout the lift is not discernible since the gradation curves represent total samples.

12. The before-and-after gradation curves show that the amount of breakage caused by spreading and compaction was the same for both types of material. The vibratory roller broke down the harder, relatively unweathered shale just as much as the shalebreaker and rubber-tired rollers broke down the partly weathered shale material. However, for the partially weathered shale, the most important factor was to obtain a relatively impervious material to serve as a transition zone between the core and the outer rock shell; permeability was only a secondary consideration. That is, breakage was encouraged rather than discouraged as is often not the case for most rock fills. It would have been very informative had the after-compaction gradation tests been carried out in such a manner as to delineate the distribution of fines with depth in a given lift.

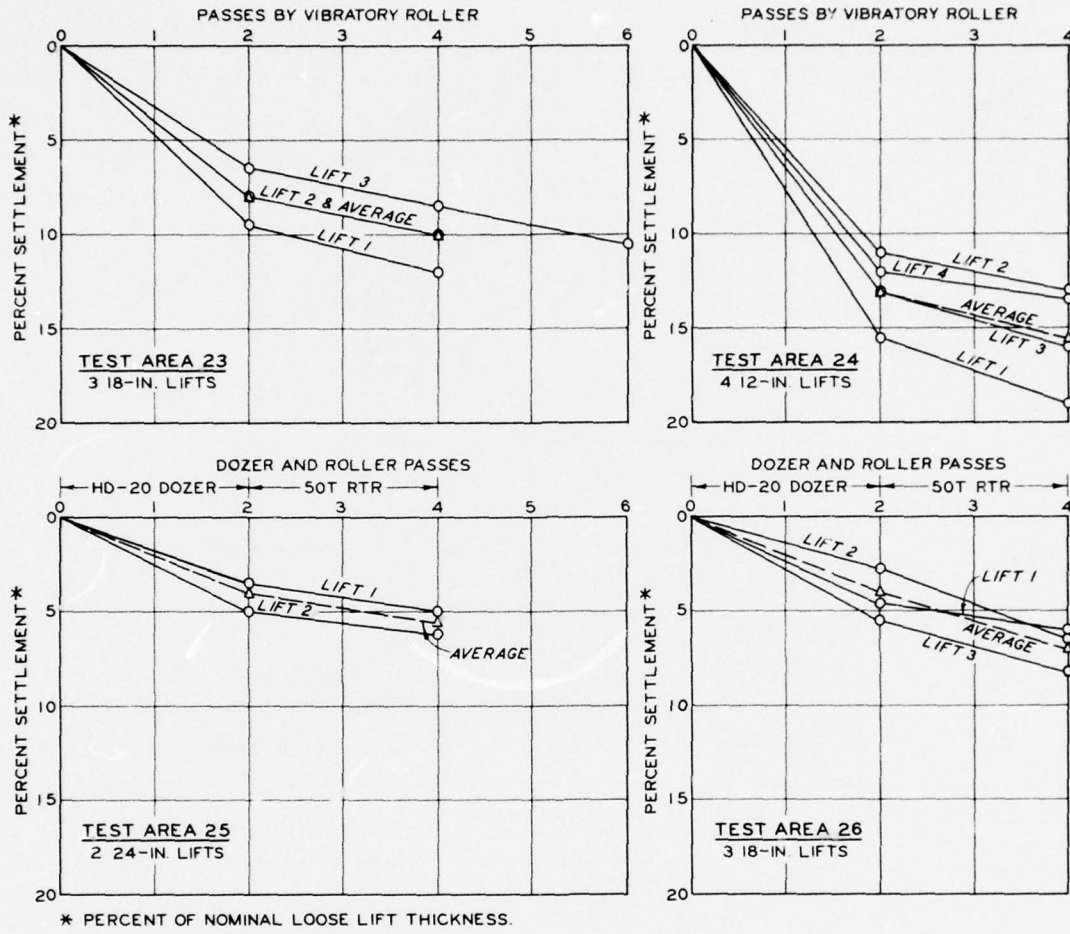
Fig. 9. Percent settlement vs compaction equipment for each lift  
 Test Zone D - relatively unweathered shale Beltzville  
 test fill

- c. Settlement measurements. Plots of the percent settlement for each lift versus the number of compaction equipment passes are shown in fig. 8 (Test Zone C) and fig. 9 (Test Zone D). By expressing the settlement obtained in terms of a percentage of the loose lift thickness (nominal loose lift thickness was used in this case as the values of actual loose lift thickness were unavailable), a comparison of the settlement characteristics of lifts of different thicknesses can be made. If actual settlement were plotted instead of percent

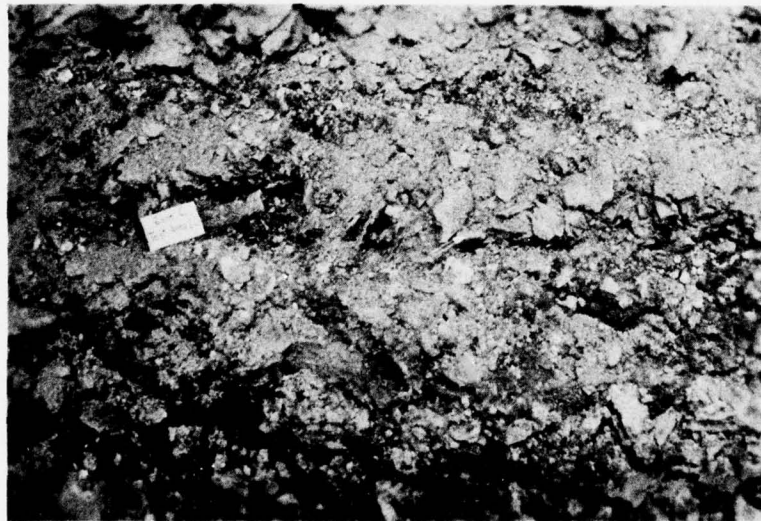
Fig. 11. Inspection trench, Zone C, test area 20, partly weathered shale, Beltzville test fill

b. Closeup view

- d. Inspection trenches. Photographs of inspection trenches in each zone are shown in figs. 11 and 12. These photographs

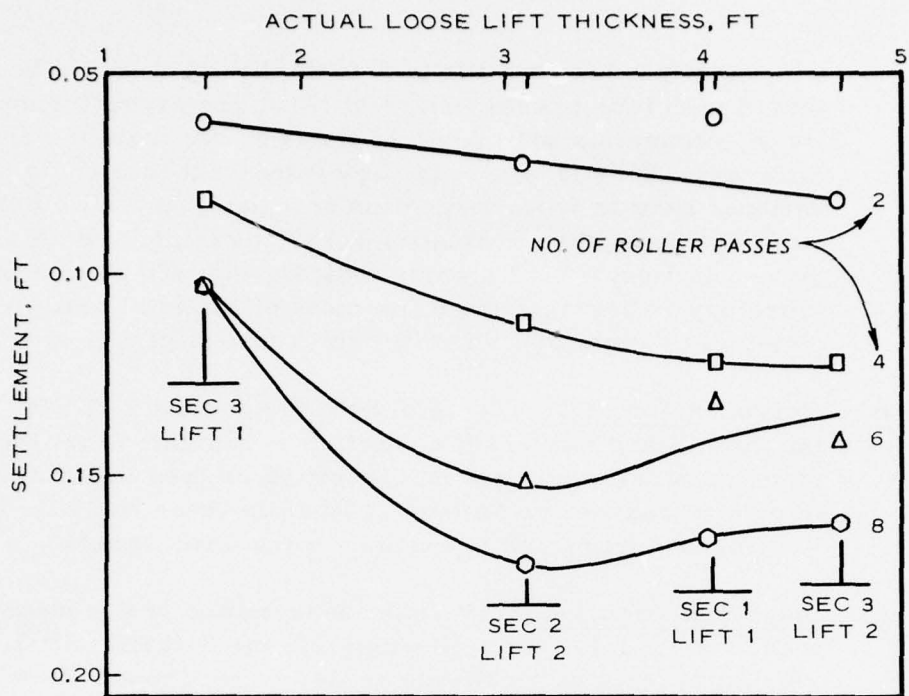
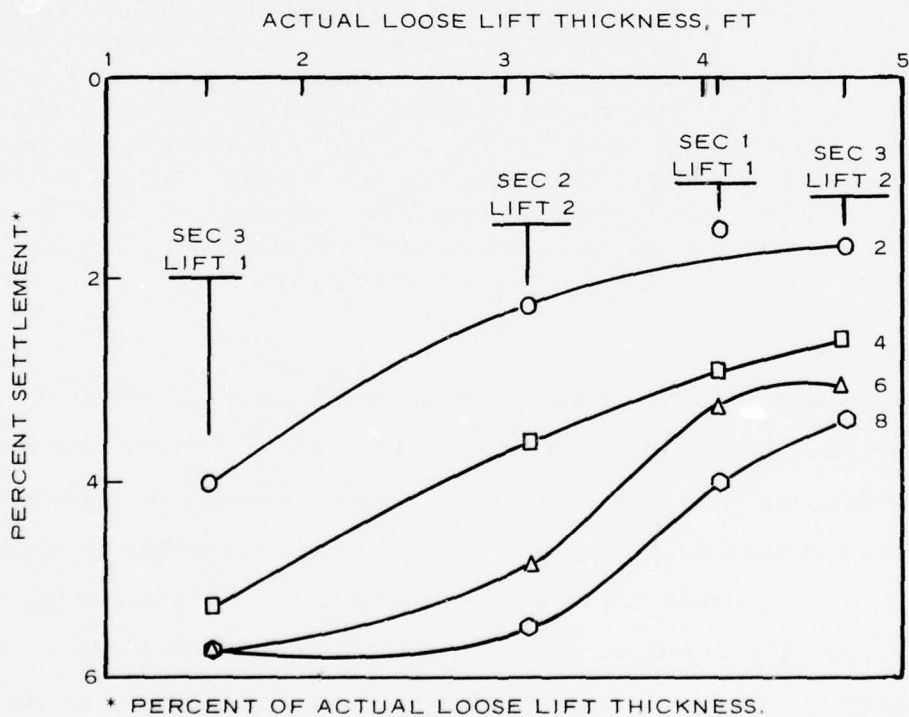
Fig. 17. Percent settlement and settlement in feet versus actual loose lift thickness for 2-ft, second 3-ft, first 4-ft, and 5-ft lifts, Laurel test fill

- a. Settlement measurements. The results of settlement measurements are shown in figs. 15 through 17. Figures 15 and 16 contain plots of percent settlement (percent of actual loose lift thickness) versus number of roller passes, while a plot of settlement in feet as well as percent settlement versus actual loose lift thickness is given in fig. 17. Settlement readings were averaged from readings taken at all 36 grid points as was done previously at the Beltzville project. An examination of figs. 15 and 16 reveals that the second 4-ft lift (for which the previously described selective loading procedure to obtain plus 3 in. rock was used) had the best settlement characteristics; all the other lifts that contained excessive fines showed less settlement except for the 2-ft lift of section 3. The curve for the second 3-ft lift, which was rolled in the forward direction only, indicates slightly more settlement than does the curve for the first 3-ft lift, which was rolled in a forward-backward pattern, indicating that rolling in the forward direction only results in more settlement. However, since only surface settlements were measured, the settlement curve for lift 2 includes any additional settlement that may have occurred in lift 1 from rolling lift 2. The 5-ft lift (fig. 16) did not compact at all well, reaching less than 4 percent settlement after eight passes. It appears from fig. 17 that a 3-ft lift thickness could be chosen as an upper limit in selecting the loose lift thickness for actual construction since the curves for six and eight passes show less settlement in feet occurring in lifts thicker than 3 ft. Also, the percent settlement of lifts thicker than 3 ft was significantly less under six and eight passes than for thinner lifts. (This same type of behavior occurs for some of the data from the Cougar test fill and is discussed in more detail in paragraph 56.) Caution should be exercised in interpreting this kind of data, and it should never be the sole means of selecting variables for prototype construction. For instance, it appears from the lower plot in fig. 17 that the same percent settlement can be obtained

with eight passes on a lift of 5-ft thickness as could be obtained with four passes on a 3-ft lift. However, the uniformity of compaction with depth in the two lifts may be very different. This is why it is very important to include observational results from inspection trenches, and all other available data when evaluating test fill results. Both sets of curves in figs. 15-17 clearly indicate that six passes of the vibratory roller accounted for most of the total settlement obtained by eight passes at lift thicknesses of 3 ft or less.

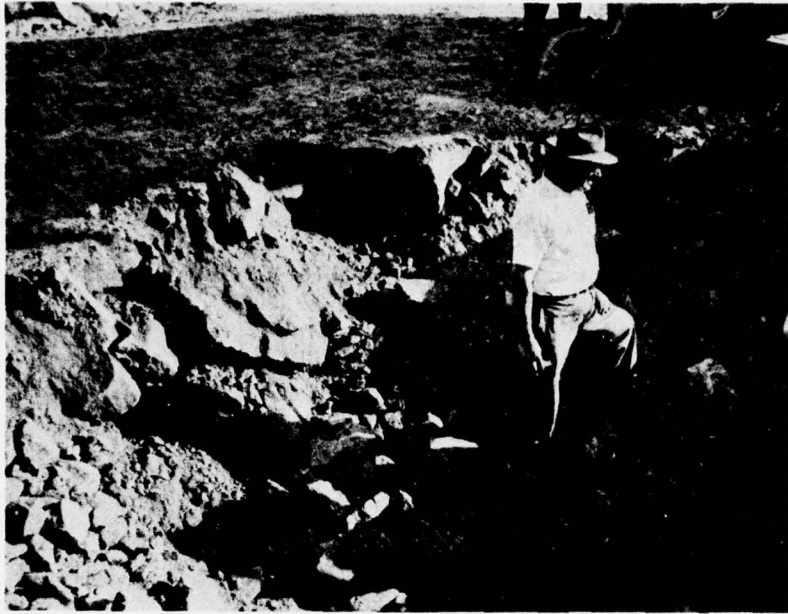
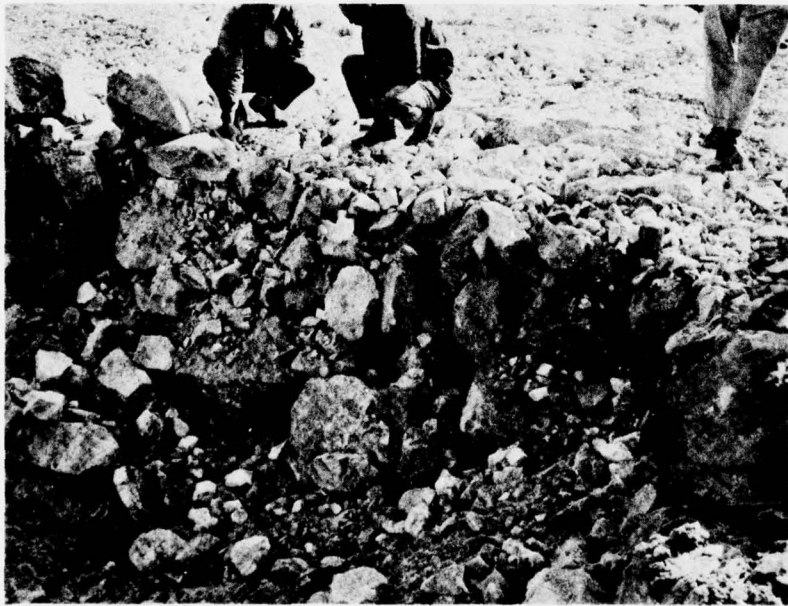
Fig. 18. Inspection trenches, Laurel test fill

a. Second 3-ft lift

b. Second 4-ft lift

- c. Inspection trenches. Visual observations of the inspection trenches revealed the following: (1) the 2-ft lift (lift 1, section 3) had practically no voids, being choked throughout by fines; (2) the upper 12 in. or so of both 3-ft lifts (section 2), the first 4-ft lift (section 1), and the 5-ft lift (lift 2, section 3) contained considerable amounts of fines, while the lower portions contained few fines but satisfactory rock-to-rock contact was in evidence; and (3) the second 4-ft lift (section 1), where plus 3-in. material was placed, revealed a much better distribution of fines throughout its entire depth. An inspection trench in the second 4-ft lift is compared to one in the second 3-ft lift in fig. 18; the greater number of fines in the 3-ft lift is evident.

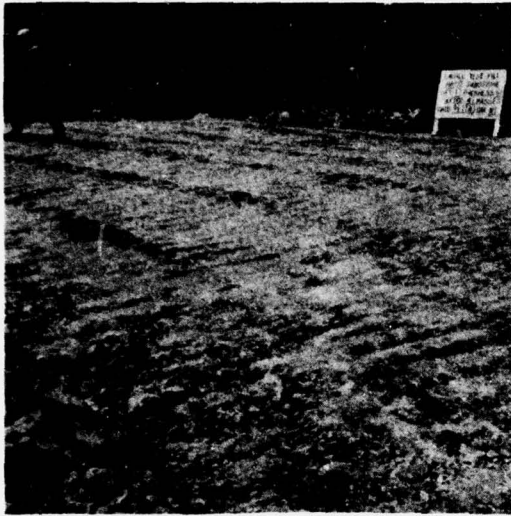
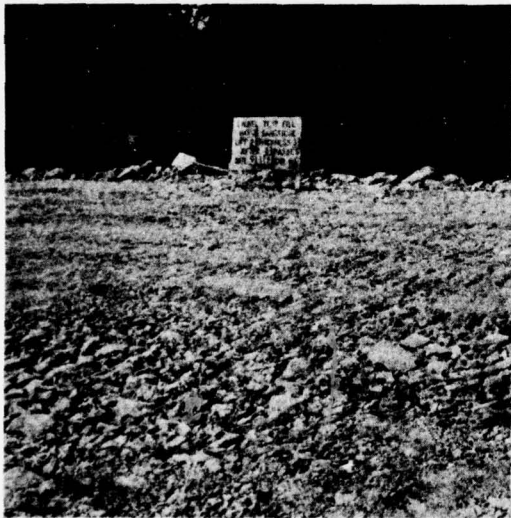
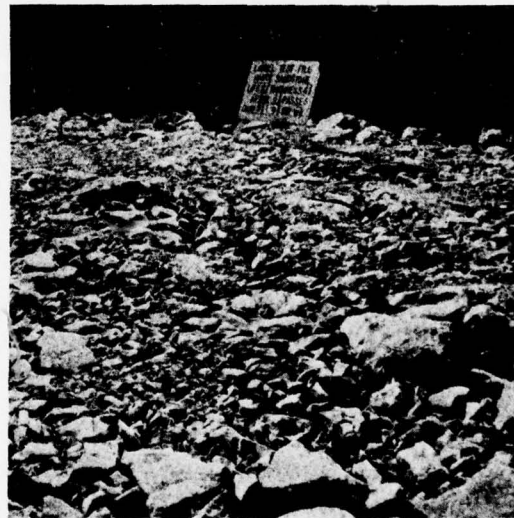
5-ft lift (quarry run)

a. After four passes

Second 3-ft lift (quarry run)

Second 4-ft lift (plus 3 in. only)

b. After six passes

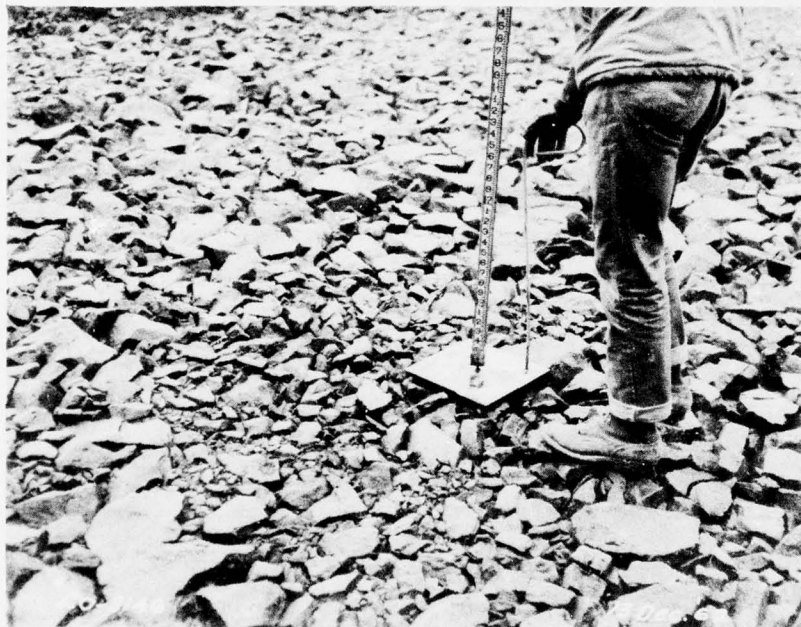
Fig. 27. Apparatus for taking level readings, Cougar test fill

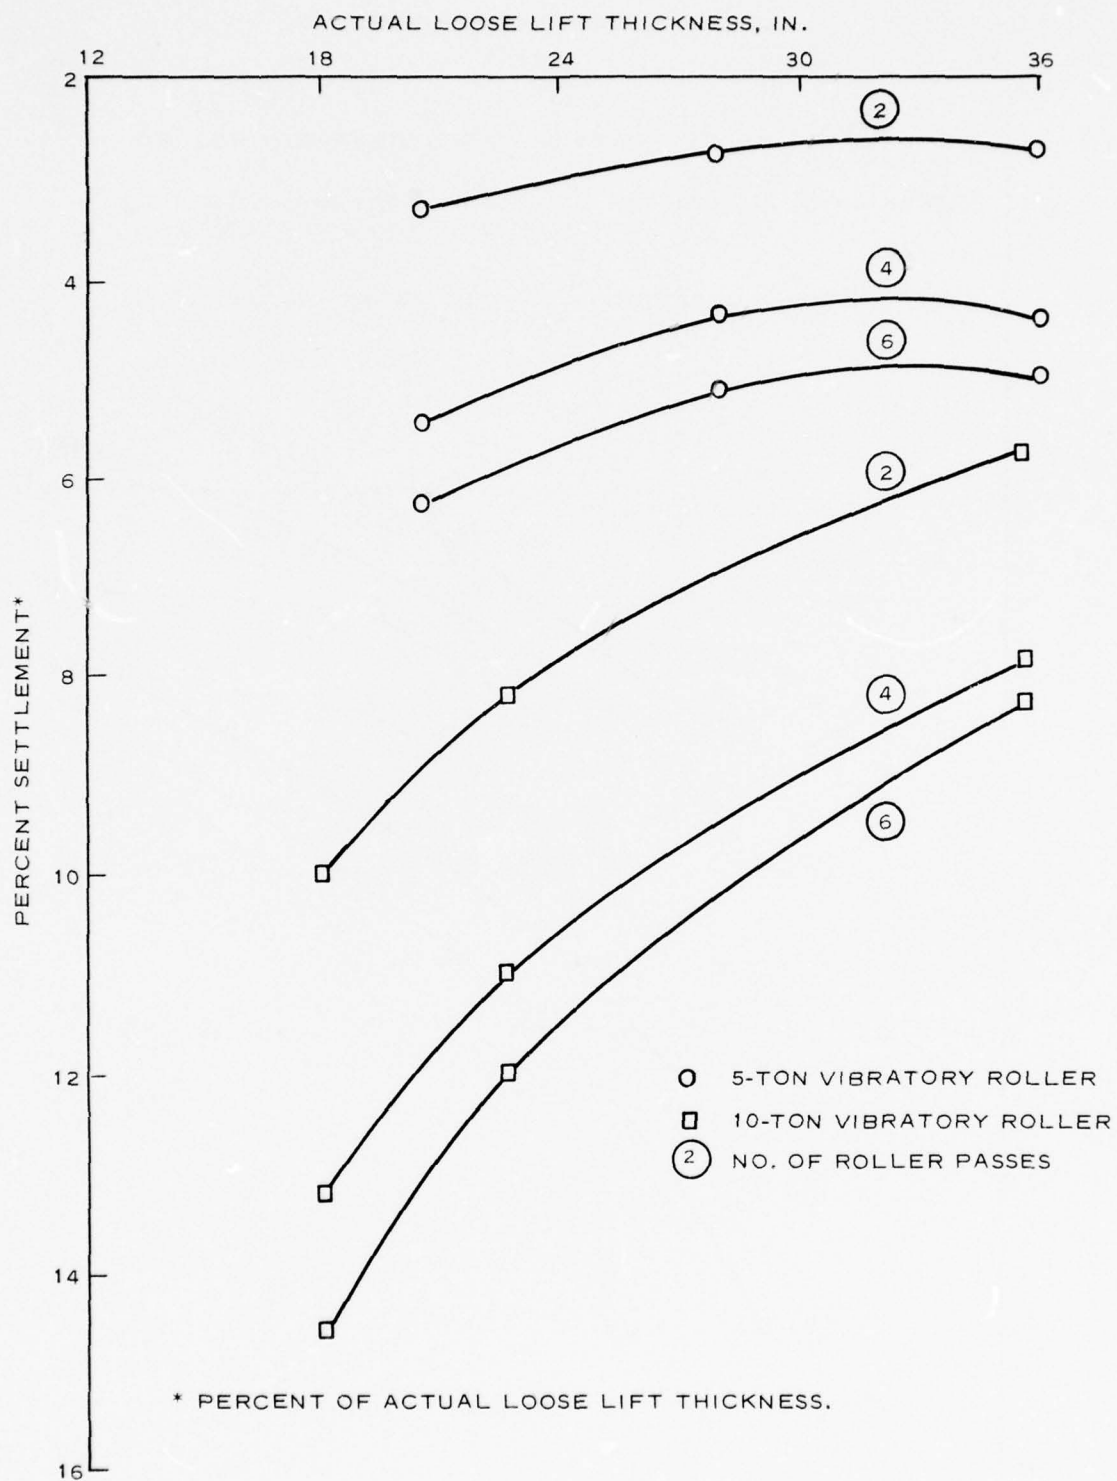
Fig. 28. Percent settlement vs actual loose lift thickness, test fill series 2, Cougar test fill

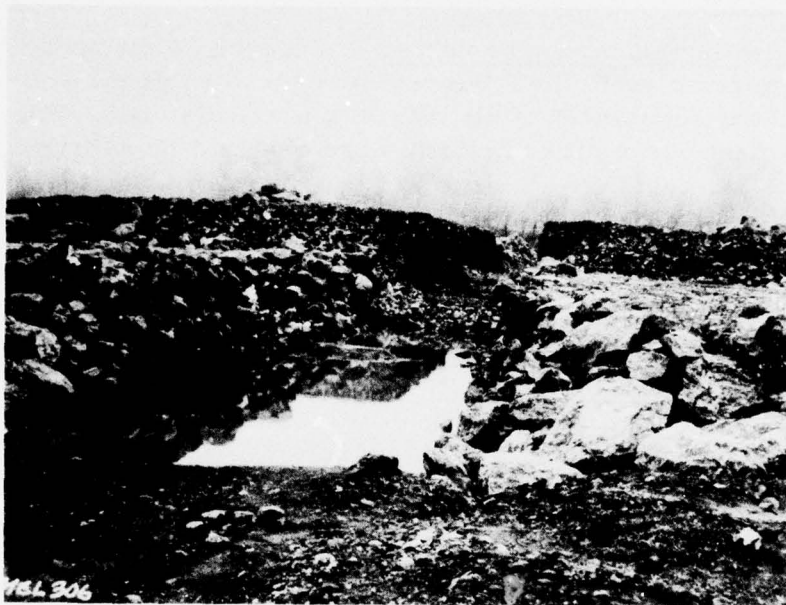
View of transverse cut through rock test fill embankments.  
From front to back:

<u>Test Fill No.</u>	<u>Description</u>
1	Weathered rock (6- to 18-in.)
2	Weathered rock (Minus 6-in. transition)
3	Unweathered rock (Minus 6-in. transition)
4	Unweathered rock (6- to 18-in.)

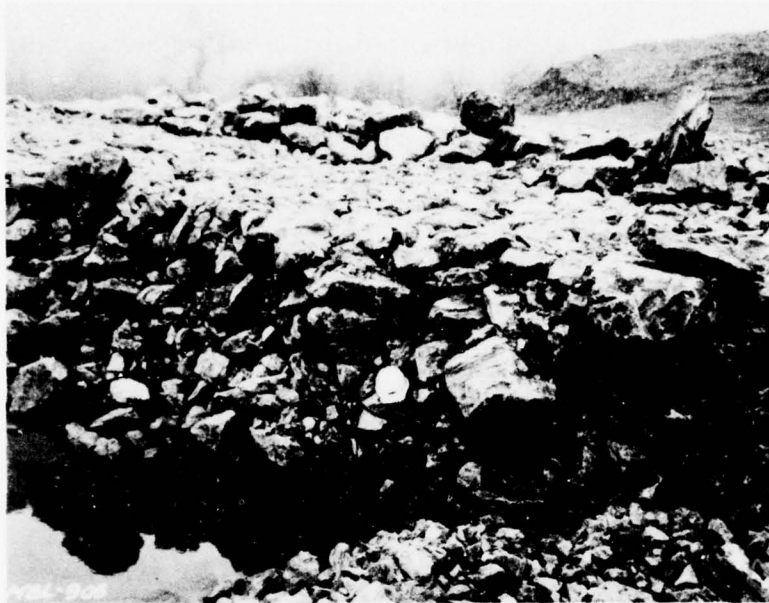
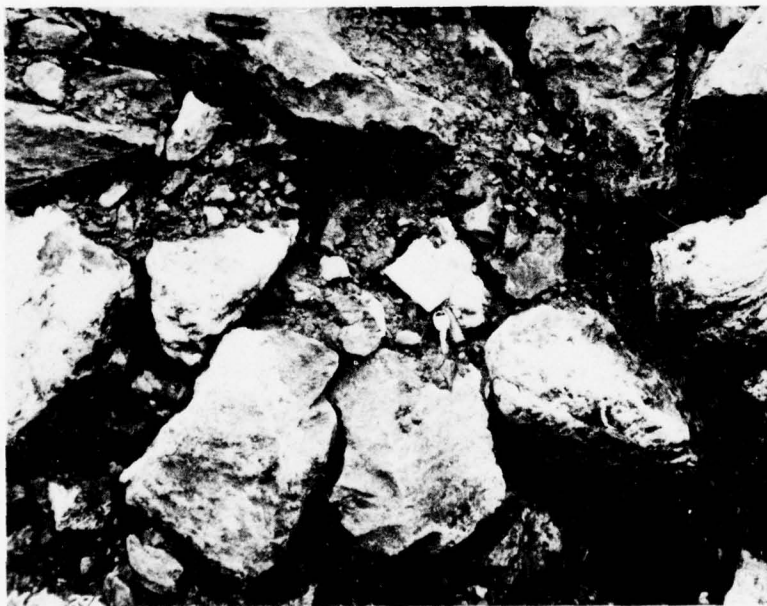
Fig. 41. Inspection trench, test fill 1, New Melones test fill

a. Section of rock test fill 1  
(6- to 18-in. weathered rock)

b. Closeup view of rock test fill 1  
(6- to 18-in. weathered rock)

were punched down into the smaller surrounding rock. Observation of the compacted rock fill in the inspection trench revealed a marked uniformity of appearance throughout the entire depth of the fills. There were no planes of demarkation at the lift boundaries, and the rock was well interlocked. Fines appeared to be well distributed in the voids. Photographs of the sections through test fills 1 and 4 are shown in figs. 41 and 42.

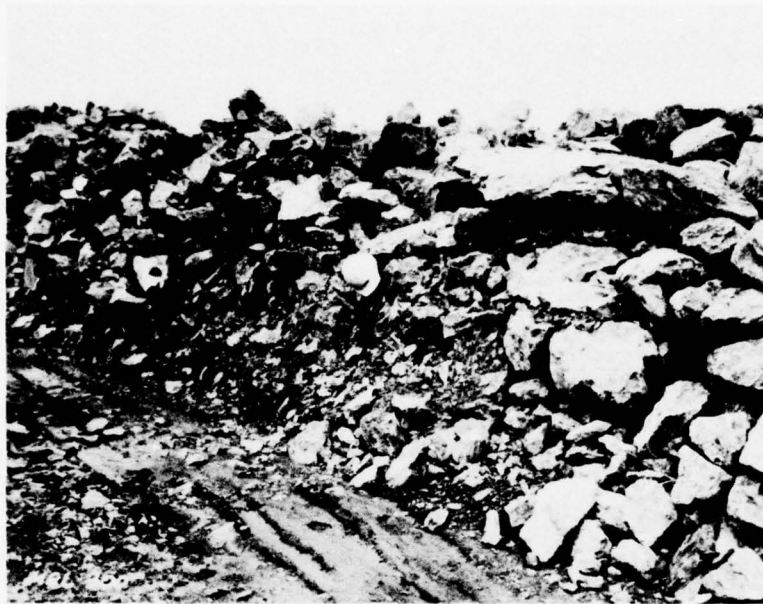
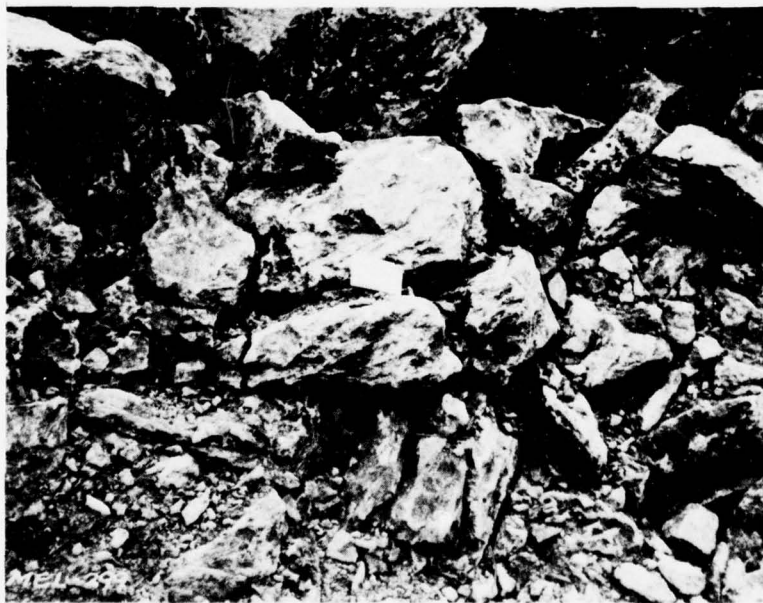
Fig. 42. Inspection trench, test fill 4, New Melones test fill

a. Section of rock test fill 4  
(6- to 18-in. unweathered rock)

b. Closeup view of rock test fill 4  
(6- to 18-in. unweathered rock)

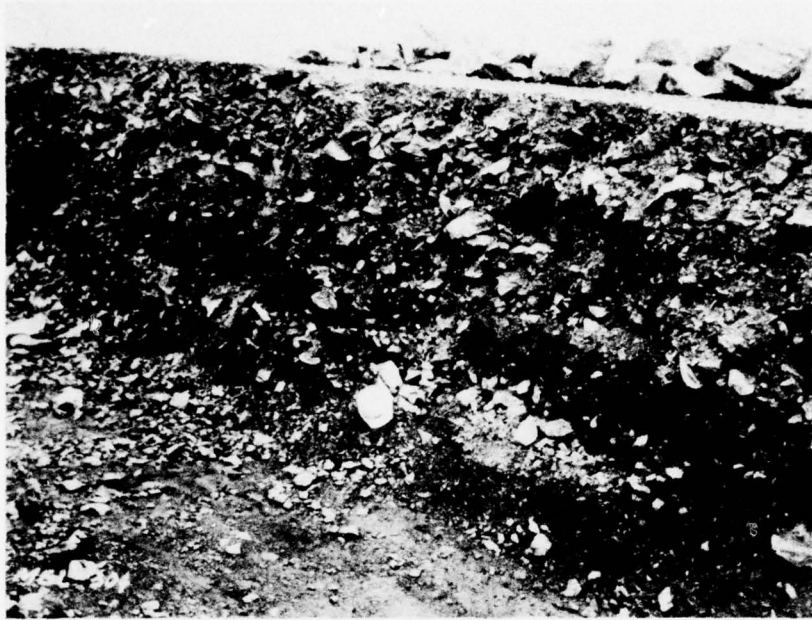
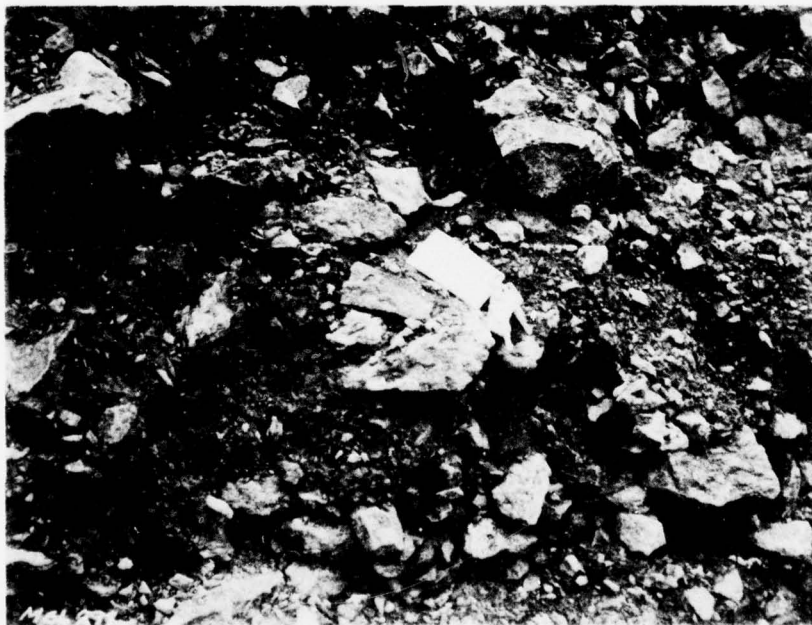
a. Section of rock test fill 2  
(minus 6-in. weathered rock transition)

b. Closeup view of rock test fill 2  
(minus 6-in. weathered rock transition)

Fig. 43. Inspection trench, test fill 2, New Melones test fill

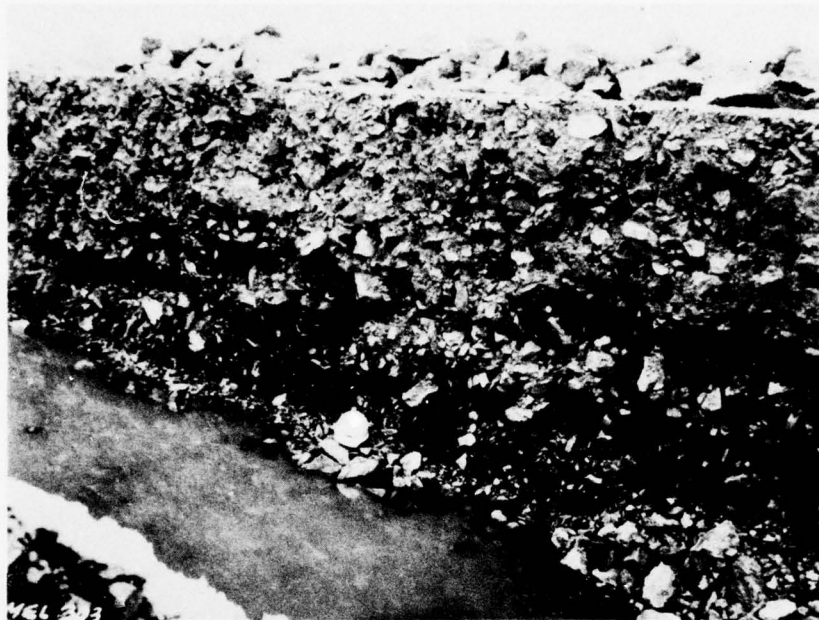
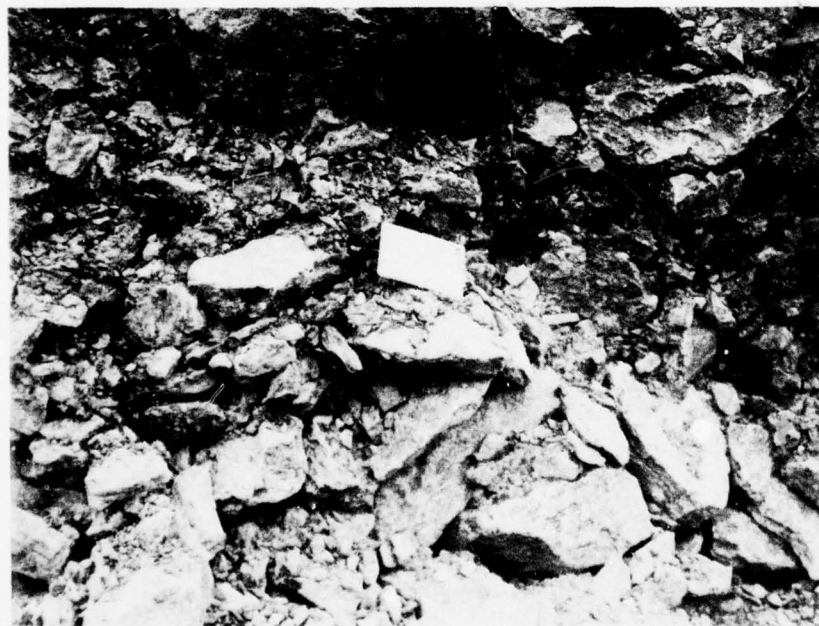
Fig. 44. Inspection trench, test fill 3, New Melones test fill

a. Section of rock test fill 3  
(minus 6-in. unweathered rock transition)

b. Closeup view of rock test fill 3  
(minus 6-in. unweathered rock transition)

- (2) An examination of test fills 2 and 3 (minus 6-in. rock) revealed some tendency toward stratification of the rock fragments. Dumping and spreading operations were probably the major cause of the stratified appearance; although it was noticed that during compaction of test fill 2 (weathered material), the surface material was reduced to a fine-grained material similar to a soil. As the rock was dumped and spread by dozer, the coarse rock rolled ahead and to the sides of the pile, resting on top of the previously compacted surface of the lift below and forming a thin layer of segregated coarse material at the lift boundary. Interlocking between lifts was generally poor, due to the coarse material overlying the extremely smooth surface of the underlying lift. Photographs of the trench through test fills 2 and 3 are shown in figs. 43 and 44.

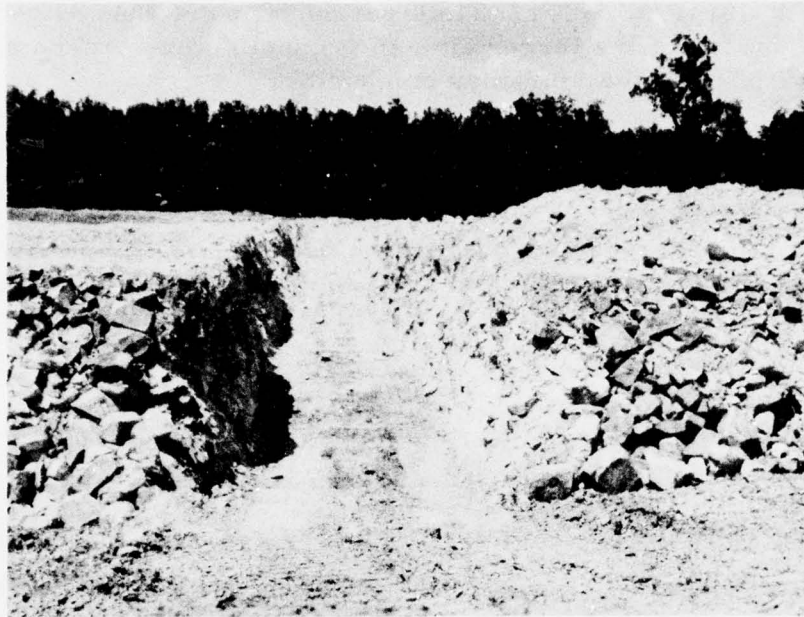
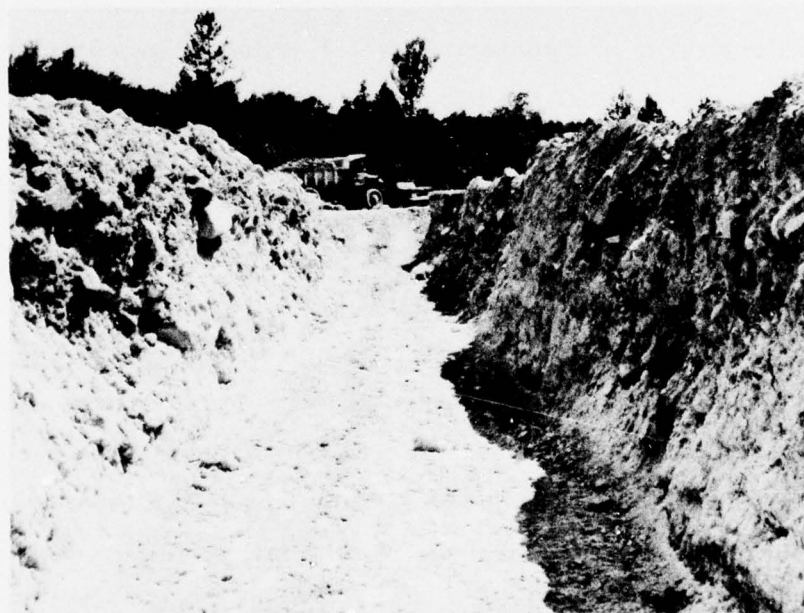
Fig. 59. Inspection trench, Gillham test fill

a. View north, inspection trench excavation

b. View south, inspection trench excavation

- d. Inspection trench. Visual examination of the inspection trench confirmed the tightness and unusually high degree of stability of all compacted material. No mention was made of any segregated or stratified zones or that any evidence of poor bonding between lifts was found. Two views of the inspection trench are shown in the photographs in fig. 59.
