MOST Project NRL Memorandum Report 1219

NRL FIELD SITE, BOCA RATON, FLORIDA

The NRL Field Site at Boca Raton, Florida is a radar test facility adjacent to deep-ocean water on the Atlantic Coast. It has two buildings with 1080 square feet of floor space and a sixty-five foot radar tower. A detailed description is given of the site and the utilities available.

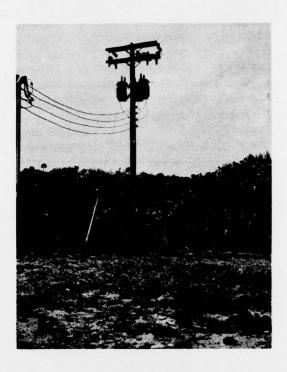
Fig. 10 - Main disconnect panel

Electrical power is supplied to the site by the Florida Power and Light Company, whose local office is located in Delray Beach, Florida. One hundred kilowatt, 120/208 volt, three-phase, four-wire

service is available. The main disconnect panel is located about seventy-five feet southwest of the south building and is well clear of the driveway to the buildings (Fig. 10). Two separate four-wire cables run underground to the north building. One runs through a metal conduit and terminates in a switch box that controls the rotation of the rapid-scan radar antenna. The other is a rubber-jacketed cable which terminates in a junction box. This junction box feeds two distribution boxes which are located on the west wall of the north building and provides a cable plug for the van containing electronic equipment. There is also a rubber-jacketed cable running from the junction box to the north wall of the south building where the radar transmitter disconnect switch is located. Since the interior of the buildings is not finished, the wiring from the distribution boxes to numerous lights and outlets is installed on the surface of the walls and ceilings.

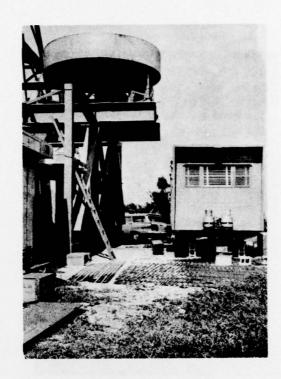
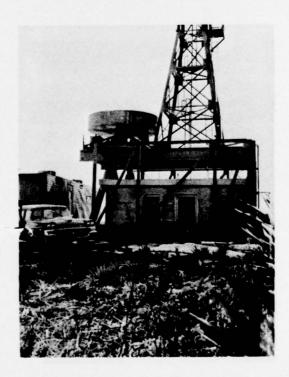
The tower was designed and erected by the G.B. Electronics Corporation. Their Drawing No. 900899 shows the tower assembly and structure. The tower consists of three sections. The lower section is fifteen feet high and was designed to mount a fourteen foot diameter rapid-scan antenna system to seaward of the center section of the tower (Figs.12 and 13). Two large 1-beams extend six feet beyond the truss on the east side of the tower to accommodate the rapid-scan antenna. The truss construction of the north and east sides of the lower section can be seen in Figs. 12 and 13. The lower section of the tower completely surrounds the north building.

Fig. 12 - Lower section of tower, east side

Fig. 13 - Lower and center sections of tower, north side

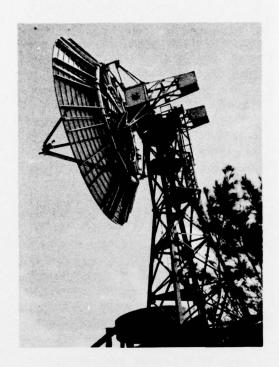
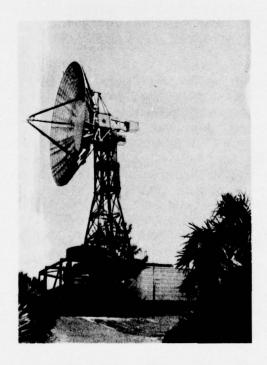
The center section of the tower, as well as the lower section, was assembled on the site by bolting together the pre-fabricated members. It is a thirty-foot section whose bottom cross-section is twelve feet square and tapers to a six foot square at its top (Figs 14 and 15).

The top section, a vertical weldment section, was bolted to the top of the center section. This section is twenty feet high giving a total tower height of sixty-five feet from the top of the footings. The pedestal containing two five-horsepower drive motors and the gear train to elevate and train the forty-foot parabolic antenna is bolted to the top of the tower.

Fig. 14 - Center and upper sections of tower

Fig. 15 - Full view of tower, west side

Vertical steel ladders run from the ground level to the pedestal. They are broken into ten-foot sections between the fifteen-foot level and the top of the tower and are offset from each other with steel gratings between the sections of the ladder at each level.
