**Structures Note 424**

**THE PERFORMANCE OF AIRCRAFT  
CONTROL CABLES  
UNDER SERVICE CONDITIONS**

| 7. Abstract<br><i>Investigations were conducted on the adverse effects of service conditions on the performance of flexible steel wire ropes used in aircraft control systems with particular reference to the Auster aircraft.</i> | |

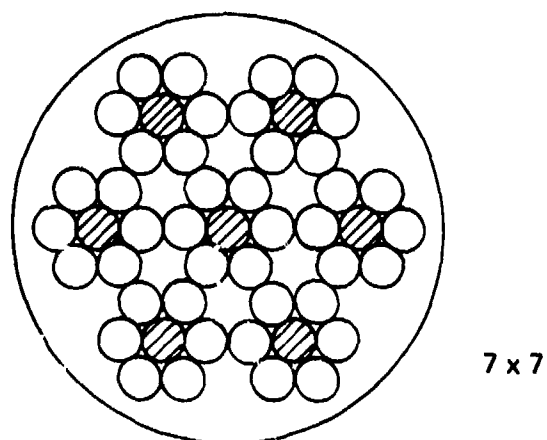
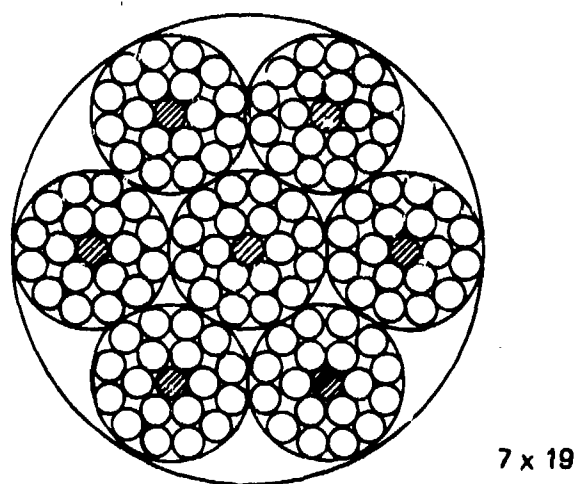
ARRANGEMENT OF WIRES IN 7 X 7 CABLE AND 7 X 19 CABLE

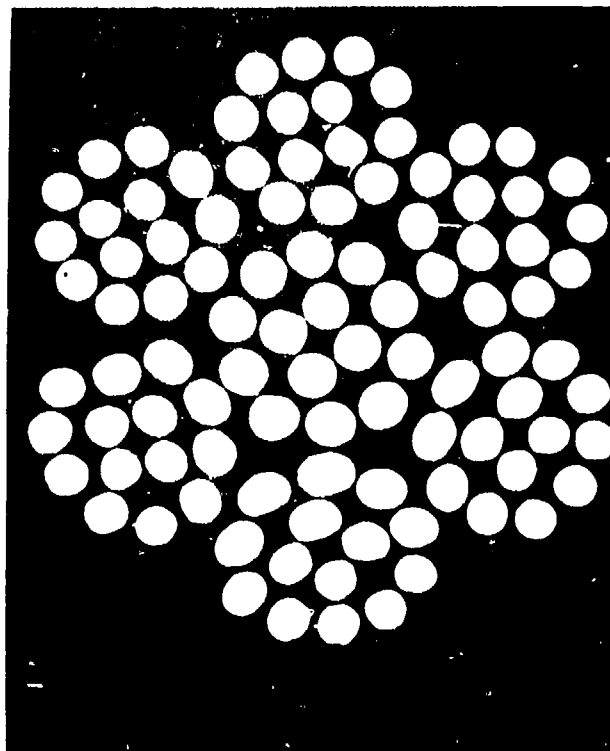
(a) As cut at one end

(b) Polished at the other end

ARRANGEMENT OF WIRES IN A 498 kN (10 CWT) 7 x 14 CABLE TO BSW 9  
(Set in araldite)

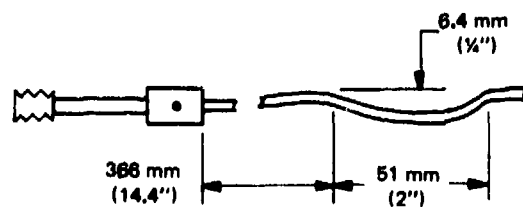
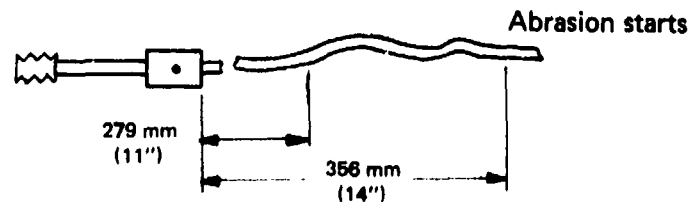
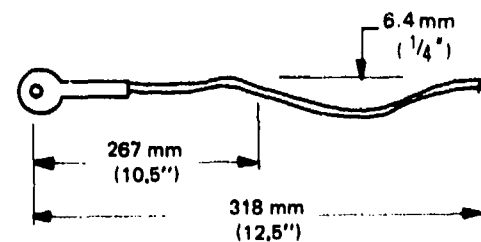
# Cable deformations

Stbd cable  
Horn . attachment end

Cable JA 2393X  
Port cable  
Horn . attachment end

Port cable  
Rudder pedal attachment end

## CABLES ON VHD

Corrosion 38 mm (1.5'') long.  
Cable JA 2393X

Corrosion 25.4 mm (1.0'') long  
Cable JA 2394X

In the Auster rudder cables most of the worn and distorted sections of cable occurred at 254-305mm (10 - 12 inches) from the rudder pedal eye attachment and 356mm (14 inches) from the horn turnbuckle attachment (Fig. 3). The wear for the former condition was at a change of direction pulley and the latter where the cable rubbed on the fabric fairlead or emerged from the rear fuselage. It was at this latter location where some of the cables were corroded and the position where VHC had severe internal corrosion which was not detected by external visual inspection.

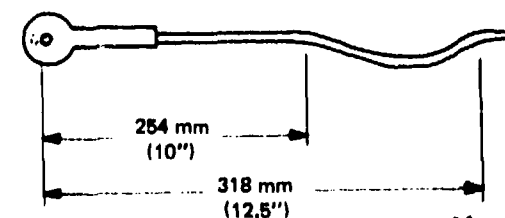
Max. abrasion measured 0.05 mm (0.002'') on dia.

## CABLES FROM VHC.

The 7 x 7 cable from VHC had worn approximately 0.051 mm (0.002 inch) where it had rubbed on the fabric but had no other abnormal change in appearance. However, extremely close inspection revealed a slight discolouration at the point of the strands. Cutting of the cable and subsequent inspection with a microscope showed that a considerable area of the strand in contact with the core strand had corroded and brinelling of the wires of adjacent strands had also occurred. This damage was attributed to the continual hammering and rubbing between the wires of the cable under fluctuating tension arising from cable vibration due to rudder buffeting from the propeller slipstream. However, the same state of corrosion and brinelling was found in a 7 x 14 cable removed from a glider where vibration could occur due to self excitation or running over uneven ground surfaces. It was interesting to note that this glider cable, while showing outer wear of approx. 0.051 mm (0.002 inch) had several core strand wires failed as shown in Fig. 7. In another glider cable wires in several strands had failed in fatigue at various locations but little or no wear was externally evident (Fig. 8). It was only after several inspections of the cable that these wires were observed because the fractures were of such a nature that the "cloth method" of detection (Ref. 6) did not indicate any failed wires.

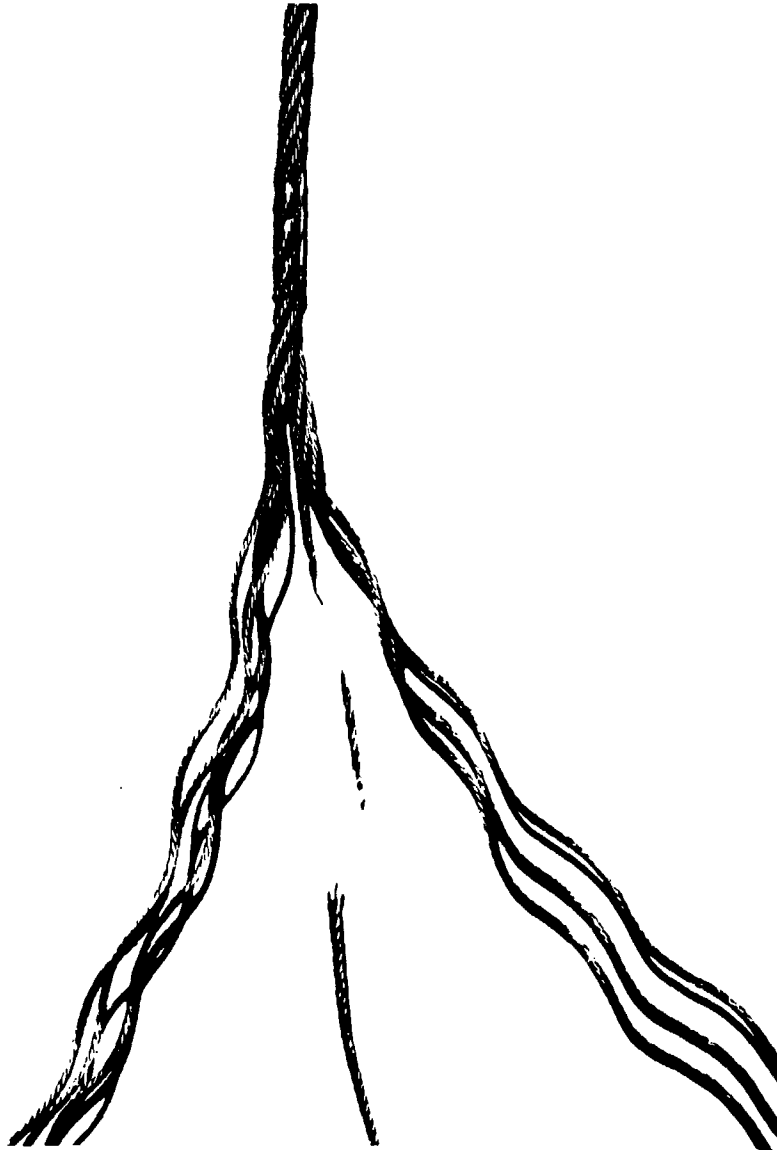
Neg. no. 5409

FIG. 5 STRAND FAILURE IN VHB SHOWING DAMAGE BETWEEN WIRES.

INTERNAL WIRE DAMAGE IN CORE STRAND VHE

In the 7 x 7 cable VHB the wires showed no marked external abrasion but were heavily damaged consistent with high pressure between wires. There was considerable deformation and in some strands the core wire had assumed a hexagonal cross-section under pressure, which was

probably combined with rubbing, from the surrounding wires. Fig. 5 shows a photo of the failure in which the damage to the wires can be clearly seen.

The difficulty of detecting internal wire damage was emphasised when the operator of VHE removed both 7 x 14 rudder cables two flying hours after a Certificate of Airworthiness because of a broken wire found in one of the cables. These cables were examined in the laboratory and one was found to have a completely broken core strand, each side of the fracture was corroded a distance of about 12.7 mm ( $\frac{1}{2}$  inch) and indications were that failure had existed for some time prior to the inspection.

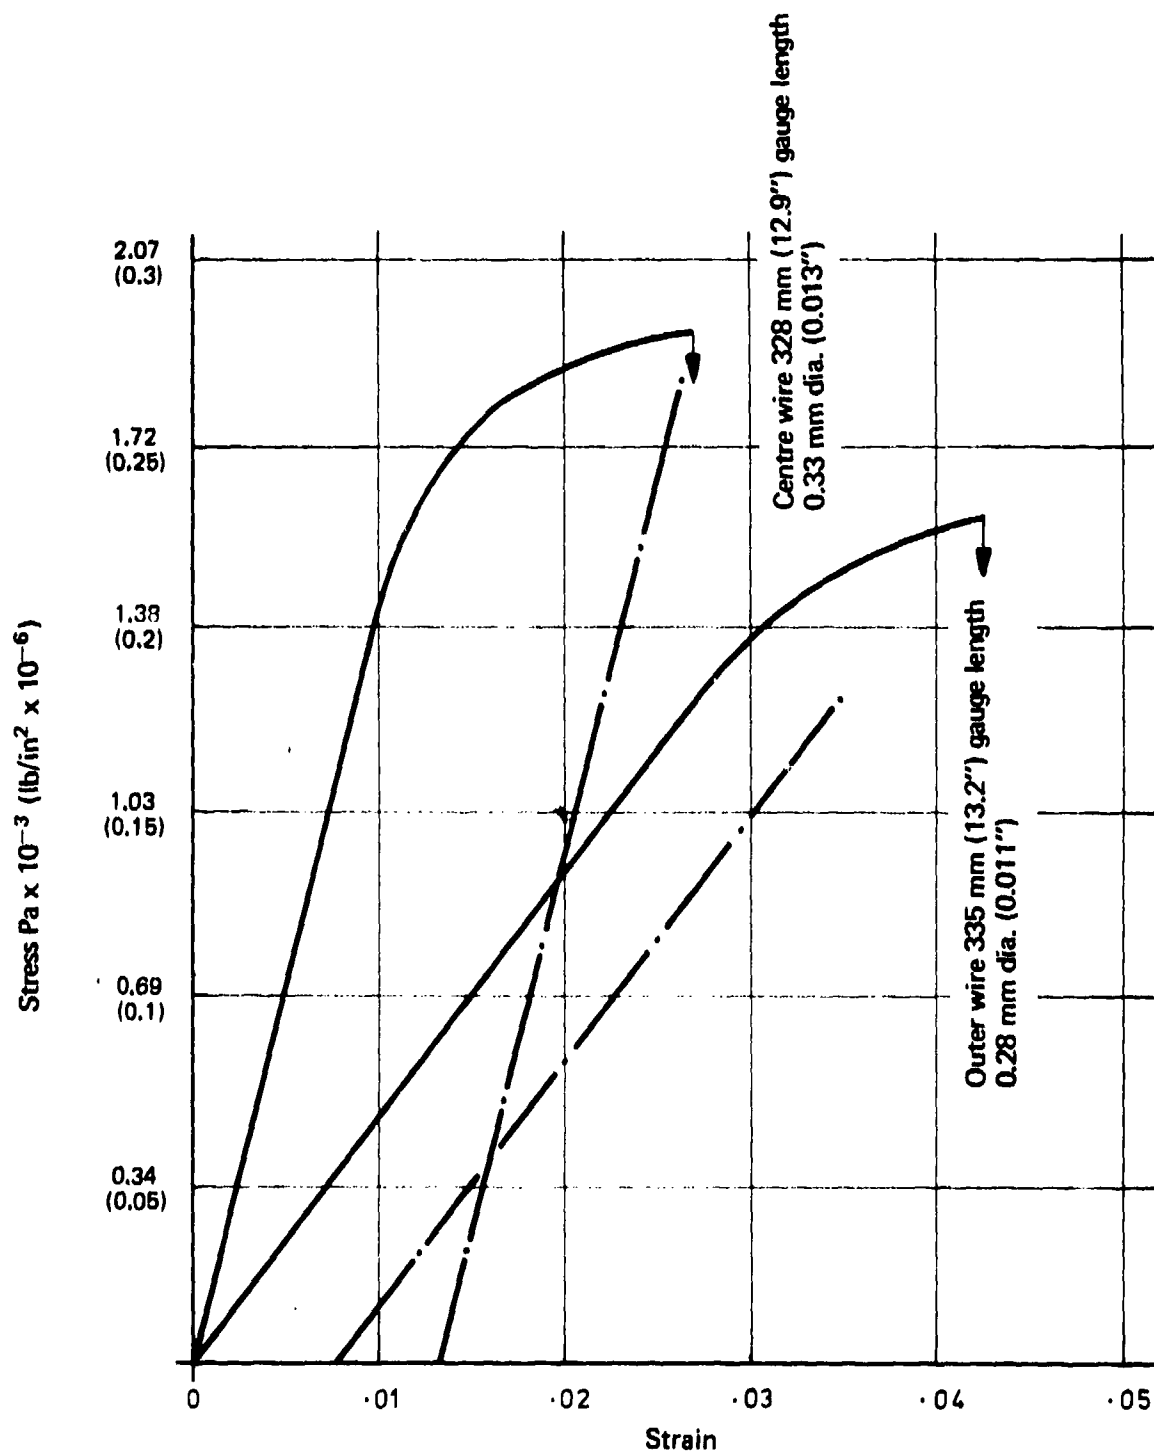
STRESS-STRAIN CURVES FOR TWO WIRES OF A 10 CWT (498 kN)  
7 X 7 GALVANIZED CABLE.

However, these graphs give the average tensile stress and an indication of the plastic elongation at failure. It is interesting to note that both the ultimate stress and the plastic deformation of the outer wire appear to be significantly less than the centre wire. It is possible that this effect is due to the superimposed bending stresses applied in straightening the preformed outer wire. In such very hard drawn wires these stresses are likely to be quite significant.

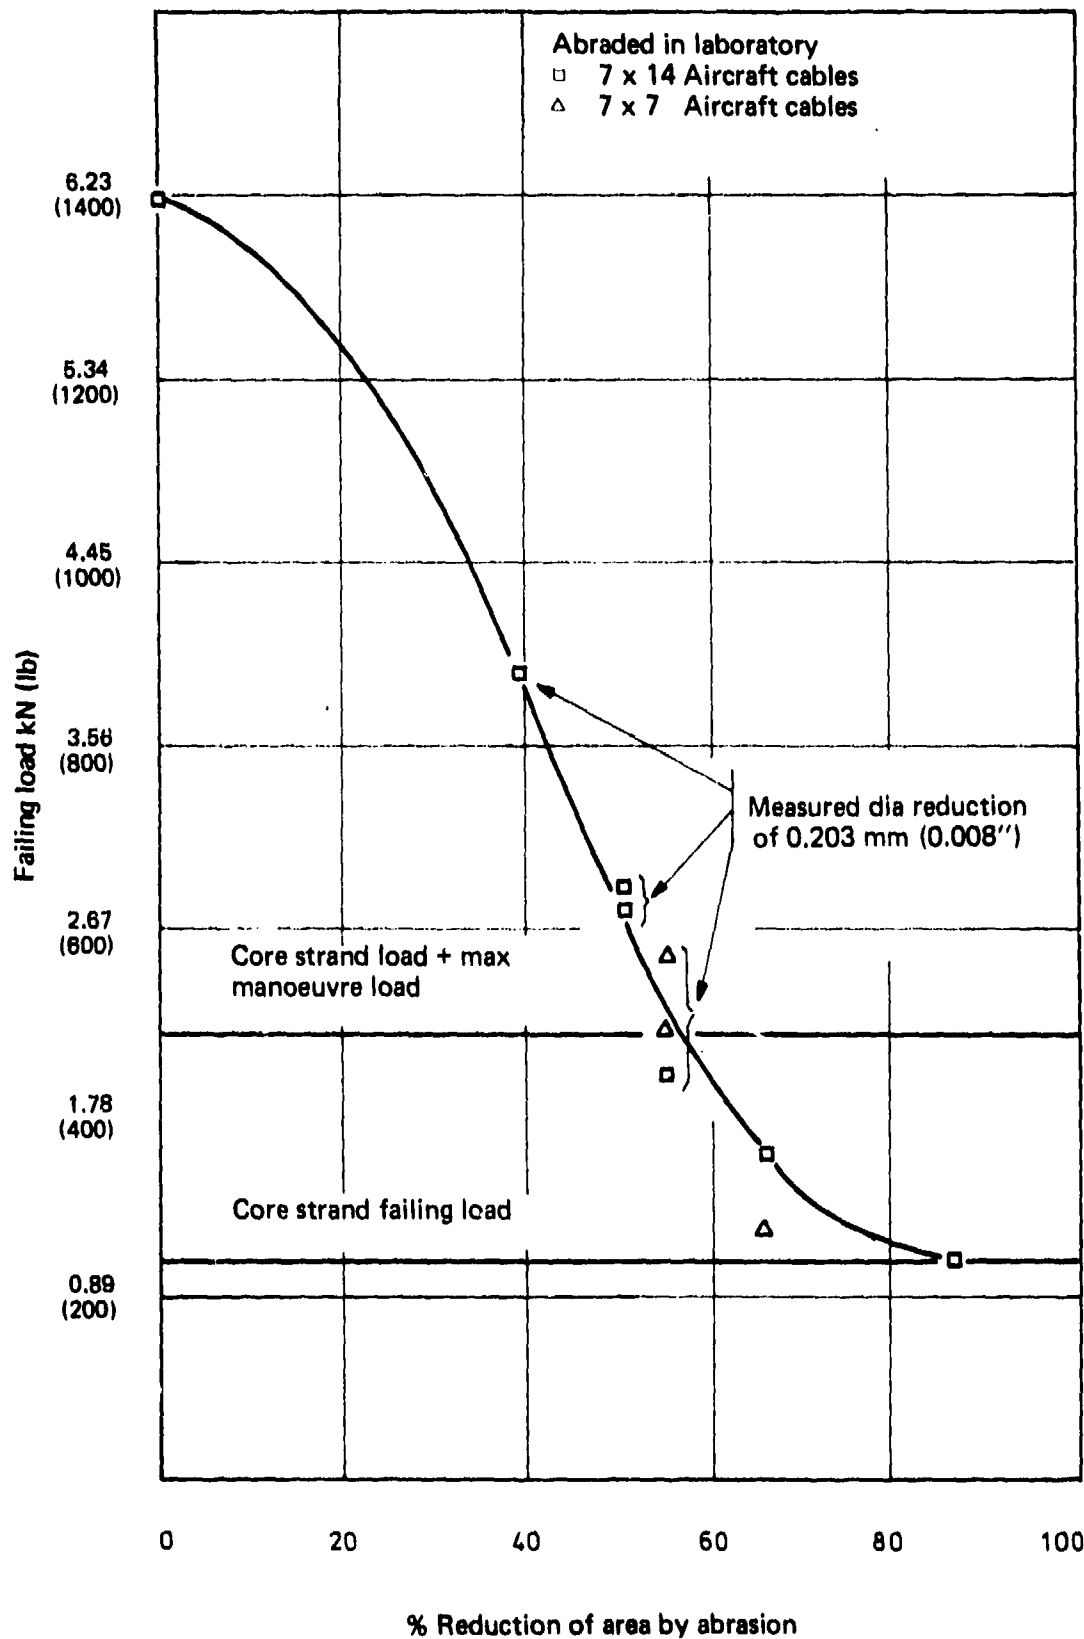
VARIATION OF FAILING LOAD WITH REDUCTION IN AREA OF CABLE.

By microscopical examination of each cable tested the area of the failed section of each wire was measured to within an estimated 5%. This enabled the failing load to be plotted against percentage reduction of area in Fig. 10, and against reduction of cable diameter in Fig. 11. There is a considerable variation in results but curves have been drawn through average values. The percentage reduction of area was estimated by the microscopic examination of abraded cables that had failed in service and an estimate of the expected failing load could be obtained from Fig. 10.

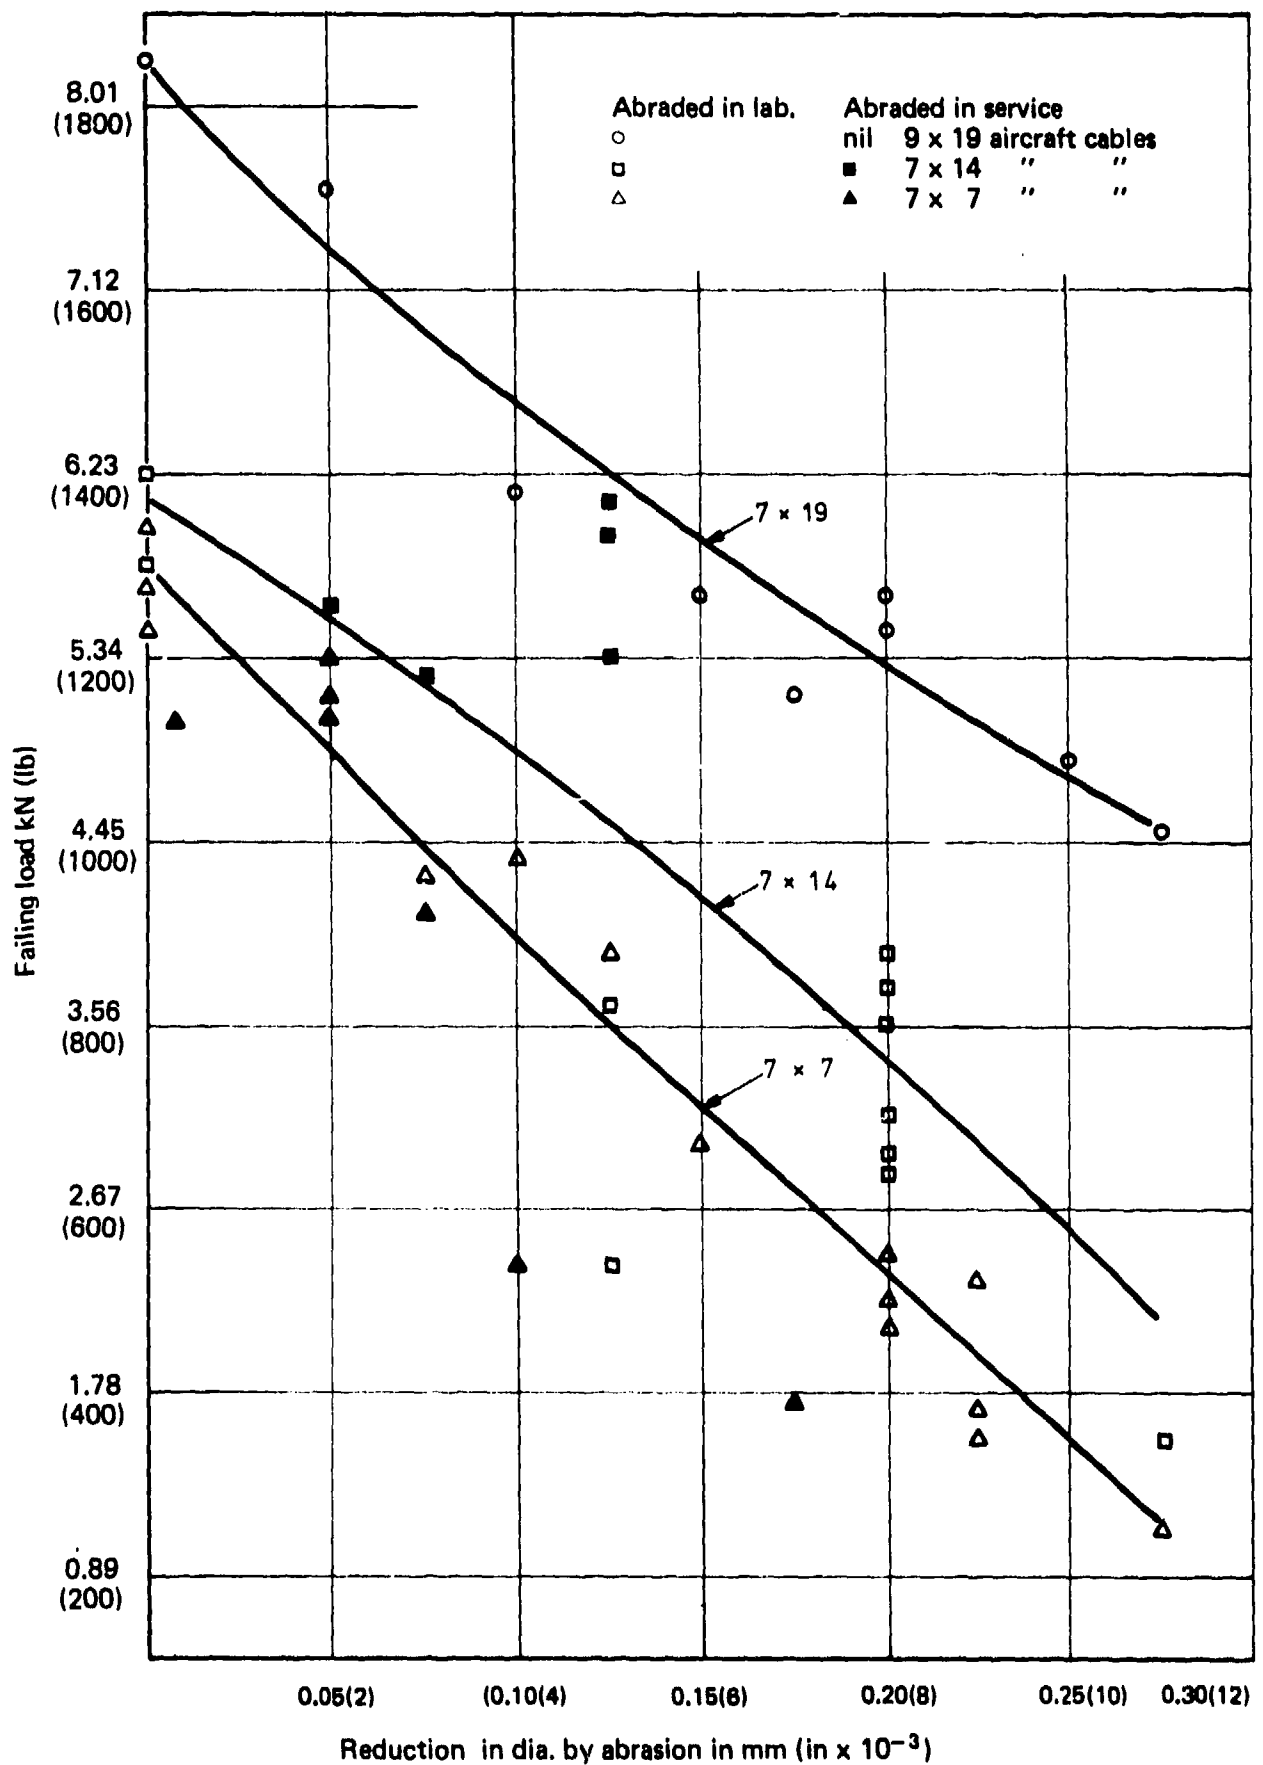
FAILING LOAD OF ABRAIDED CABLES ( Extracted from ref. 1.)

To investigate the effect of wear in service, the minimum diameter of the worn cables taken from service was measured and the failing load determined in a tension test. New cables were also abraded using fine emery cloth and rubbing the cable by hand in a longitudinal direction over a length of three inches and around one third of the circumference. This corresponded to the extent of the worn area observed on cables from service. The failing load of the cable was then determined in a testing machine, the overall length of the cable being 610 mm (24 inches).

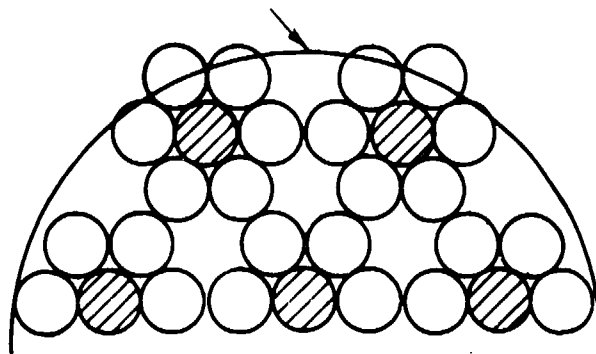
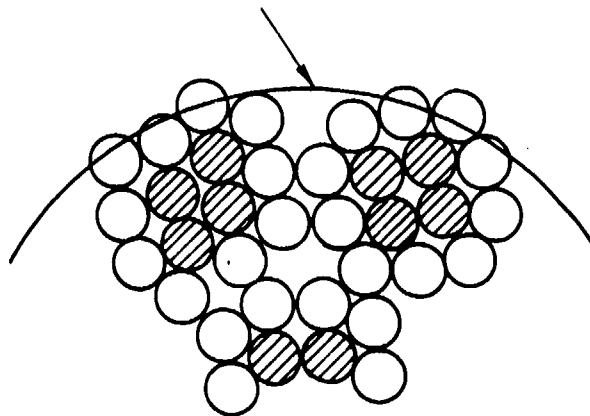
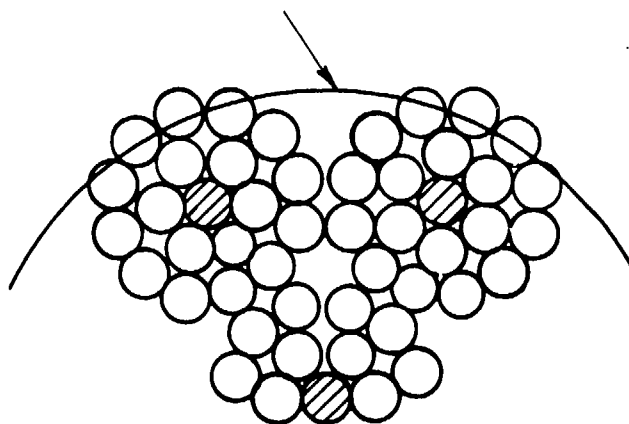
0.15 mm (0.006'') wear line

7 x 7

wire dia. 0.28 mm (0.011'')  
cable dia. 2.59 mm (0.102'')

0.15 mm (0.006'') wear line.

7 x 14

wire dia. 0.23 mm (0.009'')  
cable dia. 2.90 mm (0.114'')

7 x 19

wire dia. 0.20 mm (0.008'')  
cable dia. 3.35 mm (0.132'')

WEAR ON INDIVIDUAL WIRES OF VARIOUS CABLES.
