USAAMRDL-TR-77-41

HEAVY LIFT HELICOPTER - ADVANCED TECHNOLOGY  
COMPONENT PROGRAM - ROTOR BLADE

Boeing Vertol Company  
P.O. Box 16858  
Philadelphia, Pa. 19142

Final Report for Period July 1971 - July 1975

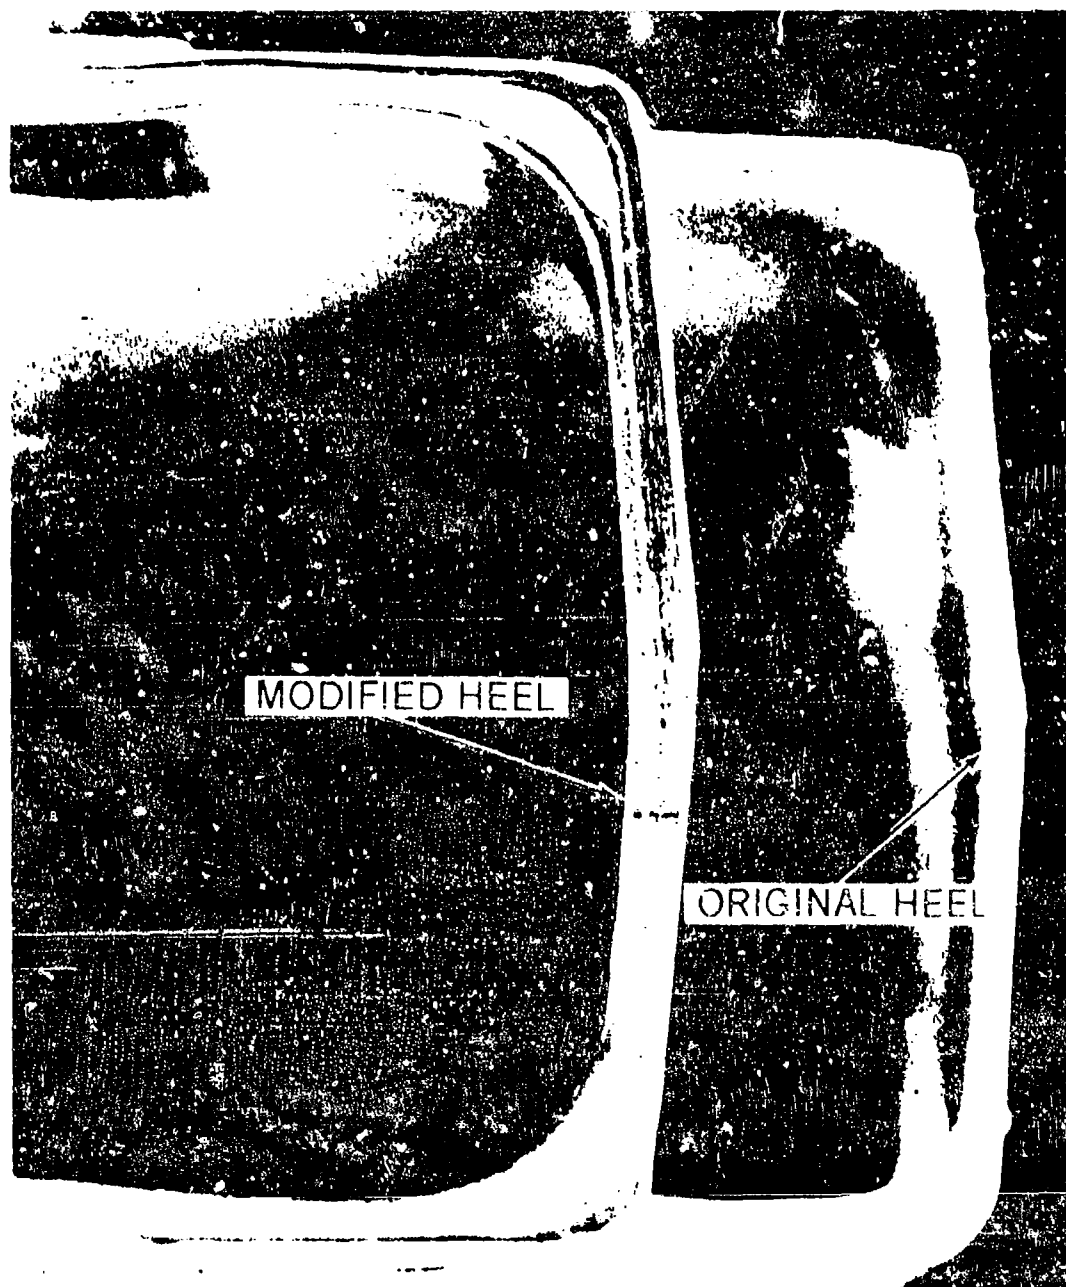
Figure 36. Comparison of HLH Spar Heels Before and After Modifications
