CEEDO-TR-78-32

THIRD INTERIM TECHNICAL REPORT  
ON USAFA SOLAR TEST HOUSE--  
DESIGN PARAMETERS

SEPTEMBER 1978

**CIVIL AND ENVIRONMENTAL  
ENGINEERING DEVELOPMENT OFFICE**

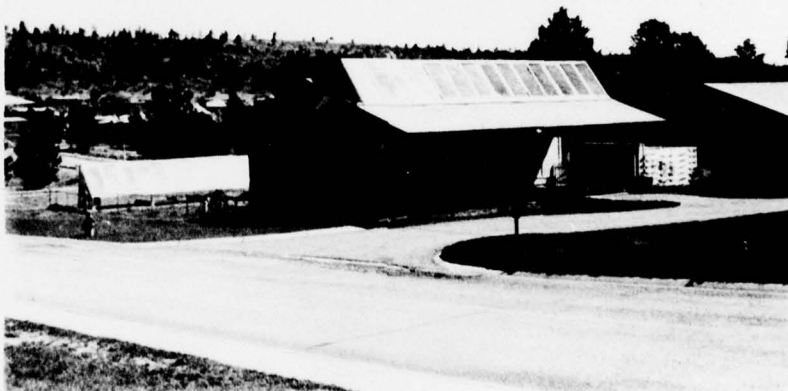
Figure 1-1. USAFA Solar Test House

This interim technical report describes the continuing performance of the Solar Test House at the United States Air Force Academy (Figure 1-1) from May 1977 to April 1978. This report is the third in a series of reports aimed at evaluating the data collected by the data and control system at the house. Data analysis, evaluation of modifications made to improve the performance of the various systems, evaluation of improved overall efficiency, and design parameter analysis are the main points of this report. The first interim technical report, FJSRL TR-76-0008, September 1976 [8], should be referenced for details on original system construction. The second interim technical report, FJSRL TR-77-0016 and CEEDO-TR-77-34, September 1977 [3], should be referenced for details on subsequent changes in the original construction and initial data analysis.

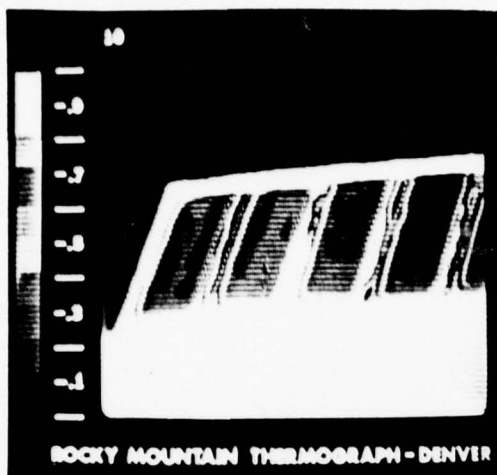
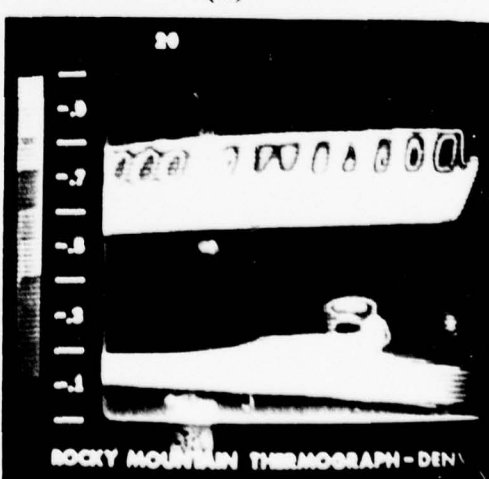
Figure 4-1. Thermography Studies

Figure 4-1a shows a typical thermograph of the first cluster of the roof array. This picture indicates a normal flow pattern with a temperature difference of approximately 30°C between the first and third panels. The fourth panel in the picture, which is the first one of the second or next cluster, is the same temperature as

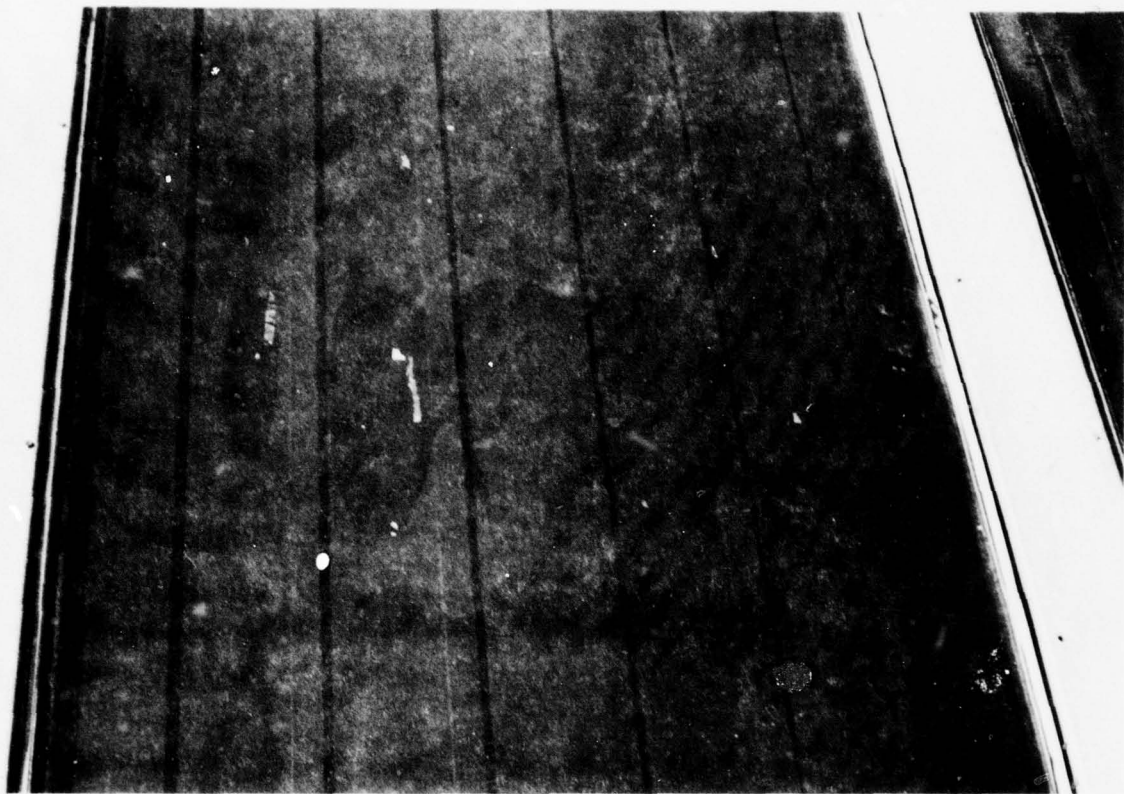
The collectors themselves have performed very well since actual data gathering on performance started in December 1975. However, minor surface deterioration has occurred on some of the collector absorption surfaces. Figure 5-11 shows this deterioration on one of the roof array panels. The surface paint has peeled off in a few locations on this collector to expose the copper underneath to direct sunlight. This specific panel's surface was the worst one of all the collectors, and the vast majority of them do not have any failures at all. This minor amount of peeling was not considered a significant problem. The stains that show up in this figure are from the outgassing mentioned in the first interim technical report. The absorbing surfaces were allowed to be in the sun without fluid flow during the first days of installation and these patterns of stains on the glass resulted. Both of these problems, the surface deterioration and the glass being stained, will be investigated by cadets in the materials area through individual research projects.

Figure 5-11a. Absorbing Surface Deterioration  
(Roof Array)

Figure 5-11b. Absorbing Surface Deterioration  
(Close-up)
