**February 1973**

MAINTENANCE-HISTORY ANALYSIS OF  
MAIN FEED PUMP TURBINES  
FOR DDG-2 CLASS SHIPS

ARINC Research Corporation  
a Subsidiary of Aeronautical Radio, Inc.  
2551 Riva Road  
Annapolis, Maryland 21401  
Publication 1012-01-2-1231

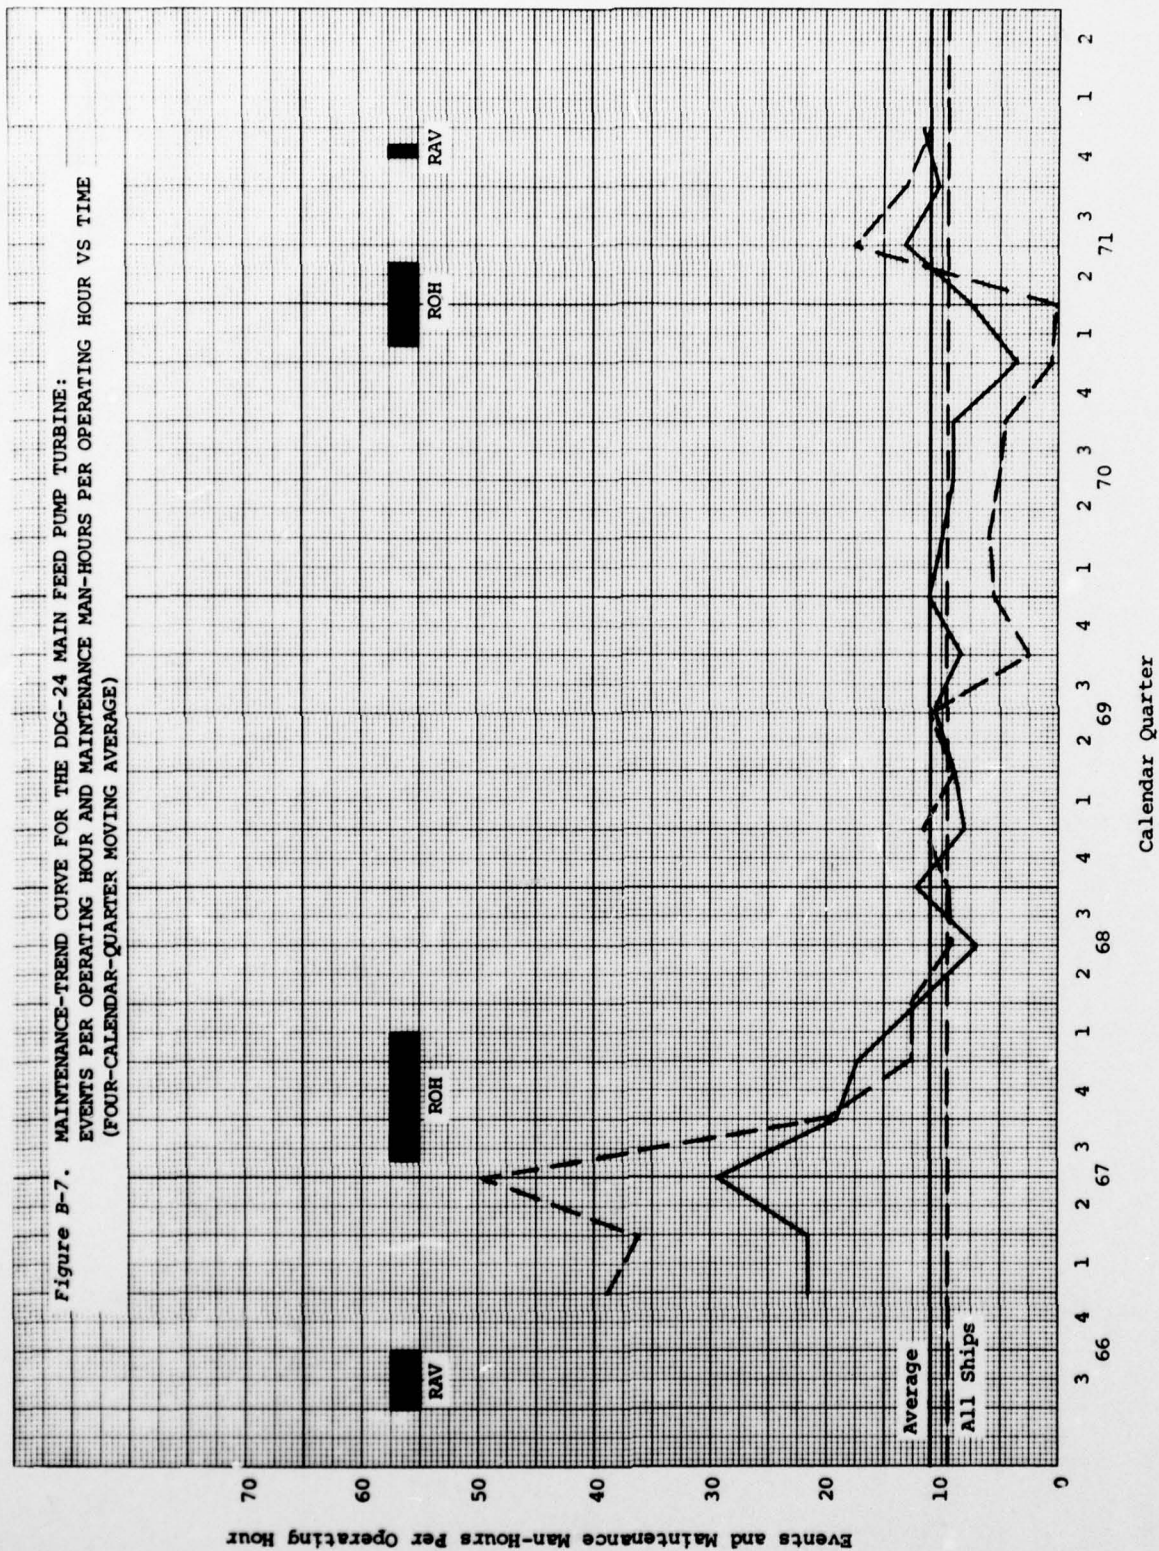
Figure B-7. MAINTENANCE-TREND CURVE FOR THE DDG-24 MAIN FEED PUMP TURBINE:  
 EVENTS PER OPERATING HOUR AND MAINTENANCE MAN-HOURS PER OPERATING HOUR VS TIME  
 (FOUR-CALENDAR-QUARTER MOVING AVERAGE)

DDG-24, Figure B-7

No data are available on possible shipyard work during the 1966 RAV and 1967 ROH. No shipyard work was reported during the ROH or RAV in 1971. The ship's force reported major work on three MFP turbines just prior to the 1967 ROH. The trends between ROHs do not indicate the need for work during ROH.
