6 UNDERWATER
NONDESTRUCTIVE TESTING
EQUIPMENT AND TECHNIQUES

10 by
FRED BARRETT
and
JOHN MITTLEMAN

Presented at the
INTERNATIONAL DIVING SYMPOSIUM
NEW ORLEANS, LA.
February 5-7, 1979

NAVAL COASTAL SYSTEMS CENTER
PANAMA CITY, FLORIDA 32407
904-234-4388

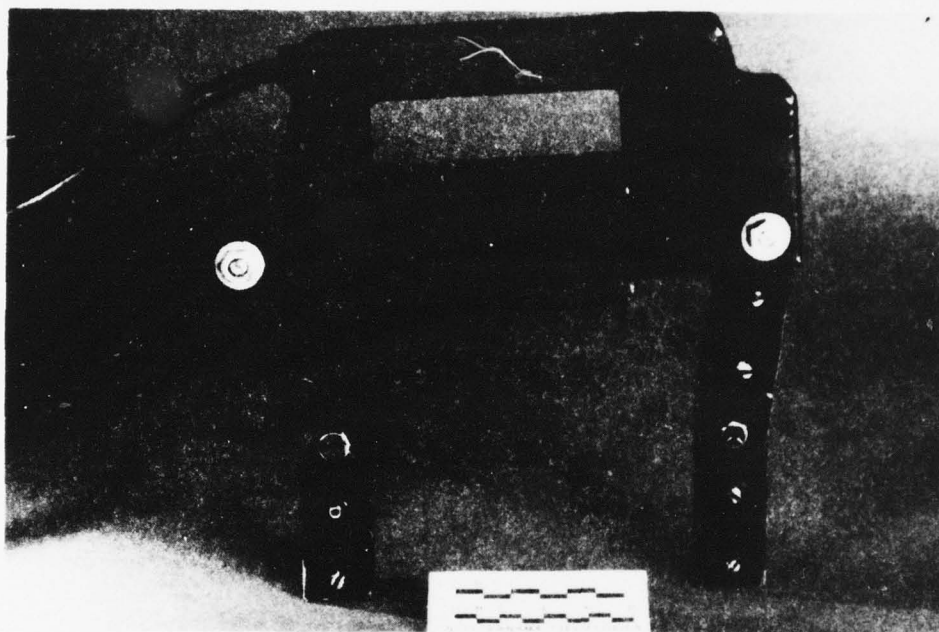
Contour Probe, Figure 1

Figure 1. Contour Probe

The probe was fabricated specifically for underwater use by Parker Research Corporation, Dunedin, Florida. It is similar to their contour probe designed for use in air. The primary differences were the elimination of an ON-OFF switch and an AC-DC switch, and addition of waterproof potting of the electrical coil. The switching was eliminated from the handle for reasons of diver safety. A special feature of the probe is the movable arms or pole pieces which make it possible to adjust to different contours, lapped plates or plates or pipes which mate at various angles.

It was considered mandatory for Navy use to use the contour probe in conjunction with a Ground Sentry (to be described in a following subsection). The necessity is based on diver safety requirements.

GENERAL SPECIFICATIONS, Contour Probe

Minimum to maximum distance across poles	0 - 18"
Power requirements	8 amps - 115 VAC
Cable - 2 conductor with braided shield serving as ground conductor.	
Neoprene external cover.	
Weight	13 pounds

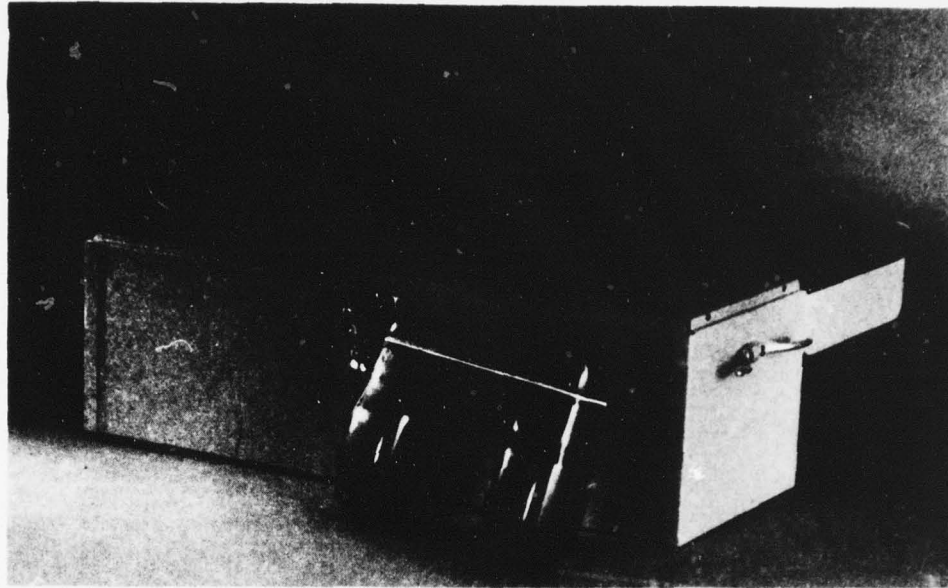
Magnetic Inspection Unit, Model WL-1UW, Figure 2.

Figure 2. Magnetic Inspection Unit

The unit was fabricated for underwater use by Texas Magnetics, Houston, Texas, and is basically the same as their Model WL-1. The unit is relatively safe for diver use as a 12-volt battery is used for power. Both the use of direct current and low voltage contribute to diver safety. A carrying case is incorporated which contains a circuit breaker, switch and pilot light. The case serves as storage space for 100 feet of cable.

Approximately 40 pounds of lifting force is created by the electromagnet. The unit requires about 3 amps.

The unit weighs 7½ lbs. Pole arms are on a fixed 5½ inch spacing.

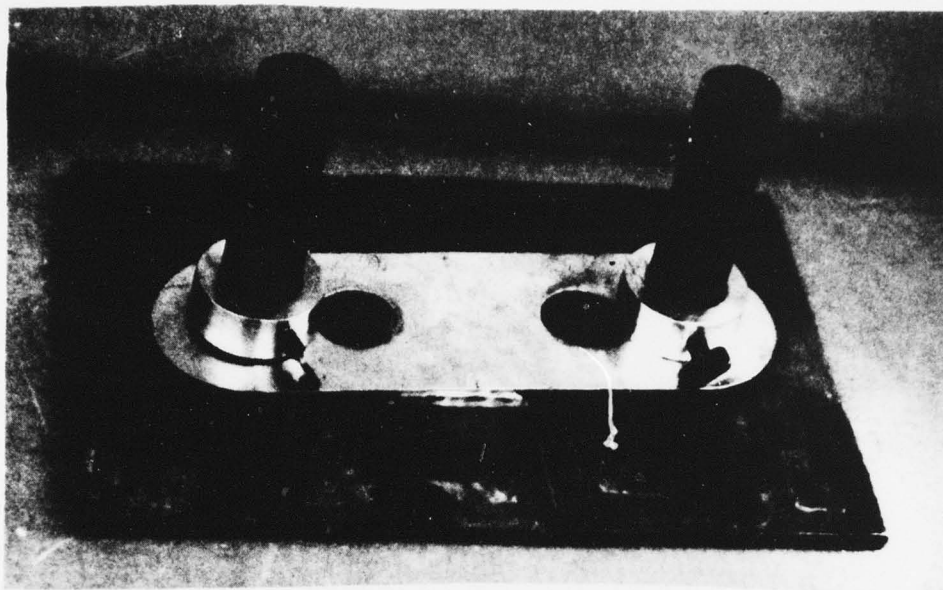
Permanent Magnets, Figure 3

Figure 3. Magnetic Rubber Pouch Held in Place By Plate Assembly

One pair of permanent magnets tested was one inch in diameter and six inches long. These magnets were purchased from Dynamold Inc., Ft. Worth, Texas.

Another pair of 1.55-inch diameter x 6-inch long magnets was obtained from Terry Magnetics, Inc., Orlando, Florida.

The liquid rubber filled pouches were held in place by a stainless steel sheet and collars for the permanent magnets and a piece of .010-inch brass shim stock for the electromagnets.

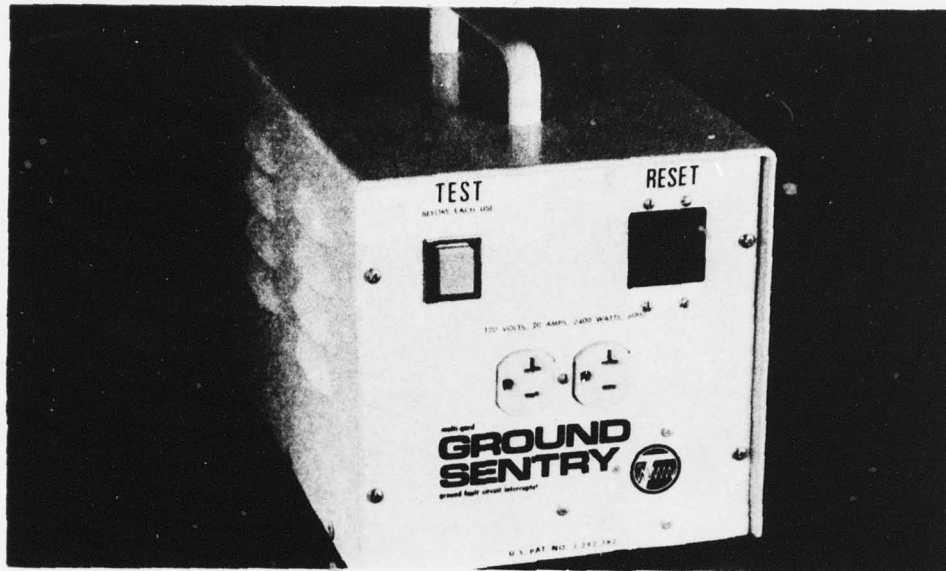
Ground Sentry - MK 6, Mod 0, Figure 4.

Figure 4. Ground Sentry

The ground sentry incorporates an isolation transformer and a ground fault interrupter. The specifications follow:

Trip current	7 milliamps
Trip time	25 milliseconds
Full load rating	10 amps
Voltage	115 VAC
Frequency	50 - 60 Hz
Circuit breaker rating	10 amps

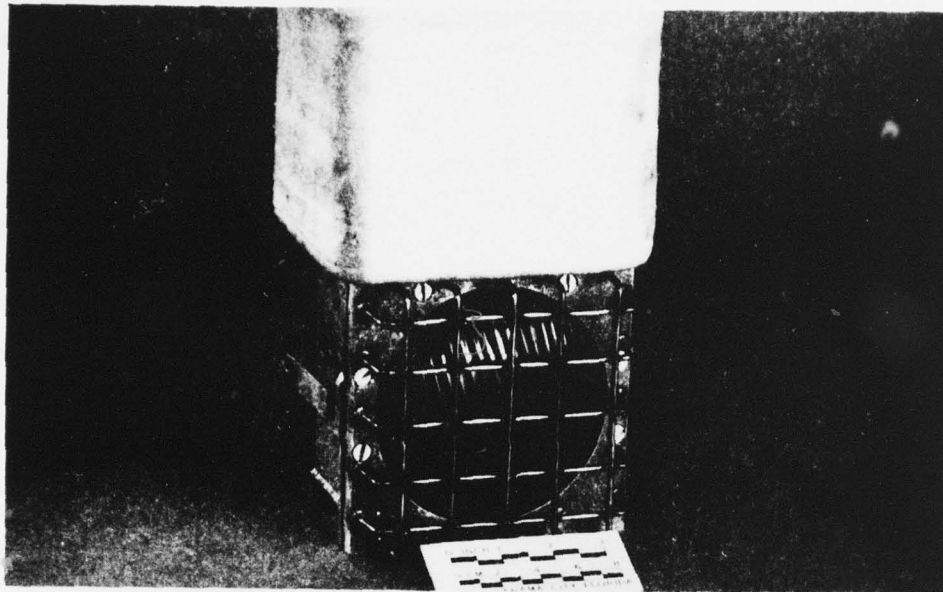
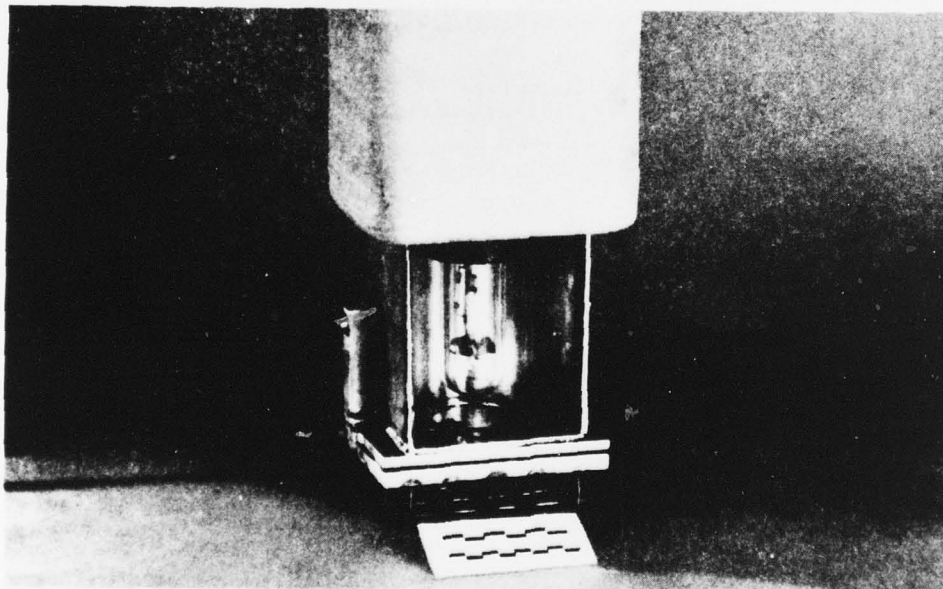
Ultraviolet-Mercury Vapor Light, Figures 5 & 6.

Figure 5. Combination Light Used as Ultraviolet Light

Figure 6. Combination Light Used as Mercury Vapor Light

The light was designed by the author. A mercury vapor light MK 12A manufactured by Sub Sea Systems, Inc., Escondido, California, was used in conjunction with a #3901 Magnaflux Corp. ultraviolet light filter. The special features of the designed light follow:

The filter may be swung underneath the light housing in order to use the assembly as a conventional mercury vapor light for preinspection by divers.

Protection against accidental breakage of the glass filter is provided.
Addition of buoyancy material makes the light neutrally buoyant.

The electrical connector on the mercury vapor-ultraviolet light failed prior to underwater testing, possibly due to operator error. A replacement connector has been ordered and the light will be tested in conjunction with the fluorescent magnetic particles in the near future.

The mercury vapor-ultraviolet light did not appear to be required in clear water with adequate light but may be necessary in dark murky water.

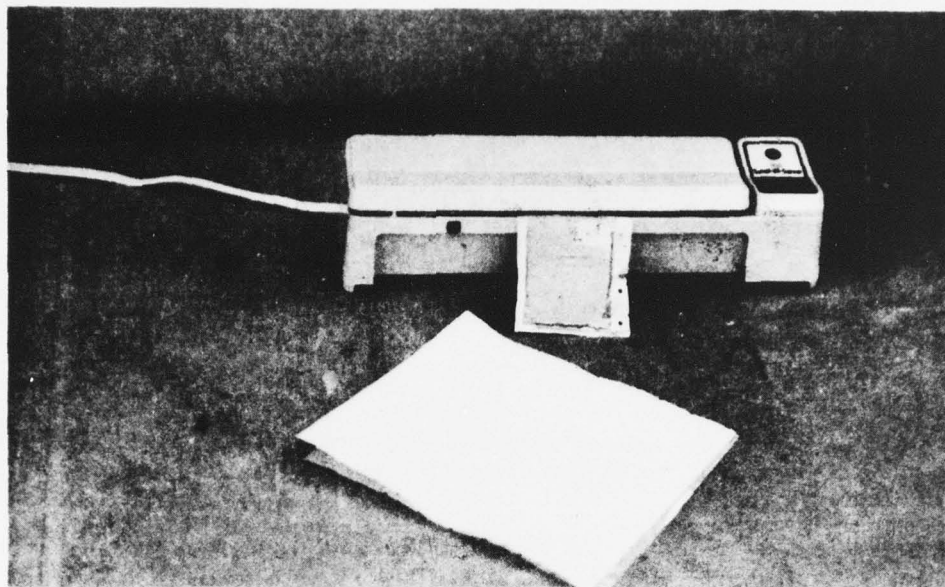
Seal-N-Save Sealer, Figure 7

Figure 7. Seal-N-Save Pouch Sealer & Pouches

The sealer and pouch material were used for packaging of the magnetic rubber for diver use. Sears was the supplier.

Magnetic Rubber. The liquid magnetic rubber was placed in plastic pouches and the required catalyst and conditioner was first placed in gelatin capsules and then the capsule added to the pouch. A Sears Seal-N-Save electrical sealer was used to seal the pouches. The catalyst causes the liquid rubber to solidify.

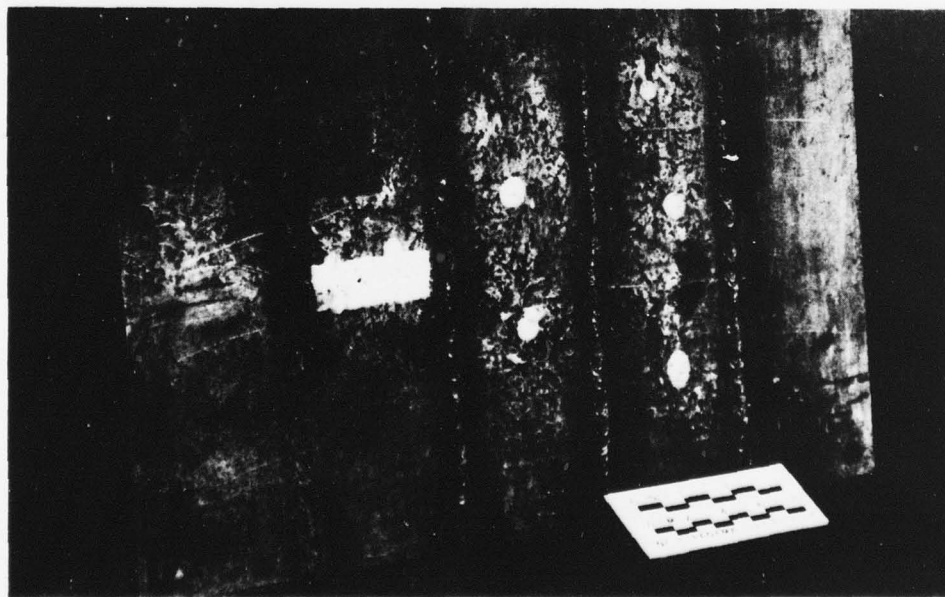
Test Plates, Figure 8

Figure 8. Test Plates

Test plates were made up specifically for the tests. The test plate array was made up of the following separate plates welded together:

<u>Plate</u>	<u>Crack Widths</u>
A (painted with ship bottom paint)	50 to 200 millionths of an inch (μ in.) and 200 to 1000 μ in.
B	50 to 200 μ in.
C	50 to 200 μ in. and 200 to 1000 μ in.
D (cracks on butt weld)	50 to 200 μ in. and 200 to 1000 μ in.
E (milled slots, 1" long x 1/8" deep)	.005 inch, .010 inch and .020 inch

A separate plate was made up with 1/32" x 1" drilled holes located 1/16", 1/8", 3/16" and 1/4" below the surface. All plates were steel, 3" x 10" x 3/8" thick.

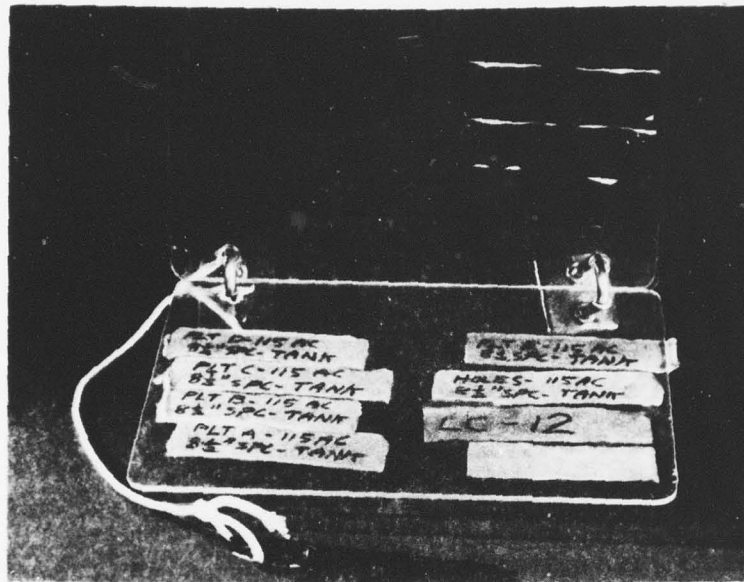
Figure 9. Acrylic Sheet Flaw Indication Recording Assembly

1. Press a strip of putty tape or duct seal onto the area.
2. Press or rub firmly while carefully holding in place.
3. Remove strip and place on an acrylic sheet.
4. Mark the rear, masking tape covered side of the tape with grease pencil to identify physical location of crack or flaw.

If a permanent record is required of the crack or other flaw indication, the following procedure should be followed, Figure 9.

The putty tape and duct seal tapes both provided excellent permanent records of flaws while using the fluorescent magnetic particles. They adhered well to the clear acrylic sheets and provided a permanent record that was easy to read on the surface.

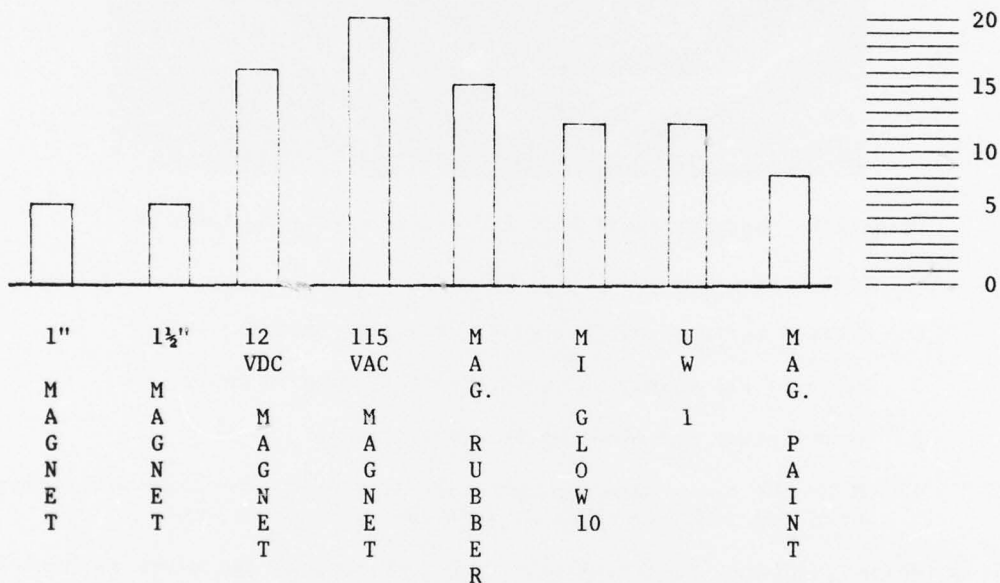
Note: Only data for the following magnet pole spacings were used:

1" dia. perm.	--	4"
1 1/2" dia. perm.	--	4"
12 VDC	--	4 1/2"
115 VAC	--	6"

Figure 10. Flaw Detection Success Rate
(Total number of plates where flaws successfully detected)

A summary and comparison of the relative effectiveness of the various tested magnets and magnetic particle mixtures are presented in Figure 10. As shown, the electromagnets are much more effective than the permanent magnets. Alternating current reportedly provides greater mobility of the

As shown in Figure 10, magnetic rubber was most effective in locating cracks with the two fluorescent particle-water mixtures falling a close second. A disadvantage of the magnetic rubber is the time required for use. It must remain in place 30 minutes or longer. It does provide an excellent permanent record of detected flaws. The fluorescent magnetic particles were very effective and had the advantages of allowing the diver to cover a larger area in much less time. The magnetic paint was not very effective and was difficult to make adhere even on freshly sanded steel plate.

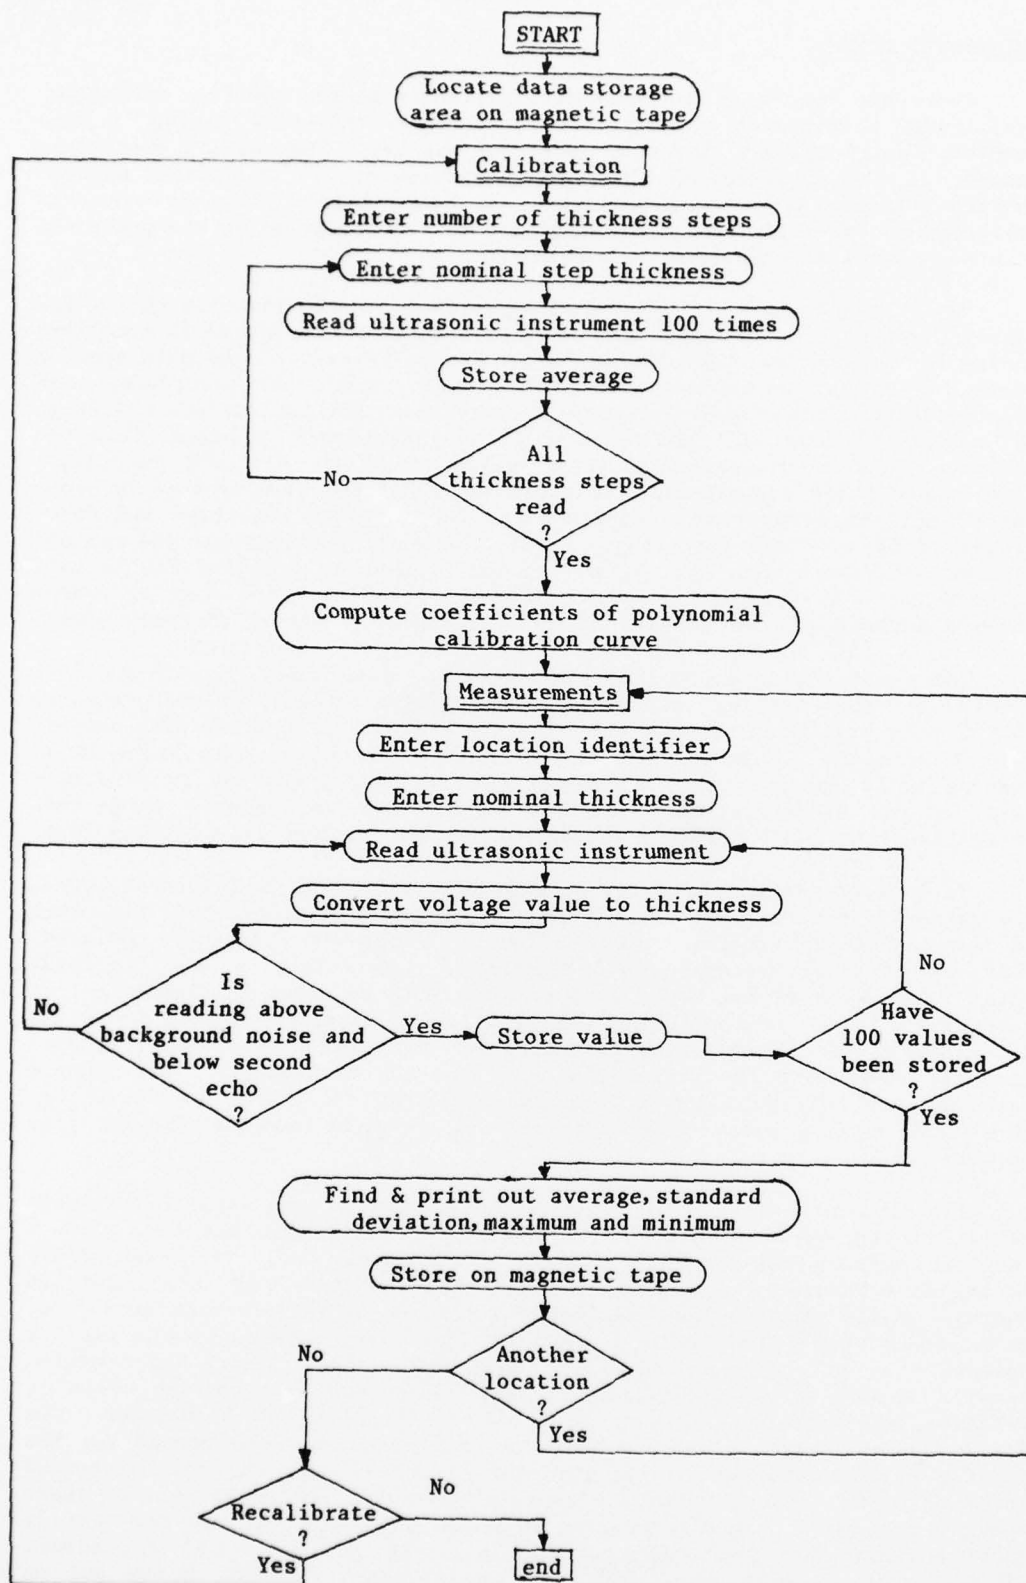
Figure 12. Simplified Computer Flow Chart for Thickness Gaging

Finally, in order to get around the problem of the natural thickness variations on corroded steel, the ultrasonic instrument was tied into a small computer that rapidly samples thicknesses and, for each basic location, accumulates one hundred individual readings. It then finds the average, standard deviation, maximum and minimum of these one hundred data. This information (along with a location identifier entered by the topside operator) is printed out and stored on magnetic tape. Since the computer samples thickness extremely quickly and can reject much of the noise it receives, virtually no skill is required to manipulate the transducer. The diver does not have to find and hold a stable reading long enough for the topside operator to record it; instead, he merely rubs the housing around for about five seconds while the computer snatches readings. A flow chart showing the basic computer program is shown in Figure 12. Beyond what is shown on that flow chart, the computer actually does a considerable amount of filtering to eliminate electrical transients. It also prints out an index of the quality of the readings which usually relates to unbonded areas of the paint system.

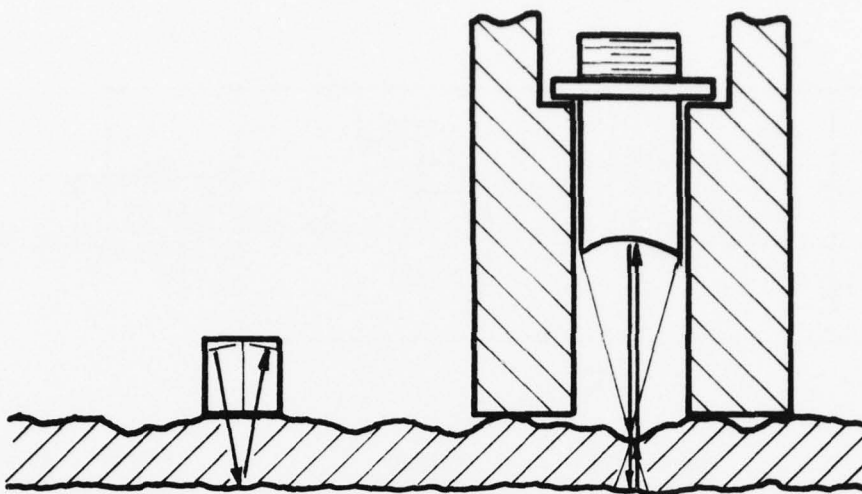
Figure 11. Dual Element Contact Transducer (Right) and Single Element Focused Immersion Transducer (Left)

Dual element contact transducers appeared to be the favorite choice for gaging sheet steel. Although this type of transducer is indeed an excellent choice for gaging new steel sheets it has several disadvantages when used on steel in the marine environment. For example, since the transducer must make intimate contact with the steel, it is clear that the minimum thickness in a corroded area will not be read if the transducer is bigger than the corrosion pits. Misleadingly large values will be recorded routinely. Also, since these transducers are typically about the size of a jelly bean, the diver's hand may have a tendency to cramp between the thumb and forefinger if he uses one very long. Finally, on well pitted steel you can get whatever thickness you want by moving the transducer around a little bit. In many cases it would be just as informative to receive a list of random numbers instead of the results of an ultrasonic gaging of corroded steel.

To overcome these obstacles to objective and credible thickness gaging the authors approached the problem from a different point of view. In place of the contact transducer style, a focused immersion transducer is used. This transducer is recessed in a housing in such a fashion that its focal point is just below the steel's average surface, as shown in Figure 11. It can easily "look" into pits and therefore gages thickness at any location. A housing was necessary, both to waterproof the cable-to-transducer connection and to provide the proper stand-off for the transducer. This housing was made amply large, like a beer can, to keep the diver from cramping. This same housing also converts readily to an angle beam housing for flaw detection.

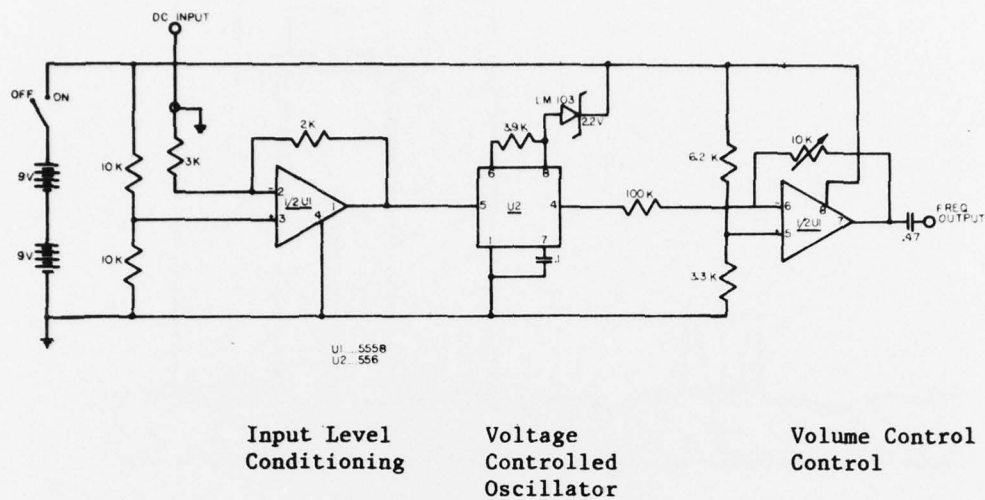
Figure 13. Audible Tone Generator Circuit

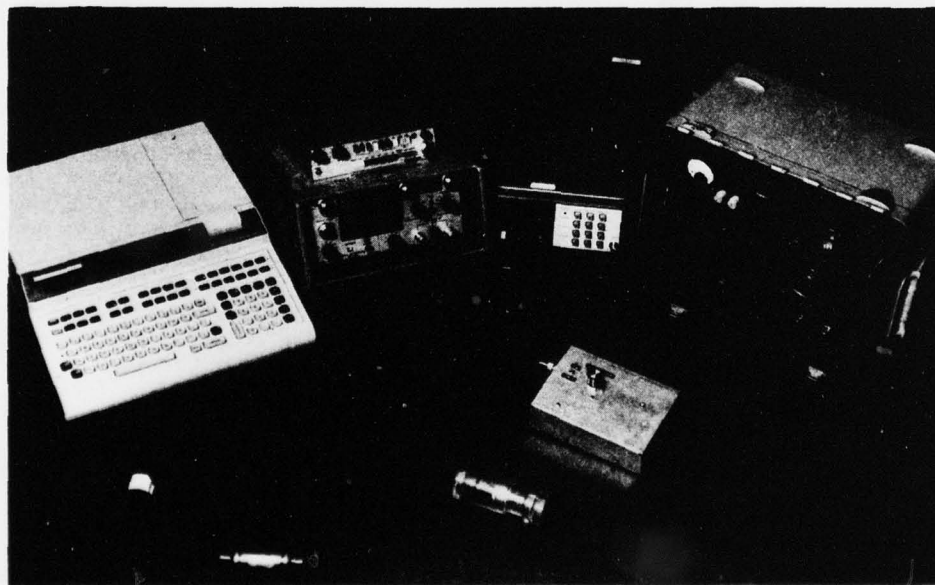
Figure 14. Underwater Ultrasonic Inspection System

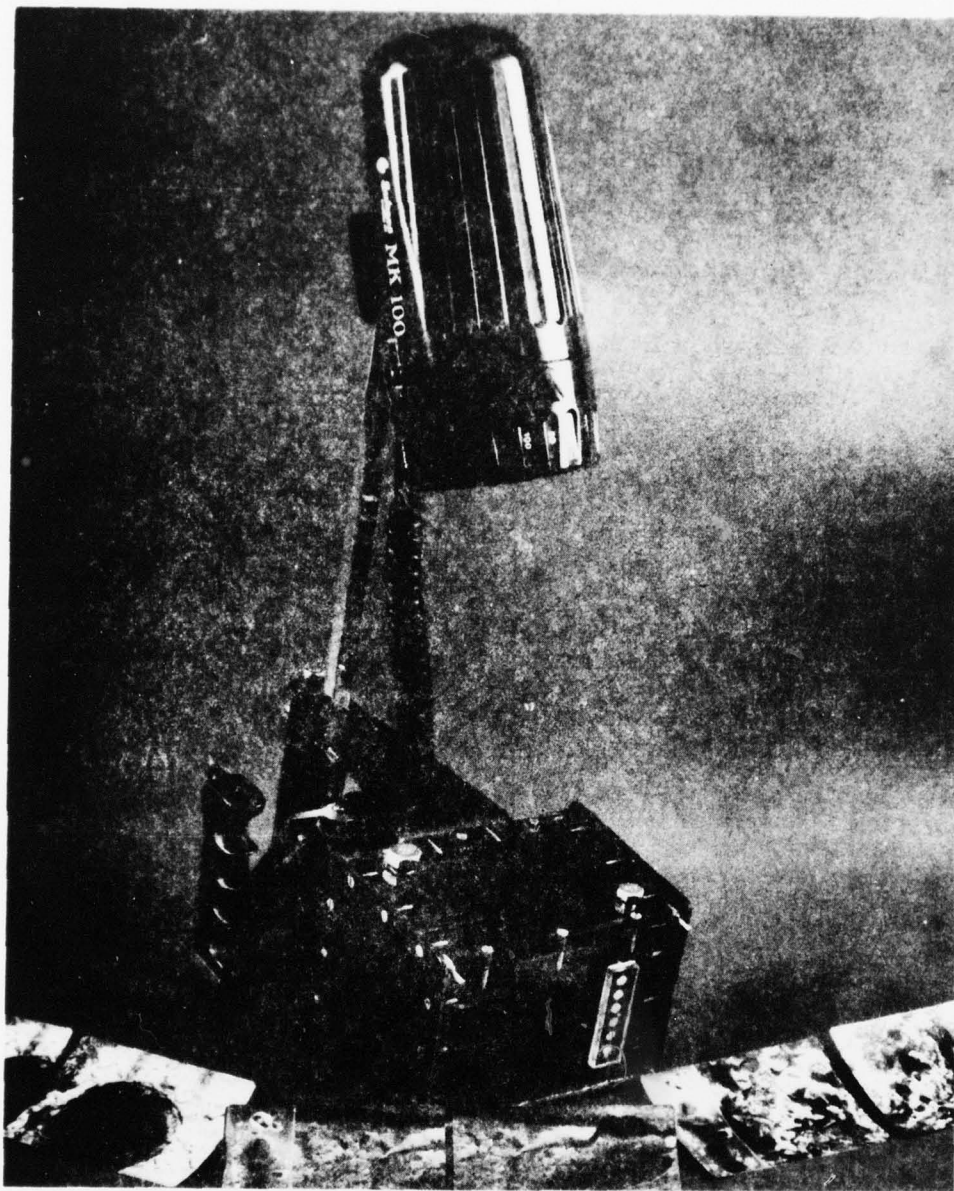
Figure 15. Stereophotography Assembly

In the Navy environment we are plagued by the turbid waters common to all shipyards. Thus, in addition to close-up tubes we found it necessary to provide a clearwater box between the camera and the subject. This box (Figure 15) was built to be pressed up to the ship's hull, eliminating all but one-half inch of dirty water from the camera's "line of sight." With this device, focus and aperture can be preset, resulting in consistently high quality photographs regardless of the diver's skill. The clearwater box was constructed in such a way that the camera, an ordinary Nikonos, can be moved about an inch sideways. If two exposures of the same area are made with this motion between them, a stereo pair results.

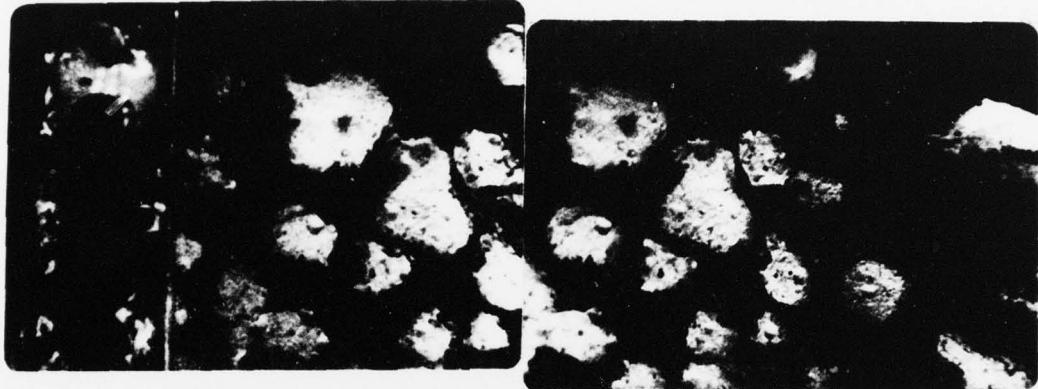
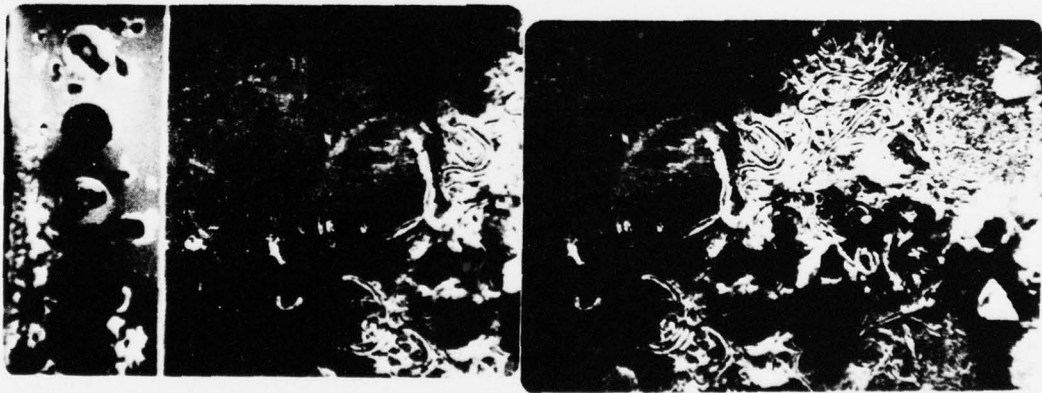
Figure 17. Unpopped Paint Blister

In the center of the stereo area there is a paint blister, as yet unpopped. There is a heavy algae slime to the left of the blister, and vestiges of a tubeworm colony to the right. Also, a small stalk of brown algae can be seen about one-half inch right of the blister.
