HEAVY LIFT HELICOPTER -- PROTOTYPE  
TECHNICAL SUMMARY

Boeing Vertol Company  
P.O. Box 16858  
Philadelphia, Pennsylvania 19142

April 1980

Final Report for Period January 1973 - August 1975

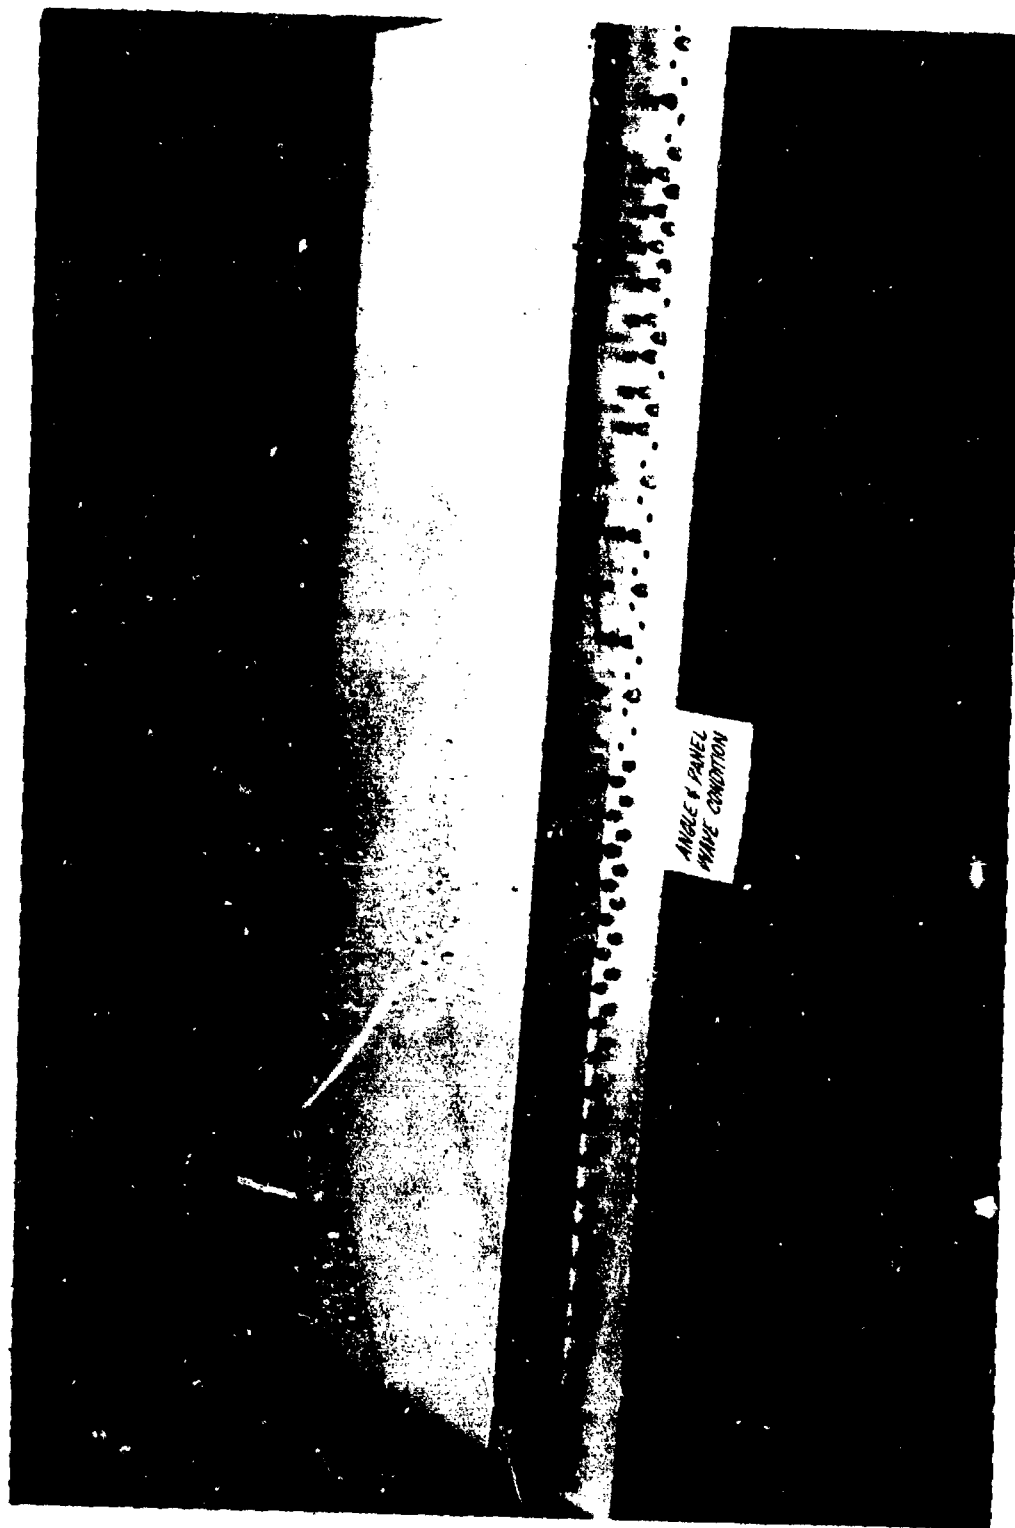
Figure 37. Bonded honeycomb panel specimen with wave condition.

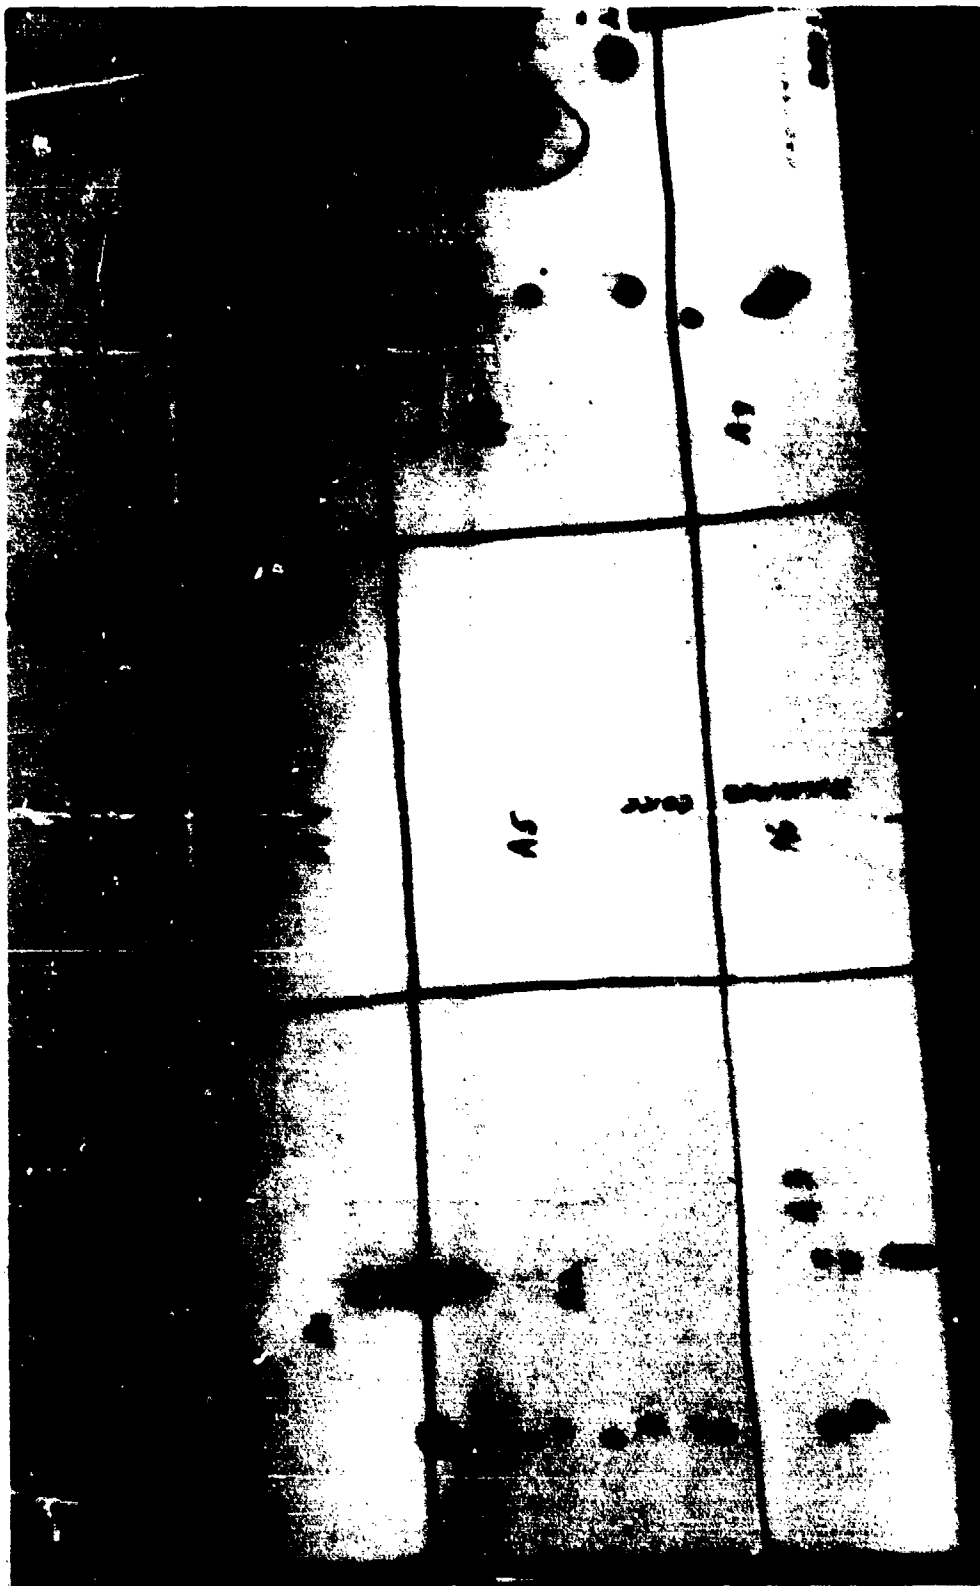
Figure 43. Compound curved panel showing anomalies in foam splice areas.

The compound curved panel SK301-11715 (non-destructively tested) was further evaluated and found to have anomalies only in the foam splice areas as indicated in Figure 43 .
