FINAL REPORT ON THE INVESTIGATION INTO HYDRAULIC GEAR
PUMP EFFICIENCIES IN THE FIRST FEW HOURS OF THE
PUMP'S LIVES AND A COMPARATIVE STUDY OF
ACCELERATED LIFE TESTS METHODS ON
HYDRAULIC FLUID POWER GEAR PUMPS

(PART III OF III PARTS)

BY: The Fluid Power Institute
Milwaukee School of Engineering

Under Contract #DAAK70-77-C#214
to the U.S. Army Mobility Equipment
Research and Development Command
Fort Belvoir, Virginia

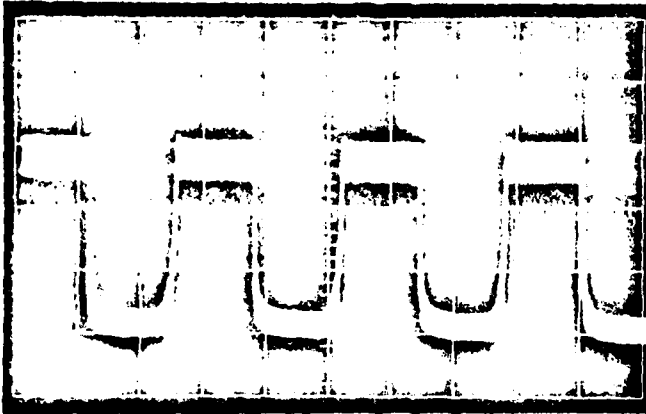
Figure A.3

Vertical Axis 1000 psi/cm

Horizontal Axis 0.5 sec/cm

Mfgr. No. 1
Pump Code No. 47740

The SAE waveform does not consider pressure ripple which is generated by the pump, therefore on some pumps depending on the ripple, the pressure variance is greater than the required 5%. However, the pumps waveshape met the SAE specifications for rise and fall rates and on and off times.

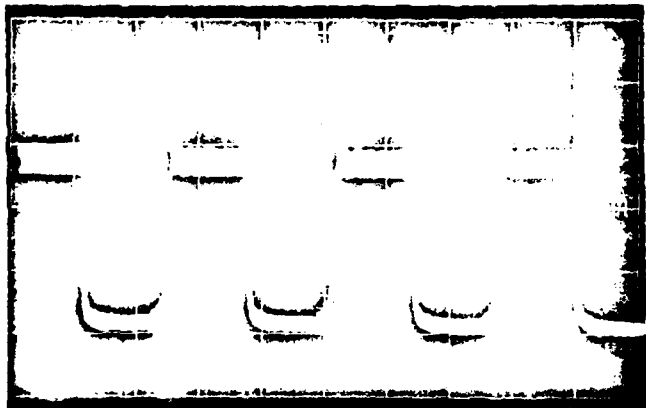
Figure A.4

Mfgr. No. 2
Pump Code No. 56941

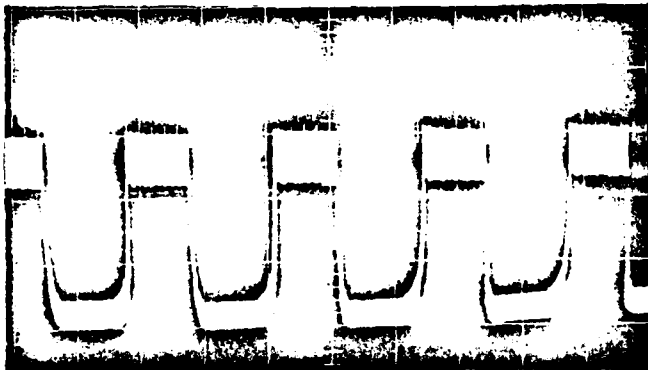
Figure A.7

Mfgr. No. 2
Pump Code No. 16439

Mfgr. No. 2 Pump Code No. 16439 Failure at 227,273 cycles 75 hours

The pump failed to complete the test. Severe wear and scoring of the driven shaft bearings and bearing surfaces caused excessive side play for the driven shaft. The gear teeth tips, wear plates and housing were severely scored and worn from misalignment caused by the excessive side play. Metal pieces were also torn away from the rear wear plate. The wear plates and driven shaft bearings also showed signs of overheating. A crack in the rear cover was found which ran from the driven shaft bearing hole into the drilled hole behind the bearing for lubrication. (Note the driven shaft refers to the shaft which is totally inside the pump and is driven by the other shaft which extends outside the pump and connects to the prime mover. This definition will be used exclusively throughout this report.) (Note the gear tooth tip is the top edge of the tooth that comes in contact with the inside surface of the pump housing. This definition will be used exclusively throughout this report.)

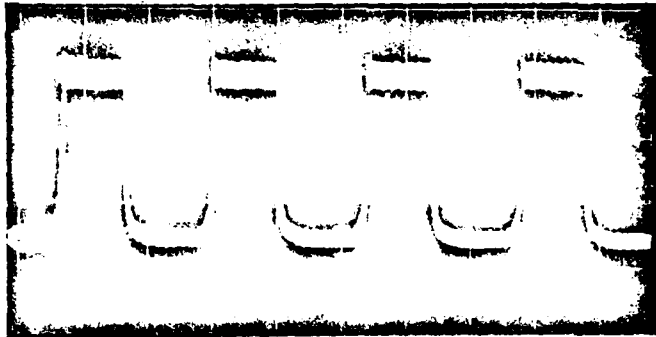
Figure A.9

Vertical Axis 1000 psi/cm

Horizontal Axis 0.5 sec/cm

Mfgr. No. 1
Pump Code No. 25331

Mfgr. No. 1 Pump Code No. 25331 Failure at 115,000 cycles 38 hours

The pump failed to complete the test. The driven shaft rear bearing siezed to the shaft and spun inside the housing causing excessive side play on the driven shaft. The excessive side play caused extensive wear and scoring of the wear plates and housing. There were also score marks on the gear teeth from misalignment caused by the excessive side play. Some scoring was also noted on the driven shaft front bearing and both bearing surfaces on the driven shaft were severely scored. The wear plates, driven shaft bearing surfaces and bearings also showed signs of overheating.

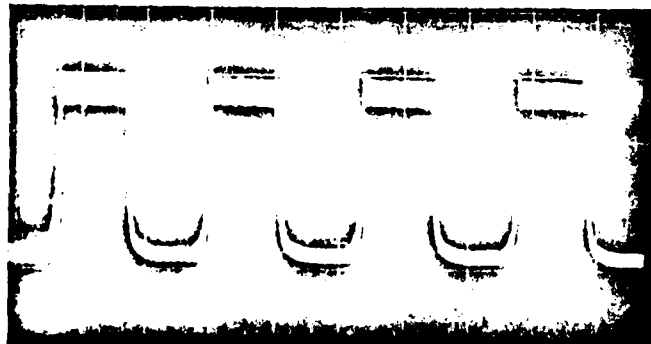
Figure A.11

Mfgr. No. 3
Pump Code No. 63661

Mfgr. No. 3 Pump Code No. 63661 Failure at 155,000 cycles 57 hours

The pump failed to complete the test. This pump did not have a catastrophic failure like the previous two. Upon disassembly it was found that there was marginal wear and scoring of the housing, wear plates, and gear teeth tips. There were also signs of overheating on the wear plates. The pump was removed from the test because of excessive noise and unstable outlet pressure. There also was a 25 percent drop in flow rate at the time the pump was removed from the test.
