Technical Memorandum 21-80

AN INVESTIGATION OF THE FIVE POINT RESTRAINT  
SYSTEM FOR AVIATORS

October 1980

U. S. ARMY HUMAN ENGINEERING LABORATORY  
Aberdeen Proving Ground, Maryland

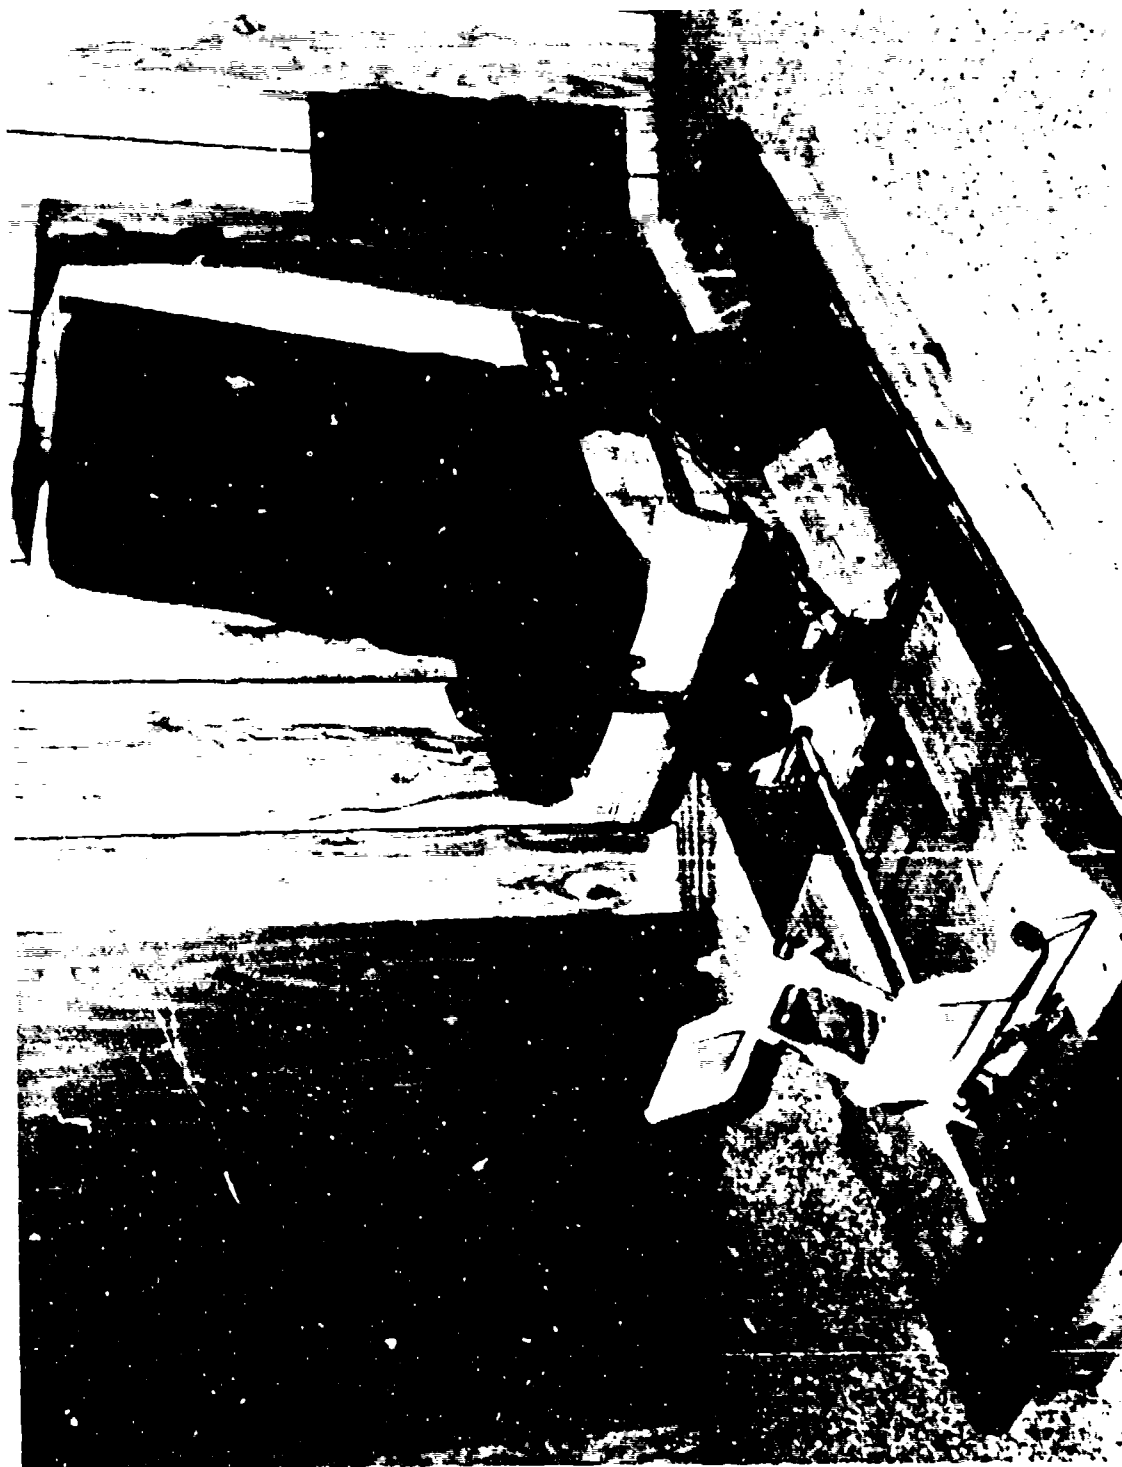
Figure 4. Seat assembly.

To evaluate the lap belt anchoring points, a fully adjustable AAH crew seat and anti-torque pedal assembly was constructed which exposed the pilot's torso while providing correct cushion support (Figure 4). Alternate anchoring points were used which ranged from 2 inches forward to 3 inches aft of the present position. These were arranged in a line parallel to the seat bottom at 1-inch intervals.

Figures 4 and 5 show the lumbar support can be adjusted in height with hook and file fasteners.

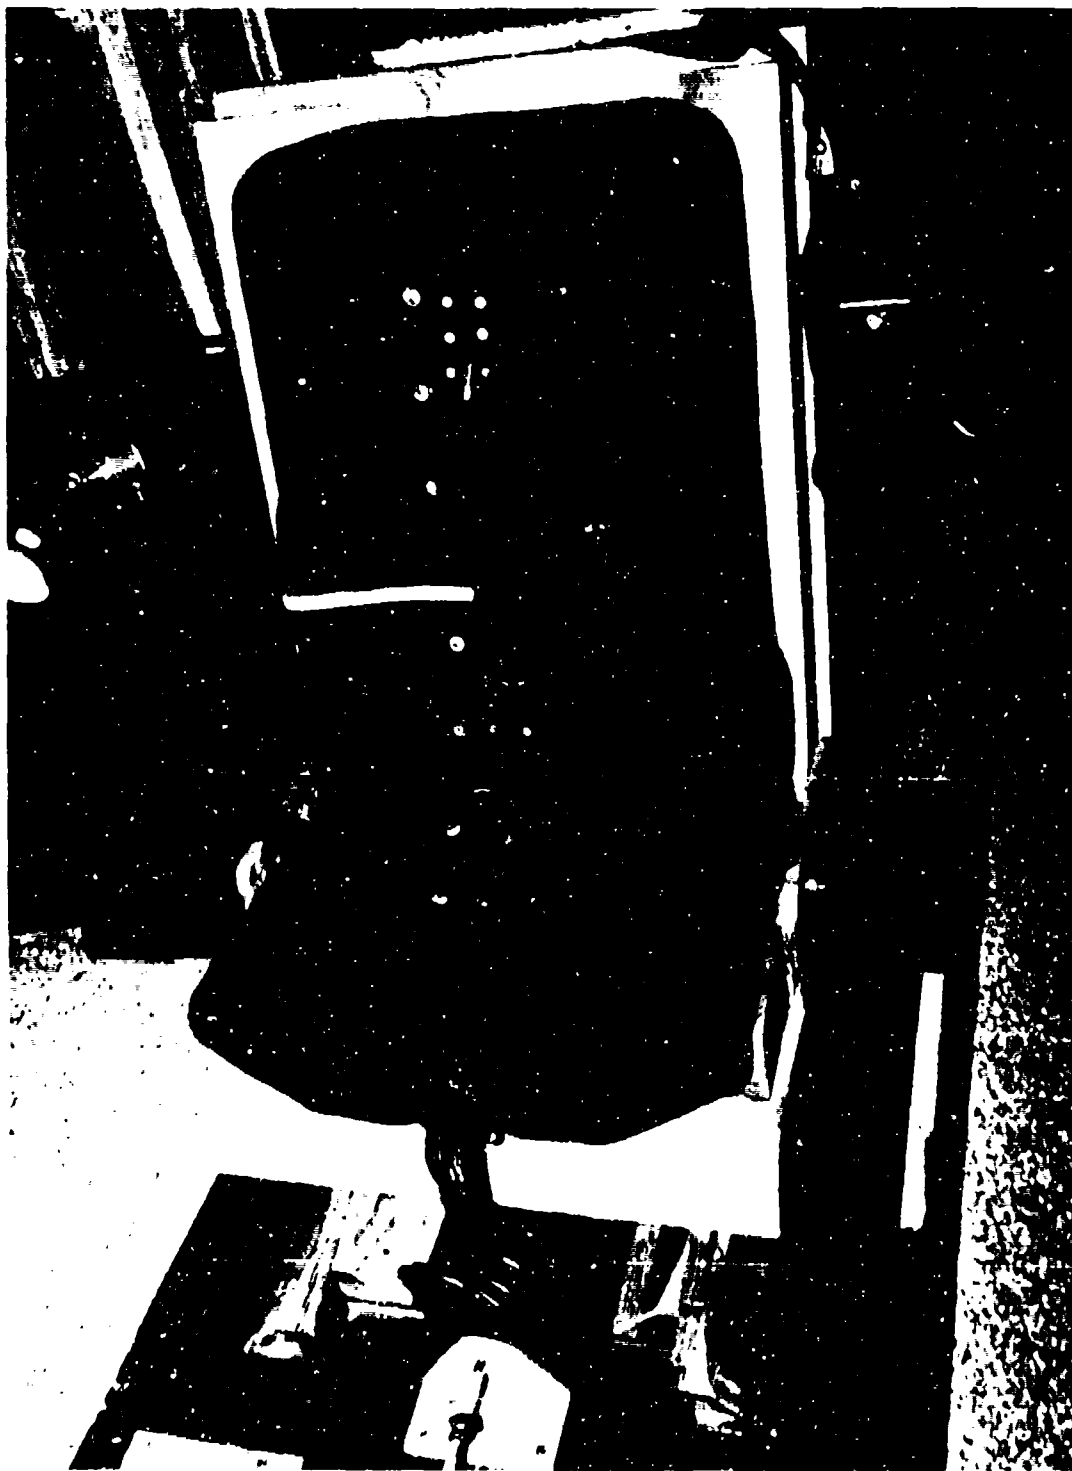
Figure 5. Cushion probes.

Six-inch long cushion probes (Figure 5) were inserted through the seat cushions to check the SRP since the lap belt anchor point location is referenced from the SRP. The probe arrays were designed to collocate with specific body points and reconstruct the two planes which define the SRP. Additional information relating to the location of the SRP is contained in the appendix.

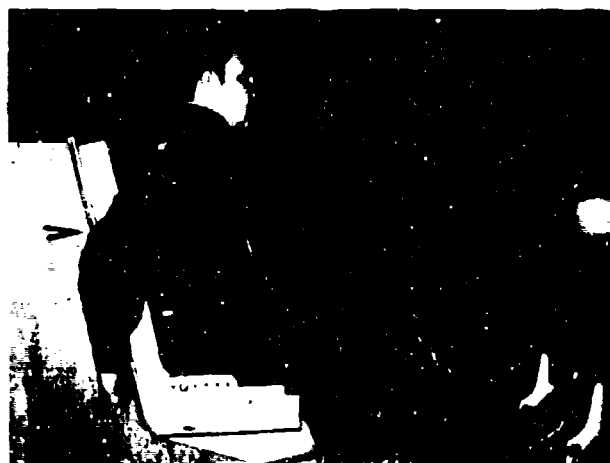
Figure 7. Anchor point 2 inches aft of present position, subject TF.

Figures 7 and 8 show subjects "TP" and "DH" with the lap belt anchored 2 inches aft of the present location. This position was suggested by the contractor as an alternate anchor position.

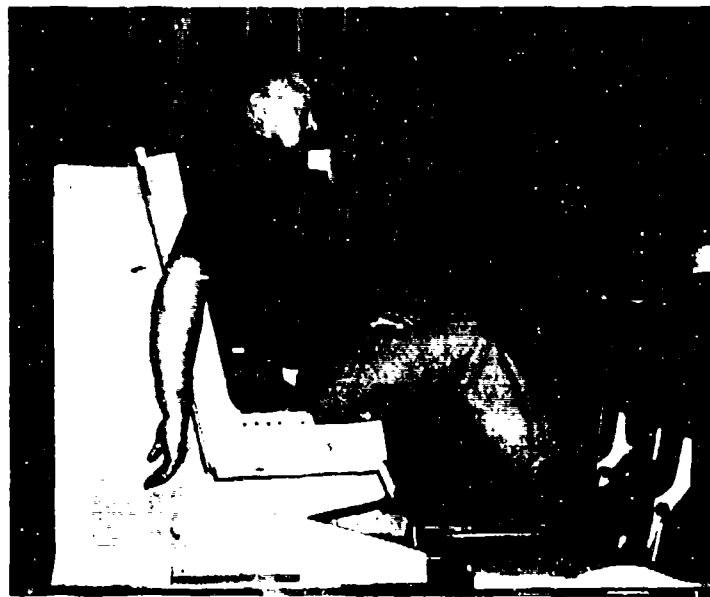
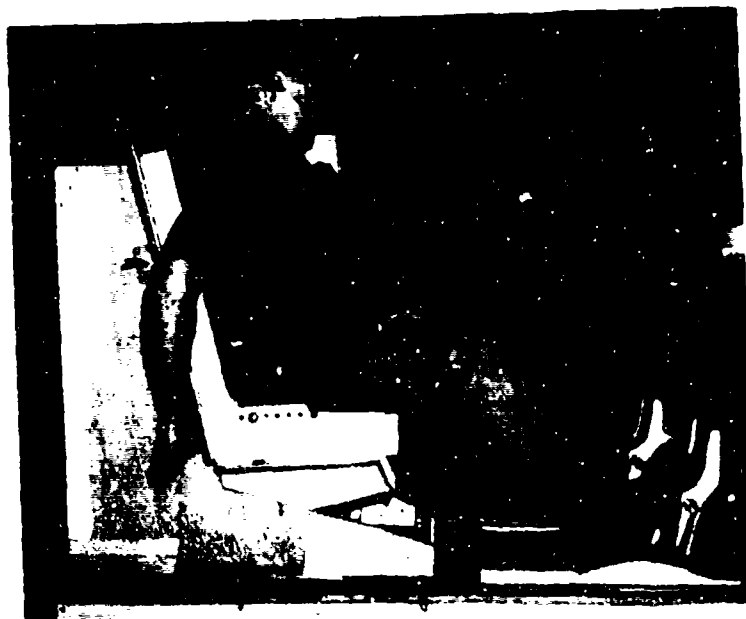
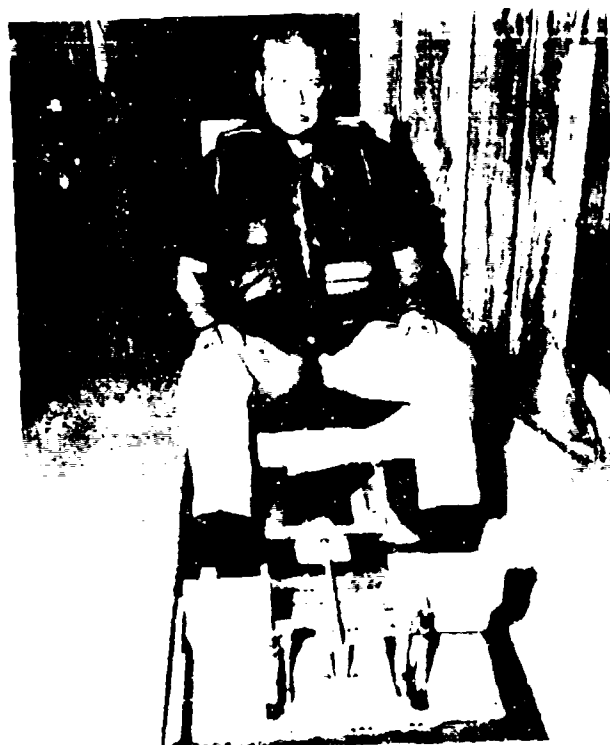
Figure 9. Subject MF, side view, forward anchor location.

Figure 10. Subject MF, front view, forward anchor location.

FIG 11. Subject MF, side view, aft anchor location.

Figure 12. Subject MF, front view, aft anchor location.

Figures 9 through 14 show at least three variations on how the shoulder straps were positioned by the subjects over the survival vest. Subject MF (Figure 10) positioned the straps outboard to keep the straps from chafing his neck as seen in Figure 12. Figure 10 also shows the straps riding over the survival radio and first aid kit which could become damaged under high "G" loading because they were sandwiched between the subject's torso and the straps. A loose crotch strap may allow the subject to move placing increased pressure on the gear.

Figures 9 through 16 display the general fit of the restraint harness while wearing the body armor and survival vest.

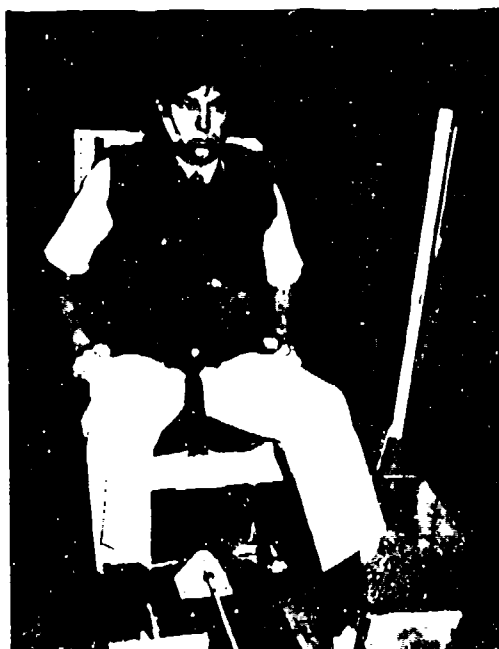
Figure 14. Subject CF, front view, aft anchor location.

Figure 14 shows the straps inboard of the survival vest gear with the straps bearing on the subject's neck.

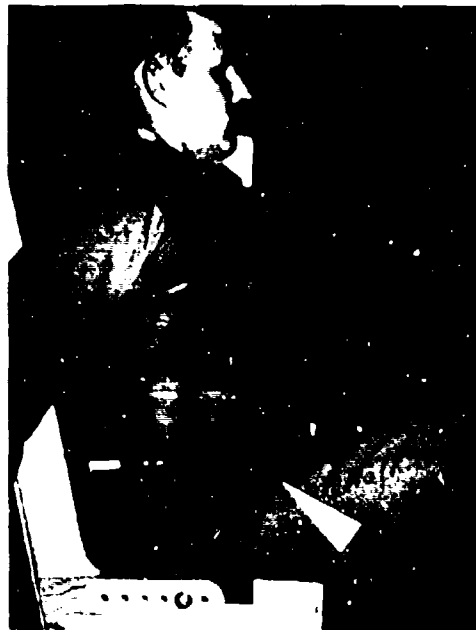
Figure 15. Cinch buckle riding over body armor.

Figures 15 and 16 show two positions of the lap belt take-up buckle. Figure 15 shows how pressure is exerted by the edge of the buckle, and Figure 16 shows belt pressure distributed across the webbing. The position of the lap belt take-up buckle will depend on how the subject is strapped into the seat.

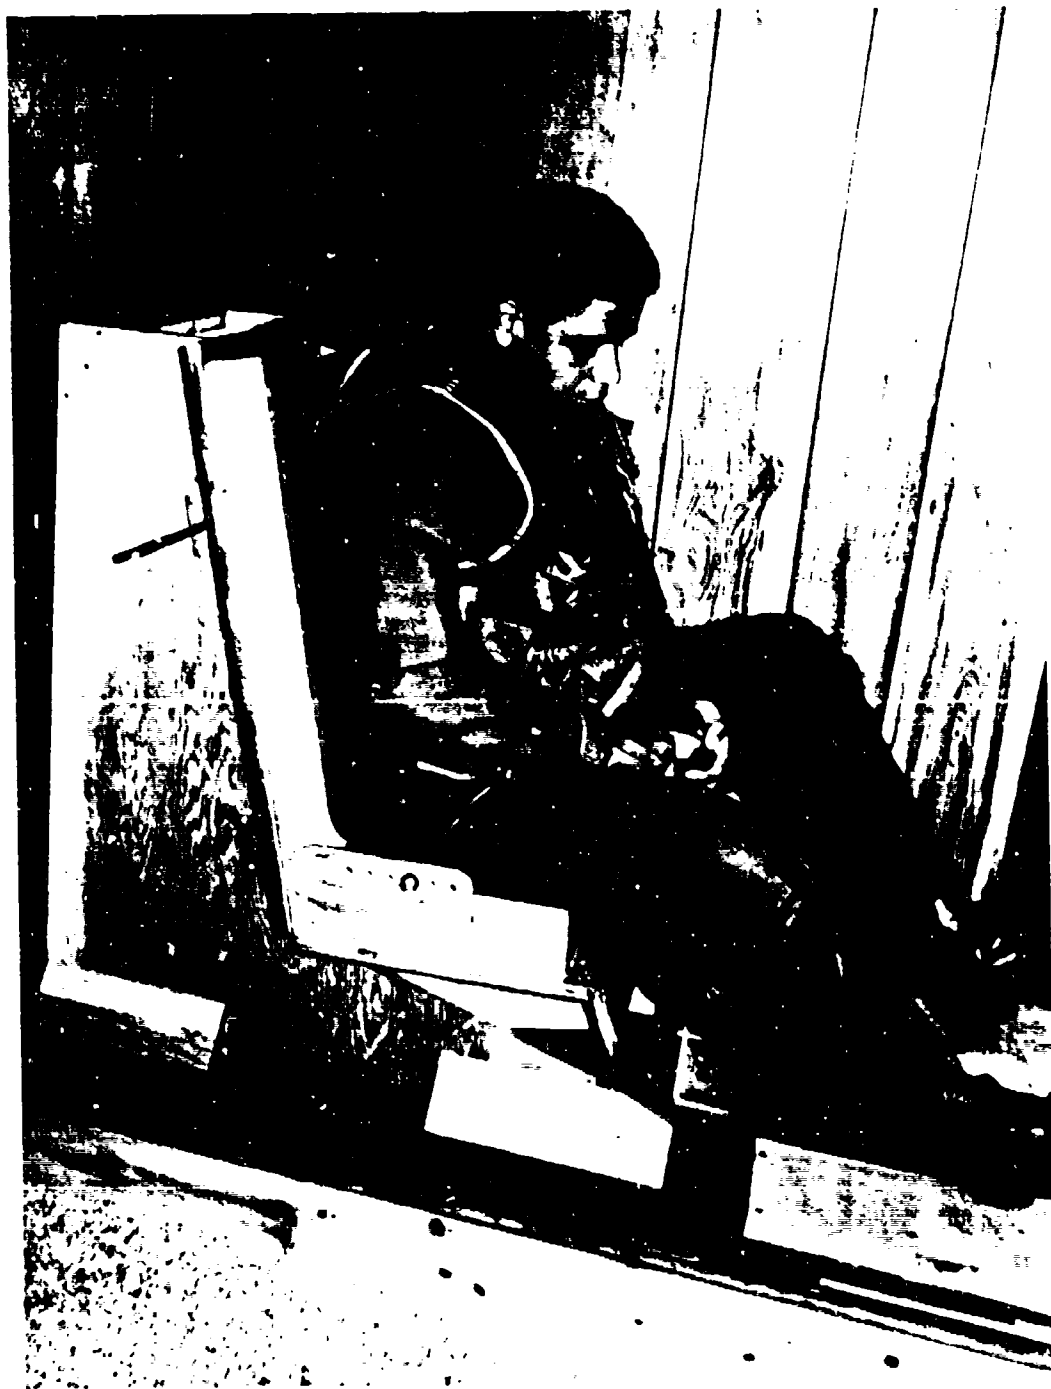
Figure 17. Vision restriction.

Several subjects had difficulty inserting the attaching spades while wearing the body armor and survival vest because they could not see the release mechanism (see Figure 17).
