FLOOD PLAIN INFORMATION  
CONNECTICUT RIVER, WEST RIVER  
AND  
WHETSTONE BROOK

BRATTLEBORO  
VERMONT

PREPARED FOR  
THE TOWN OF BRATTLEBORO  
BY  
DEPARTMENT OF THE ARMY  
NEW ENGLAND DIVISION CORPS OF ENGINEERS  
WALTHAM, MASS.

JANUARY 1972

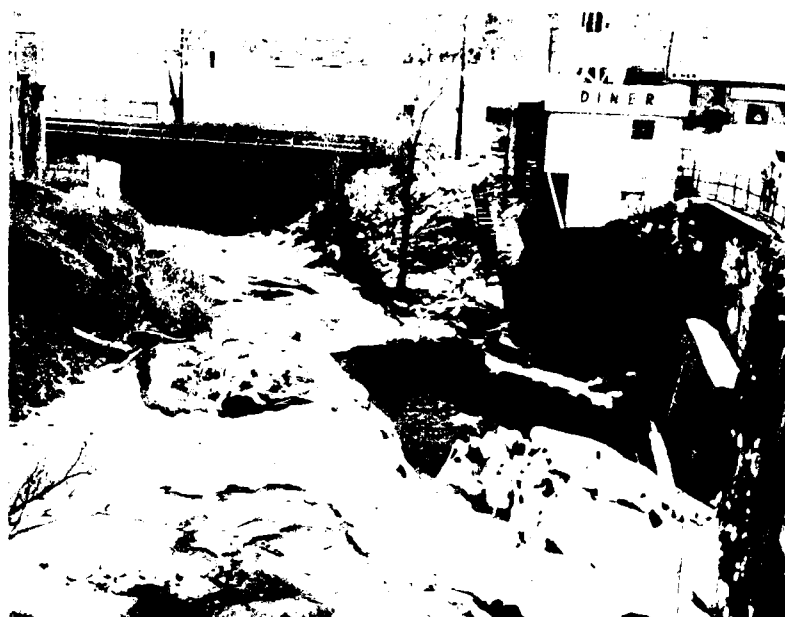
Whetstone Brook, looking downstream from Main Street (Route 5) bridge toward railroad bridge and Connecticut River.

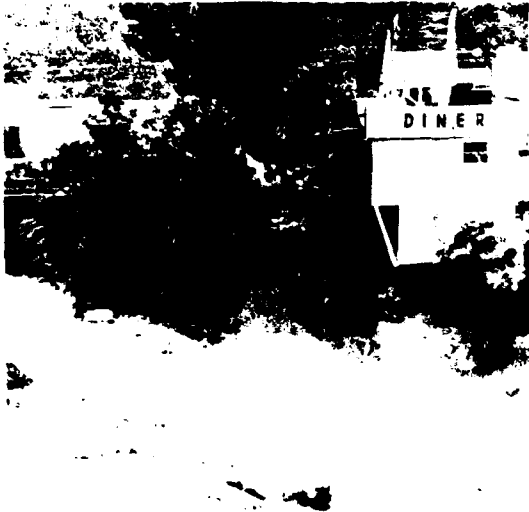
Looking downstream from Main Street during high water of July 1969 (see opposite page).

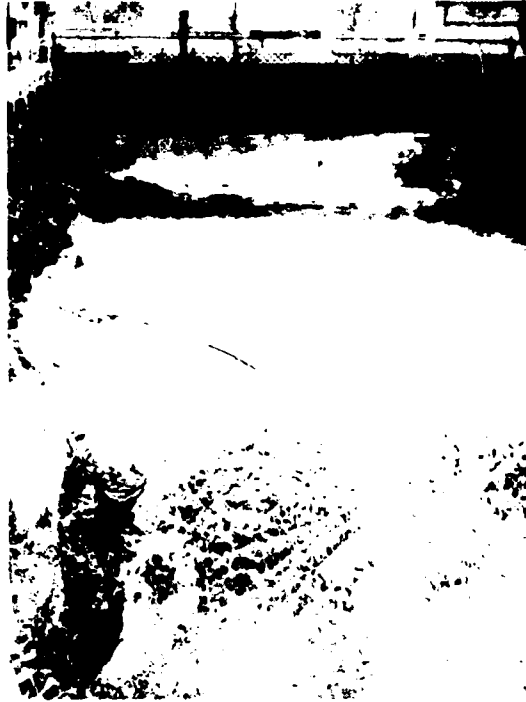
Looking upstream through Main Street bridge during highwater of July 1969 (see opposite page).

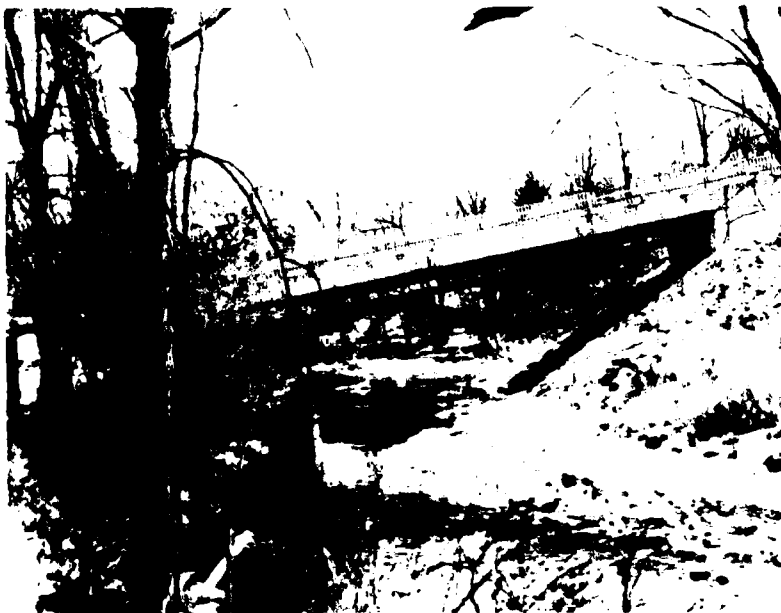
Figure 2

Whetstone Brook looking downstream through Elm Street bridge. A portion of the flood flow will bypass this bridge because of low left-bank approach.

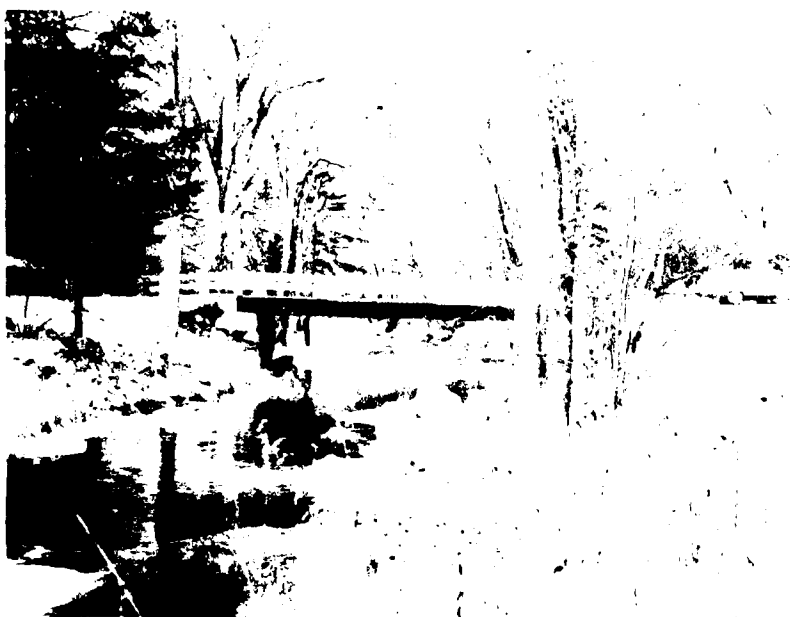
Brookside Terrace bridge. Both Standard Project and Intermediate Regional Floods will overtop this bridge deck.

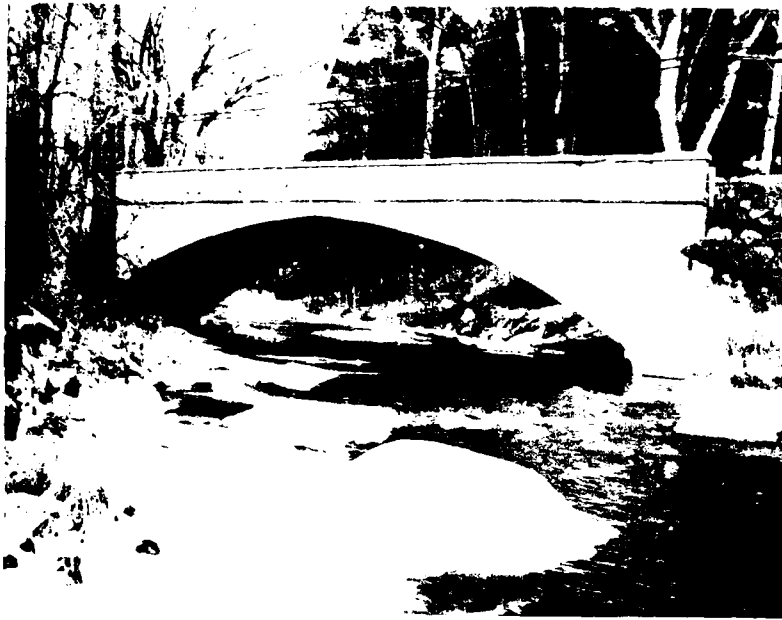
State Highway 9 bridge over Whetstone Brook. Standard Project Flood will overtop bridge deck by about three feet.

The one major bridge which is inadequate is that on State Highway 9 between Brattleboro and West Brattleboro. The deck of the concrete-arch bridge will be overtopped by both the Standard

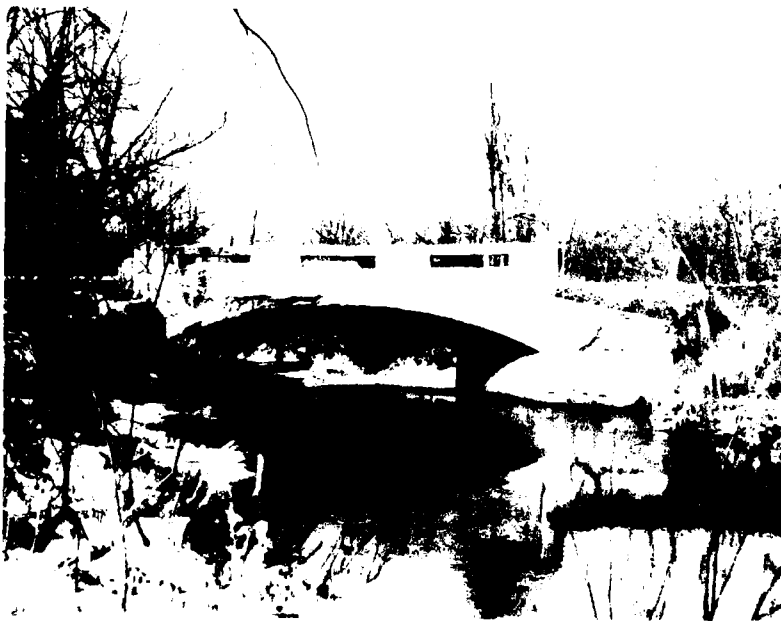
Meadowbrook Road bridge. Both Standard Project and Intermediate Regional Floods will overtop this bridge deck.

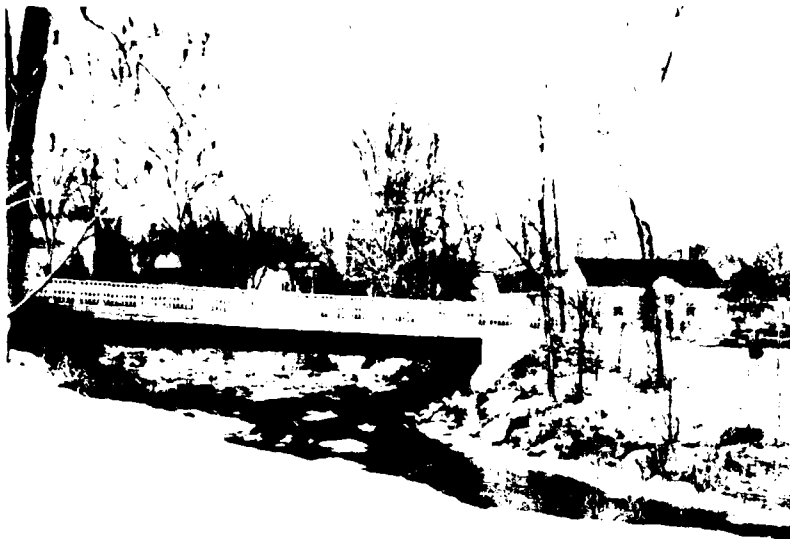
George F. Miller Drive bridge over Whetstone Brook. Entrance to Melrose Terrace housing development. Considerable flow will bypass this bridge through area in vicinity of cars.

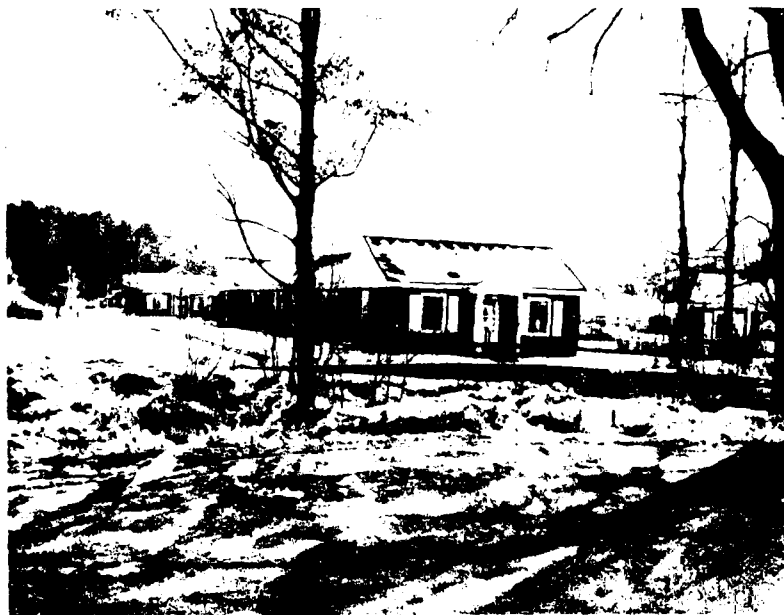
Melrose Terrace Housing Development for Elderly, looking downstream. Standard Project Flood will overtop bank in foreground to a depth of as much as five feet.

Within the upper of these critical areas, where the valley is wide and the stream gradient relatively flat, are several clusters of mobile homes, the total number of units being in excess of three hundred. Also within this same reach two housing developments for the elderly, each having a capacity of about 100 persons, have been constructed by the Brattleboro Housing Authority. Both the mobile homes and housing developments will be affected seriously by a major flood with heavy property damage and possible loss of life resulting.

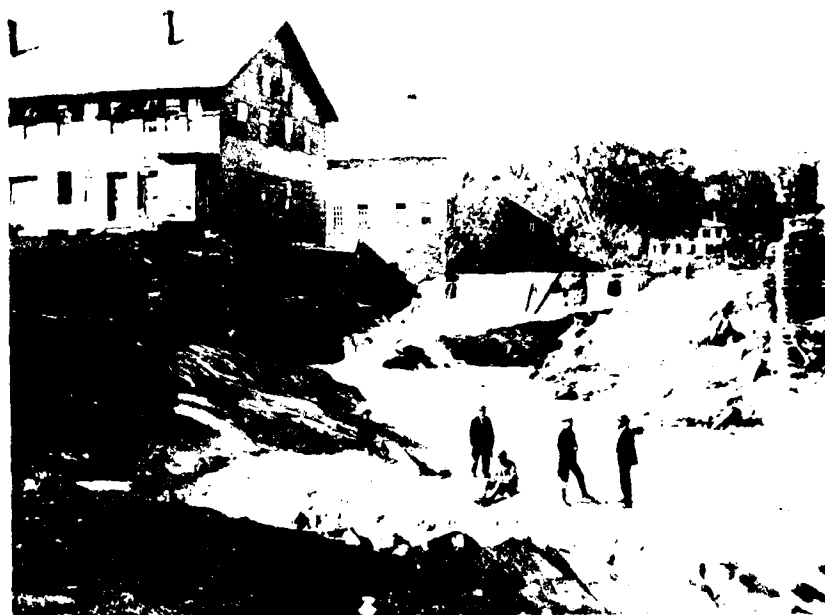
destruction resulting from flood of October 1869. View looking up Whetstone Brook from below Main Street (Route 5) bridge. Damaged abutments of old bridge in foreground. Note inadequate bridge structure and encroachment on flood plain at left. See also figure 1.

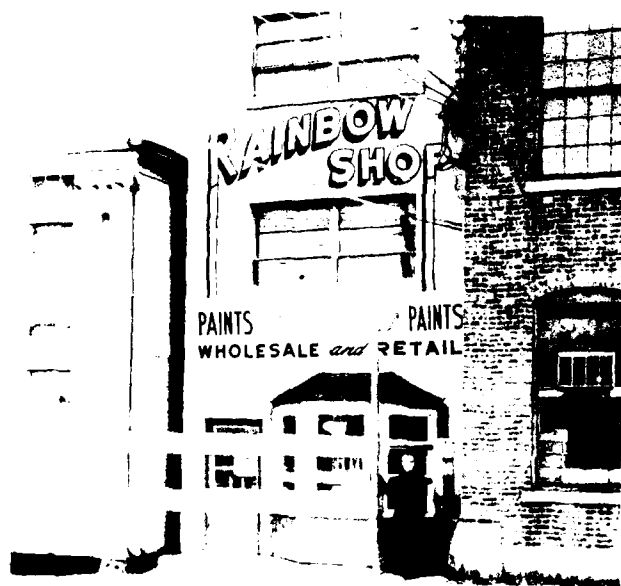
Flood Heights at Rainbow Shop, east side of Elm Street.

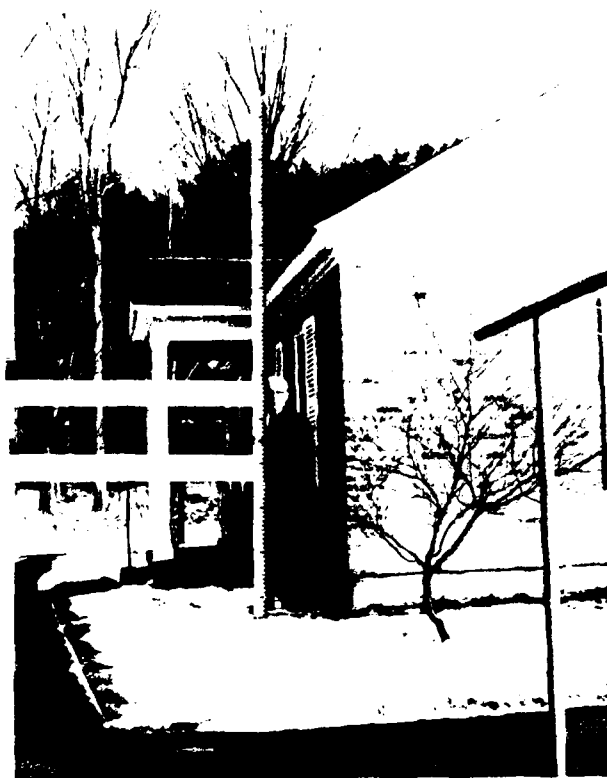
Flood Heights, upstream end of Melrose Terrace Housing Development for the Elderly, West Brattleboro.

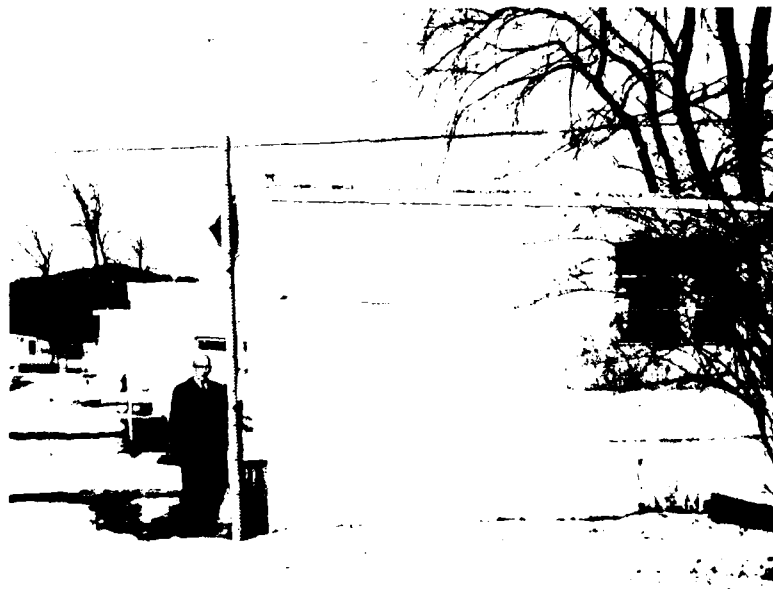
Flood Heights, mobile home in Glen Trailer Park, across Whetstone Brook from photograph above.

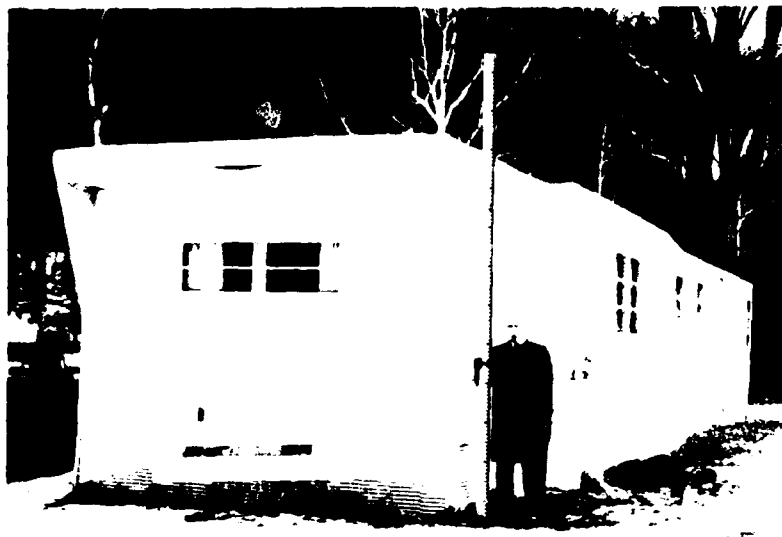
Flood Heights, mobile home in Mountain Home Trailer Park on left bank of Whetstone Brook opposite Country Kitchen, West Brattleboro.

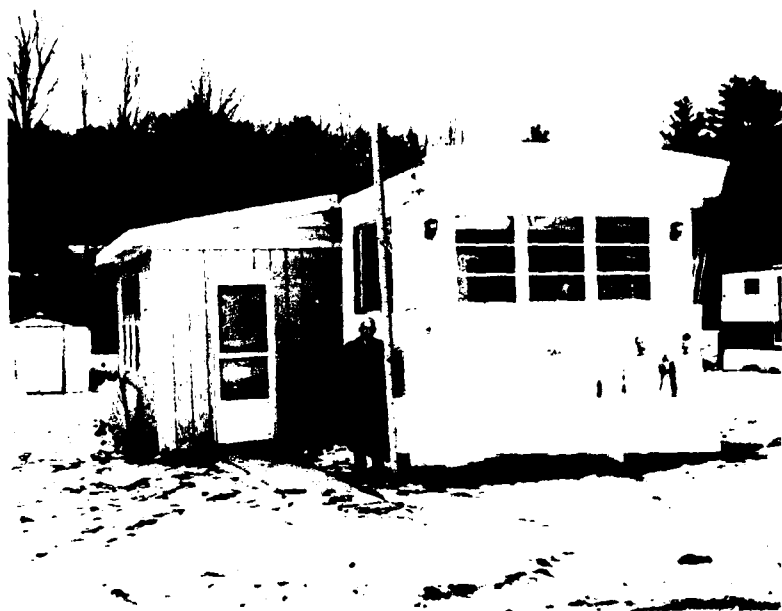
Flood Heights, mobile home, in Mountain home Trailer Park, right bank Whetstone Brook just downstream from Mountain Road, West Brattleboro.
