AFWAL-TR-81-2023

HIGH VOLTAGE TESTING

W.G. Dunbar **Boeing Aerospace Company** P.O. Box 3999 Seattle, Washington 98124

Interim Report for Period 24 September 1979 - 20 January 1981

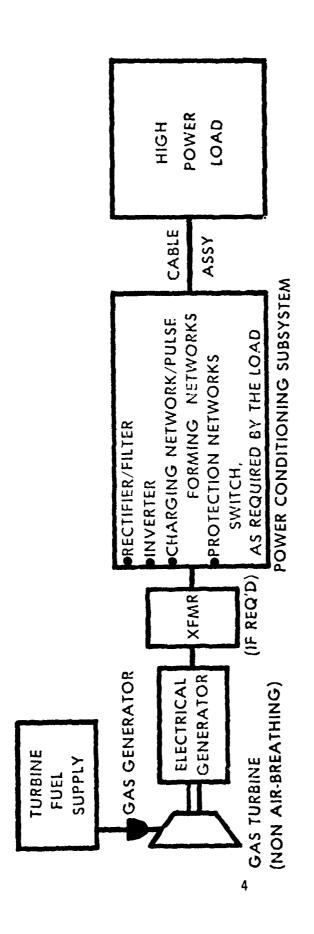
Figure 3.0-1: High Voltage/High Power Airborne System

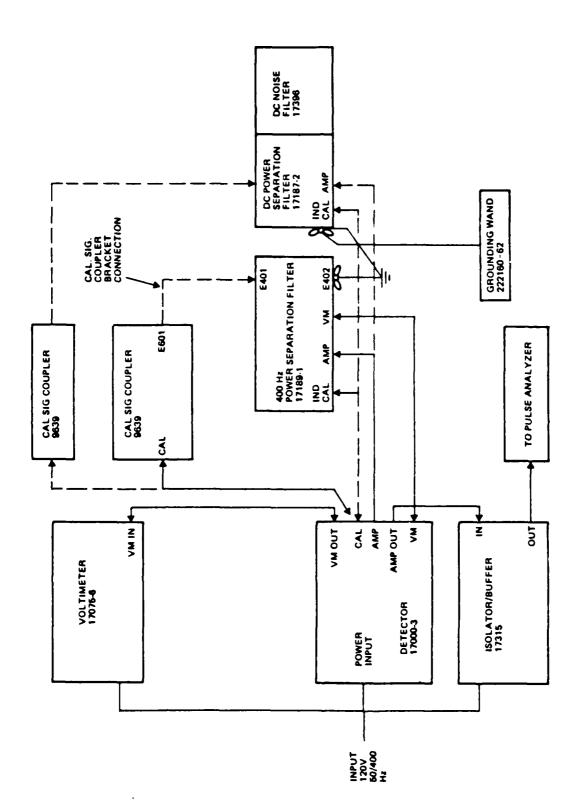
Figure 4.1-1 Corona Test System Schematic

A system schematic diagram for the facility is shown in Figure 4.1-1.

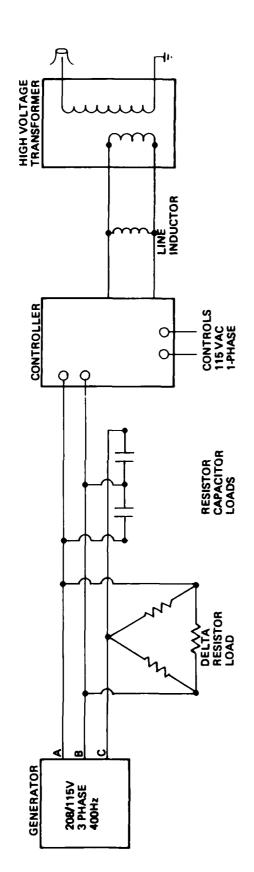
Figure 4.2-1: Power Supply and Auxiliary Components

4.2.2 <u>Auxiliary Components</u>. A three-phase, 400 Hz, 25 Kva, 209/115 volt, ac generator will be used to supply the low voltage input ac energy requirements for the high voltage power supply. This power source should be operated with 0.8 lag to 0.8 leading power factor. The high voltage power supply is a capacitive (leading power factor) load due to the capacitance of the bushing and windings. Therefore it is necessary to 1) decrease the capacitive current demand and 2) balance the generator output (current). To do this, capacitors and resistors must be added to the non-connected phases and an inductor added to the connected phase as shown in Figure 4.2-1. In addition, a delta-connected, balanced resistor network is connected to the primary of the transformer to correct the generator power factor. The component values were calculated as shown below.

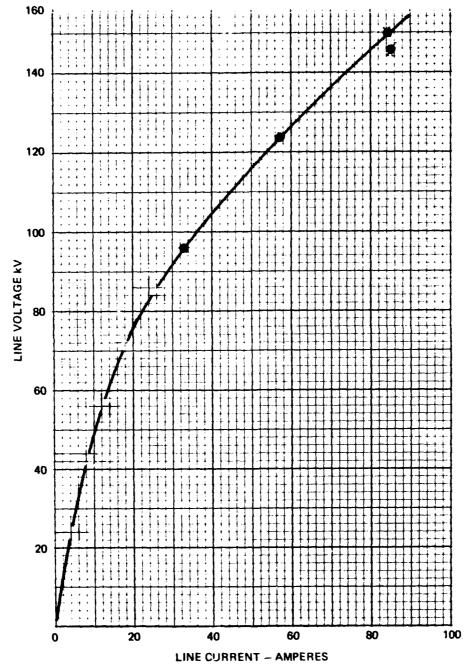
Figure 4.2-2: Power Supply Electrical Input Requirement

Data collected during the qualification test are shown in Figure 4.2-2 and Table 4.2-2.

A 400Hz, high-voltage transformer reflects a capacitive reactance into the power line rather than an inductive reactance like most low voltage transformers. This capacitance comes from the high voltage bushings and winding capacitances.

The capacitive reactance based on the data shown in Figure 4.2-2 is calculated as follows:

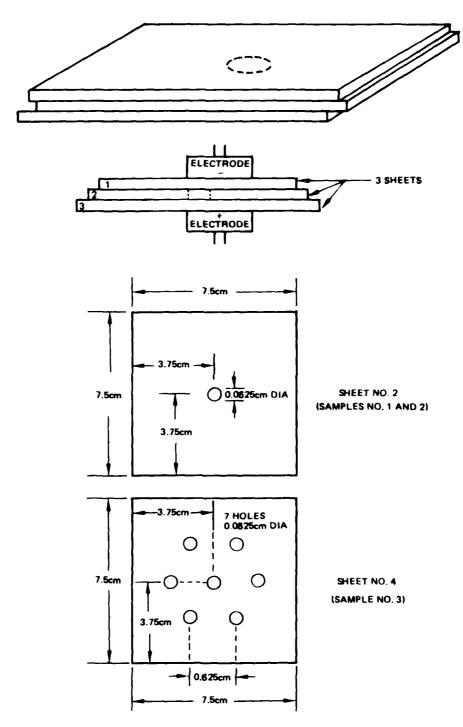
Figure 5.4-1: Insulation System Test Samples

The second set of evaluation tests were made at the WPAFB using the Partial Discharge Detection system described in paragraph 4.1. The three test samples tested included the following configurations: Sample 4) three sheets polyimide; one sheet had a single perforation, Sample 5) a silicone/polyimide/silicone sandwich with a single hole in the polyimide sheet, and Sample 6) a silicone/polyimide/silicone sandwich with seven holes in the polyimide sheet.

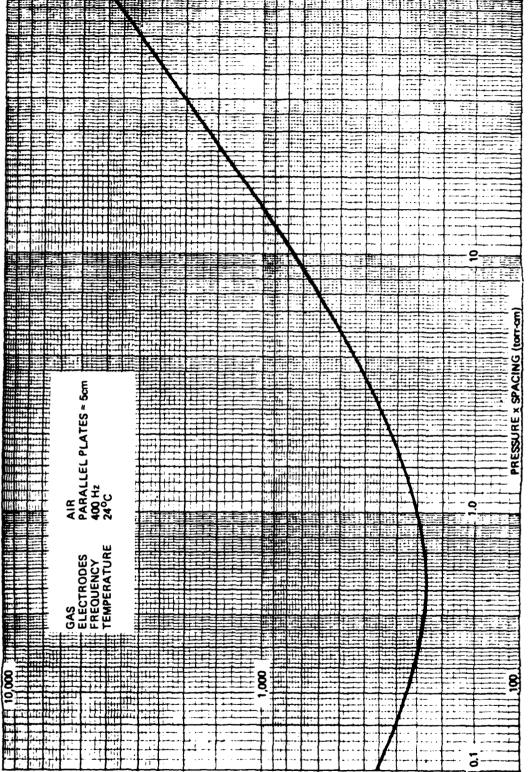
Figure 5.4-2: Paschen's Law Curve

The applied voltage (V 1) required to obtain partial discharges across the polyimide void (V $_2$) is (Reference 1)

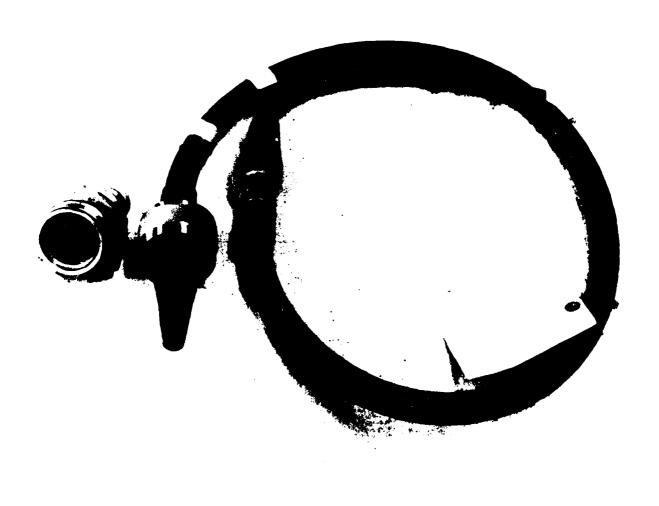
Figure 6.2-1: Cable Assembly and Connector

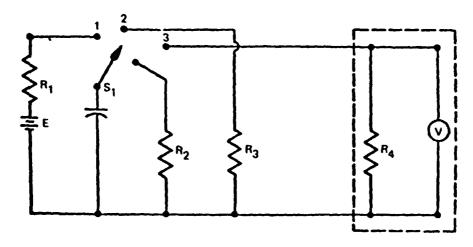
Figure 6.3-1 Typical production Dielectric Absorption Test Method

- 6.3.4 <u>Dielectric Absorption</u>. The three capacitors listed in Table 6.2-2 shall be tested for dielectric absorption. The dielectric absorption time shall be within 15 minutes.
- 6.3.4.1 <u>Procedure</u>. Each component identified in Table 6.2-2, in turn shall be attached to the electrical circuit of Figure 6.3-1.

The capacitor shall be charged at 50 percent of the dc voltage rating for 2 hours \pm 1 minute. The initial surge current shall not exceed 50 milliamperes. At the end of this period, the capacitor shall be disconnected from the power source and discharged through a 5 ohm \pm 2 percent resistor for 10 ± 1 seconds. The discharge resistor shall be disconnected from the capacitor and the recovery voltage shall be measured with an electrometer or other suitable device having an input resistance of 10,000 megohms, or greater. Recovery voltage shall be read at the maximum voltage within a 15 minute period. The dielectric absorption shall be computed from the following formula:

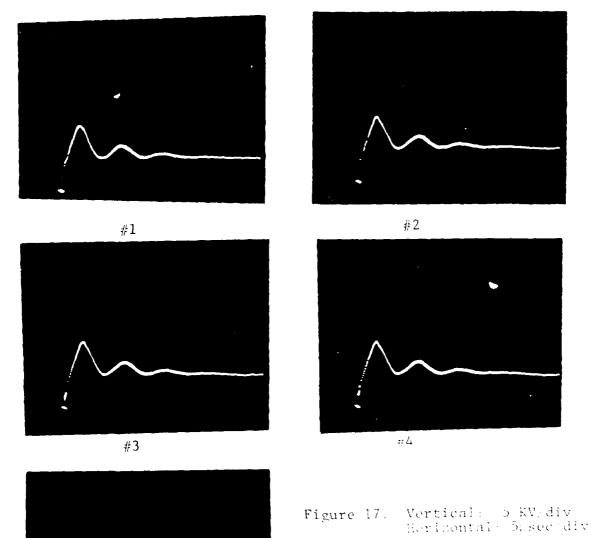
This Series of Oscillograms Shows the Waveforms of the Impulse Voltage Applied to the C-1 Serial #13 Capacitor with the Same Charge Voltage Each Shot. No Noticeable Deterioration in Waveform Was Noted After the 5 Shots - Voltage

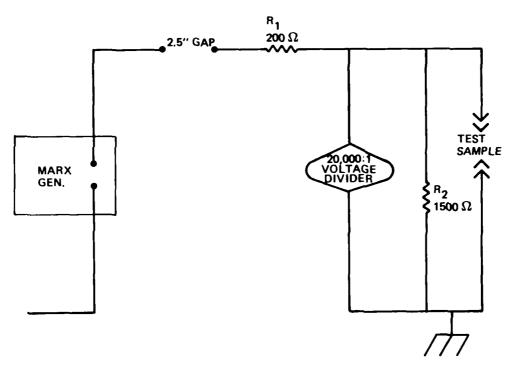
Figure : Impulse Test Setup
