TECHNICAL REPORT M-313

Laboratory Evaluation of EMP/EMI Shielded  
Enclosure Performance and Design Standards

STUDY OF EMI/RFI SEALS ON SHIELDED-  
ENCLOSURE PERSONNEL ACCESS DOORS

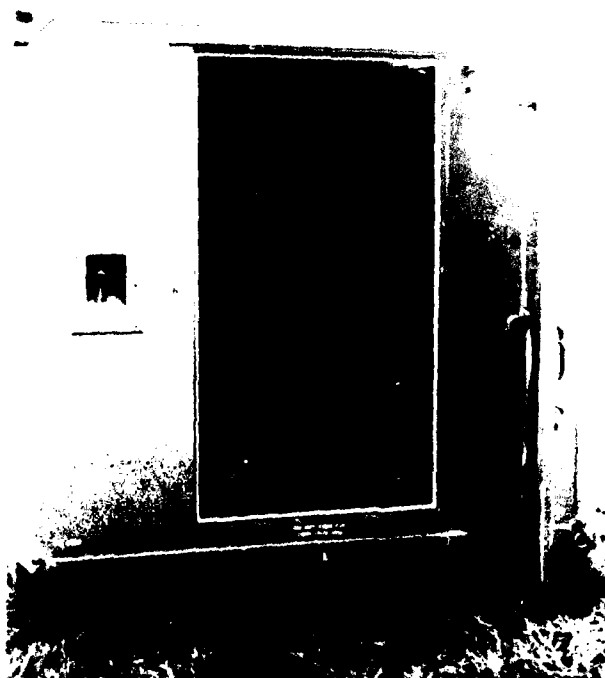
Figure A2. Single-mesh gasket door frame.
