March 1983

## Low-Cost Stator Material for M734 Alternators

Jonathan E. Fine

**U.S. Army Electronics Research  
and Development Command  
Harry Diamond Laboratories**

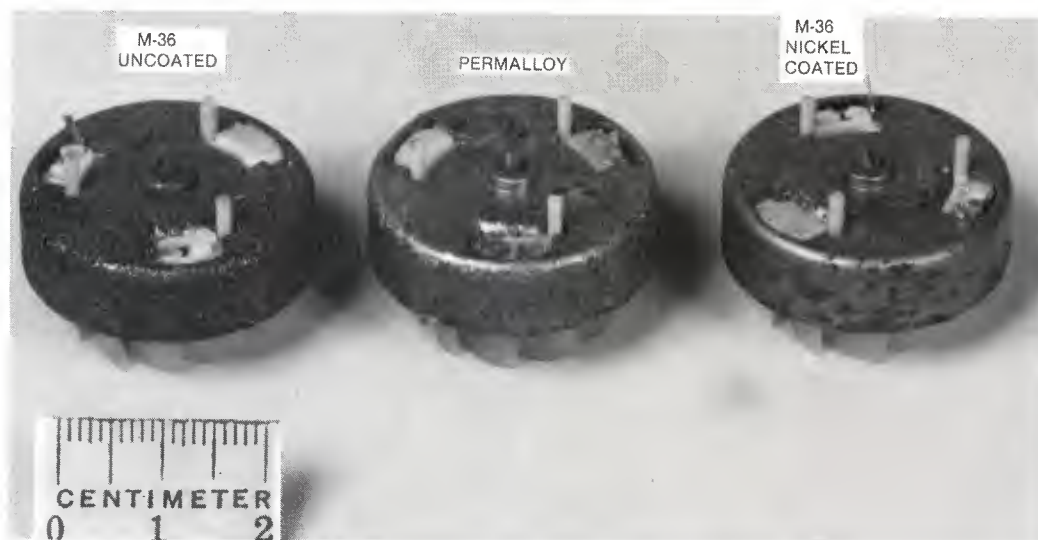
Figure 5 shows three alternators, one of each type, after 14 days of recycling. Considerable scale appears on the uncoated M-36 alternator (left), and a few small rust spots on the nickel-coated unit (right). The Permalloy control (center) had no noticeable marks. During part of each cycle, the alternators in the trays are removed from the chamber and placed on a table at ambient conditions for one hour. This affords time for a visual inspection of the units without disturbing the test. During the first two weeks of the test, the alternators were observed daily. Most of the visible corrosion occurred within the first few days of the tests, and did not change much on successive days. The appearance after 14 days is quite similar to that after completion of the test, as shown in figure 6.

Figure 5. T&H test units after 14 days.

An electrical continuity test was performed on the alternators after the T&H conditioning. This involved using an ohmmeter to measure the resistance between two points on the alternator, one on the housing and the other on the end plate. Before the T&H conditioning, an ohmmeter typically would read zero resistance. After the tests, the M-36 nickel-coated units and the Permalloy controls exhibited continuity, indicating that the electrical contact between the stator parts was not noticeably affected. However, no continuity was

found on the uncoated M-36 units on which an oxide crust clearly could be observed. When the crust was scratched away at one point on the end plate and one point on the housing, continuity was achieved, thus showing that even the M-36 coating was not affected electrically at the surface contact between the two stator parts.
