CENTER and LABORATORY TECHNICAL REPORT

INTEGRALLY CAST LOW-COST COMPRESSOR

MARCH 1983

AVCO LYCOMING DIVISION

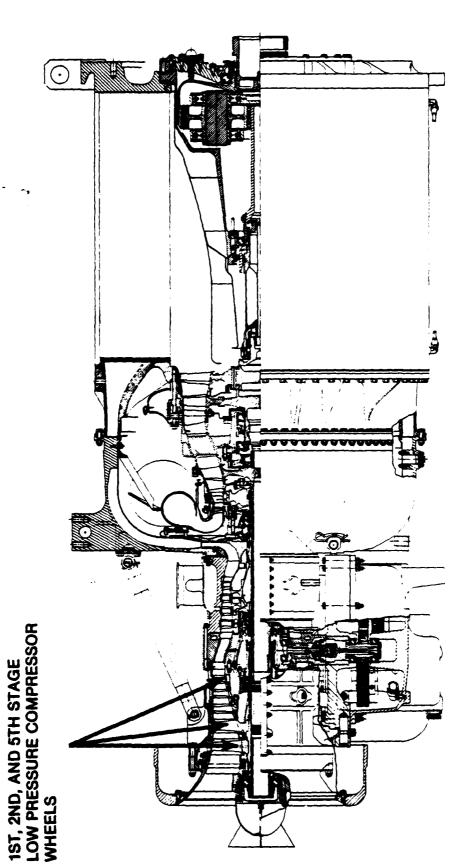
Figure 1. AGT 1500 Engine Schematic

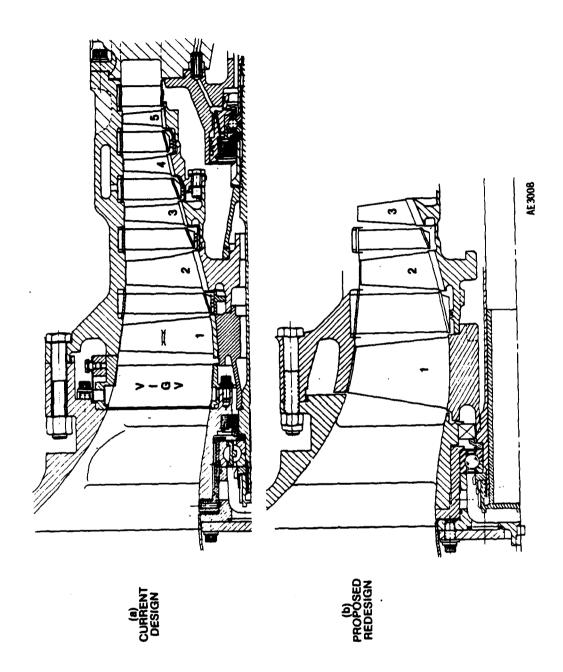
Figure 2. AGT 1500 Low Pressurs Compressor Section Redesign

Of the three stages finally selected, the fifth-stage rotor was the most technically challenging because its extremely thin airfoils (0.021-0.33 in. or 0.553-0.838 mm range of maximum thickness) would be difficult to cast. The third- and the fourth-stage low-pressure compressor rotors had also been considered as candidates for the effort; but, since these stages had airfoils with length-to-width ratios greater than those of the fifth-stage rotor, they would have been even more difficult to cast than the fifth stage. A decision to attempt third- and fourth-stage integrally cast rotors was, therefore, post-poned pending experience with fifth-stage casting development. Table 1 compares the early estimates of the relative risks associated with the casting of the various low-pressure compressor stages versus their estimated cost savings.

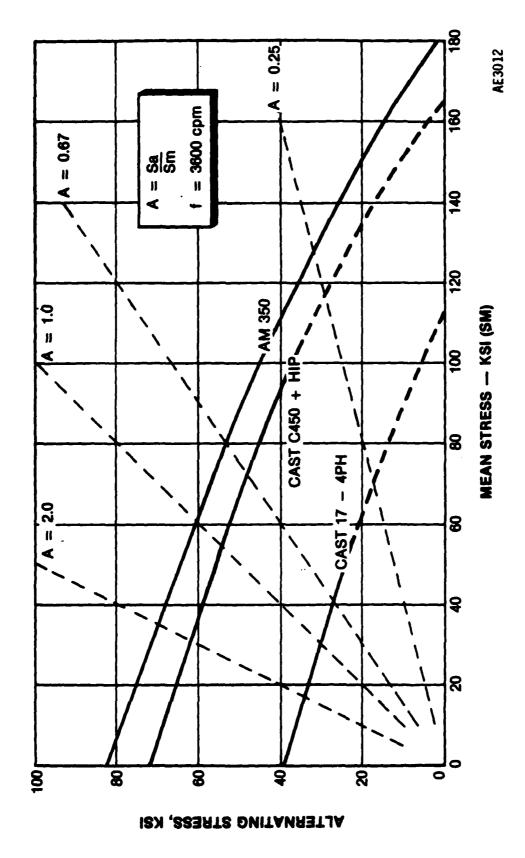
Figure 4. Typical High-Cycle Fatigue Properties for Common Compressor Alloys

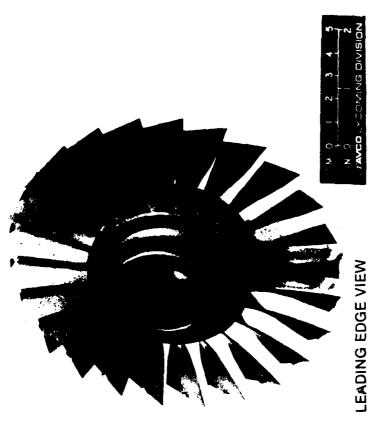
Figure 10. LTS 101 Integrally Cast Axial Compressor Rotor

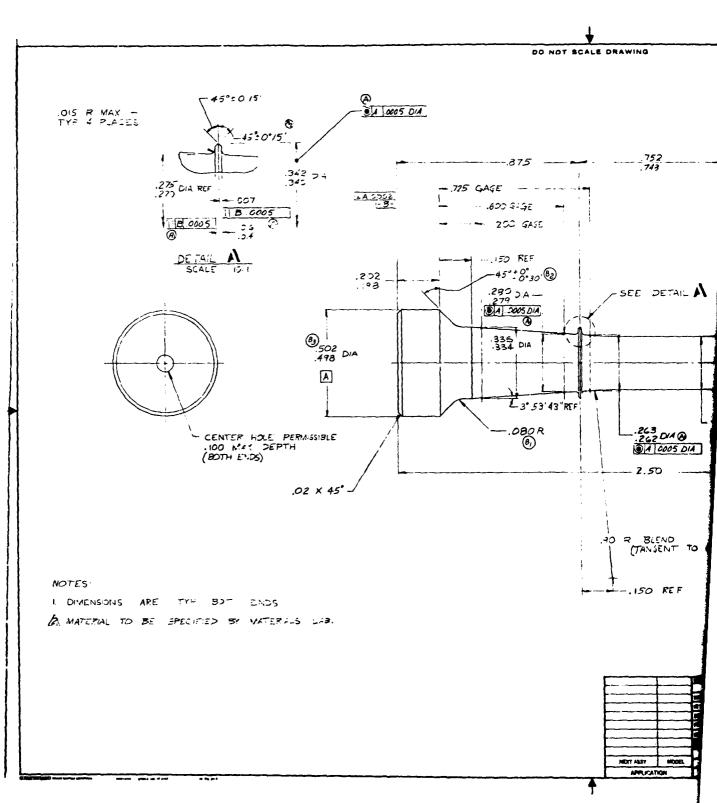
Figure 11. LCF Test Specimen Used for Cast Rotor Mechanical Property Evaluation

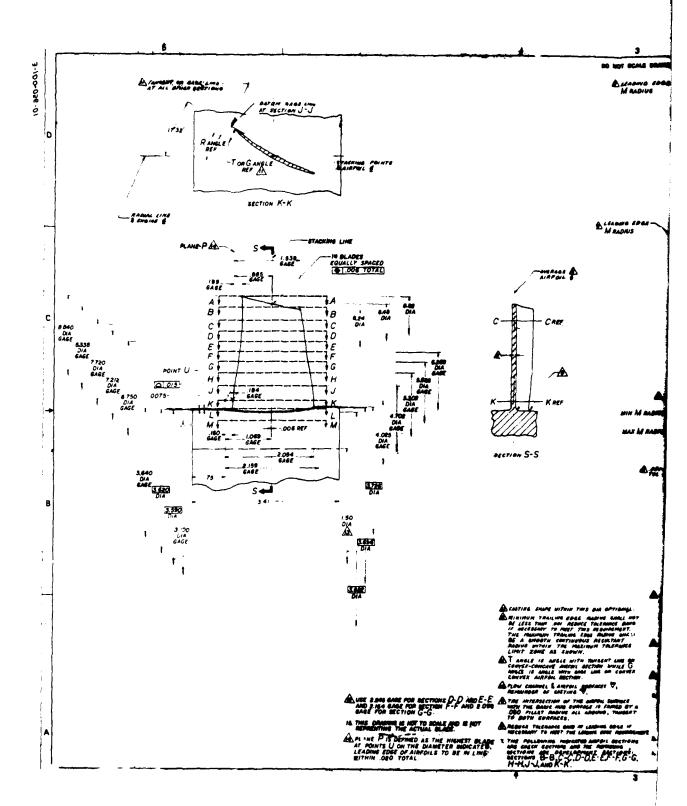
Figure 13. P/N 3-100-056-01, First-Stage Integrally Cast Rotor

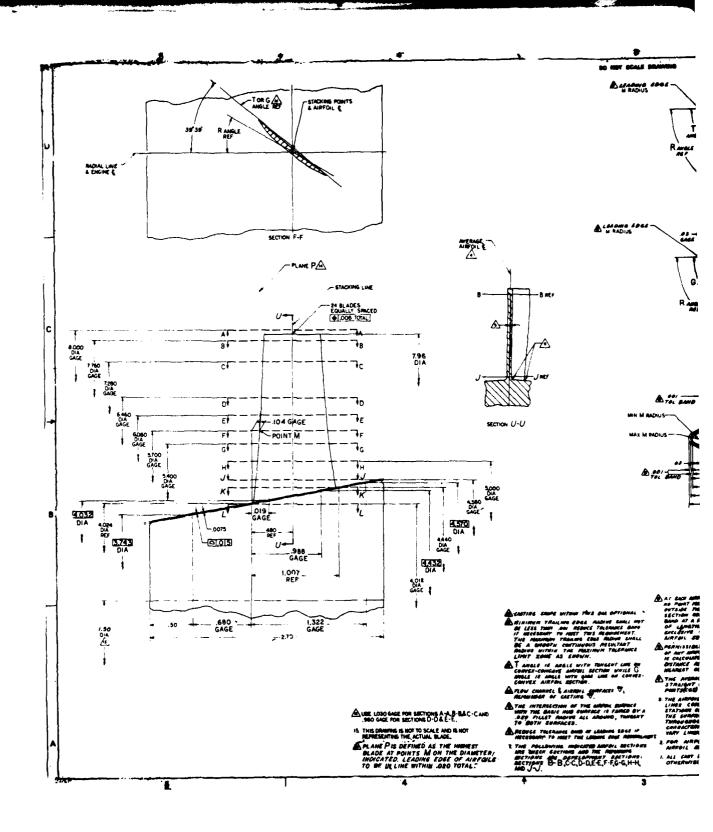
Figure 14. P/N 3-100-057-01, Second-Stage Integrally Cast Rotor

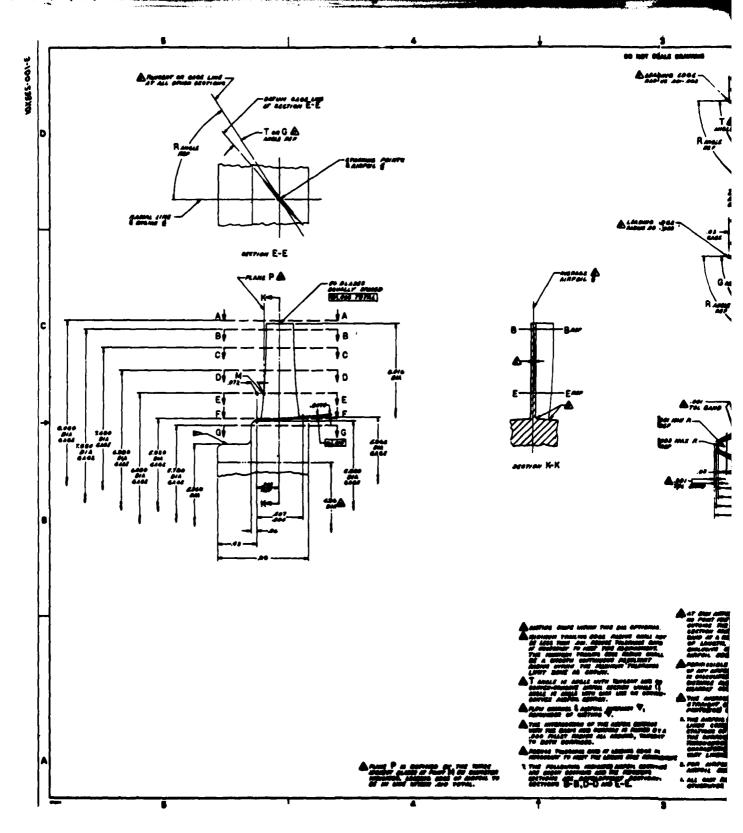
Figure 15. P/N 3-100-233X01, Fifth-Stage Integrally Cast Rotor

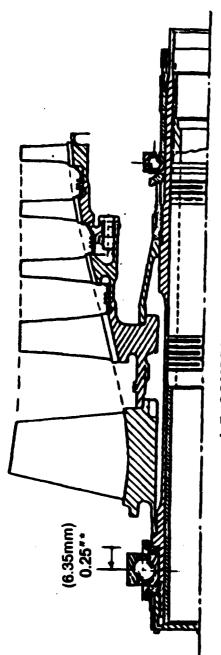
L.P. COMPRESSOR ROTOR PROPOSED DESIGN HB-1

- 1. Design HB-1, with approximately 0.25 in. (6.35 mm) front bearing relocation (forward of its current low-pressure compressor position)
- 2. Design HB-2, with approximately 1.0 in. (25.4 mm) front bearing relocation (forward of its current low-pressure compressor position).

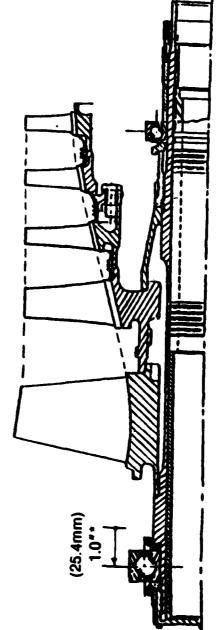
L.P. COMPRESSOR ROTOR PROPOSED DESIGN HB-2

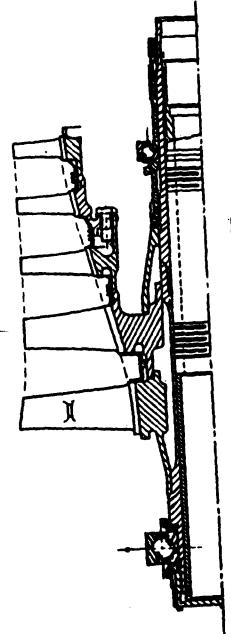
L.P. COMPRESSOR ROTOR CURRENT PRODUCTION DESIGN (1979)

Figure 17. Current LP Compressor Rotor Assembly Splined to the LP Turbine Rotor Assembly

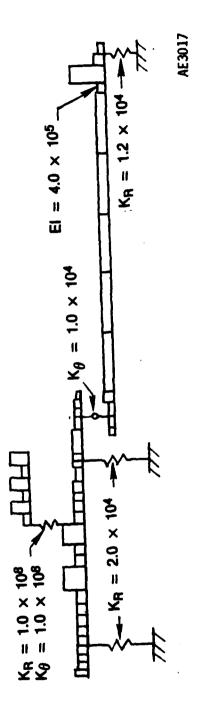
Figure 18. LP Compressor-Turbine Rotor/Shaft Lateral Vibration Model

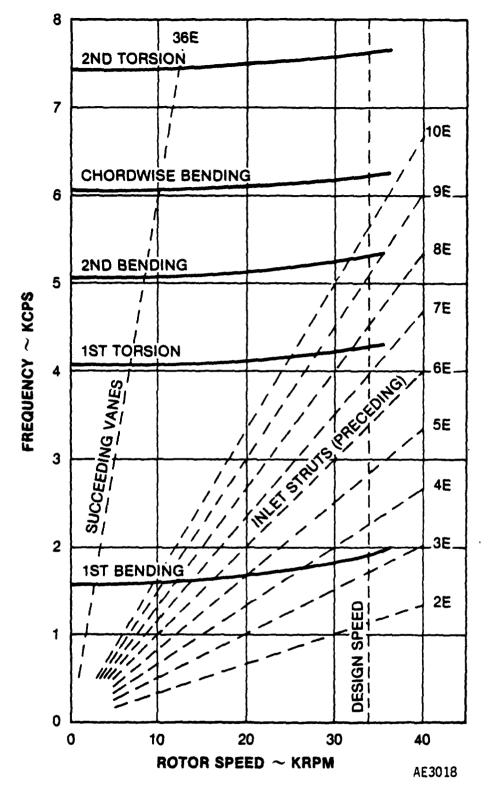
Figure 19. AGT 1500 Low Pressure Compressor First-Stage Blade Excitation Diagram

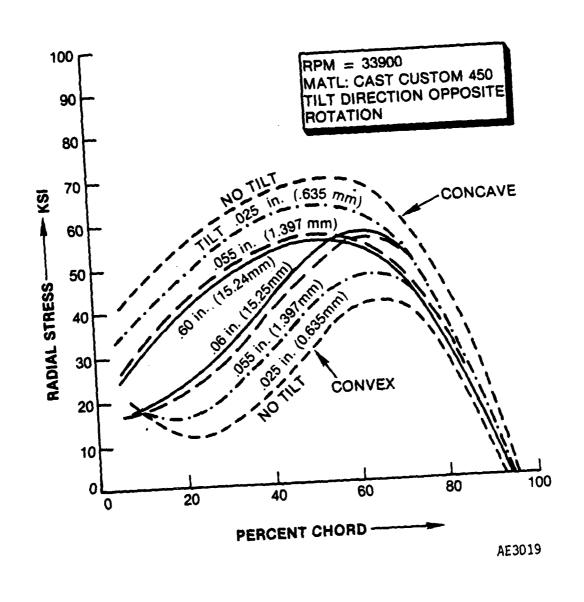
Figure 20. Steady State Stress Versus Chordal Distance for Selected Airfoil Tilts for the AGT 1500 LPC First-Stage Blade

It was also required that the redesigned blade have balanced concave and convex, steady-state operating stresses (i.e., bending from centrifugal and gas loads had to be minimized). This was achieved by shifting or tilting the airfoil sections to produce more efficient radial load paths. A study was conducted to evaluate airfoil stress distributed at various tilts.

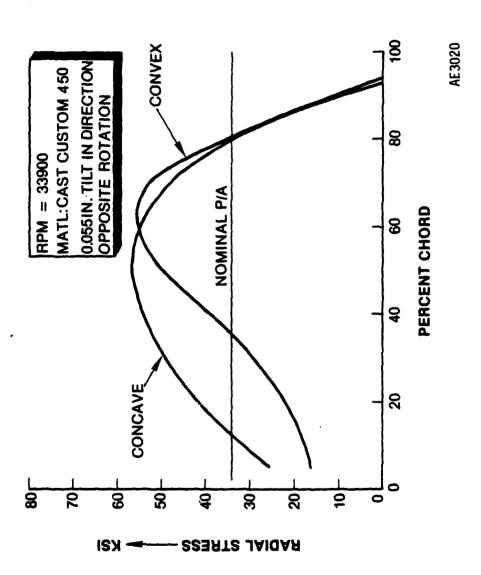
Figure 21. Steady-State Stresses Versus Chordal Distance for the AGT 1500 LPC First-Stage Blade With Optimum Tilt

The airfoil was also analyzed for vibratory stresses. A plot of normalized vibratory stresses at approximately 10 percent span from the base is shown for the primary mode (first bending) in Figure 22. This figure shows that the maximum vibratory stresses occur at the leading edge of the airfoil (concave) and at the 40 percent chordal width (convex) where the steady-state stresses were 38 KSI (262 MPa) (Figure 21).

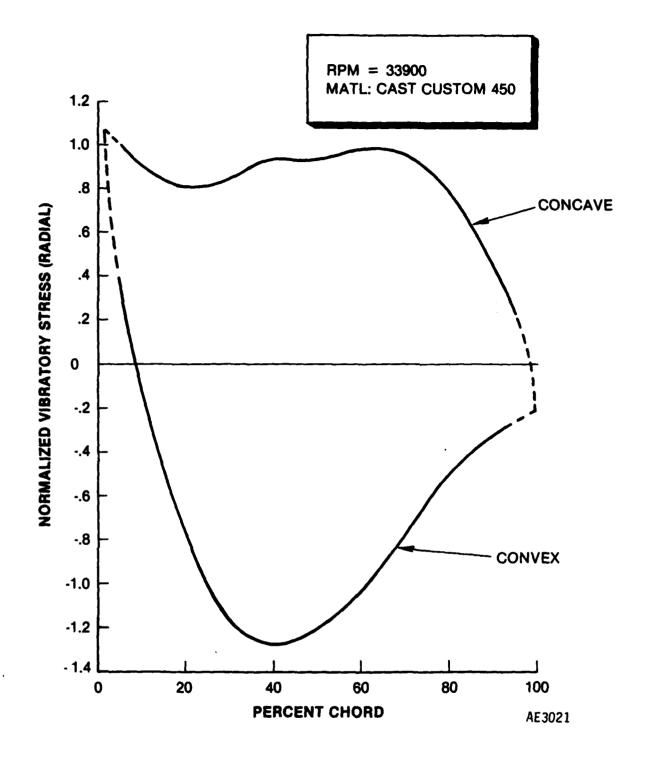
Figure 22. Normalized Vibratory Stresses Versus Chordal Distance for AGT 1500 LPC First-Stage Blade

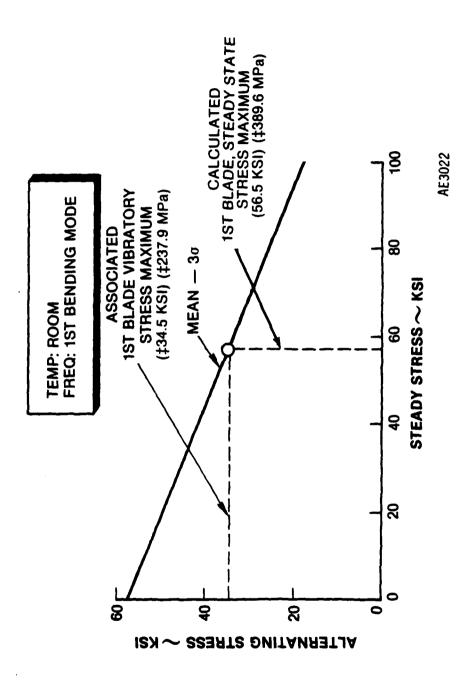
Figure 23. Goodman Diagram for Cast Custom 450 Alloy First-Stage LP Compressor Blade Calculated Maximum Allowable Stresses

A previously developed Goodman diagram for cast Custom 450 material is shown in Figure 23. Based upon the calculated maximum steady-state stress which exists in the first-stage blade of 56.5 KSI (389.5 MPa), at the 53 percent chordal width, the associated maximum allowable vibratory stress can be graphically found at this blade location to be \pm 0. KSI (237.9 MPa). Based upon experience with other engines, these allowables will be well beyond the actual operating vibratory stresses of the first-stage airfoil.

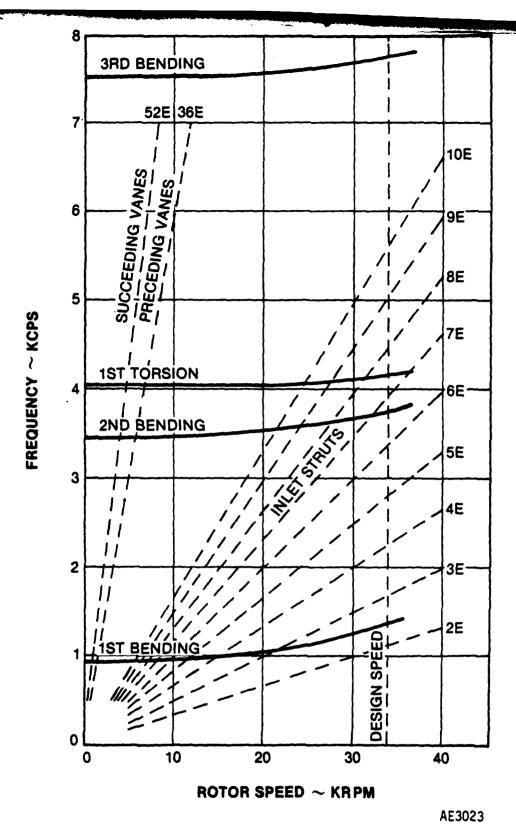
Figure 24. AGT 1500 Low-Pressure Compressor Second-Stage Blade Excitation Diagram

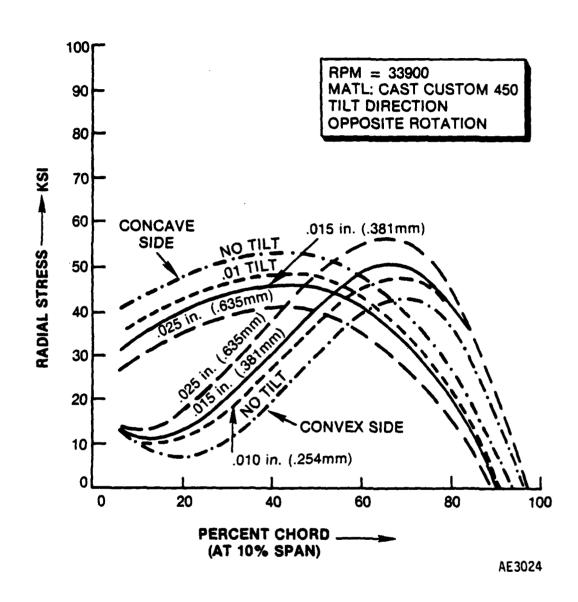
Figure 25. Steady-State Stress Versus Chordal Distance for Selected Airfoil Tilts for the AGT 1500 LPC Second-Stage Blade

As can be seen from Figure 25, the maximum steady-state stress level for the basic airfoil shape (without tilt) is 53 KSI (365 MPa) at 43 percent of the chord from the leading edge at the concave surface. The worst steady-state stress imbalance for this blade occurred at the 20 percent chordal width. There the differential between the concave stress of 48 KSI (331 MPa) and the convex stress of 7 KSI (48.2 MPa) was 41 KSI (283 MPa)

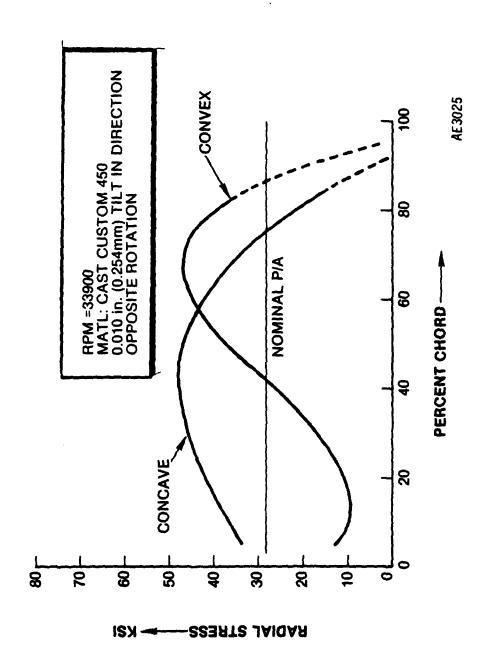
Figure 26. Steady-State Stresses Versus Chordal Distance for the AGT 1500 LPC Second-Stage Blade With Optimum Tilt

Figure 26, however, shows that incorporating the optimum tilt of 0.10 in. (.254 mm) reduced the maximum steady-state stress to 47.5 KSI (327.5 MPa) (at the 43 percent chordal width, concave side) and the worst steady-state stress imbalance to 32 KSI (220.6 MPa). This imbalance is calculated based upon the 43 KSI or 296.5 MPa) at the con-cave side, and 11 KSI (75.8 MPa) at the convex side for the 20 percent chordal width. This figure shows that the application of optimized tilt not only re- duced the airfoil's tendency to bend during operational loads (i.e., reduced concave/convex stress imbalance), but also reduced the magnitude of the maxi- mum steady-state stress in the second blade by approximately 5.5 KSI (37.9 MPa) (based on a design speed of 33,900 rpm).

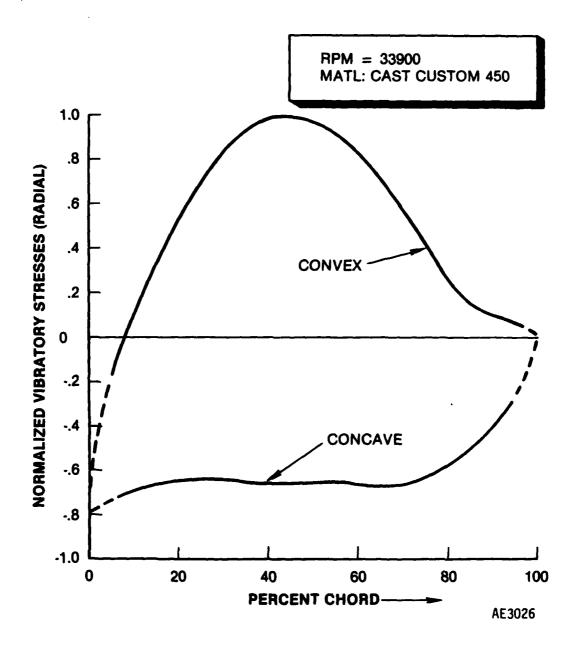
Figure 27. Normalized Vibratory Stresses Versus Chordal Distance for AGT 1500 LPC Second-Stage Blade

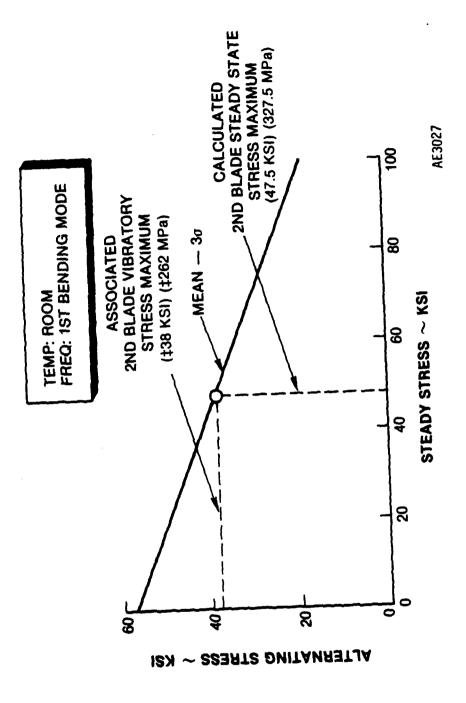
Figure 28. Goodman Diagram for Cast Custom 450 Alloy Second-Stage LP Compressor Blade Calculated Maximum Allowable Stresses

The previously developed Goodman diagram for cast Custom 450 material is shown in figure 23 and again in Figure 28. Based upon the calculated maximum steady-state stress which exists in the second-stage blade (47.5 KSI) at the 43 percent chordal width. The associated maximum allowable vibratory stress can be graphically found at this blade location to be +/- 38 KSI (262 MPa). Based upon experience with other engines, these allowables will be well beyond the actual operating vibratory stress es of the second-stage airfoil.

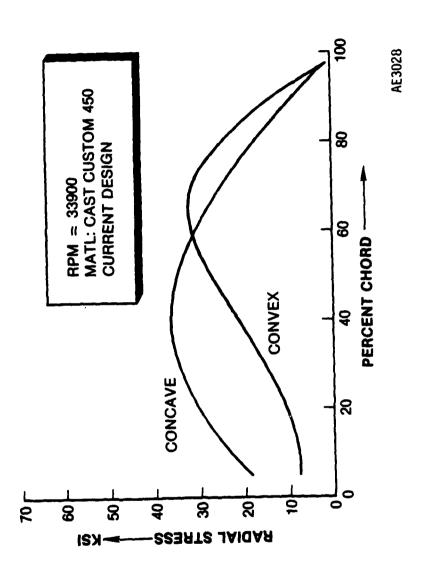
Figure 29. Steady-State Stress Versus Chordal Distance for the AGT 1500 LPC Fifth-Stage Blade

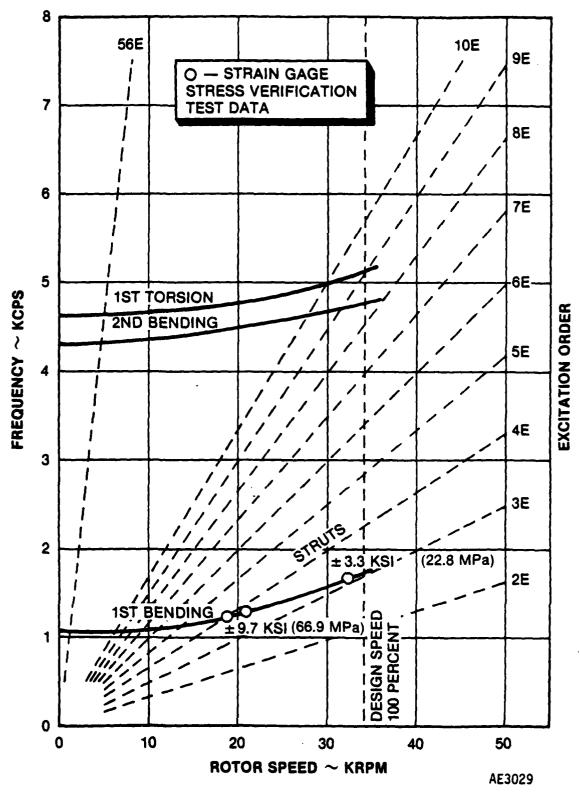
Figure 30. AGT 1500 Low-Pressure Compressor Fifth-Stage Blade Excitation Diagram

Natural frequencies for the primary modes of vibration are shown in the excitation diagram in Figure 30. Strain-gage measurements were made on wrought wheels to determine the actual vibratory stresses which existed at the maximum steady-state stress location (24 percent chordal width) for selected levels of engine speed. The strain-gage tests measured a vibratory stress of +/-3.3 KSI (22.7 MPa) at 96 percent of design speed (approximately 32,500 rpm) and +/-9.7 KSI (66.9 MPa) at a reduced speed condition (approximately 19,000 rpm) in the vicinity of the location of the calculated maximum steady-state stress (37 KSI) (255 MPa) for the airfoil.

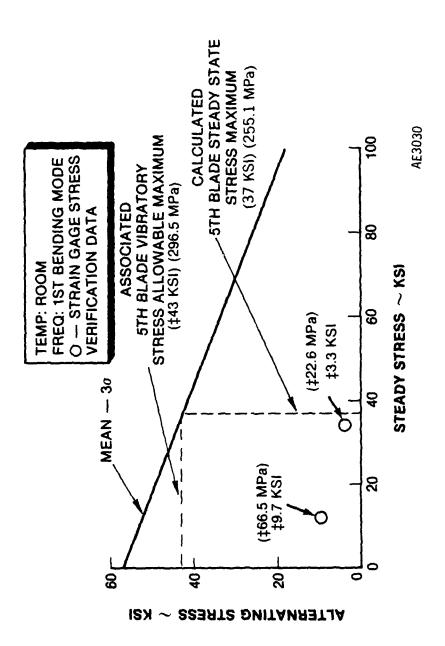
Figure 31. Goodman Diagram for Cast Custom 450 Alloy Fifth-Stage LP Compressor Blade Calculated Maximum Allowable Stresses

The Goodman diagram for cast Custom 450 material is shown again in Figure 31, in which the measured +/- 3.3 KSI (\pm 22.6 MPa) vibratory stress is plotted. The abscissa location of this point in the diagram was selected to be less than the predicted maximum steady-state stress of 37 KSI (254 MPa). The 37 KSI (254 MPa) maximum steady-state, stress was calculated at 100% of design speed (33,900 RPM). The \pm 3.3 KSI (\pm 22.6 MPa) vibratory stress was measured at only 96% of design speed (a lower steady state stess environment). It can be seen that this \pm 3.3 KSI (\pm 22.6 MPa) vibratory stress is well below the allowable maximum vibratory stress of +/- 43 KSI (\pm 295 MPa) (graphically determined) at the maximum steady-state stress location.

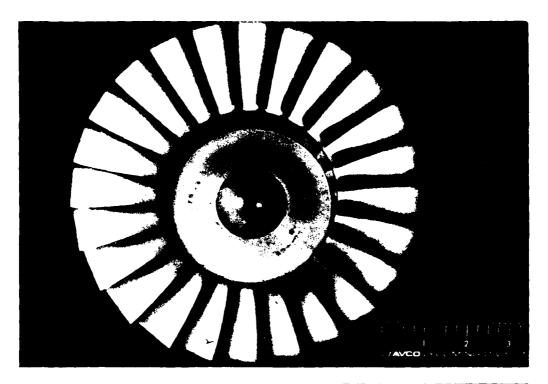
Figure 33. Second-Stage Rotor Investment Casting Pattern

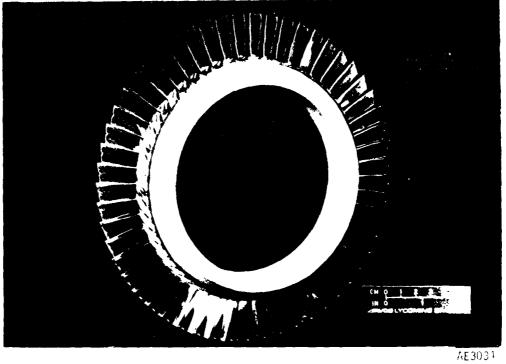
Figure 34. Fifth-Stage Rotor Investment Casting Pattern

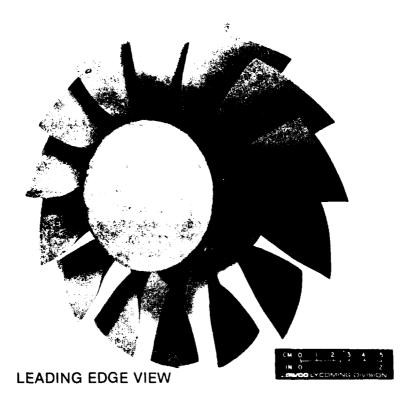
Figure 35. First-Stage Integrally Cast Rotor

The selected process (Pl) demonstrated its ability to produce rotors with a minimum of misruns. Misruns are produced when the molten alloy solidifies prematurely during pouring and does not completely fill portions of airfoil edges and corners. Because the Pl process did not have a misrun problem the process received a "good" rating in the category of mold fill. The process was also capable of providing castings with a minimum of surface pitting and hot-tear cracks. Normally this would have been sufficient for it to earn a "good" rating for its surface integrity. However, the occasional appearance of rough surface finishes (up to 180 rms instead of 90 rms on the airfoil and flow channel surfaces) reduced the overall rating to "fair". However, it was found that by using hand blending and abrasive flow finishing, acceptable surface finishes can be achieved on the majority of the castings.

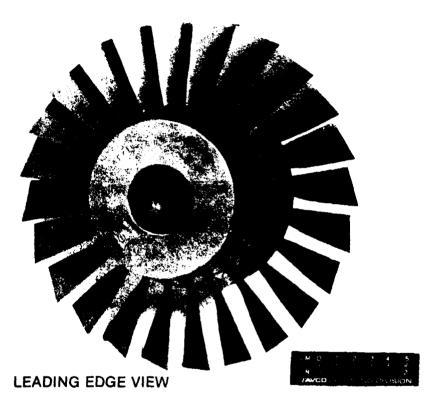
Figure 36. Second-Stage Integrally Cast Rotor

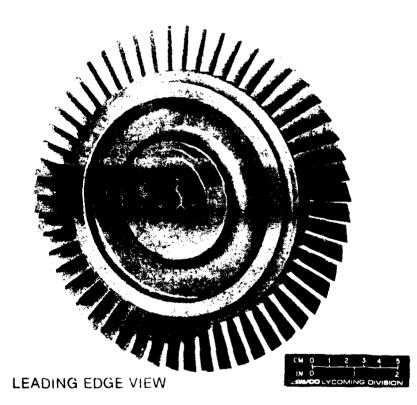
Figure 37. Fifth-Stage Integrally Cast Rotor

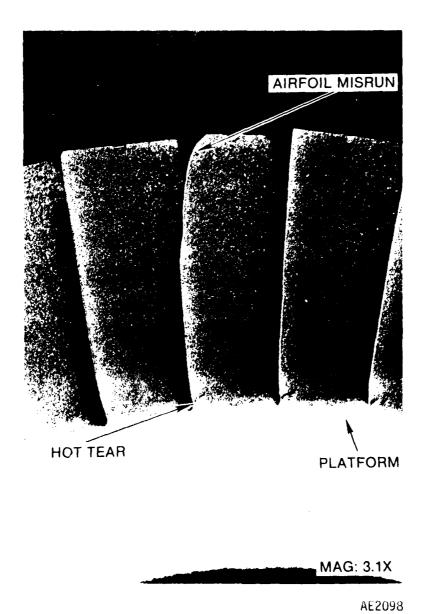
Figure 38. Example of Airtoil Misron and Hot Tear Cracking in Fifth-Stage As-Cast (Unfinished) Rotor

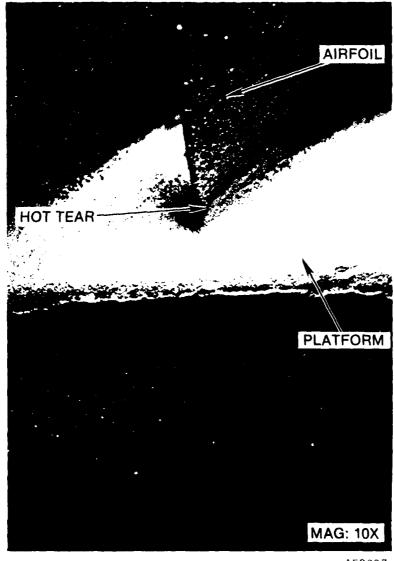
Figure 39. Magnified View of a Hot Tear at the Trailing Edge Fillet Radius of Fifth-Stage Rotor

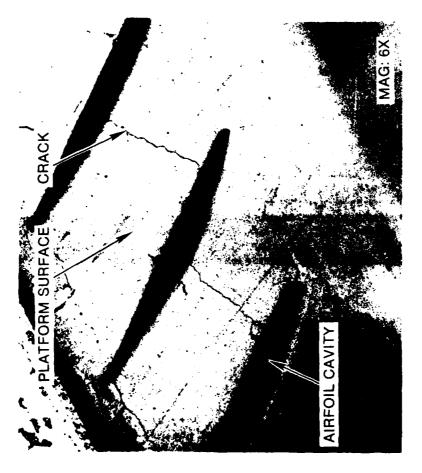
Figure 41. Interior of Fifth-Stage Mold Showing Cracks After Dewax, Burnout, and Firing

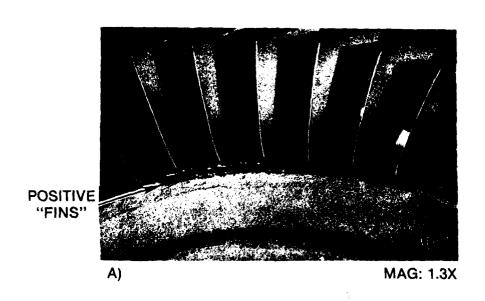
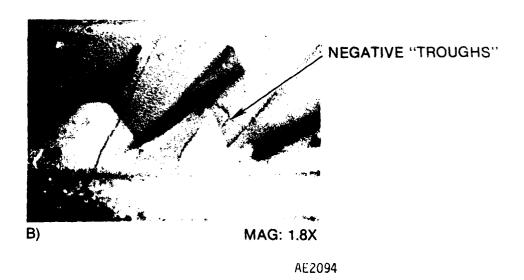
Figure 42. Examples of Fifth-Stage Rotor Fins and Troughs

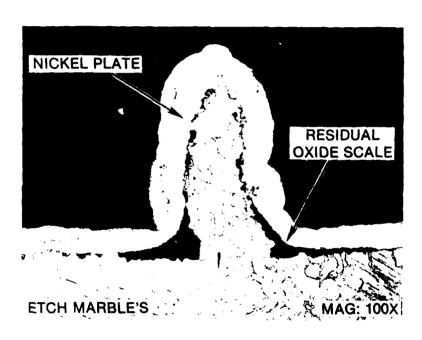
Figure 43. Microstructure of a Metal Fin (Produced by the Intrusion of Molten Alloy Into a Mold Split)

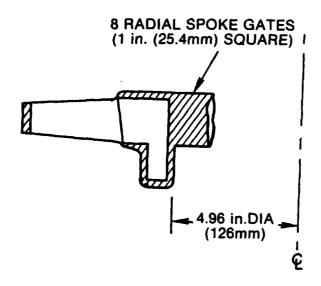
Figure 45. Sketch of the P34, Fifth-Stage Gating System

- (5) P16 process casts the rotor hub solid. The P34 process casts the rotor hollow using eight gate runners which extend from the central pouring cup to the ID of the rotor platform.

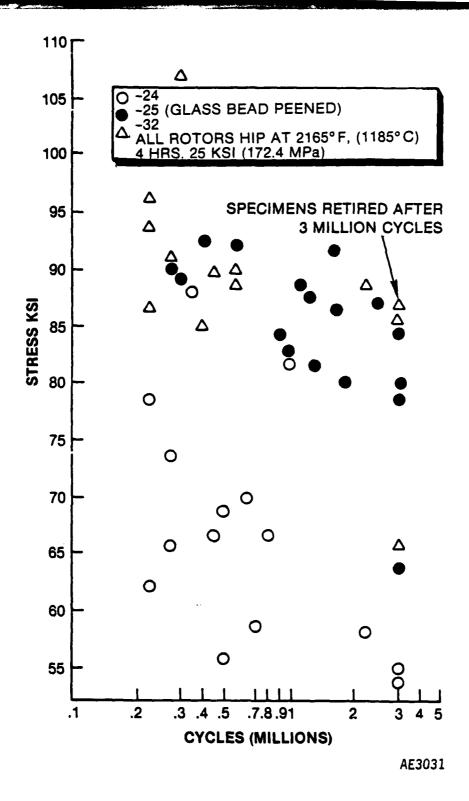
Figure 46. High-Cycle Fatigue Comparison of Fifth-Stage Wheels HIP'D at 2165°F (1185°C)

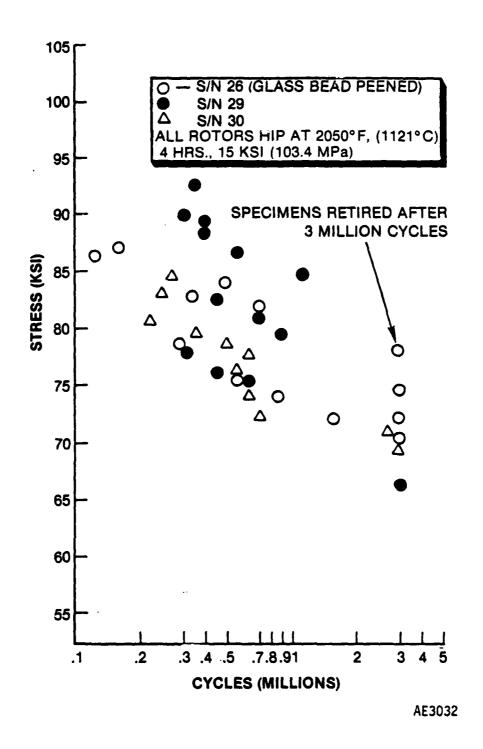
Figure 47. High-Cycle Fatigue Comparison of Fifth-Stage Wheels HIP'D a 2050°F (1121°C)

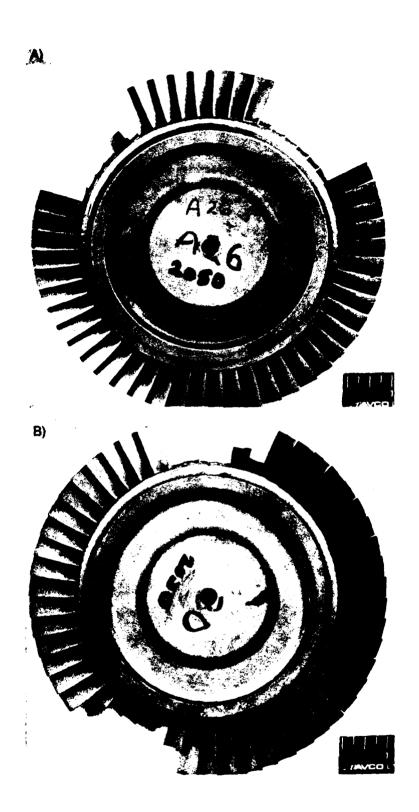
Figure 54. HCF Failure Location of Fifth-Stage Wheels: A) With Glass Bead Peened Surfaces and B) Without Peened Surfaces

As a minor evaluation (not included in the original scope of the contract), the effect of glass-bead peening on fifth-stage airfoil HCF failure locations was conducted. Airfoil fractures in cast fifth-stage rotors were more randomly located than would have been expected. Prior to HCF testing, two (of six) fifth-stage rotors were glass-bead peened per AMS2430H, using No. 13, 0.0025 inch B glass shot (MIL-G-9954) at an intensity of 2.5N. All airfoils were peened twice (edges were masked to help prevent edge rollover).

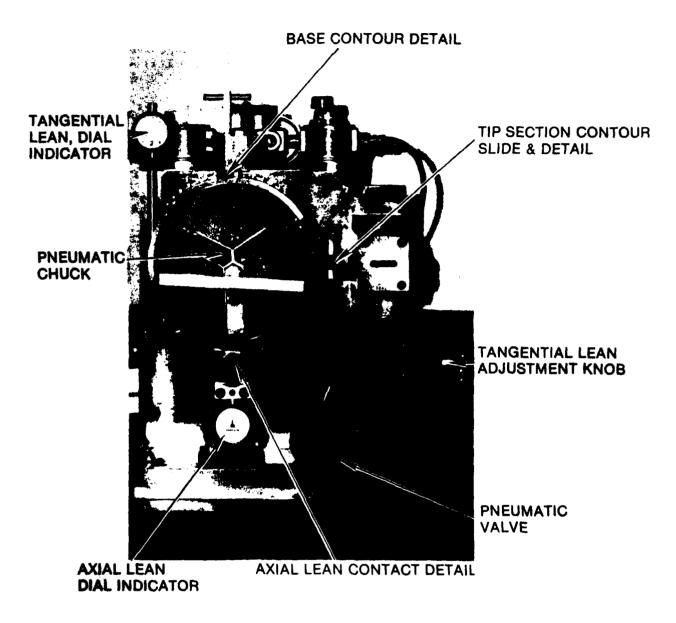
Figure A-1. Fifth-Stage Blade Angle Contour Gage (Ready for Rotor Positioning)

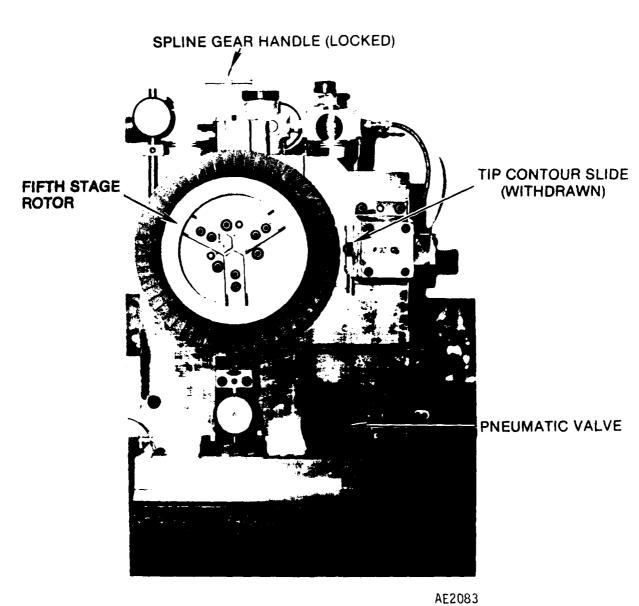
Figure A-2. Rotor Placed Into Gage

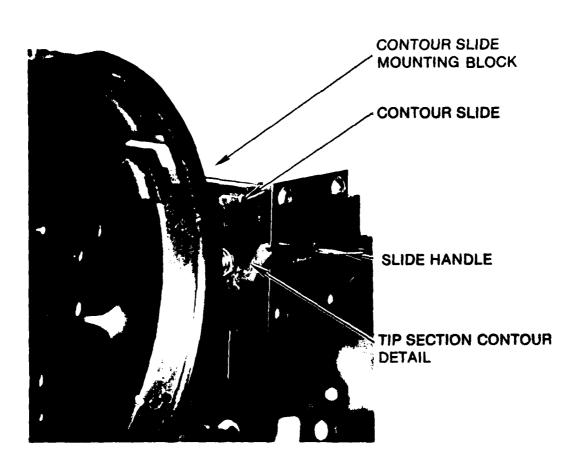
Figure A-4. Tip Section Contour Slide and Detail
