Structures Technical Memorandum 361

AIRCRAFT FATIGUE - WITH PARTICULAR EMPHASIS ON
AUSTRALIAN OPERATIONS AND RESEARCH

J.Y. MANN

APRIL, 1983

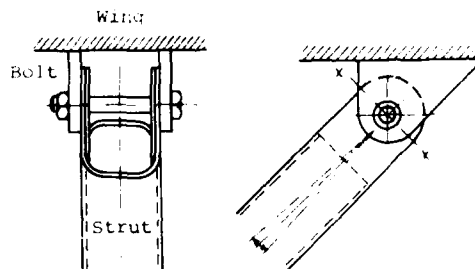
FIG. 3(b) DORNIER "MERKUR" WING/STRUT ATTACHMENT (Ref.)

of-balance oscillator should be mounted on the wing to reproduce slipstream induced vibrations. However, it was the tragic crash with the loss of six lives of a Dornier Merkur high-wing monoplane (Fig. 3(a)) of the German airline Lufthansa near Schleiz in Eastern Germany in September 1927^{28,29} which focussed attention on fatigue as being a potential problem in aircraft structures. This accident, which resulted from the failure of a wing to strut fitting (Fig. 3(b)), led to an extensive program of research at the Deutsche Versuchsanstalt fuer Luftfahrt (DVL) in Berlin²⁹ on the fatigue of full-scale wing spars made of wood, steel and duralumin²³. On 17 June 1929, the 'City of Ottawa'^{*}, a Handley-Page W.10 aircraft operated by Imperial Airways, was lost in the English Channel together with seven lives as the result of the fatigue failure of an engine connecting rod stud³⁰; and on 27 July 1934 a Swissair Curtiss Condor biplane crashed near Tuttelingen in Germany with the loss of eleven lives³¹ because of the failure of a wing strut. These accidents provided further evidence that the aircraft fatigue problem was not under control.

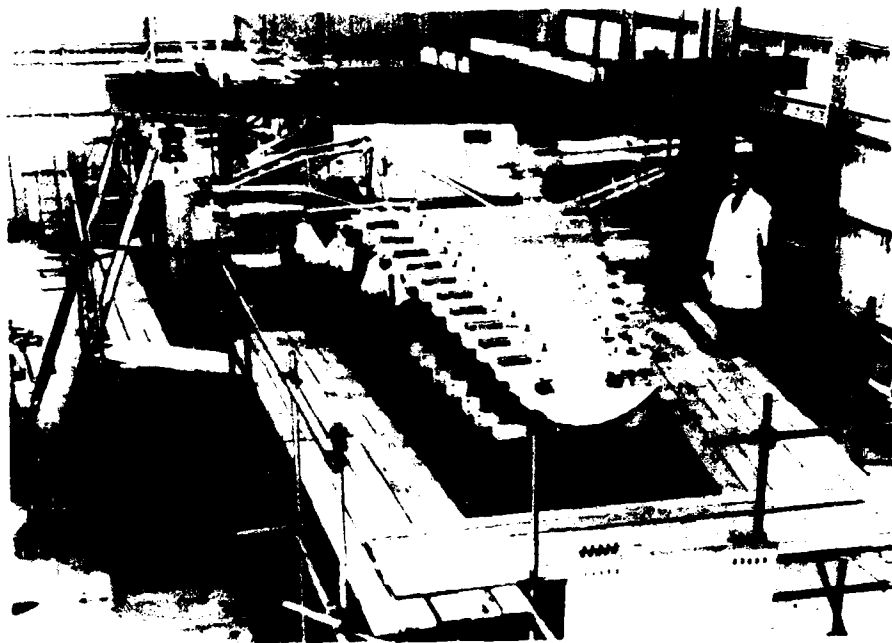
FIG. 4 "MOSQUITO" WING TEST RIG

Mr. H.A. Wills, the first Head of the then Structures and Materials Section of the Division of Aeronautics, was one of those who foresaw that the main criterion for the safe operation of aircraft structures in the future would be fatigue performance rather than static strength behaviour, and that this consideration would limit their economic service lives. Although the Mosquito accident was subsequently shown⁵⁵ to have been the result of a defective glued joint and not structural fatigue, the investigation into the cause of the accident involved the static strength testing of full-scale wings using a specially developed loading system consisting of whiffle-trees and hydraulic jacks. The potential of this newly developed hydraulic system for the rapid and automatic application of repeated loads to full-scale aircraft structures was soon realised⁵⁶ and a series of fatigue tests on Mosquito wings (Fig. 4) at a cyclic frequency of 5 cpm followed^{24,57} at the Division of Aeronautics to provide information in a field in which little or no reliable experimental data were available. These tests were (to the author's knowledge*) the first carried out in any country on complete full-scale wings using hydraulic actuators as the basis for the loading system.

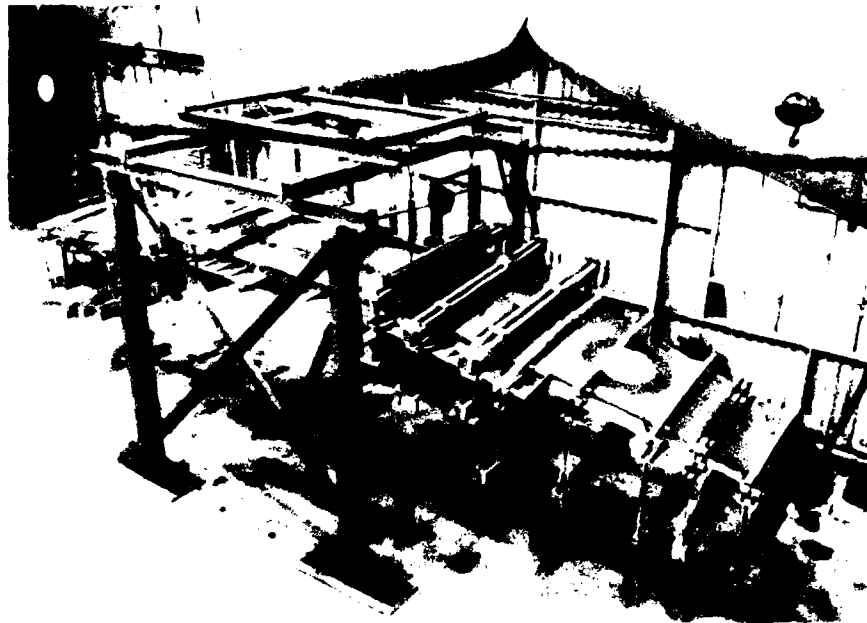
FIG. 6(b) "BOOMERANG" VIBRATION FATIGUE TEST RIG (WITH A2W WINGS IN BACKGROUND)

At the conclusion of World War 2 a number of wings from the CA-12 Boomerang fighter (Fig. 6(a)) designed by Commonwealth Aircraft Corporation (CAC), Melbourne were made available for fatigue research. In contrast to the Mosquito wings these were an all-metal wing, basically of conventional riveted aluminium alloy sheet construction with formed spars and stressed skins. Commencing in late 1947 twelve Boomerang wings were fatigue tested under a variety of constant-amplitude conditions to establish an S/N curve for this full-size aircraft structure covering a life span from about 100 cycles to over 1.6×10^6 cycles. Eight wings were tested in the hydraulic-loading rig previously used for the Mosquito (by then redesigned and operating at about 15 cpm), and four in a rig (Fig. 6(b)) which employed a mechanical oscillator to vibrate the wings at close to their resonant frequency of about 750 cpm. The resonant testing rig allowed millions of low-amplitude loads to be applied in a relatively short time and provided an appreciation of the fatigue damage caused by such cyclic loads in the long-time operation of aircraft. These tests, which were completed in 1949,⁷¹ clearly confirmed the greatly inferior fatigue performance of a large metal structure relative to that of its simple joints and unnotched material. They also emphasized the serious reductions in the fatigue strength of metal wings caused by stress concentrations such as cut-cuts, riveted and bolted joints, as compared with the findings from the tests on the adhesive-bonded wooden wings of the Mosquito which appeared to be highly resistant to fatigue and for which the ultimate static strength was not appreciably reduced by some thousands of applications of a load within the limits of +25% to +90% of the ultimate failing load.

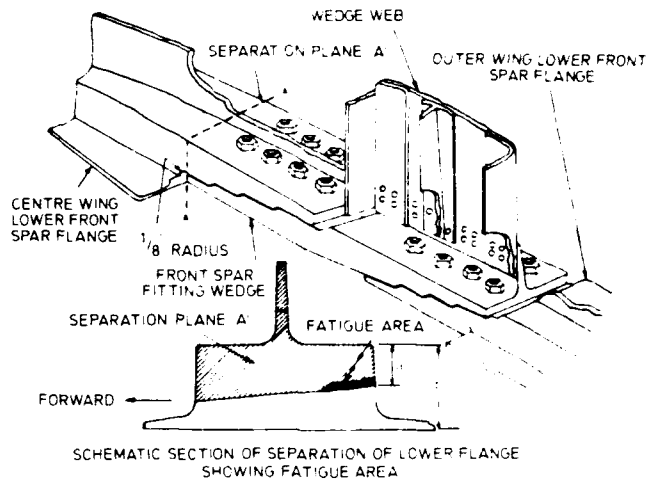
FIG. 7 MARTIN 2-0-2 WING ROOT FITTING FATIGUE FAILURE (Ref.)

On 29 August 1948 the crash of a Northwest Airlines Martin 2-0-2 near Winona, Minnesota after only 1321 flying hours with the loss of 37 lives was apparently the first major aircraft accident in the United States resulting from structural fatigue failure. This resulted from extensive fatigue cracking in the lower boom of the front spar of the port wing at a joint between the centre section and outer wing⁹⁷⁻⁹⁹ as shown in Fig. 7. Although it was reported that the aircraft which crashed was flying through a severe thunderstorm at the time, fatigue cracks were subsequently found at similar locations in the spars of three other 2-0-2's; and a disturbing feature of the accident was that the 2-0-2 wing had been subjected to a full-scale fatigue test (single-load-level at a high alternating load range) before it entered airline service⁹⁹.

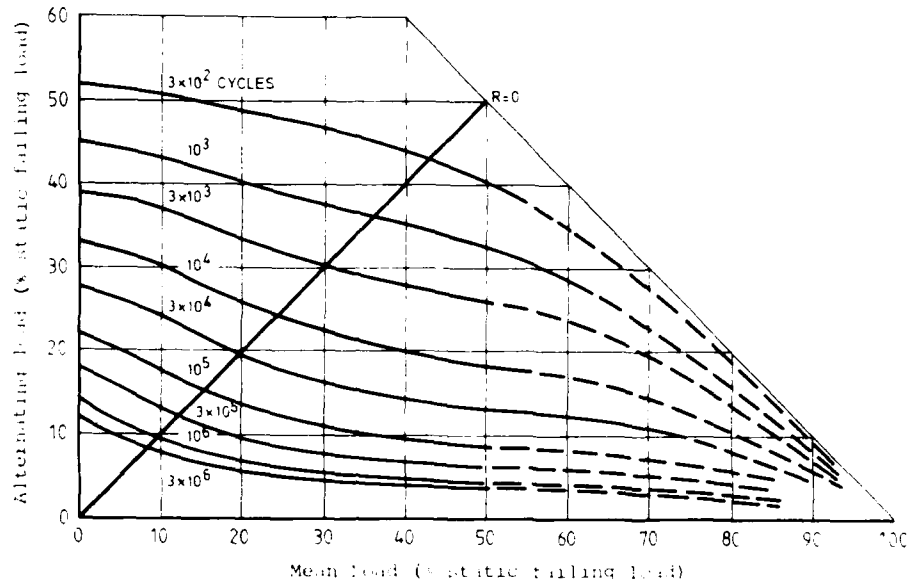
FIG. 9 ALTERNATING LOAD - MEAN LOAD DIAGRAM FOR MUSTANG WING FINAL FAILURE

behaviour of full-scale aluminium alloy aircraft structures, and provided the basis for the alternating stress-mean stress diagram shown in Fig. 9. When used in conjunction with an appropriate cumulative damage hypothesis, this enabled predictions to be made of the fatigue lives of aircraft structures under a range of flight loading conditions. The constant-amplitude Mustang tests also indicated that the logarithmic normal distribution provided a good approximation to the frequency distribution of fatigue lives for such structures, and that a figure of 0.20 was a conservative estimate of the standard deviation of log. life¹⁴⁶. The benefits of static preloading (which reduced the effective value of stress concentrations by plastic deformation) were again demonstrated by tests which showed that the value of preload which provided a maximum relative increase in fatigue life was 80% to 85% of the static UFL.

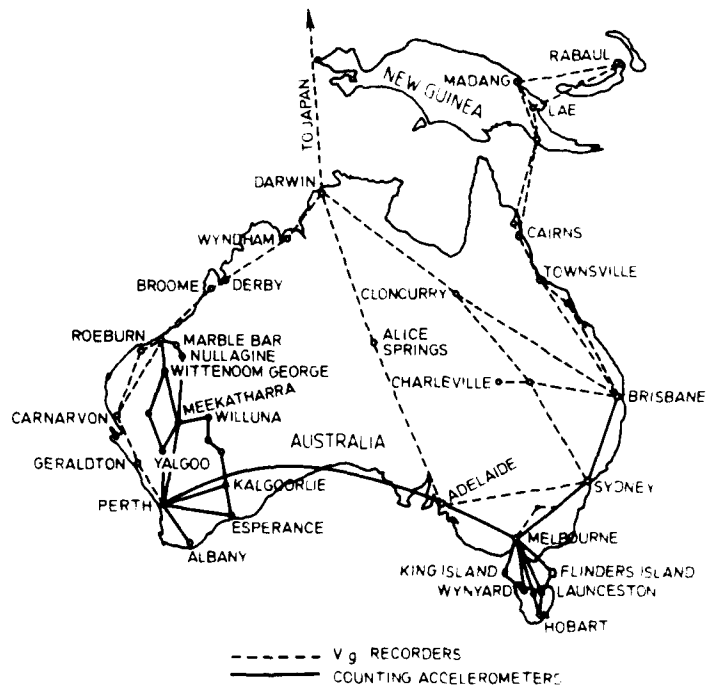
FIG. 10 FLIGHT LOADS MEASUREMENTS, AUSTRALIAN ROUTES-EARLY 1950's (Ref. 10)

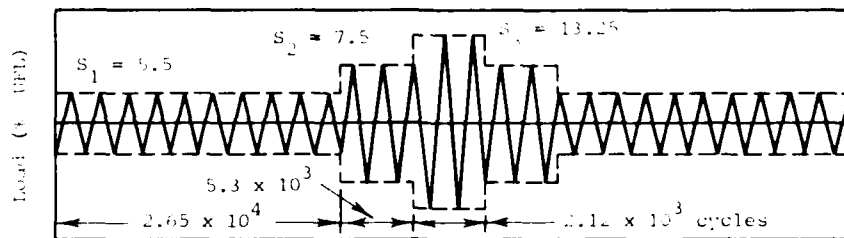
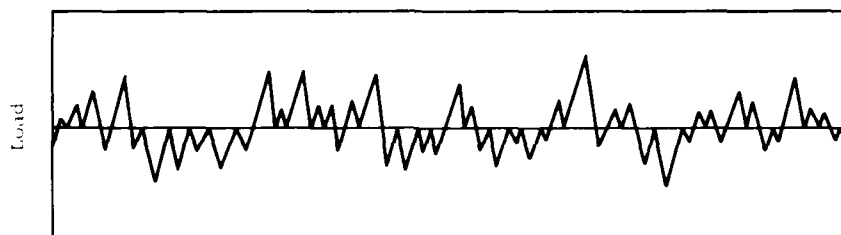
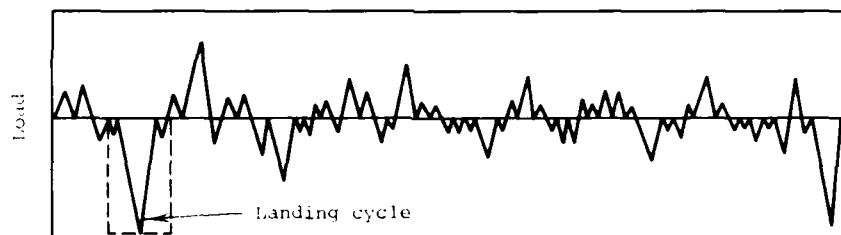
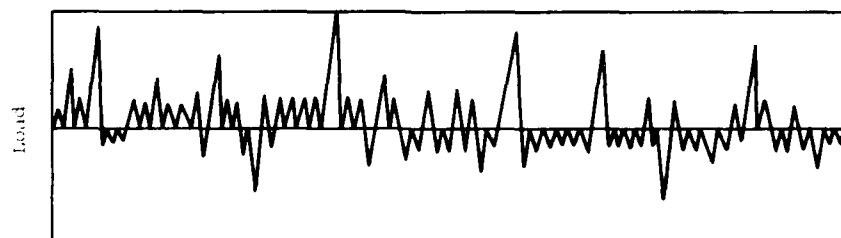
(a) Program block 3-load-level test (vibration rig)

(b) Typical random gust load sequence (hydraulic rig)

(c) Typical ground-air-ground cycle/gust load sequence (hydraulic rig)

(d) Typical manoeuvre load sequence (hydraulic rig)

FIG. 11 EXAMPLES OF VARIOUS MULTI-LOAD-LEVEL SEQUENCES USED DURING MUSTANG WING INVESTIGATIONS

The original objectives of the Mustang program were extended to include multi-load-level tests (program and random loading) under symmetric (gust) and asymmetric (manoeuvre) spectra, the effects of ground-air-ground cycles, comparisons of various life estimation methods and an investigation into the residual static strength of fatigue-cracked wings. Some of the loading sequences used (which include the three-load-level 'Airworthiness' test and a representation of the ARL 24-load-level random gust load sequence) are illustrated in Fig. 11. The results were summarised by Payne in Reference 146 and, among other things, showed that the simple three-load-level test and random gust sequence test were equivalent as regards fatigue lives for all types of failure observed in the structure. Further detailed information was published in References 155-160.

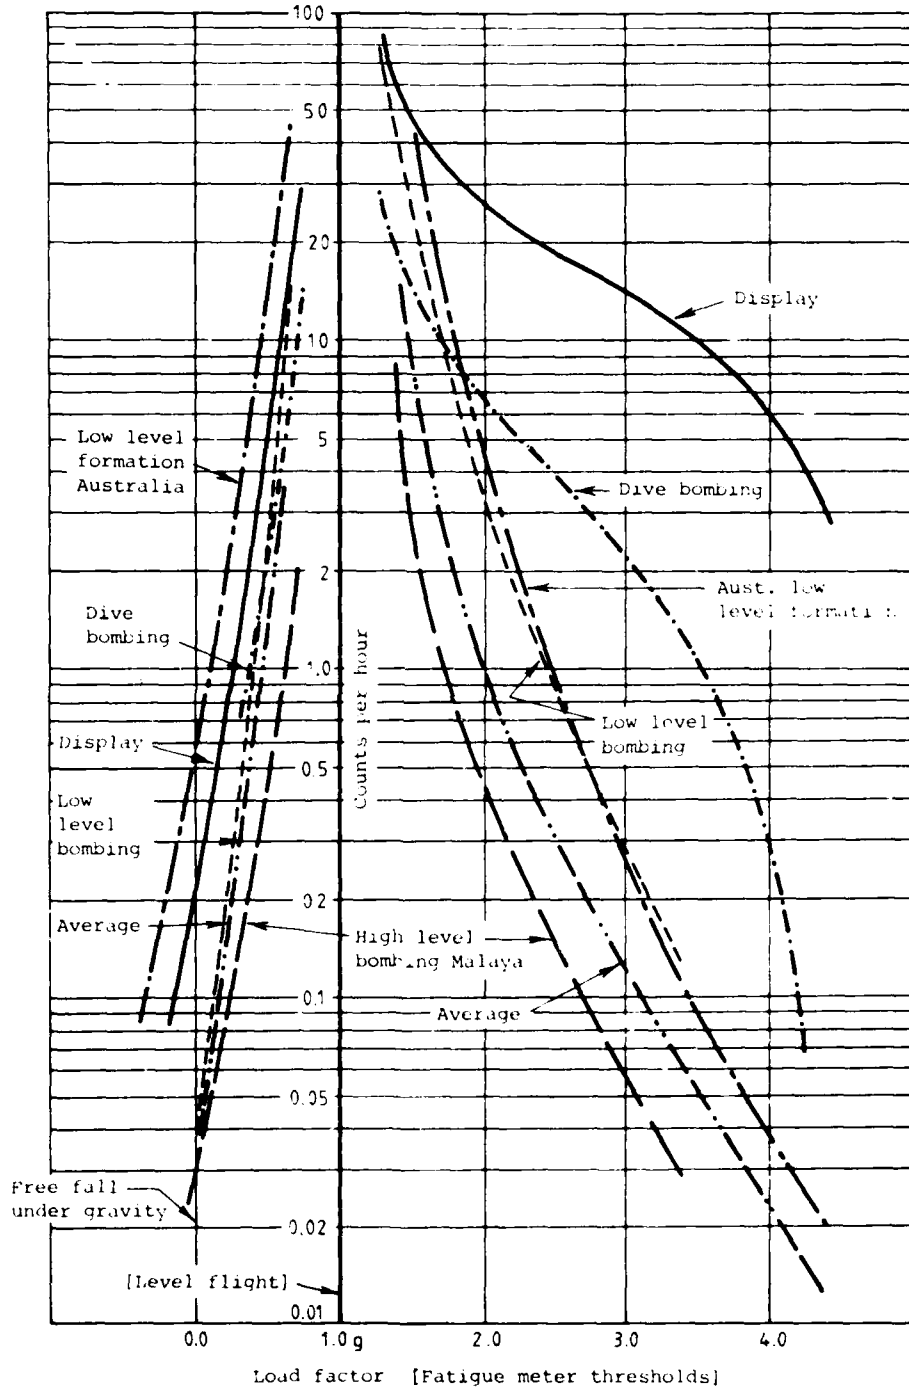
FIG. 12 LOAD-FREQUENCY CURVES FOR R.A.A.F. CANBERRA AIRCRAFT (Ref. 10)

One of the first aircraft on which a fatigue-life assessment was made was the Canberra, the flight loads measurements on which have already been referred to¹⁷⁰. Based on these measurements a simple arithmetical damage formula was derived for progressively calculating (from Fatigue Meter readings) the fatigue life consumed by the structure in various roles¹⁸⁰ and this allowed the aircraft to be safely operated by the RAAF into the 1980's. However, it was probably the promulgation (in the United Kingdom in late 1960) of the relatively short safe-life of 2000 hours for the Avro Lincoln bomber which accelerated

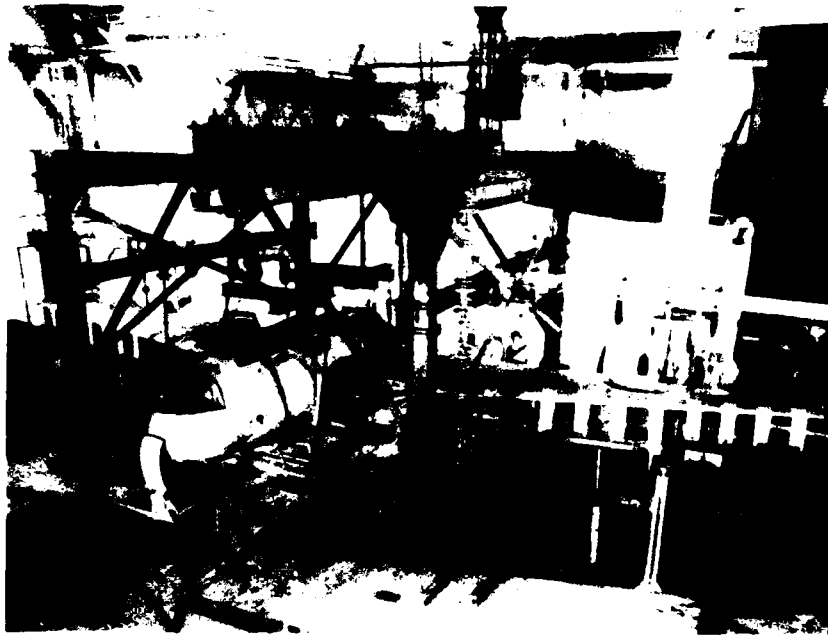
FIG. 13(a) "VAMPIRE" FULL-SCALE FATIGUE TEST RIG, WITH "DOVE" WING IN FOREGROUND (Ref. ...)

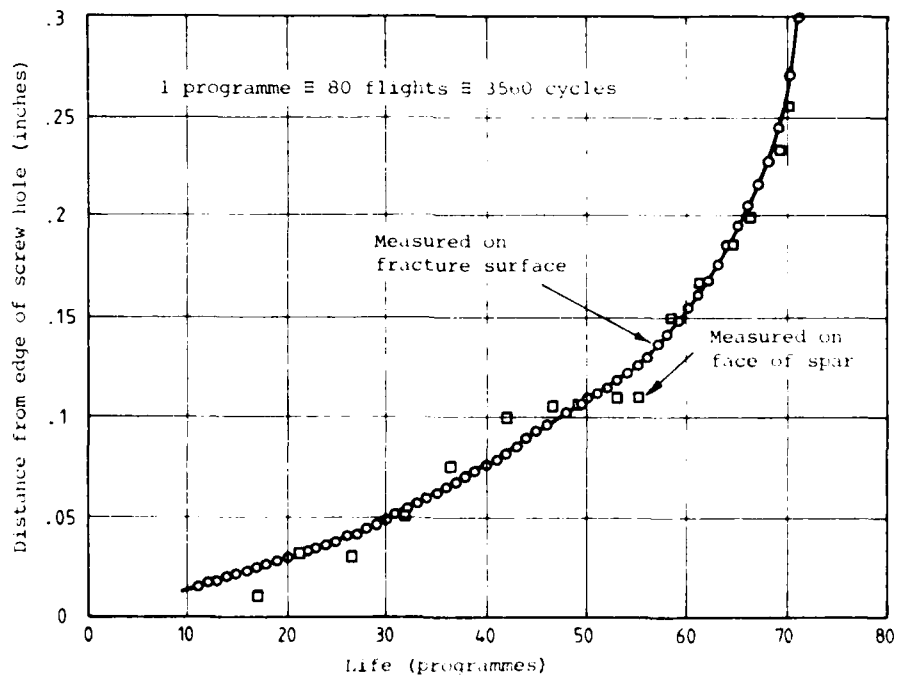
FIG. 13(b) CRACK LENGTH VERSUS LIFE, "VAMPIRE" SPAR (Ref. ...)

The variety of fatigue failures in both aluminium and steel structural components of the Vampire provided the opportunity for utilizing the fractographic analysis techniques developed by Ryder at RAE¹⁸⁵, to study the fractures of aluminium alloy specimens¹⁸² and to determine fatigue crack propagation rates in some fractured structural items¹⁸⁶⁻¹⁸⁸. A typical example is shown in Fig. 13(b).

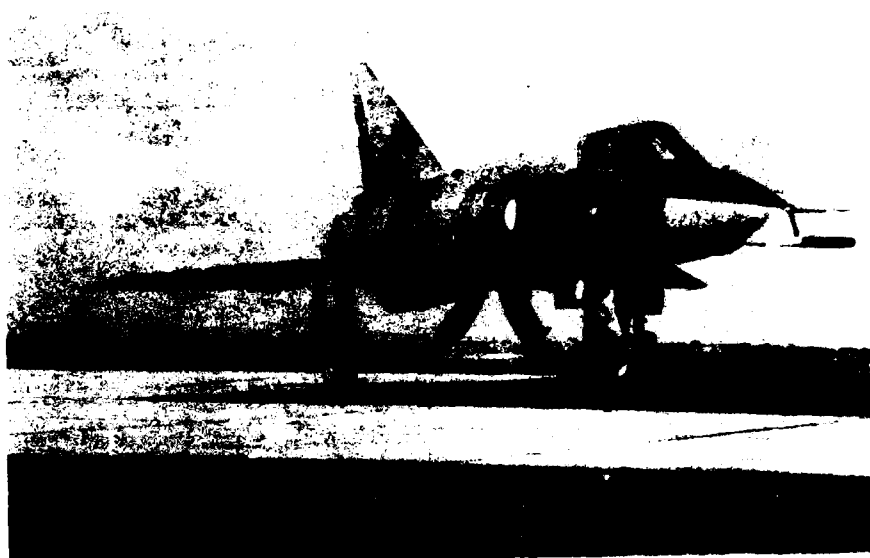
FIG. 14 RAAF MIRAGE AIRCRAFT A3-76 SHOWING ARL DESIGNED GUST PROBE

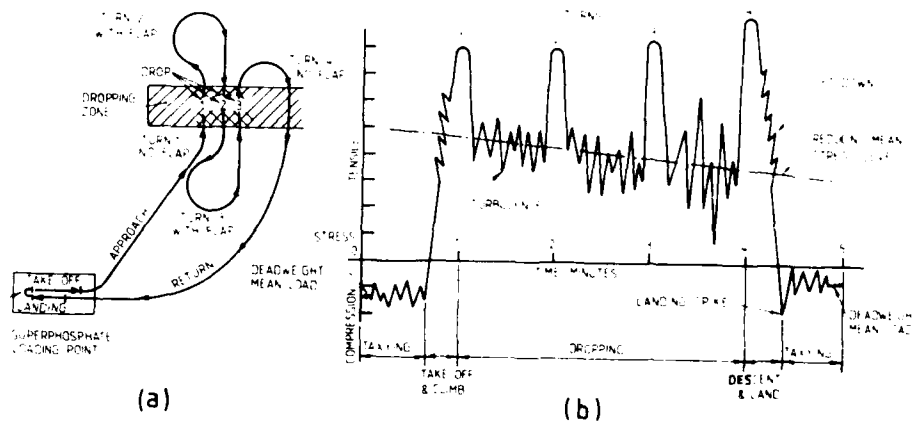
FIG. 15 (a) TYPICAL FLIGHT PATH FOR AERIAL AGRICULTURE OPERATIONS
 (b) STRESS-TIME PROFILE ON WING SPAR FLANGES FOR AIRCRAFT
 AT VARIOUS STAGES OF OPERATION (Ref. 10)

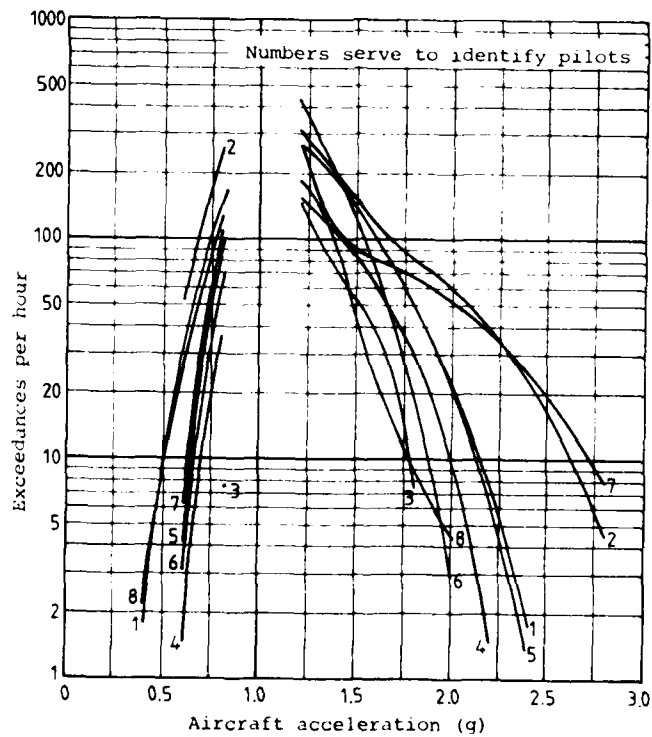
FIG. 16 VARIABILITY IN LOAD HISTORY CAUSED BY DIFFERENT PILOTS
 IN THE SAME AIRCRAFT (Ref. 10)

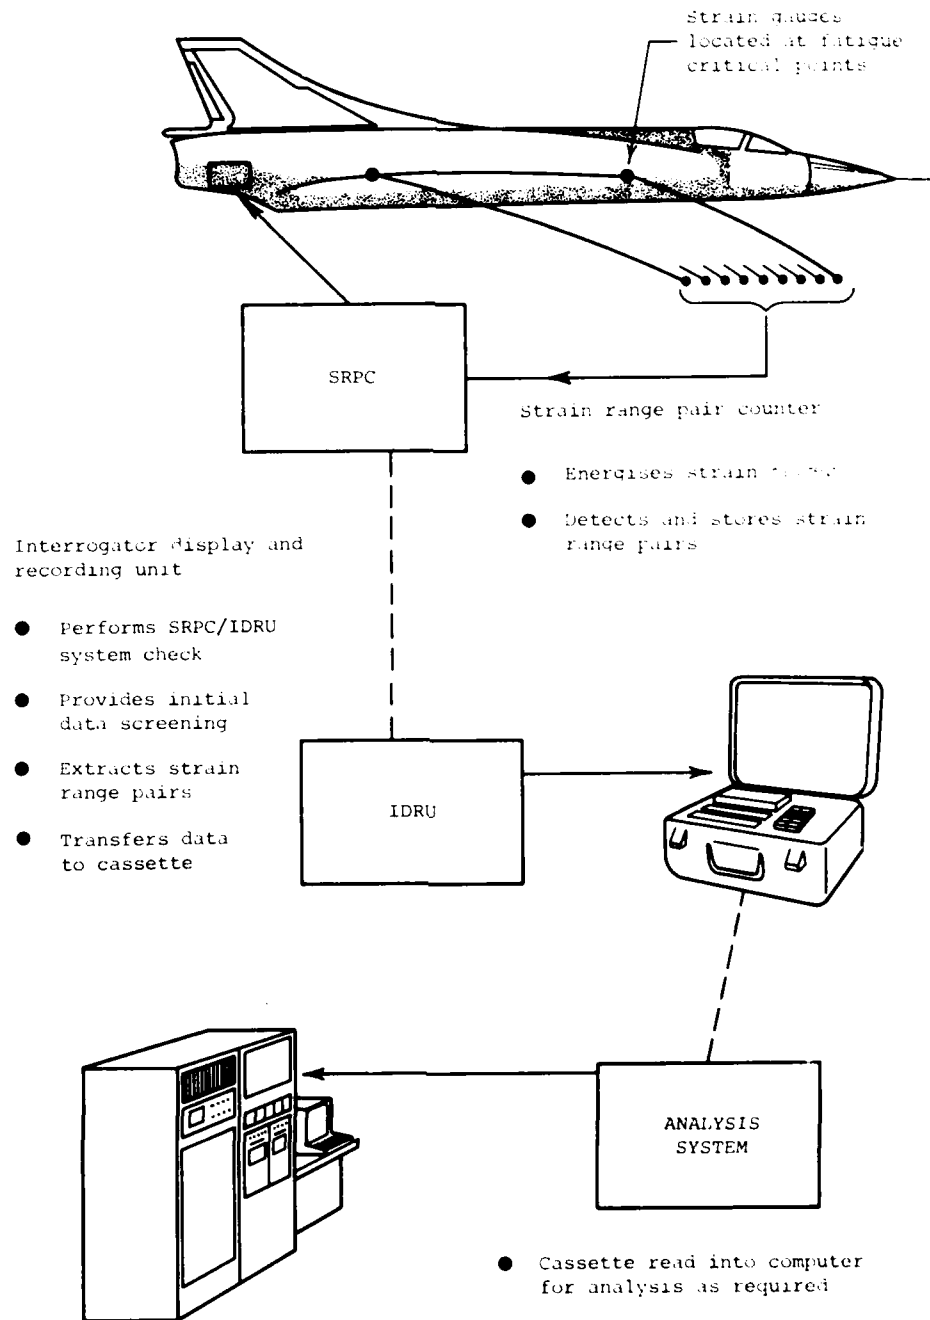
FIG. 17 THE AIRCRAFT FATIGUE DATA ANALYSIS SYSTEM (AFDAS)

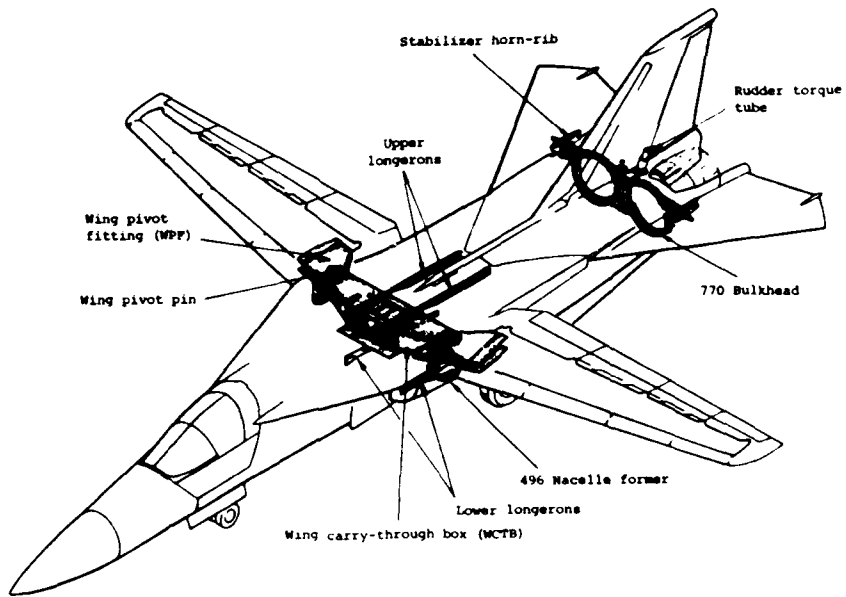
FIG. 19(a) D6AC STEEL STRUCTURAL MEMBERS IN F-111

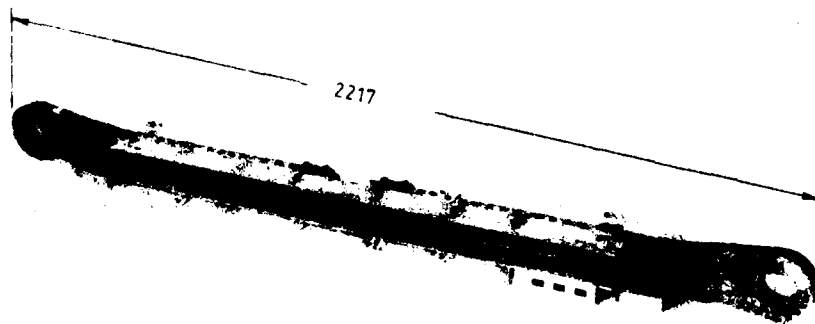
FIG. 19(b) D6AC STEEL "HUMPHRIES" SPECIMEN

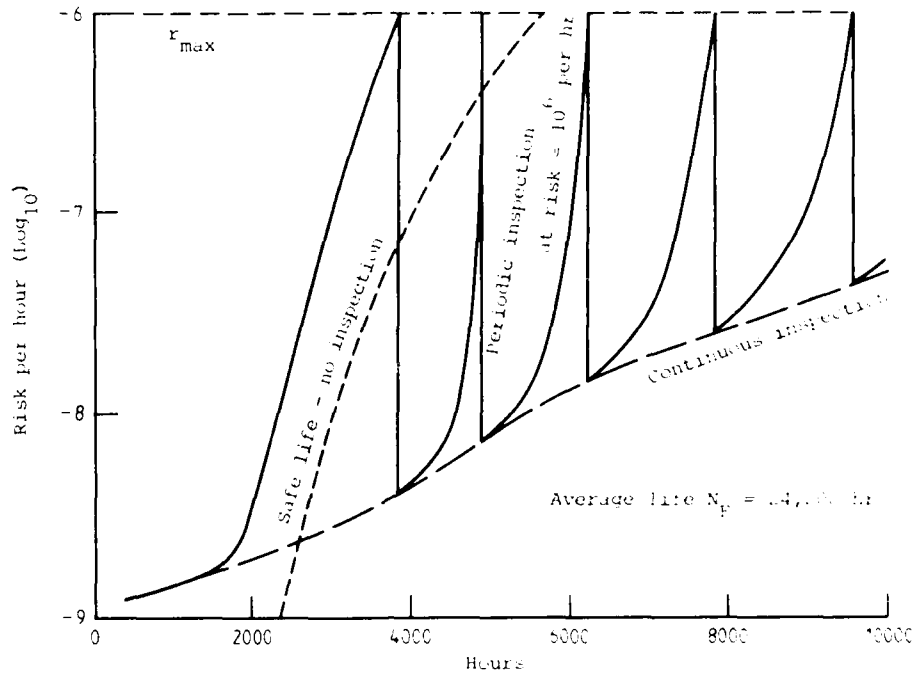
FIG. 18(a) RISK PER HOUR vs LIFE

ARL has taken an active part in the development of the reliability approach to structural fatigue²¹⁰⁻²²⁰. In this approach (which makes use of representative residual strength and fatigue crack propagation data) the increasing risk of failure in a structural component as a function of service life as the crack propagates can be calculated for any prescribed load spectrum, taking into account the variability in static strength during crack growth and the variability in crack propagation rates²¹⁷. It requires an appreciation of the impossibility of achieving absolute safety, and agreement regarding acceptable risk. The reliability approach provides a quantitative solution to both the fail-safe and safe-life philosophies and has been developed to provide a method for establishing inspection intervals on the basis of an acceptable risk of failure per hour. The optimum procedure (Fig. 18) would be continuous inspection so that cracks are always limited to the detectable size. However, as this is usually not feasible in practice inspections are carried out at prescribed

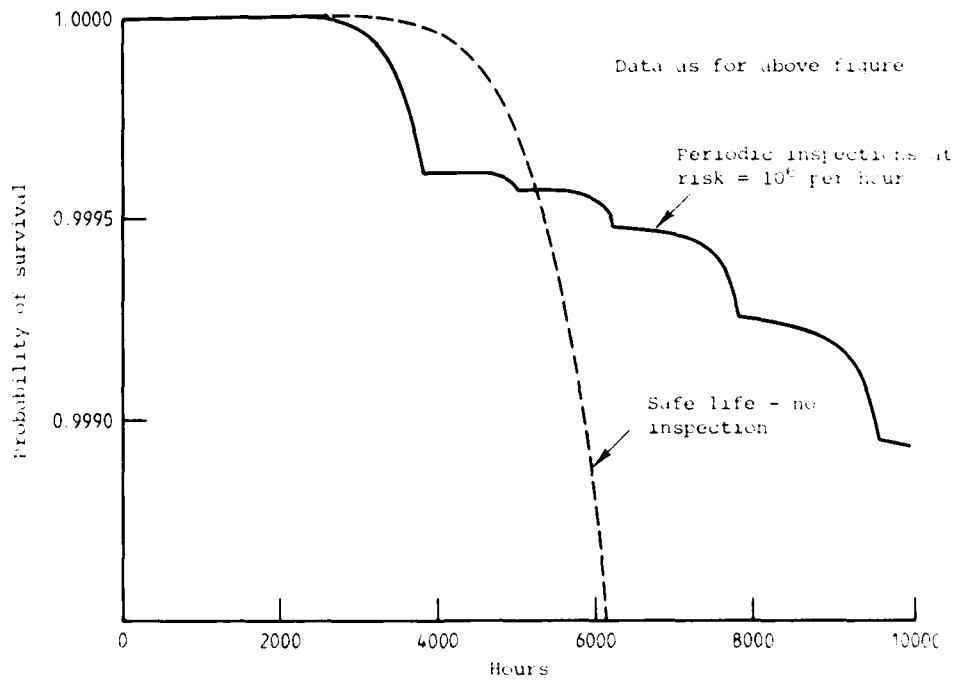
FIG. 18(b) PROBABILITY OF SURVIVAL vs LIFE (ref. 1)

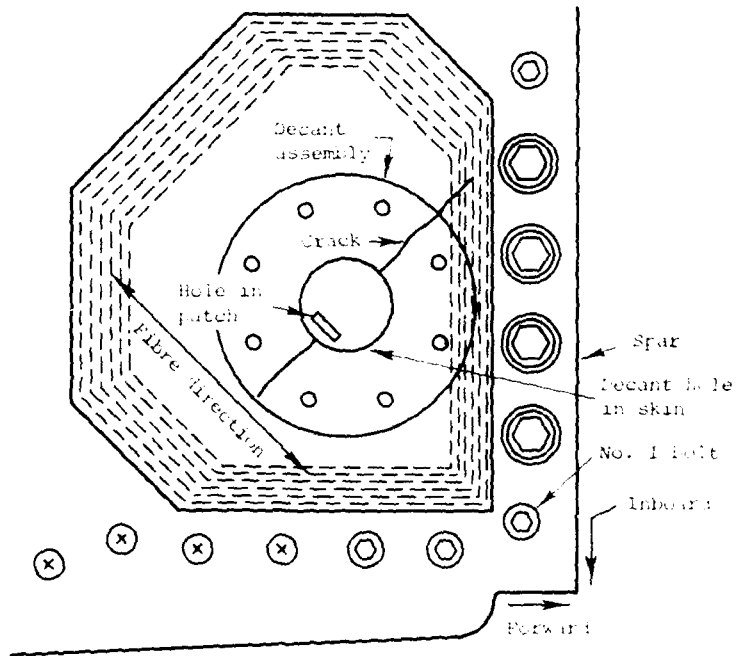
FIG. 20 BFRP PATCH FOR MIRAGE DECANT HOLE FATIGUE CRACKING

several wings. A suitable multi-layer BFRP patch (Fig. 20) was designed and incorporated as a routine field repair on the RAAF Mirage fleet²⁴⁵⁻²⁴⁷.

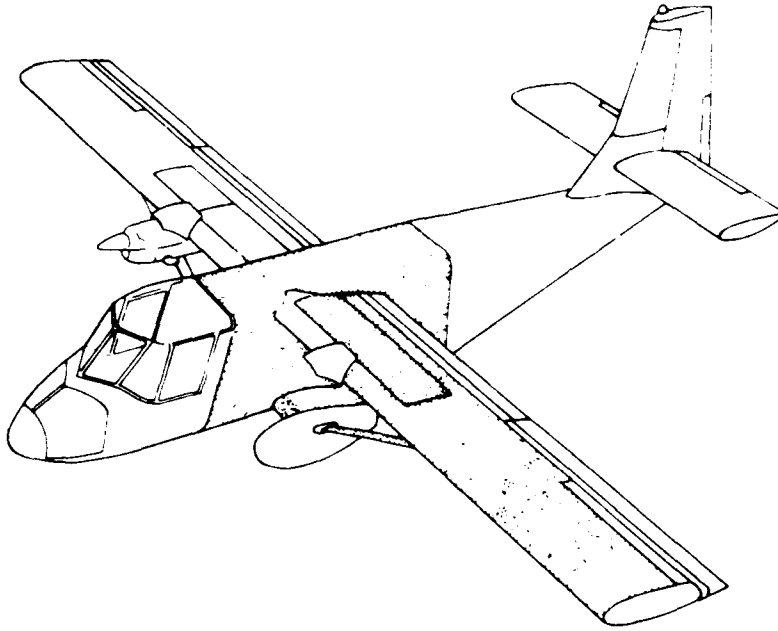
FIG. 21 GAF "NOMAD N22" (Shaded area shows extent of structural fatigue test article)

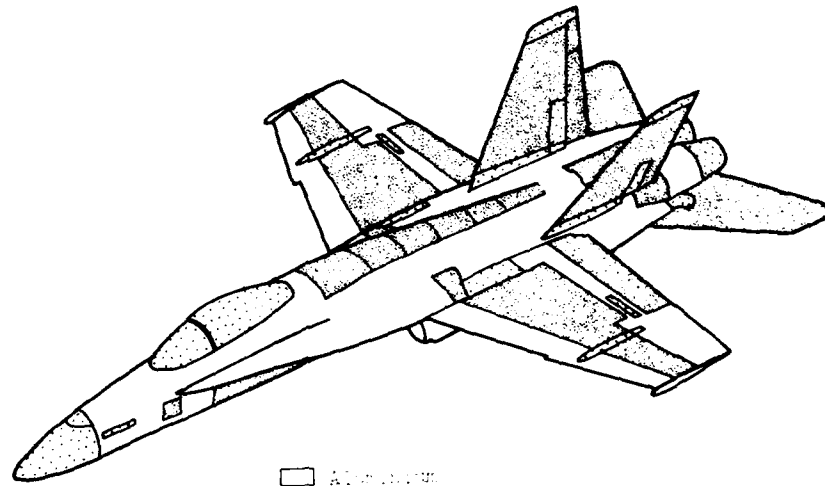
- Aluminum
- ▨ Invar/Epoxy
- ▩ Graphite/Epoxy Composites

FIG. 23 F/A-18, INDICATING APPLICATIONS OF GRAPHITE/EPOXY COMPOSITES
