TECHNICAL REPORT SL-84-13

BLAST DOOR AND ENTRYWAY DESIGN AND EVALUATION

DEPARTMENT OF THE ARMY
Waterways Experiment Station, Corps of Engineers
PO Box 631
Vicksburg, Mississippi 39180

Prepared for Federal Emergency Management Agency
Washington, DC 20472

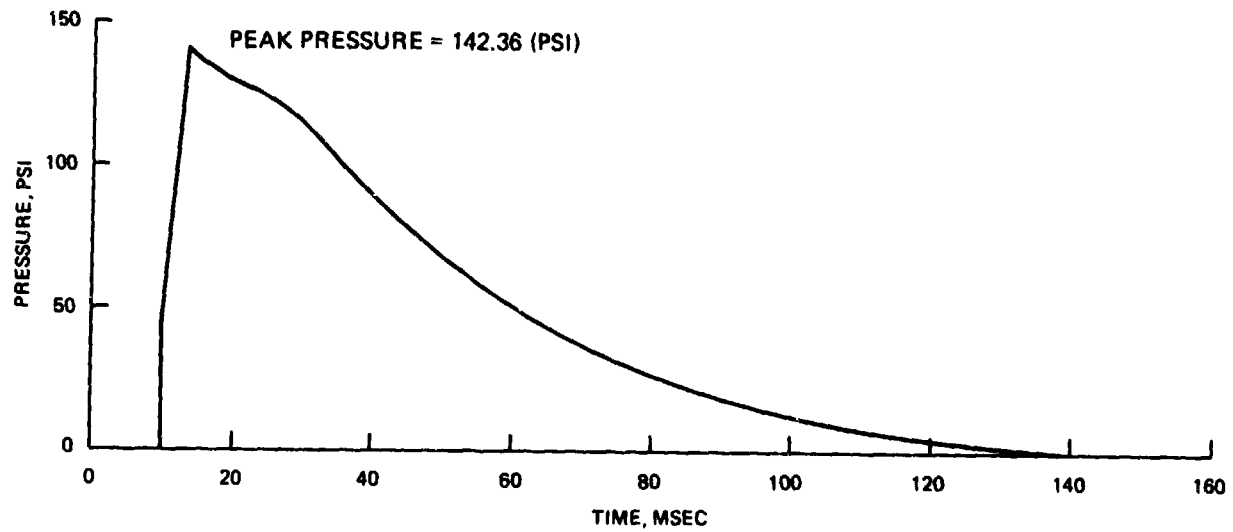
Figure 2.4. Pretest predicted loading history for blast door.

Pressures at various points inside the entryway were calculated with the ANSWER computer code, which is based on a modification of the work found in References 11, 12, and 13. The ANSWER code was developed at WES in the Explosion Effects Division of the Structures Laboratory. The pressure-time history computed at the center of the blast door and used for the blast door response analysis is shown in Figure 2.4. From Figure 2.4, the predicted peak pressure on the blast door is about 142 psi.

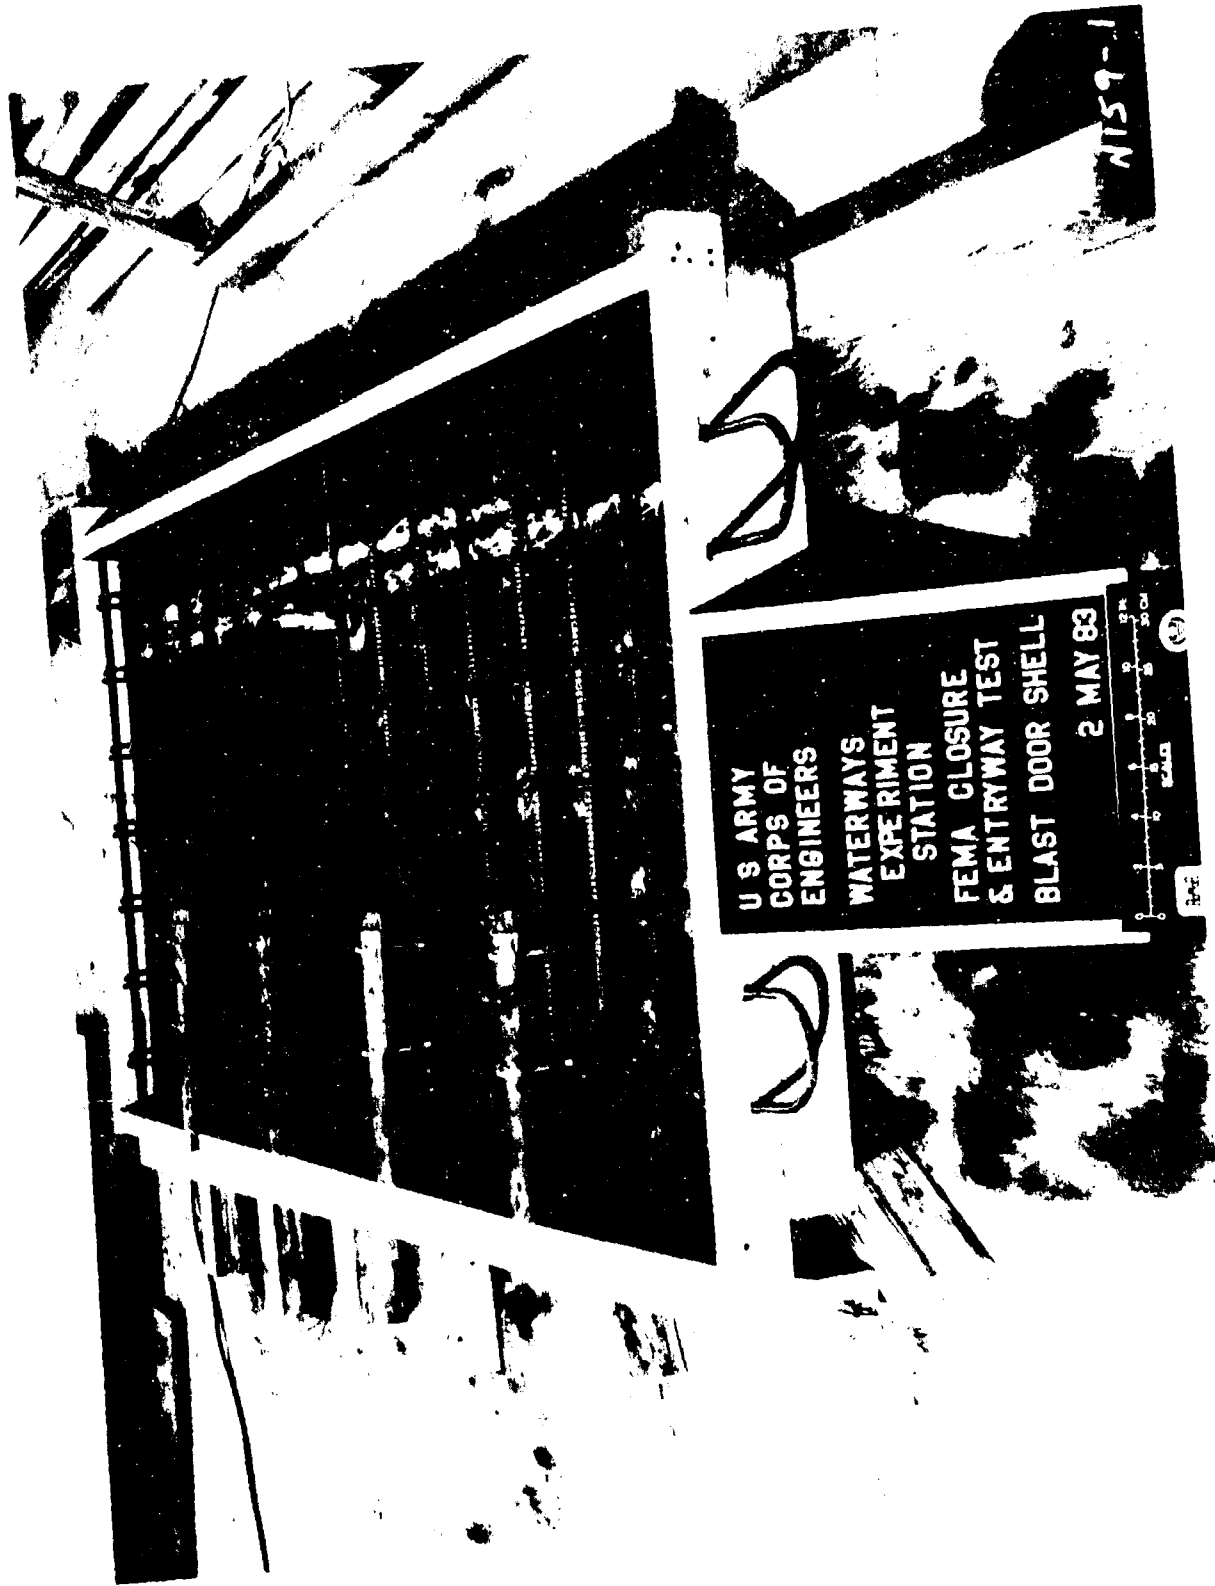
Figure 2.13. Blast door shell prior to concrete placement.

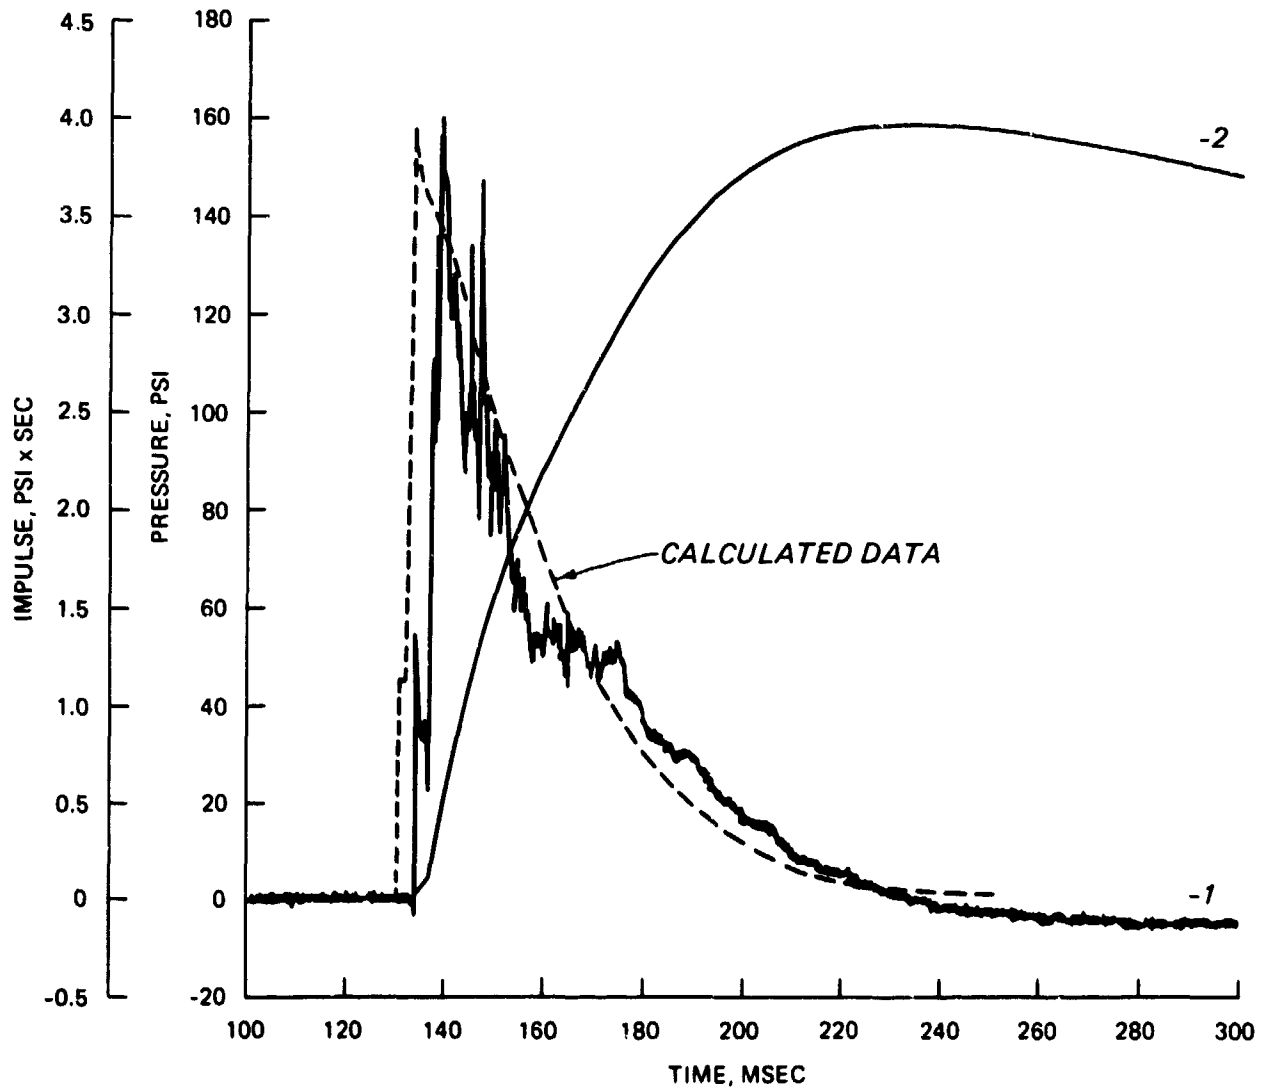
Figure 5.1. Comparison of measured to calculated pressure data for blast door loading.

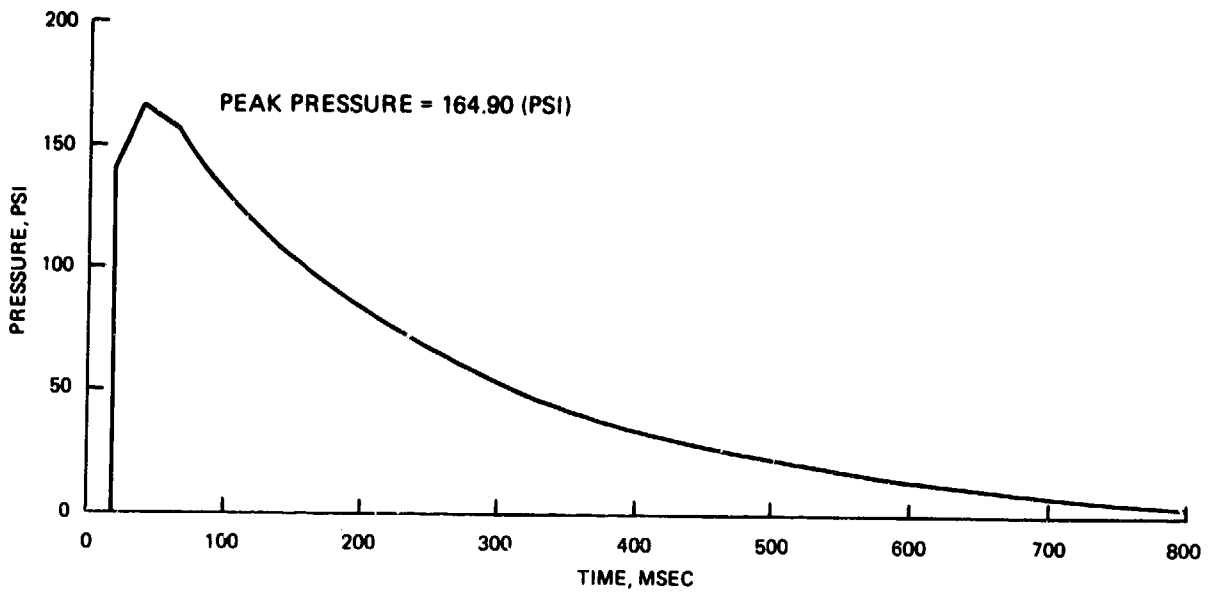
Figure 5.3. Calculated loading history of blast door for 1-MT, 50-psi event.

The predicted loading history for the blast door is shown in Figure 5.3. The calculated peak pressure on the door is 165 psi. Note that this peak pressure is substantially higher than the peak pressure of 142 psi predicted for the 1-KT, 50-psi overpressure level at the DIRECT COURSE event. This is because the airblast associated with a 1-KT event decays much more rapidly than the airblast from a 1-MT event at the same overpressure level. Hence, the incident pressure at the closed end of the entryway will be higher for a 1-MT event than for a 1-KT event, and the reflected pressures at the same point will be higher by an even larger margin.

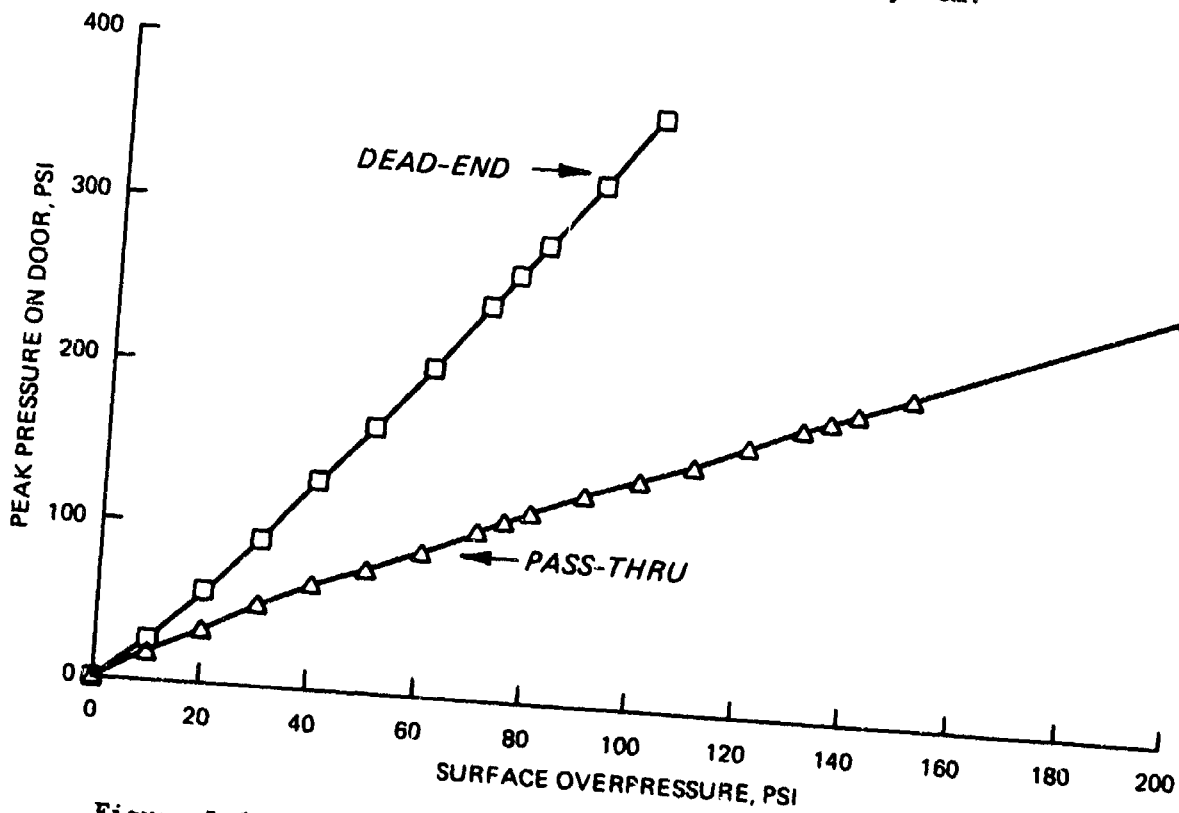
Figure 5.6. Comparison of incident to peak pressure on closure in dead-end and pass-through entryway systems.
