TECHNICAL REPORT ARLCB TR 85008

# WEAR OF PROJECTILE ROTATING BANDS

ROBERT S. MONTGOMERY

MARCH 1985

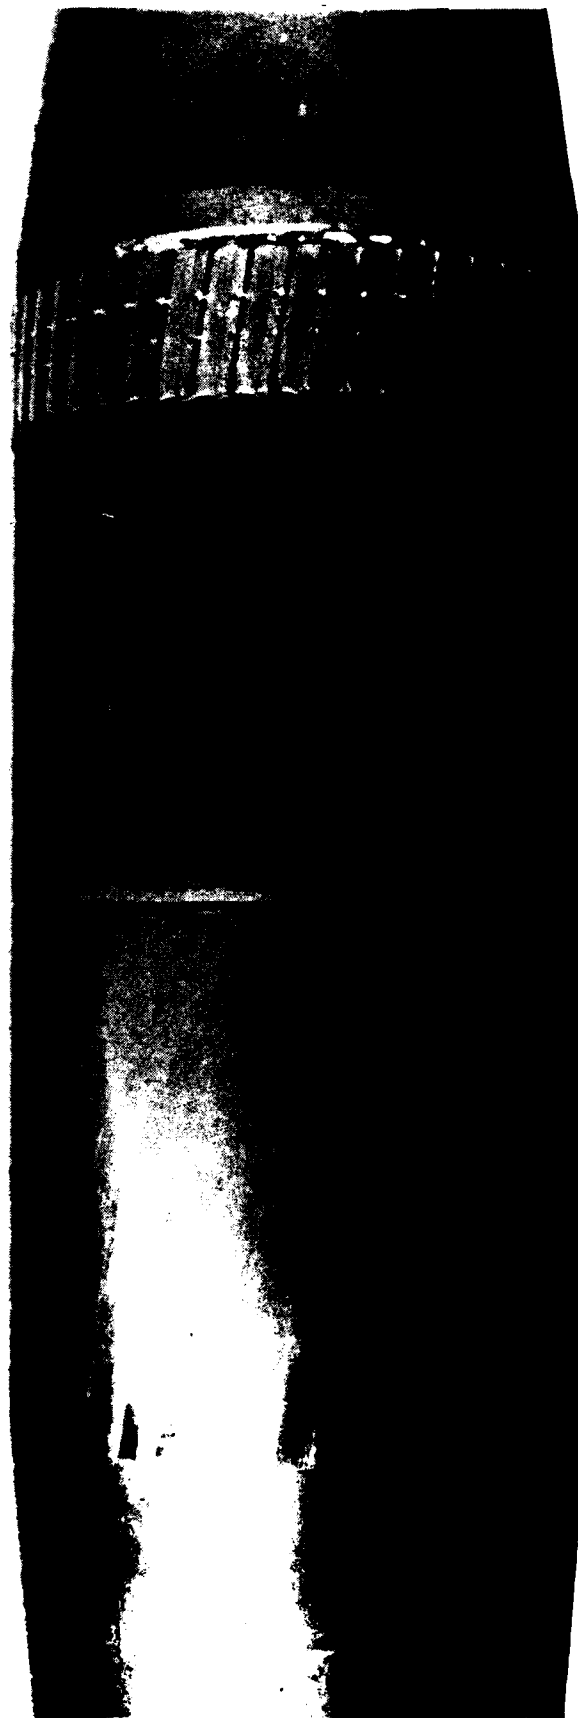
Figure 6. Recovered 155 mm projectile showing boucrelet engraving.

Large cannon projectiles start from rest with their bourrelets in contact with and supported by the bottom of the bore. If they are balanced or if an off-center center-of-gravity is toward the bottom, they will not move from contact with the bore. (Of course, contact with the bore will follow the twist of the rifling.) If the bearing pressure is sufficient, the bourrelet will engrave as illustrated in Figure 6. There will also be a single engraving of the rotating bands. On the other hand, if the projectile is sufficiently imbalanced and the center-of-gravity is toward the top, it will move to a fully "cocked" attitude with the bourrelet contact on the bore on the side of the projectile toward the off-center center-of-gravity. An asymmetrically eroded origin-of-rifling as usually occurs with a chromium-plated bore, might also result in a fully "cocked" attitude of the projectile. In this case, there is seldom enough bearing pressure sufficiently long to cause body engraving on the bourrelet of the projectile. However, there is sometimes body engraving produced to the rear of the rotating band. In this case, there is also "double" engraving observed on one side of the band. (This would be the side of the projectile originally in the 6 o'clock position.) This is where the band is worn significantly deeper near the driving edge and there is a definite "shelf" in the grooves of the band worn by the lands of the rifling. This is illustrated in Figure 7 which shows a portion of the band from a recovered eight-inch projectile. This "shelf" is produced when the projectile assumes the "cocked" attitude and the bearing pressure becomes significantly greater on the band on the side opposite the
