TECHNICAL REPORT HL-86-6

# LOCK AND DAM 1, RED RIVER WATERWAY

## Hydraulic Model Investigation

June 1986

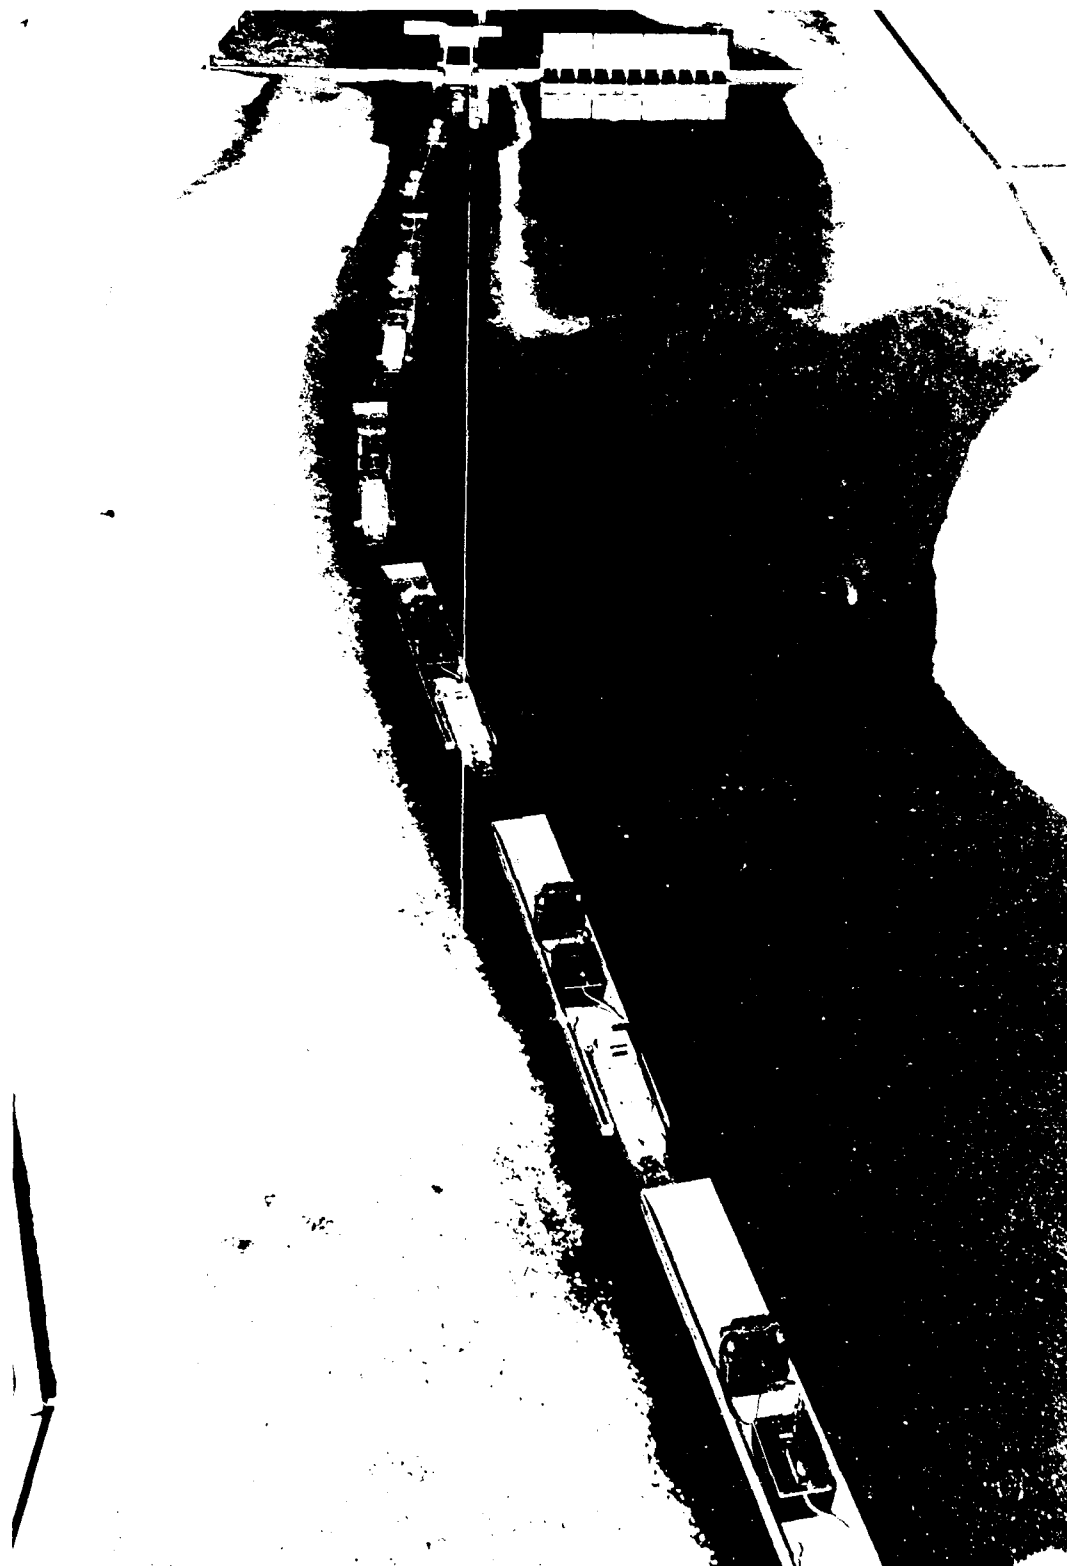
Photo 4. Plan B-34, downbound tow approaching the canal and lock from upstream; discharge 26,000 cfs, tailwater at 47.2 (normal)

72. Results. Velocities and current directions are shown in Plates 27-30. The effects of currents on the model tow are shown in Photographs 1-14. These results indicated that this plan would develop satisfactory navigation conditions throughout the test reach. Current directions upstream of the lock with this plan were generally straight and parallel to the left bank from at least 1 mile just upstream of the lock approach canal entrance. The

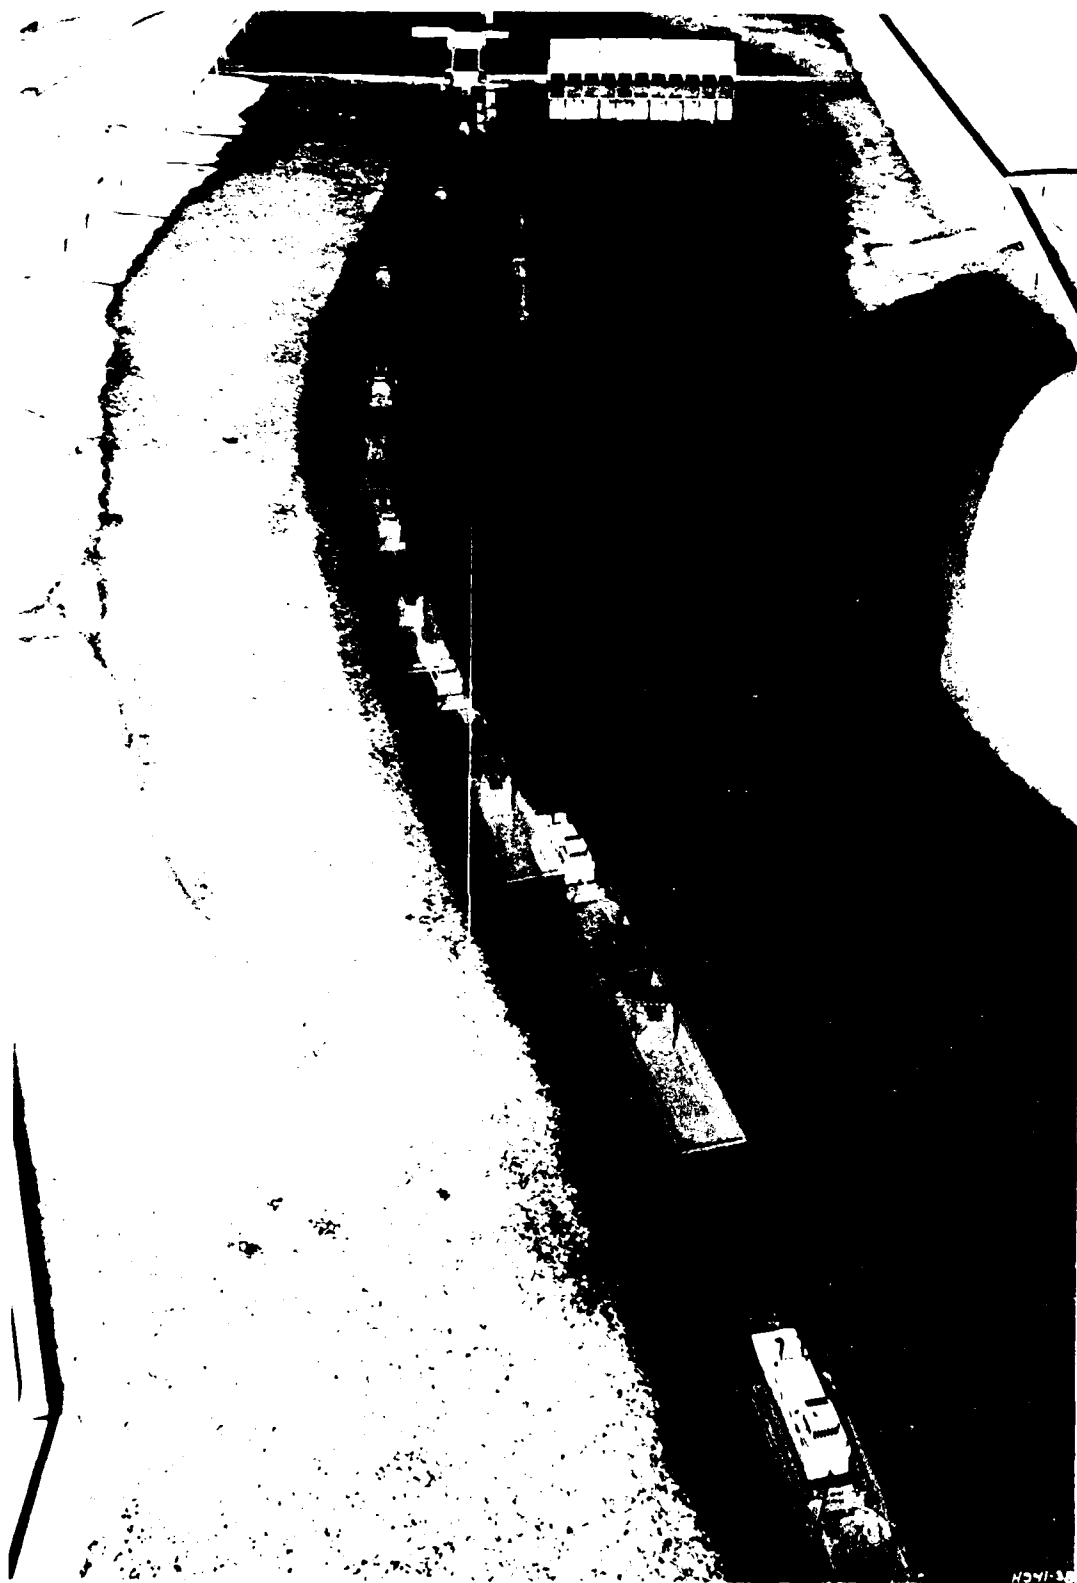
Photo 8. Plan B-34, upbound tow leaving the lock and canal;  
discharge 145,000 cfs, tailwater el 42.9 (minimum)

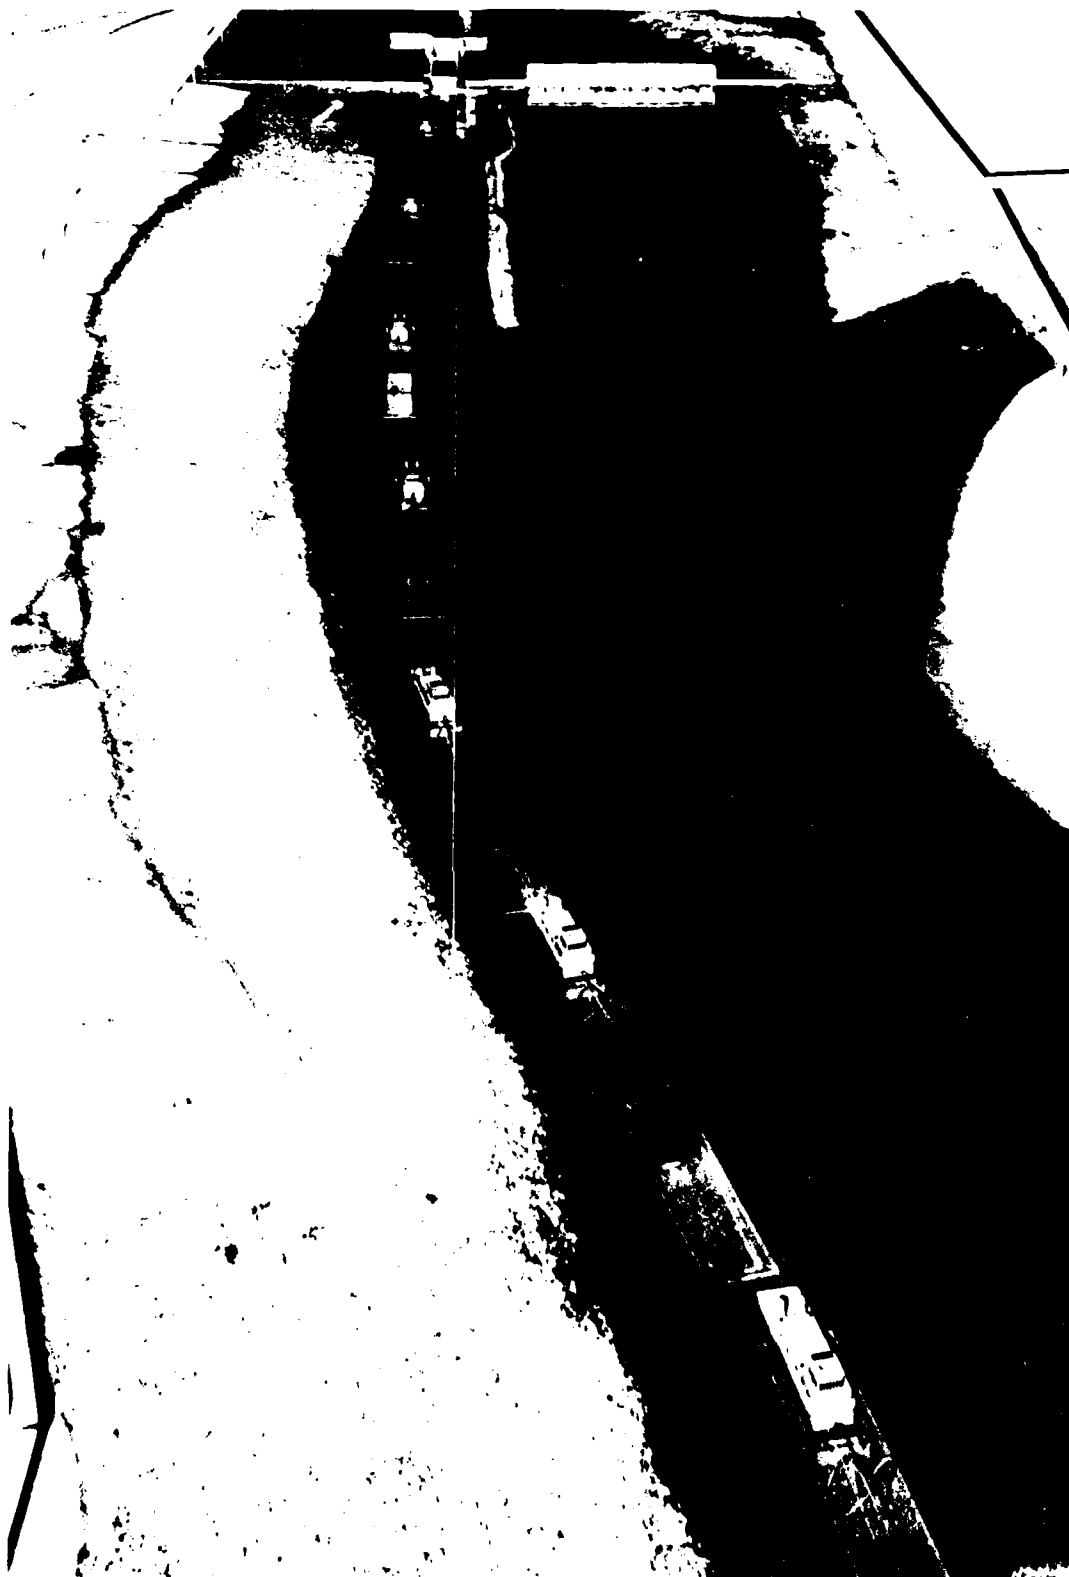
Photo 19. Plan B-34, upbound tow leaving the lock and canal;  
discharge 31,000 cfs, tailwater el 21.0 (normal)
