11. TITLE (Include Security Classification) Through-Transmission/Pulse-Echo Ultrasonic Equipment Evaluation			
12. PERSONAL AUTHOR(S) Hegeon Kwun			
3a. TYPE OF REPORT Final	13b. TIME COVERED FROM 9/27/86 TO 9/26/87	14. DATE OF REPORT (Year, Month, Day) 1987, September 26	15. PAGE COUNT 57

THROUGH-TRANSMISSION/PULSE-ECHO ULTRASONIC EQUIPMENT EVALUATION

FINAL REPORT
SwRI Project 17-7958-834

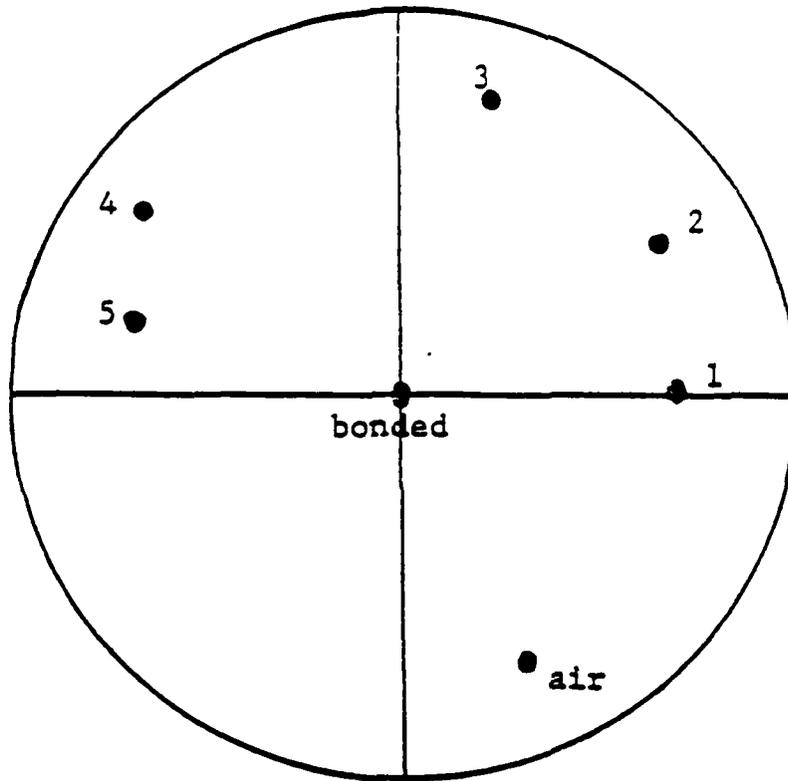
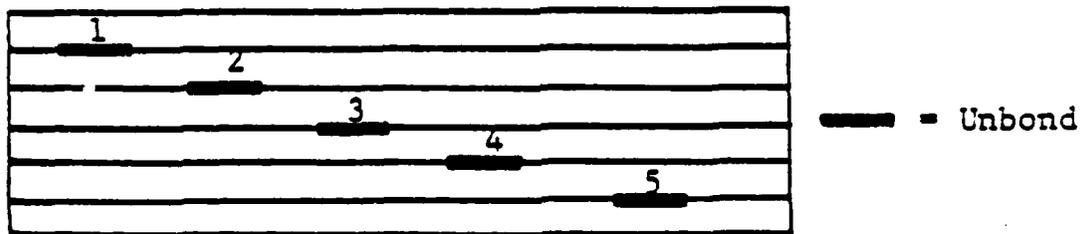
Figure 1. BondaScope Ultrasonic Impedance Plane Presentation for a Multi-layered Laminate

(a) BondaScope Display of Unbonds in Laminate Shown Below

(b) Multi-layered Bonded Laminate with Unbonds

When in use, the instrument is first calibrated or balanced on defect-free material. This calibration positions the dot at the center of the CRT screen. As the probe scans the test piece, the dot will displace from the center of the CRT when anomalies are encountered. The amount of displacement correlates with the changes in the amplitude and phase of the acoustic impedance of the material at that location. Figure 1 illustrates an example of the dot display obtained from a sample of multi-layered bonded laminate with unbonds (from the operating manual of the instrument). In this example, the dot was displaced from the center and moved counterclockwise with the increasing depth of the unbond from the surface of the sample. The position of the dot on the CRT display is used for flaw detection as well as its characterization.

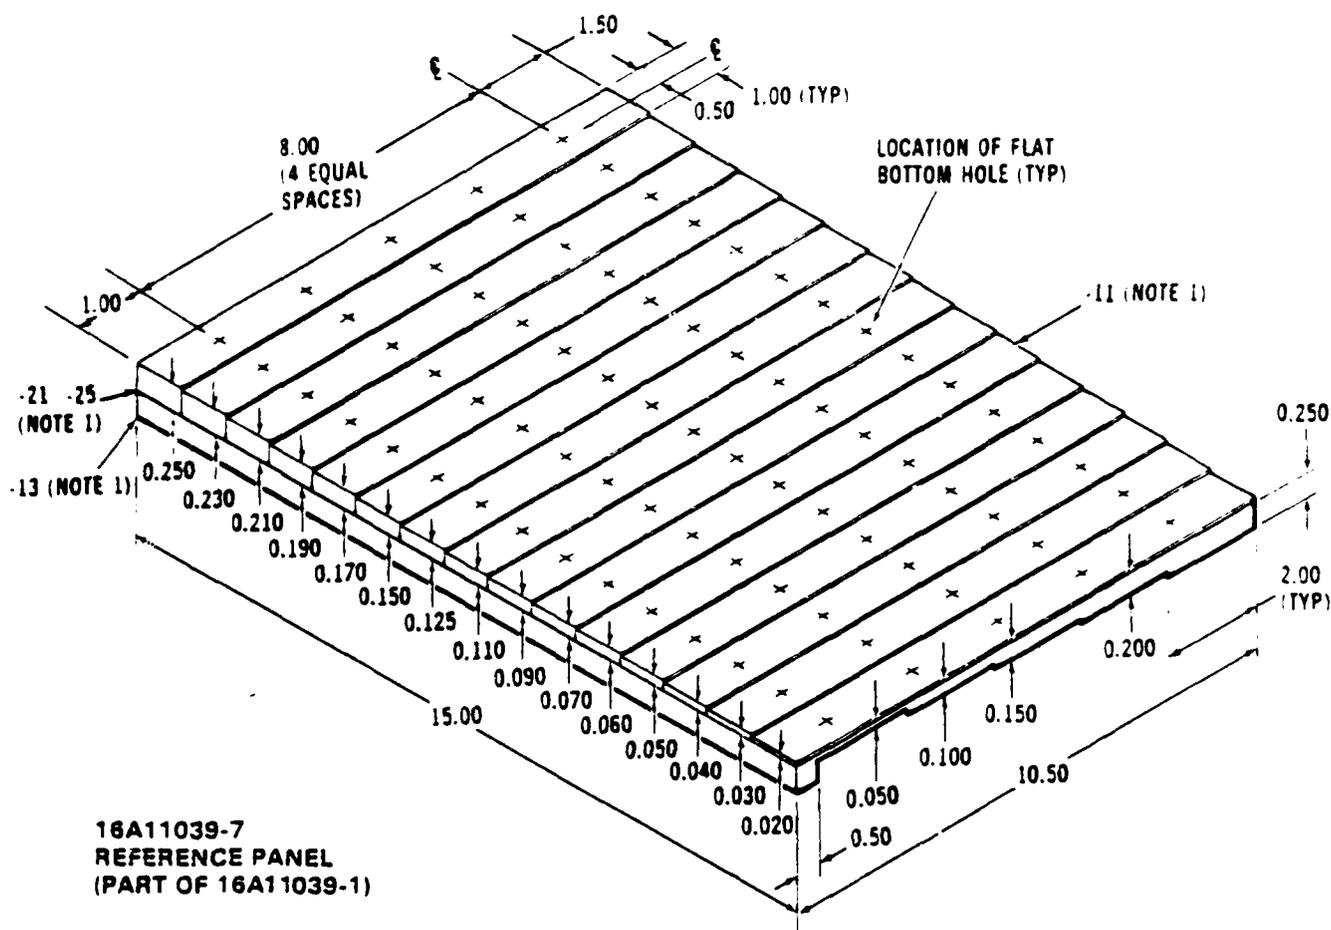
Figure 16A11039-7 Metal-Metal Reference Part

1. Materials: (See table 1-3.)
 - 11/-13, 2024-T851 aluminum
 - 21, FMS-3018, Form IB adhesive
 - 25, FMS-3018, Form II adhesive primer
2. Dimensions with two digits after the decimal point uses ± 0.03 tolerance while three digits after the decimal point uses ± 0.010 tolerance.
3. After evaluation of reference part for bond line integrity, drill 0.75-inch diameter flat bottom holes from bottom surface of reference part to adhesive bond line.
4. Finish: one coat epoxy primer (Military Specification MIL-P-23377) and two coats urethane coating (Military Specification MIL-C-83286).

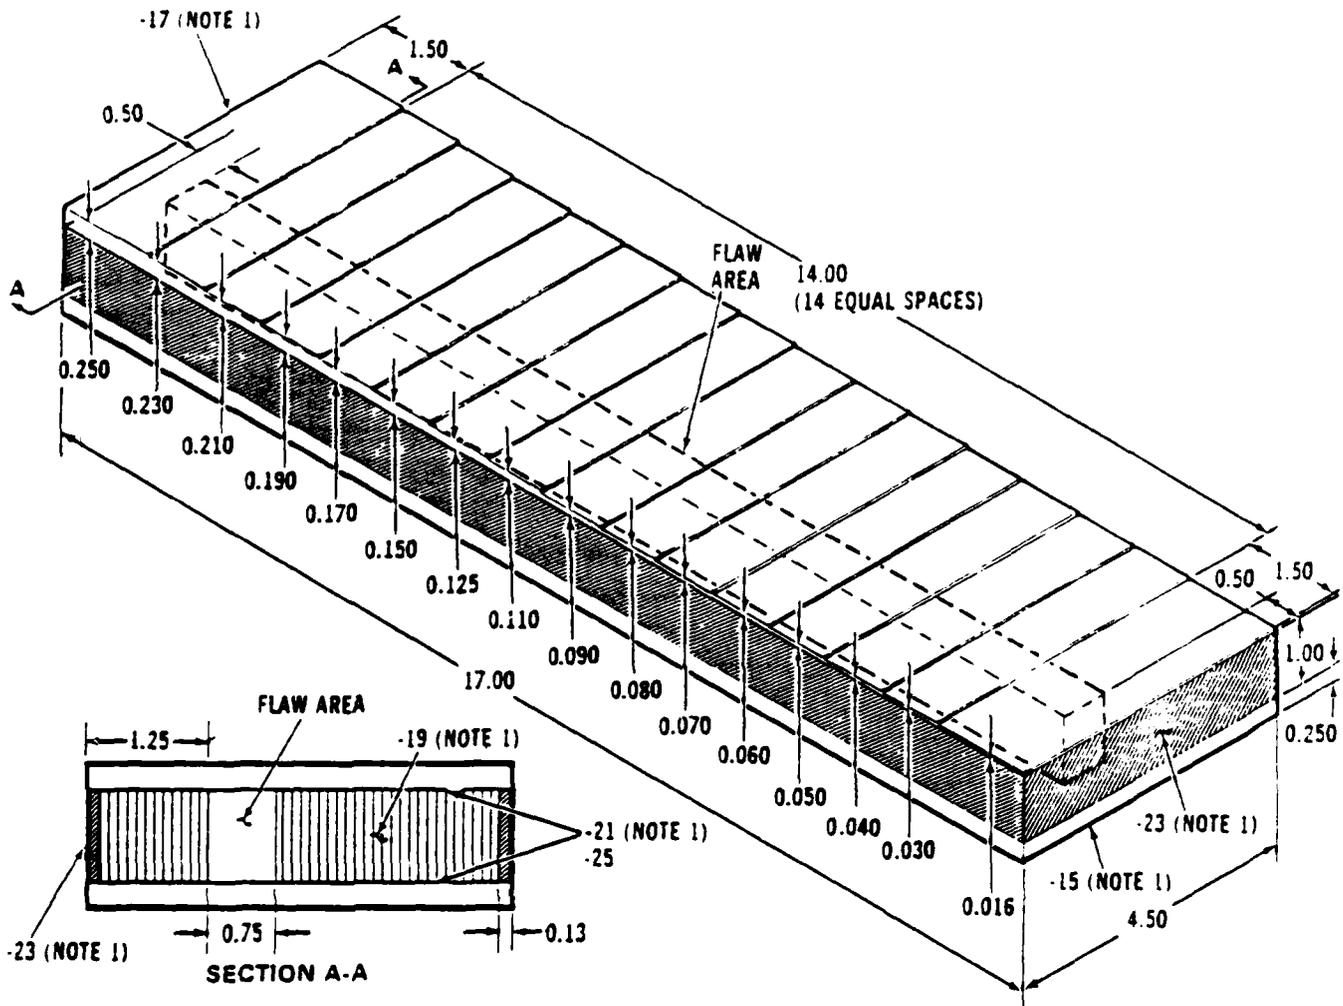
Figure 16A11039-9 Metal-Core Reference Part

1. Materials: (See table 1-3.)
 - 15/-17, 2024-T851 aluminum
 - 19, P190-18 (5052-18) aluminum core
 - 21, FMS-3018, Form IB adhesive
 - 23, FMS-1044, Type V sealant
 - 25, FMS-3018, Form II adhesive primer
2. Dimensions with two digits after the decimal point uses ± 0.03 tolerance while three digits after the decimal point uses ± 0.010 tolerance.
3. Install flaw area as follows:
 - a. Cut plug from core.
 - b. Install teflon tape on cut sides of plug and reinstall plug in core.
 - c. Bond stepped top to core. Insure waffle imprint of plug remains in the adhesive.
 - d. Remove plug and discard.
 - e. Bond bottom skin.
 - f. Seal exposed areas of core with sealant.
4. Finish: one coat epoxy primer (Military Specification MIL-P-23377) and two coats urethane coating (Military Specification MIL-C-83286).

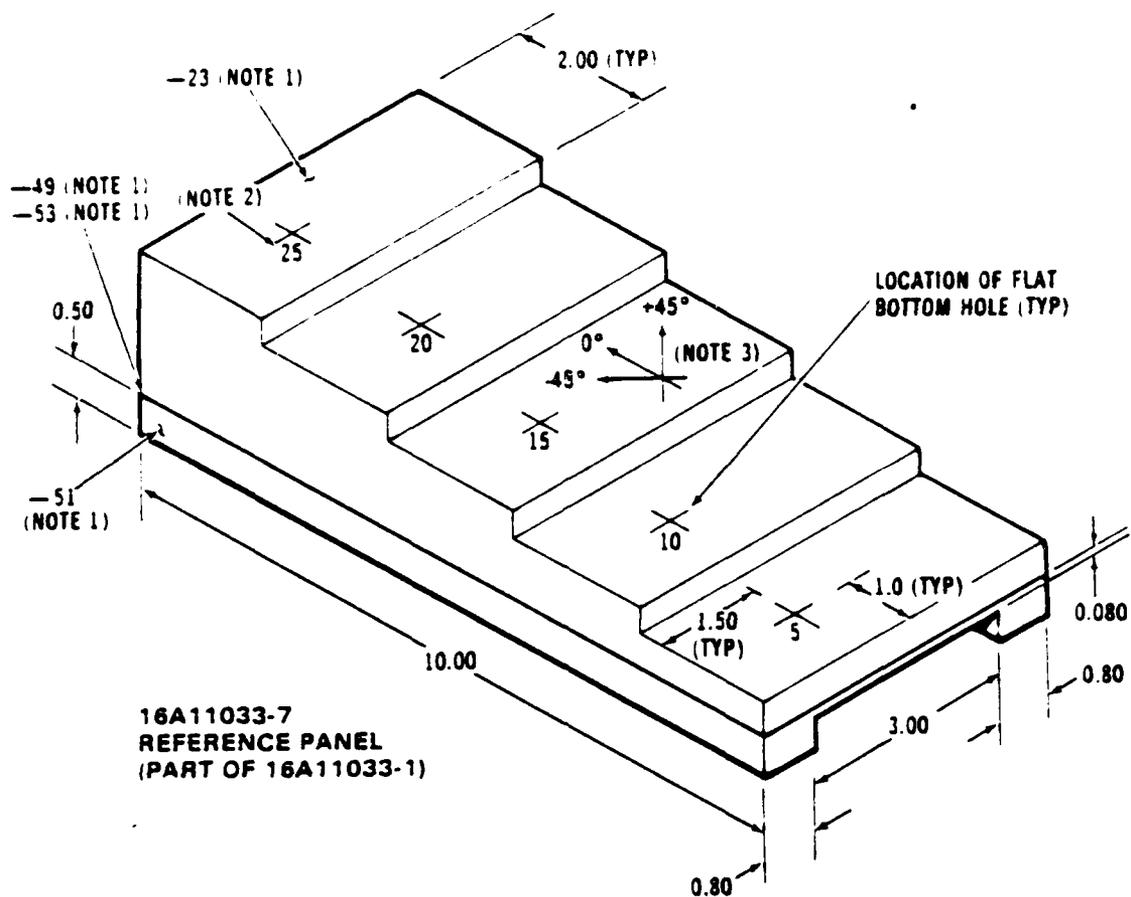
Figure 16A11033-7 Aluminum-Graphite Reference Part

- b. Aluminum—one coat epoxy primer (Military Specification MIL-P-23377) and two coats urethane coating (Military Specification MIL-C-83286), except holes which are unfinished.

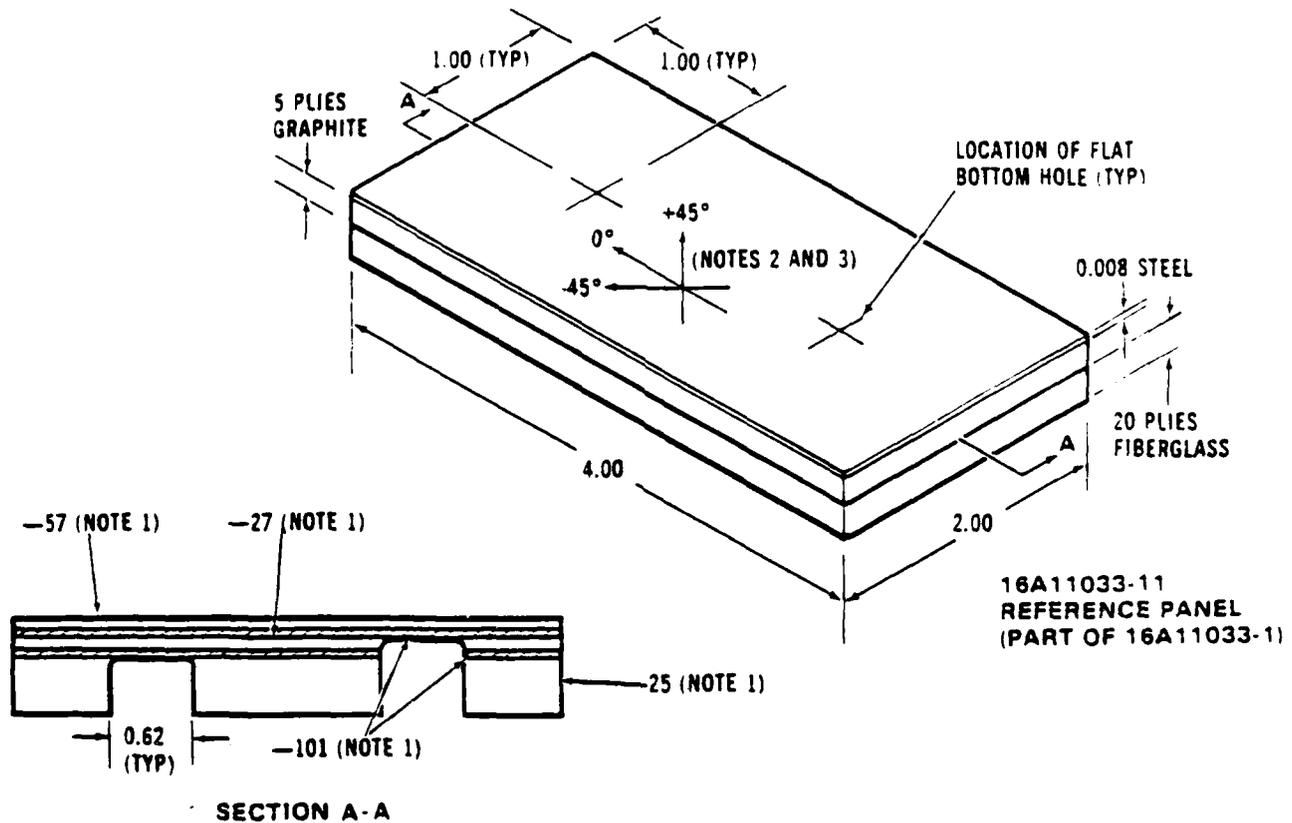
Figure 16A11033-11 Steel-Graphite Reference Part

1. Materials: (See table 1-3.)
 - 25. FMS-1023. Class 1. Type A fiberglass
 - 27. FMS-2023. Type 3 or Type 5. Form A or Form C graphite-epoxy tape
 - 57. CRES Type 321 annealed steel (Military Specification MIL-S-6721)

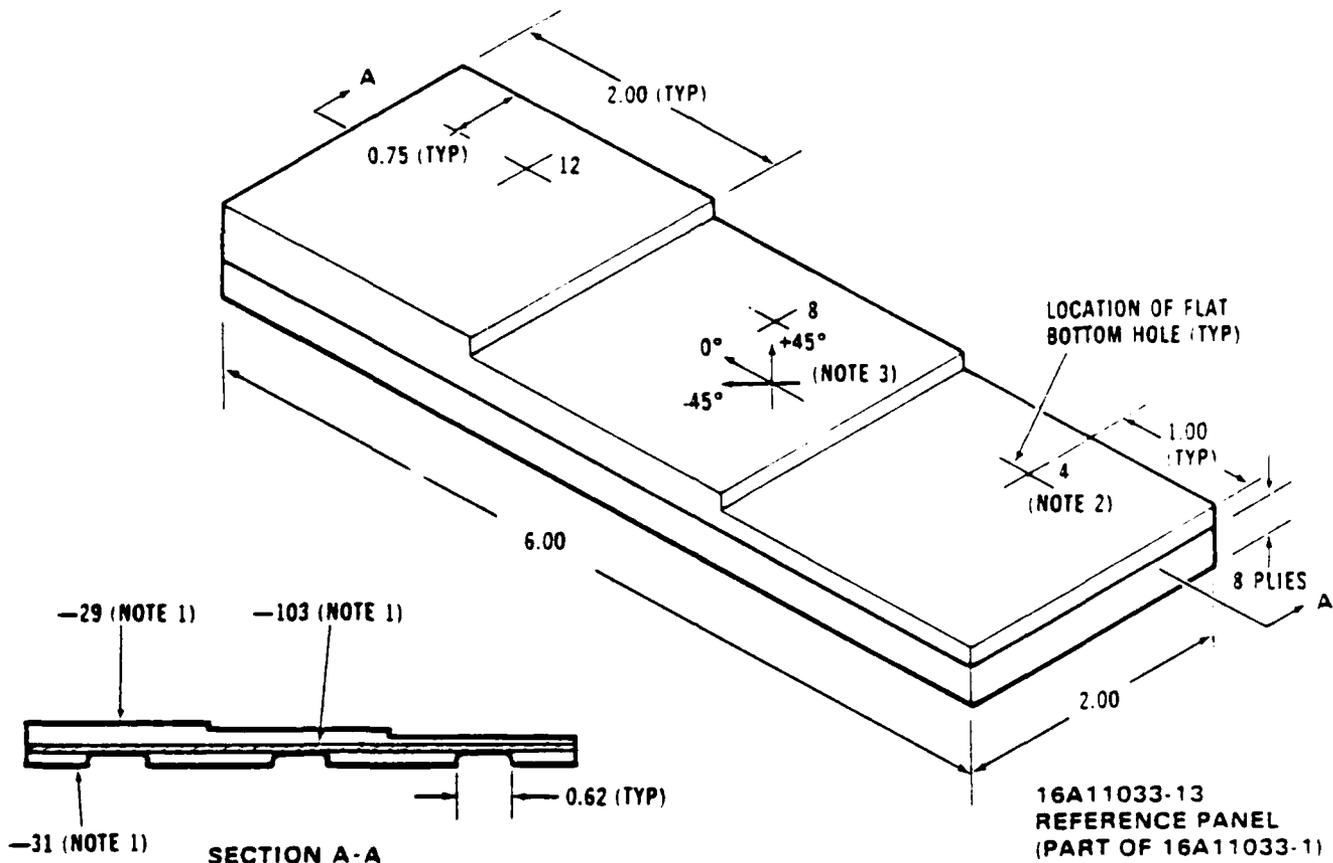
Figure 16A11033-13 Graphite-Graphite Reference Part

1. Materials: (See table 1-3.)
 - 29, FMS-2023, Type 3 or Type 5, Form A or Form C graphite-epoxy tape and P5284-3 cloth (1 ply-upper surface)
 - 31, FMS-2023, Type 3 or Type 5, Form A or Form C graphite-epoxy tape and P5362-1 cloth (1 ply-lower surface)

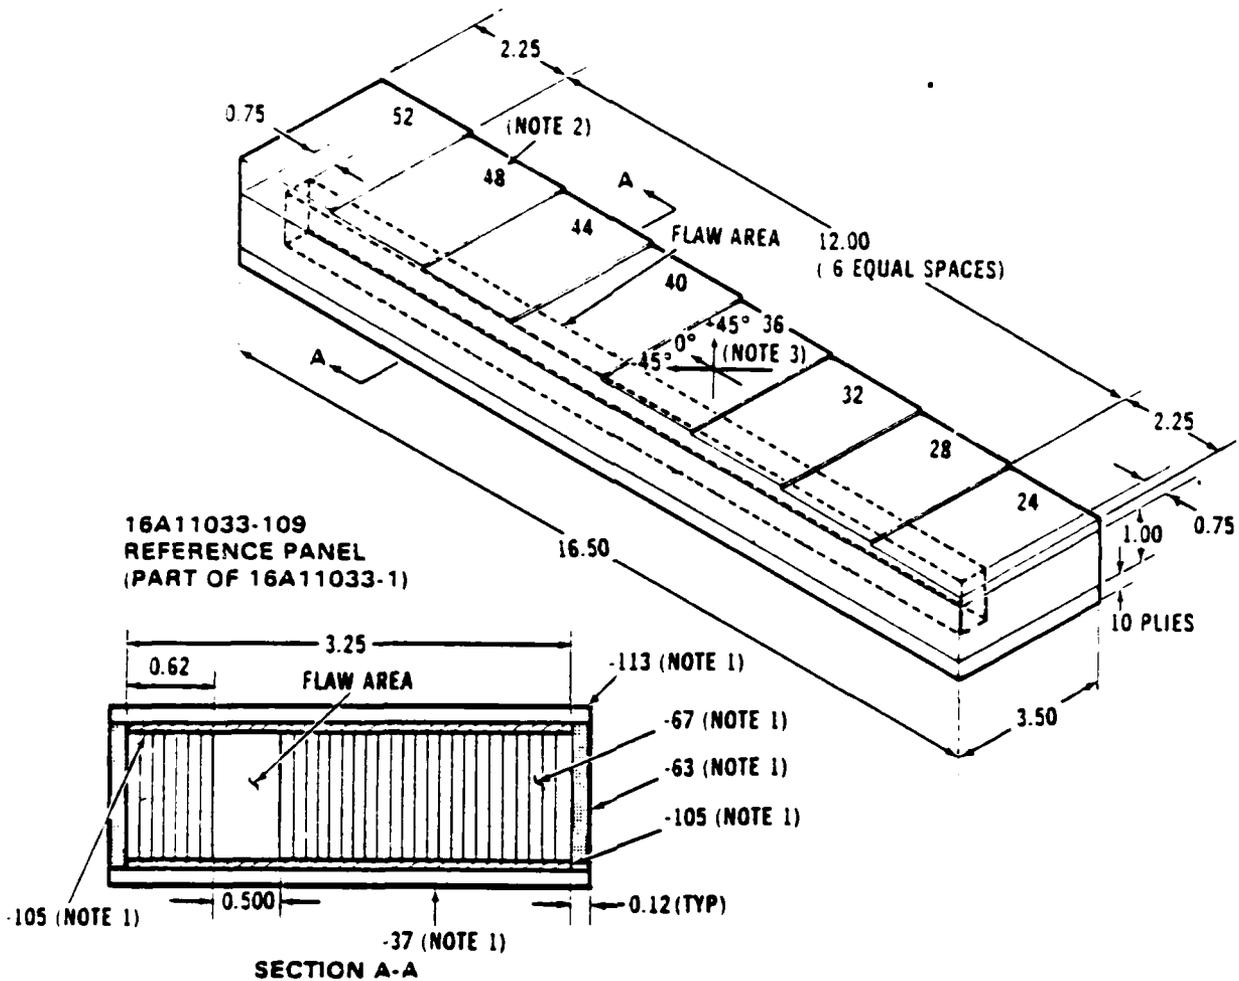
Figure 16A11033-109 Graphite-Core Reference Part

-113 ply 1-12	+++++-----
ply 13-24	-----+++++
ply 25-28	-----
ply 29-32	+++++
ply 33-36	-----
ply 37-40	+++++
ply 41-44	+++++
ply 45-48	-----
ply 49-52	+++++
-37 ply 1-10	----- 00 -----
4. Dimensions with two digits after the decimal point uses ± 0.03 tolerance while three digits after the decimal point uses ± 0.010 tolerance.
5. Install flaw area as follows:
 - a. Cut plug from core.
 - b. Assemble core to stepped top. Lay strip of teflon sheet in plug cut out area of core and reinstall plug in core. Cover core surface with teflon sheet. Bond assembly.
 - c. Remove teflon sheet, plug, and teflon strip and discard.
 - d. Bond bottom skin.
 - e. Seal exposed areas of core with sealant.
6. Finish: two coats epoxy primer (Military Specification MIL-P-23377) and two coats urethane coating (Military Specification MIL-C-83286).

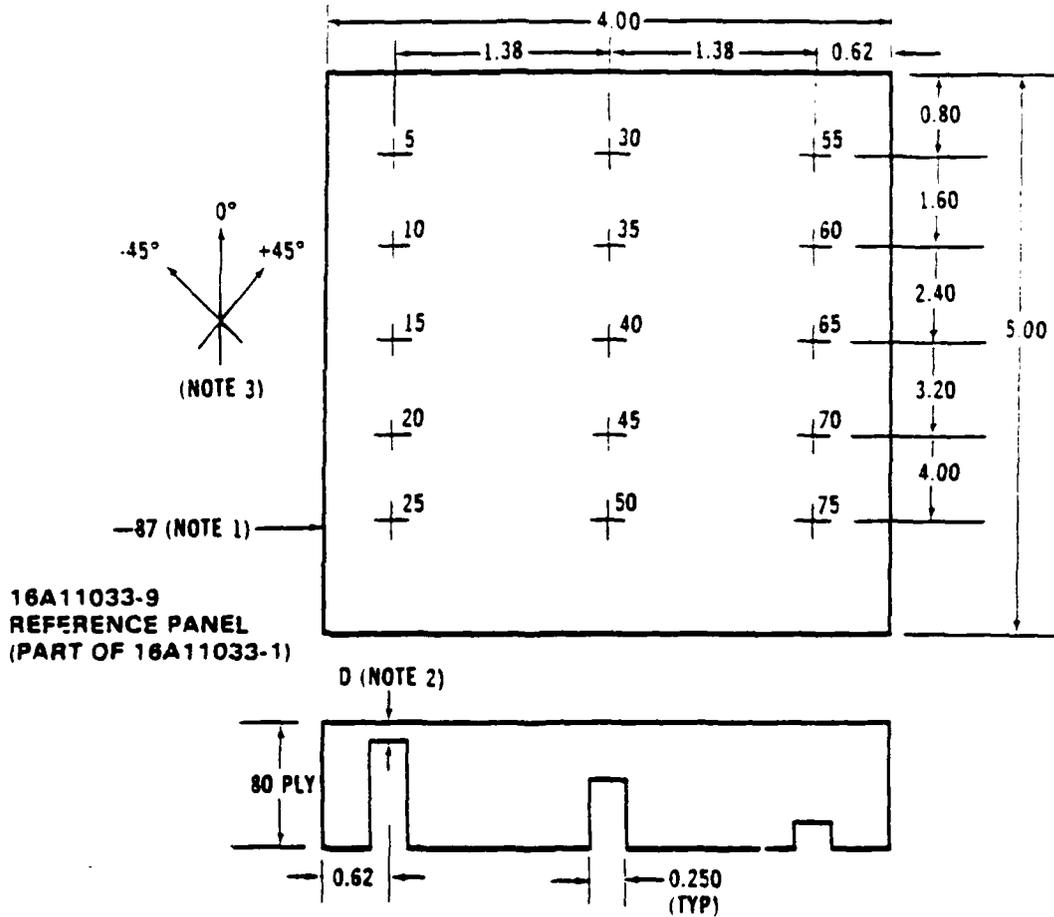
Figure 16A11033-9 High Resolution Reference Part

1. Material: (See table 1-3.) - 87, FMS-2023, Type 3 or Type 5, Form A or Form C graphite-epoxy tape and P5284-3 cloth (1 ply-upper surface).
2. Ply designation indicates depth to hole.

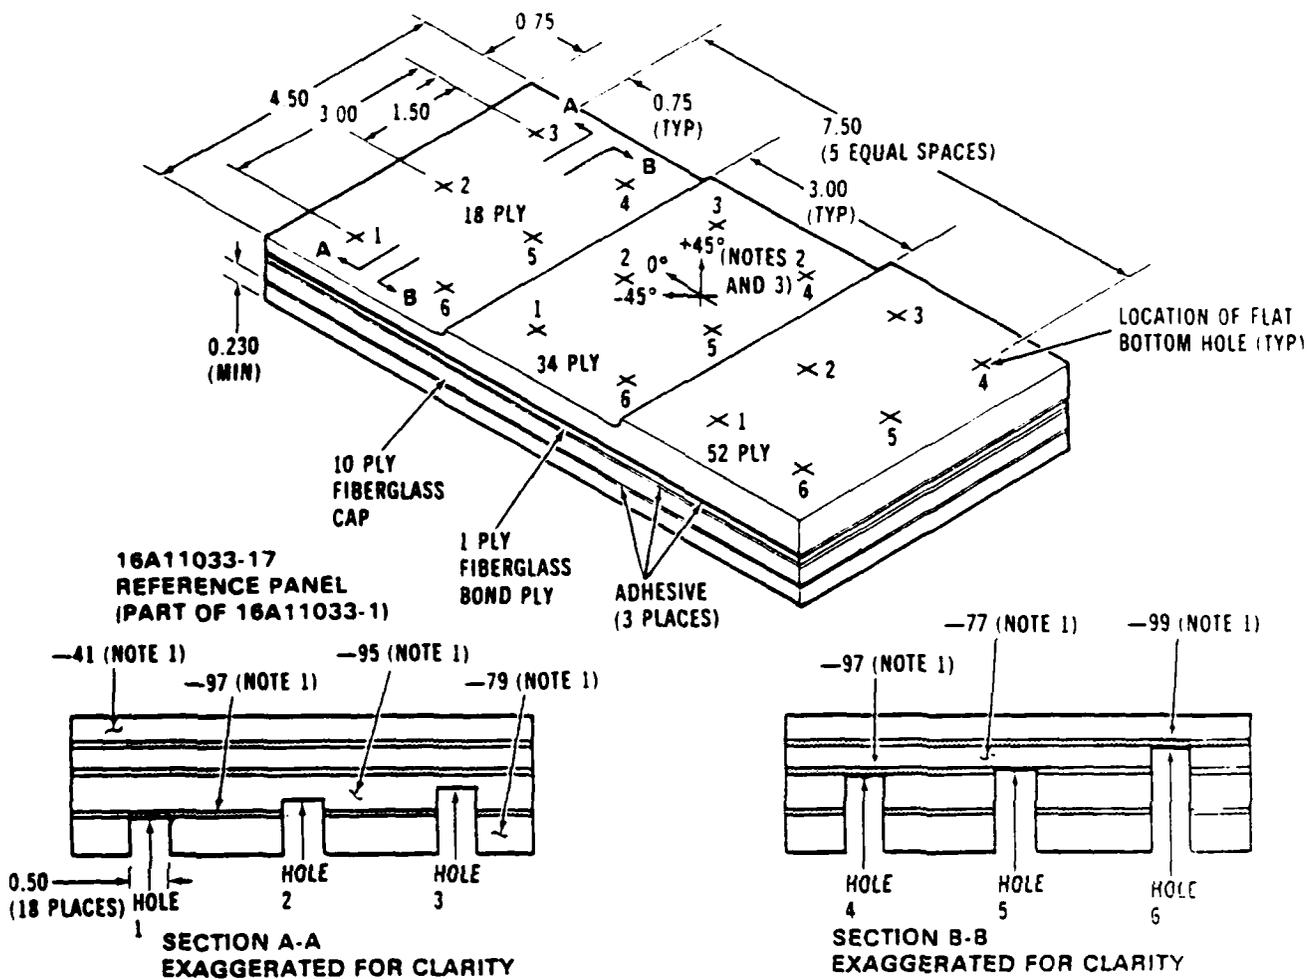
- NOTES:**
- Materials: (See table 1-3.)
 - 41, FMS-2023, Type 3 or Type 5, Form A or Form C graphite-epoxy tape and P5284-3 cloth (1 ply-upper surface)
 - 77, P5284-5, Style 181 glass fabric
 - 79, Type 1, Composition B titanium (Military Specification MIL-T-9046)
 - 95, FMS-1023, Class 2, Type A fiberglass
 - 97, FMS-3018, Form 1B adhesive
 - 99, FMS-3011 adhesive
 - Orientation of graphite-epoxy plies is as follows (where + is 45°, - is -45°, and 0 is 0°):

ply 1-6	+0+0
ply 7-12	+0+0
ply 13-18	+0+0
ply 19-26	+0+--+
ply 27-34	--+0+
ply 35-40	0+0+
ply 41-46	0+0+
ply 47-52	0+0+
 - Orientation of each ply of fiberglass is 90° to adjacent plies, e.g., +45°, -45°, +45°, -45°, etc.

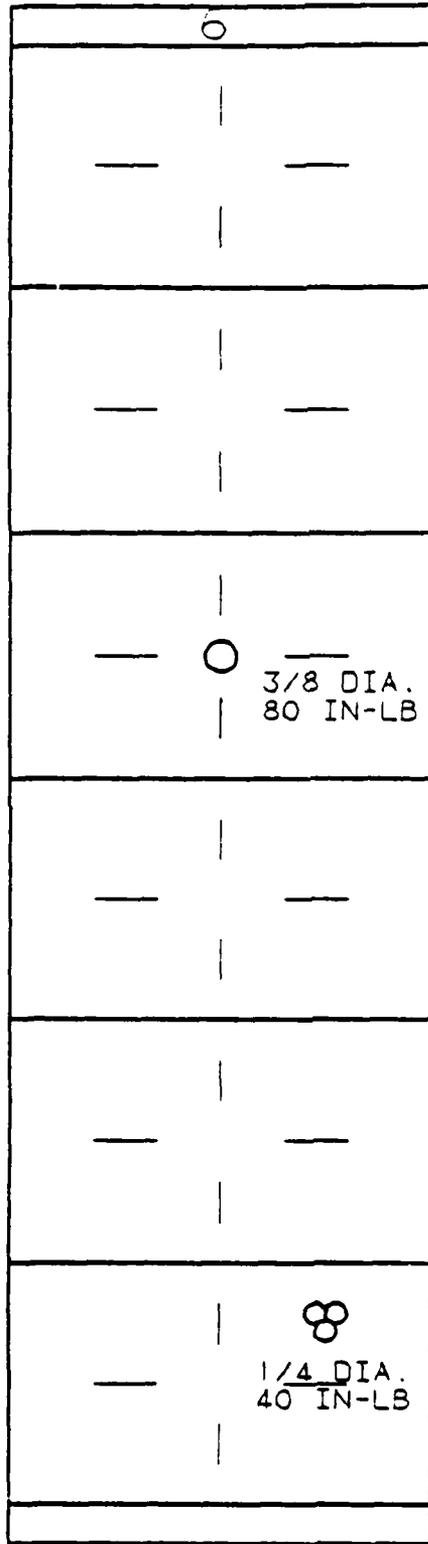
IMPACT DAMAGE ENERGY LEVELS
AND LOCATIONS

#1. The Impact Damage standard was a 32-ply graphite/epoxy laminate with flaws produced by hitting the standard with a weight dropped from a given height. One of the defects was 3/8 inch in diameter and was produced by an 80 in-lb impact. The other defect was a cluster of three 1/4-inch diameter damaged areas, each produced by a 40 in-lb impact.

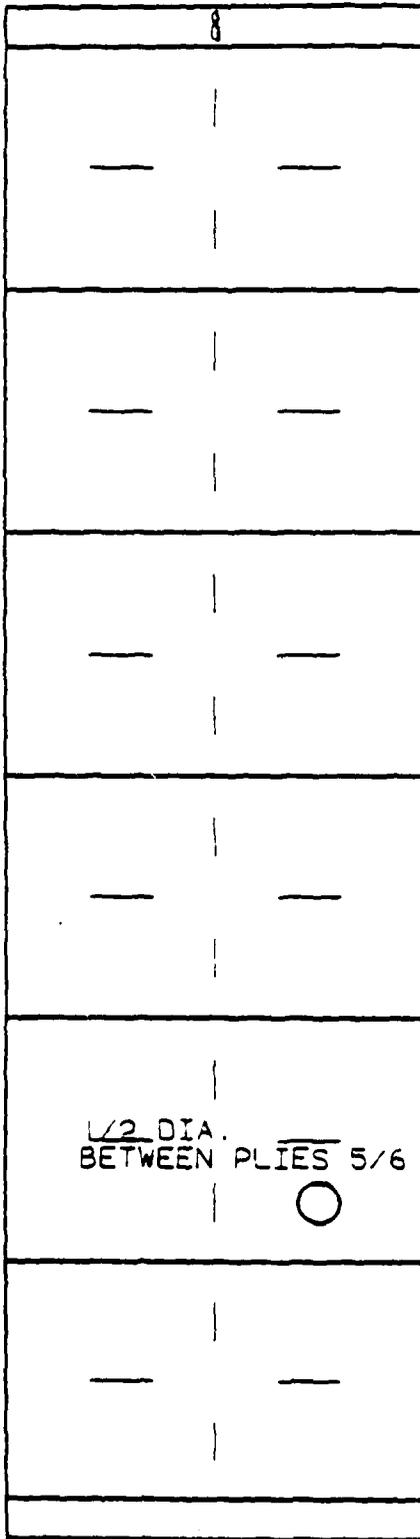
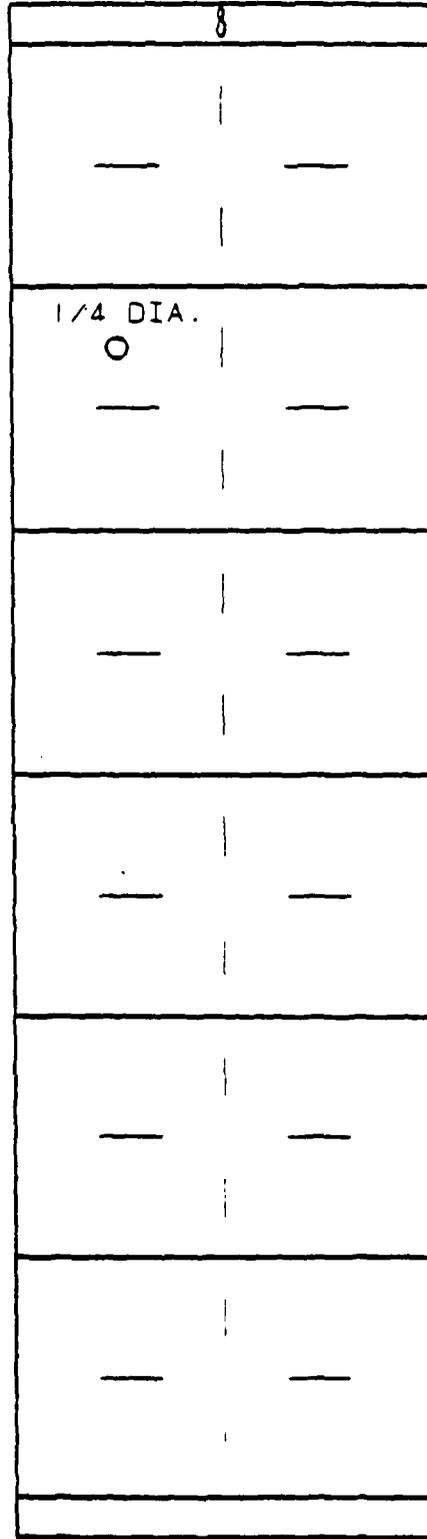
DELAMINATION ENVELOPE LOCATIONS

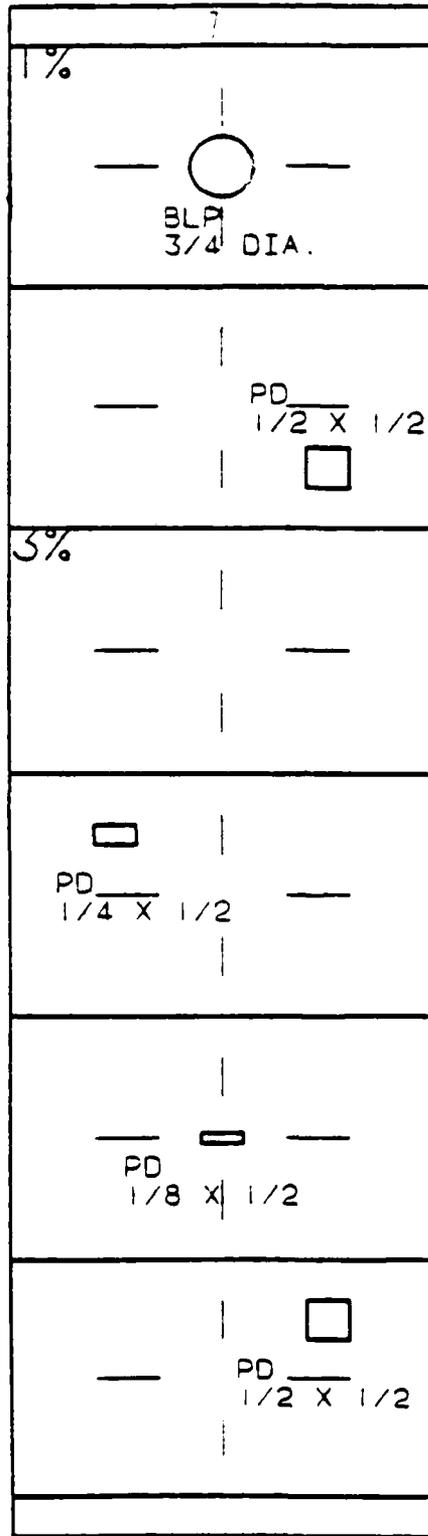
REPAIR PANEL FLAW LOCATIONS

#3. The Repair patch standard consisted of a 36-ply graphite/epoxy laminate base with a 36-ply graphite/epoxy laminate on top with 1/2-inch ply dropoffs. The sample contained one 1% bondline porosity defect 3/4 inch in diameter, one 3% bondline porosity defect area, two rectangular delamination defects 1/4 x 1/2 inch and 1/8 x 1/2 inch, respectively, and two square delamination defects 1/2 x 1/2 inch.
