# A STUDY OF MOISTURE INTRUSION INTO THE TOW MISSILE LAUNCH TUBE

FINAL REPORT  
SwRI Project 15-7958-807

Prepared For  
United States Navy  
Pacific Missile Test Center (PMTTC)  
Pt. Mugu, California 93042

May 5, 1985

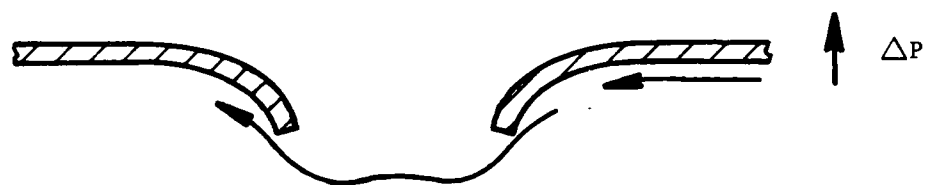
It is difficult to explain the causes of the observed differences in moisture intrusion because of the complicated flow field in front of the diaphragm. We offer one plausible, but not proven, explanation for the observed effects. The flow along the surface of the diaphragm must be parallel to the diaphragm surface. Simulated flow fields, over four different hole configurations, are shown in Figure 6. Configurations (a) and (b) represent some of the holes in the as-received diaphragms. Some holes are small and some have lips that protrude to the front of the diaphragm. For a given pressure differential,  $\Delta P$ , across the hole, these configurations will have less flow through the hole than for configurations (c) and (d). The larger the hole, the more time (at a constant velocity) for the flow to turn and enter the hole. Clearly, configuration (d) acts as a scoop and configuration (b) acts to divert the flow from the hole.

(a)

(b)

The pressure differential and airstream velocity clearly influence the flow through the hole. Higher incident velocity will give higher flow velocity along the diaphragm surface, and higher velocity parallel to the surface will reduce flow through the hole; however, higher incident velocities may also increase the pressure differential across the hole which will increase flow through the hole. Additional calculations, beyond the scope of this study, are necessary to quantify the causes for the observed behavior.
