REPORT NO. EVT 31-87-1 (E)  
MIL-STD-1660 TEST  
OF  
XM87 AND XM88 VOLCANO MINE PALLET

The U.S. Army Defense Ammunition Center and School (USADACS), Evaluation Division (SMCAC-DEV), has been tasked by the U.S. Army Armament Research, Development and Engineering Center (SMCAR-AEP), Picatinny Arsenal, NJ, to design, fabricate, and test a metal pallet for the PA113 Volcano Mine Cannister. This engineering report contains the results of the MIL-STD-1660 pallet testing sequence of the palletized PA113 Volcano Mine Cannister. As a result of these tests, recommendations to strengthen the pallet and modify the PA113 bundling procedure evolved.

EVT 31-87-1 (E)

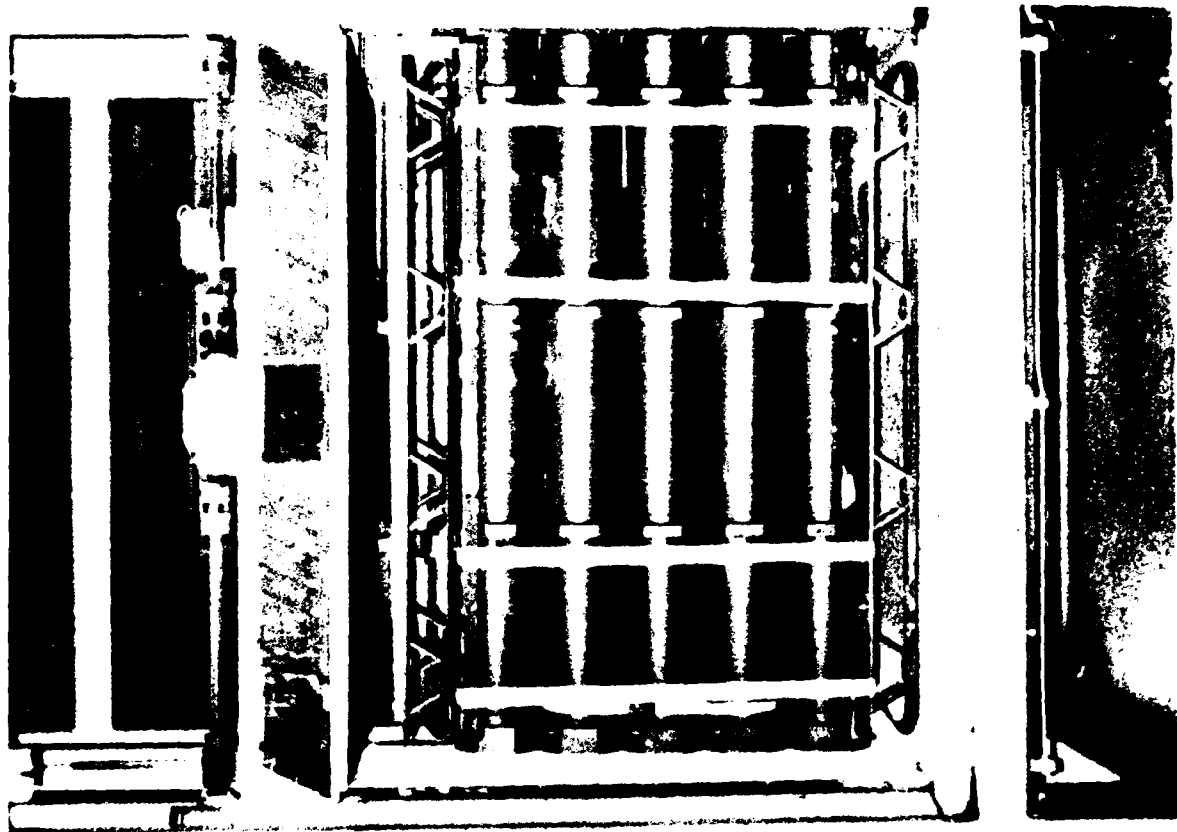
4. FORKLIFTING TEST. This test shall be conducted by using procedures of Method 5011 of Federal Standard 101, Procedure 6.2, Lifting and Transporting by Forklift Truck. The forklift hazard course that will be used is shown in Figure 1.

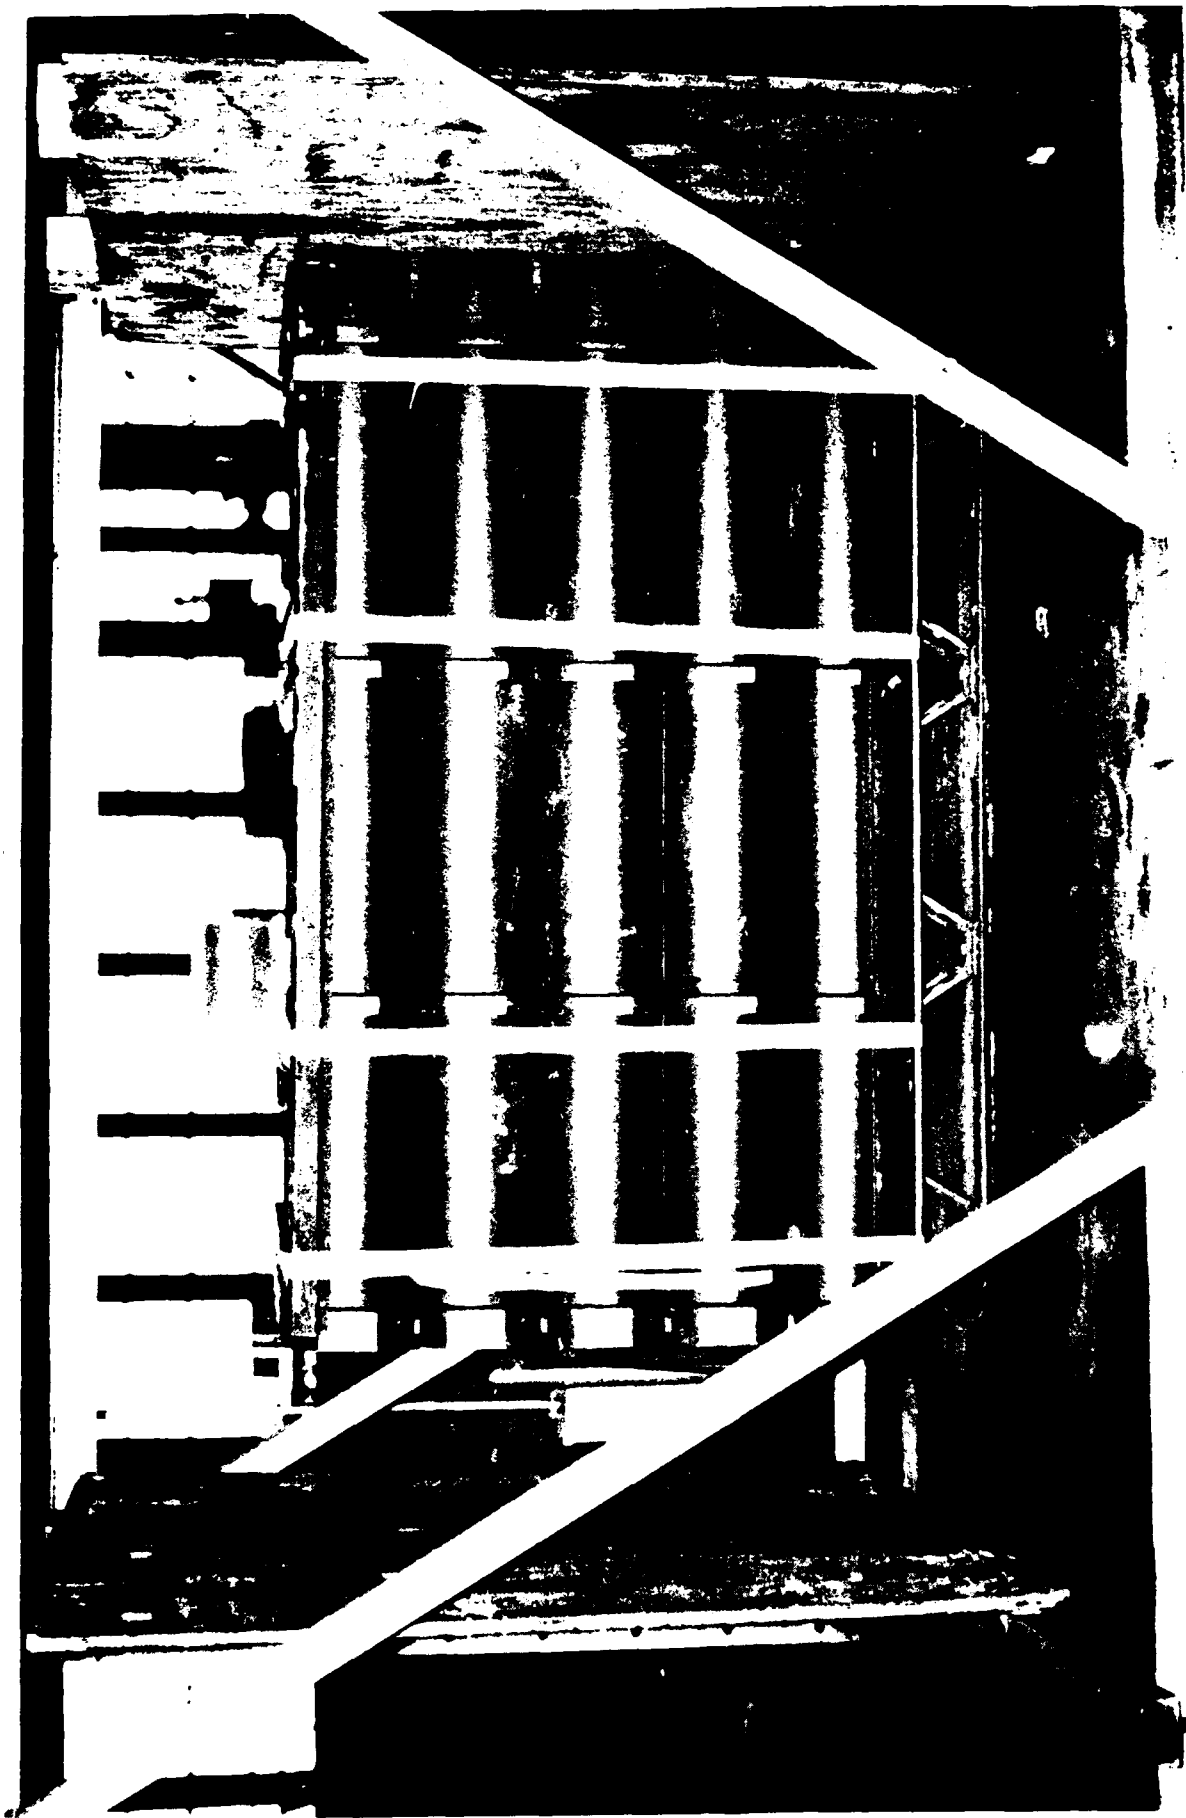
Photo 1. This photo shows the PAl13 Volcano Mine Pallet in the Compression Tester.

The subject pallet was loaded to 9500 pounds compression for a period of one hour. At the end of this period of time, the compressive load had decreased to 9100 pounds. When the compression load was removed and test specimen removed from the Compression Tester, no measurable deformation in the load was evident.

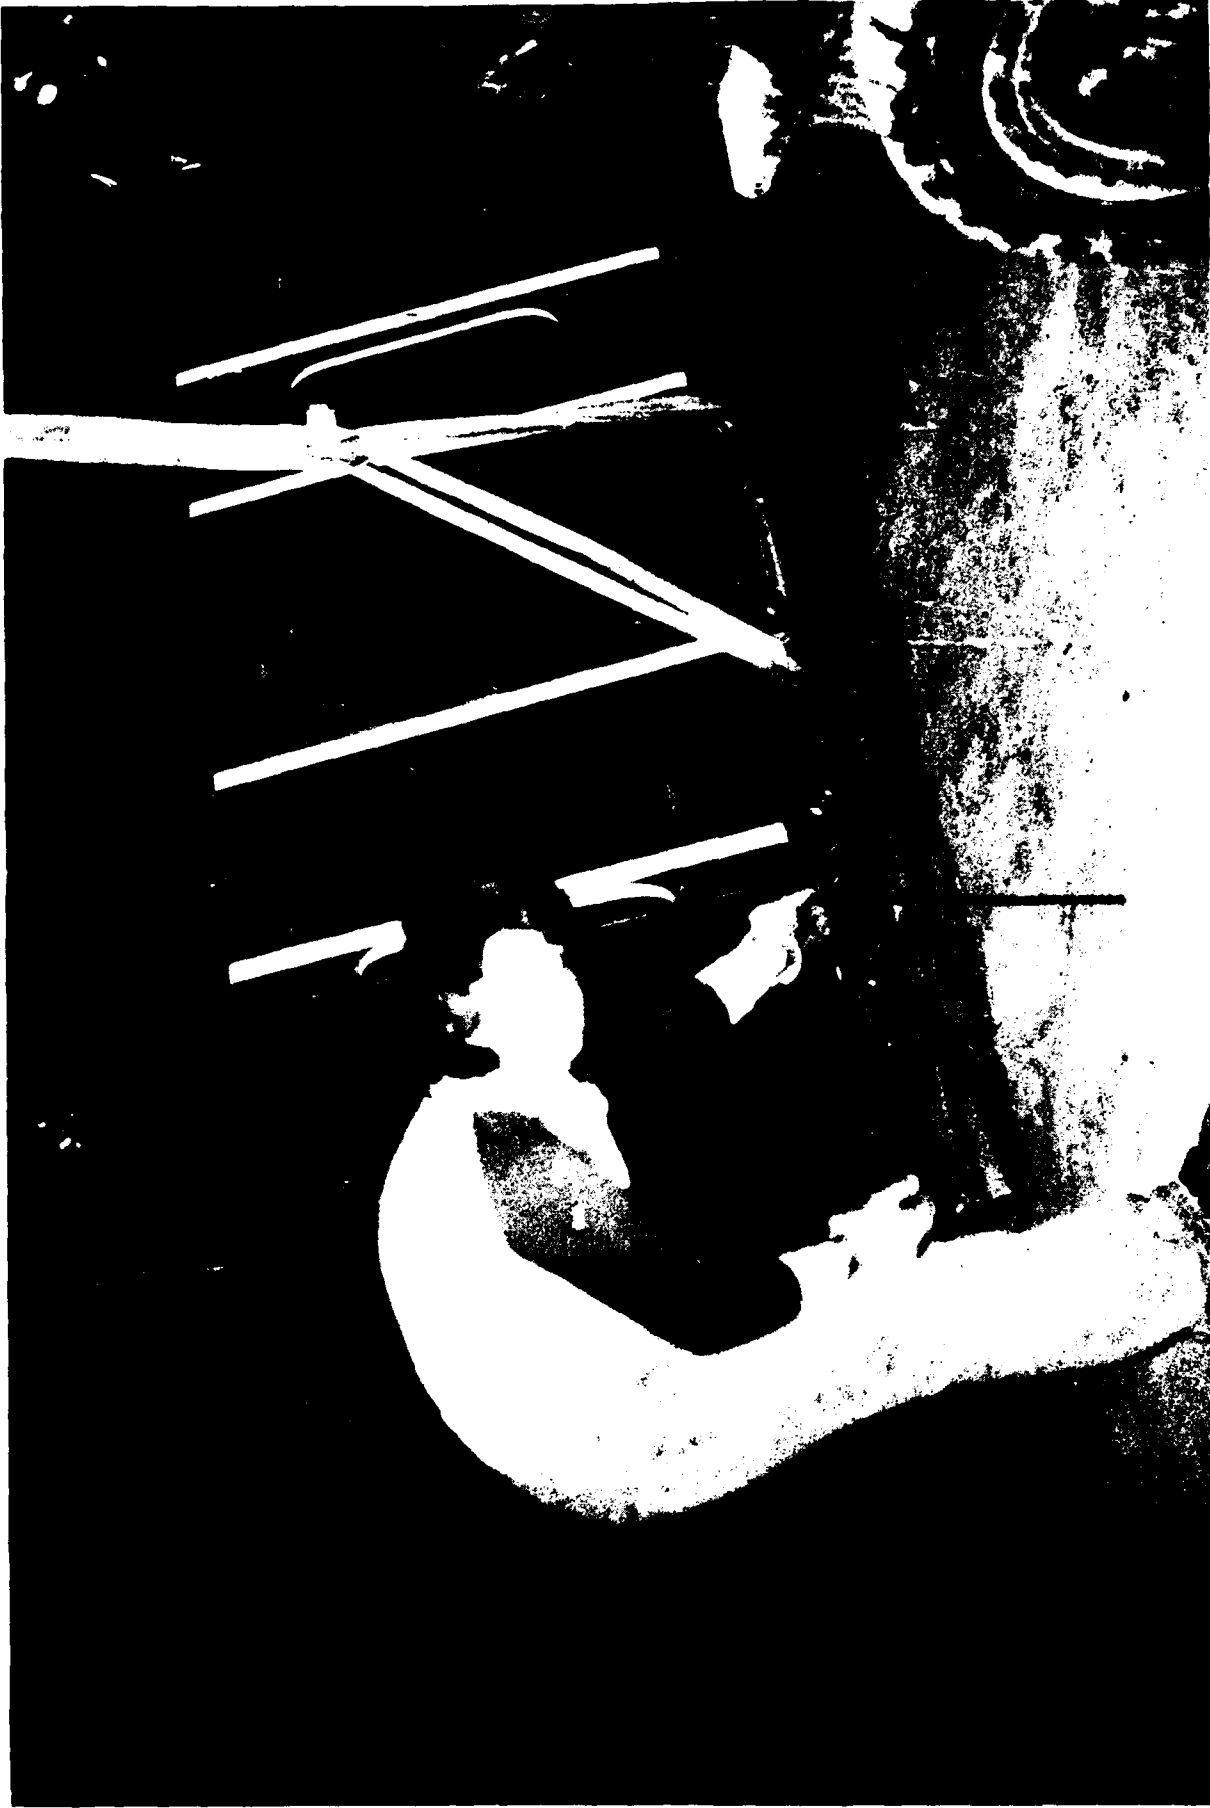
EVT 31-87	DEFENSE AMMUNITION CENTER AND SCHOOL - SAVANNA, IL	MARCH 1987
<p>Photo 4. This photo shows the Volcano Mine Pallet after 90 minutes of vibration in the Transportation Simulator. Note that the pallet base has bowed at the center.</p>

1. CONCLUSIONS. The PA113 Volcano Mine Cannister Pallet, as designed, is unsatisfactory for the following reasons. First, the pallet base is not strong enough to prevent excessive flexing in the unitization straps to maintain a solid load. Second, the hoisting provisions, where attached to the top lifting adapter, caused the metal to buckle when lifted by two slings. No metal deformation was experienced when hoisted from four points. Third, the bundling straps, as shown in the Volcano Mine Unitized Load drawing, do not provide load unity between the pallet base, top lifting adapter, and the top and bottom rows of containers.

2. RECOMMENDATIONS. The Volcano Mine Pallet successfully passed the compression and transportation tests. It did not survive the Edgewise Drop and Sling Compatibility Tests. It is recommended that the pallet and unitization procedure be redesigned. The redesign should include consideration of heavier gauge material in the pallet, pallet adapter, and top lifting adapter. Finally, it is recommended that a five-wide by four-high unitized configuration be investigated to reduce/eliminate the bounce on rebound from edgewise drops.

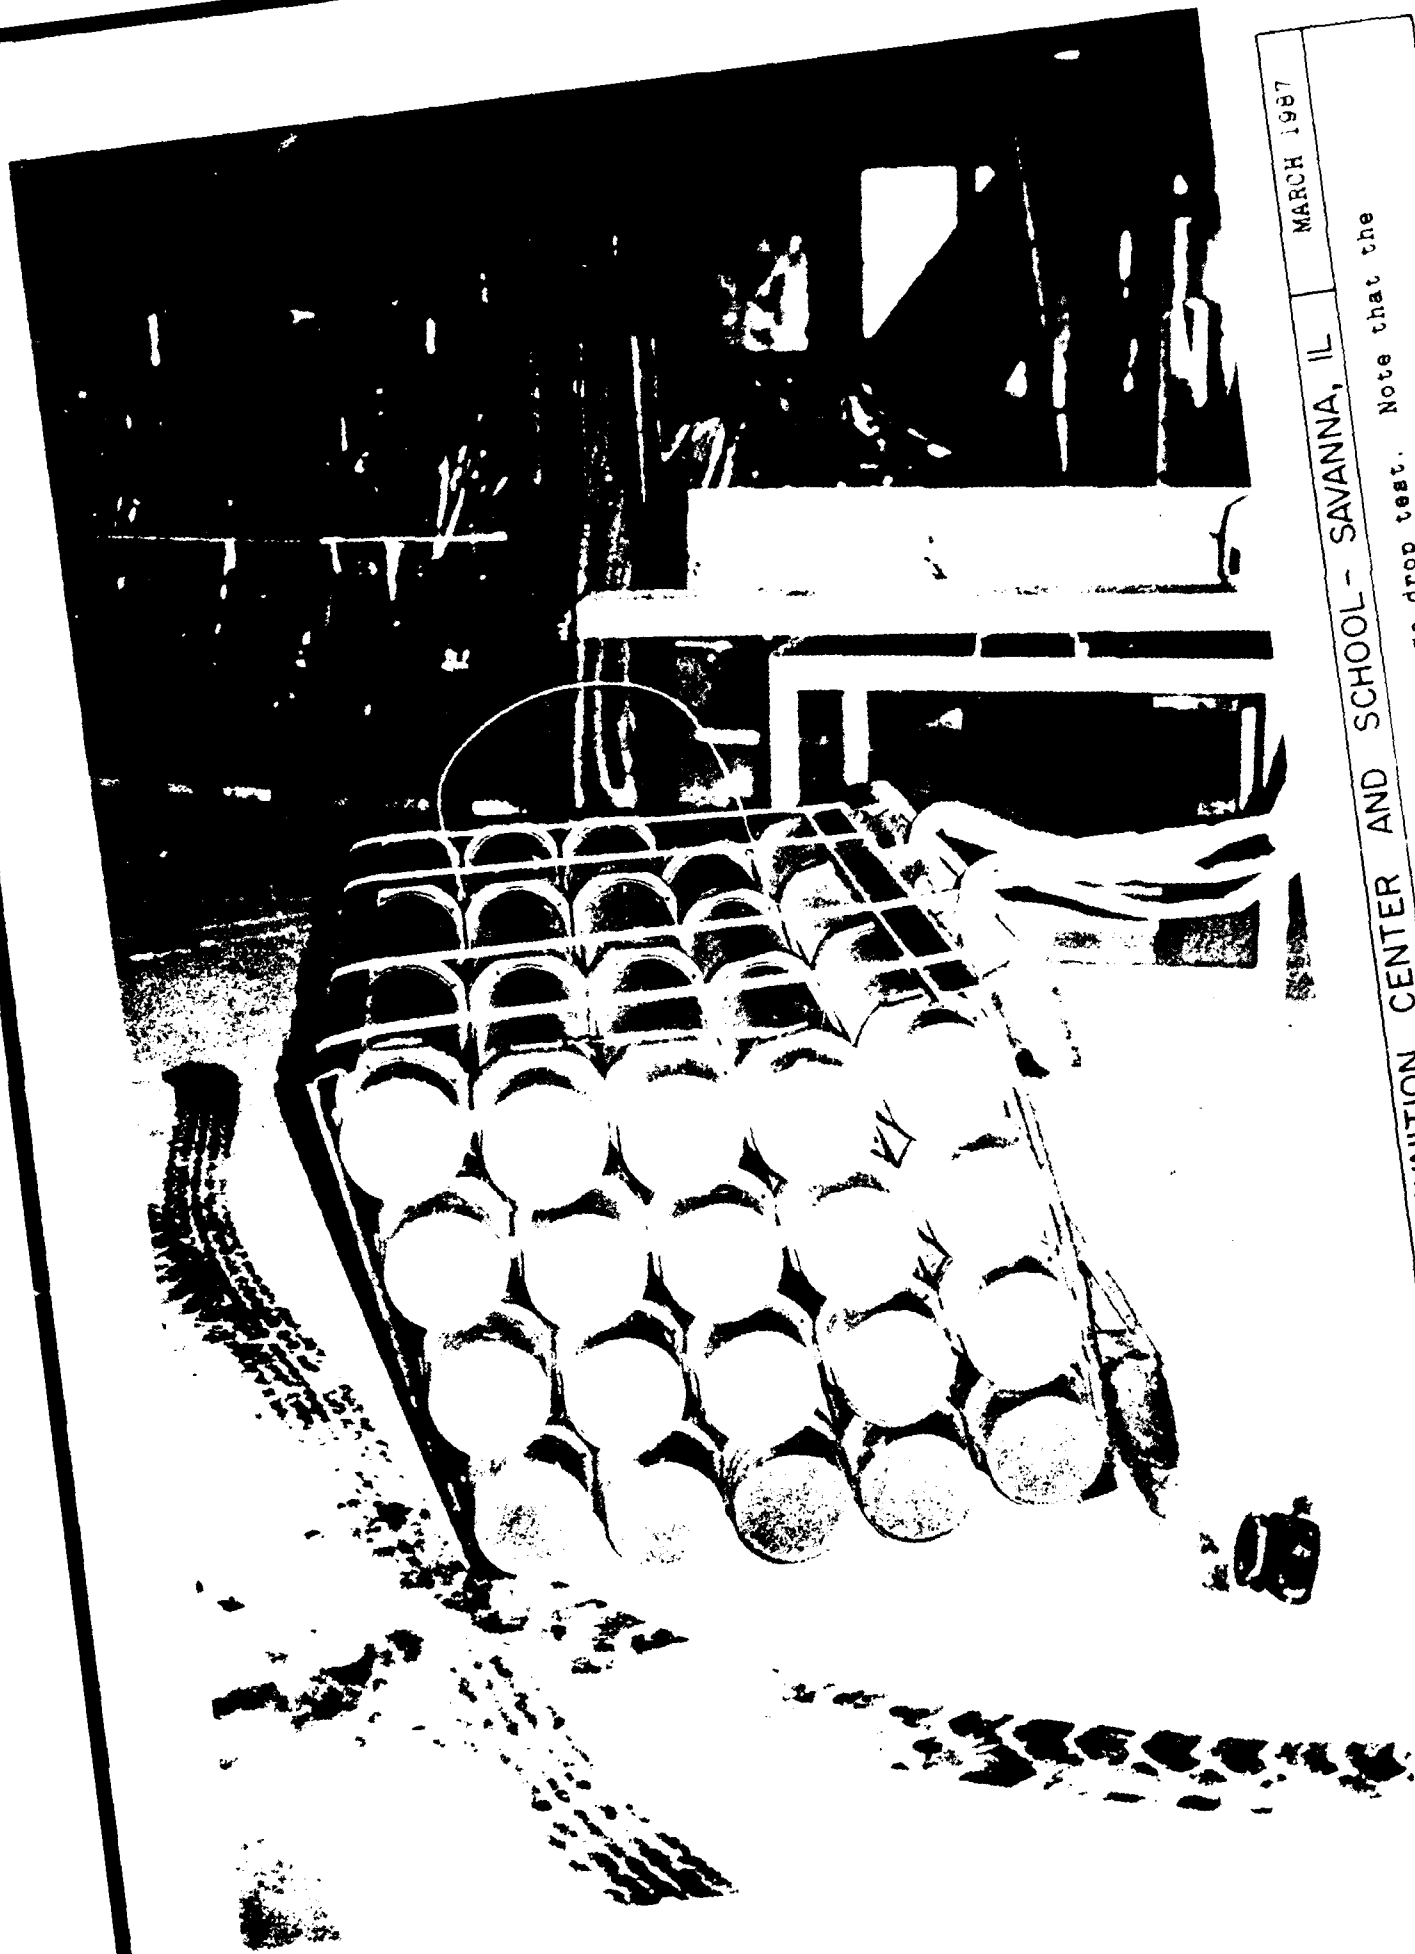
Photo 5. This photo shows the Volcano Mine Pallet raised 24 inches prior to dropping for the edgewise rotational drop test.

Each side of the pallet base was placed on a beam displacing it six inches above the floor. The opposite side was raised to a height of 24 inches above the floor and then dropped. This process was repeated in either a clockwise or counterclockwise direction on all four sides of the pallet.

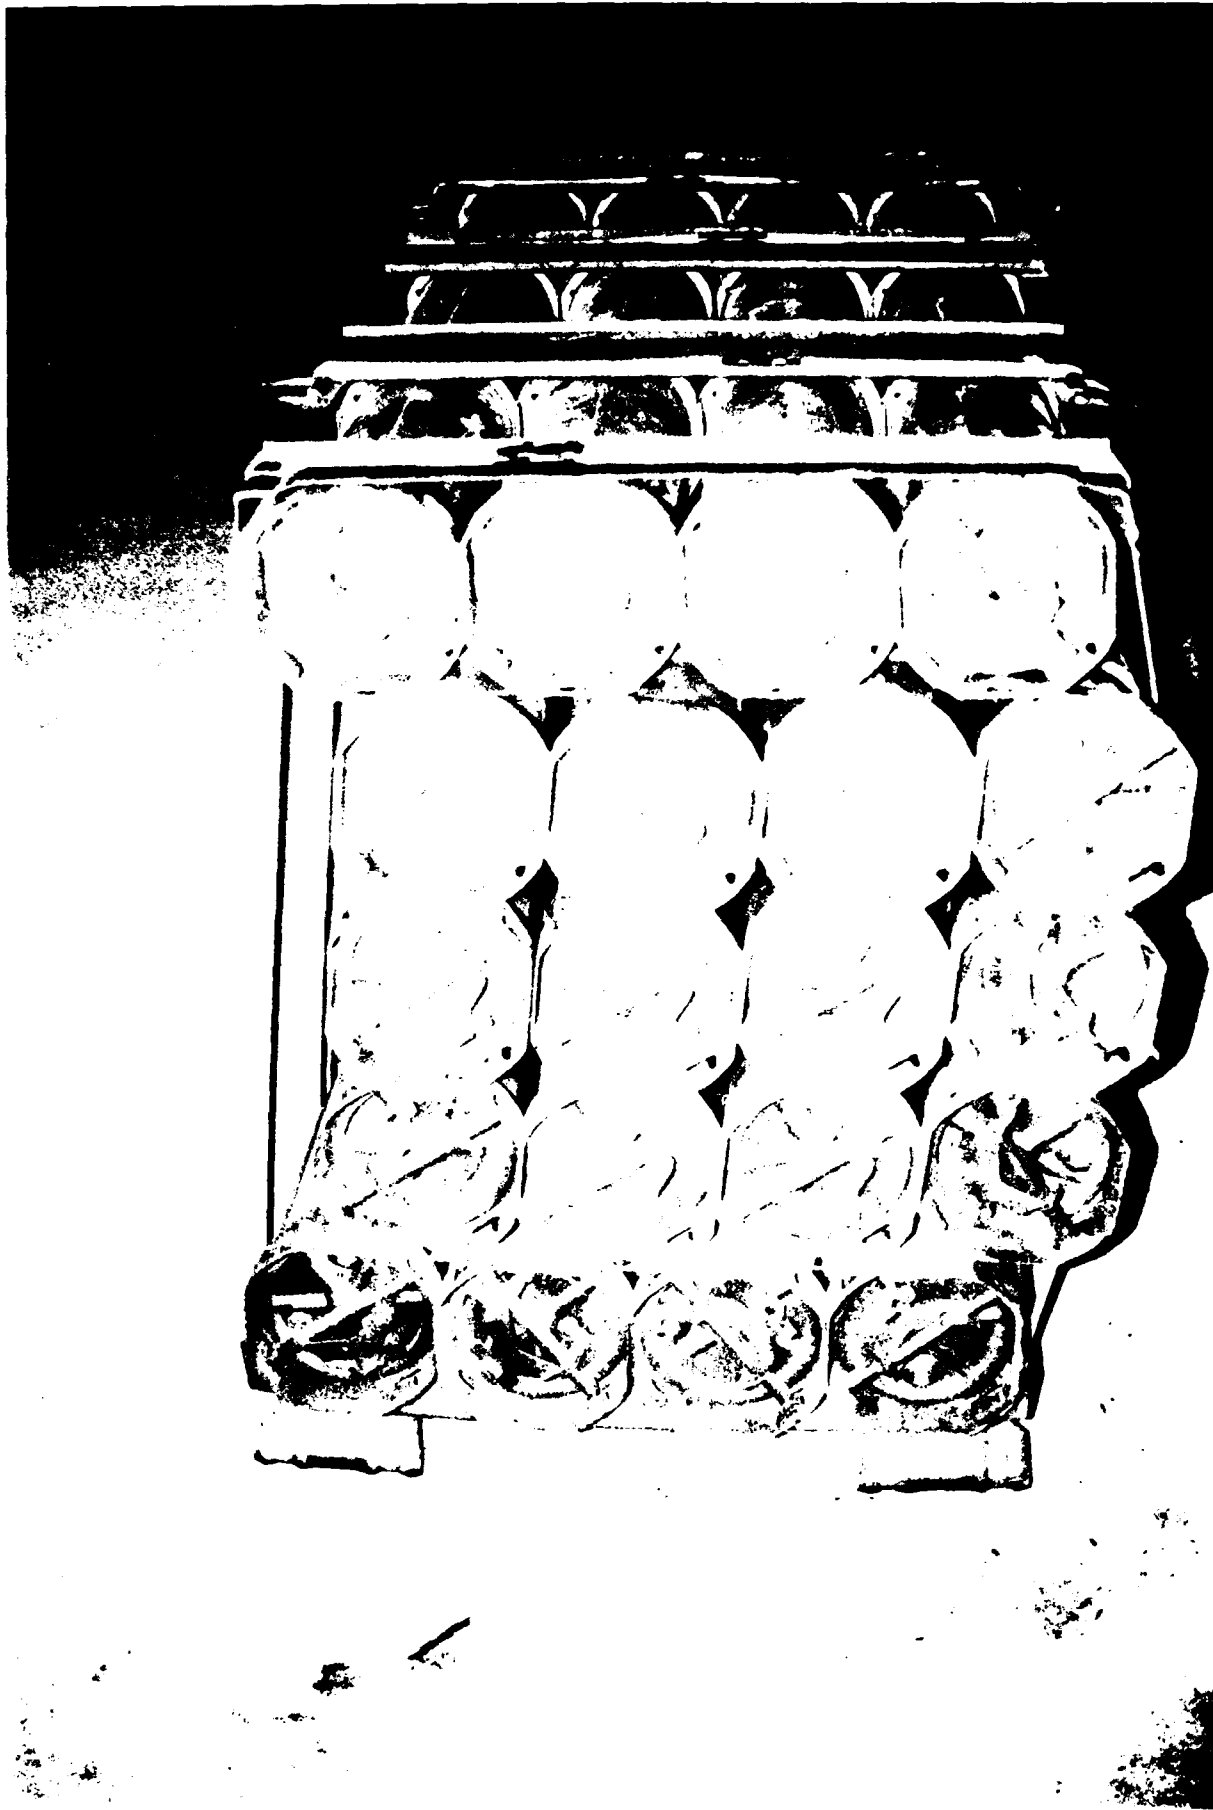
In addition, the pallet warped enough to loosen up the unitizing straps, permitting the containers to become disengaged within the unit and break the bundling straps as shown in the unitization procedure.

Photo 7. This photo shows the Volcano Mine Pallet after the second drop. Note that one bundling strap has broken and that the pallet has bounced onto its side.

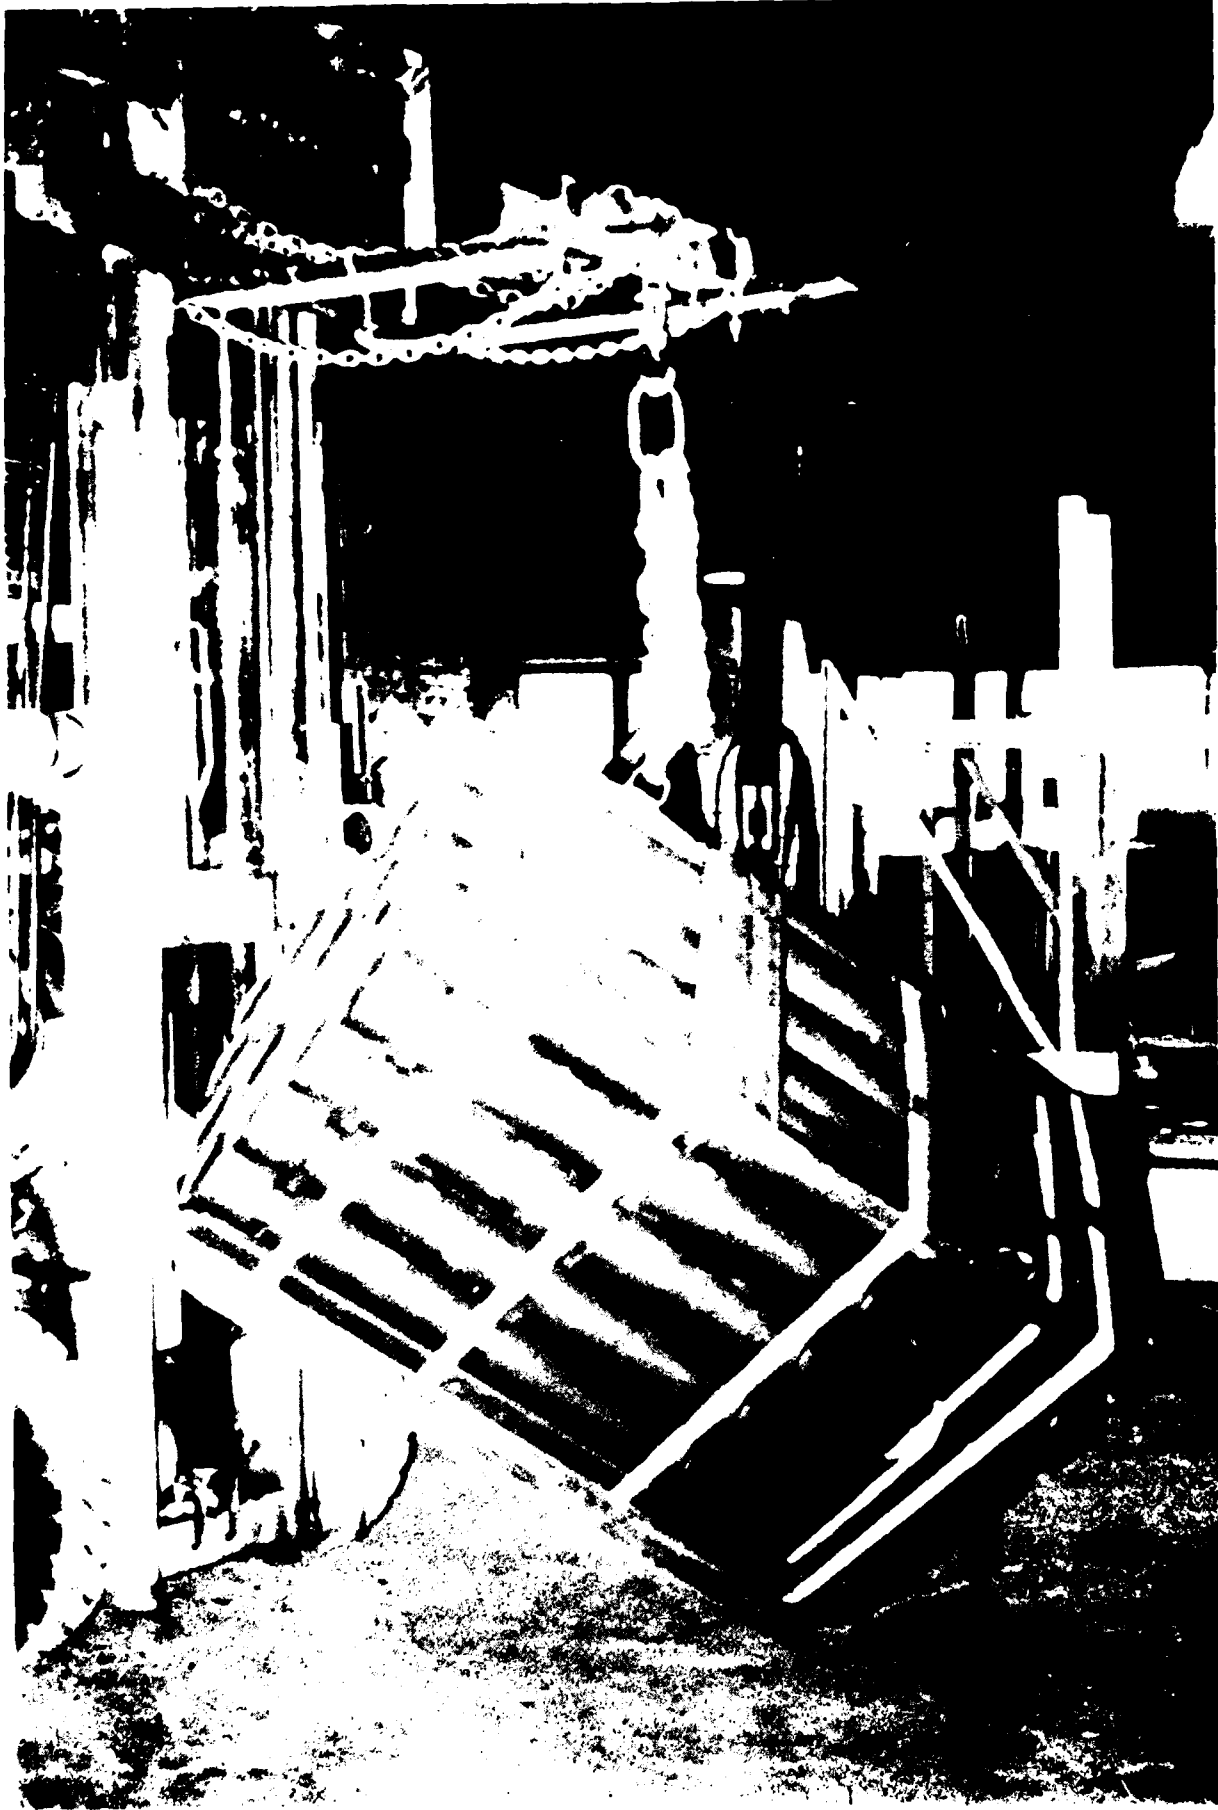
Photo 11. This photo shows the Volcano Mine Pallet being lifted from two diagonal points by a sling with an intruded angle between 20 and 25 degrees.

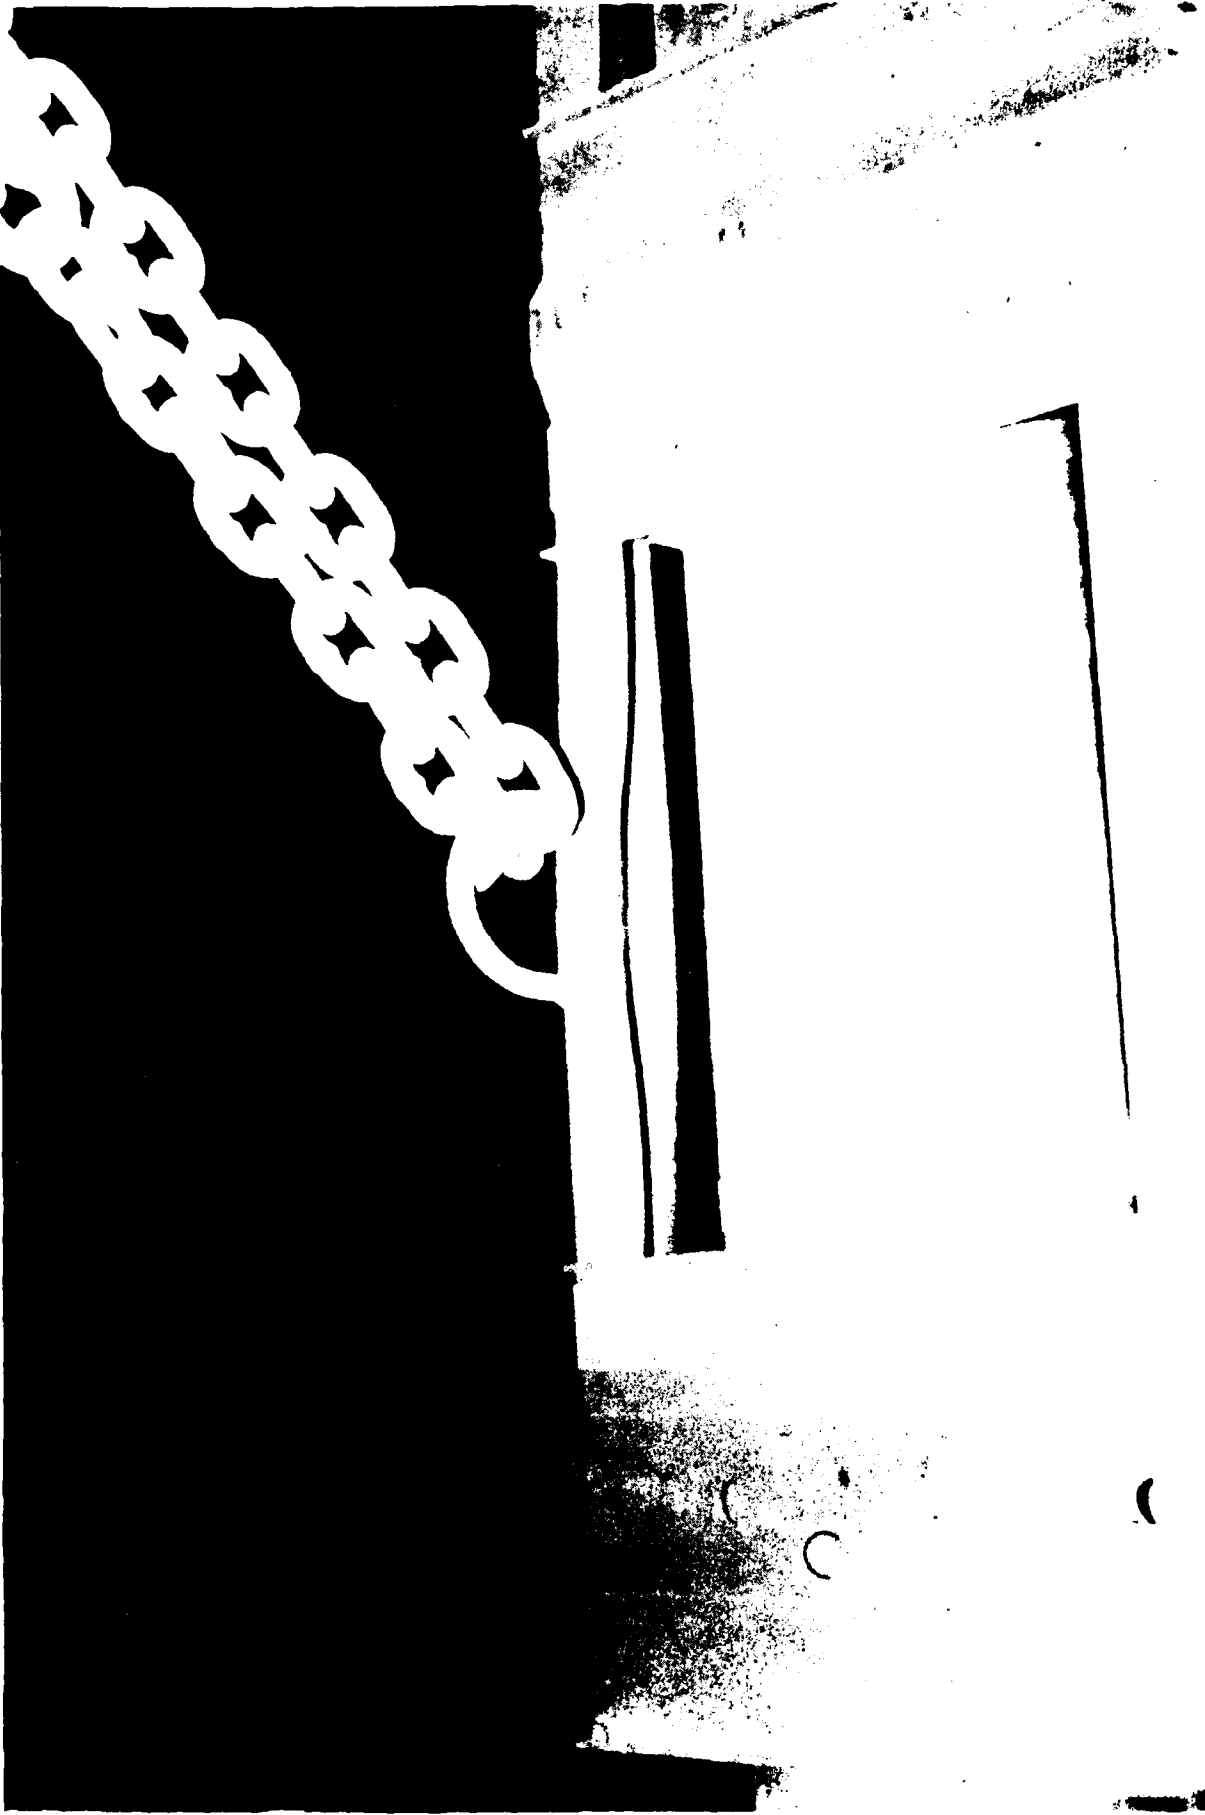
The Sling Compatibility Test consisted of lifting the pallet from the hoisting attachment provisions with an included sling angle between 20 and 25 degrees. There were five lifts performed. The first lift was with all four hoisting provisions, the second with three, the third with two diagonal hoisting provisions, the fourth with two opposite diagonal hoisting provisions, and the fifth with one hoisting provision. The included angle was maintained, where possible, between 20 and 25 degrees. All hoisting attachment provisions maintained the test loads applied; however, metal deformation occurred in the top lifting attachment.

Photo 12. This photo shows deformation in the Pallet Adapter of the Volcano Mine Pallet when being lifted by a sling. The connecting attachment or lifting eye was also deformed.
