AGARD REPORT No.771

Fuel Tank Technology

AGARD Report No.771
FUEL TANK TECHNOLOGY

Papers presented at the 68th Meeting of the Structures and Materials Panel of AGARD in Ottawa,
Canada, 23—28 April 1989.

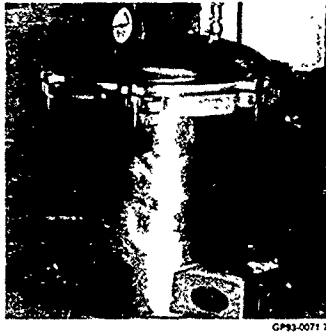
Figure 7. Hydrolytic Stability Screening in Steamclave

The second accelerated test is hydrolytic stability screening in the steamclave (Figure 7). This is a test in which material samples are placed in a pressure vessel at 103E + 01 Pa (15 psig), 121°C (250°F) and 100% relative humidity (RH). Standard tensile specimens are used and at intervals during the exposure, samples are withdrawn and tested (Figure 8).

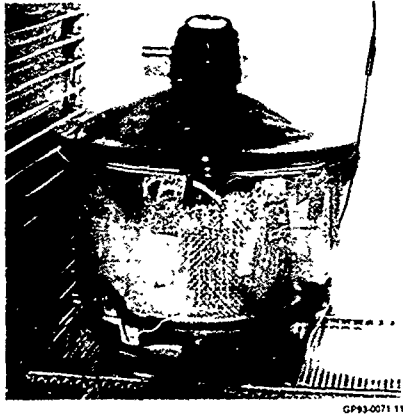
Figure 11 Long Term Humidity Exposure Desiccator Test

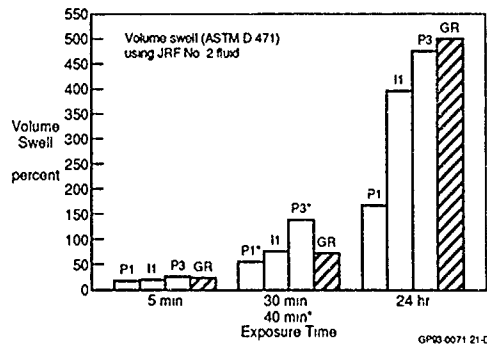
Figure 21. Development of Self-Sealing Materials

Various material concepts in this part of the program were considered. However, the investigative effort was concentrated on sprayable high swell urethanes and isoprenes. Volume swell determinations were conducted in accordance with ASTM D471, except that Jet Reference Fuel No. 2 was substituted for the ASTM fluids. The volume swells and response times for two polyurethanes (P1, P3) and one type of isoprene (I1) are shown in (Figure 21). It is apparent that one of the high swell urethanes (P3) and the isoprene (I1) kept pace with gum rubber (GR) in response time and swell volume.
