WRDC-TR-90-4075

FAILURE ANALYSIS TECHNIQUES FOR THE EVALUATION OF  
ELECTRICAL AND ELECTRONIC COMPONENTS IN AIRCRAFT  
ACCIDENT INVESTIGATIONS

Failure Analysis Associates  
115 Flanders Road  
Westborough, MA 01581

Final Report for Period September 1989 - April 1990

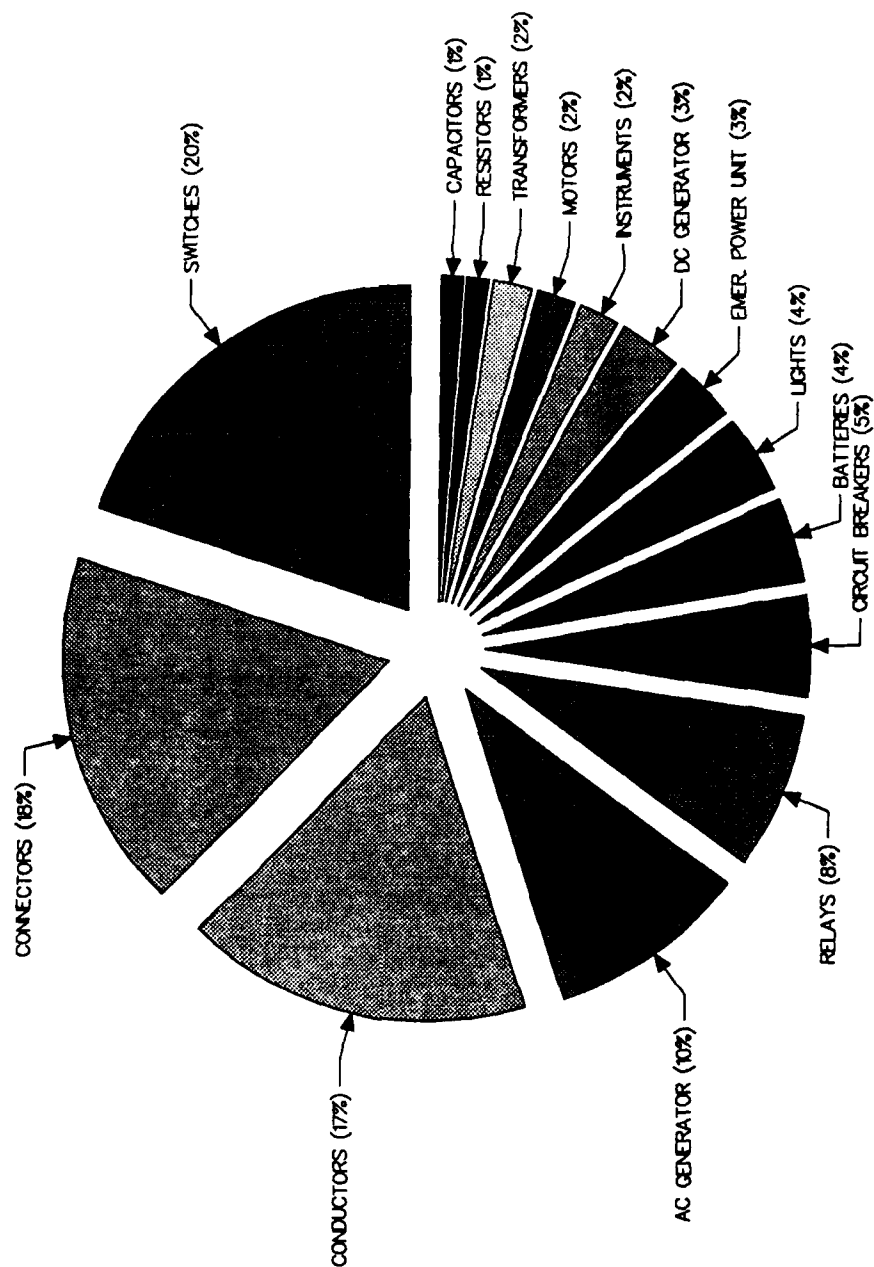
Fig. 1 Summary of Electrically-Related Aircraft Incidents  
 Approximate Composition by Component  
 (Based on Data Supplied by Norton Air Force Base [1])  
 1986-1989

FaAA reviewed other reports on the failures of electrical equipment on aircraft to support the results shown in Figs. 1 and 2. A paper describing the Avionics Integrity Program (AVIP) [2] includes a summary of electrical failure causes on aircraft. The data is shown in Fig. 3. The paper suggests that connectors account for about 40% of maintenance repairs on aircraft electrical equipment. The formation of surface films that cause connectors to be non-conductive is identified as a major problem. Interconnections on circuit boards (the traces, plated through holes, sockets) and electronic components on circuit boards are also identified as major contributors to failure.

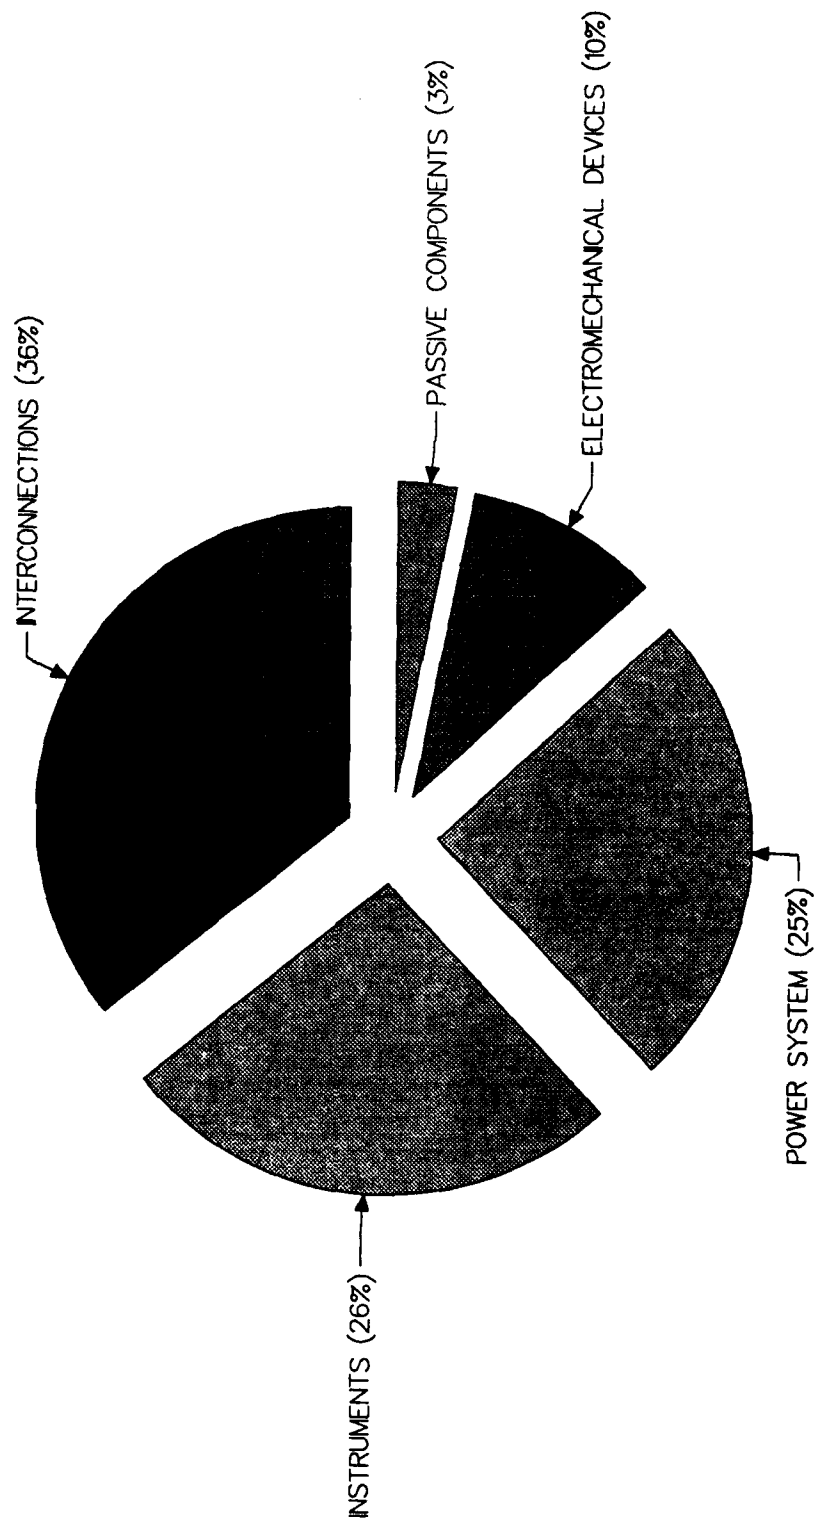
Fig. 2 Summary of Electrically-Related Aircraft Incidents  
Approximate Composition by Basic Function  
(Based on Data Supplied by Norton Air Force Base [1])  
1986-1989

The data of Table 3 have been grouped according to basic system functions and combined percentages for each of the basic functions have been computed as shown in Table 4. The results are represented in Fig. 2. It is apparent from this figure that interconnections (i.e. connectors and conductors (wiring)) are the largest single contributor to electrical failures on aircraft as recorded in the database. The absence of electronic components from the data shown in Figs. 1 and 2 may be due to the level of detail used in the repair or the accident investigation. It is expected that more active and passive electronic components are actually failure causes than are indicated in Figs. 1 and 2. One reason for this is that the materials used in printed wiring boards and electronic components are not likely to survive post-impact damage. This damage may prevent the components from being identified as failure causes even if they did play a causal role in the mishap. As the complexity of installed electronic equipment continues to grow and fly-by-wire aircraft become more common, accident investigation analysis will be driven to identify electronic devices despite the difficulties caused by post-impact damage.

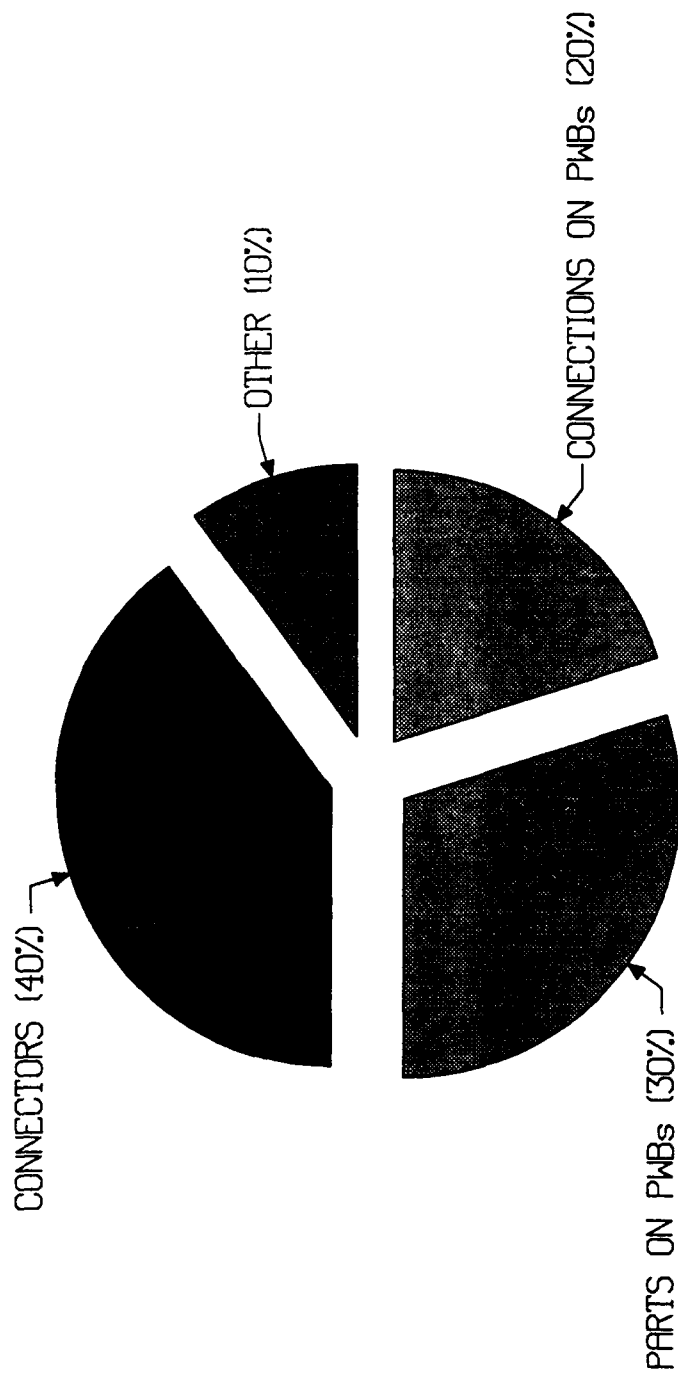
Fig. 3 Causes of Aircraft Electronic Equipment Failures

(Aeronautical Systems Division, Wright-Patterson AFB [2])

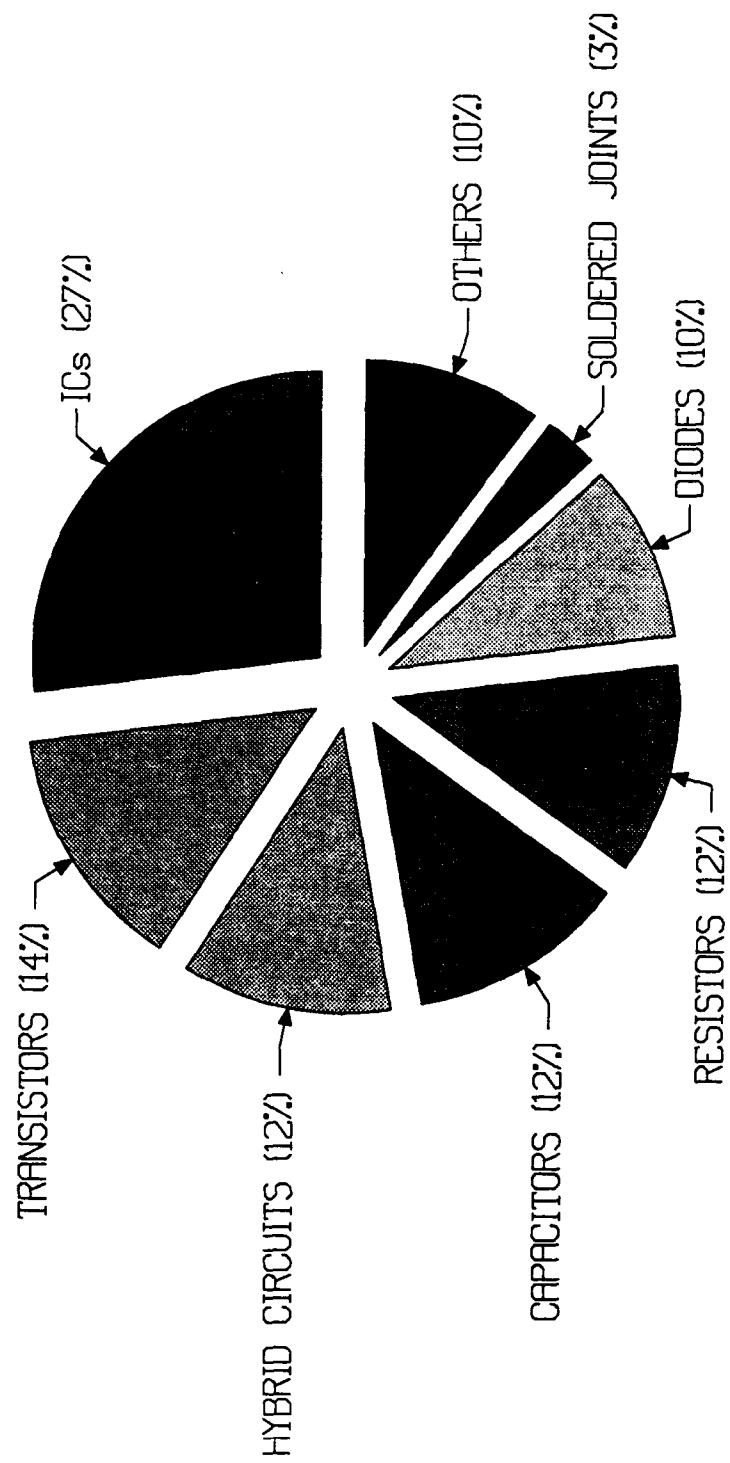
Fig. 4 Part Replacement Data for Printed Wiring Boards

(Based on Data from Hughes Aircraft [3])

A study based on repair records for printed wiring boards (PWBs) at Hughes Aircraft [3] presented data which is depicted in Fig. 4. The data is accumulated from four types of PWBs of different ages and complexity levels. The study was based on part replacement data from factory test and quality control activities, not field failures. Over 58,000 repair records were used as the initial source of data for the study. The goal of the study was to rank components in terms of their replacement frequency rather than their failure rate. The reported composite replacement frequency ranking (from highest to lowest) was: ICs; transistors; hybrid circuits, capacitors and resistors; diodes.

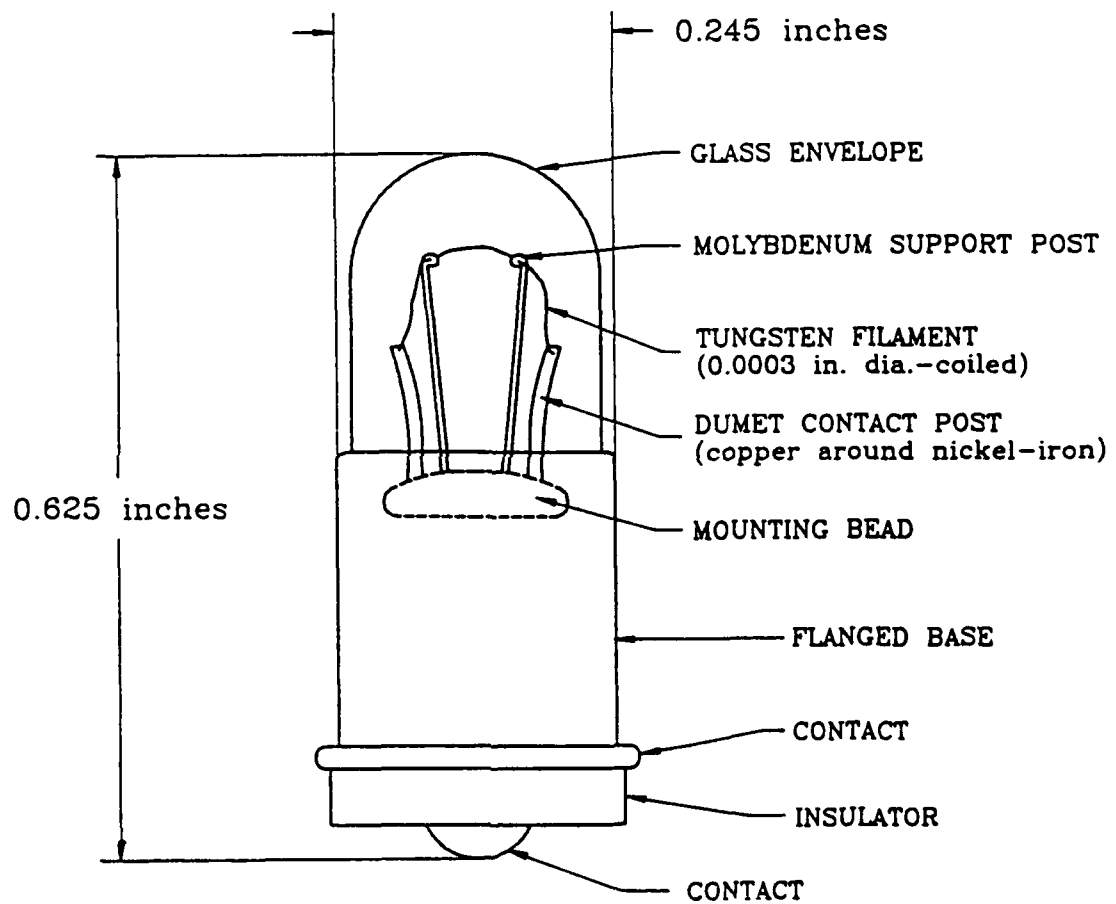
Fig. 2.1 General Construction of  
Type 327 Lamp

The material used for the filament is tungsten wire, which is typically made by a powder metallurgy process. A nearly pure form of tungsten is used for lamp filaments. The filament for a 327 lamp is about 300 microinches in diameter, has a total (uncoiled) length of about 2.1 inches, and has a mass of about 40 micrograms. Mechanical properties of Tungsten wire include tensile strengths from 250,000 to 600,000 psi at room temperature, depending on the diameter [2.6]. The tensile strength at the operating temperature of 1500 to 2000°C can be as much 20 times lower than at room temperature. Other data on the 327 lamp is presented in Table 2.2. Military standard MS 25237 [2.7] describes the mechanical and performance requirements of the 327 lamp.

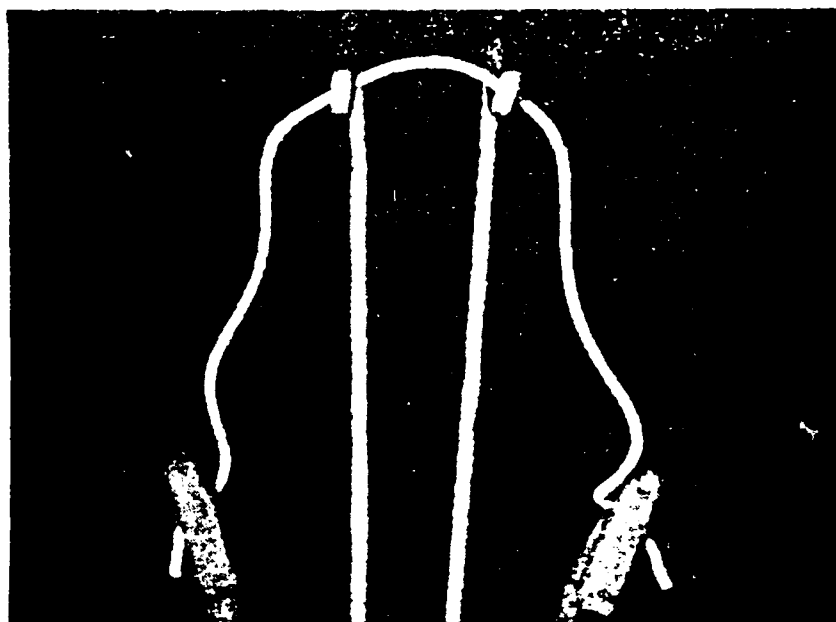
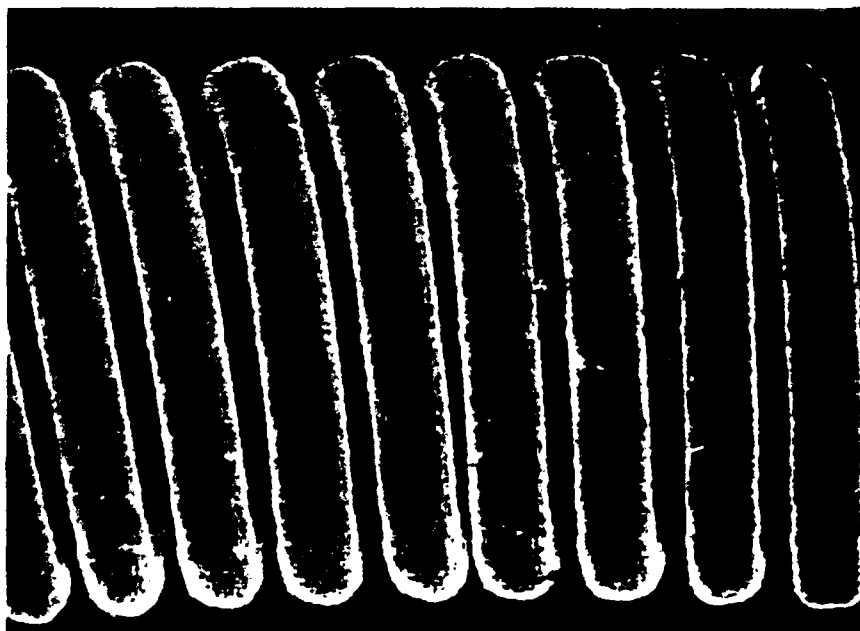
Fig. 2.2 New filament of Type 327 lamp [2.1]. a - 20X, b - 1000X.

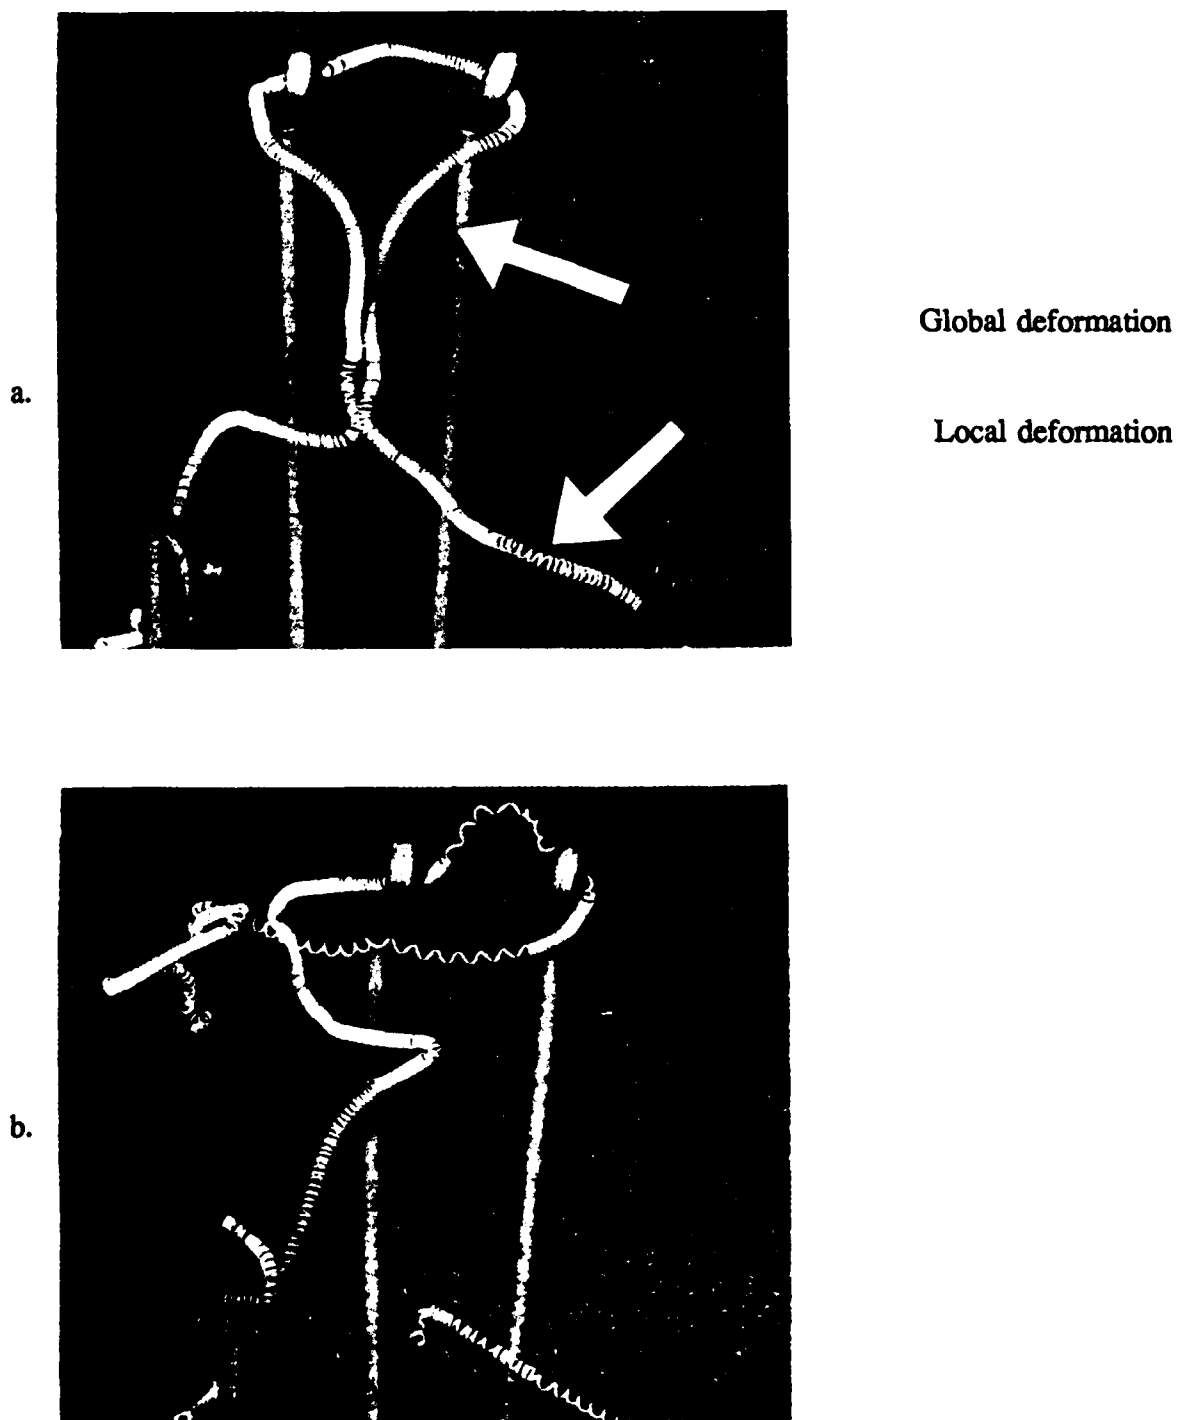
Fig. 2.4 Deformation of filament impacted at 4006 G for 0.9 millisec. Filament ON.  
(a) Global and local deformation (b) Resonance and multiple fractures (Ref. 2.1).

Impacts containing high frequency components produce other distinct deformation characteristics. In high-g, short duration impacts the support posts can resonate and cause severe deformation, tangling, and multiple filament fractures. This type of resonance deformation is shown in Fig. 2.4b. The loading on the filament was a peak acceleration of about 4000 g's occurring over a period of about 0.9 msec [2.1]. Violent resonance of the support posts and filament of the 327 lamp can occur when excited between 1300 and 1550 Hz [2.1]. For very short duration impacts that excite this resonance lower g values of acceleration can cause failure. Hot filaments tend to show extreme amounts of local and global deformation. Cold filaments typically fracture with little or no deformation. A half sinusoidal deceleration corresponding to 1300 Hz would last about 385 microseconds.

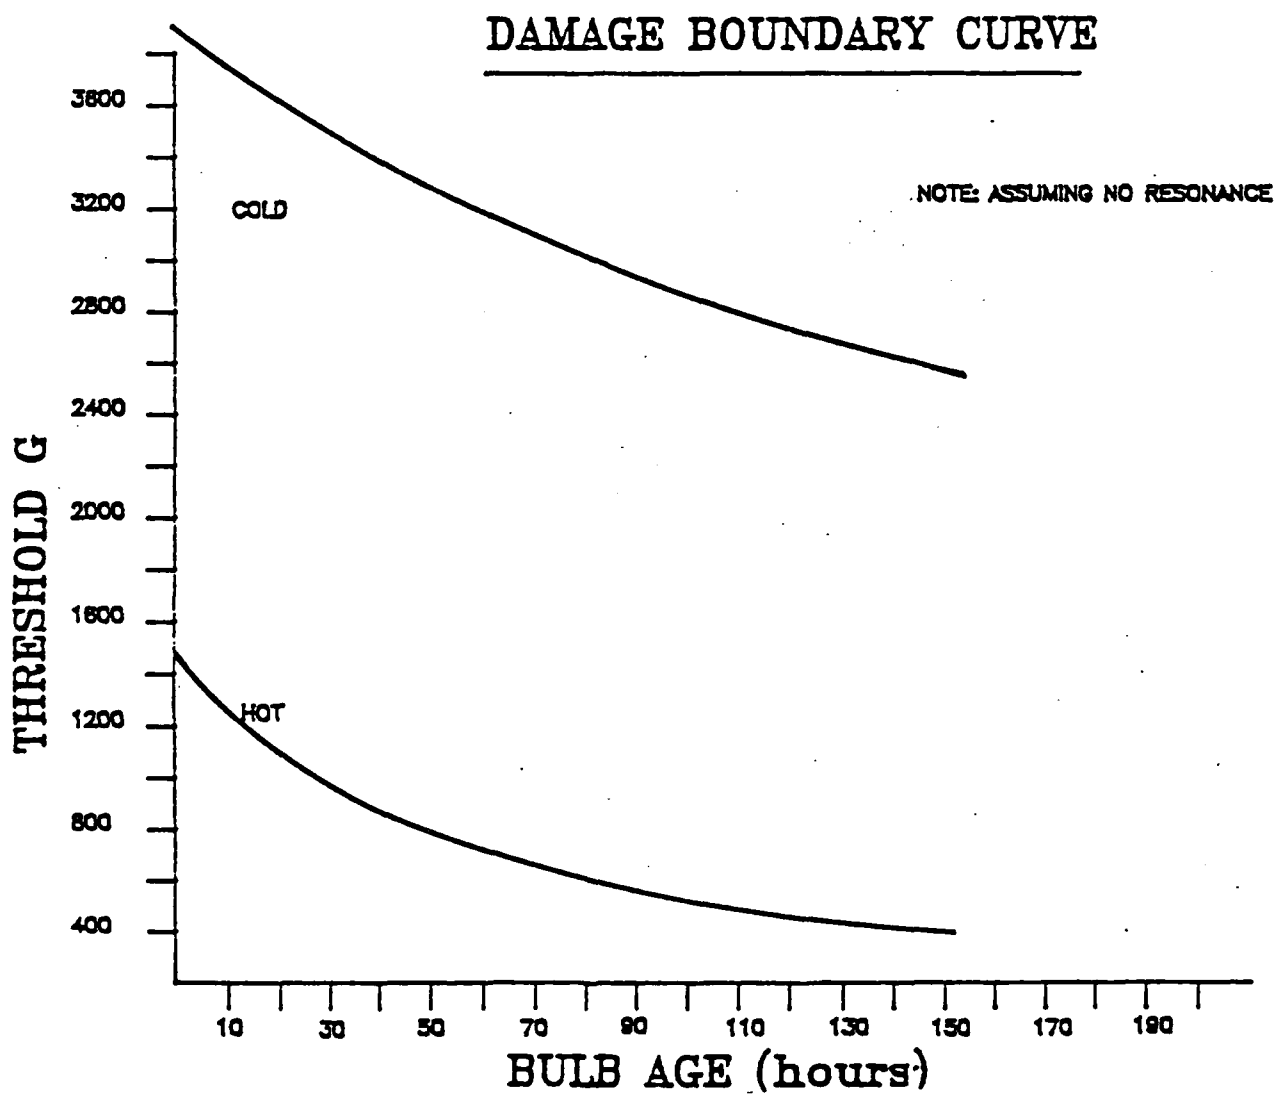
Fig. 2.6 Relationship between g levels for filament damage and lamp age for hot and cold Type 327 lamp [2.1].

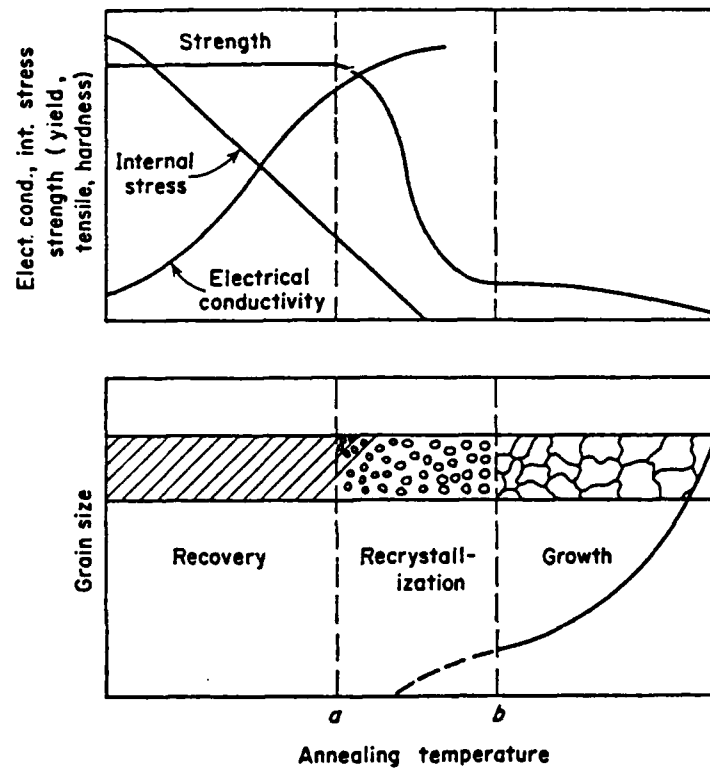
Fig. 3.2 Effect of heating a plastically deformed metal on grain size and properties [3.9].

It is apparent from Fig. 3.2 that, in general, the strength of the material decreases rapidly during the recrystallization procedure. No research has been found on how the strength of copper strands could be analyzed as part of an accident investigation method. It is conceivable that tests such as tensile strength or microhardness could be done on individual strands of copper wire to identify the extent of the time-temperature exposure of the wire. This data might be useful in conjunction with an examination of the microstructure. It is not clear that practical tests could

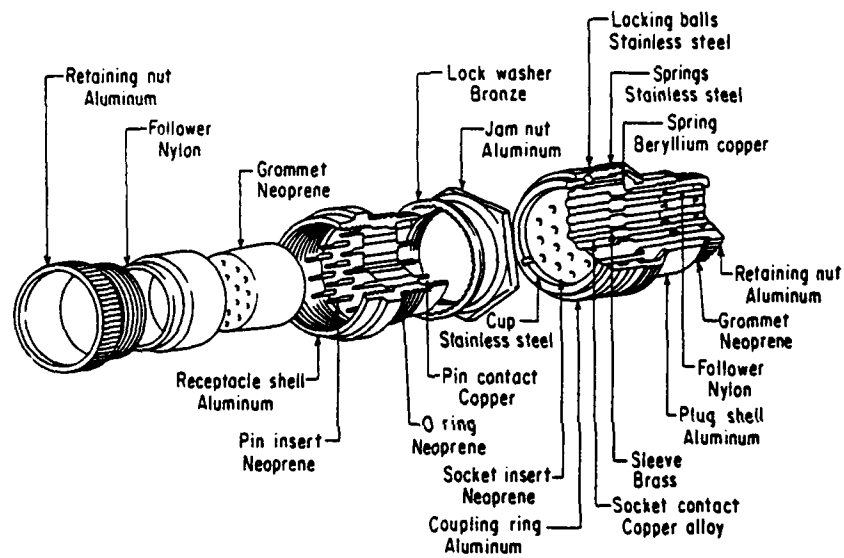
Fig. 4.1 Component Parts of a typical Cylindrical Connector [4.2].

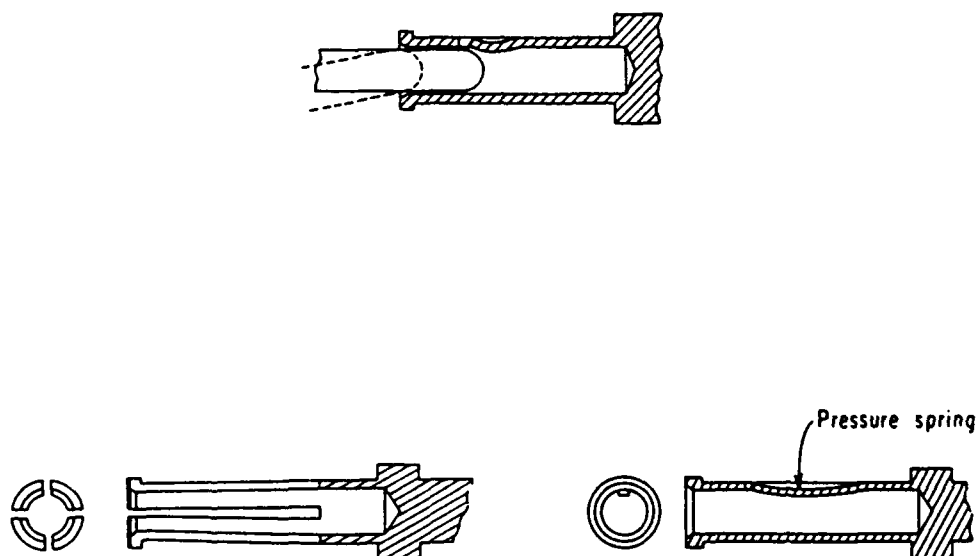
Fig. 4.2 Two Styles of Pin and Socket Contact Construction [4.2].

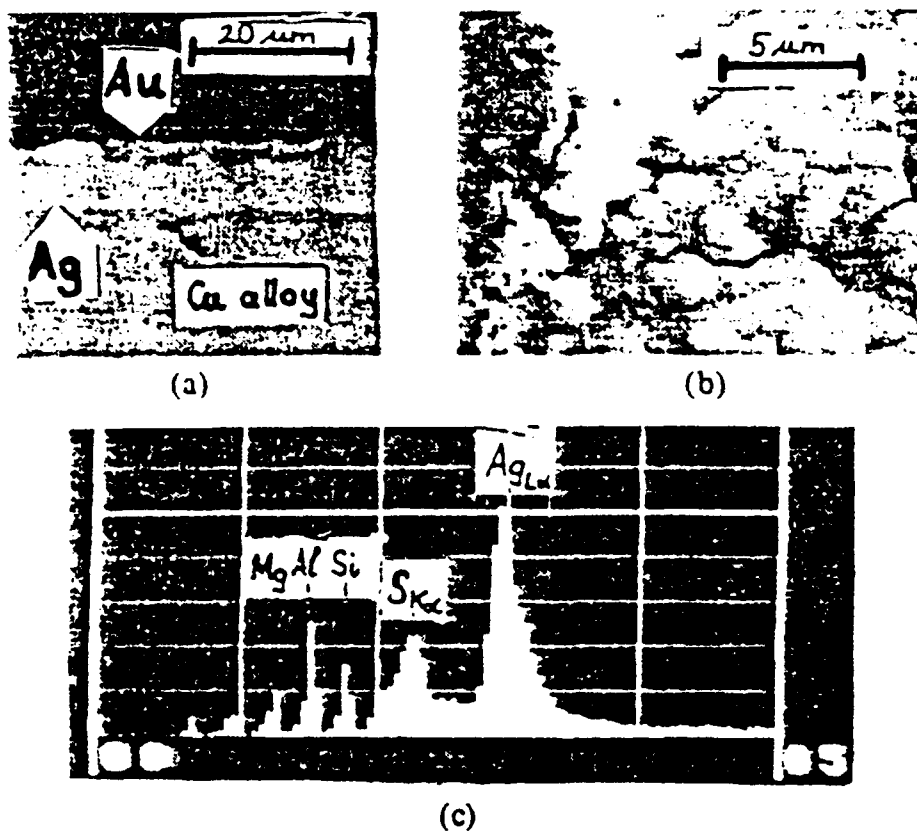
Fig. 4.3 Surface analysis of contaminated contact. (a) Light microscopic cross section shows silver islands growing through the gold electroplate. (b) Secondary electron image represents characteristic view of silver sulfide and its morphology (15 kV). (c) EDAX spectrum of the area shows that it was really silver-sulfide [4.5].

Additional testing of gold plated contacts for corrosion related problems using SEM, EDAX, electron microprobe, Auger electron spectroscopy and laser microprobe examinations is described in [4.6]. In this report EDAX X-ray maps showed chlorine and sodium present in the nickel underplate of gold plated contacts. The cause was identified as improper washing before the nickel plating.

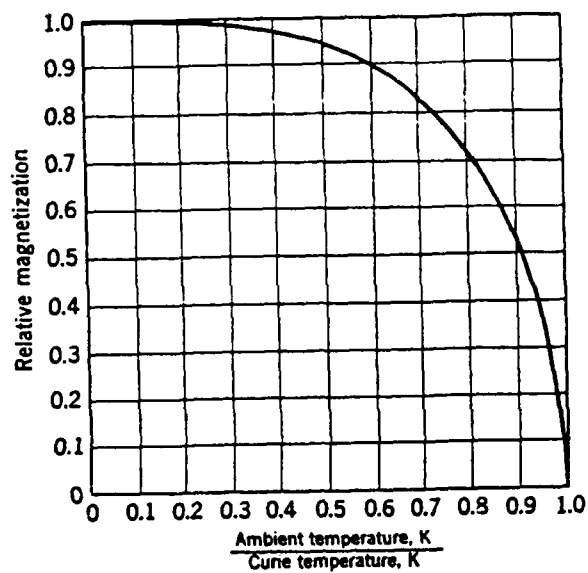
Fig. 6.1 Theoretical curve of magnetization versus temperature [6.1].

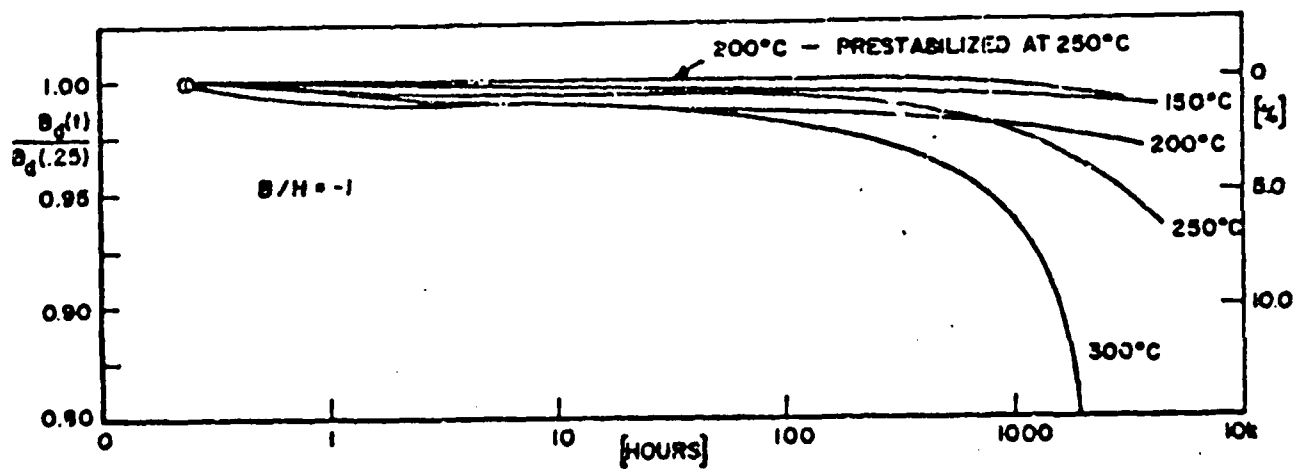
Fig. 6.2 Effect of aging in air at elevated temperatures. Samarium cobalt [6.4].

Temperature excursions above the normal operating temperature, but below the Curie temperature, will result in some irreversible loss of magnetic field strength. In practice, a magnet will stop performing its intended function if the exposure time is too long or temperature is too high. As a result, there is little data to characterize the irreversible loss of magnetization when the loss of magnetic field strength is more than about 20%. Table 6.3 shows the irreversible loss in magnetization for Alnico materials. Notice that the irreversible loss increases with decreasing Curie temperature. Fig. 6.2 shows the effect of aging on SmCo<sub>5</sub> permanent magnets at elevated temperature [6.4]. The Curie temperature is 700-750° F.

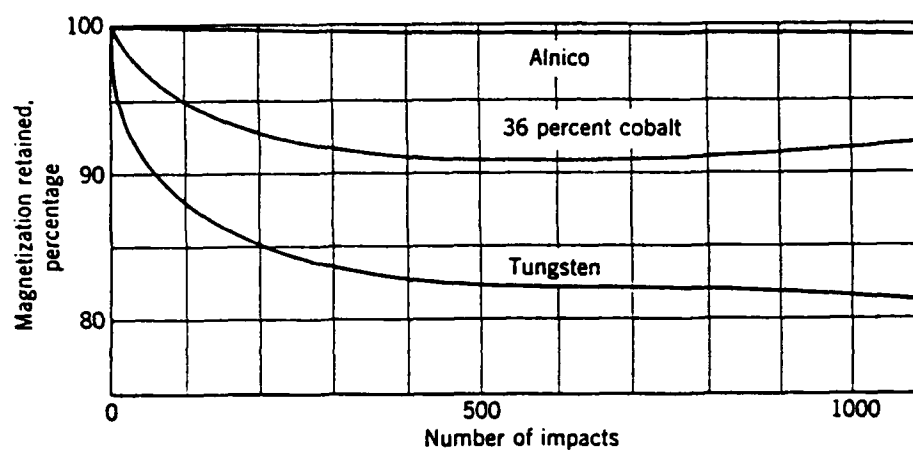
Fig. 6.3 Demagnetization of Permanent Magnets due to Repetitive Impact [6.1].

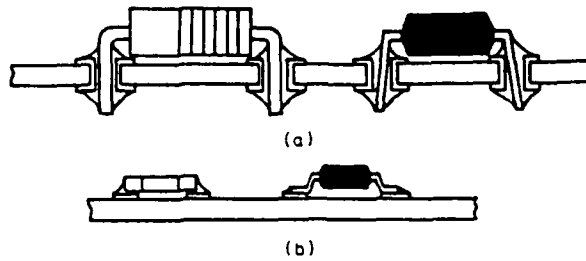
Fig. 7.1 Component mounting on through-hole (a) and surface-mount (b) printed wiring boards [7.1].

In through-hole boards the component leads fasten the components to the board. However, in surface-mount construction the solder joints alone provide the mechanical fastening of the components as well as the electrical connection. Without the compliant lead connection, mismatch between the coefficient of thermal expansion (CTE) of the components and the board material causes considerable stress on the solder joints [7.2]. Metal core boards have been developed to remove heat and help control the CTE of the board material. Fig. 7.4 shows a copper-invar-copper board construction designed to reduce solder joint stress in surface mount applications. Another construction, shown in Fig. 7.5, uses a compliant surface layer to reduce solder joint stress [7.3].

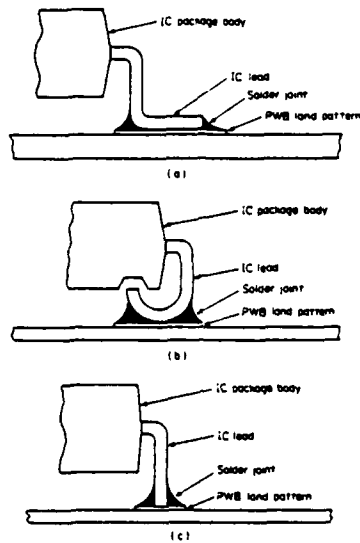
Fig. 7.2 Some examples of surface-mount component leads [7.1].

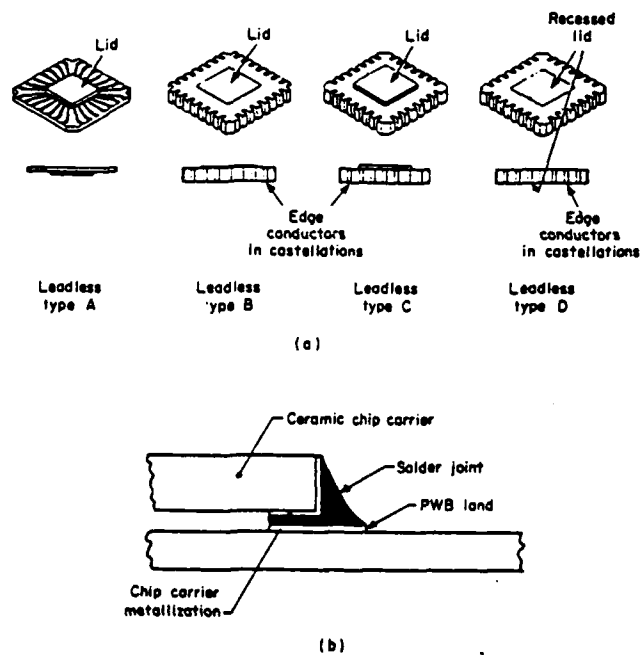
Fig. 7.3 Ceramic leadless devices for surface-mount [7.1].

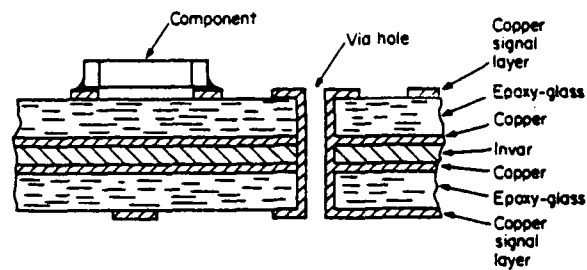
Fig. 7.4 Copper-Invar-Copper printed wiring board structure [7.1].

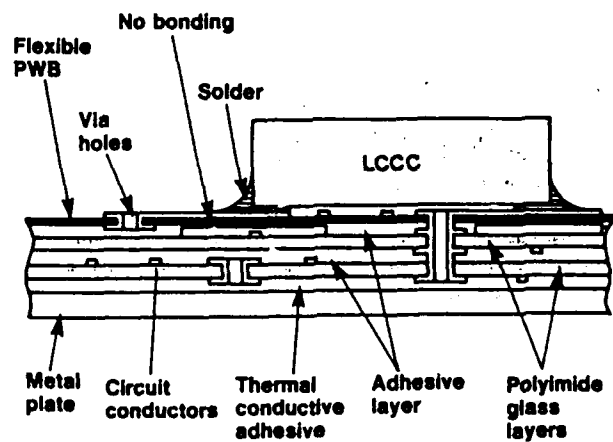
Fig. 7.5 Compliant layer printed wiring board [7.3].

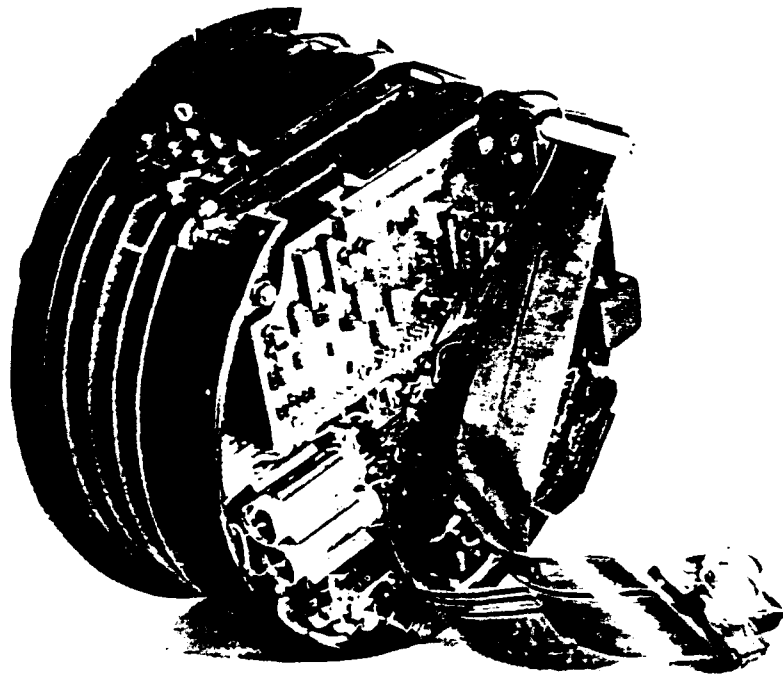
Fig. 7.6 Application of flexible printed wiring [7.4].

Flexible printed circuit boards are used both for flexible circuit connections and for the construction of circuitry whose geometry would not be possible using conventional methods. In both cases copper circuit traces are laminated between two sheets of a plastic film. Polyimide films like DuPont's Kapton are used almost exclusively in these applications. For circuit traces a flexible sheet is constructed with terminations at the ends allowing the majority of the sheet to flex as needed by the application. In flexible circuit boards, components are mounted on the flexible laminate. The finished "board" is fitted into the housing, using the flexibility of the construction to allow the circuit board to be inserted into an unusual shape. Flexible circuits are used in aerospace applications to reduce the size and weight of circuitry in addition to providing flexibility. An illustration of a "flexible circuit board is shown in Fig. 7.6 [7.4].

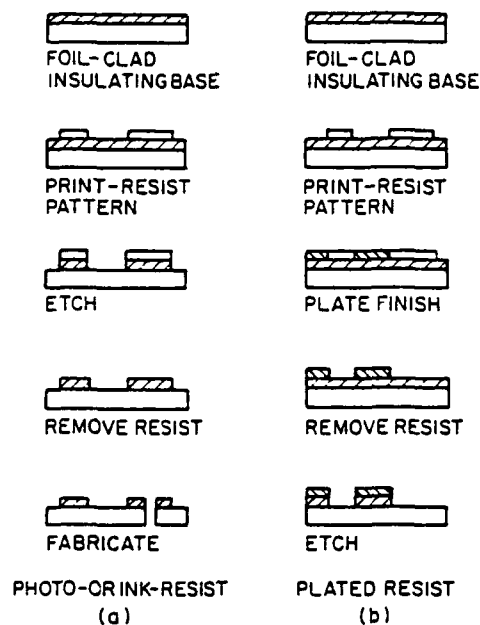
Fig. 7.7 Steps in two processes for single sided printed wiring boards [7.1].

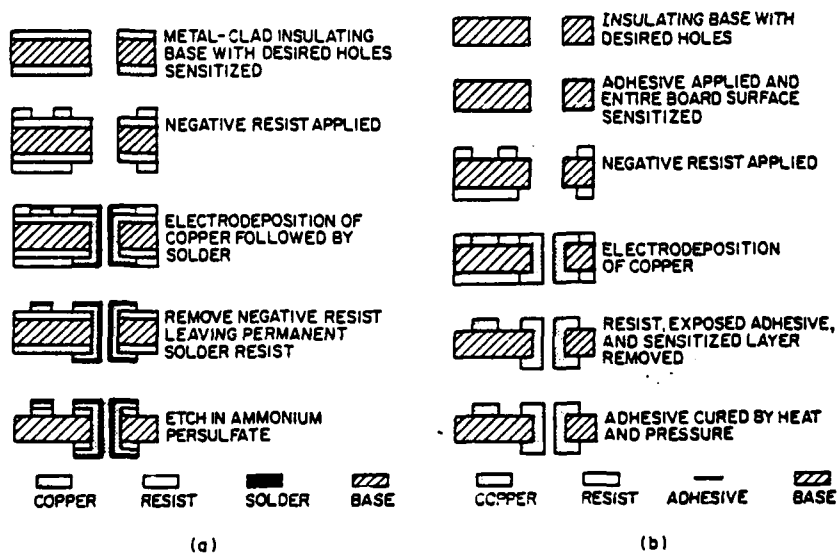
Fig. 7.8 Steps in subtractive (a) and additive (b) process for boards with plated-through-holes [7.1].

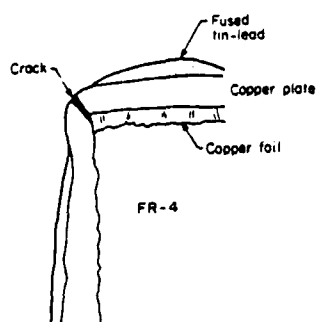
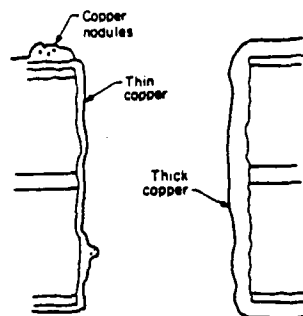
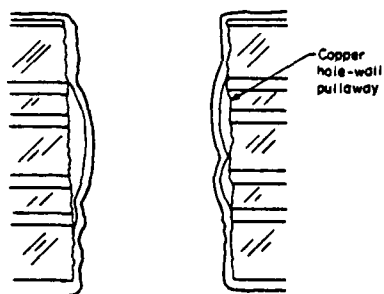
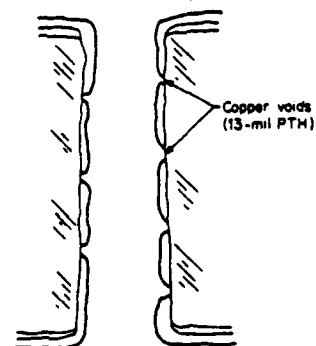
Fig. 7.9 Printed wiring board problems that show up after copper plating: (a) corner cracking; (b) copper nodules; (c) hole-wall pullaway; (d) copper voids [7.1].

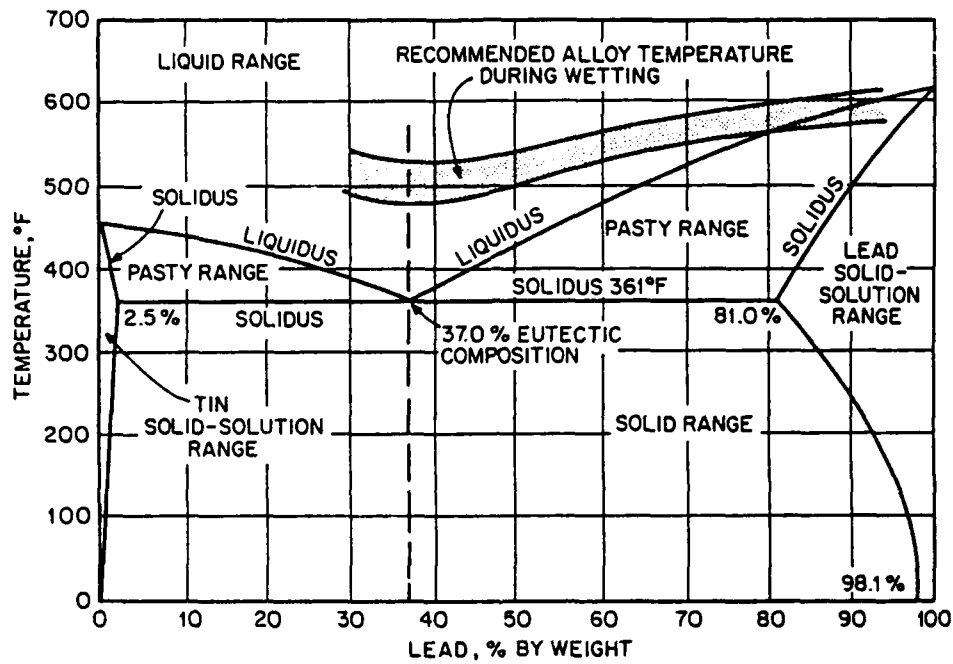
Fig. 7.10 Binary phase diagram for tin-lead solder alloys [7.1].

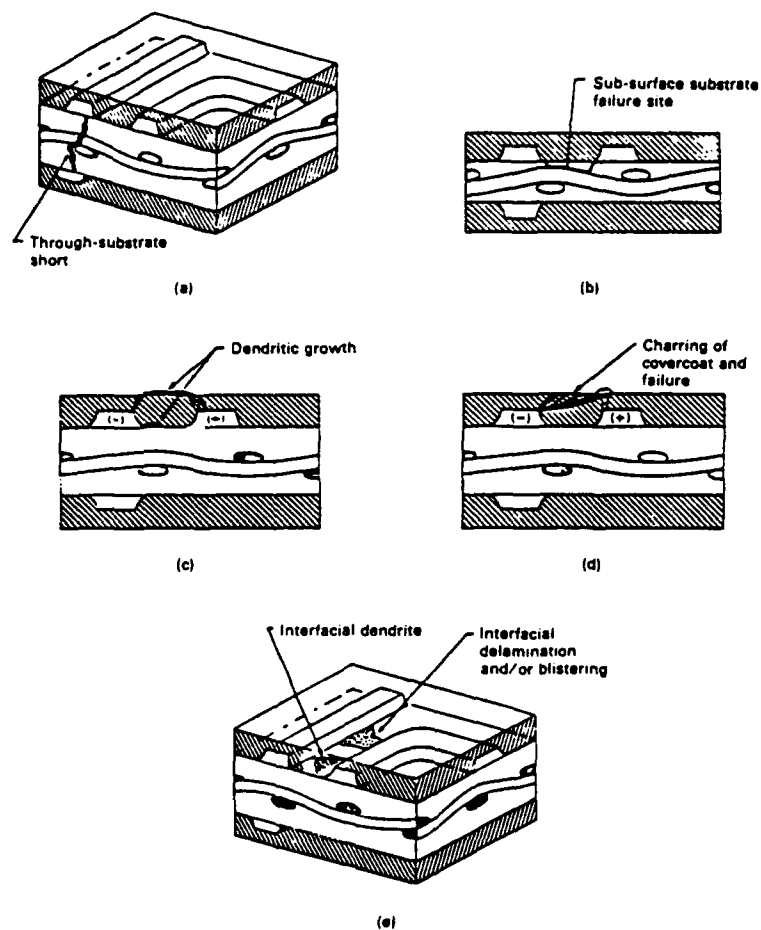
Fig. 7.12 Insulation failures on printed wiring boards [7.1].
