INTERIM REPORT

REPORT NO. EVT 10-89

ENGINEERING TEST OF 105mm  
HOWITZER CARTRIDGES IN  
HORIZONTAL CONFIGURATION

PALLETIZED UNIT LOAD FOR THE  
105mm HOWITZER CARTRIDGE IN  
THE HORIZONTAL CONFIGURATION

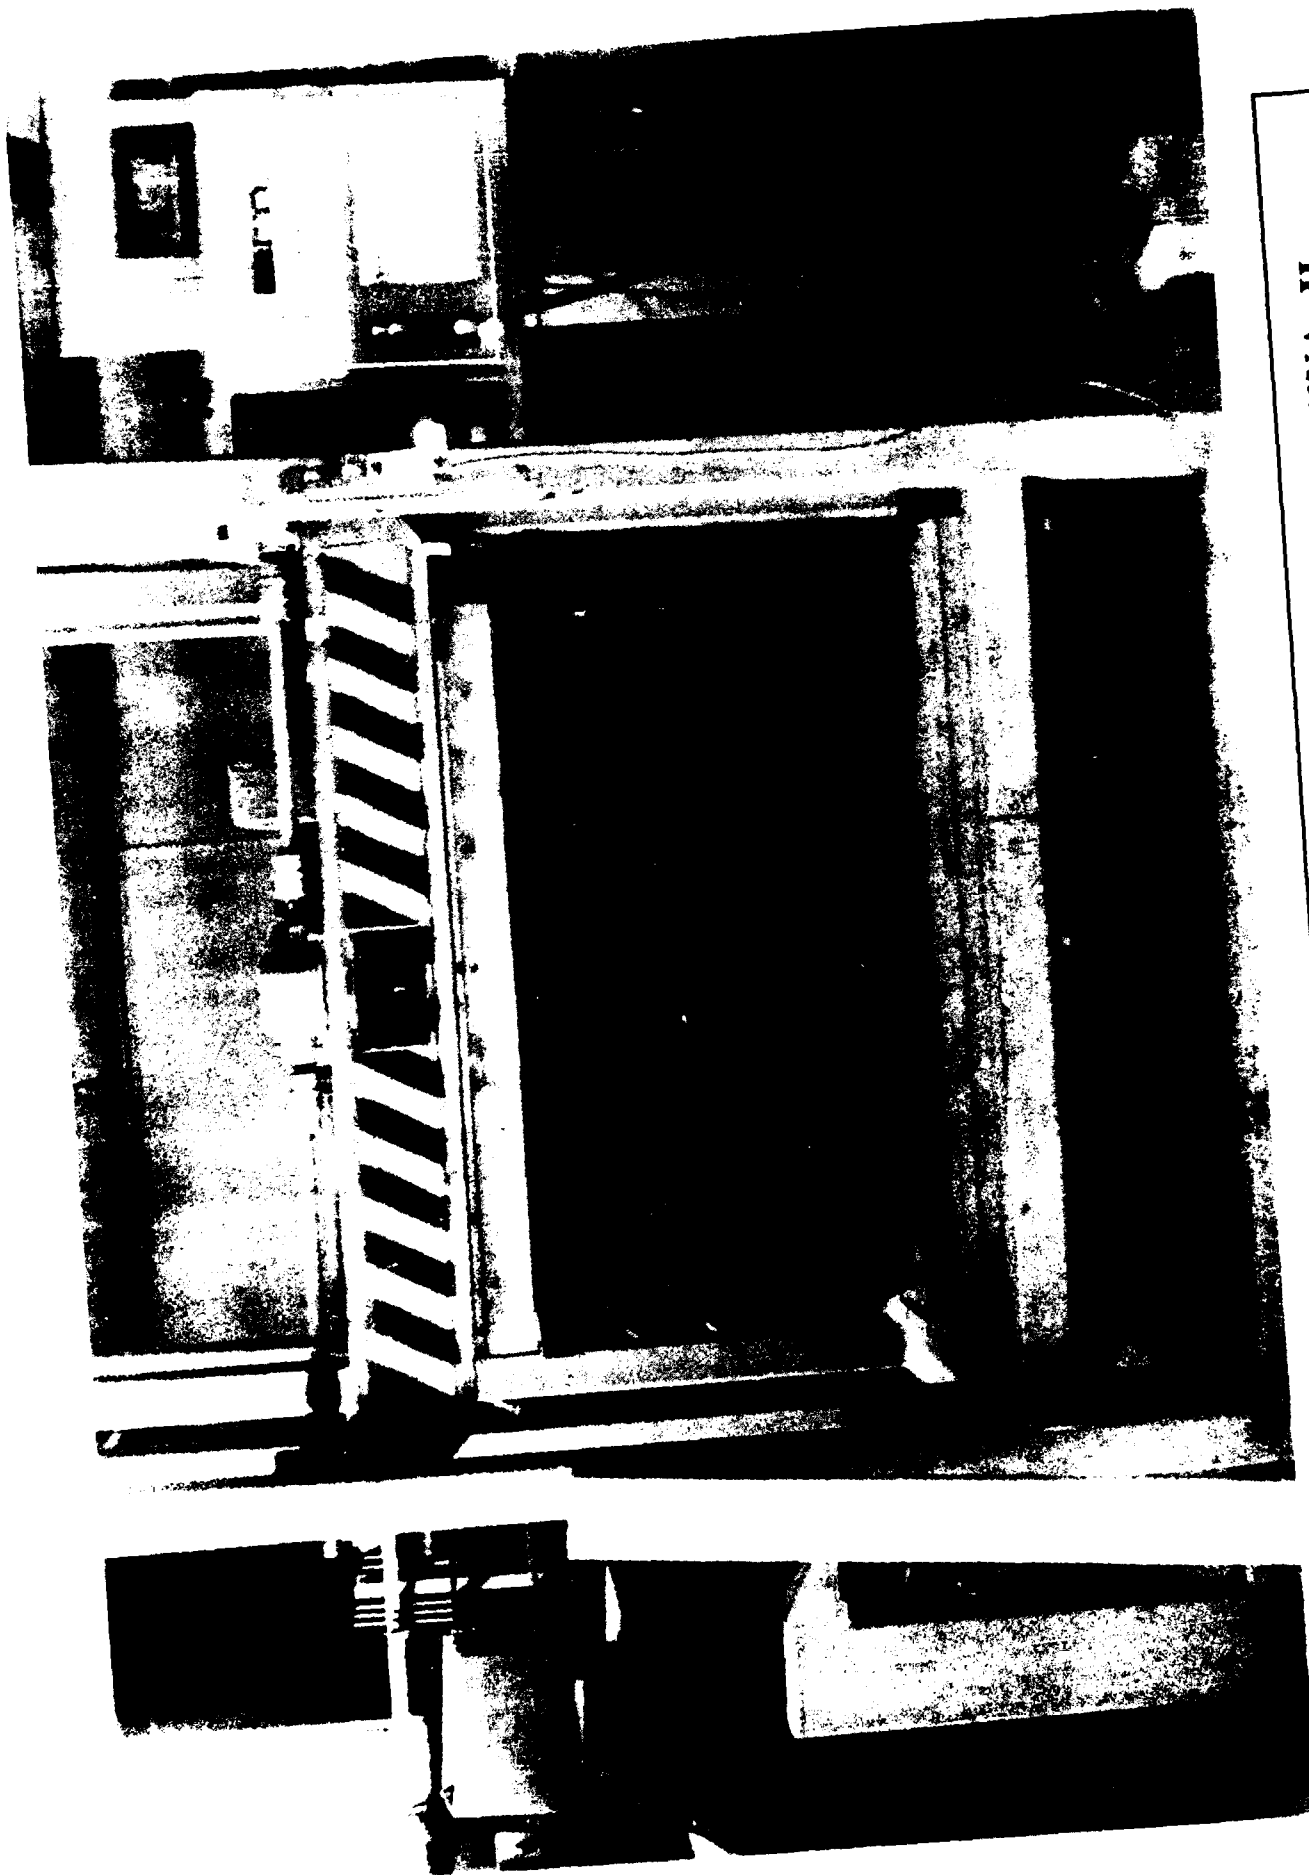
Photo 1: This photo shows the pallet in the Compression Tester.

1. STACKING TEST. During the first phase of testing, the pallet assembly was noted to be fabricated incorrectly. However, since the production pallet and assemblies would vary significantly, the pallet was tested as is to obtain engineering data. In order to conduct the stacking test, wood shims had to be placed on top of the pallet to evenly distribute the load from the compression tester because the pallet base was improperly assembled. The test pallet was loaded to 14,800 pounds compression for a period of one hour. At the end of the one hour period, the compression load had not decreased and the load had not compressed. No damage was noted to the pallet or contents.

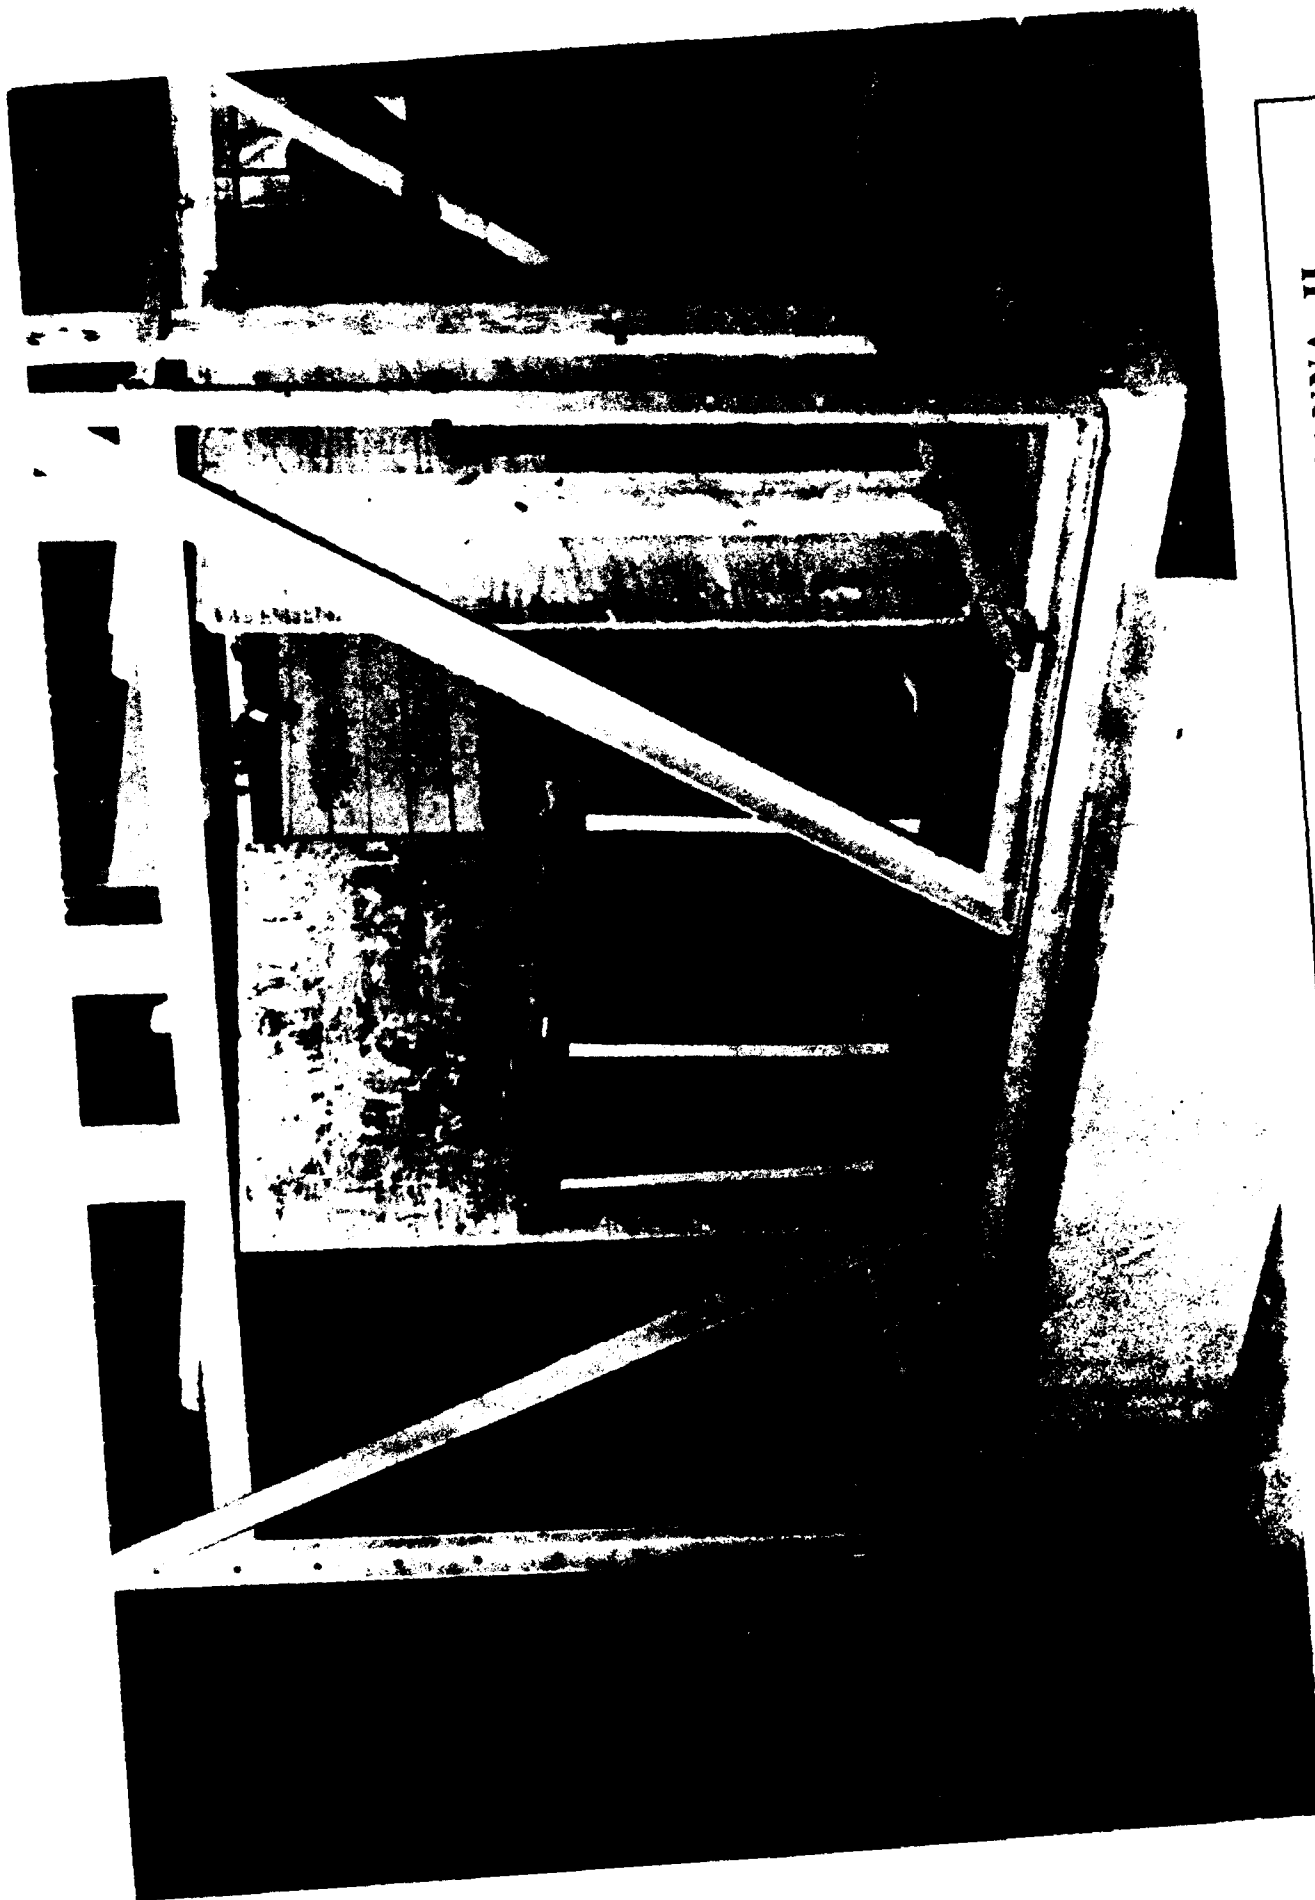
Photo 3: This photo show the pallet in the Transportation Simulator in the Lateral Orientation

2. REPETITIVE SHOCK TEST. The test pallet successfully passed both the longitudinal and lateral transportation simulation. Duration of the test was 90 minutes for each orientation of the pallet. In order to achieve the required 1/16-inch clearance between the pallet and the Transportation Simulator bed, the equipment was operated at 225 rpm for the longitudinal orientation and 215 rpm for the lateral orientation. Damage to the pallet consisted of several cracks in the posts of the pallet near the welds that attach the skid to the post.

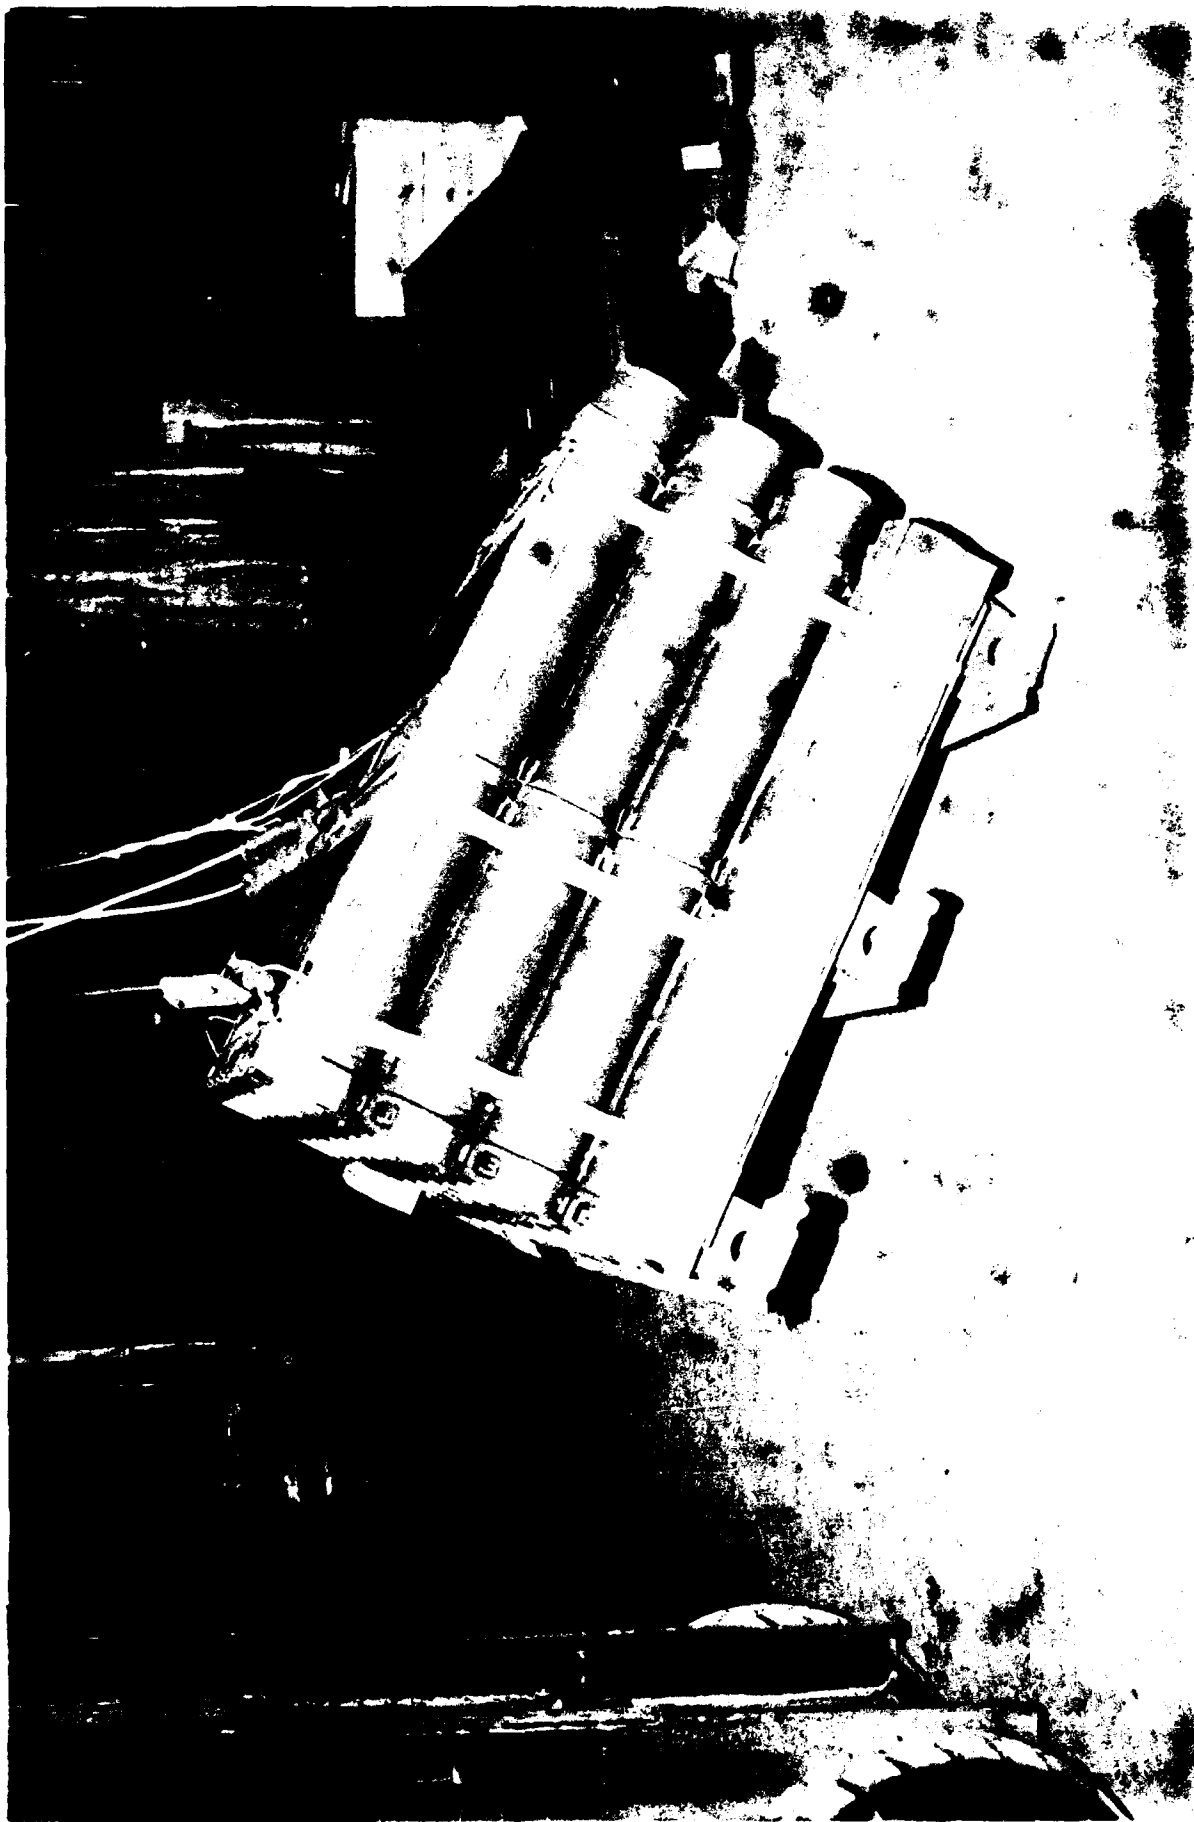
Photo 4: This photo shows the pallet raised 24 inches prior to the first edgewise drop

3. EDGEWISE DROP TEST. Each side of the pallet base was placed on a beam displacing it 6 inches above the floor. The opposite side was raised to a height of 24 inches above the floor and then dropped. This process was repeated in a clockwise

direction until all four sides of the pallet had been tested. During drops 2 and 4, the pallet base was bent allowing the pallet to rock. Also, additional cracks in the posts were discovered following the drop tests.

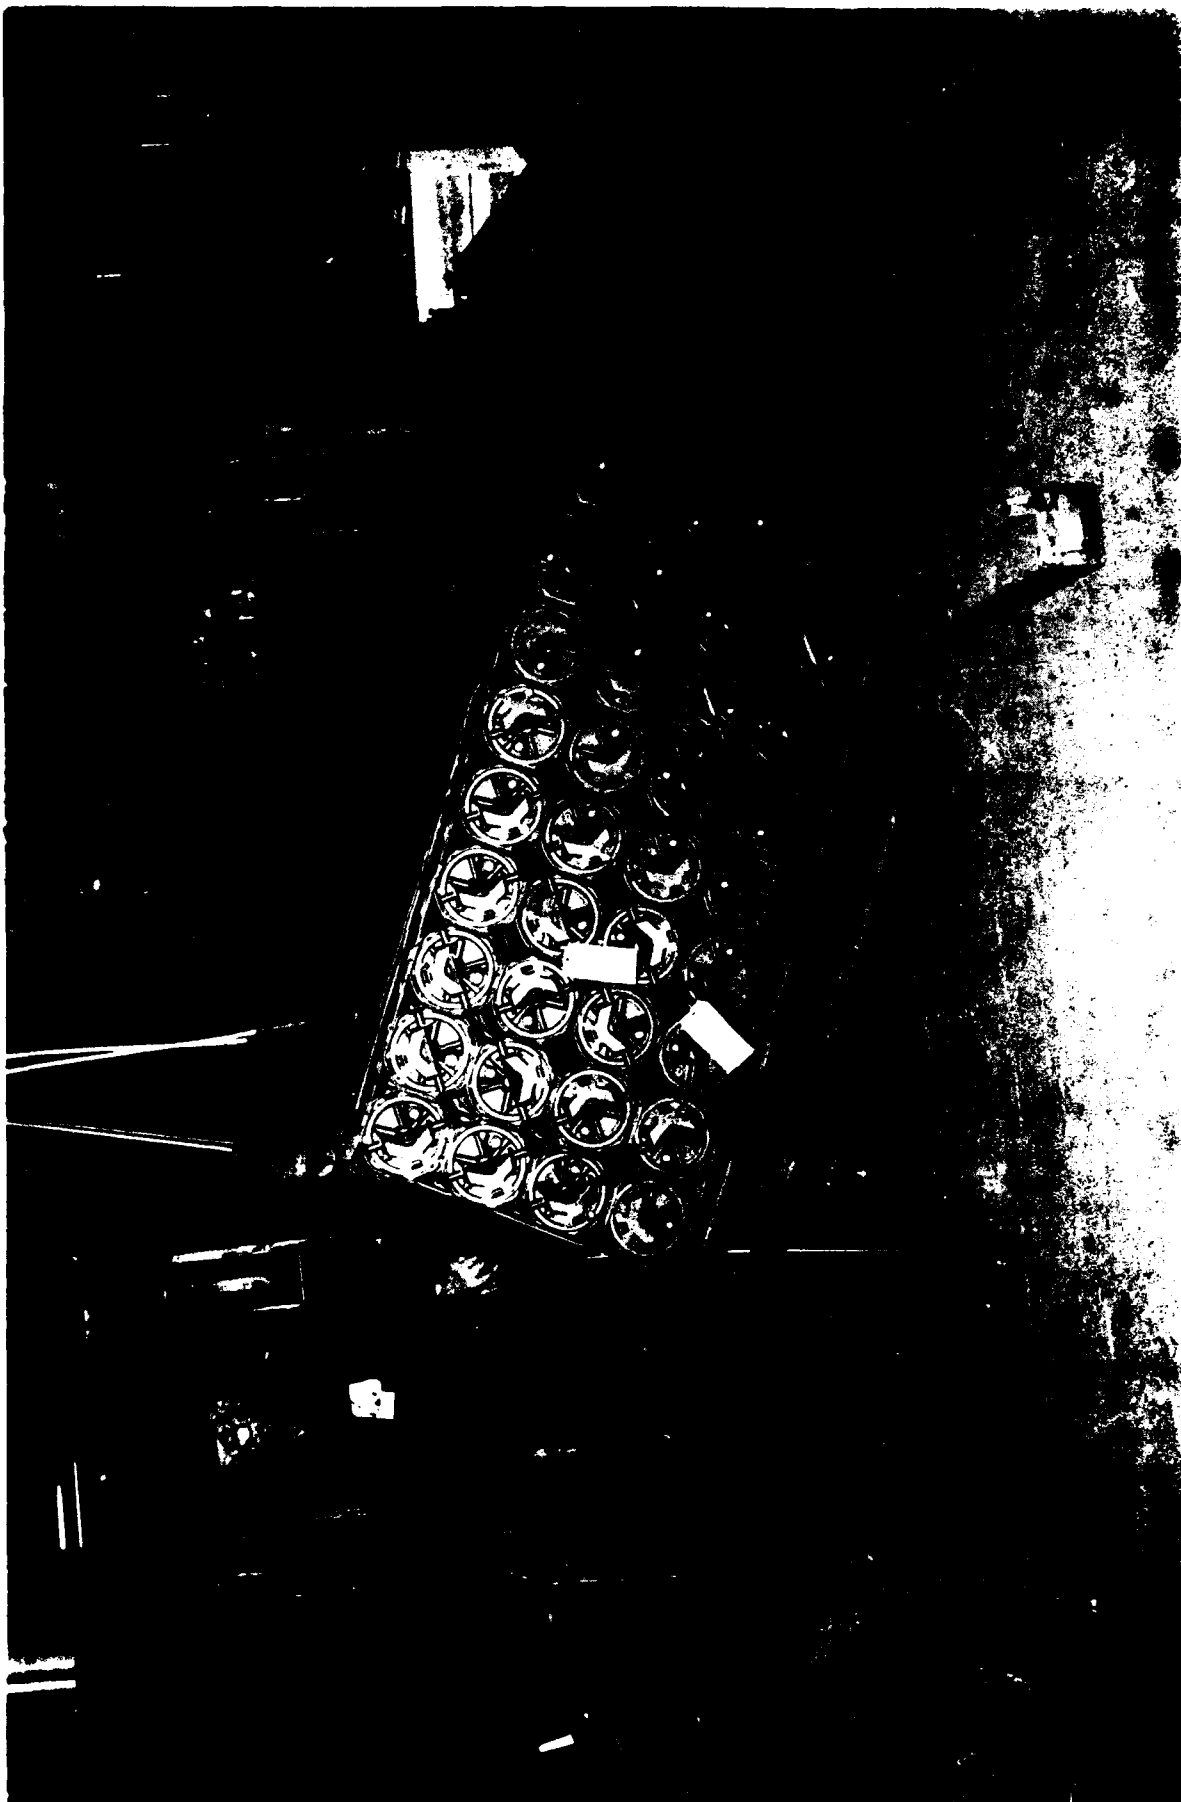
Photo 7: This photo show the pallet raised 24 inches prior to the fourth edgewise drop.

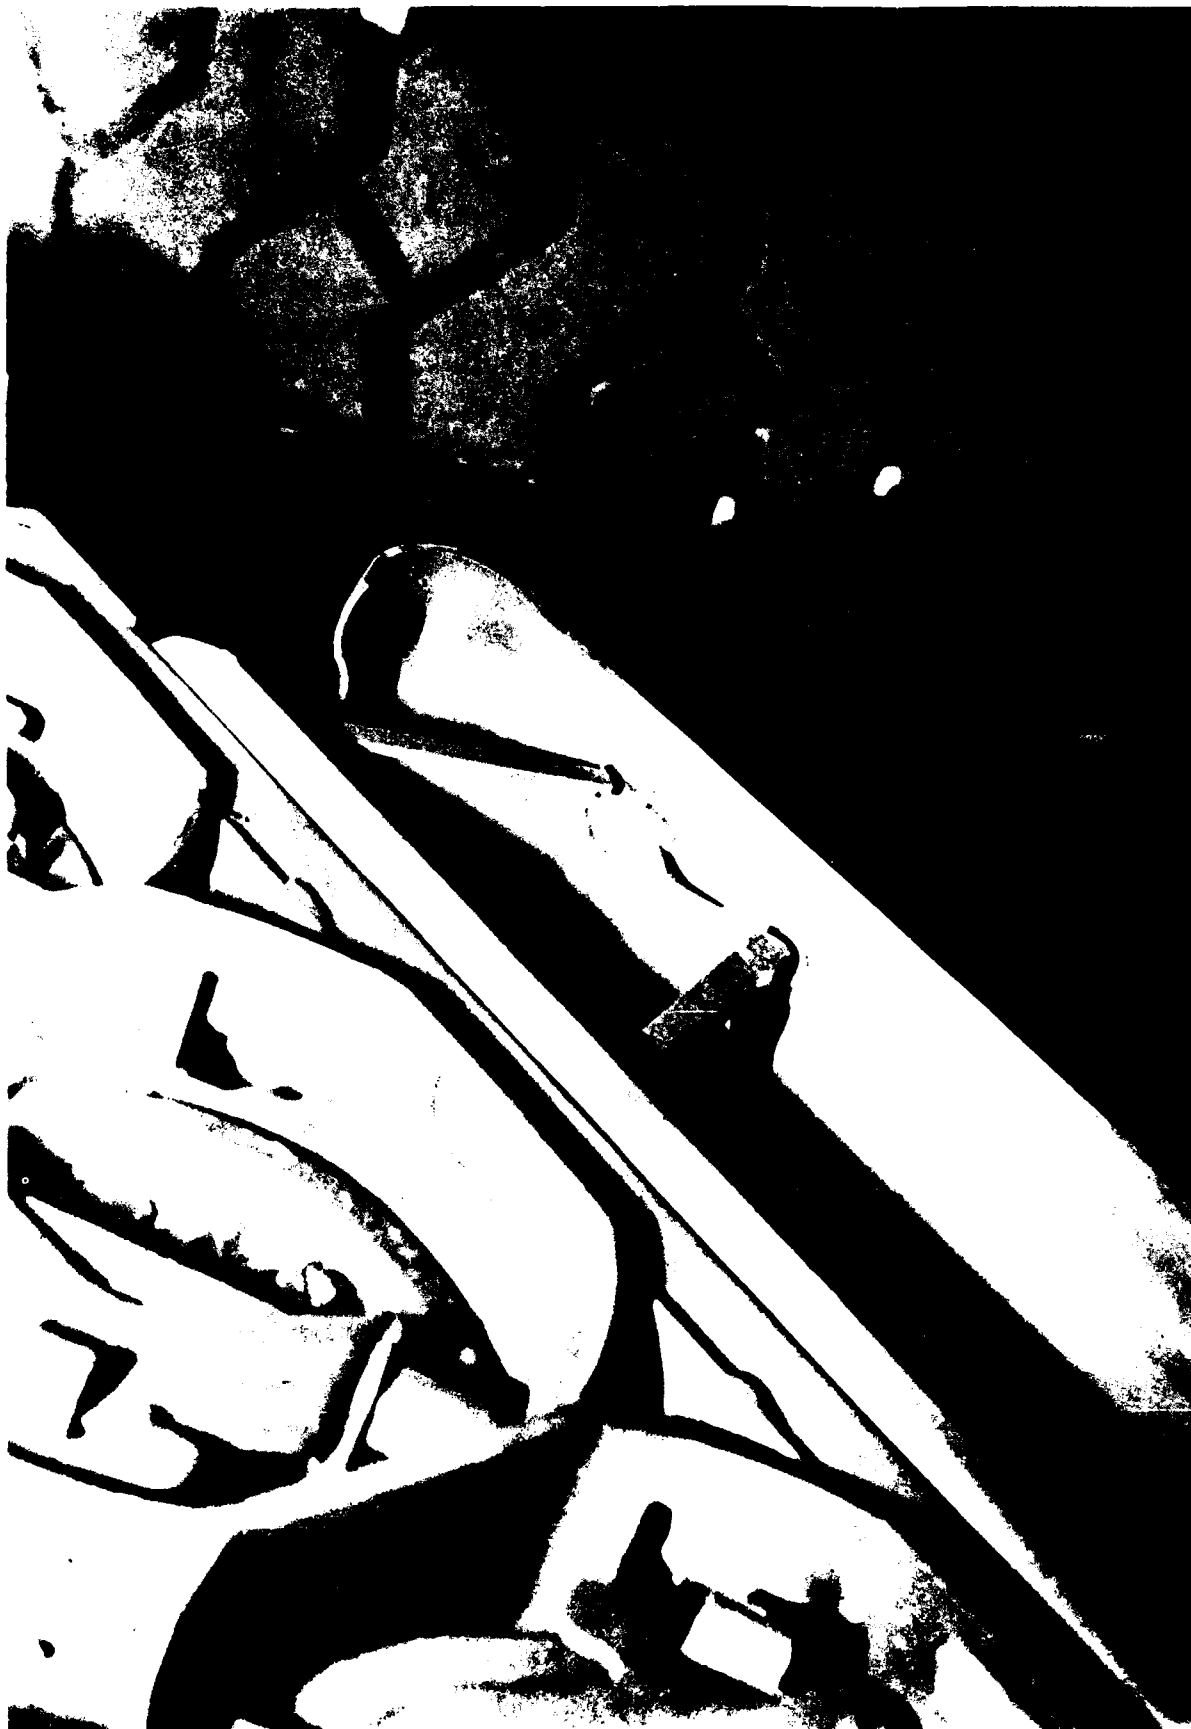
Photo 17: This photo shows additional cracks that formed on the posts during the test.

1. CONCLUSIONS. The test pallet marginally passed all phases of the MIL-STD-1660 criteria for ammunition unit loads. The only damage sustained by the test pallet during the series of tests was small cracks in the posts and bending of the pallet base and top lift frame. The unit load as tested is unacceptable, however, for the following reasons.

2. RECOMMENDATIONS. Since there were major problems with the pallet at the time it was tested, it is recommended that the above problems be corrected and additional testing be conducted utilizing a smaller standard pallet to provide a more efficient (taller) unit load. The change to the smaller standard pallet is due to a change in the maximum weight of the pallet from 4000 pounds to 2500 pounds. Also, in addition to the problems mentioned above, a design change should be made to the posts on the pallet to eliminate the cracking that occurred during testing. The

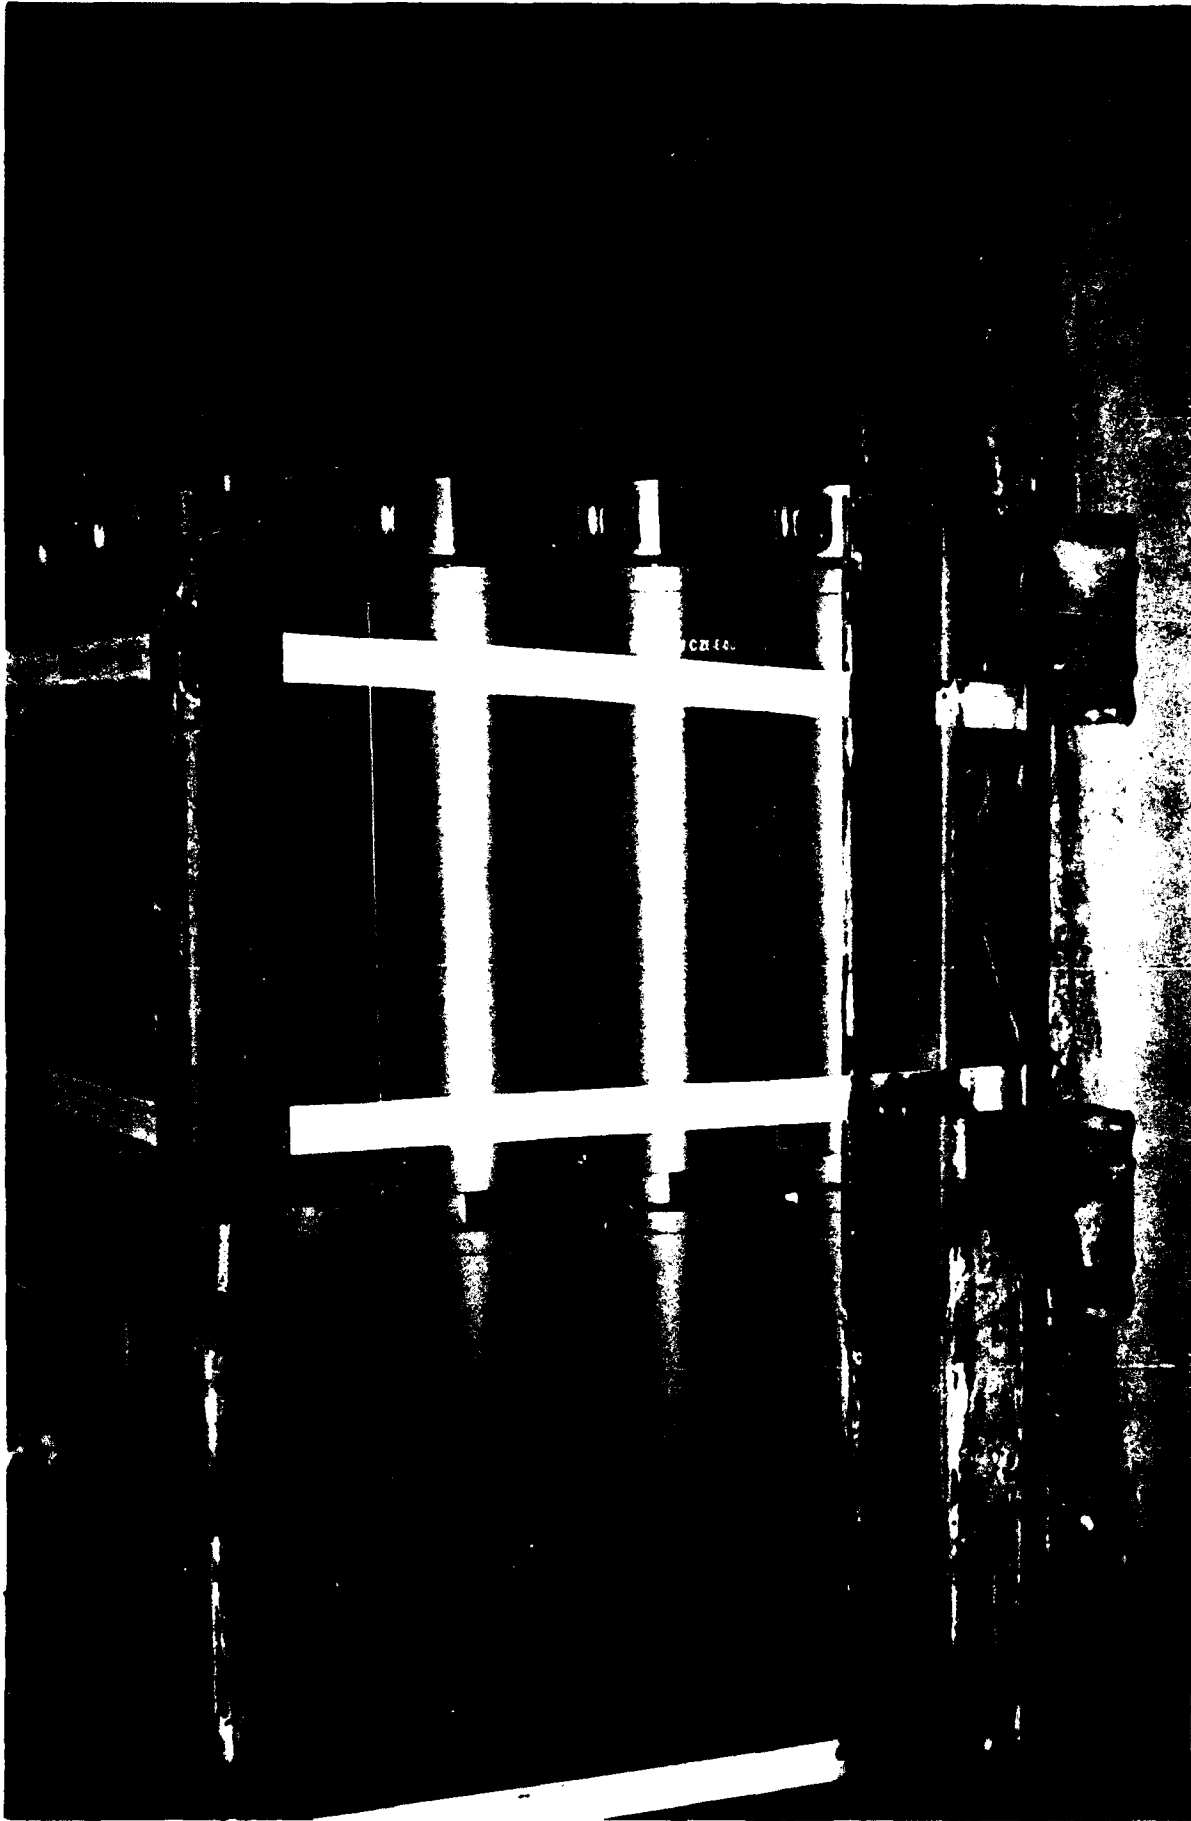
Photo 18: This photo shows the banding strap that is at an angle with the other straps.

- a. The pallet top lift was not parallel with the pallet base due to improper manufacture of the pallet base. This defect would make stacking of the pallet unsafe and impractical.
- b. The restraining strap at the bell end of the pallet was not parallel with the other two straps.
- c. The top lift frame does not extend far enough towards the non-bell (base) end of the pallet to support the skid of the upper pallet when stacked.
