DOT/FAA/CT-91/17

## Bird Ingestion into Large Turbofan Engines

May 1992

Interim Report

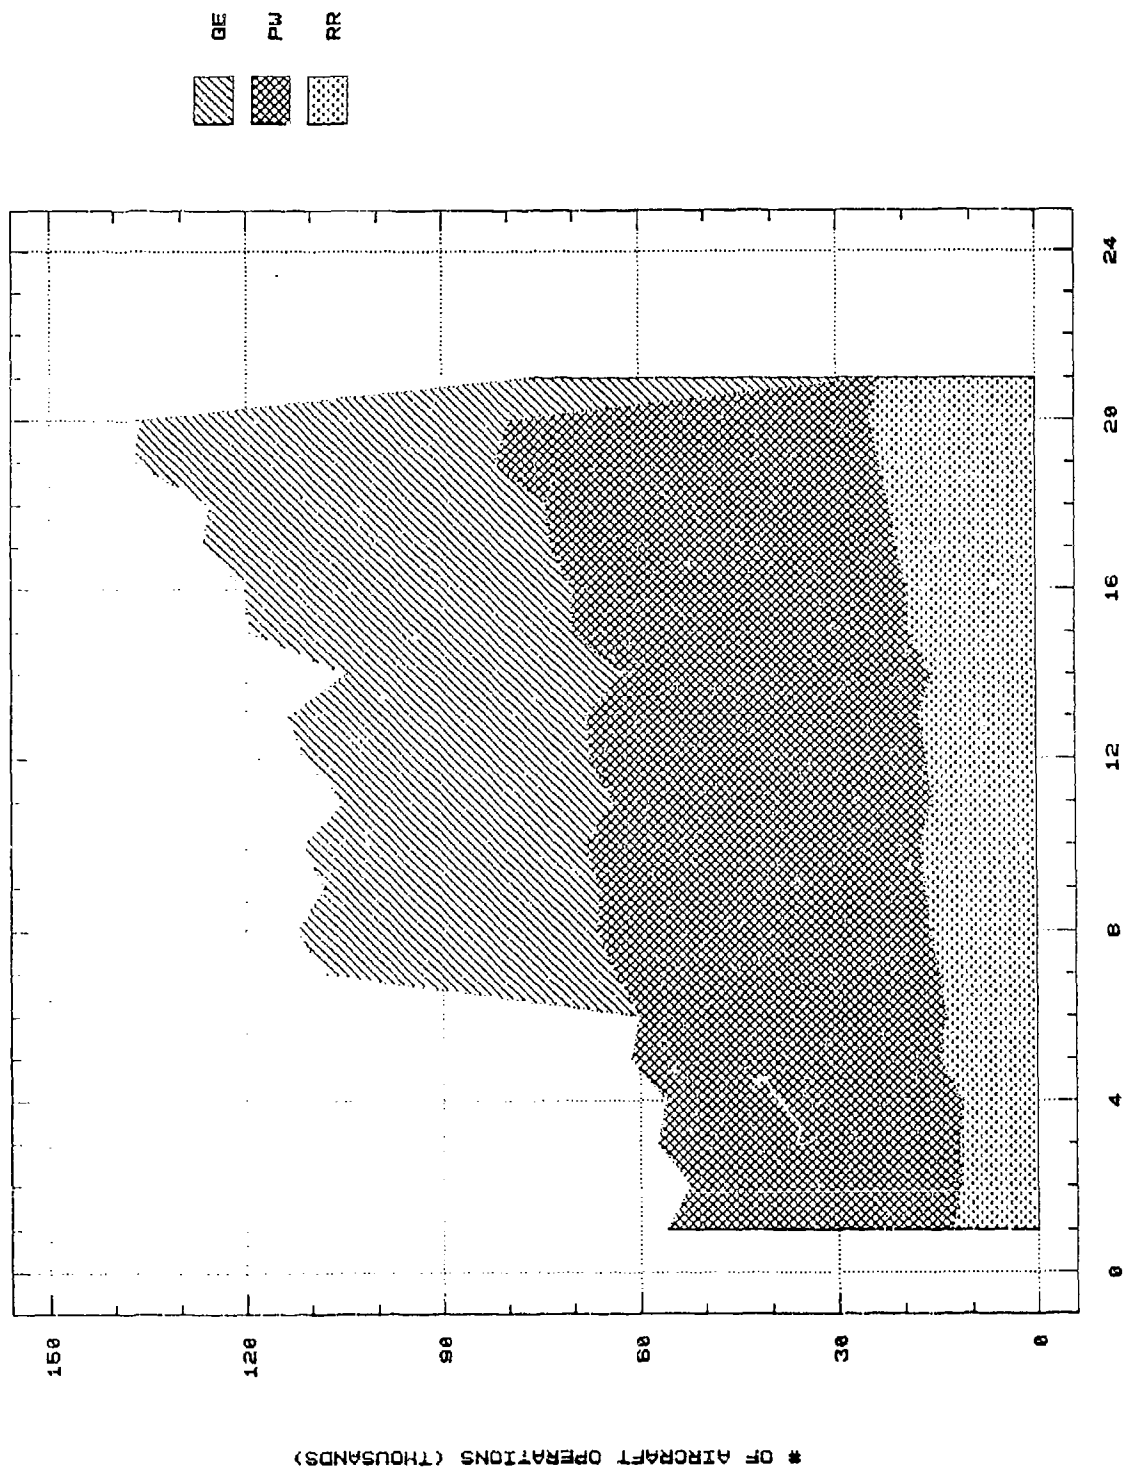
FIGURE 2.1. MONTHLY AIRCRAFT OPERATIONS BY ENGINE MANUFACTURER

As noted in the Introduction, the IAE and CFMI operational data were collected by PW and GE, respectively, and correspond to their reporting periods.

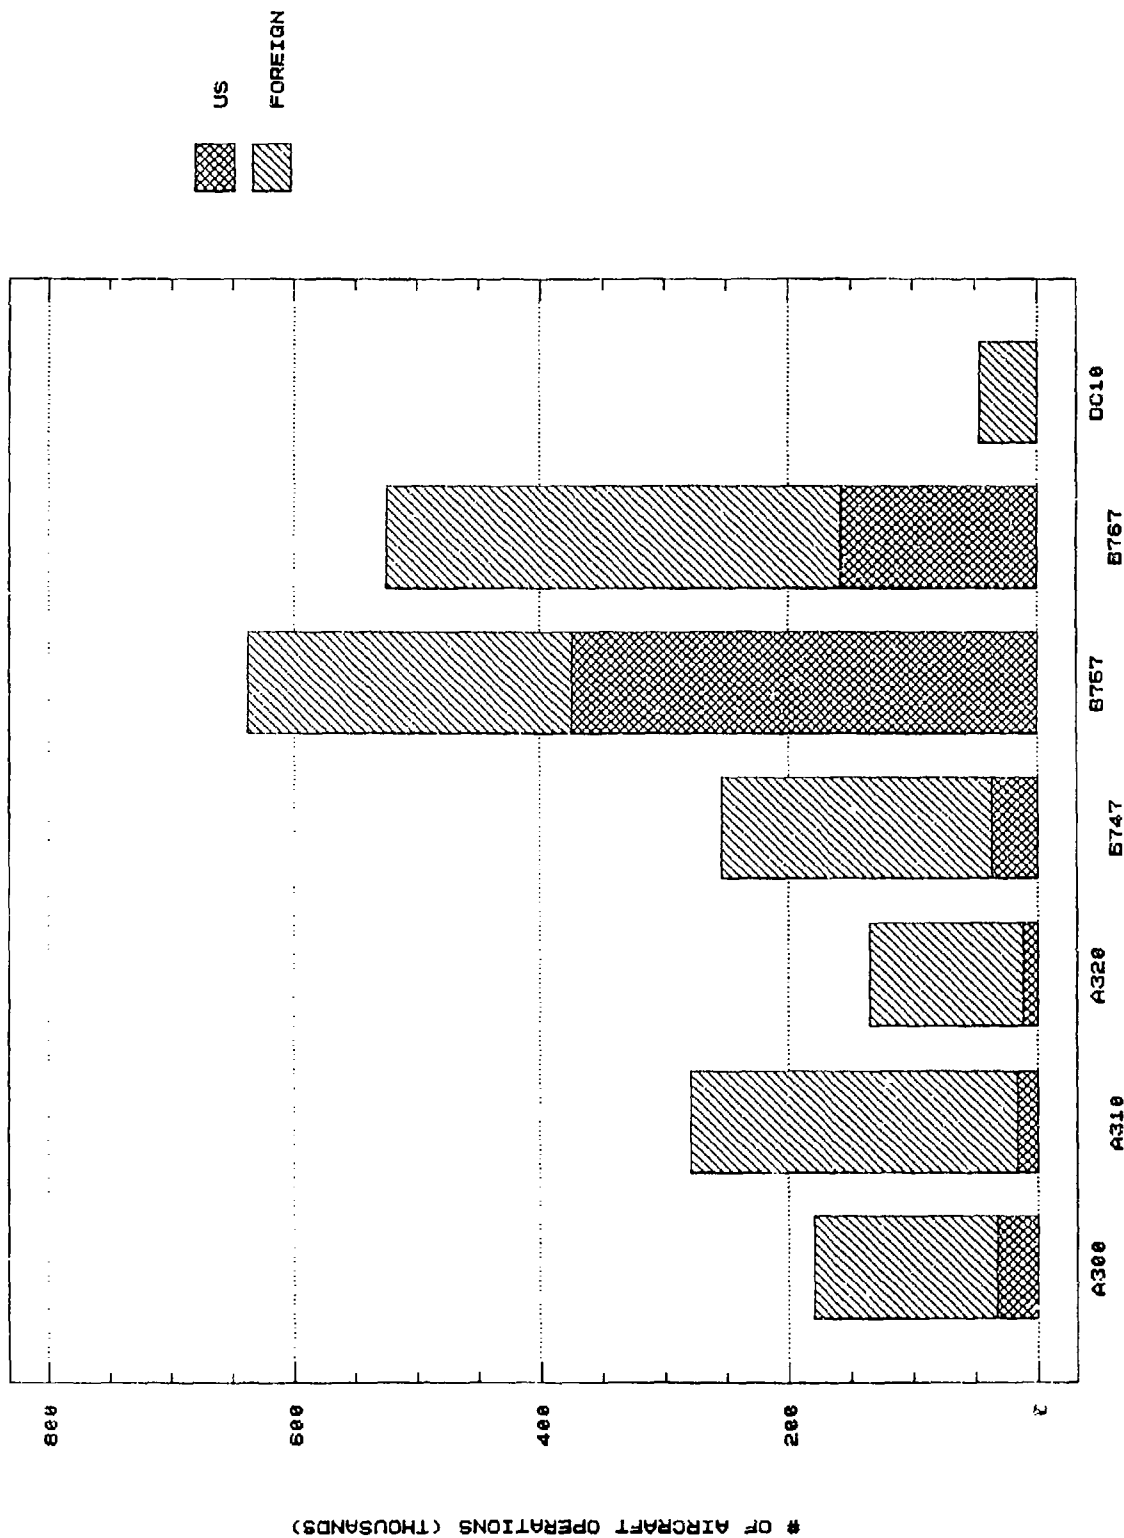
Figure 2.2 indicates the total number of worldwide aircraft operations for each aircraft type, broken down by United States and foreign categories. As in the previous figure, these numbers correspond to the reporting periods of each engine manufacturer. The B757 and B767 flew the largest number of both domestic and worldwide operations. The five remaining aircraft types operated in a predominantly foreign environment. Overall, about 70 percent of the total fleet's operations were foreign. The precise numbers used to generate figure 2.2 can be found in table 3.1. Although worldwide operational data are believed to be fairly accurate, the breakdowns according to United States and foreign stemmed, in some cases, from educated guesses by the engine manufacturers and should be viewed as approximations.

FIGURE 2.2. AIRCRAFT OPERATIONS BY AIRCRAFT TYPE, US/FOREIGN

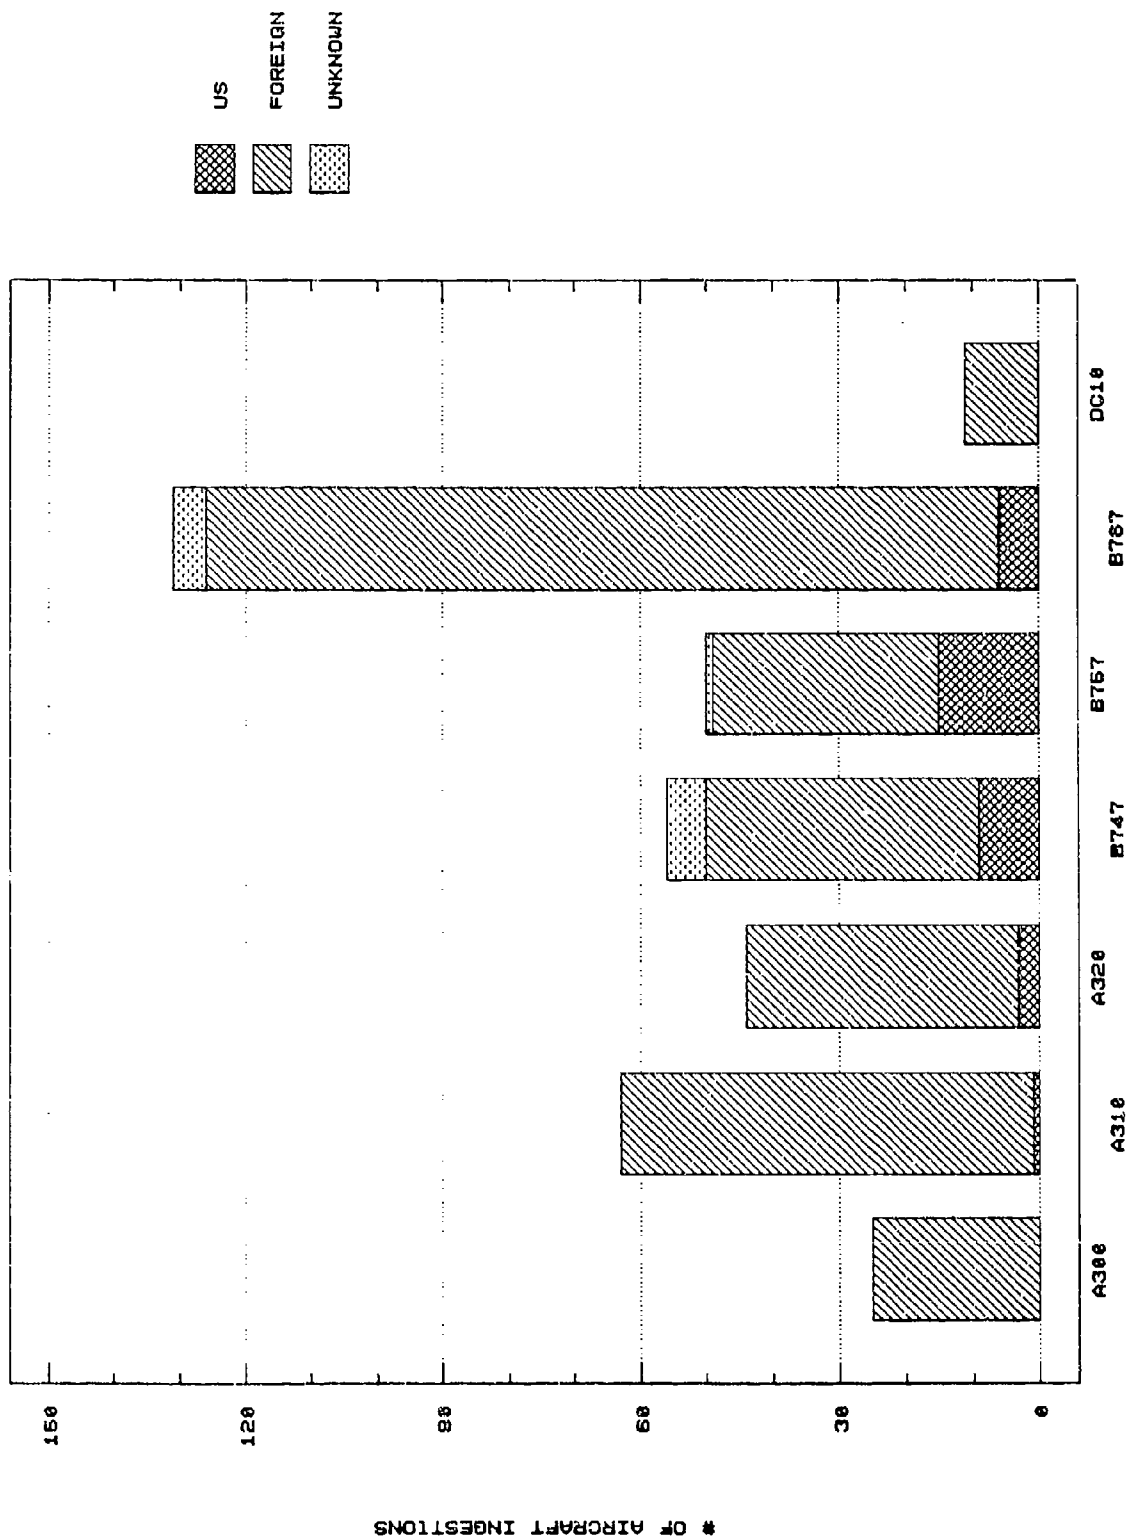
FIGURE 3.1. AIRCRAFT INGESTIONS BY AIRCRAFT TYPE, US/FOREIGN

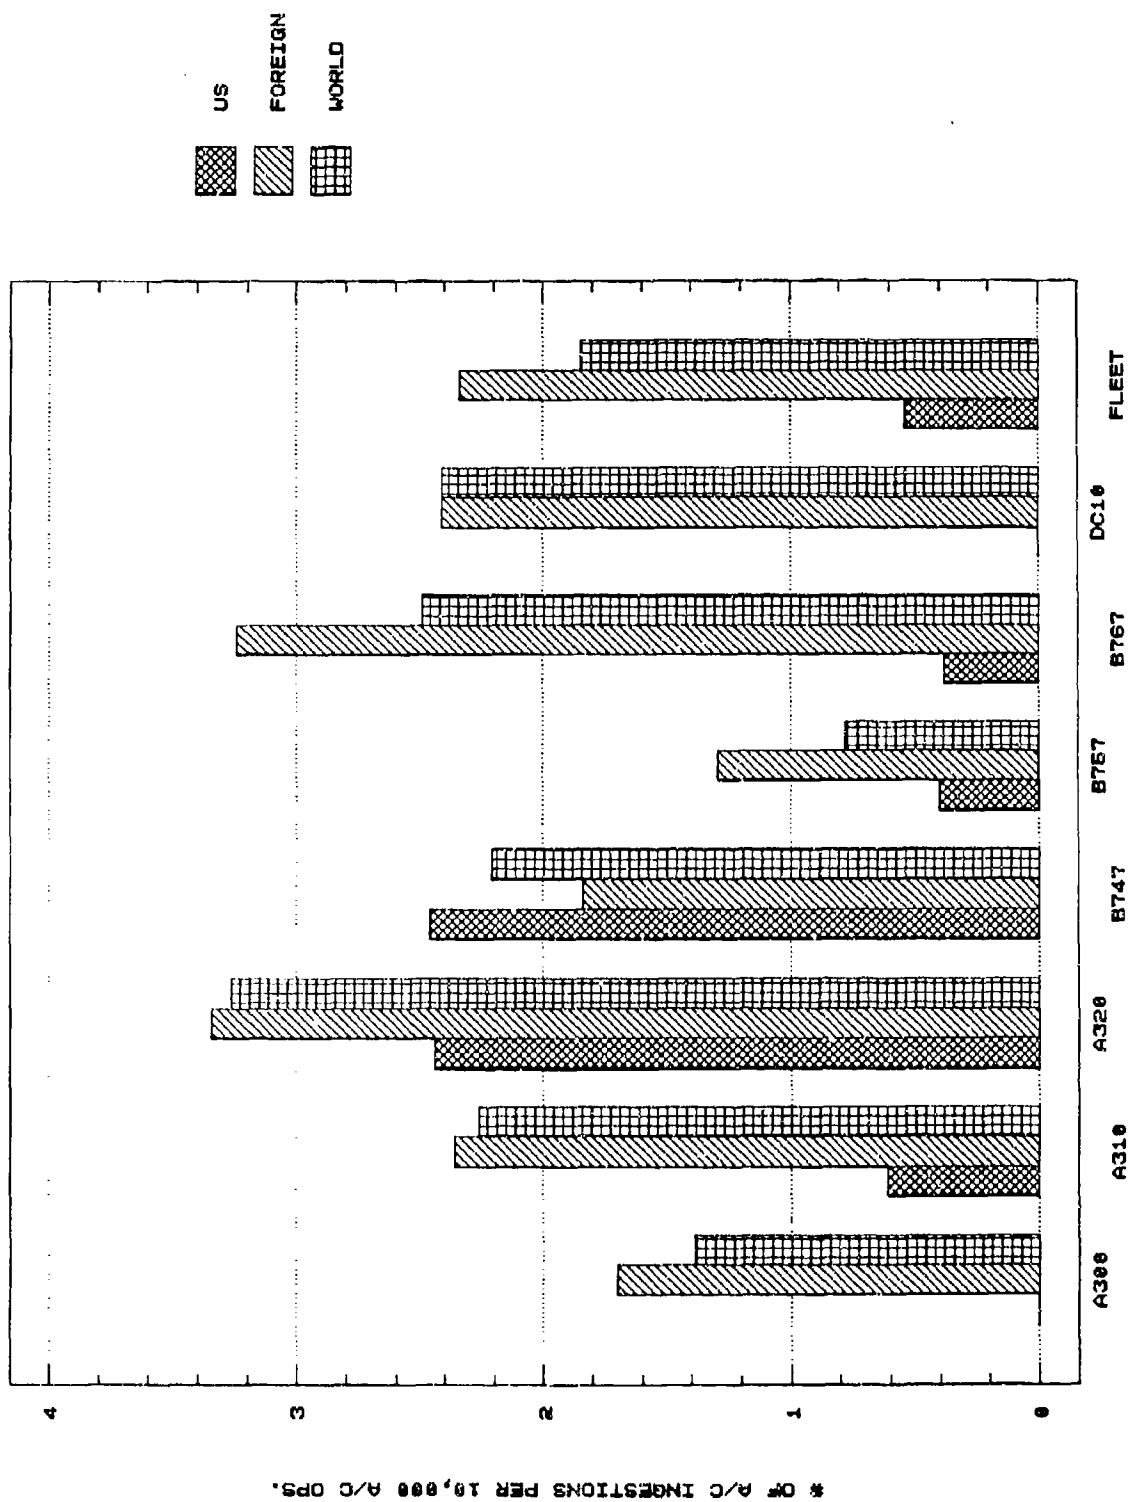
FIGURE 3.2. INGESTION RATES BY AIRCRAFT TYPE, US/FOREIGN/WORLDWIDE

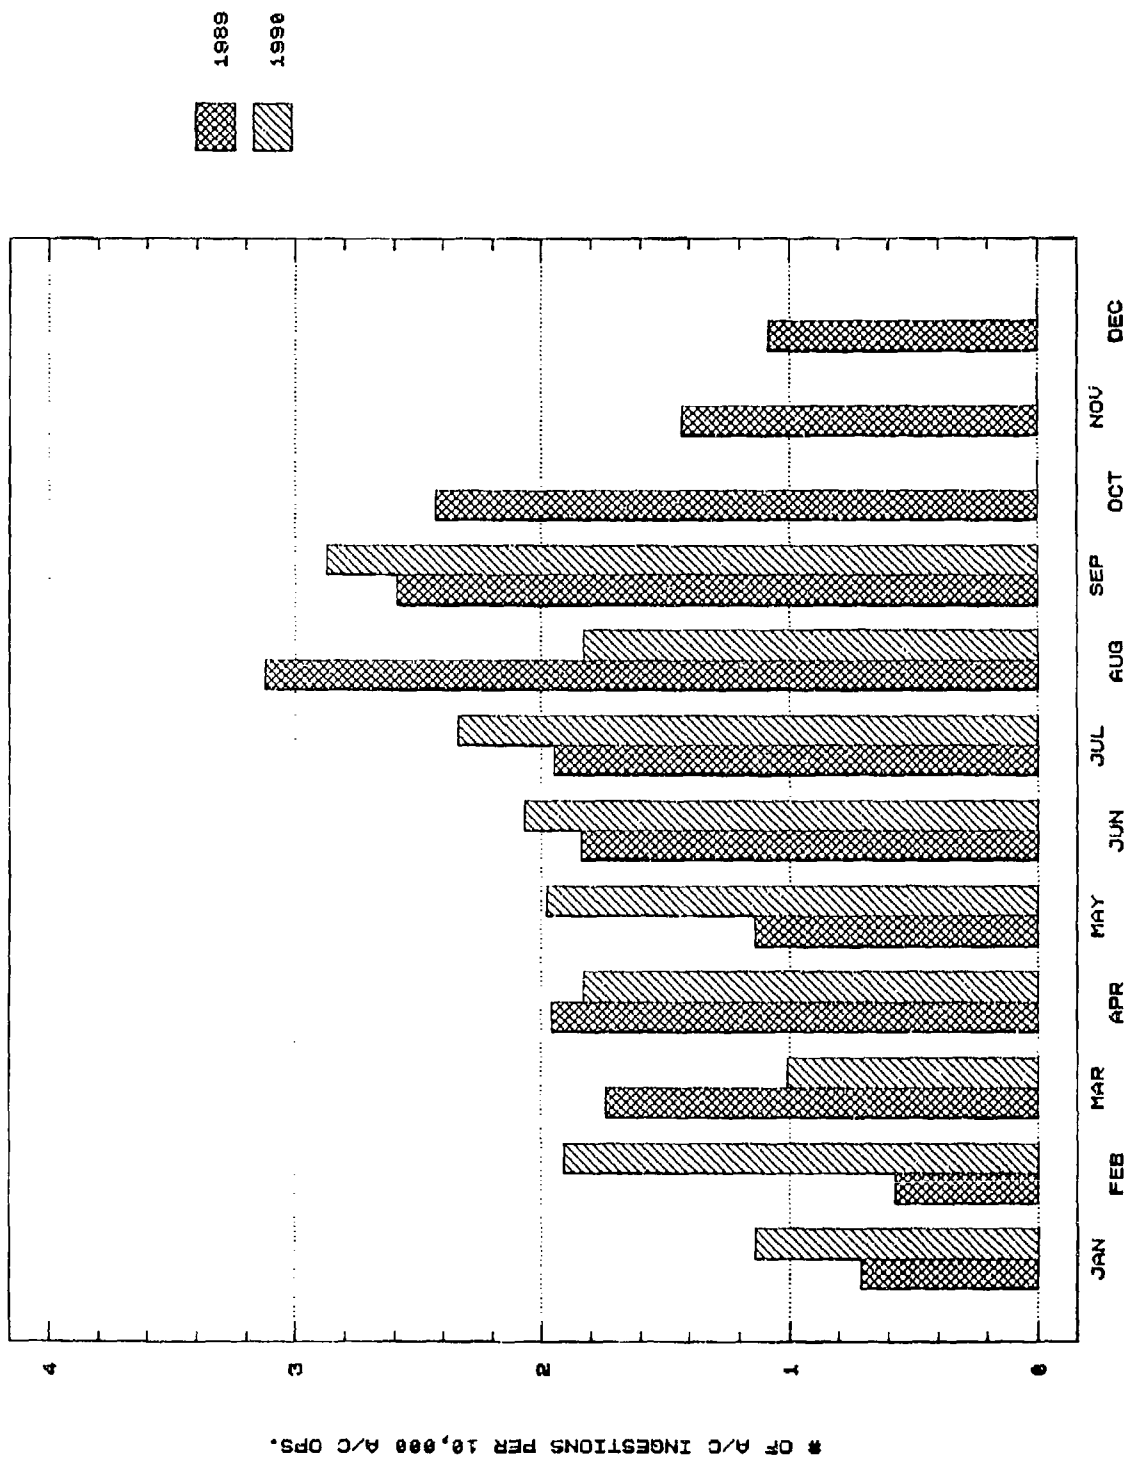
FIGURE 3.3 WORLDWIDE INGESTION RATES BY MONTH AND YEAR

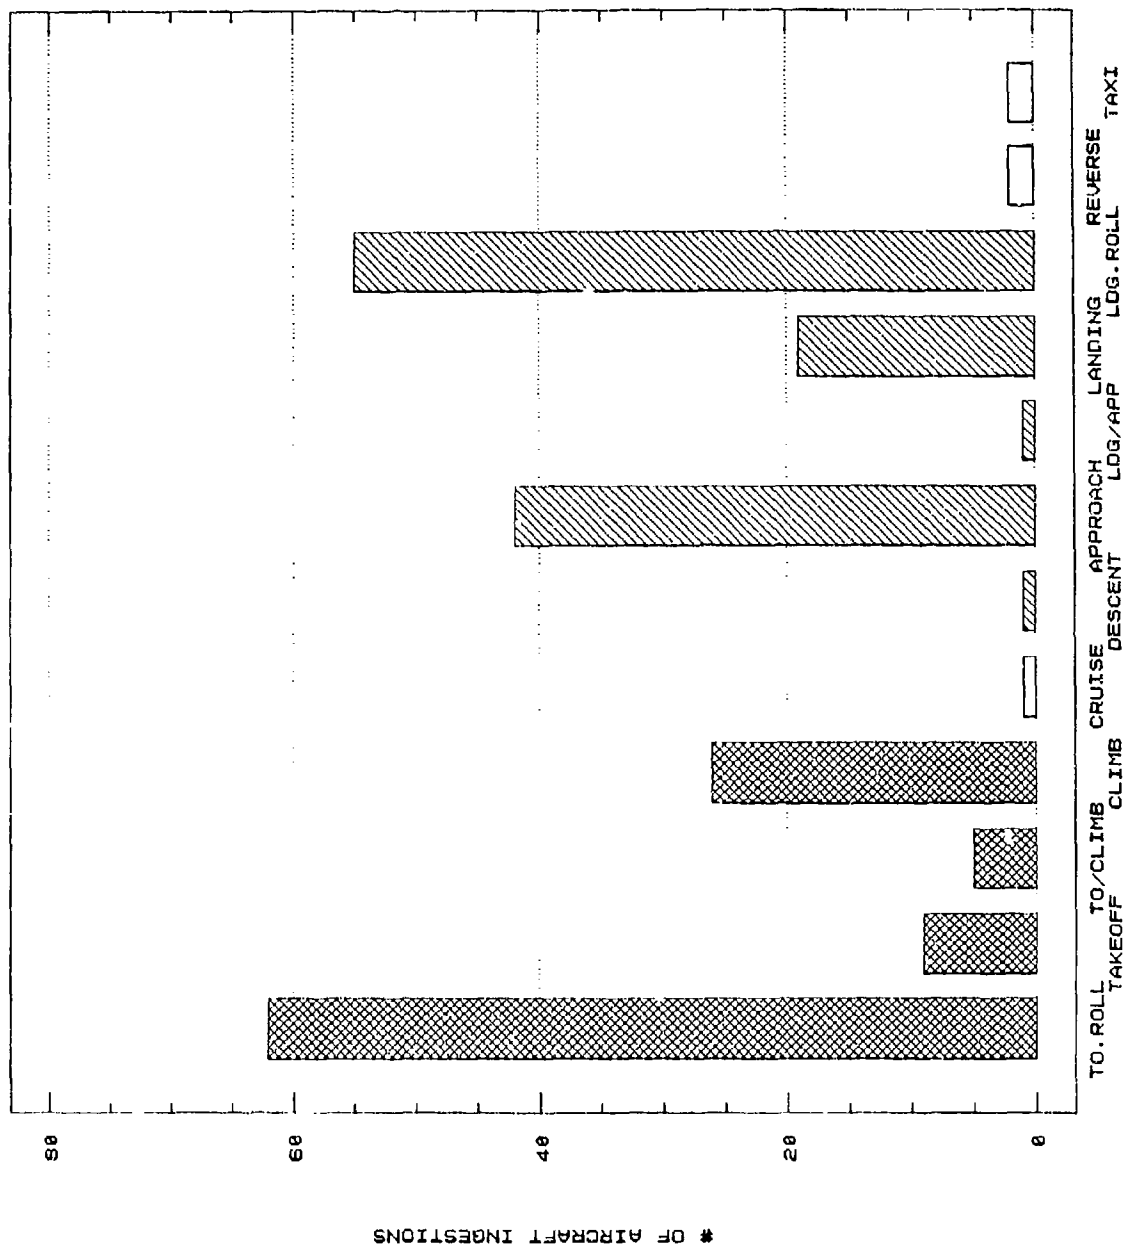
FIGURE 3.4. AIRCRAFT INGESTIONS BY PHASE OF FLIGHT

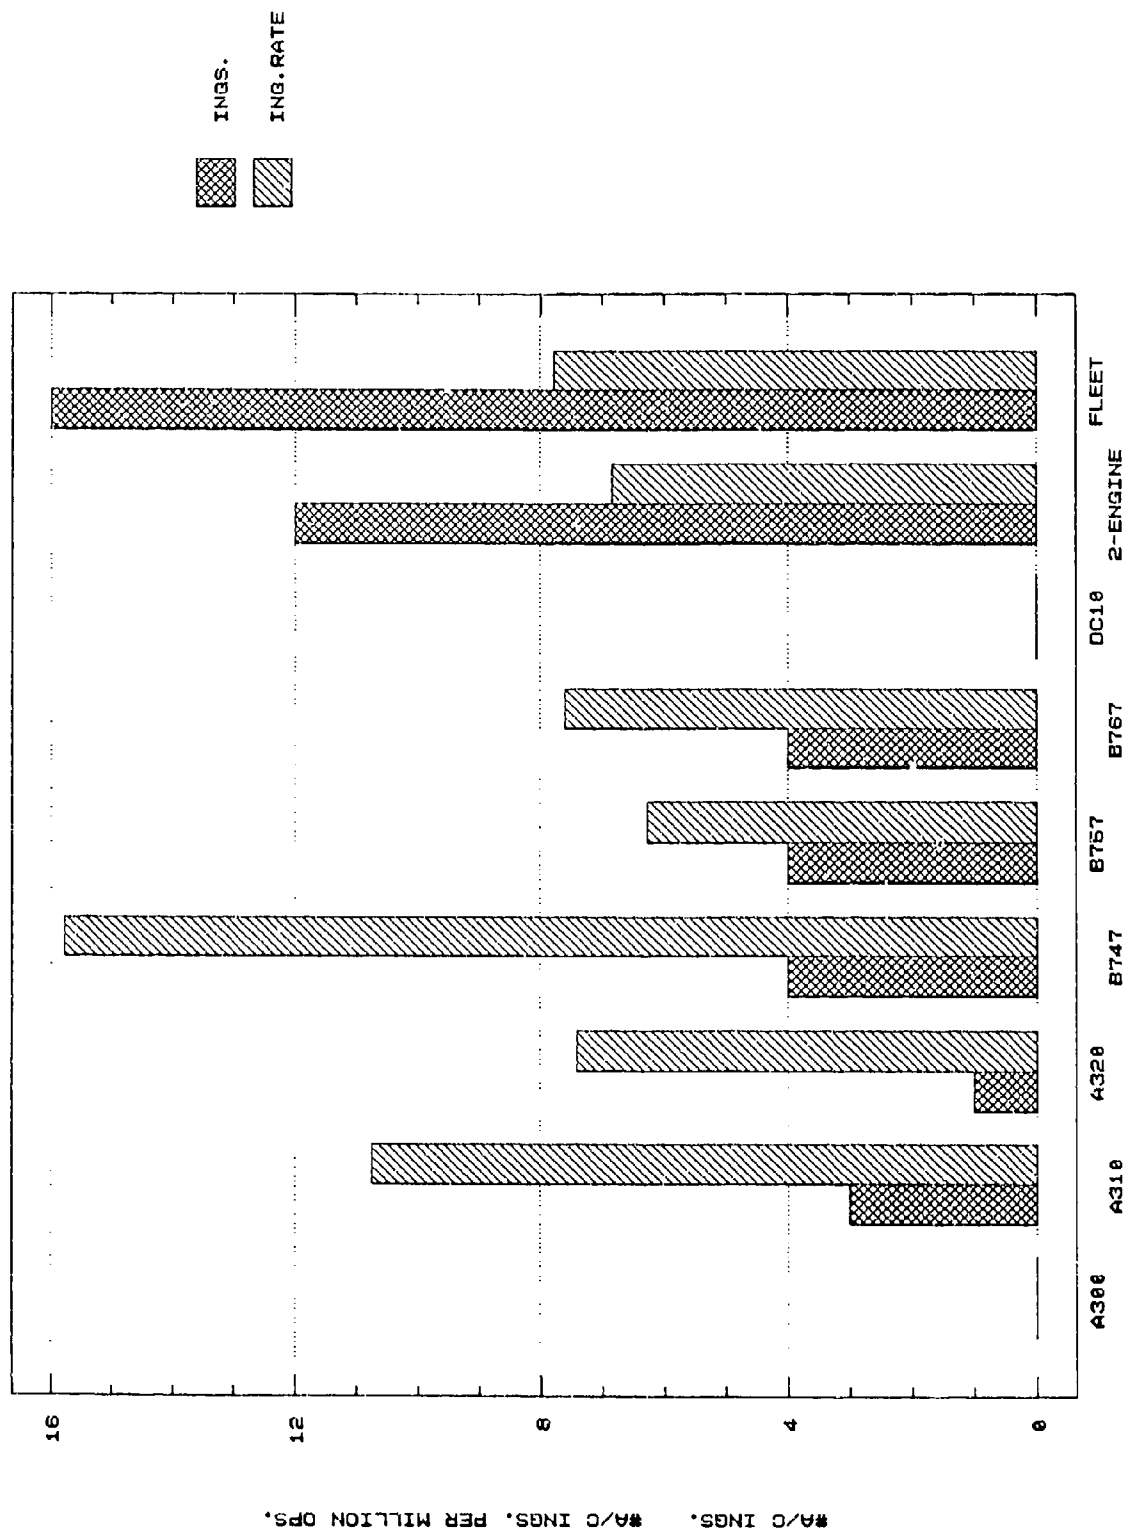
FIGURE 3.5. MULTIPLE ENGINE INGESTIONS AND INGESTION RATES BY AIRCRAFT TYPE

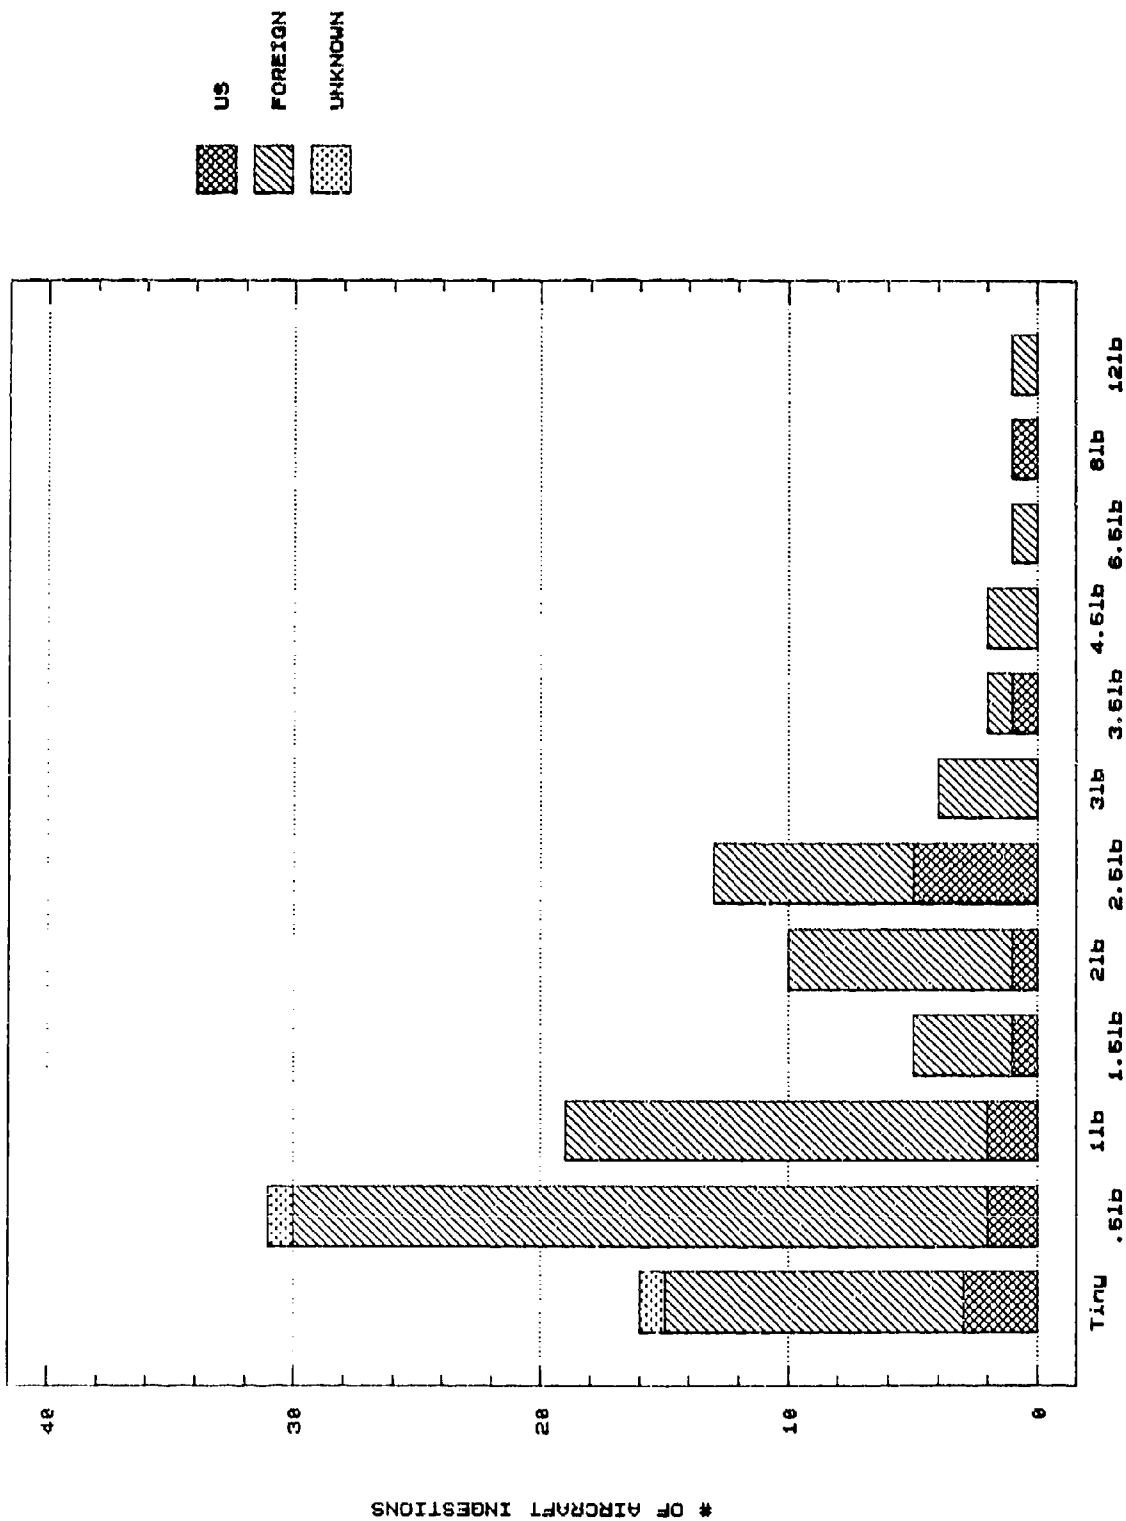
FIGURE 4.1. AIRCRAFT INGESTIONS BY BIRD WEIGHT CLASS, US/FOREIGN

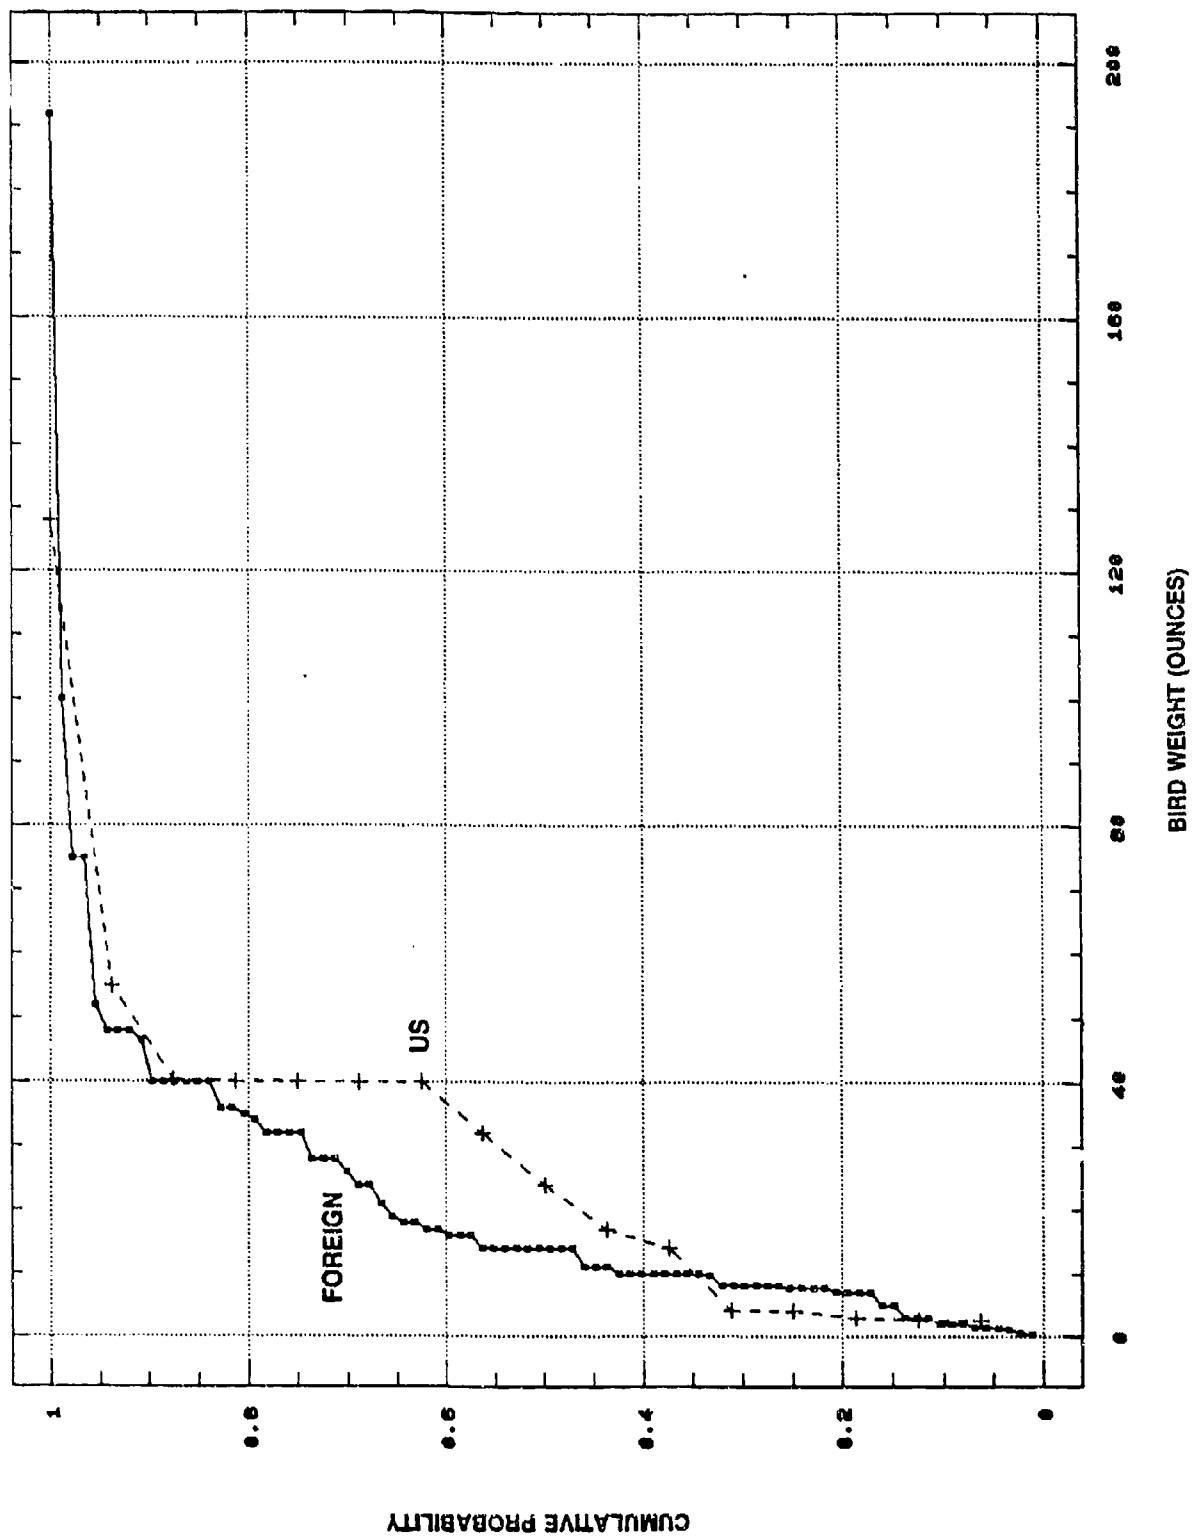
Figure 4.2 plots the cumulative distribution functions (see appendix B) for both United States and foreign bird weights. The two distributions diverge between 10 and 40 ounces, with a larger percentage of foreign bird weights falling into this range. However, apparently because of the sparse number of United States weights, an application of the Kolmogoroff-Smirnov Two-Sample Test (see appendix B) yields  $P = 24$  percent and, thus, fails to show that the domestic and foreign bird weight sample distributions are indeed statistically different at a sufficiently high confidence level. (The corresponding distributions were shown to be different by this two-sample test in the previous FAA large engine study, reference 1.)

FIGURE 4.2. CUMULATIVE BIRD WEIGHT DISTRIBUTIONS - US VERSUS FOREIGN

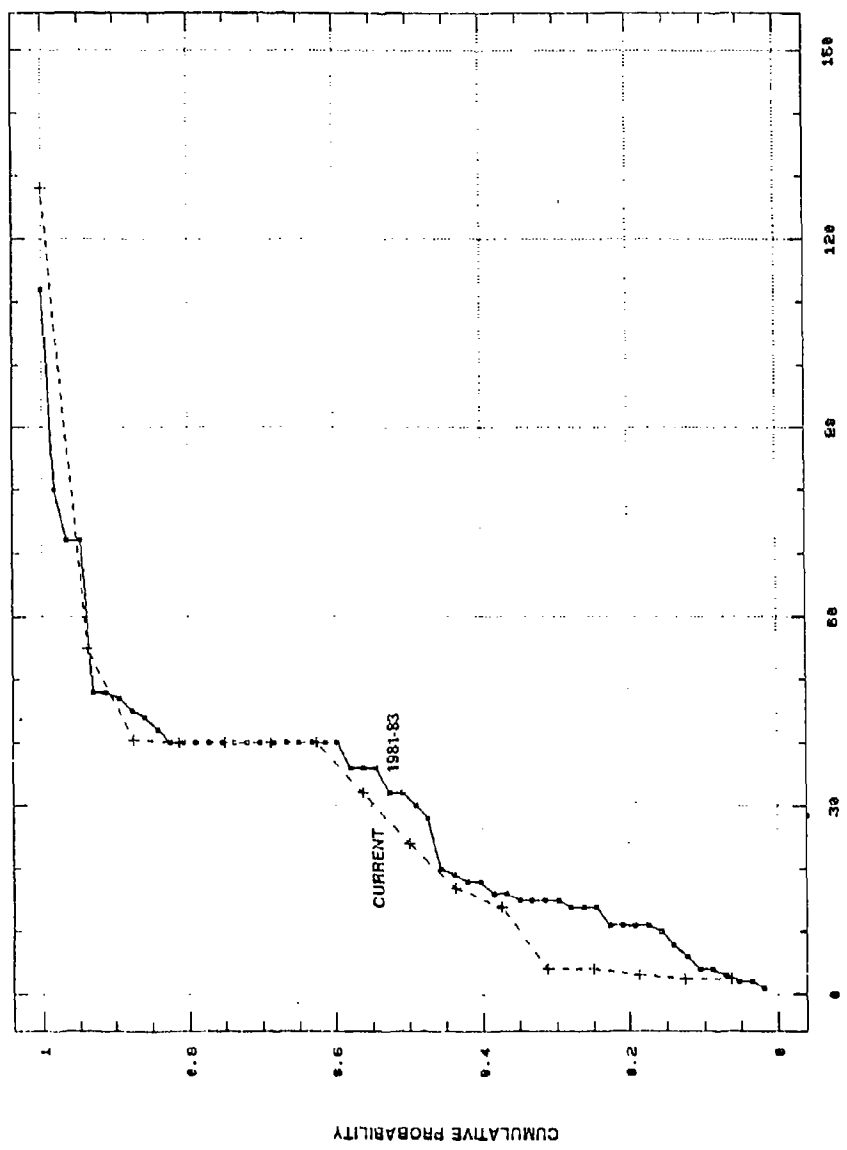
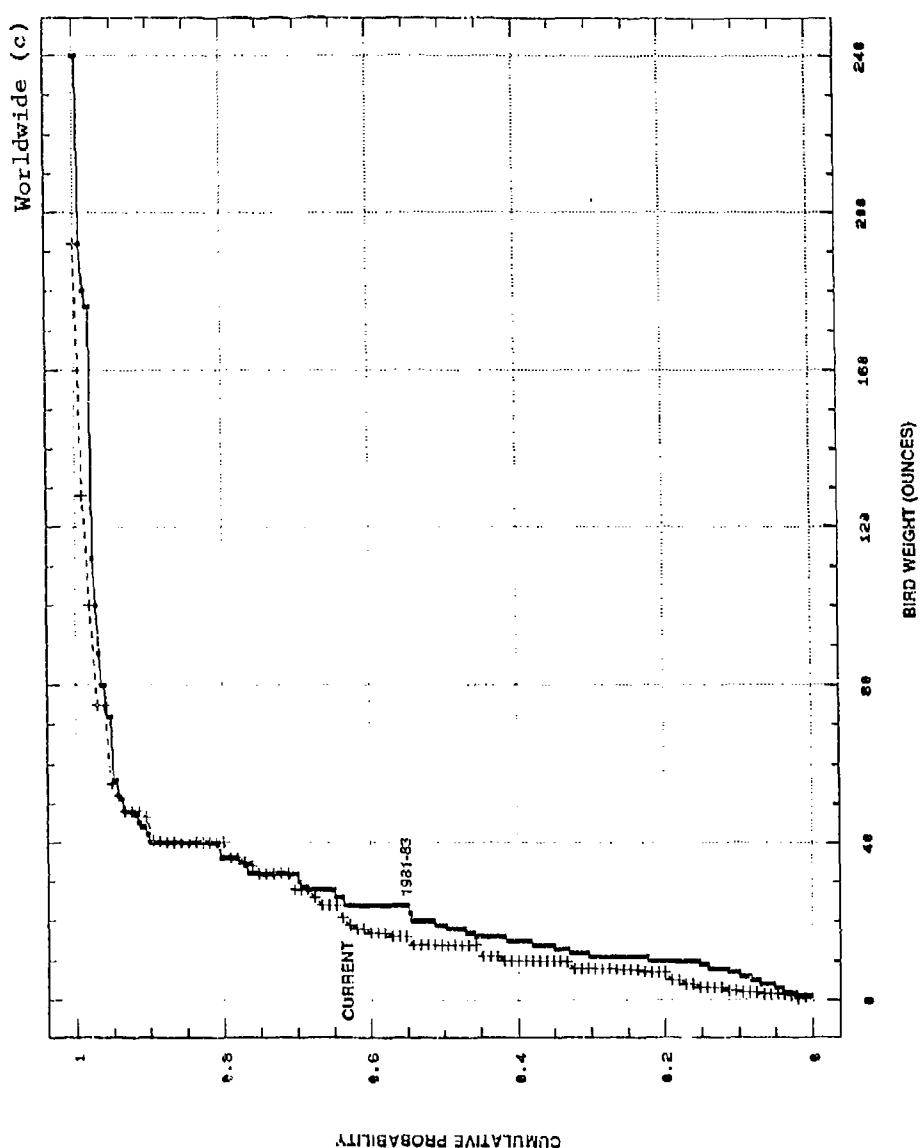
FIGURE 4.3. CUMULATIVE BIRD WEIGHT DISTRIBUTIONS - CURRENT VERSUS 1981-83 STUDY - US/FOREIGN/Worldwide

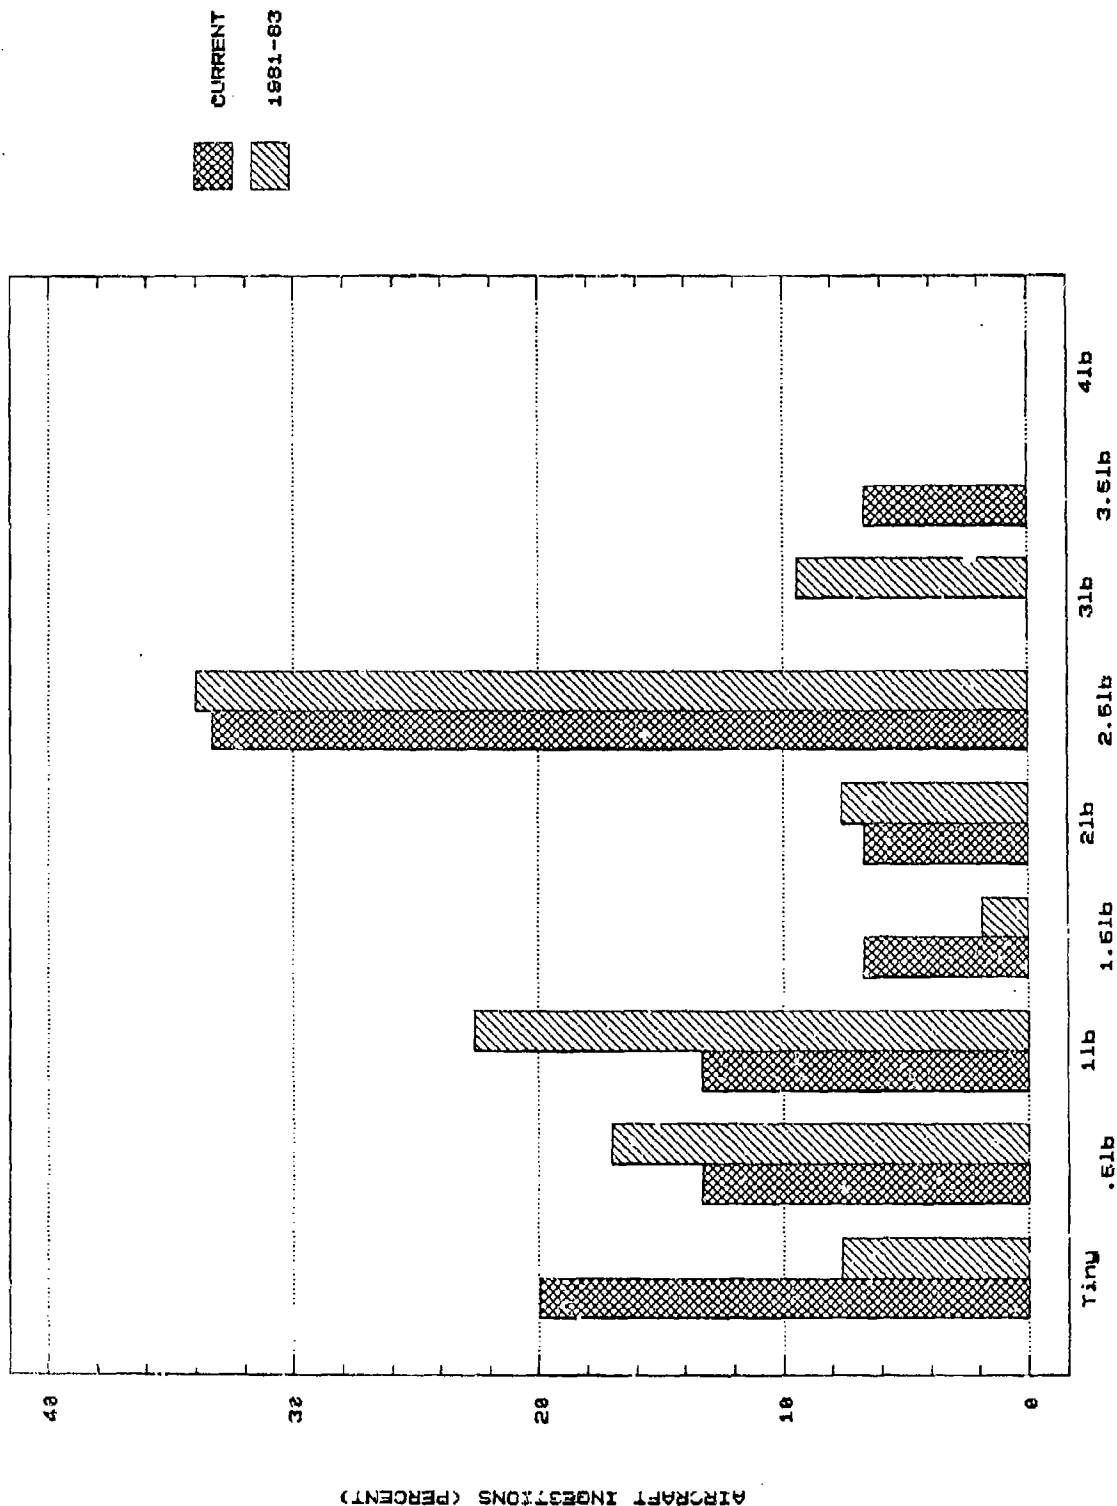
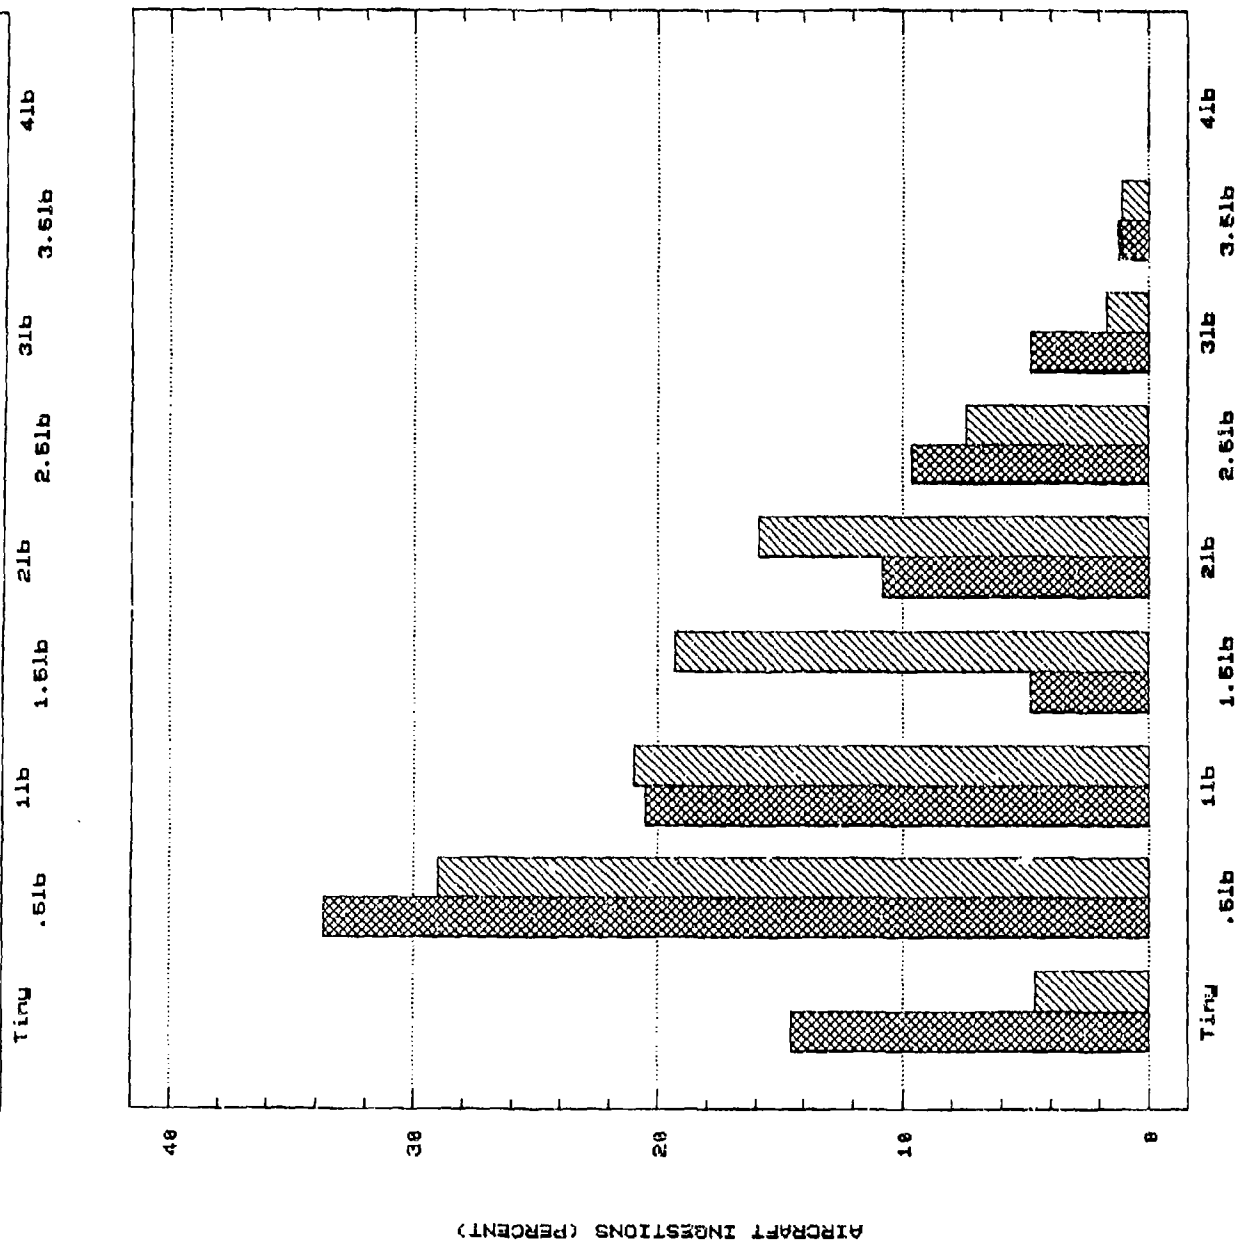
FIGURE 4.4. RELATIVE FREQUENCY BIRD WEIGHT DISTRIBUTIONS - CURRENT VERSUS 1981-83 STUDY - US/FOREIGN

United States distributions are bimodal with about 45 percent of the weights in the 1-pound or smaller classes and about 35 percent in the 2.5-pound class. The foreign distributions are similar in most weight classes. Two exceptions are the "tiny" and 1.5-pound classes. The latter contains relatively fewer weights from the current study while the opposite is true for the former.
