DOT/FAA/CT-91/17

## Bird Ingestion into Large Turbofan Engines

May 1992

Interim Report

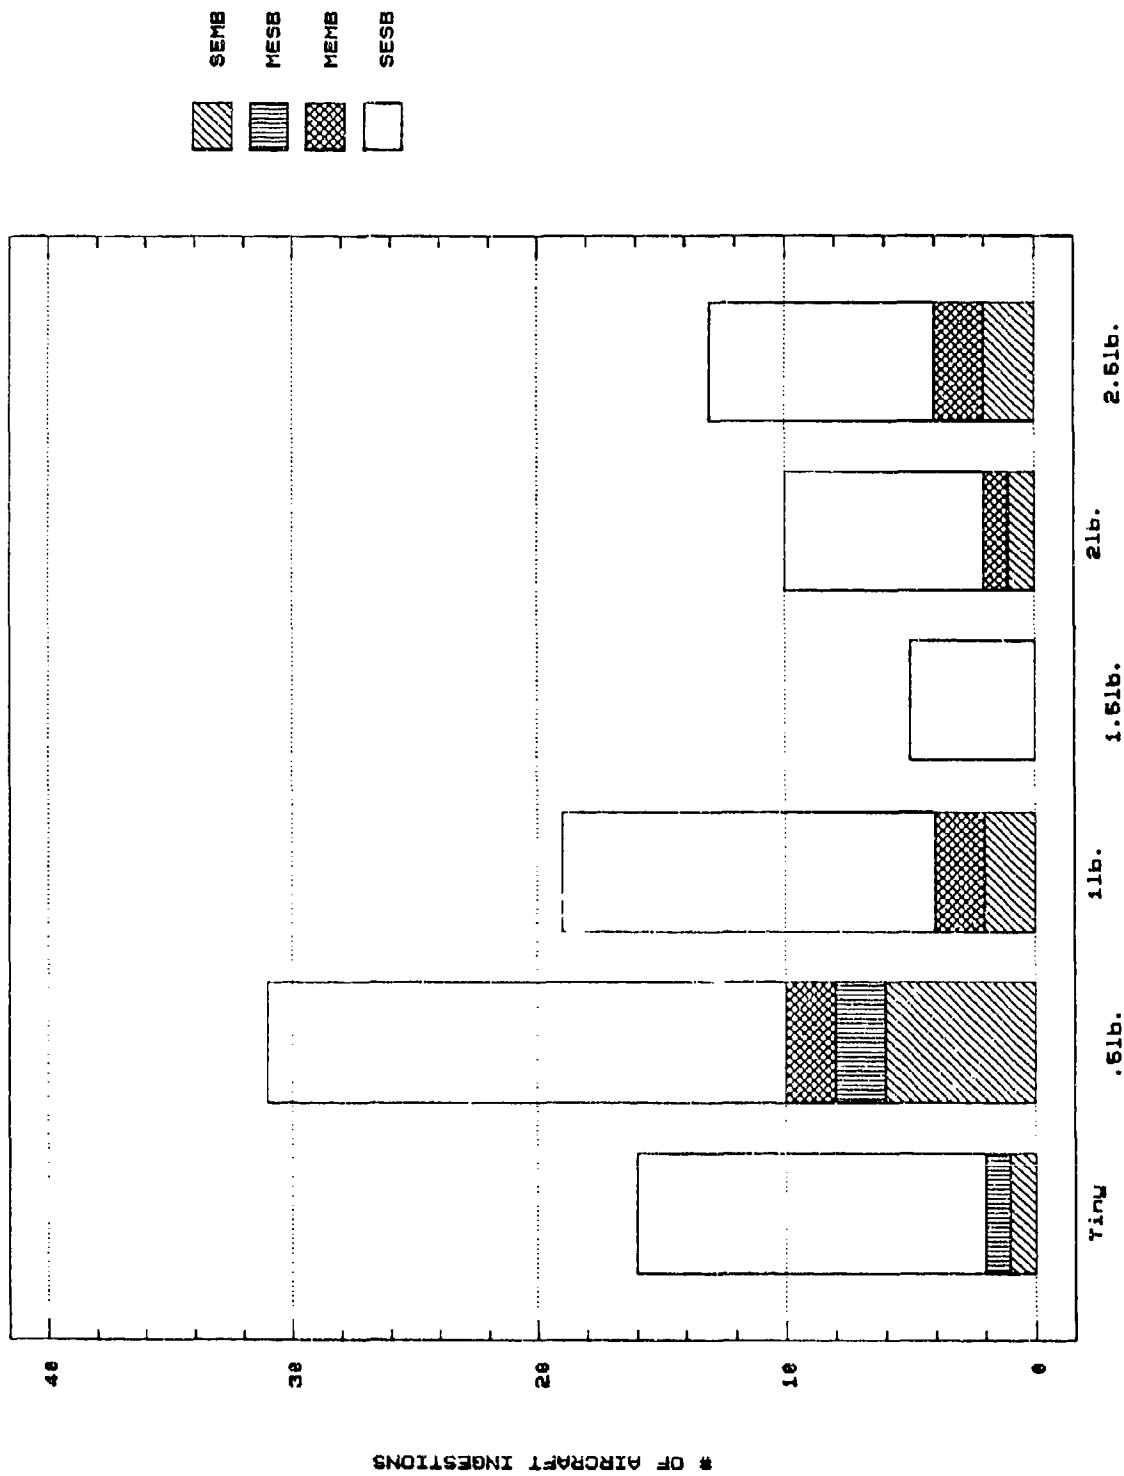
As indicated in Section 3, there were 16 multiple engine and 29 multiple bird aircraft events, including 8 that fell into both categories. Bird weights, none of which are over 40 ounces, were obtained in 22 of these 37 events. Figure 4.5 contains a frequency distribution of all bird weights up to the 2.5 pound weight class (the initial portion of figure 4.1). The numbers of single engine-multiple bird (SEMB), multiple engine-single bird (MESB) and multiple engine-multiple bird (MEMB) aircraft events for each weight class are shaded as indicated. The single engine-single bird events (SESB) remain unshaded. The 0.5-pound class contains the greatest number (10) of these "multiple" events, as well as the highest percentage (32 percent). The 1-pound and 2.5-pound classes each contain four "multiple" events, representing 31 percent of the latter's total and 21 percent of the former's. The 1.5-pound class is conspicuous by the absence of any multiple engine or multiple bird events.

FIGURE 4.5. MULTIPLE ENGINE AND MULTIPLE BIRD EVENTS BY BIRD WEIGHT CLASS

loss of two engines during the critical takeoff or climb phases could be catastrophic, even in three- or four-engine aircraft. Table 5.6 summarizes the 16 multiple engine events in the data, all of which involved two engines. In event 138, one engine lost power due to a fan blade transverse fracture and was shut down. The cockpit symptoms following ingestion were a surge and high exhaust gas temperature. The other affected engine also surged and, fortunately, recovered. This is the only event in which two engines were damaged significantly. Three other events, 102, 201, and 323, resulted in multiple engine damage. Significant damage in a single engine occurred in the first and the last of these events. The B767 in event 201 received minor damage in each engine and performed an air turnback. As noted above, both engines of the B767 in event 152 surged, but evidently recovered. The takeoff was aborted. It is interesting to note that the affected engines were on the same wing in all four B747 multiple engine events. Verified bird weights were obtained in 10 of the multiple engine events. They are listed in Table 5.6 and were included in figure 4.5 of the previous section.

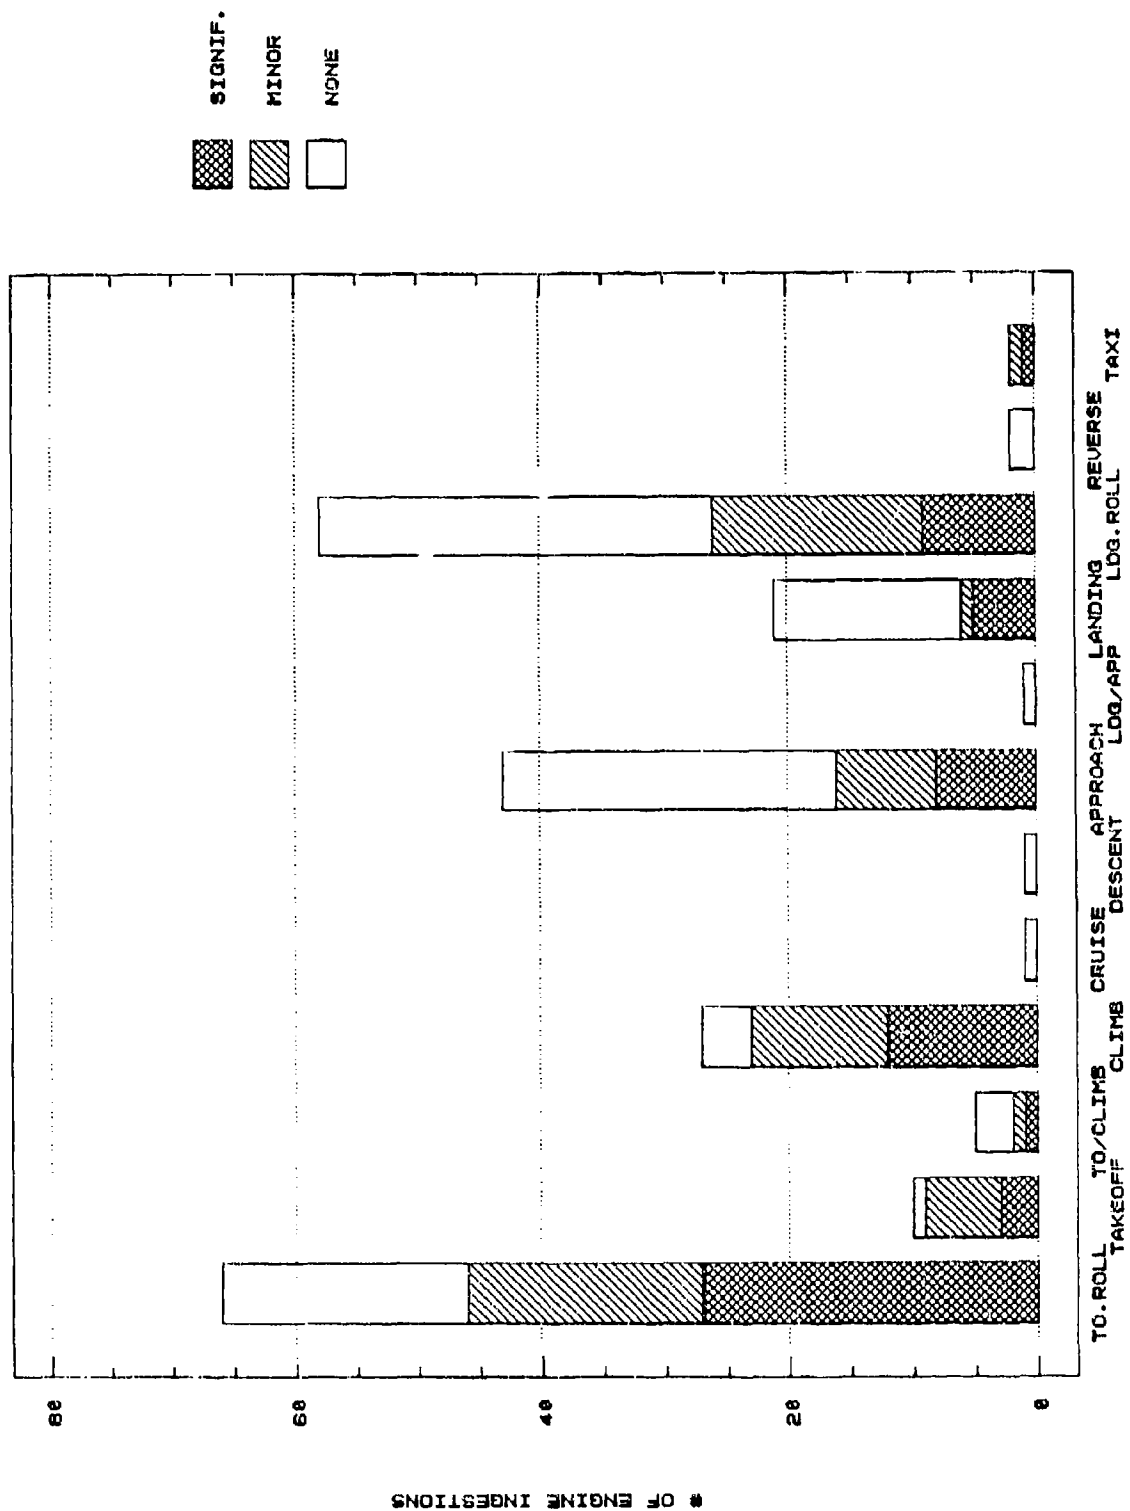
The frequency of significant damage, minor damage, and no damage for each reported category of phase of flight is illustrated in figure 5.1 for the 237 engine events in which this information is known. The "takeoff," "takeoff roll," "climb," "landing roll," and "approach" categories each contain several damaging events. However, more than half of the engine ingestions in each of the latter

FIGURE 5.1. ENGINE DAMAGE FREQUENCIES BY PHASE OF FLIGHT

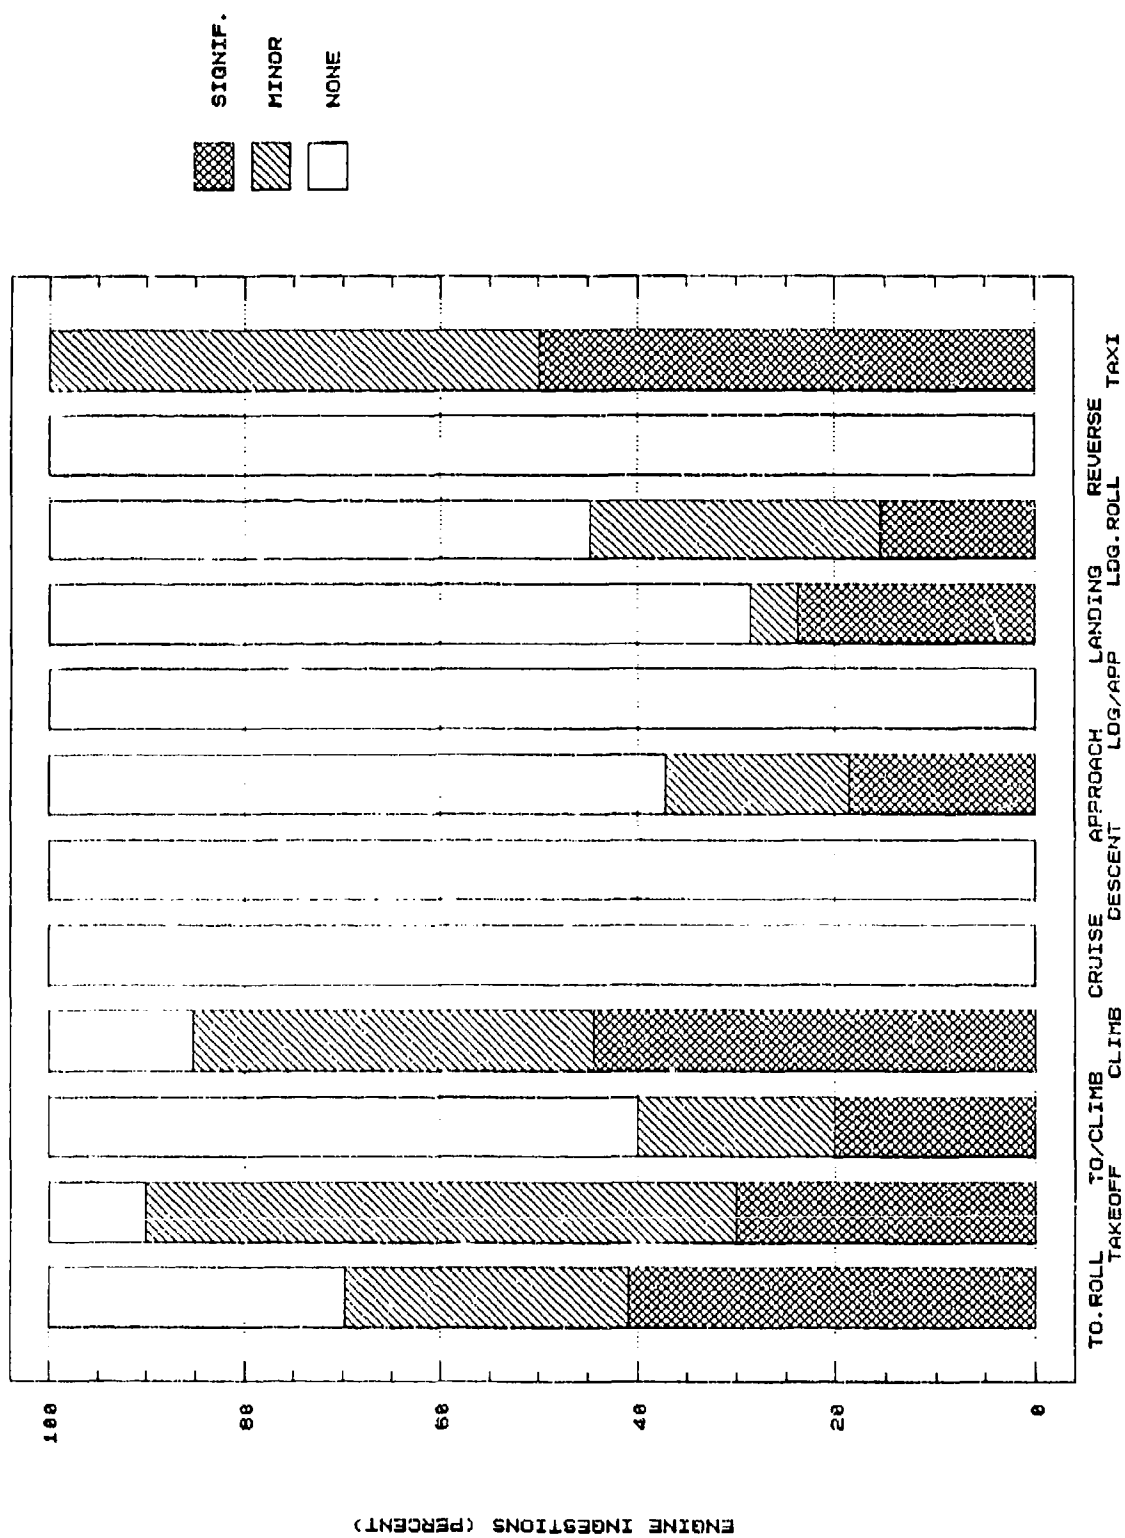
FIGURE 5.2. RELATIVE FREQUENCY OF ENGINE DAMAGE BY PHASE OF FLIGHT

two categories were nondamaging. This suggests looking at the "relative frequencies" of damage for each phase of flight category, which is shown in figure 5.2. Clearly the "climb," "takeoff," "takeoff roll," and "taxi" phases have the highest percentages of both minor and significant damage. However, as figure 5.1 shows, the taxi phase contains only two events. Among the departure phases, only the "takeoff/climb" category (which contains but 5 events) has relatively few damaging events. These facts, along with the above remarks concerning fan speed in various phases of flight, suggest grouping phases of flight according to "departure" and "arrival" for analysis of engine damage.

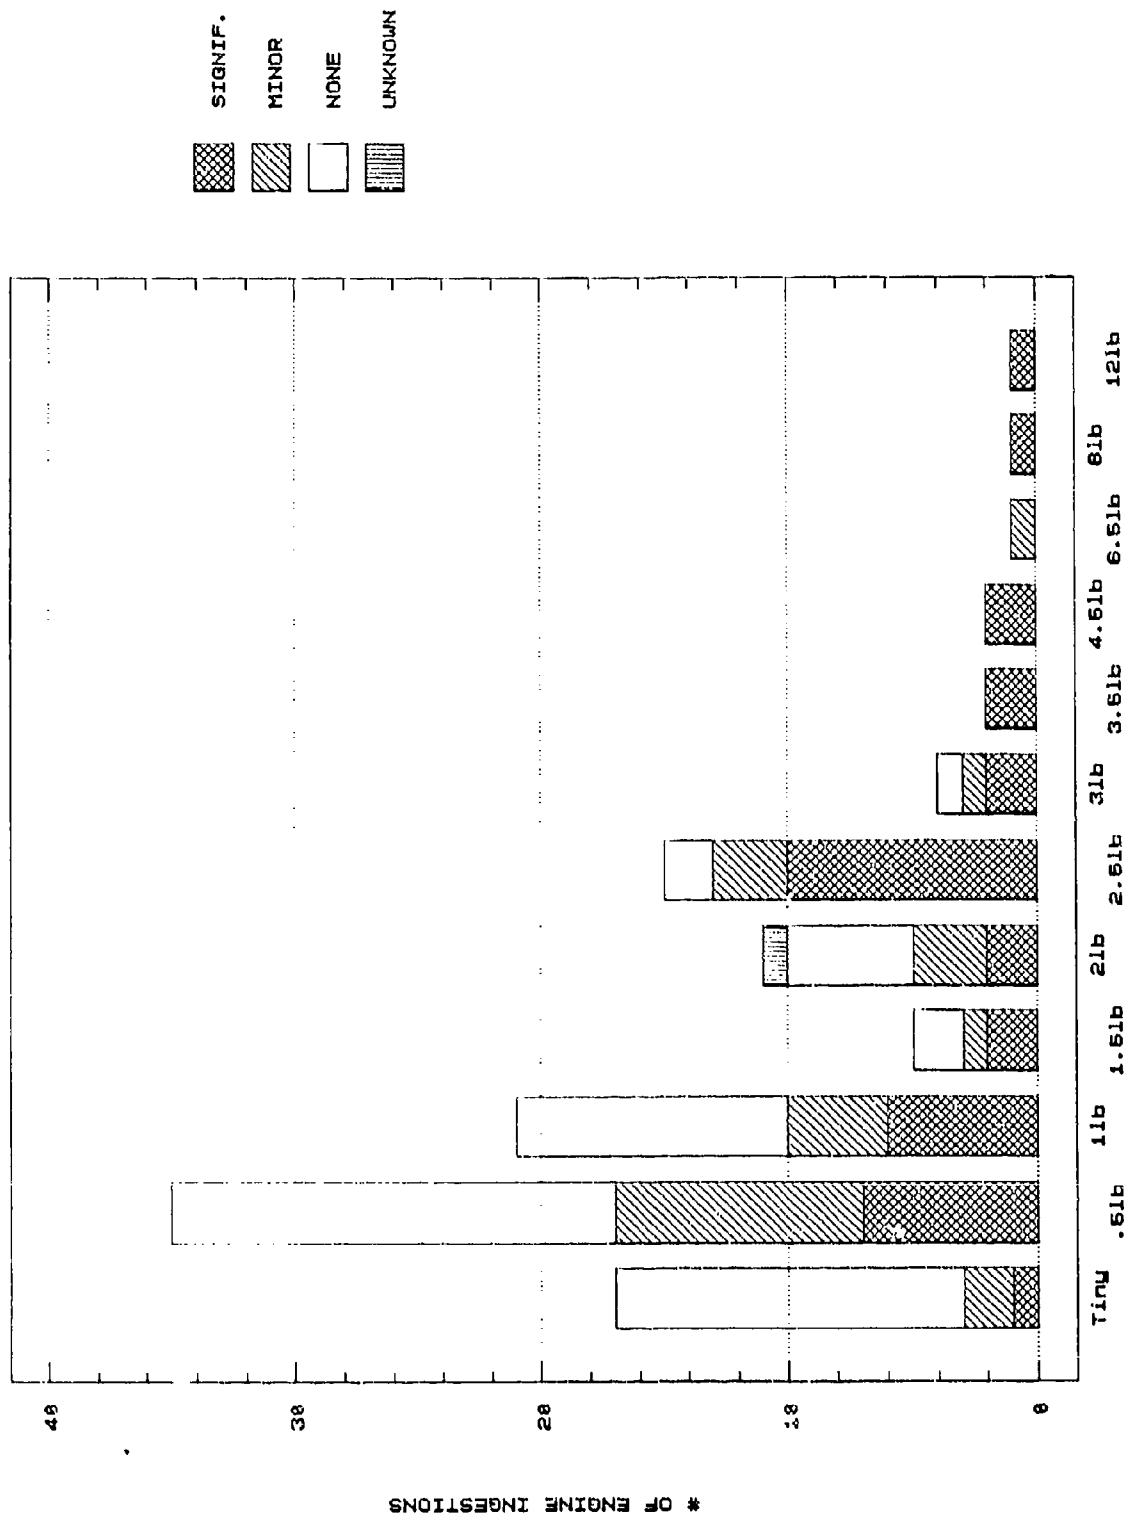
The relationship between engine damage and weight of ingested birds is examined next. Figure 5.3 is a frequency histogram depicting engine damage category according to bird weight class for the 115 engine ingestions in which a species identification was made. The weight classes are the same as those used in the previous section, as defined in table 4.5. The number of engine ingestions that resulted in no damage, minor damage, and significant damage is shown for each weight class. The 2.5-pound weight class had the greatest number of events with significant damage while the 1.5-pound and 2-pound weight classes had relatively few. Three (3) of the four ingestions in the 3-pound class caused damage. All ingestions over 3 pounds were damaging, for the most part significantly, but were few in number. The 0.5-pound class contains a large number of damaging ingestions but more than half in this class were nondamaging.

FIGURE 5.3. ENGINE DAMAGE FREQUENCIES BY BIRD WEIGHT CLASS

As figure 5.3 indicates, engine damage information was not reported for one (2-pound) ingestion. Using the remaining 114 engine events, figure 5.4 examines bird weight versus engine damage from the relative frequency viewpoint. Here the percentage in each damage category is represented for each weight class. With few exceptions, the overall trend is for the relative frequency of both damaging and significantly damaging ingestions to increase with bird weight.

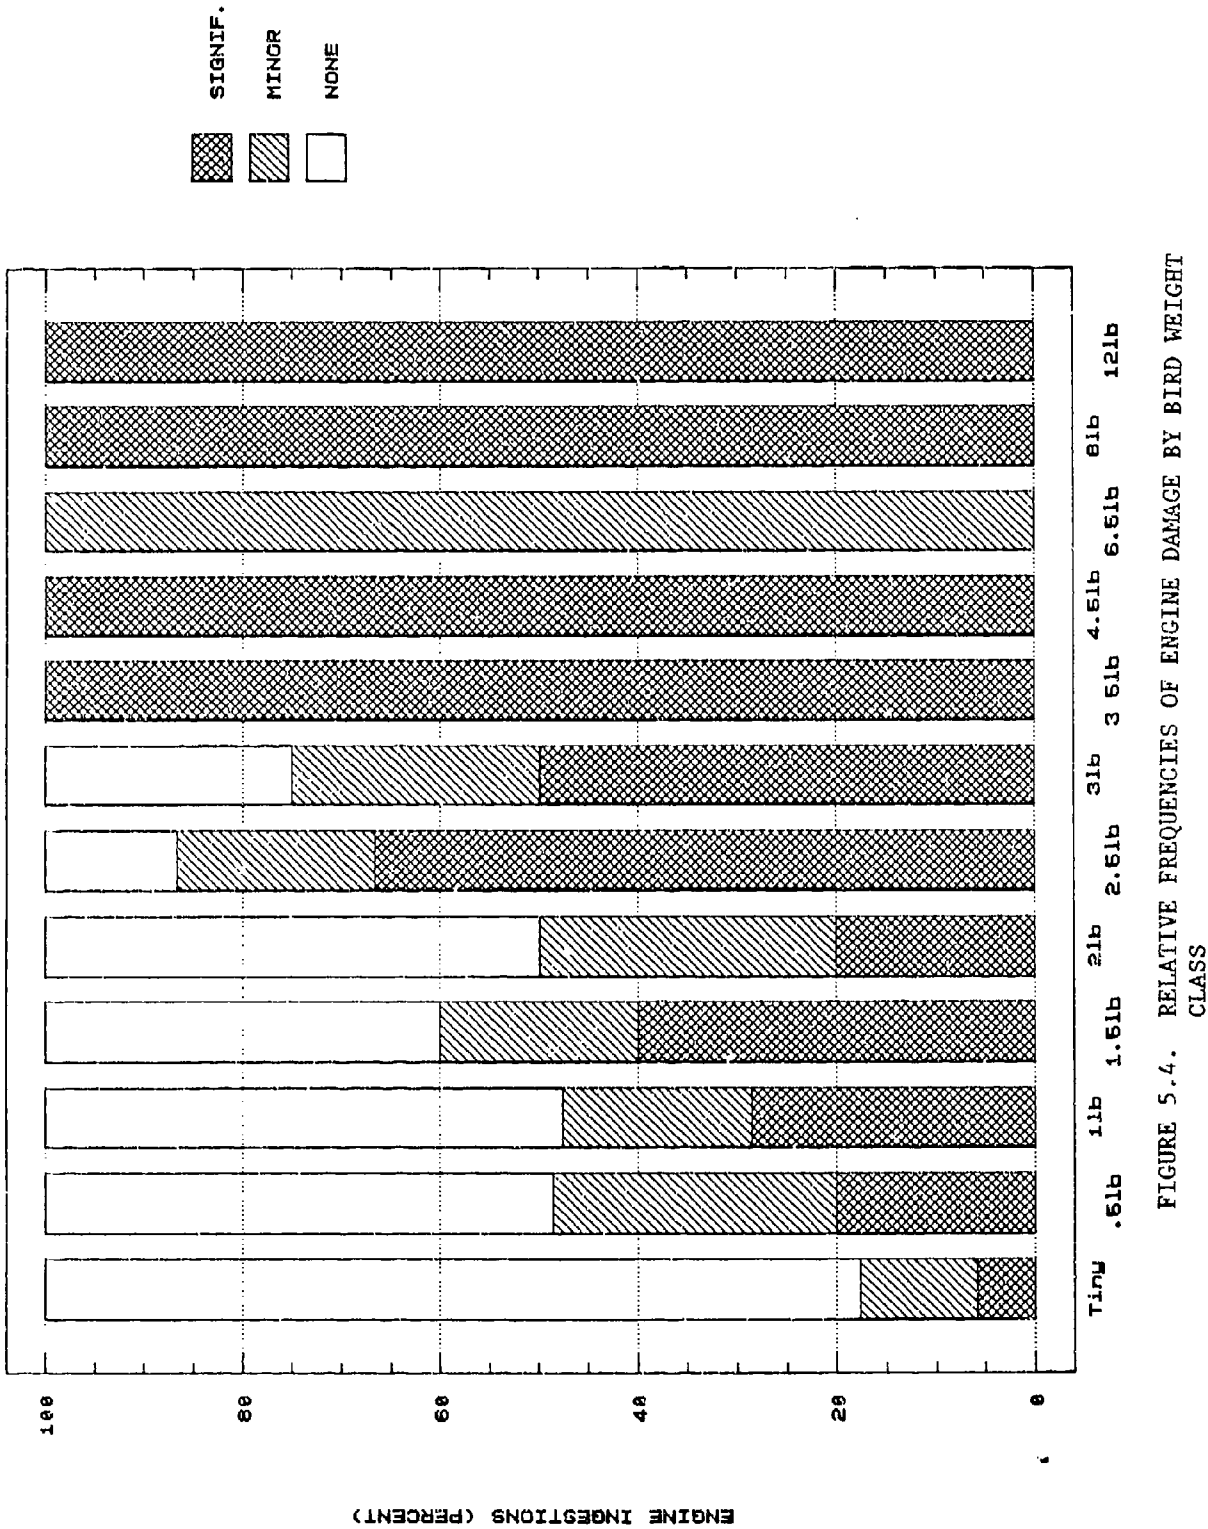
FIGURE 5.4. RELATIVE FREQUENCIES OF ENGINE DAMAGE BY BIRD WEIGHT CLASS

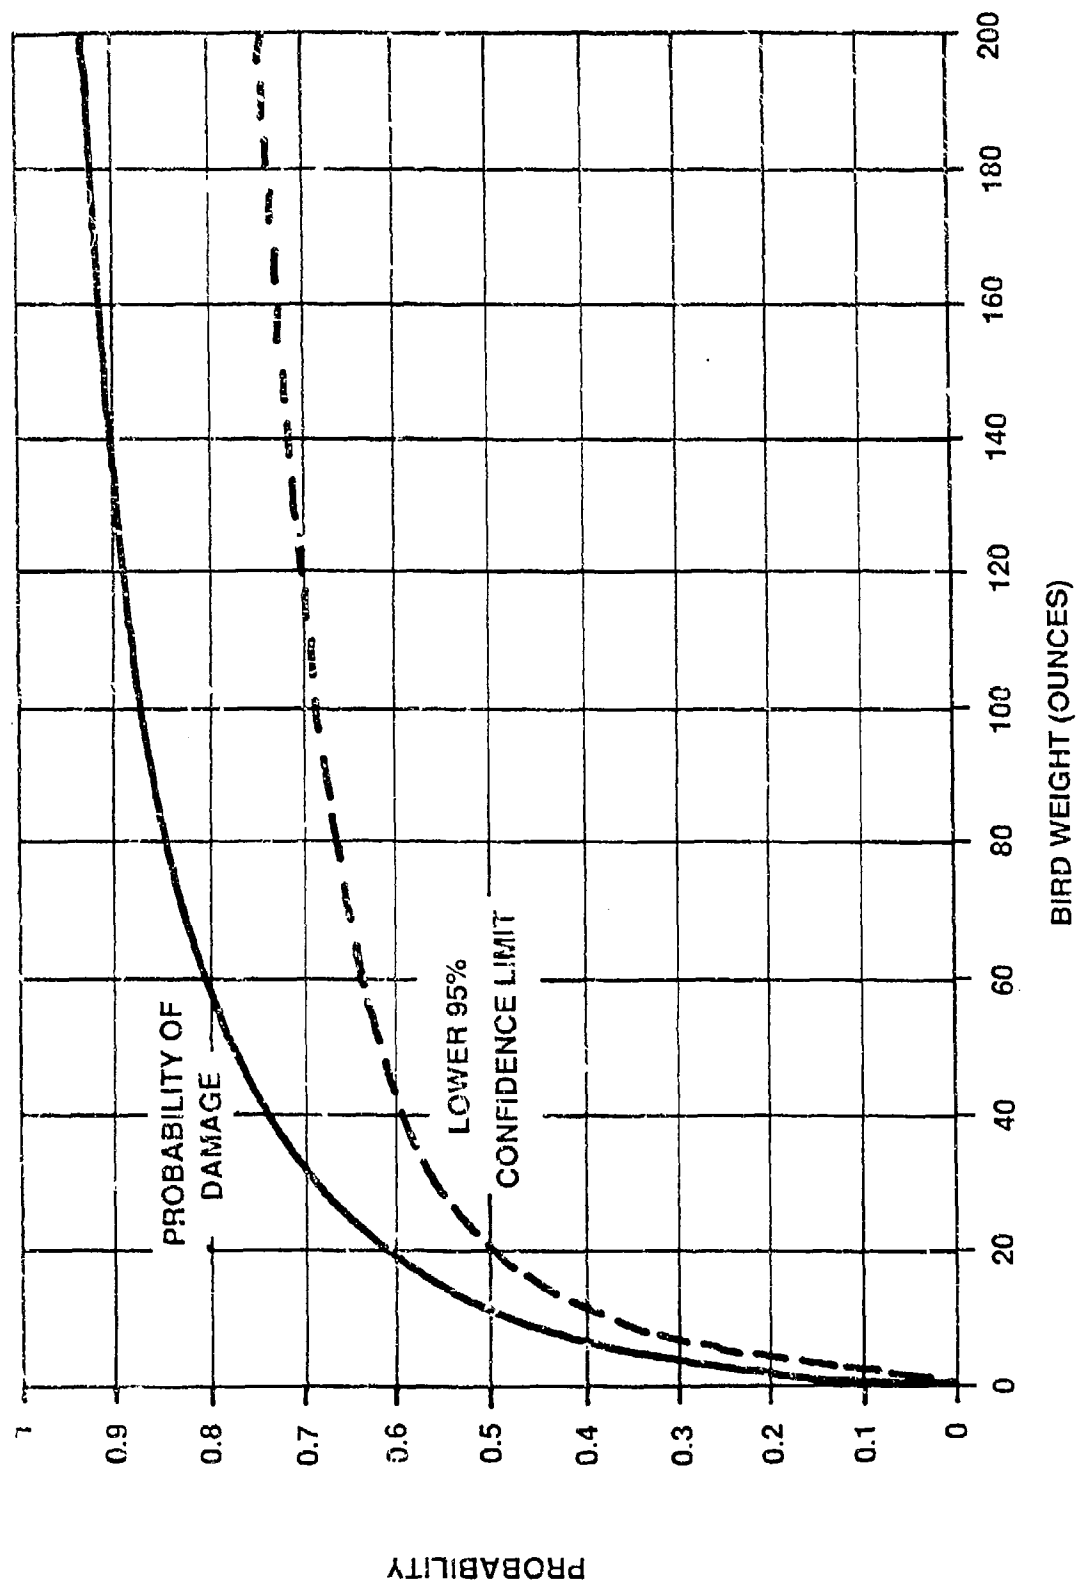
In reference 2, a logistic model is used for the probability of various "severities" of damage as a function of bird weight. Specifically, the logarithm

of the odds ratio,  $\log(\text{probability}/(1-\text{probability}))$ , is modeled as a linear function of bird weight. A rationale for choosing this particular model is also presented there. The same computer program used in reference 2, which also generates a lower 95 percent confidence bound, was applied to the data in this report. The resultant probability of damage (resp. significant damage) curves are given in figure 5.5 (resp. figure 5.6). The probability of damage reaches 50 percent at about 10.7 ounces and the probability of significant damage curve does likewise at 36 ounces. It should be kept in mind, however, that these probability curves are a result of "smoothing" the data which generated figure 5.4 by means of a particular model and should not be taken as gospel. For example, figure 5.6 puts the probability of significant damage at around 50 percent for a 2-pound bird ingestion while figure 5.4 places it at 20 percent. It should also be noted that this model assumes that probability of damage increases with bird weight. Moreover, no factors other than bird weight were used to generate the curves in figures 5.5 and 5.6. In particular, the phase of flight and the number of birds ingested were both ignored.

FIGURE 5.5. PROBABILITY OF ENGINE DAMAGE BY BIRD WEIGHT - LINEAR LOGISTIC MODEL

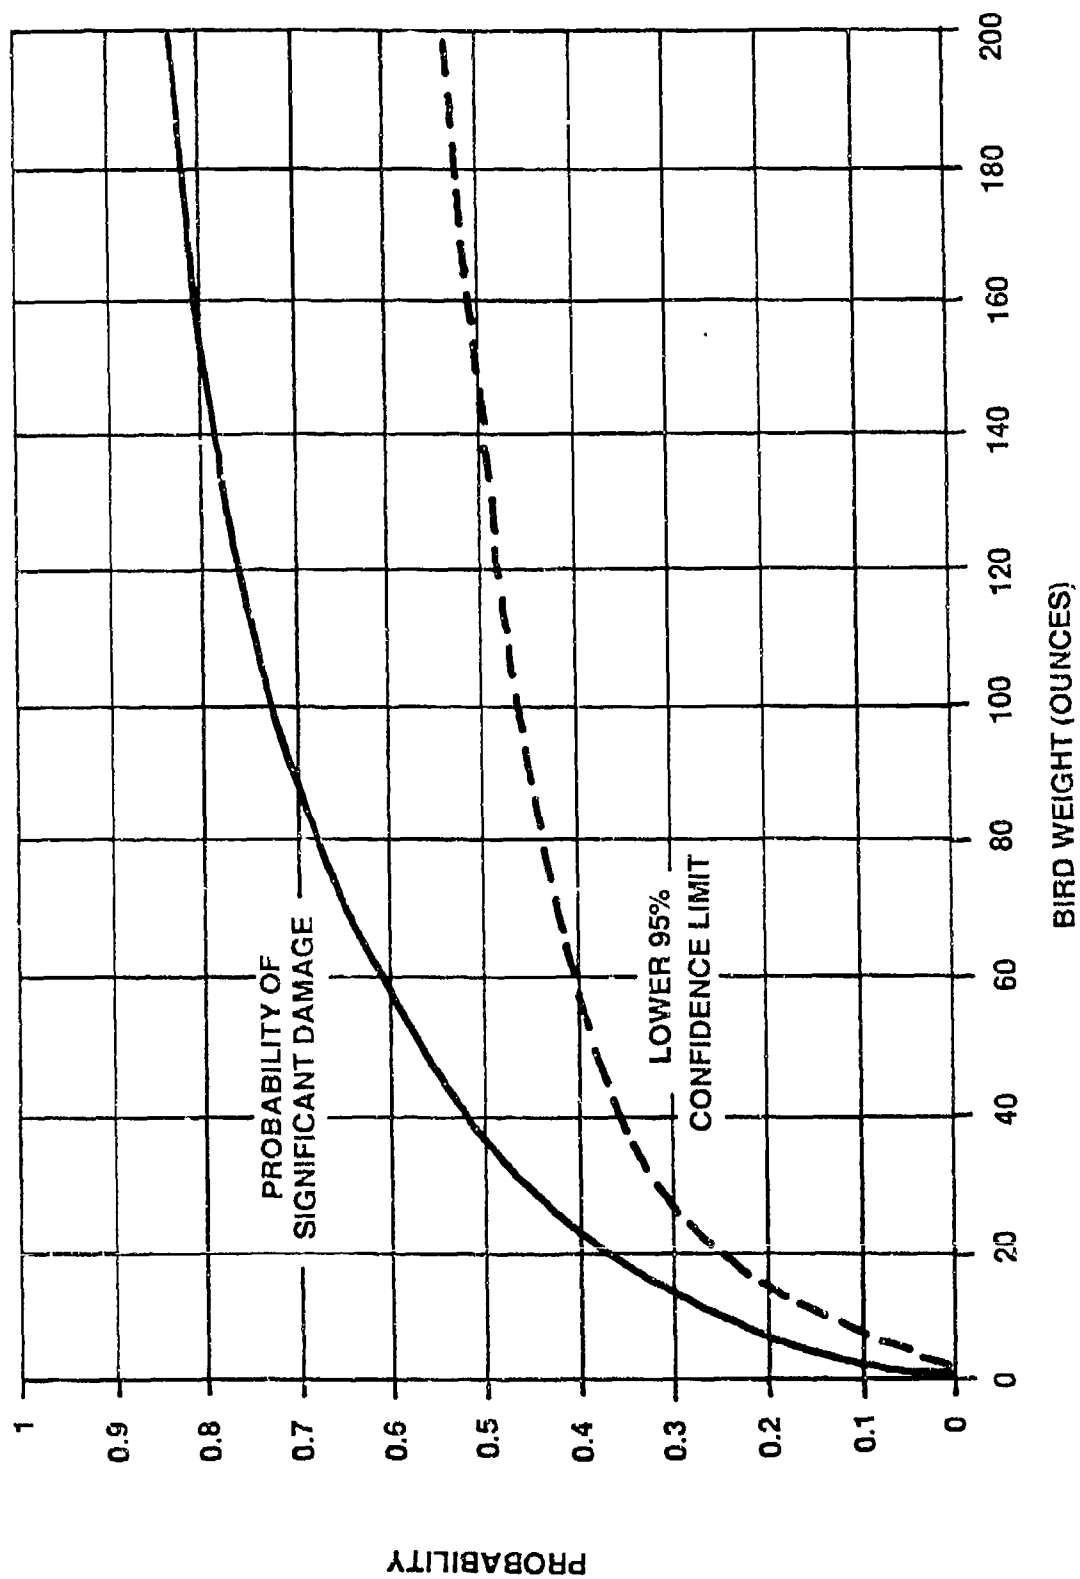
FIGURE 5.6. PROBABILITY OF SIGNIFICANT ENGINE DAMAGE BY BIRD WEIGHT -  
LINEAR LOGISTIC MODEL

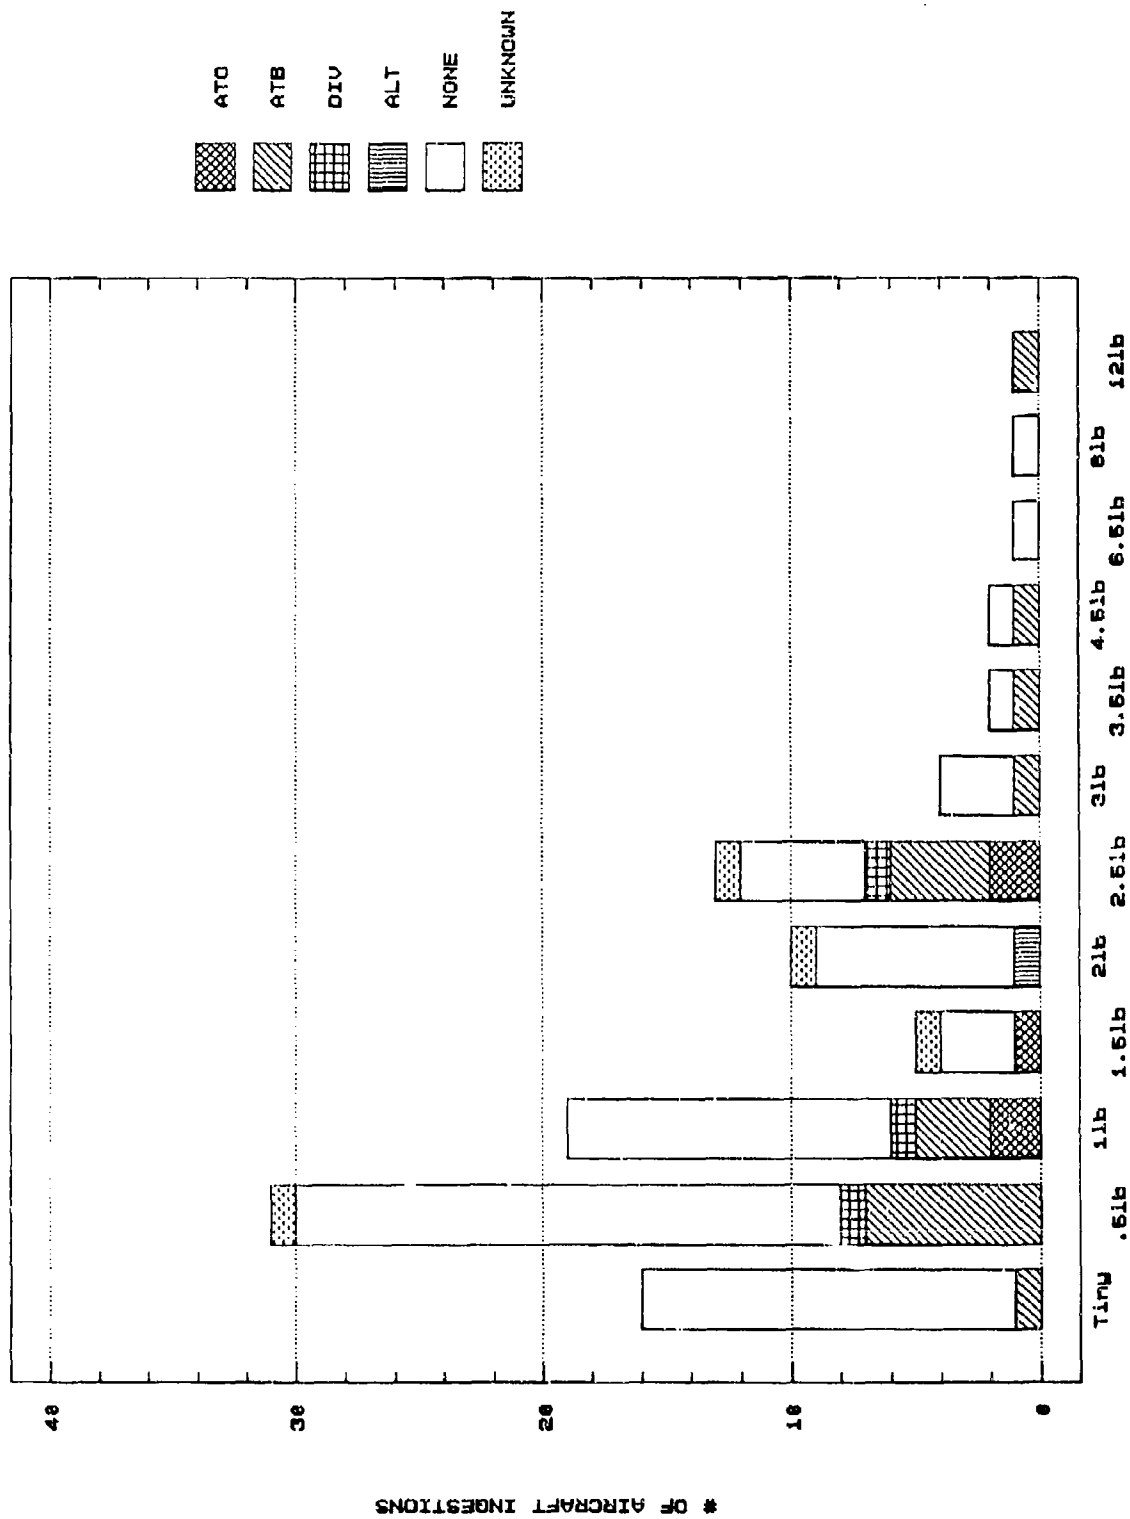
Verified bird weights were obtained in 28 of the 53 crew action events. Figure 5.8 indicates the bird weight class involved in each of these events, and for the "no crew action" and "unknown crew action" events as well. The greatest number of crew action events, eight, occurred in the 0.5-pound class, followed by seven for the 2.5-pound class. This latter class, however, contains the

FIGURE 5.8. CREW ACTIONS BY BIRD WEIGHT CLASS

largest relative frequency of crew action events, 54 percent. The aforementioned event (317) in which an ATB was evidently unrelated to the bird ingestion, accounts for the single "tiny" bird event in figure 5.8.
