ARL-STRUC-TM-561

Aircraft Structures Technical Memorandum 561

**LAU-7/A MISSILE LAUNCHER STATIC AND DYNAMIC STRAIN SURVEYS**

*This Technical Memorandum describes the results of static and dynamic strain surveys carried out on a LAU-7/A launcher (serial number NMH-230) as removed from a Royal Australian Air Force (RAAF) F/A-18 aircraft.*

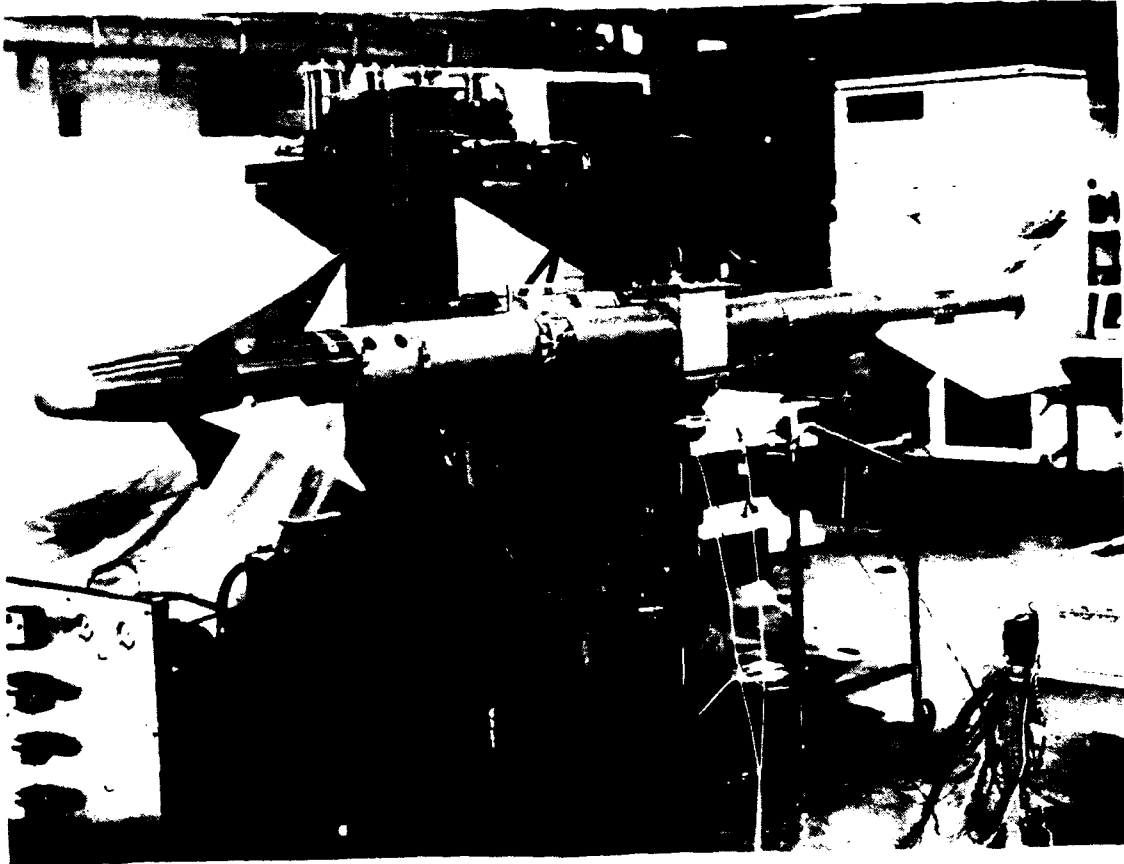
FIG. 2: LAUNCHER TEST RIG

Figure 2 shows the launcher with a Dummy Air Defence Missile (DADM) fitted and mounted in the test rig. Load was applied to the DADM at its centre of gravity (C.G.) using a conventional hydraulic actuator and hand pump. The DADM aft and forward

hangers transferred the load applied to the missile into the launcher upper and lower rail flanges. The applied load was measured using an Interface brand load cell and a digital load cell read-out box calibrated to suit the load cell capacity.

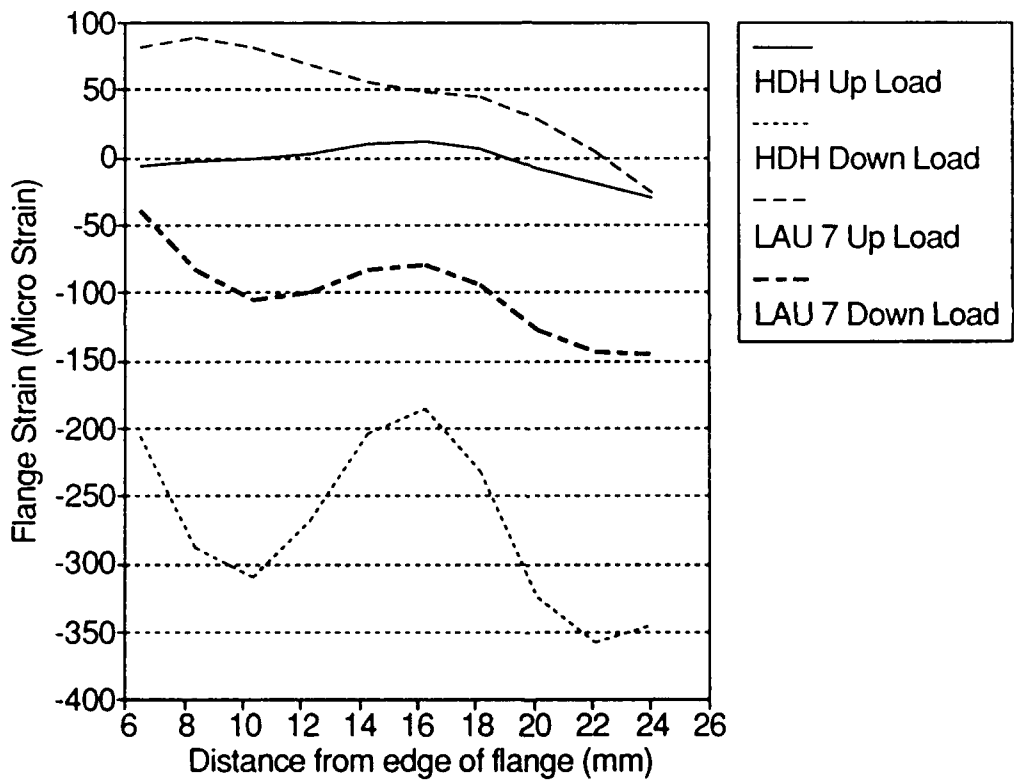
FIG. 3: UPPER FLANGE STRAIN DISTRIBUTION AT 100% LOAD  
STRIP GAUGE 11 AFT HANGER LOCATION

Figures 3 to 8 inclusive are plots of the strip gauge data presented in Table 3 for the aft missile hanger location, i.e. gauges 11,12,13,14,15, and 16.

For the down loading case the plots for gauges 11 and 12 (Figs. 3 and 4) indicate that the HDH snubber does cause the upper flange of the launcher to carry more load at the aft missile hanger location. The compressive strains produced with the HDH snubber are about 100 microstrain higher than with the LAU-7/A snubber. The result for gauge 13 (Fig. 5) shows little change.

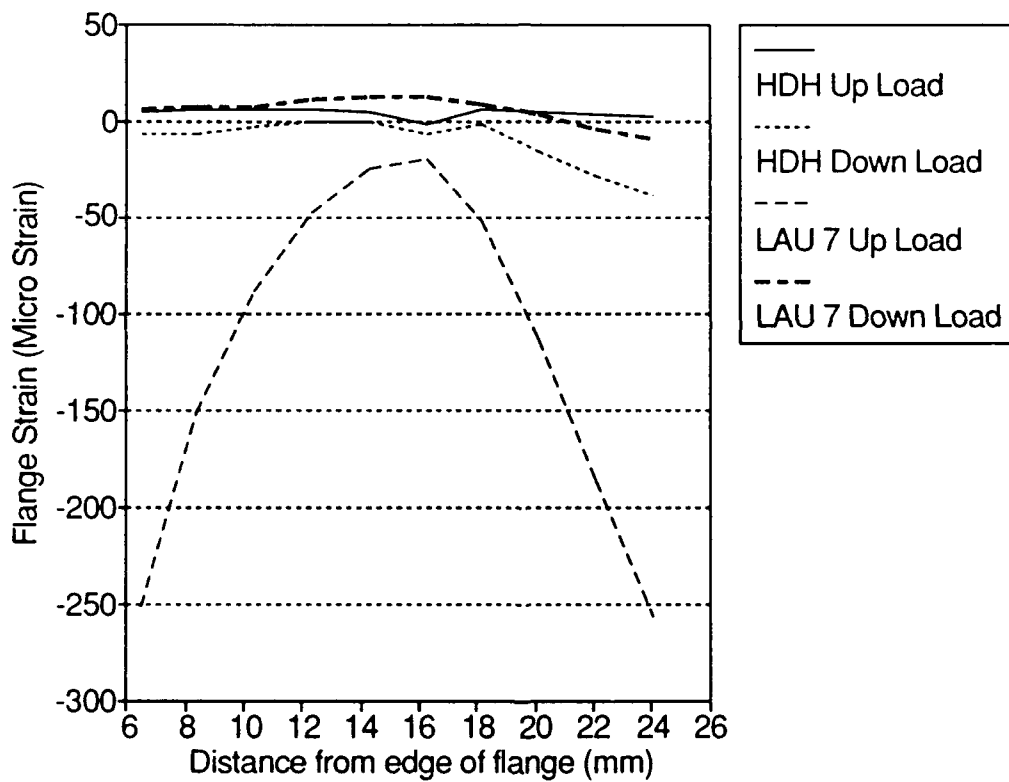
FIG. 5: UPPER FLANGE STRAIN DISTRIBUTION AT 100% LOAD  
STRIP GAUGE 13 AFT HANGER LOCATION

Obtaining consistent static and dynamic strain surveys was difficult with either snubbing system. This is attributed to slippage of the missile relative to the launcher at the aft hanger location, resulting from ineffective snubbing action. Some anomalous strain results, such as from gauges 12 and 13 for up loading with the LAU-7/A snubbing system (Figs. 4 and 5), are perhaps attributable to this slippage.

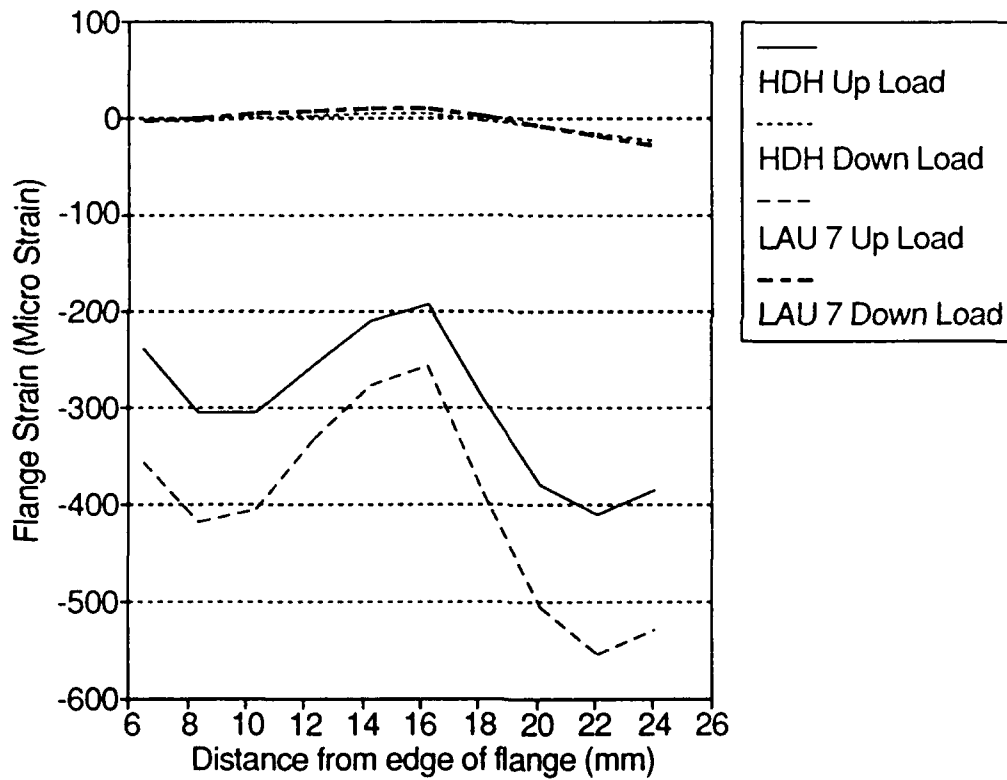
FIG. 6: LOWER FLANGE STRAIN DISTRIBUTION AT 100% LOAD  
STRIP GAUGE 14 AFT HANGER LOCATION

Note that for up loading, generally only the gauges on the lower flange give significant response. (Vice versa for down loading). The plots for gauges 14 and 15 (Figs. 6 and 7) indicate that the flange strains produced at the aft missile hanger location during up loading of the missile are lower when the HDH snubber is fitted. The strain produced at gauge 16 (Fig. 8) is approximately the same for both types of snubber.
