REPORT FR9201-01

**ADVANCED BRISTLE SEALS  
FOR  
GAS TURBINE ENGINES**

**PHASE I FINAL REPORT COVERING PERIOD OF MAY THRU NOVEMBER 1992**

**ENGINEERED DESIGNS, INC.**

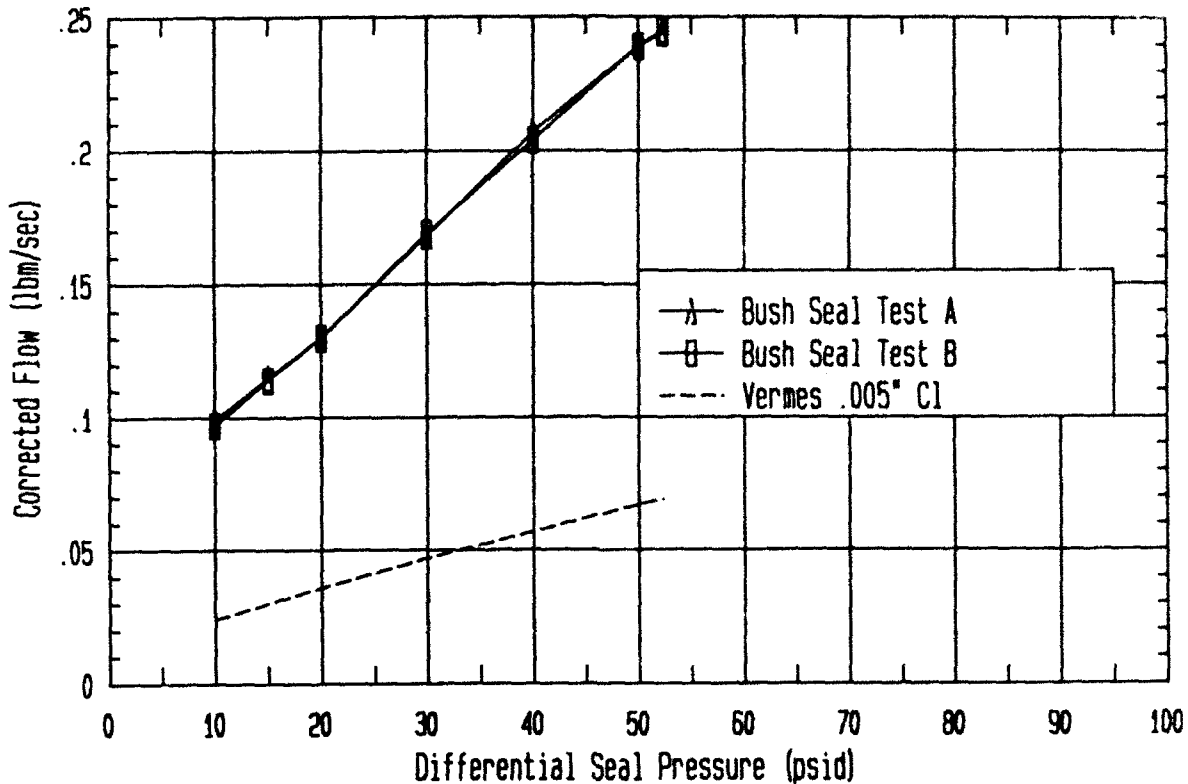
FIGURE 12. TEST SEQUENCES A & B VERSUS PREDICTED FLOW

The recorded and corrected data from these test sequences are tabulated in Appendix D as Tables D-1 and D-2. The results of this testing are plotted in Figure 12 along with the predicted flows using the Vermes equation. As can be seen, the flows are significantly larger than those predicted by Vermes. This discrepancy led to additional investigative test sequences being run.

After the results of the static testing were studied, it was determined that higher flows were experienced than were predicted. Potential causes were determined to be: that the calibration and/or correction of the flowmeter was inaccurate; that the test article radial gap was different during pressurization than was measured statically; that there was air flow through the bristle bundles or some other unaccounted for leakage; or a combination of these possibilities. Additional static test sequences were conducted to determine the discrepancy in flow.

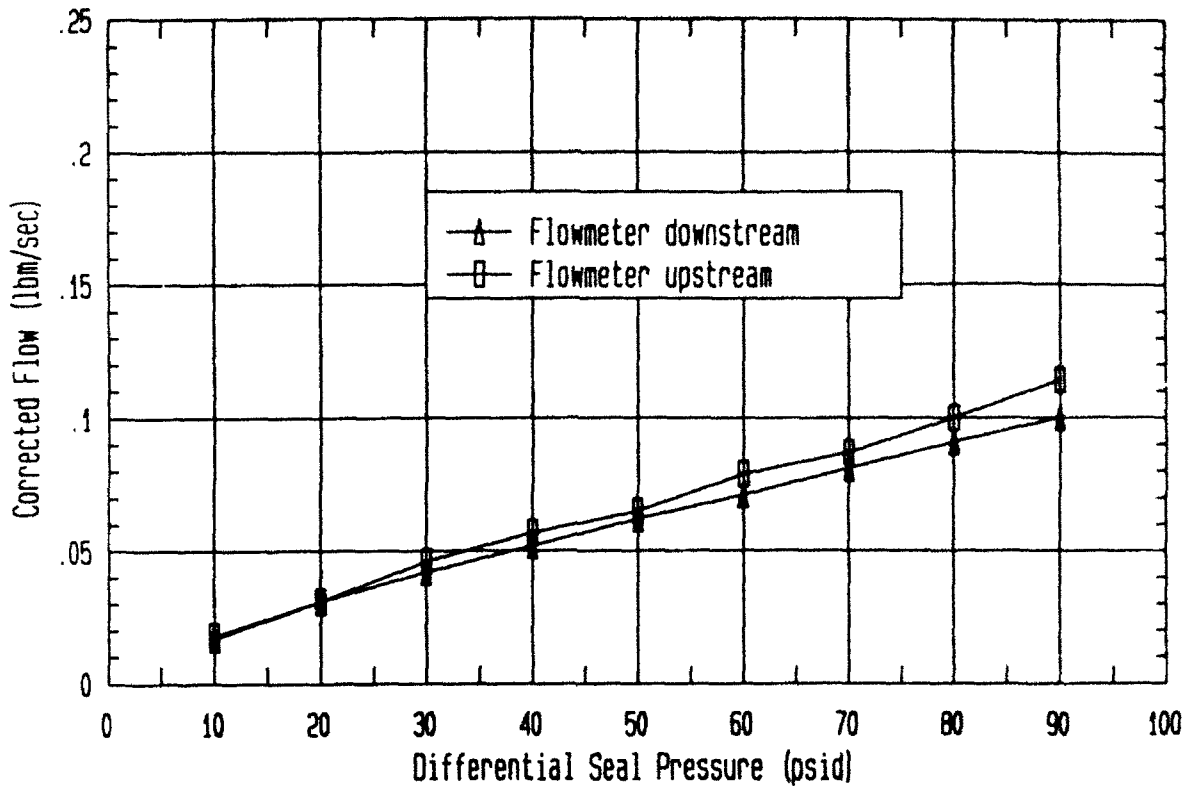
FIGURE 13. SIMPLE ORIFICES VERSUS PREDICTED FLOW

Investigative Test Sequences C, D, & E were performed to determine if the positioning of the flow meter was incorrect. The vendor of the flowmeter indicated that some reading differences could be caused by the regulator being installed up stream of the flow meter. While no strong reason could be established because there were long straight sections of tube between the components, a simple test was conducted in which the regulator and flow meter were reversed. This testing was conducted with only a constricting orifice (a sample nozzle) in place of the test head and test article. Data from these test sequences are tabulated in Appendix D, Tables D-3, D-4, and D-5. No significant differences were found as shown in Figure 13.

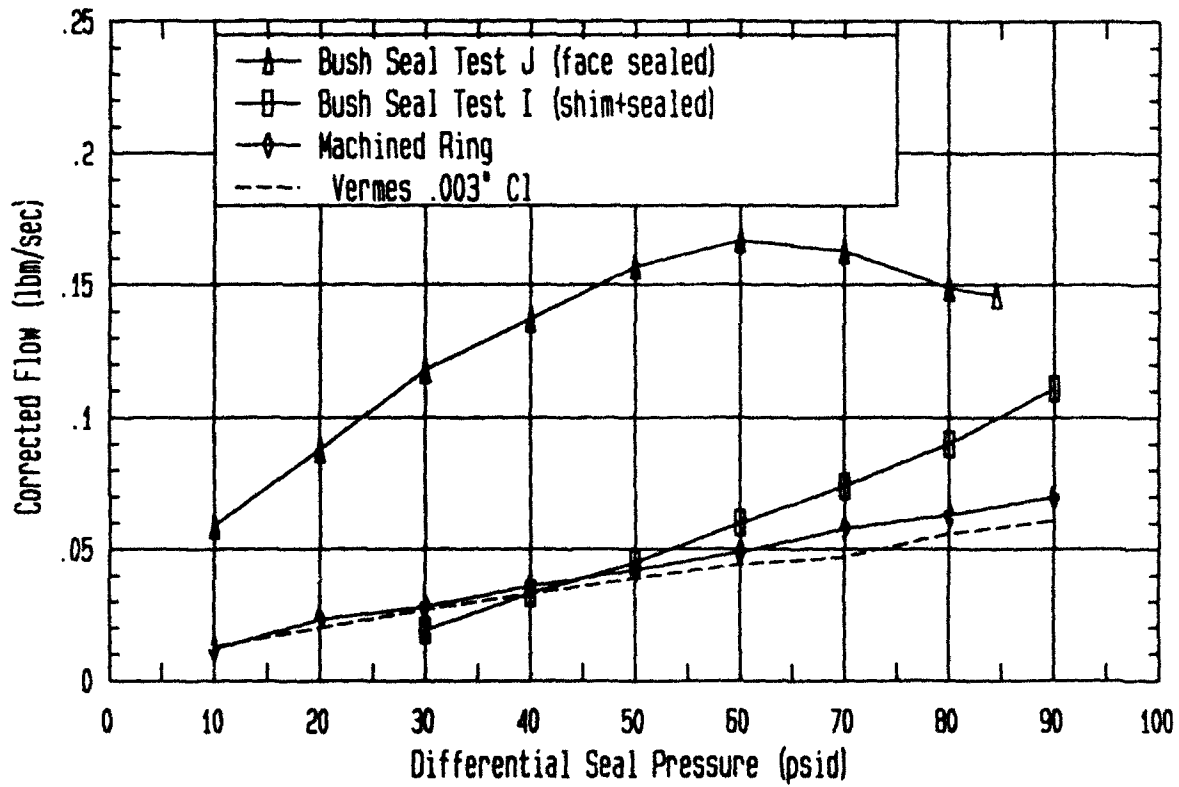
FIGURE 19. SHIMMED AND RTV SEALED TESTS VERSES PREDICTED FLOW

The collected data of test sequences H through J are tabulated in Appendix D, Tables D-8, D-9, and D-10. Plotted data is shown in Figure 19. This investigative testing tends to confirm that the bush seal test article was leaking through and/or around the bristle bundles. The exposed axial face of the bristle bundles gives the pressurized air access to the space between the bristle

bundles. It was observed that during the testing with the shim, but without the RTV, that the bristle bundles in the loose bundle area did deflect in an axial direction. Visual observation of this same area during the testing with only the RTV showed the RTV dimpling in an axial direction, as well as deflecting radially inward at the higher pressure points. The deflection radially inward could explain the way the flow curve for this case changed with increasing pressure.
