Miscellaneous Paper CERC-93-8  
August 1993

## Coastal Geologic and Engineering History of Presque Isle Peninsula, Pennsylvania

by *Richard J. Gorecki*  
*U.S. Army Engineer District, Buffalo*

*Joan Pope*  
*Coastal Engineering Research Center*

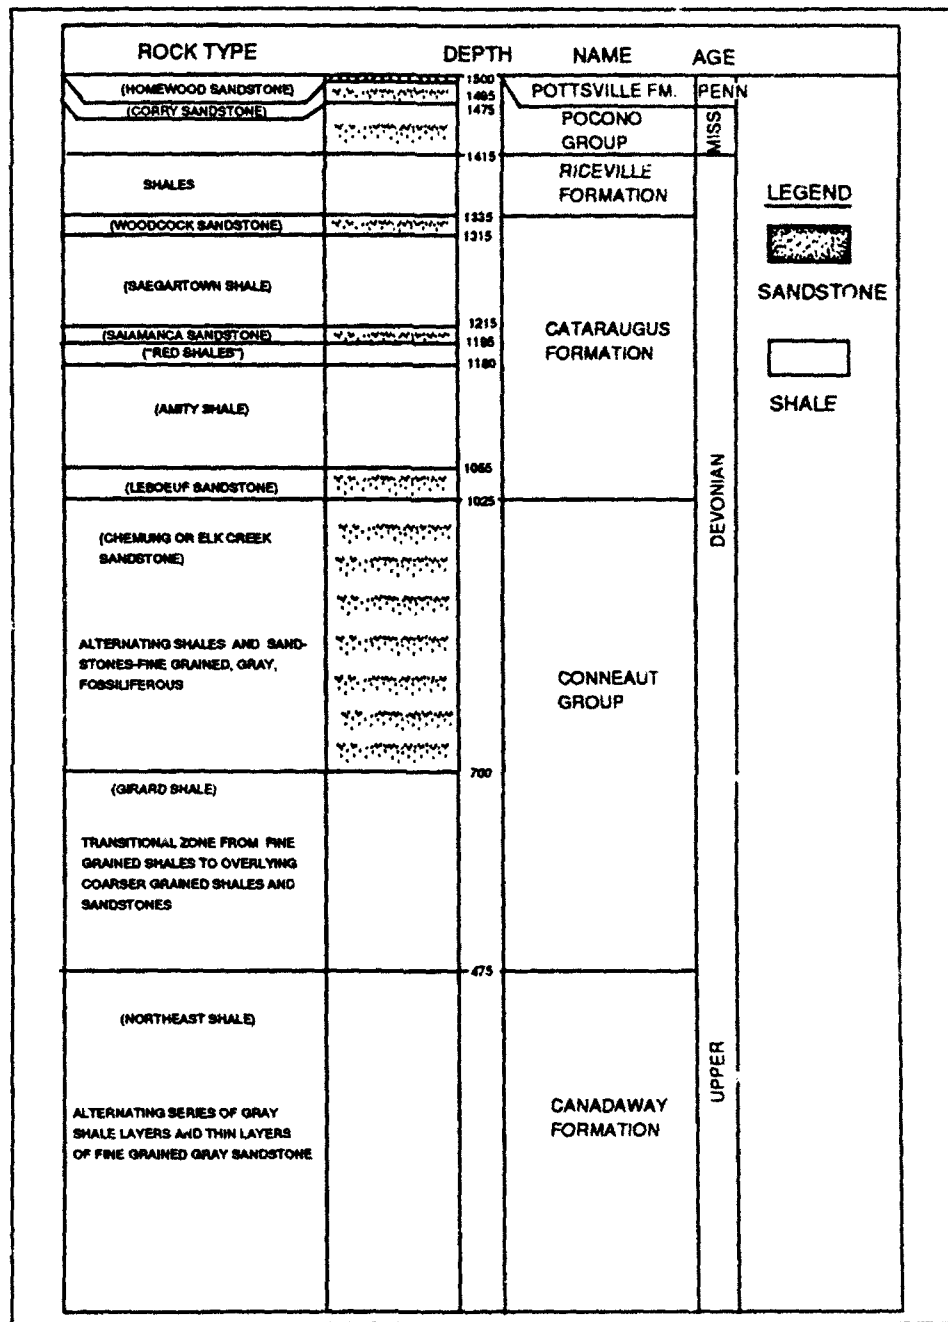
Figure 3. Bedrock exposed in Erie County Pennsylvania (modified from Tomikel and Shepps (1967))

Bedrock exposed in Erie County, Pennsylvania, is predominantly Upper Devonian shales and siltstones of the Conneaut and Canadaway Groups. Figure 3 is a geologic column of exposed rock. At Presque Isle, there is a lakeward slope of the rock surface with contours parallel to the mainland. At the junction of the neck of the peninsula with the general shore, the bedrock surface is only 2 ft below LWD. A gas well drilled near the northeast corner of the Waterworks ponds on Presque Isle (Figure 2) shows rock to be about 112 ft deep. Borings taken in 1965 by a consulting firm for the state of Pennsylvania extended in a line across the harbor entrance channel and showed that the rock surface sloped lakeward with a 1 on 125 slope and a depth approximately 60 ft below LWD near Beach No. 11 (Rummel, Klepper, and Kahl-Fertig Engineering Company 1968). The bedrock here is likely to be the gray shale of the Java Formation of the Venango Group (Socolow 1980).

30 ft below LWD. Bedrock at the project site is from the Java Formation of the Venango Group. The Java formation is a fissile, horizontally bedded gray shale.

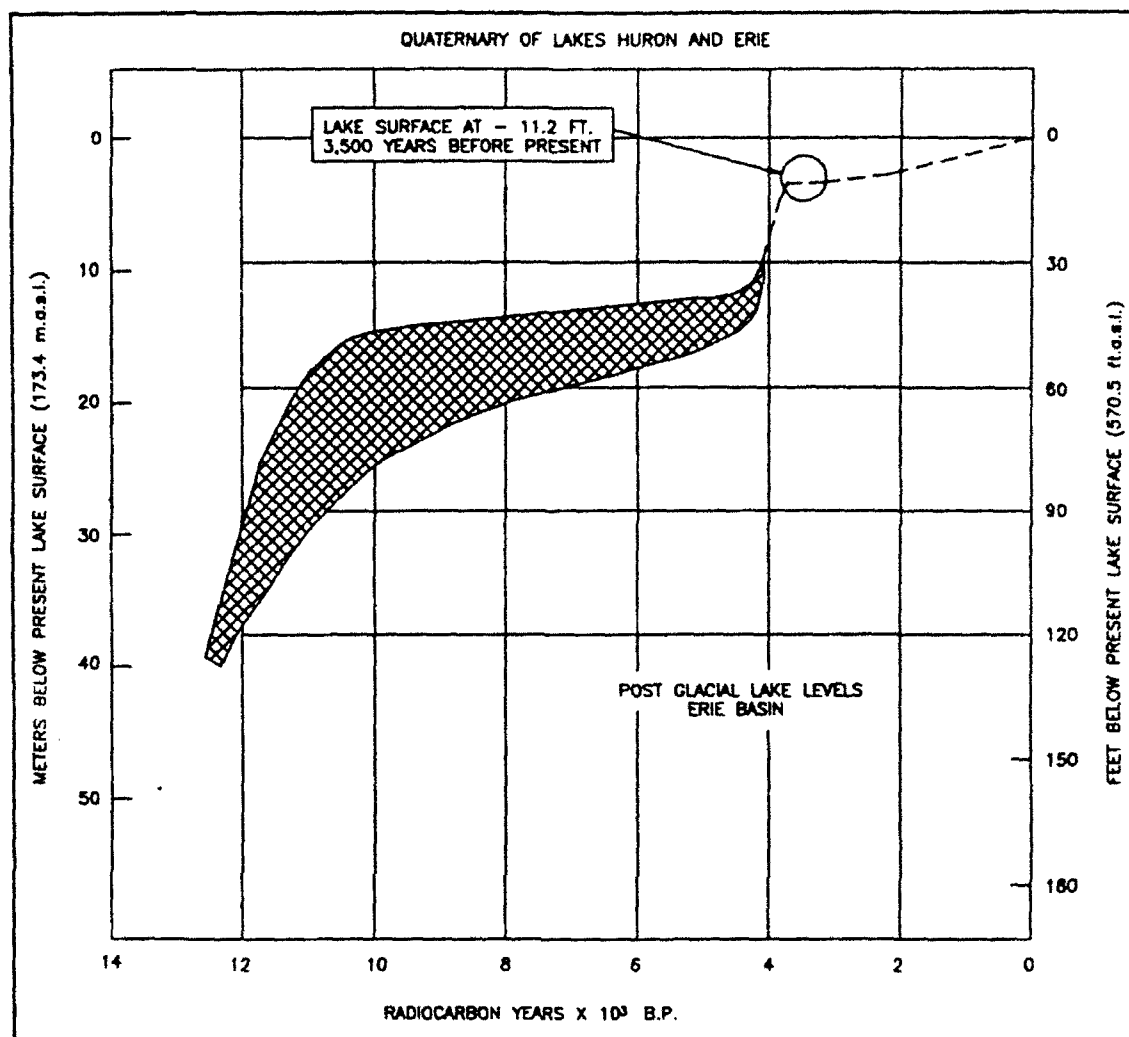
Figure 8. Post-glacial history of Lake Erie water levels (modified from Lewis (1969))

In another study of water levels, Lewis (1969) compared radiocarbon dates with known lake levels and developed the diagram shown as Figure 8. This shows the rate of change in water level in the Erie Basin during post-glacial time. Lewis prefers to use the curve near the upper envelope. If the lower curve is adopted, it would mean that levels in the eastern basin of the lake would have been lower than the channel along the southern margin of the Long Point-Erie Moraine for more than 1,500 years. Lewis' diagram also shows the steep rise of water from 5,000 to 3,800 years B.P. This initial rise corresponds to the abandonment of the North Bay, transferring more flow into the lower Great Lakes.

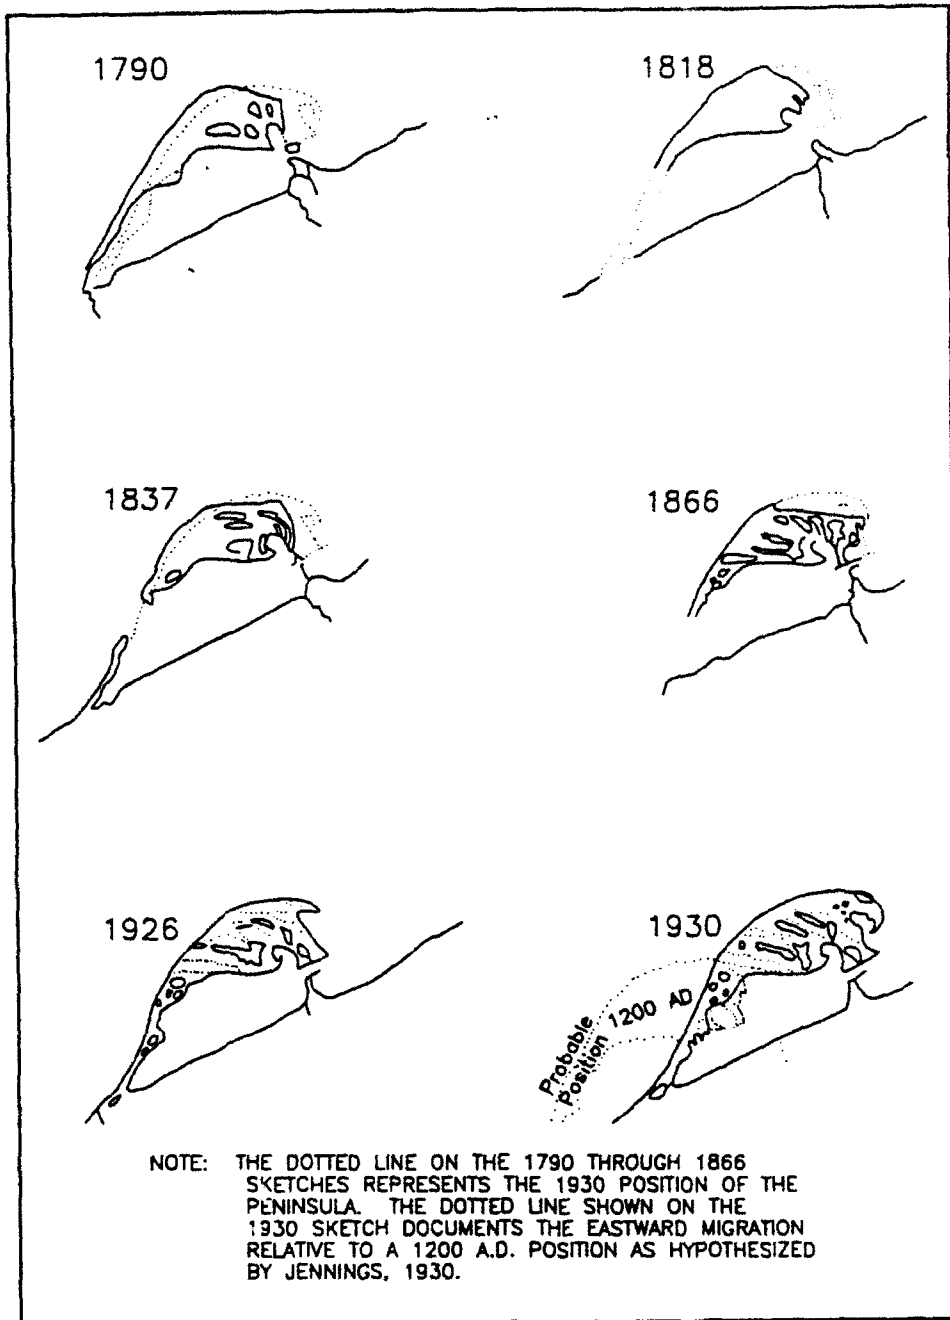
Figure 9. Growth and migration of Presque Isle (modified from Jennings (1930))

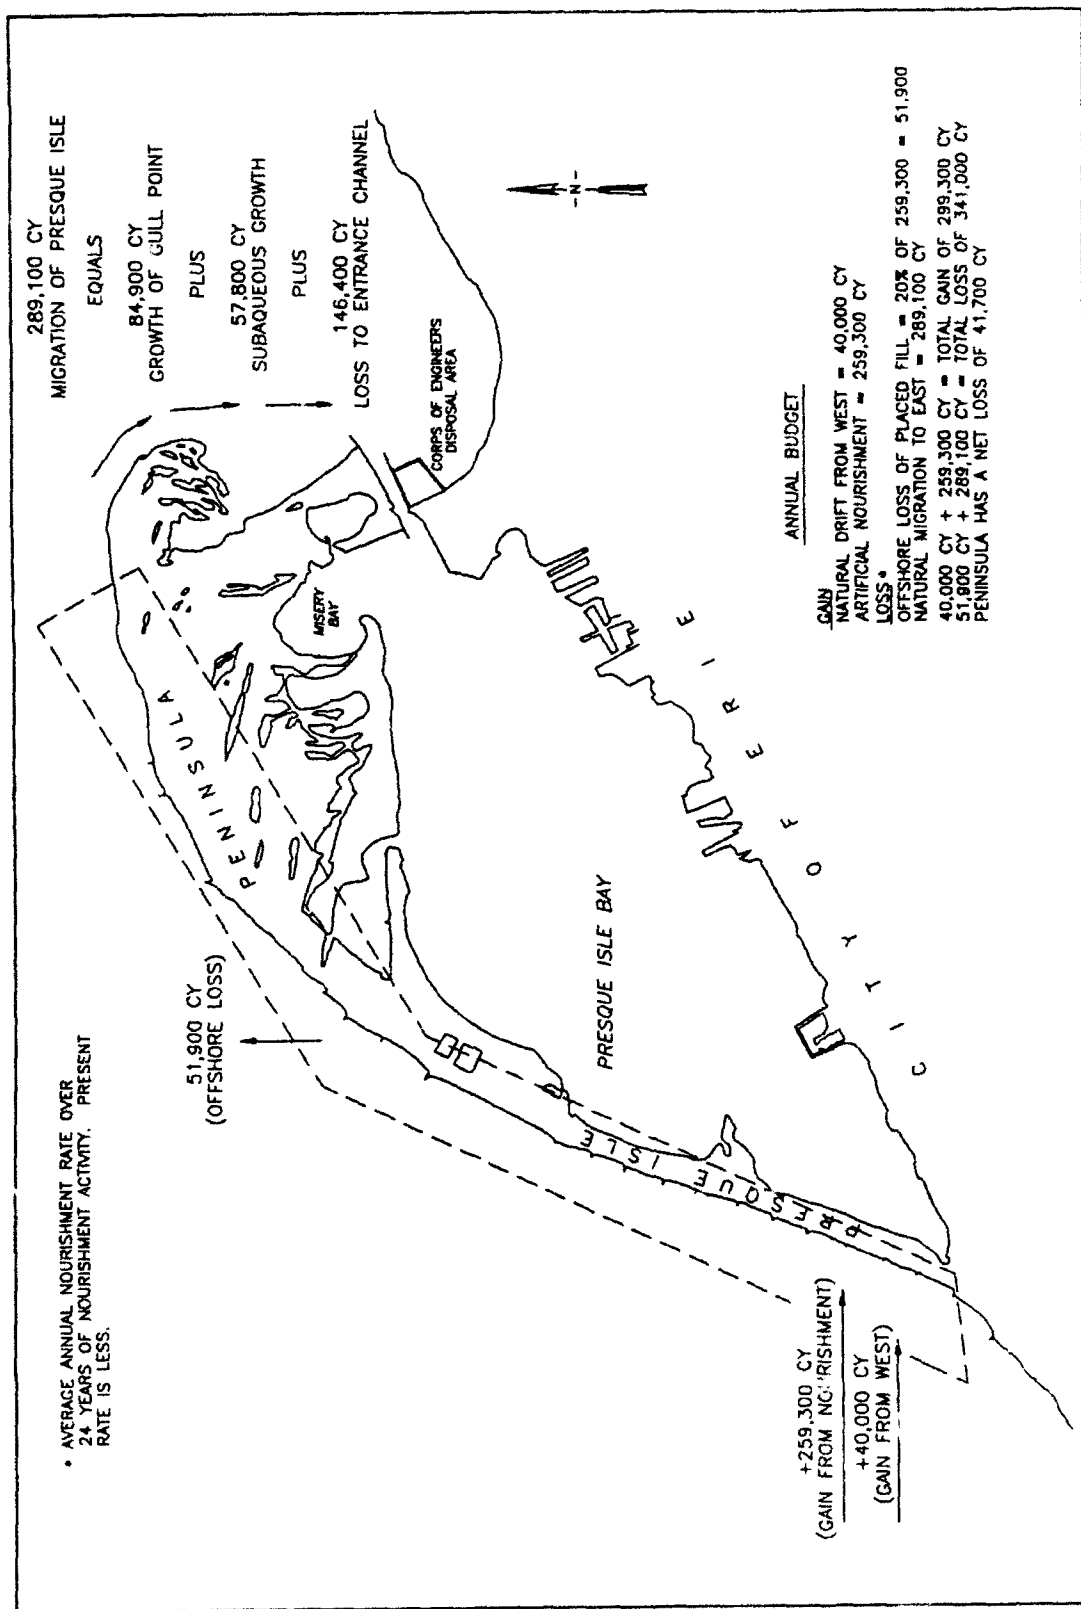
Figure 10. Present Presque Isle sediment with annual nourishment (modified from USAED, Buffalo (1980))

The main area of loss to the Presque Isle system is at the distal east end. Here the drifting sediment builds Gull Point, spills over the eastern end of the platform, building a new platform and is recurved shoreward and landward, shoaling across the Erie Harbor entrance channel. Estimates have been made to summarize losses at the east end based on historical changes at Gull Point, bathymetric charts, and dredging records for the Erie Harbor entrance channel (USAED, Buffalo 1980). Based on these figures, the present condition (with replenishment) is that an estimated 146,400 cu yd of littoral material accumulate in the entrance channel per year, 84,000 cu yd per year are involved in building Gull Point, and 57,800 cu yd per year build the new platform at the distal end (Figure 10).

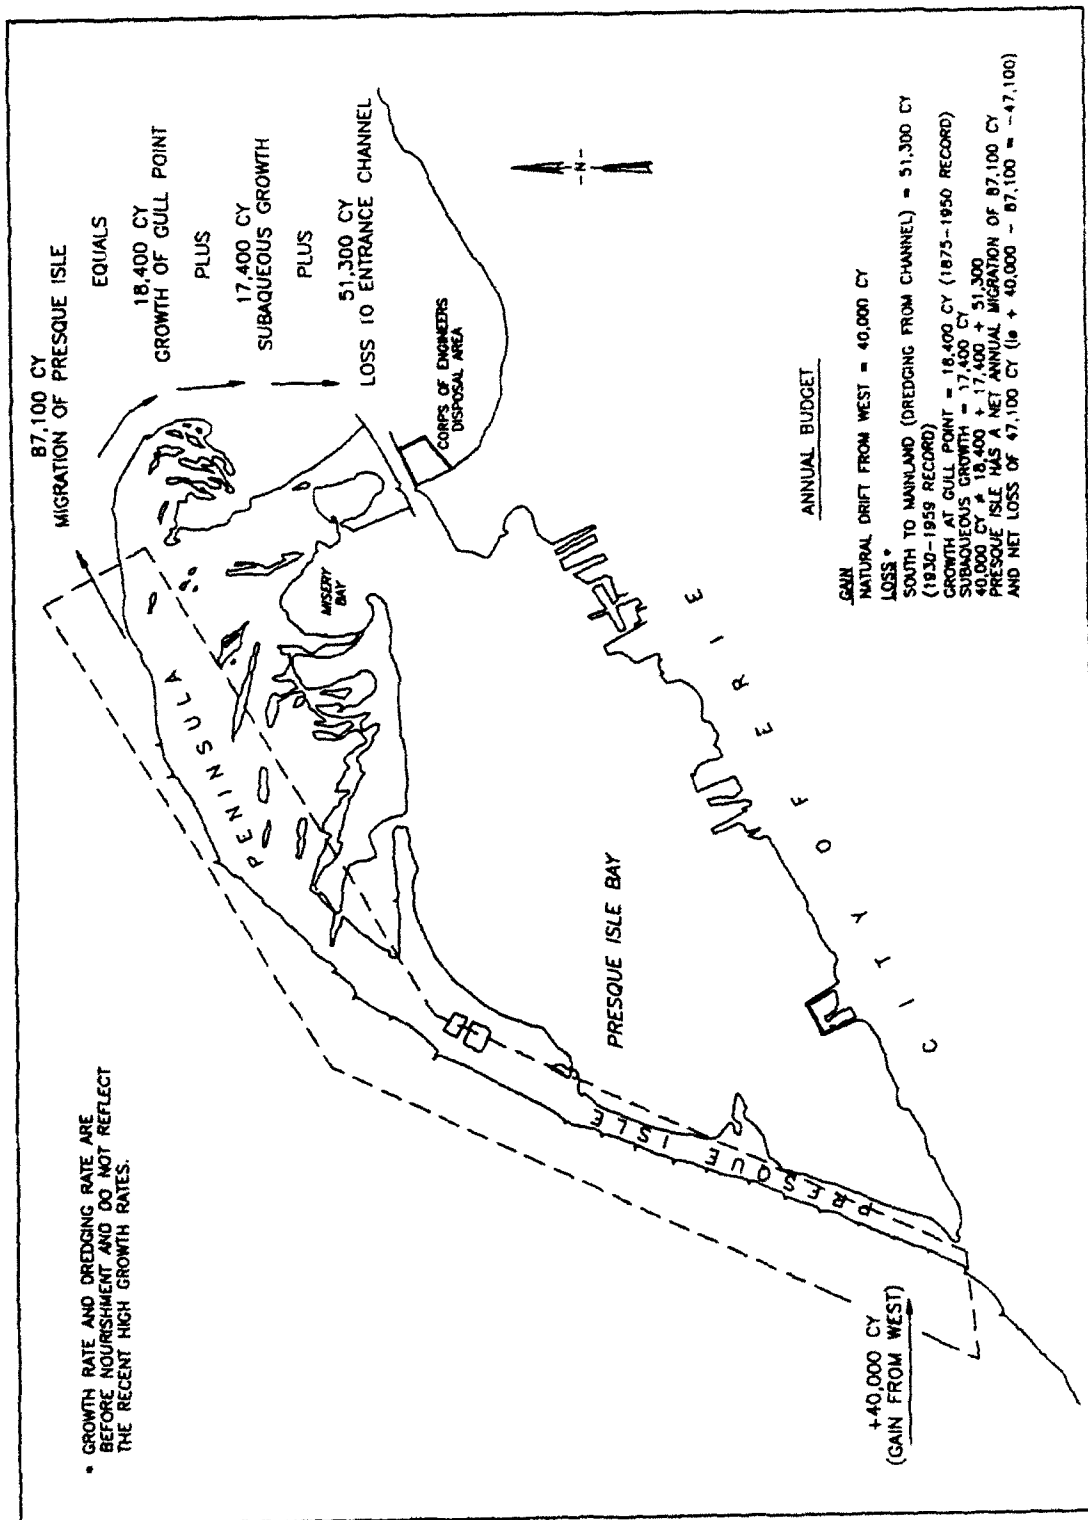
Figure 11. Presque Isle sediment budget without annual nourishment (modified from USAED, Buffalo (1980))

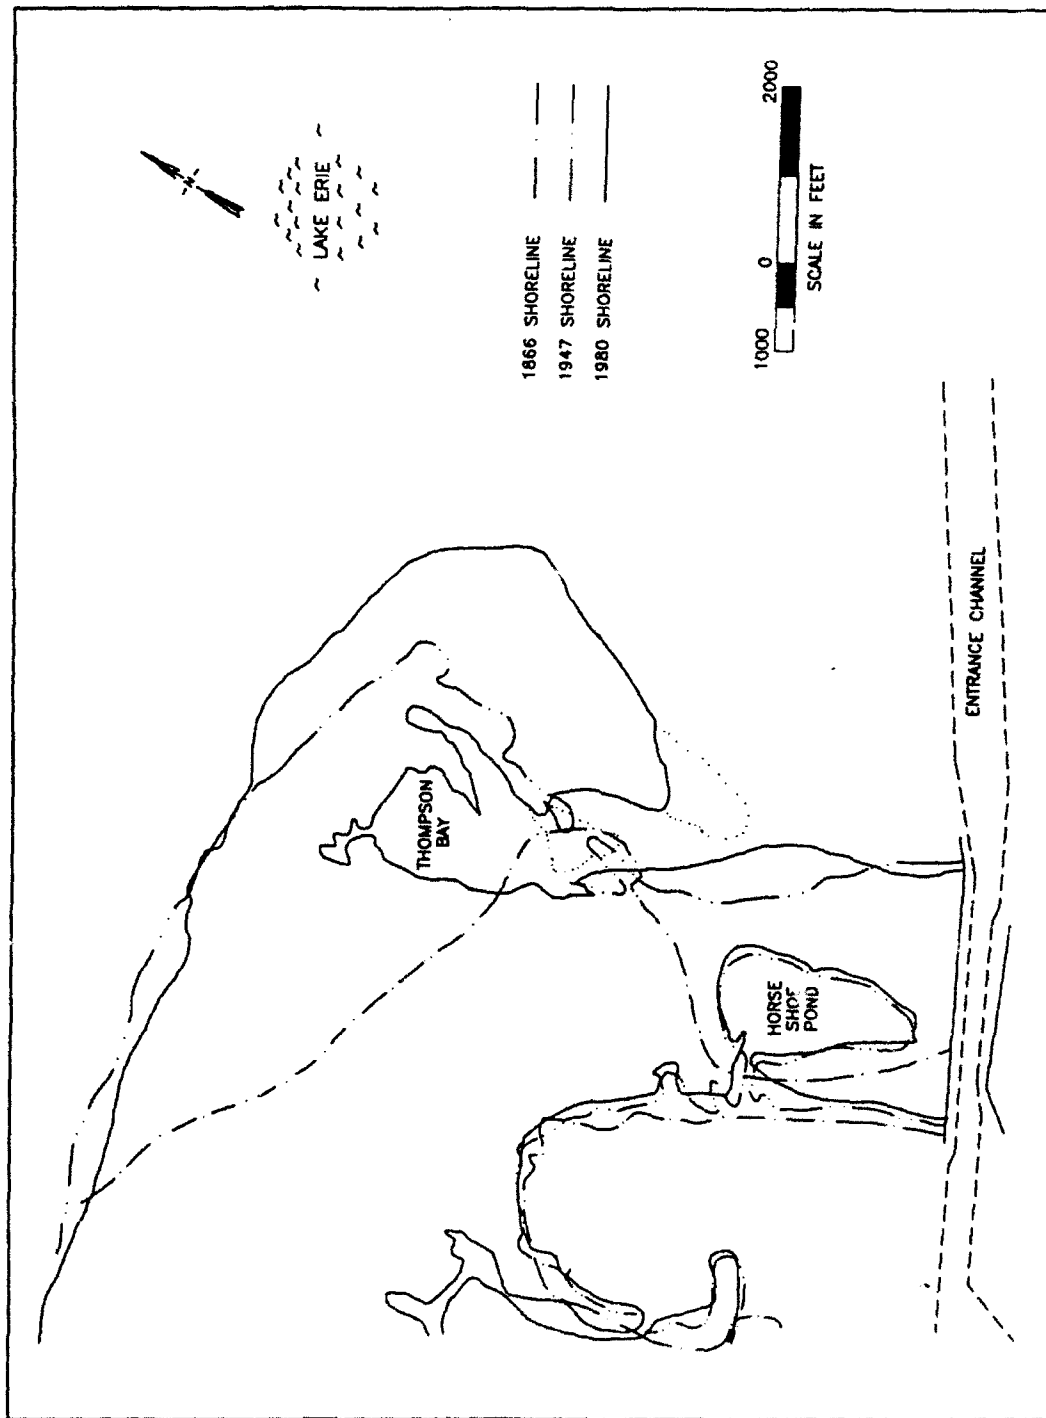
Figure 12. Presque Isle eastern 6-ft contour changes (1875-1980) (modified from USAED, Buffalo (1986))

material placed on the beaches ends up in the entrance channel. This will occur as Gull Point continues to migrate along an axis which intersects the entrance channel. The historical maps of the shoreline, and the 6-, 12-, and 18-ft below LWD depth contours which were originally presented in House Document 231 (U.S. Congress 1953) were updated and are shown in Figures 12 through 15.

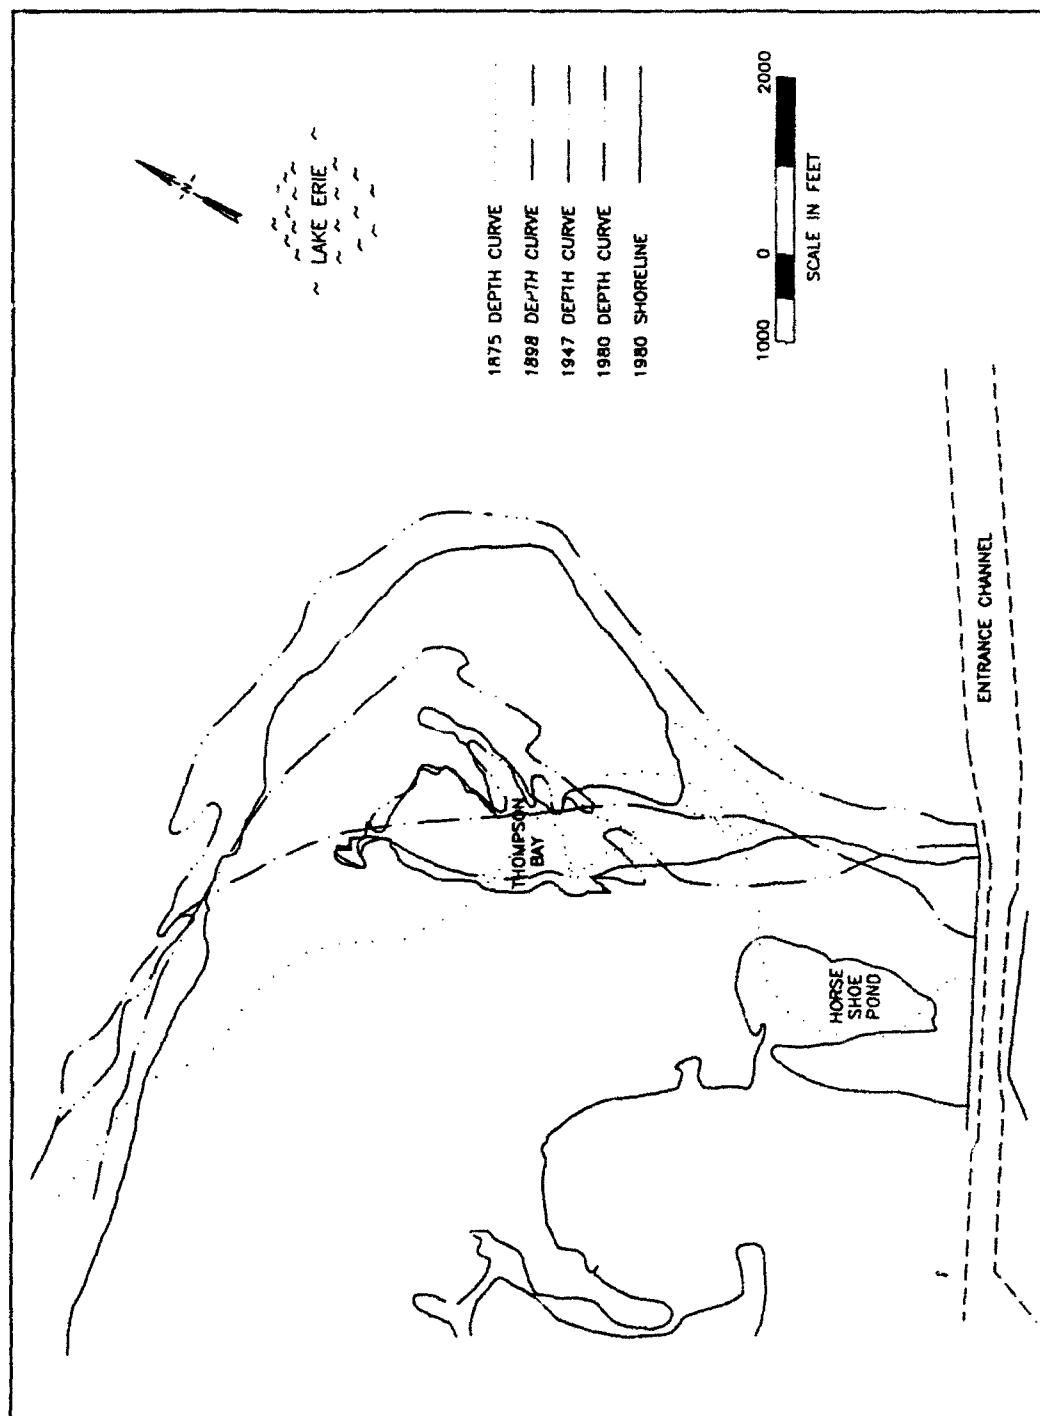
Figure 13. Presque Isle eastern 12-ft contour changes (1875-1980) (modified from USAED, Buffalo (1986))

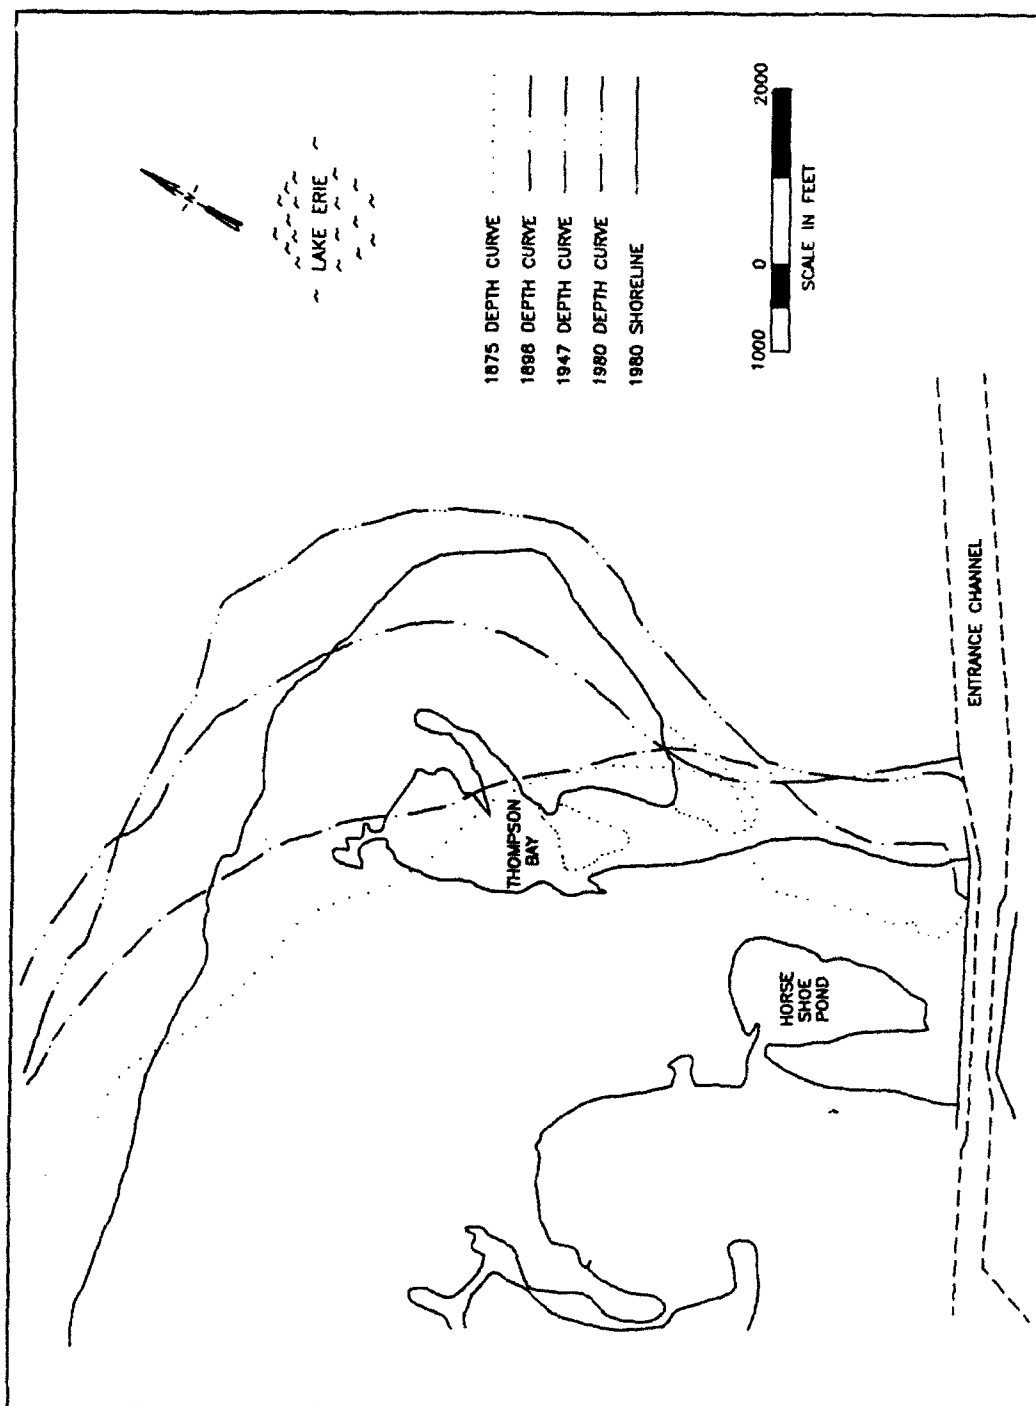
Figure 14. Presque Isle eastern 18-ft contour changes (1875-1980) (modified from USAED, Buffalo (1986))

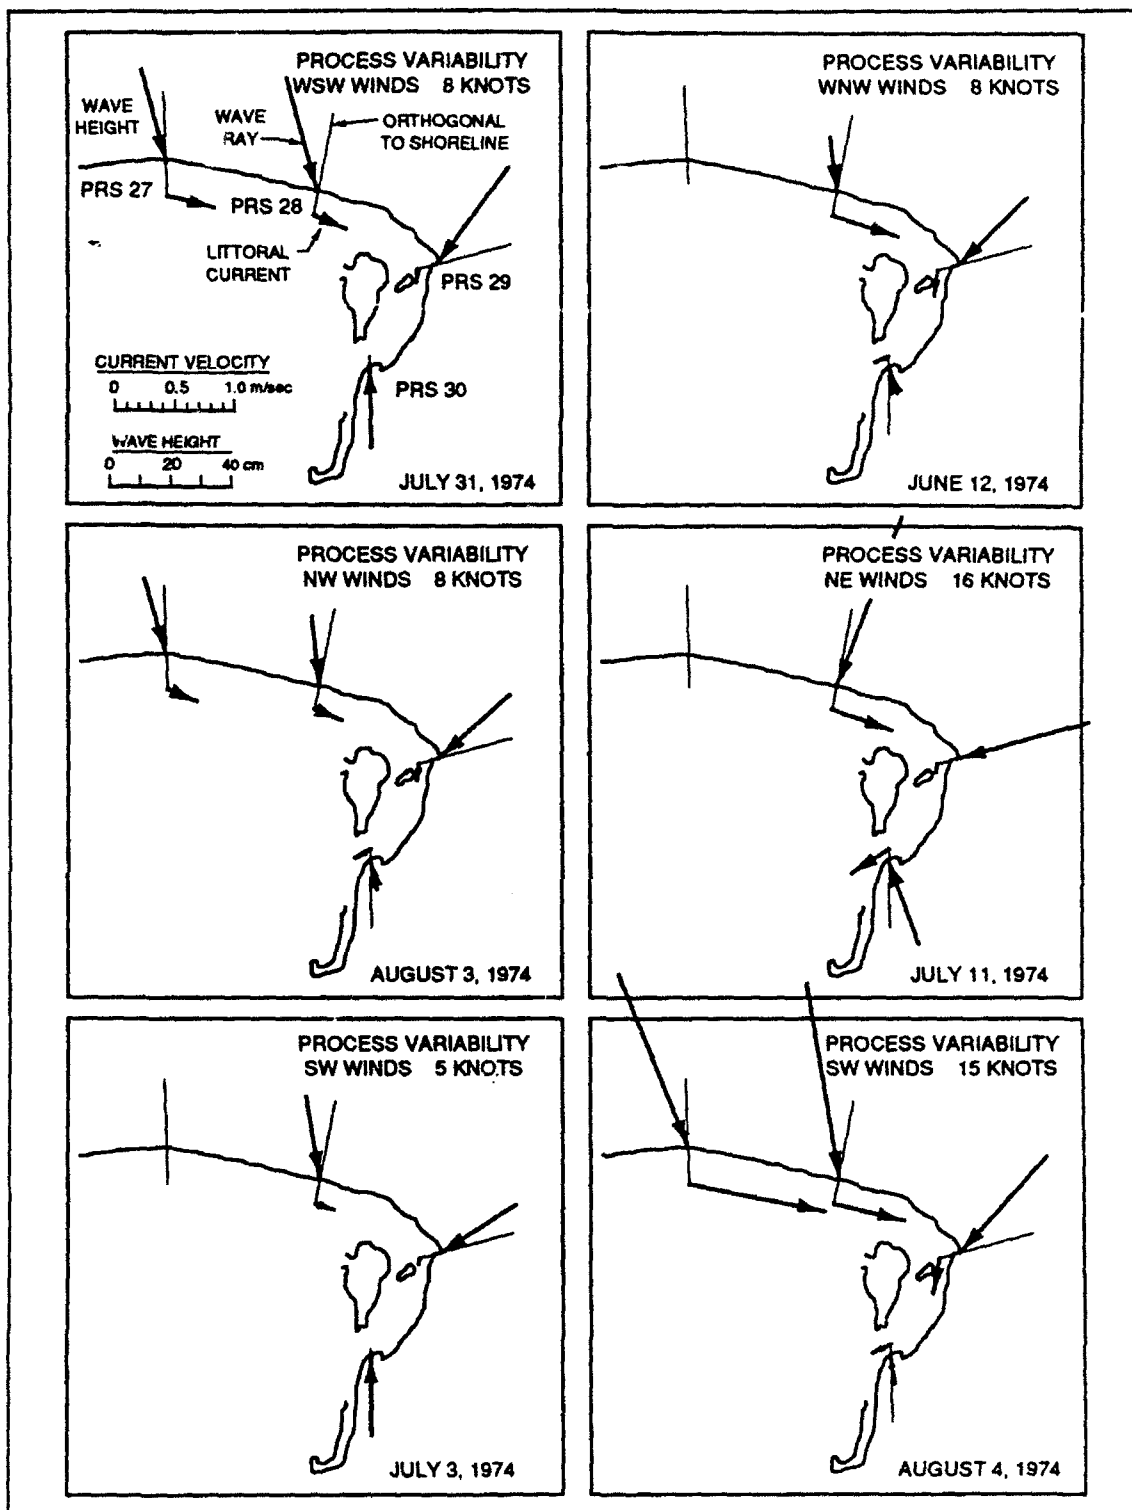
Figure 16. Observed wave height and longshore current velocity for various wind speeds and directions at Gull Point (modified from Messinger (1977))

At Erie, PA, 65 percent of the winds originate from the southwest to northwest and about 20 percent originate from the north to northeast (Messinger 1977) (wind data based on records of U.S. Coast Guard at Erie Harbor for the period of 1 January 1928 to 31 December 1941 and 1 January 1945 to 31 December 1971.) The process variability for the Gull Point area is presented in Figure 16 and indicates the observed wave height and longshore current velocity for various wind speeds and directions. Figure 16 shows that for winds out of the southwest to northwest, the longshore current direction is mainly to the east along the northern shoreline, with a small component of transport to the south along the recurve. The longshore current velocity decreases toward the east due to the sheltering effect of the peninsula and wave shoaling/refraction on the platform.

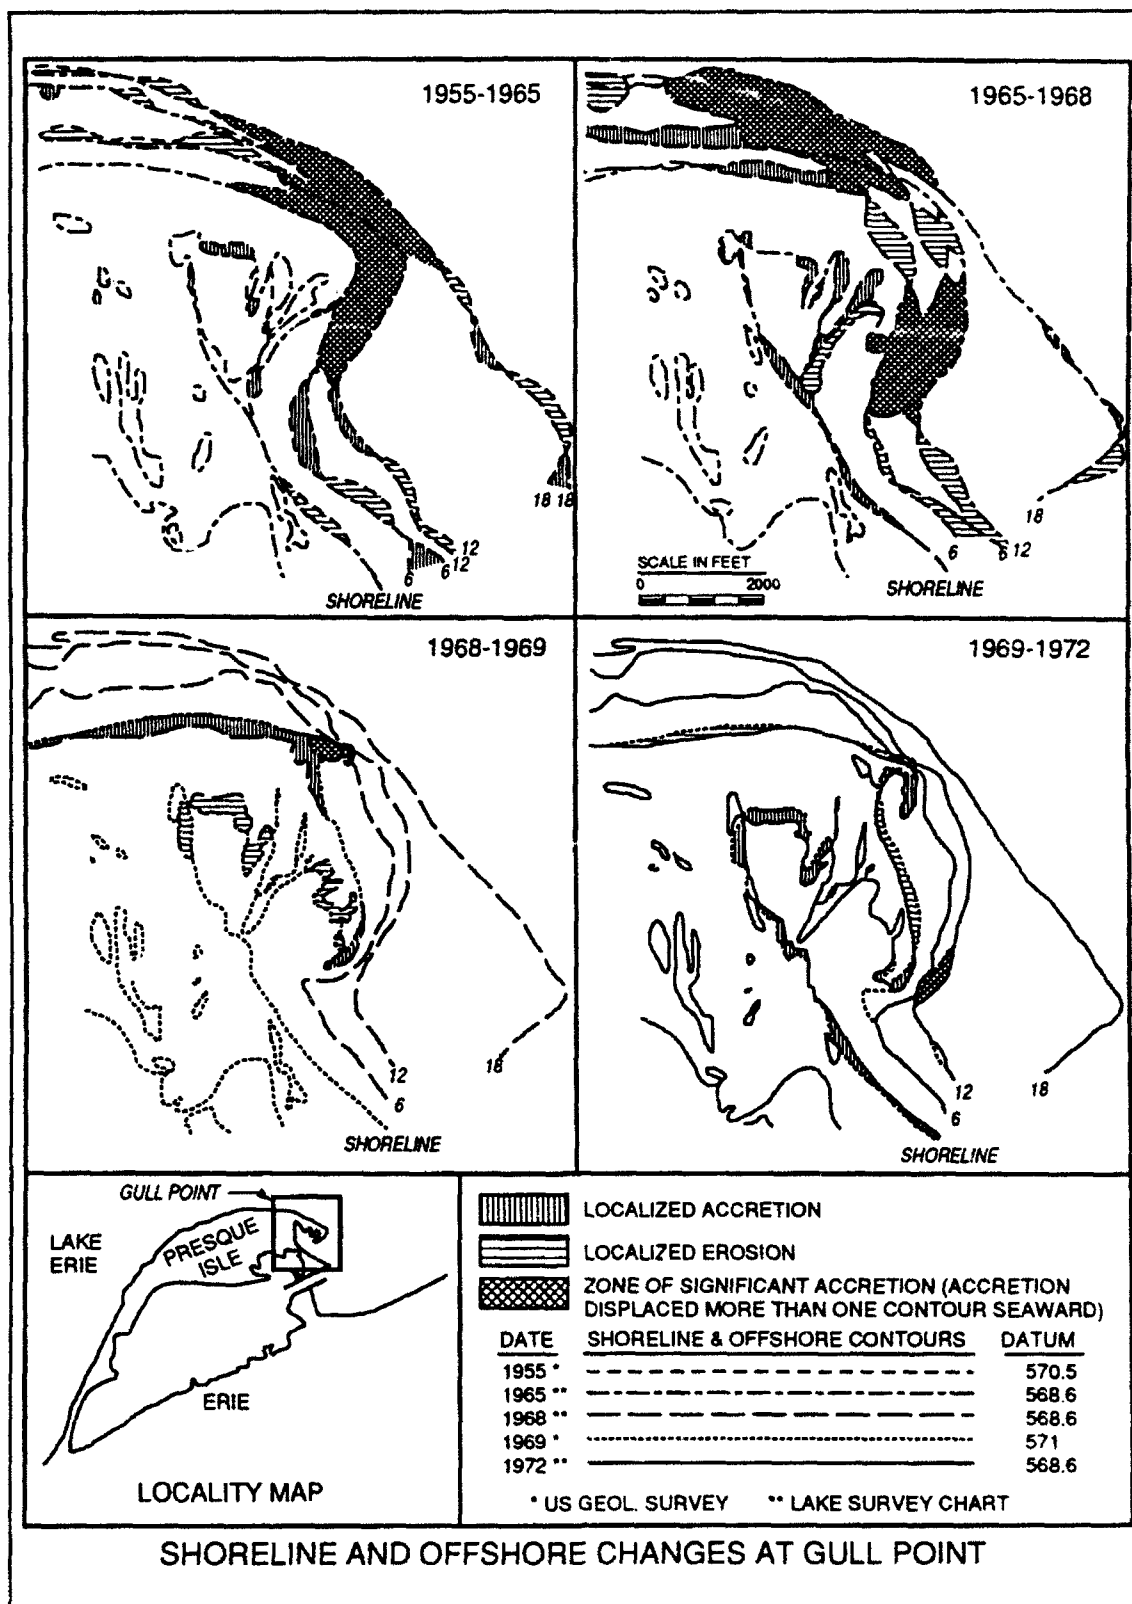
Figure 17. Growth of Gull Point from 1955 to 1972 (modified from Messinger (1977))

The growth of Gull Point, which has accelerated within recent times due to the beach nourishment program, is shown on Figures 17 through 19. Growth of Gull Point during the period from 1955 to 1972 (Figure 17) was greatest during the mid 1960's probably in response to the over 5,000,000 cu yd of sand that were placed on the peninsula beaches during construction of the initial beach erosion control project and early beach nourishment phases of the 1960's. During the period from 1975 to 1991, beach nourishment has been carried out on an annual basis to the order of about 160,000 to 185,000 cu yd per year. This has resulted in dramatic growth of Gull Point and the offshore platform (Figures 18 and 19) with dredging quantities in the Erie Harbor entrance channel increasing by about 4,400 cu yd per year. Continuation of the annual nourishment program at the present rate will continue to result in greater annual maintenance costs to Erie Harbor and will shorten the time frame of Gull Point/offshore platform advance to the entrance channel.

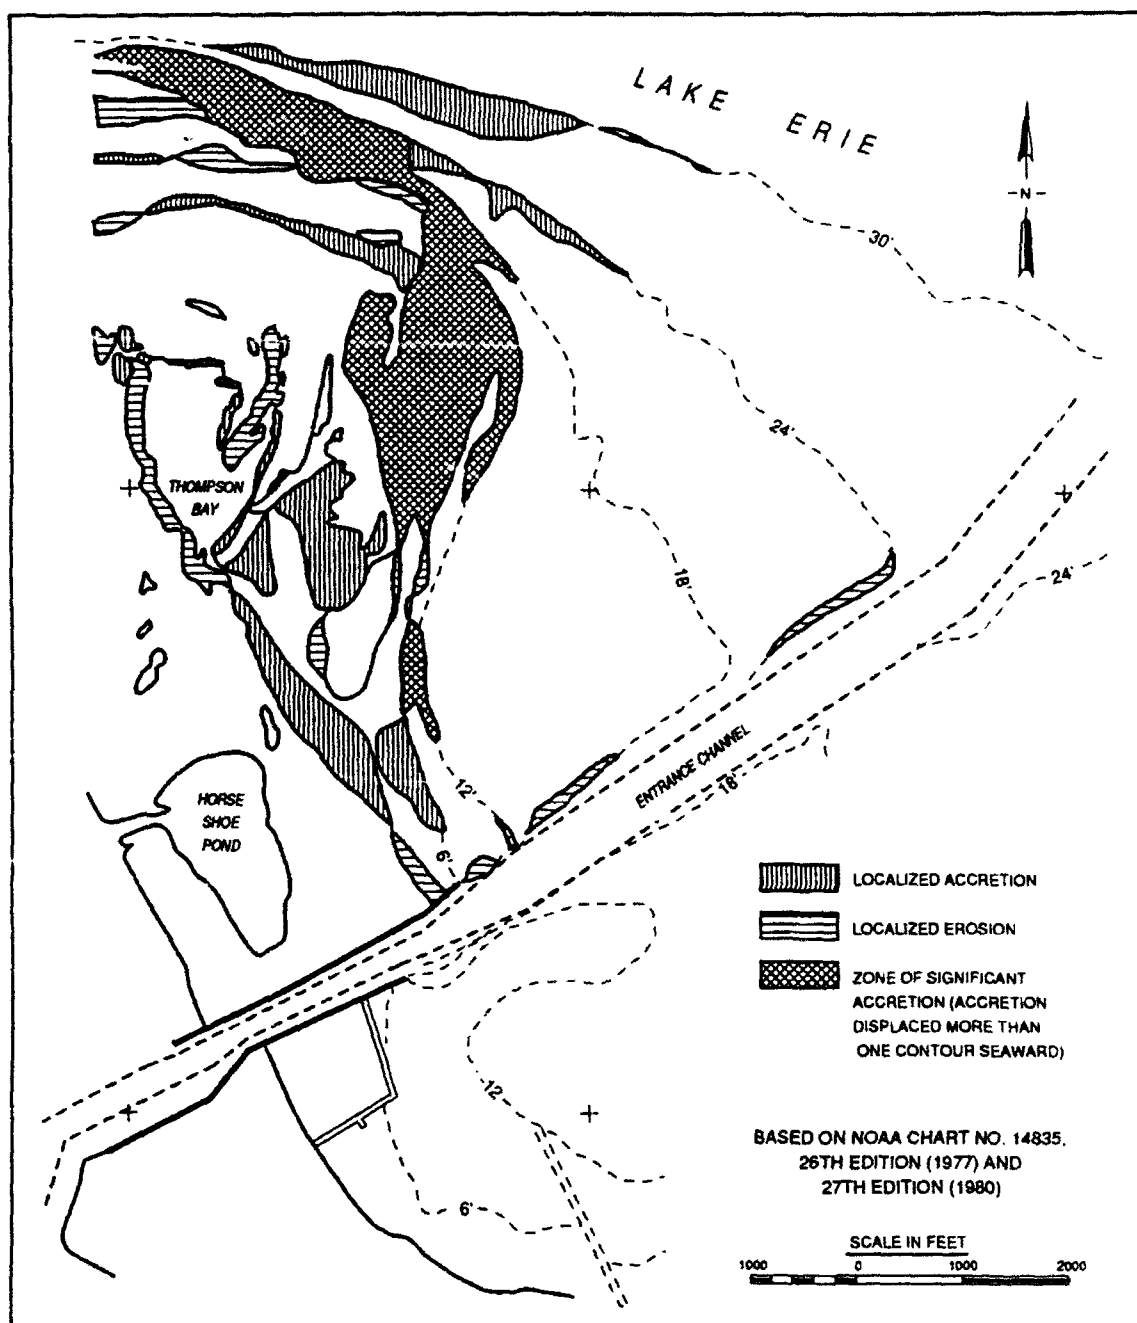
Figure 18. Growth of Gull Point from 1977 to 1980 (modified from USAED, Buffalo (1986))

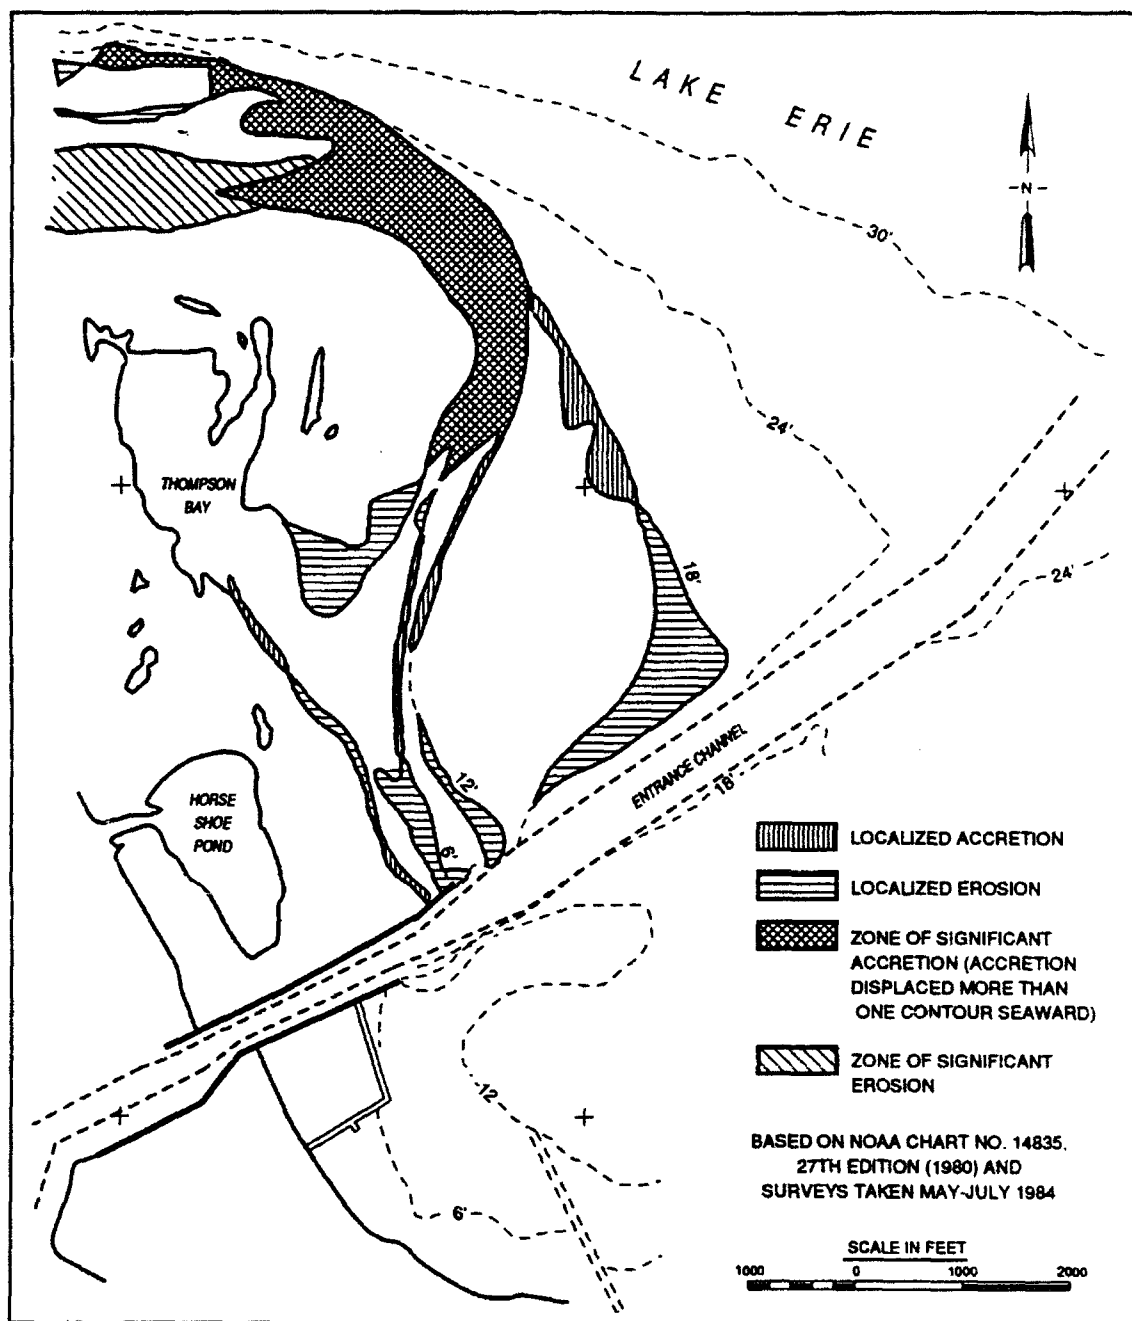
Figure 19. Growth of Gull Point from 1980 to 1984 (modified from USAED, Buffalo (1986))

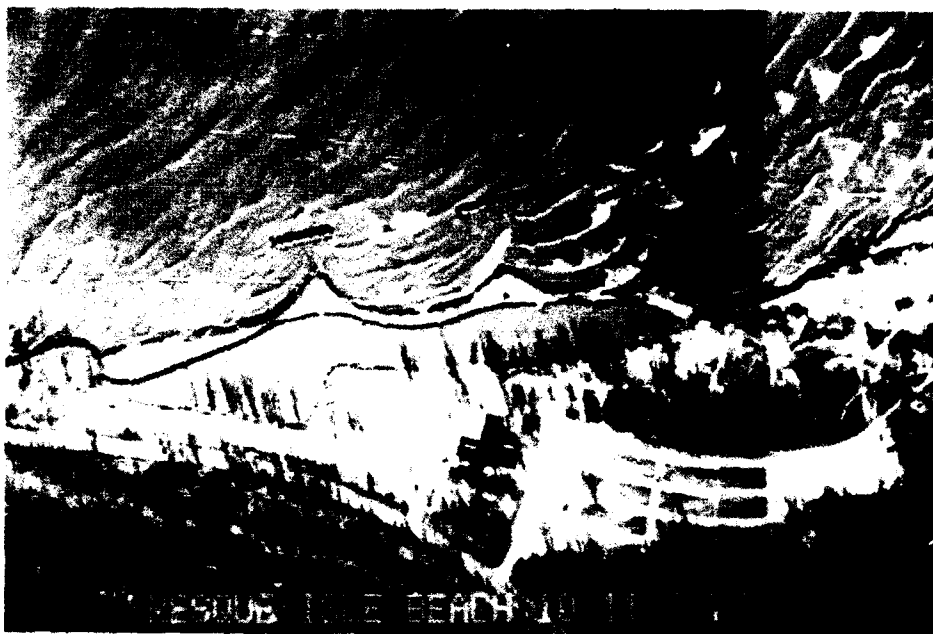
Figure 24. Beach No. 10, 9 November 1978

- a. By November 1978 (Figure 24), distinct salients were present behind the western and center breakwaters.
- b. On 6 April 1979, the project was subjected to a severe storm which may have exceeded the design event (design lake stage = 575.3 ft IGLD or +6.7 ft LWD and design wave = 7.0 ft) when winds gusting to 62 knots caused waves estimated by state park personnel to be 8 to 10 ft. A field inspection after the storm showed that there had been major changes along other portions of the peninsula shoreline; however, the breakwaters performed as designed with only slight movement of the stones, and salients still existed behind each structure as shown in Figure 25.
- c. In November 1979 (Figure 26), tombolos existed behind the western and center breakwaters and one had almost formed behind the eastern structure.

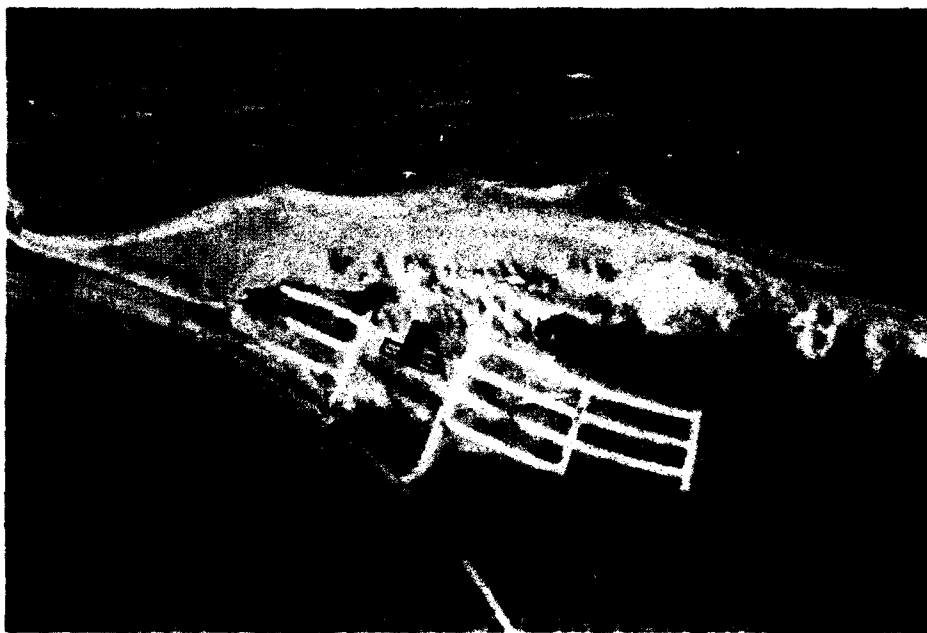
Figure 27. Beach No. 10, 17 April 1980

- d. Salients were still present in April 1980 (Figure 27). The 1980 fall photography (Figure 28) showed that there was not much change in the beach since the spring.

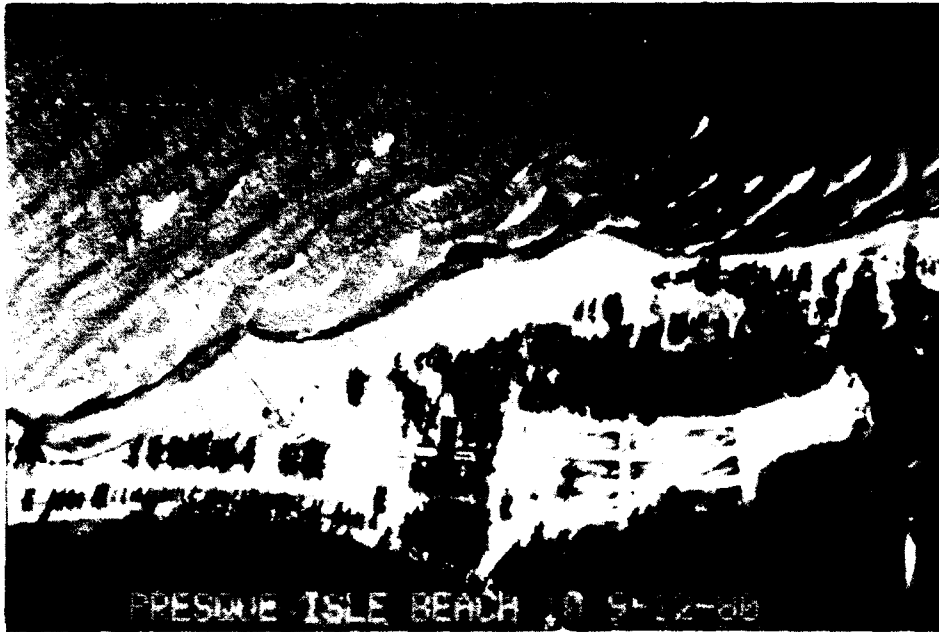
Figure 28. Beach No. 10, 12 September 1980
