Miscellaneous Paper CERC-93-8  
August 1993

## Coastal Geologic and Engineering History of Presque Isle Peninsula, Pennsylvania

by *Richard J. Gorecki*  
*U.S. Army Engineer District, Buffalo*

*Joan Pope*  
*Coastal Engineering Research Center*

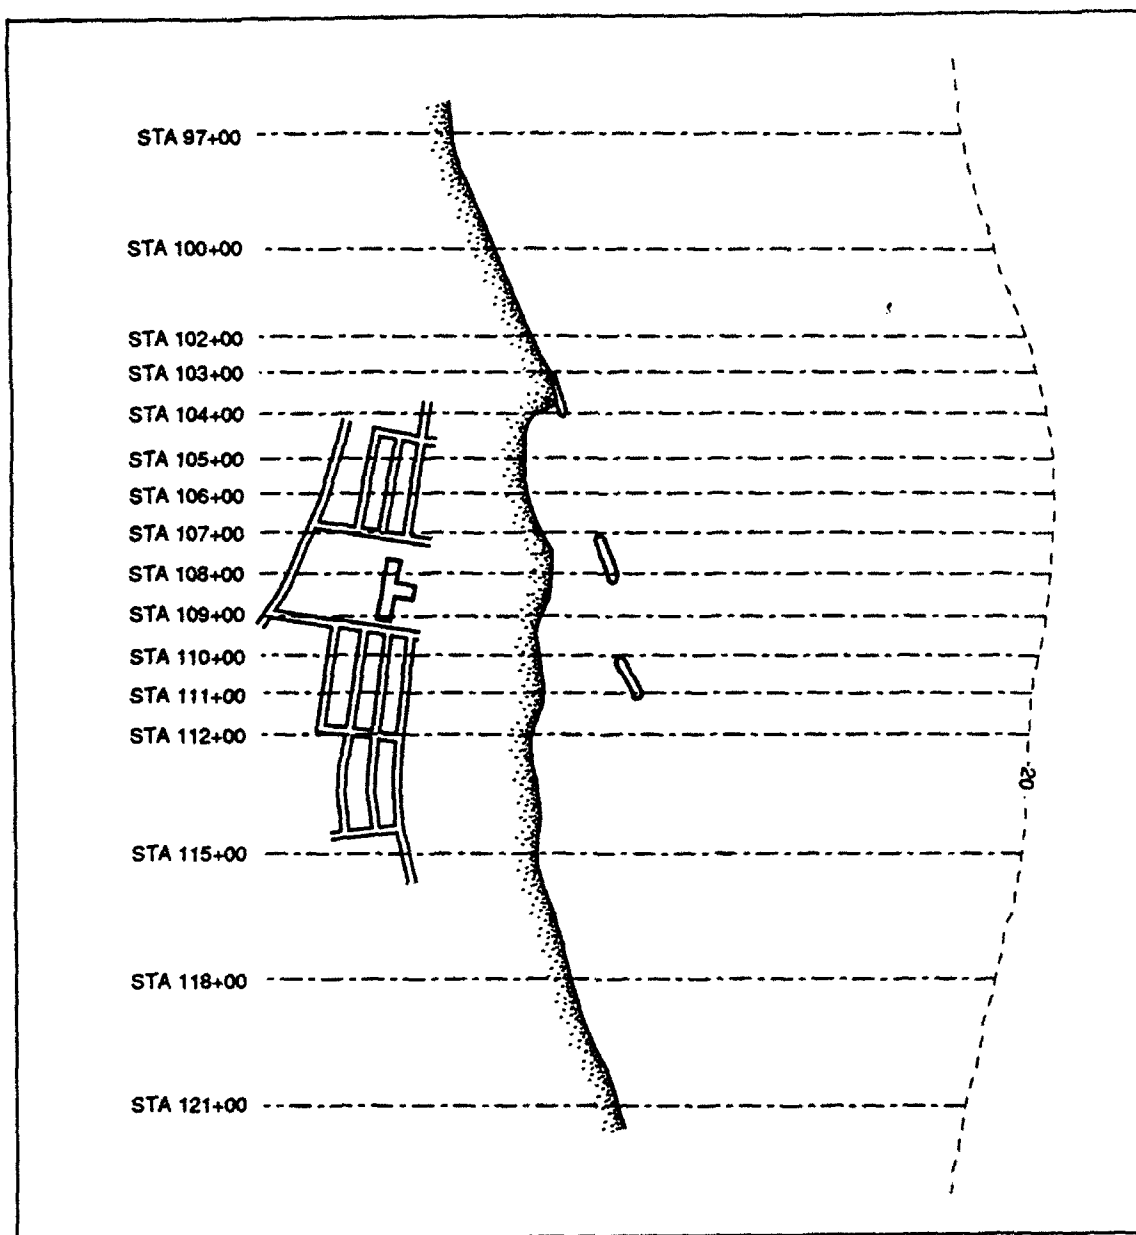
Figure 36. Survey lines established for Beach No. 10 monitoring program (modified from Gorecki (1985))

A survey plan (Figure 36) consisting of 16 profile lines was established between Stations 97+00 and 121+00. Each profile line extended from the top of the parking lot or dune through the beach area and offshore to a depth of 20 ft below LWD. A total of 13 surveys were completed. The data for each profile line from the current survey was plotted for comparison with the

data from the previous survey. In order to quantify beach versus offshore volume changes, the survey area was divided into two zones. Area "A" is in the lee of the breakwaters and is bounded between Stations 102+00 and 112+00. Area "B" extends offshore from the breakwaters to the 20-ft depth contour and was bounded between Stations 97+00 and 118+00. Data for each profile line were input into the Interactive Survey Reduction Program (Birkemeier 1984) to compute the volume changes in Areas "A" and "B."

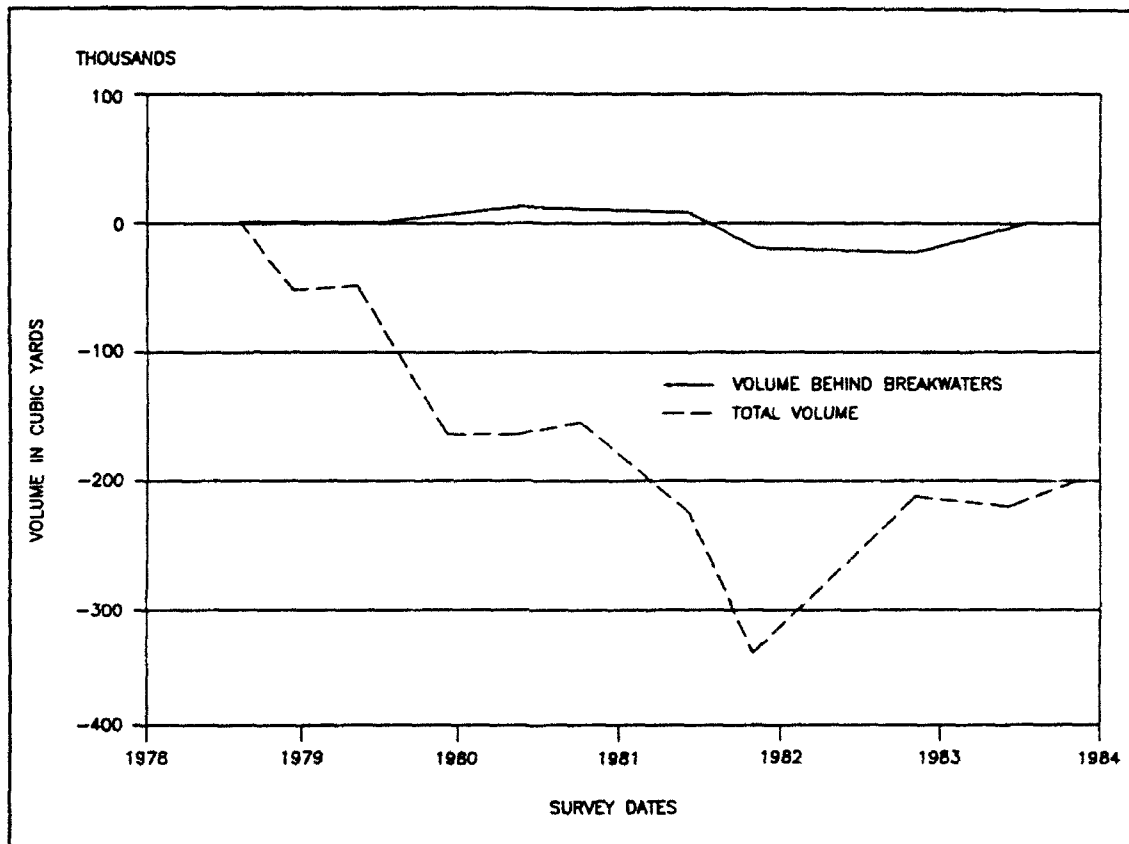
Figure 37. Volume changes measured at Beach No. 10, 1978 through 1984 (modified from Gorecki (1985))

The net results, as shown in Tables A1 and A2, indicated that during the period from July 1978 through October 1981 there were extensive losses in the offshore zones in Area "B," while there was a tendency towards accretion in the lee of the breakwaters (Area "A"). During the period from October 1981 through October 1983, a reversal was observed and accretion occurred in the offshore zones of Area "B" and losses occurred in the lee of the breakwaters in Area "A." These variations are illustrated in Figure 37.

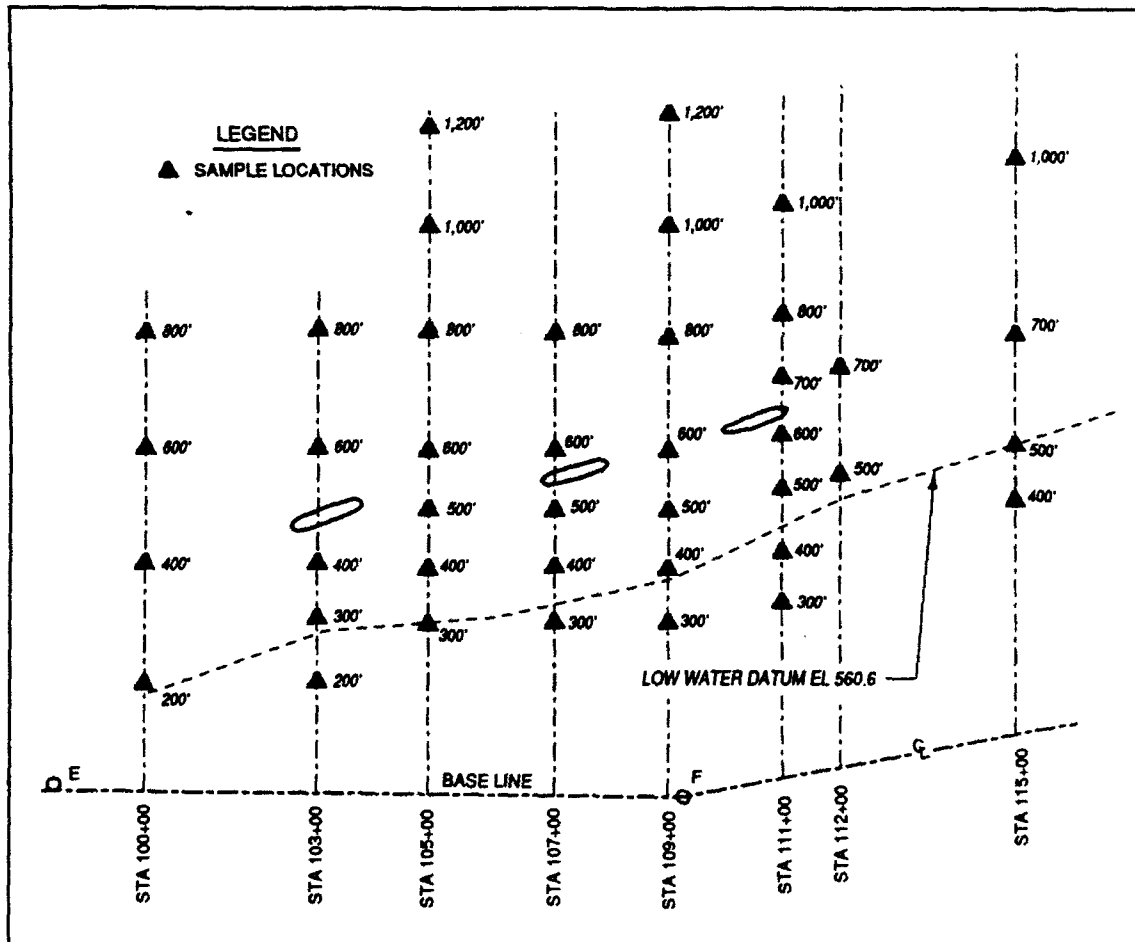
Figure 38. Sediment sampling plan established for Beach No. 10 monitoring program (modified from Gorecki (1985))

A sediment sample was collected at each of 41 locations during each of the six fall surveys (Figure 38). A gradation analysis was performed on each sample, and the results are presented in Tables B1 through B8. The results of the gradation analyses were evaluated to determine the grain size distribution in the vicinity of the breakwaters. Generally, the sampling has shown the usual progression from coarse sand near the water's edge to fine sand at the 20-ft depth. Coarser material collected lakeward of the middle and east breakwaters during the initial sampling is thought to have occurred because of dredging operations for the breakwater foundations. As documented through successive samplings, the coarse pocket was gradually reduced in area and by November 1981 had entirely disappeared. Hence, fine gravel to coarse sand was found between the water's edge and the breakwaters, and fine sand was found lakeward of the breakwaters.

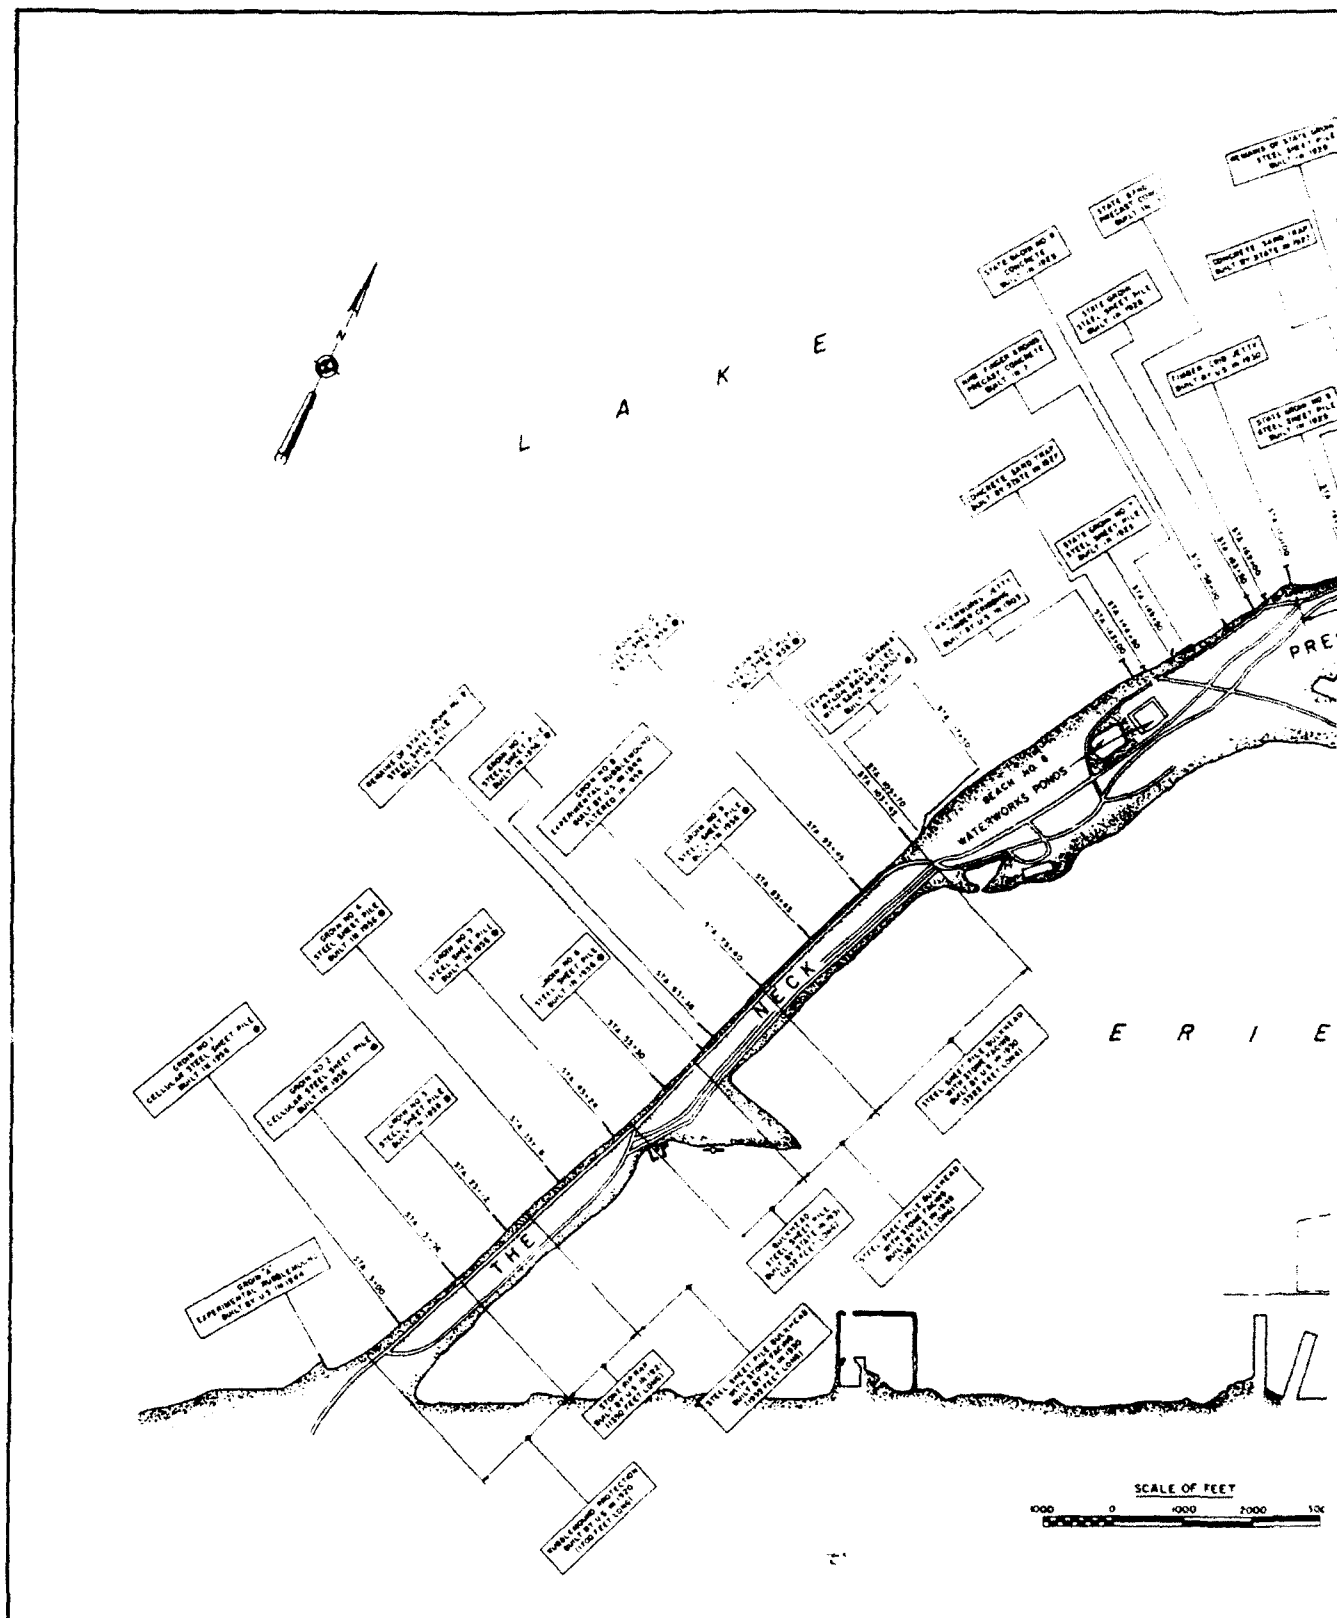
Figure 39. Shore protection structures existing at Presque Isle prior to breakwater construction (USAED, Buffalo 1980)

In 1956, the Federal Government, in cooperation with the Commonwealth of Pennsylvania, completed an erosion control project consisting of a seawall, bulkhead, and groin system along the neck of the peninsula, and restoration of the beaches by placement of sand fill. Since 1956, the project has proved to be inadequate, and sand nourishment measures were required periodically through the 1960's and early 1970's, and annually from 1975 to 1991, to protect the shore protection and erosion control structures and park facilities throughout the peninsula. Sand fill is placed each year to provide sand berms with crest elevations of 10.0 to 12.0 ft above LWD and crest widths of 60 to 75 ft at selected locations as stopgap measures. These sand nourishment measures do not represent a complete solution to the erosion problem because they fail to maintain a continuous sand berm of sufficient width and elevation to provide protection for the backshore dunes and park facilities. The annual sand nourishment costs are escalating, making the continuation of annual nourishment an increasingly expensive means of controlling beach erosion. With the completion of the breakwater project in November 1992, future annual nourishment requirements will be reduced significantly.

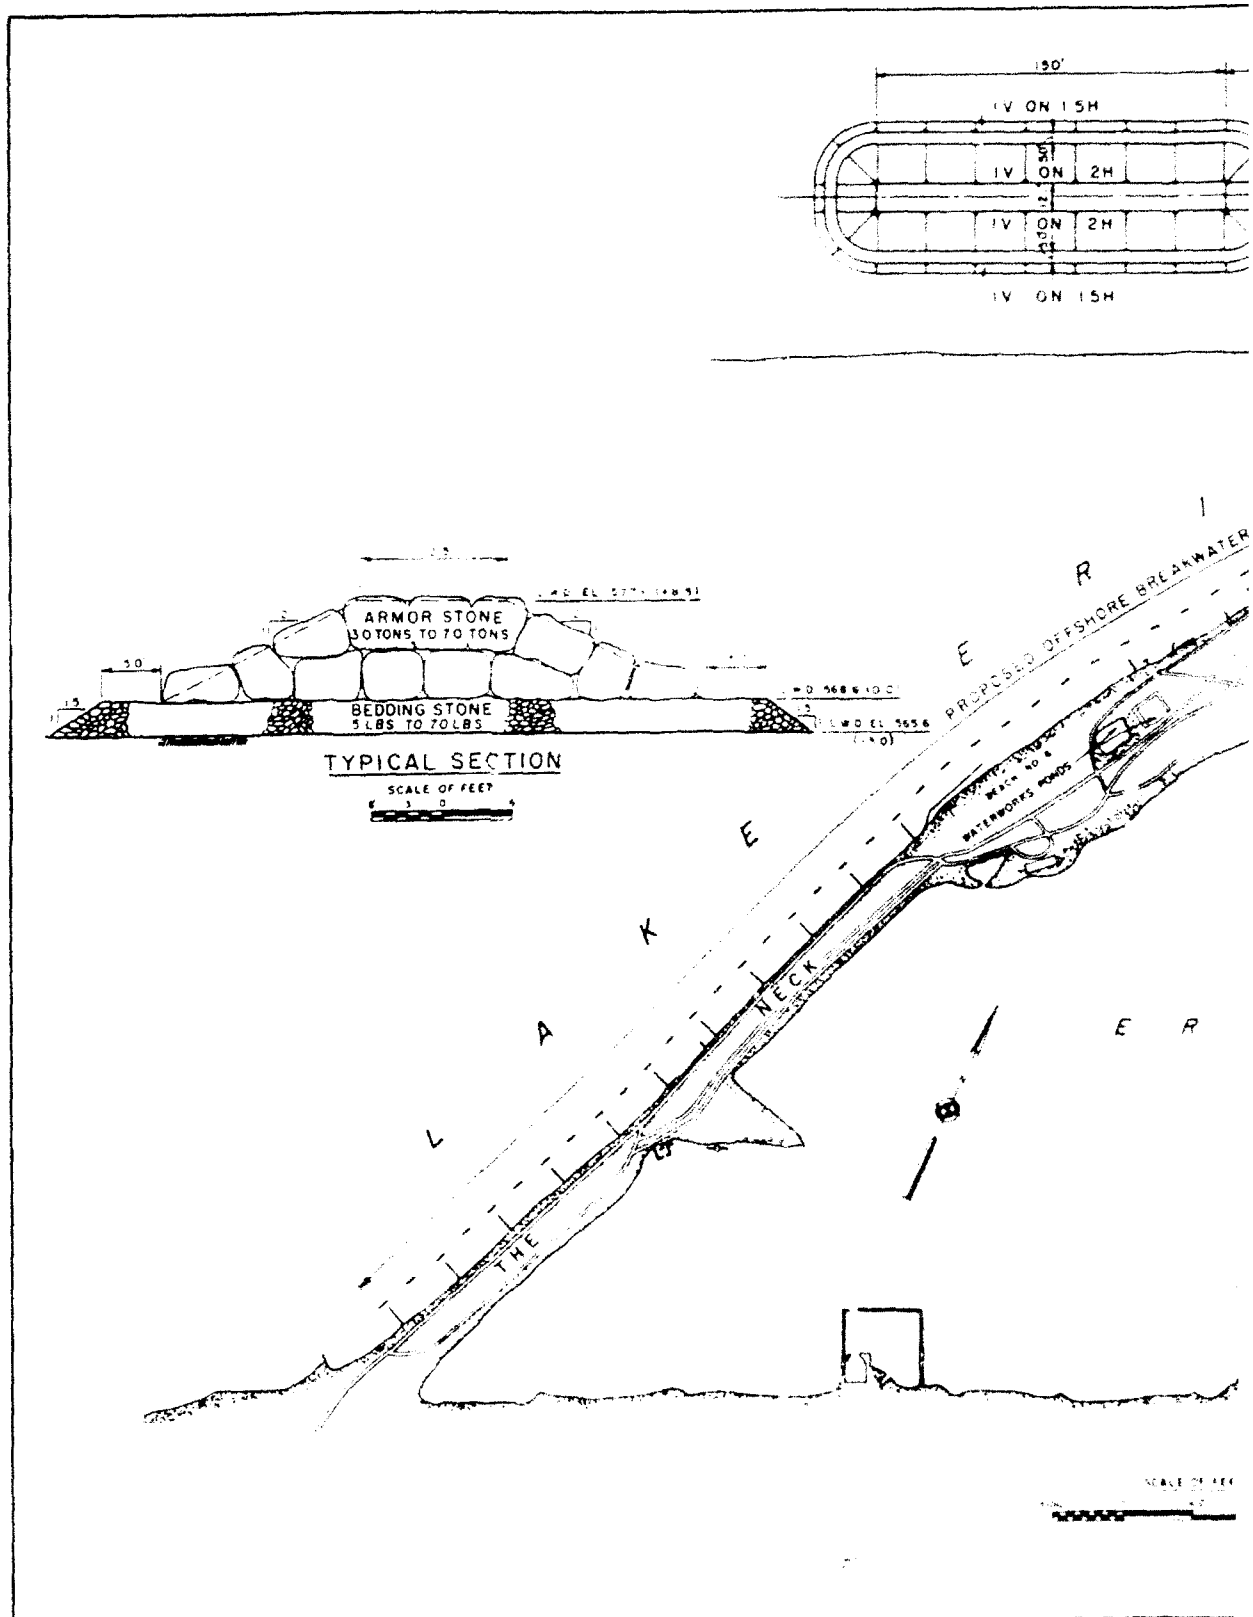
Figure 42. Present authorized plan of erosion control structures at Presque Isle (modified from USAED, Buffalo (1986))

The plan of improvement recommended in the Phase II GDM is shown in Figure 42 and consists of constructing structures for wave attenuation and beach restoration along 5-1/2 miles of shoreline on the lakeward side of Presque Isle Peninsula. The recommended plan was designed to protect and maintain the environmentally unique Presque Isle Peninsula and to satisfy the projected recreational beach demand from the surrounding area. The plan of improvement requires the placement of an estimated 560,000 tons of sand fill to provide a protective berm with a minimum 75-ft width and a crest elevation 10.0 ft above LWD; construction of an estimated 58 offshore rubble-mound breakwater segments aligned parallel to the shoreline; and an annual nourishment requirement of approximately 38,000 cu yd of sand fill in order to maintain the protective sand berms at the minimum design 75-ft crest width and a crest elevation 10 ft above LWD. Section 501(a) of the Water Resources
