Naval Facilities Engineering Service Center, Port Hueneme, CA 93043-4328

HORIZONTAL DRILLING SYSTEM (HDS) FIELD TEST REPORT - FY91

TR-2002-OCN

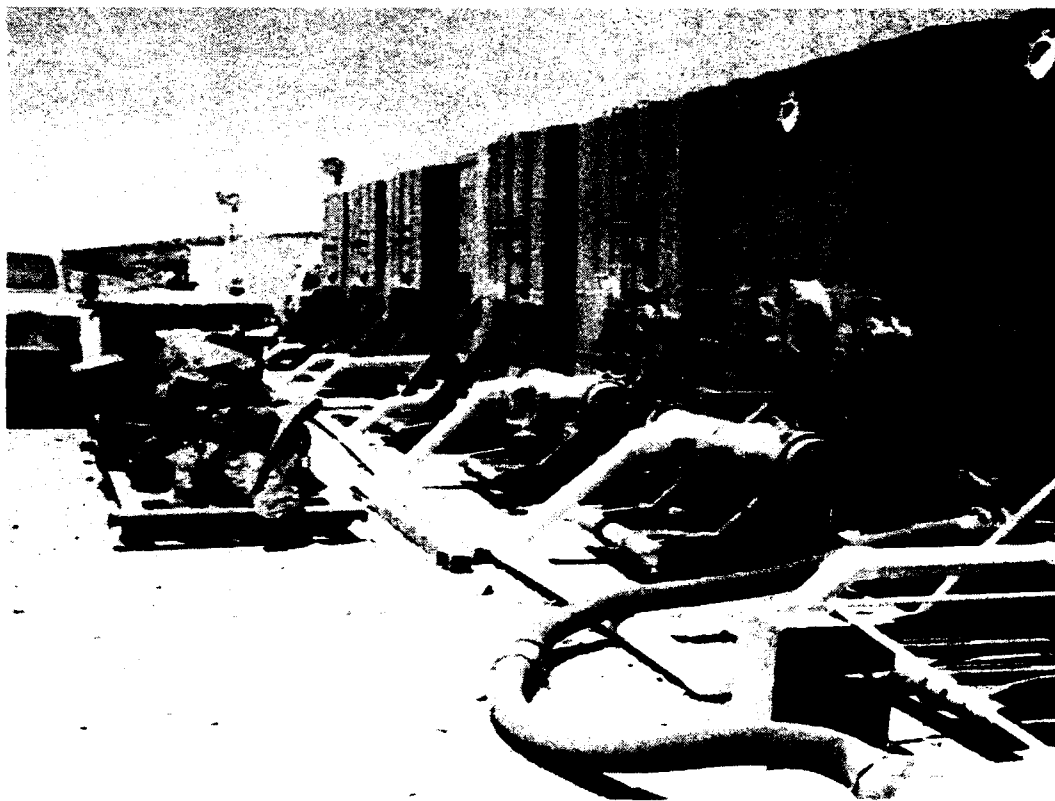
Figure 9
Storage tank configuration.

3.3 Water Storage and Distribution System (Figures 8 and 9)

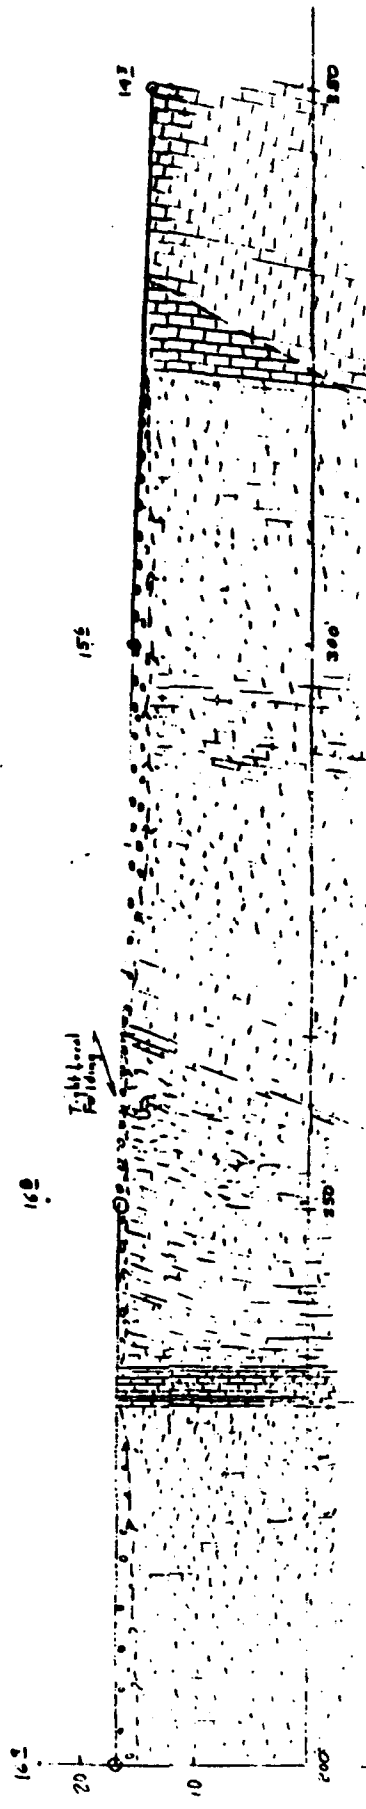
Figure 11a
 Site geology and trajectories elevation view.

SCALE 1" = 10'
 SECTION THROUGH ...

Test site location/selection was almost entirely dependent on geology. The goal during the field test was to duplicate a specific geology type (contorted limestone) found at a potential HDS installation location. Geophysical analysis of core samples from the potential installation location was used as the basis for selecting the field test site. The Christmas Canyon area (Rocksites B) of NWC, China Lake offered geology that was remarkably close to matching the target geology. The test area was composed of local tight folds of cherty and shaley limestone. The material strength of the limestone was measured at 25,000 psi, with a bulk strength of 5,000 to 10,000 psi. Typical surface geology is described in Figures 10 and 11, and Reference 3 documents the geology of Rocksites B.

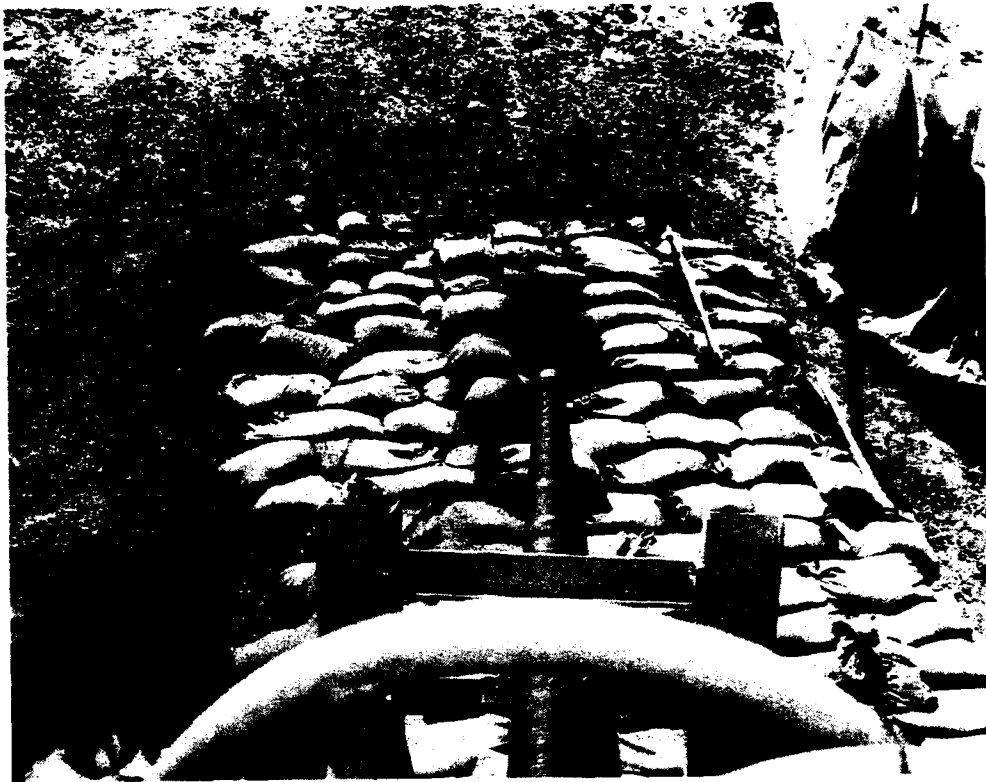
Figure 14
Entrance test A1, initial.

After drilling 110 feet, the drill string was deviating severely. It was backed out and restarted three times in an attempt to straighten the trajectory. The drill string had a tendency to climb sharply (approximately 0.16-inch raise per 12-inch advance); this was causing higher than acceptable levels of drill string torque. The torque was being measured at the launcher aft rotator. The high measured value was primarily due to two conditions: (1) additional reactive loads were present at the points of contact between the drill string and the curved hole, and (2) the drill pipe was rubbing the inside of the forward rotator due to the severe (large) exit angle at the forward rotator. During the second attempt to straighten the trajectory, the drill string was backed out and restarted at a slower advance rate. Unfortunately, the pipe followed the original hole. On the third restart, high pressure and flow was used at the outset. The net effect was to essentially erase the original hole and create a new drilling path. Figure 15 shows the result of using high pressure and flow at the entrance area. The net effect was to wash away the surrounding material and excavate a cavity into the hillside. This was a very undesirable condition both environmentally and in terms of increased suspended pipe length.

Test A1 was terminated at 110 feet for two reasons:

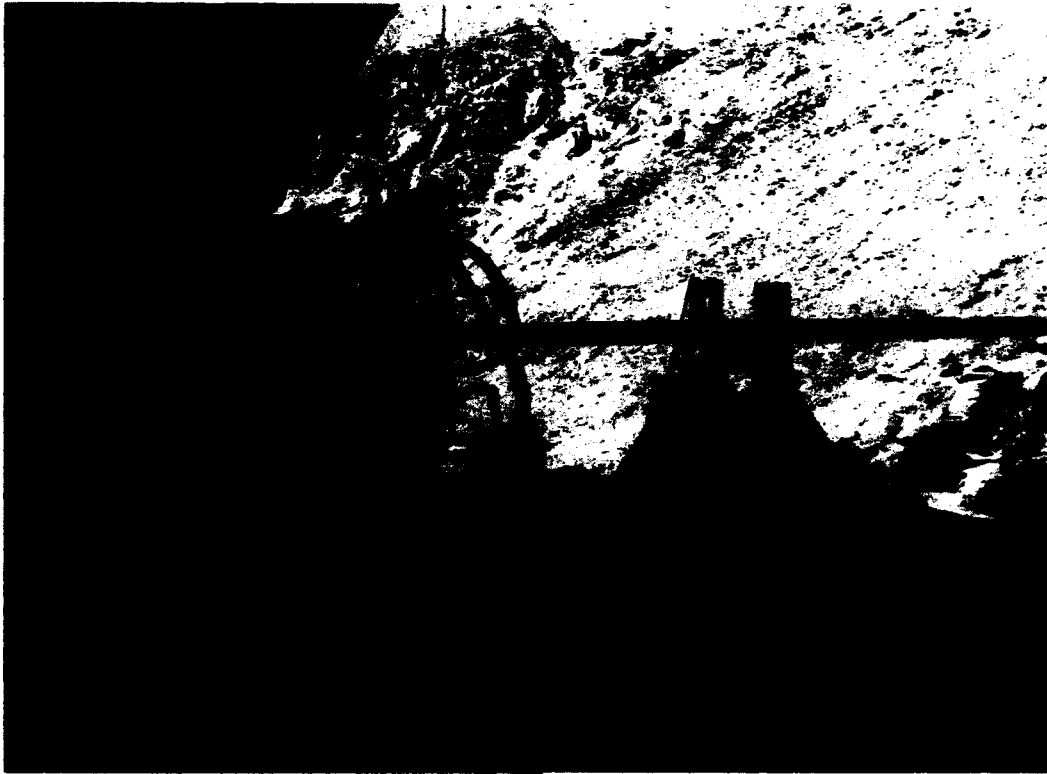
Figure 18
Entrance of test A2.

4.2.2 Test A2 (No Steering) - 2 Through 7 July, 398 Feet (Figures 18, 19, and 20). Test A2 was a continuation of the Test A1 philosophy, where the main objective was to determine natural deviation without controlled steering. Again, the straight drillhead was used throughout. The launcher assembly was moved to a new trajectory of 265 degrees, true.

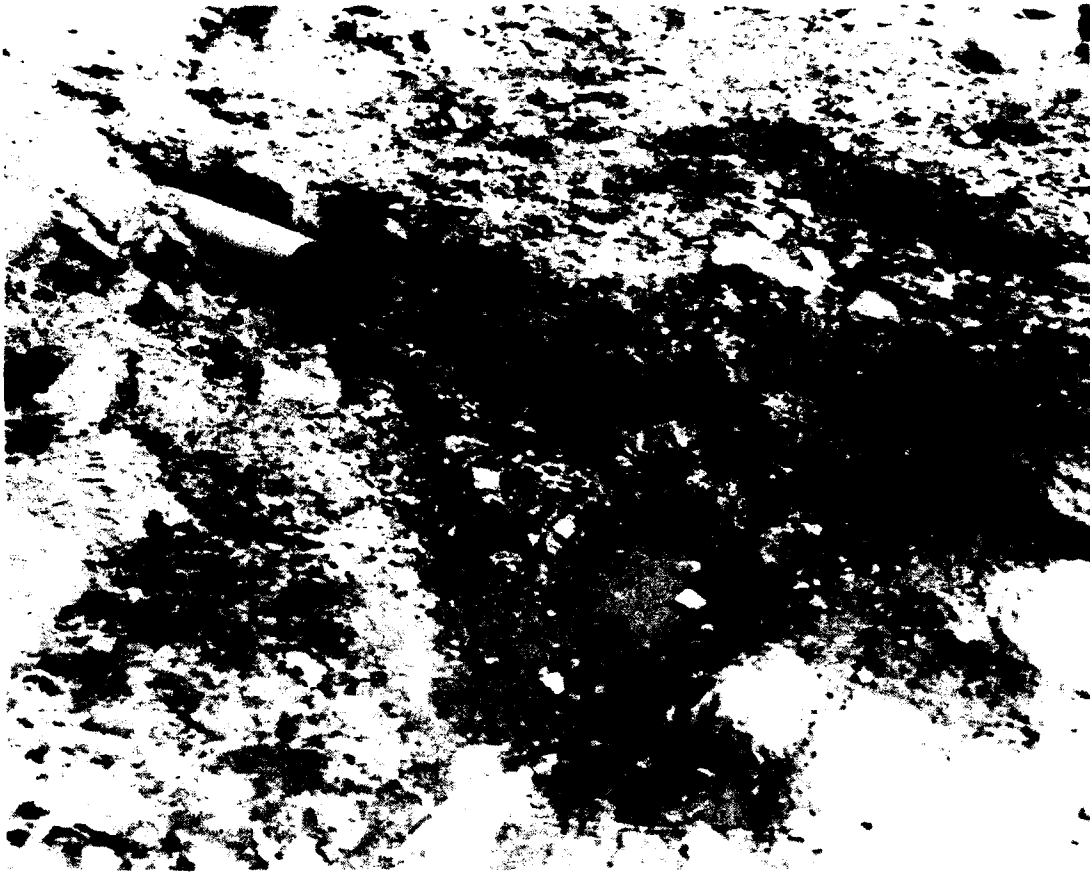
Figure 21
Test B exit.

Test B was terminated as a result of an exit event measuring 397 feet from the launcher assembly. Surveyed results showed a 10-foot vertical deviation and an 11-foot horizontal deviation to the right.
