# VHF Direction Finder (VDF) Operational Test and Evaluation (OT&E) Integration and OT&E Operational Test Report

May 1994

DOT/FAA/CT-TN94/12

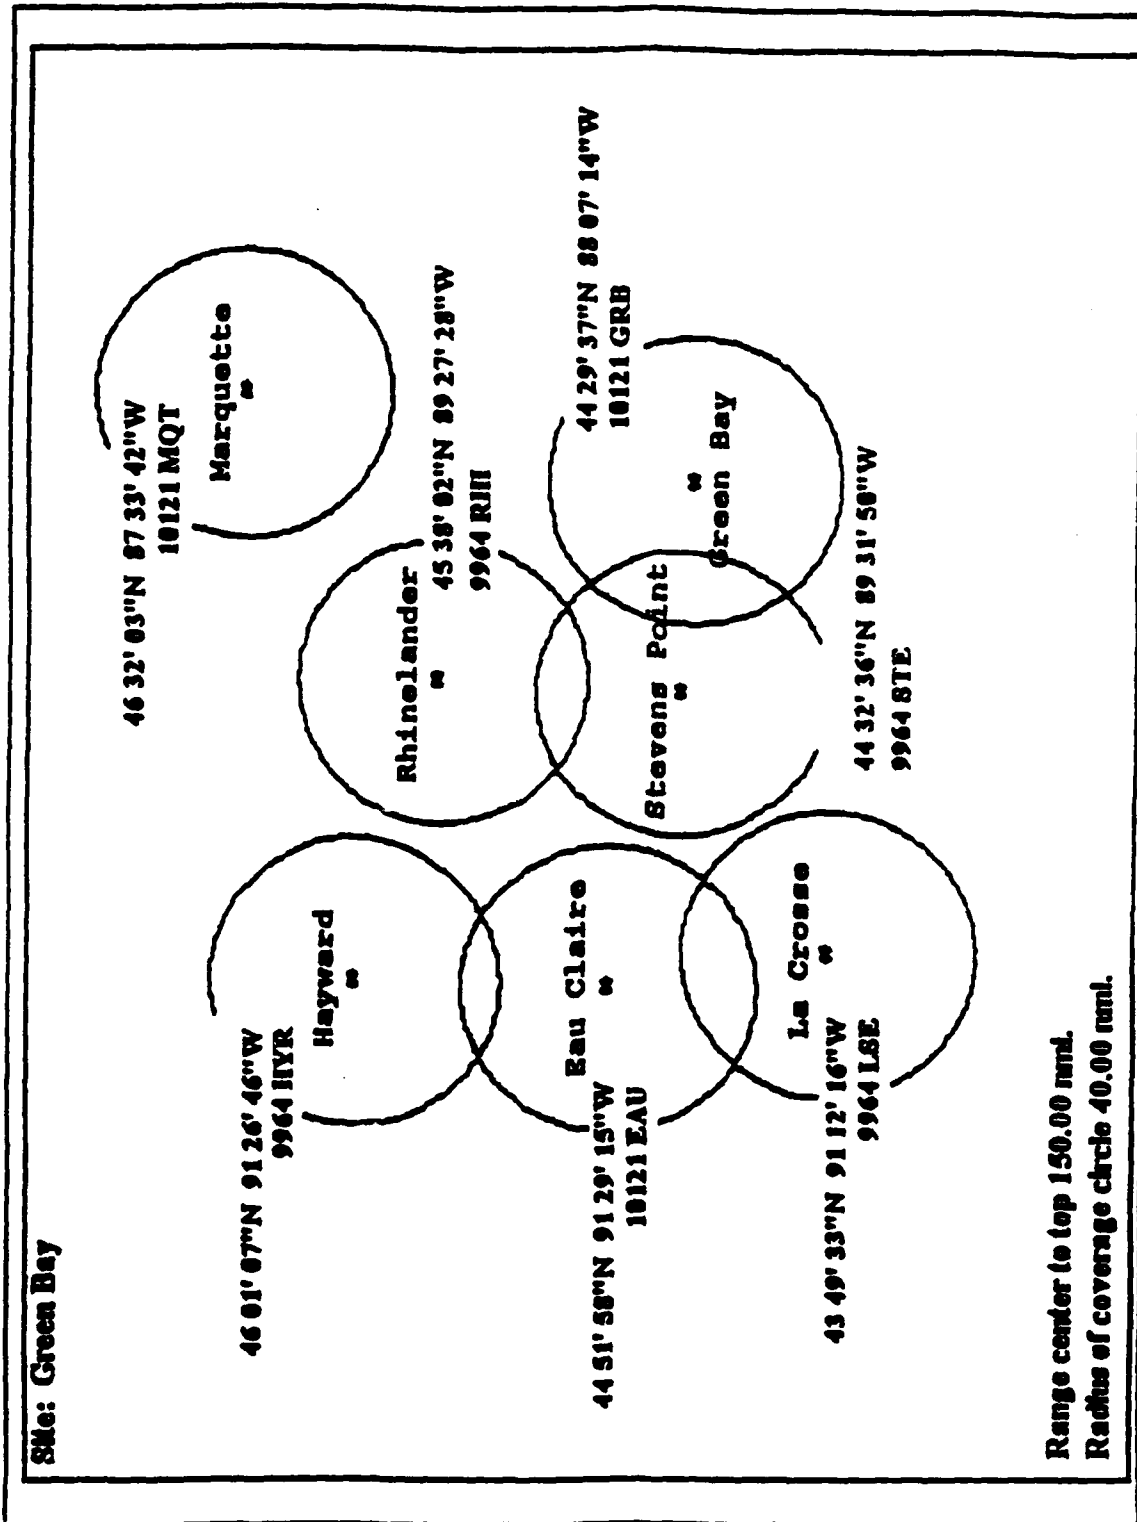
FIGURE 3.2-1. DF ANTENNA LOCATIONS

The tested system as installed at the Green Bay, WI, AFSS was configured with three FA-10121 antennas and four FA-9964 antennas. The seven antennas, with their Receiver/Processor Groups, were at various locations throughout Wisconsin. See figure 3.2-1 for the locations. Information from the antennas is carried by dedicated telephone lines and received by seven modems in the Remote Maintenance Monitor Computer (RMMC) subsystem rack located in the AFSS. An Input/Output Terminal Type 2 (IOT-2), and a printer are attached to the RMMC for maintenance actions. Two IDCUs, which constitute the AFSS Specialists' work station were installed, one in the operations room and another in an adjacent training room. See figure 3.2-2 for a block diagram of the equipment as installed at Green Bay AFSS.

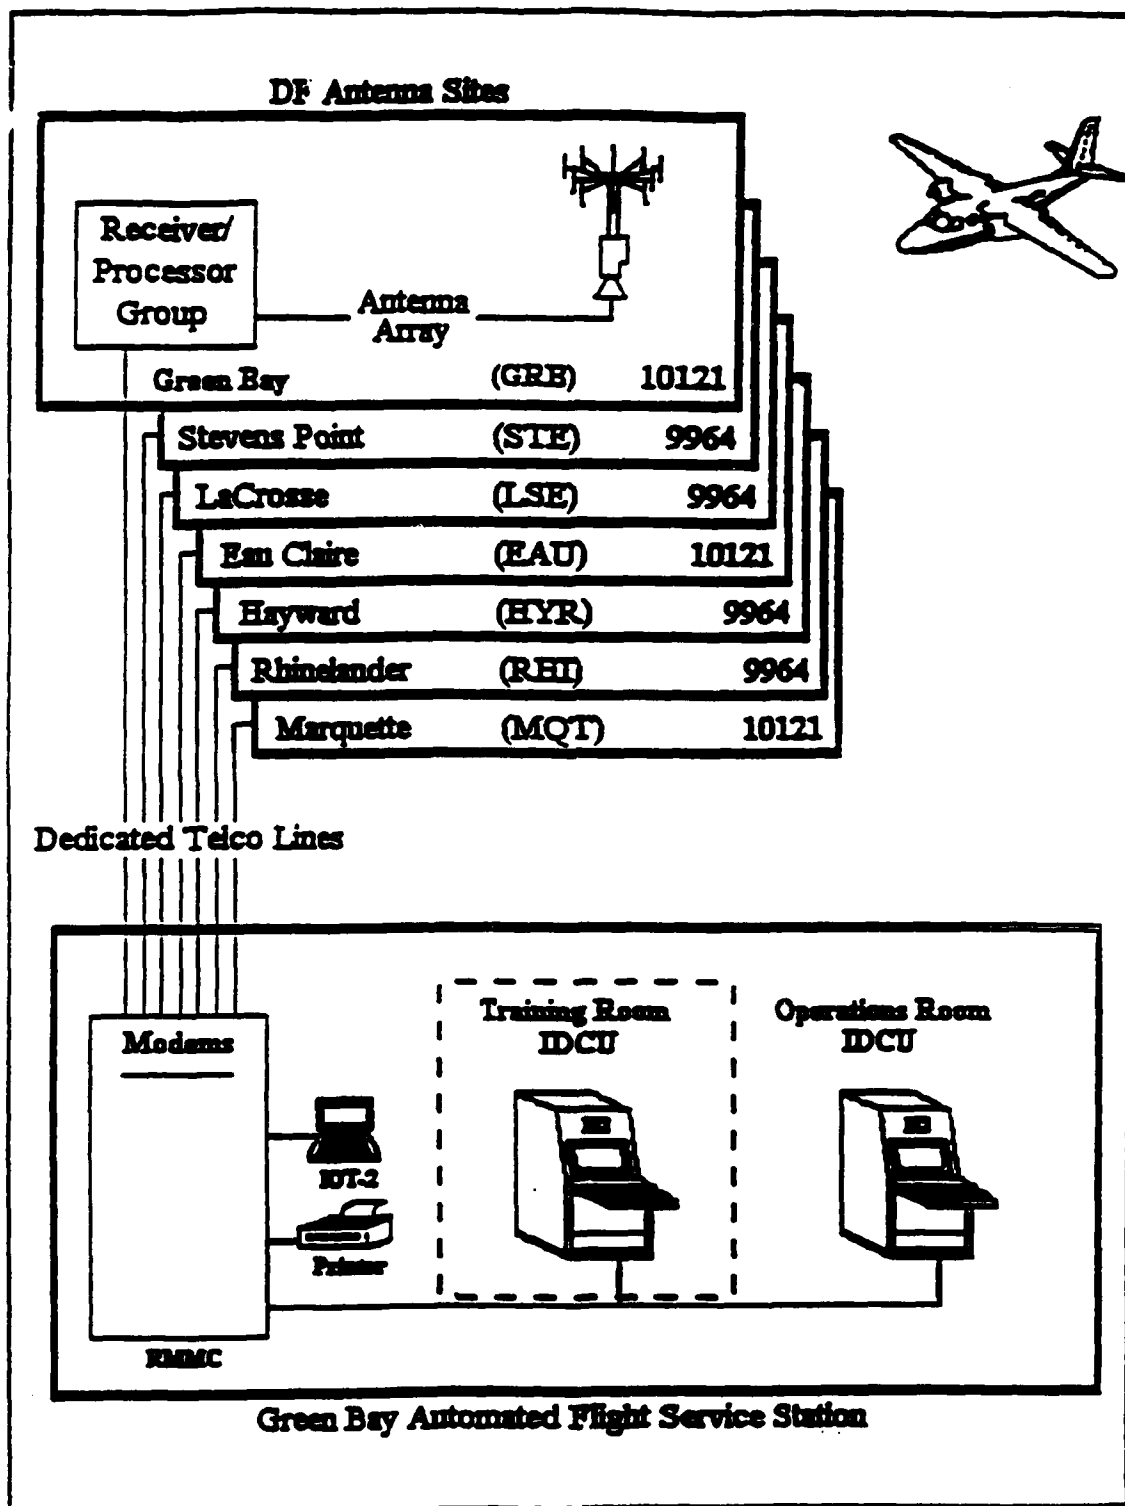
FIGURE 3.2-2. DF EQUIPMENT CONFIGURATION

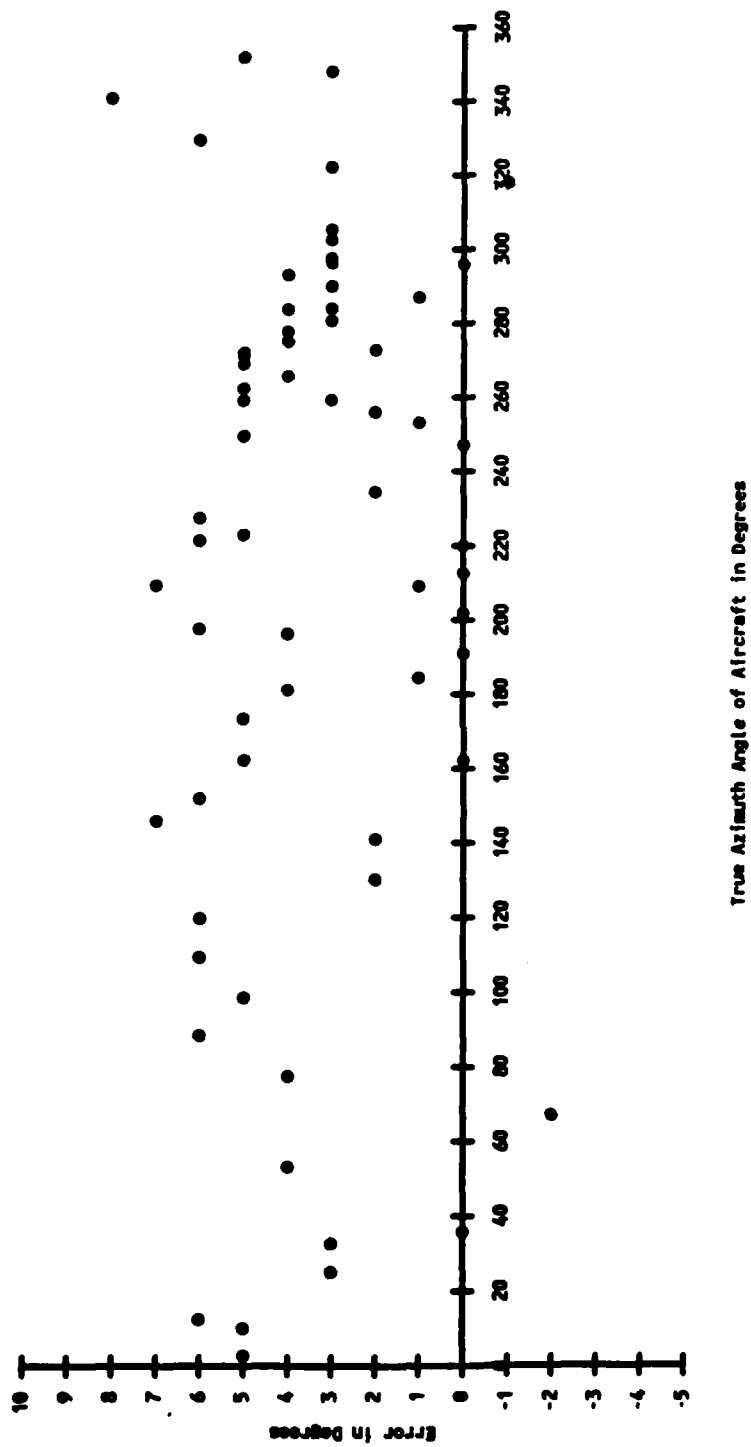
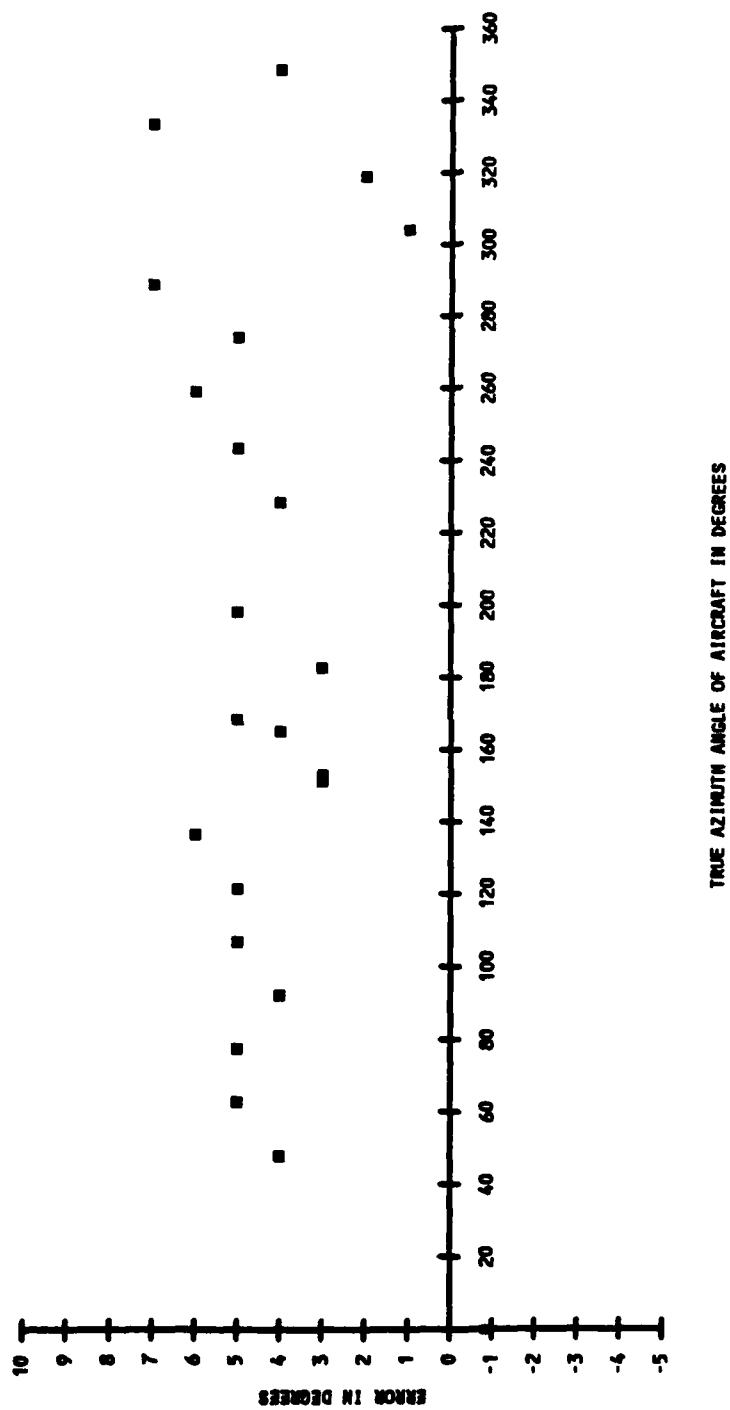
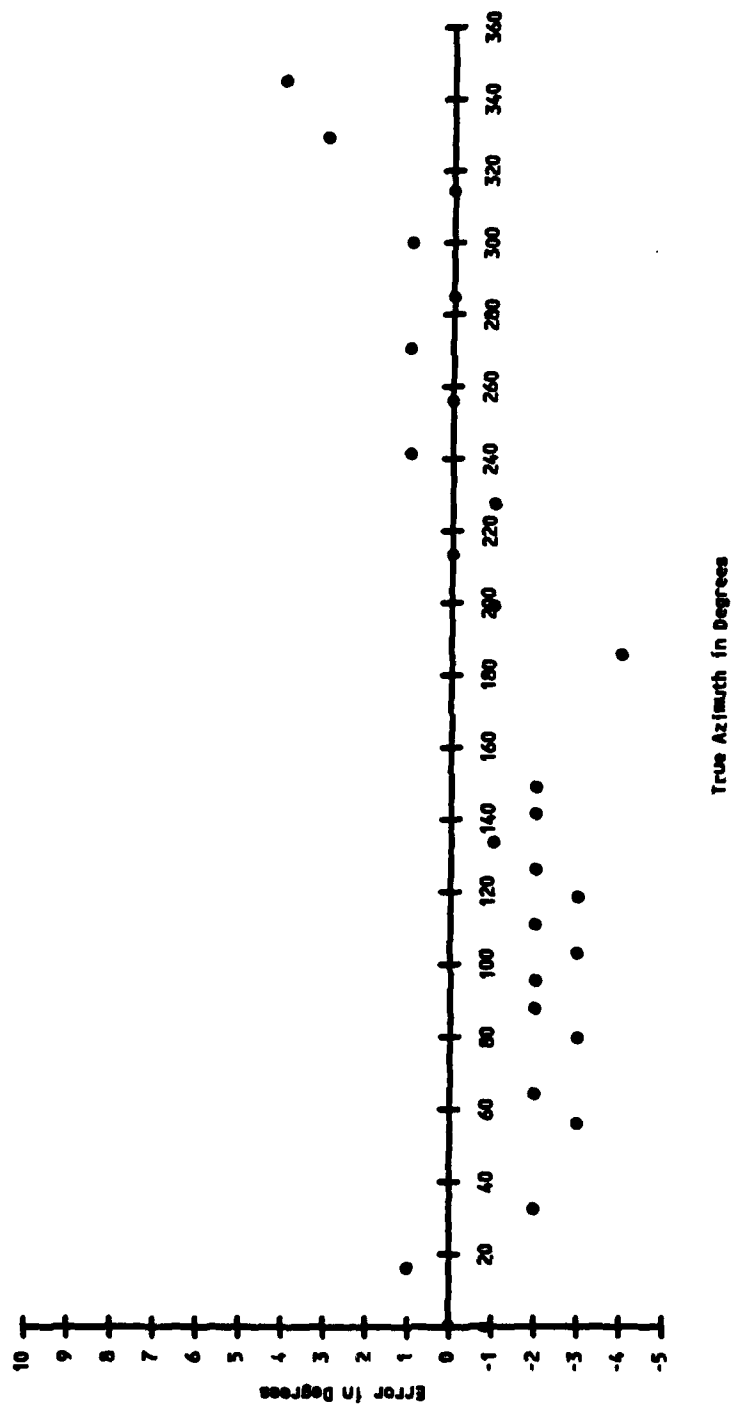
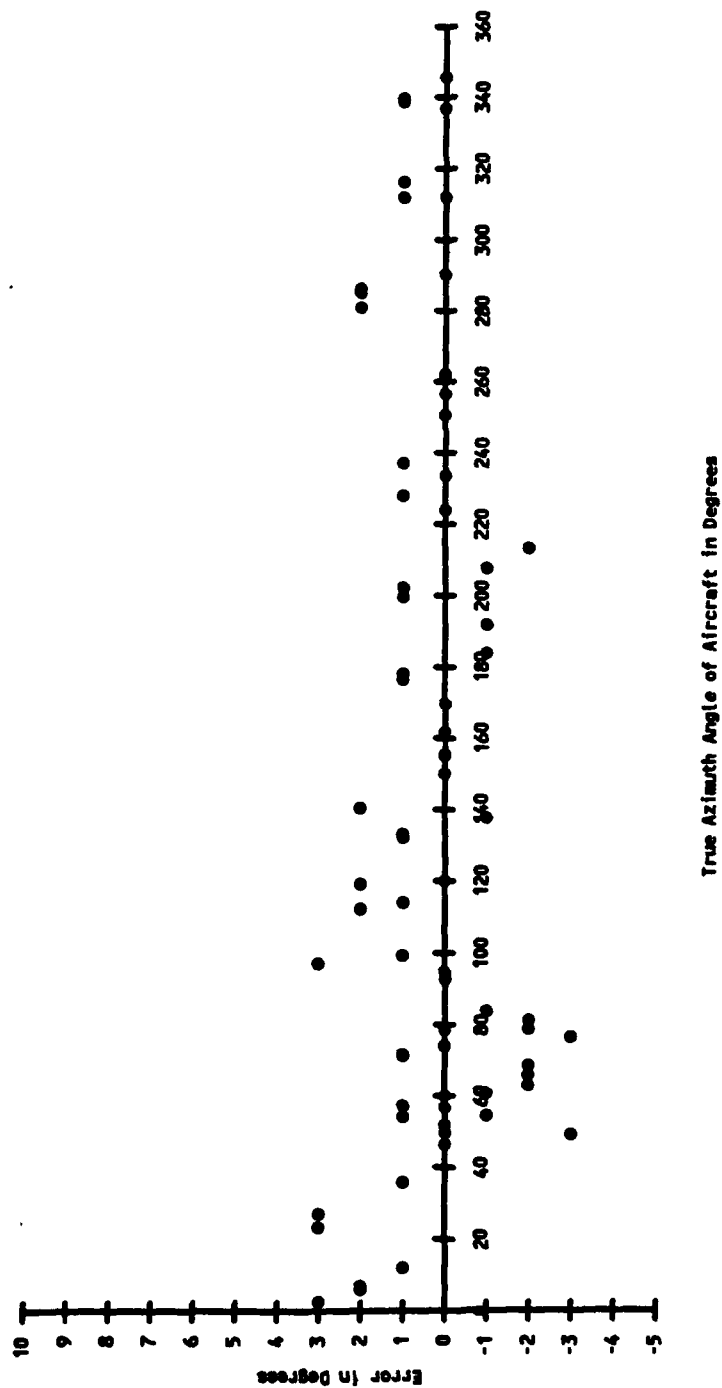
FIGURE 5.3-4. GREEN BAY ERROR AS A FUNCTION OF TRUE AZIMUTH

FIGURE 5.3-5. MARQUETTE ERROR AS A FUNCTION OF TRUE AZIMUTH

FIGURE 5.3-6. RHINELANDER ERROR AS A FUNCTION OF TRUE AZIMUTH

FIGURE 5.3-7. STEVENS POINT ERROR AS A FUNCTION OF TRUE AZIMUTH

It can be seen from section 5 of VHF Direction Finder (VDF) Operational Test and Evaluation (OT&E) Integration and OT&E Operational Test Logs and Data, table 5.3-1 and figures 5.3-4 through 5.3-7, that the FA-9964 antennas have lower average error and lower deviations from average than the newer FA-10121s. However, these figures do not take into consideration the different sites of the respective antennas. It is plausible that the older FA-9964 antennas are located at more favorable sites or that installation of FA-10121 antenna sites have different siting constraints than the FA-9964 systems; therefore, the FAA would need to identify and correct our siting procedures. It should also be noted that the Green Bay and Marquette FA-10121 antenna errors were heavily biased toward the positive with both having an average error of +4 degrees. If the errors were balanced during commissioning flight inspection, accuracy figures would improve. However, the distribution of errors would remain unchanged regardless of average error. Note that the FA-10121 antenna sites were prepared for operation using surveyed target bearings and that the operational rule for current commissioned DF systems is that flight inspection provides the final authority for course alignment.

It was also found that transmissions of approximately 1 second in duration were less reliable at the Stevens Point FA-9964 site than at the Green Bay FA-10121 site. A look at the data shows that a single point biases the results, however the point is within expected variation and so there is no reason to discard it. At the Stevens Point FA-9964 site, all data taken at the 2-second and greater transmission durations showed azimuth errors similar between sets. Data from the 1-second transmission duration tests was not included in figures 5.3-1 to 5.3-7 data in order to prevent a slight biasing of the results.

c. Consider balancing observed antenna bearing errors during commissioning flight inspections. A detailed airborne analysis of the site error by azimuth should be conducted during the first installations, starting with the three sites already installed. Any special case problems should be identified and corrected. Changes to site selection procedure and installation instructions could be derived from the analysis of the site errors.
