TECHNICAL REPORT ARCCB-TR-94013

QUALIFICATION OF M256 BRECHBLOCK REPAIR PROCEDURE

**DAVID A. PORTER
WILLIAM E. MARCOUX
ALICE E. FISH**

MARCH 1994

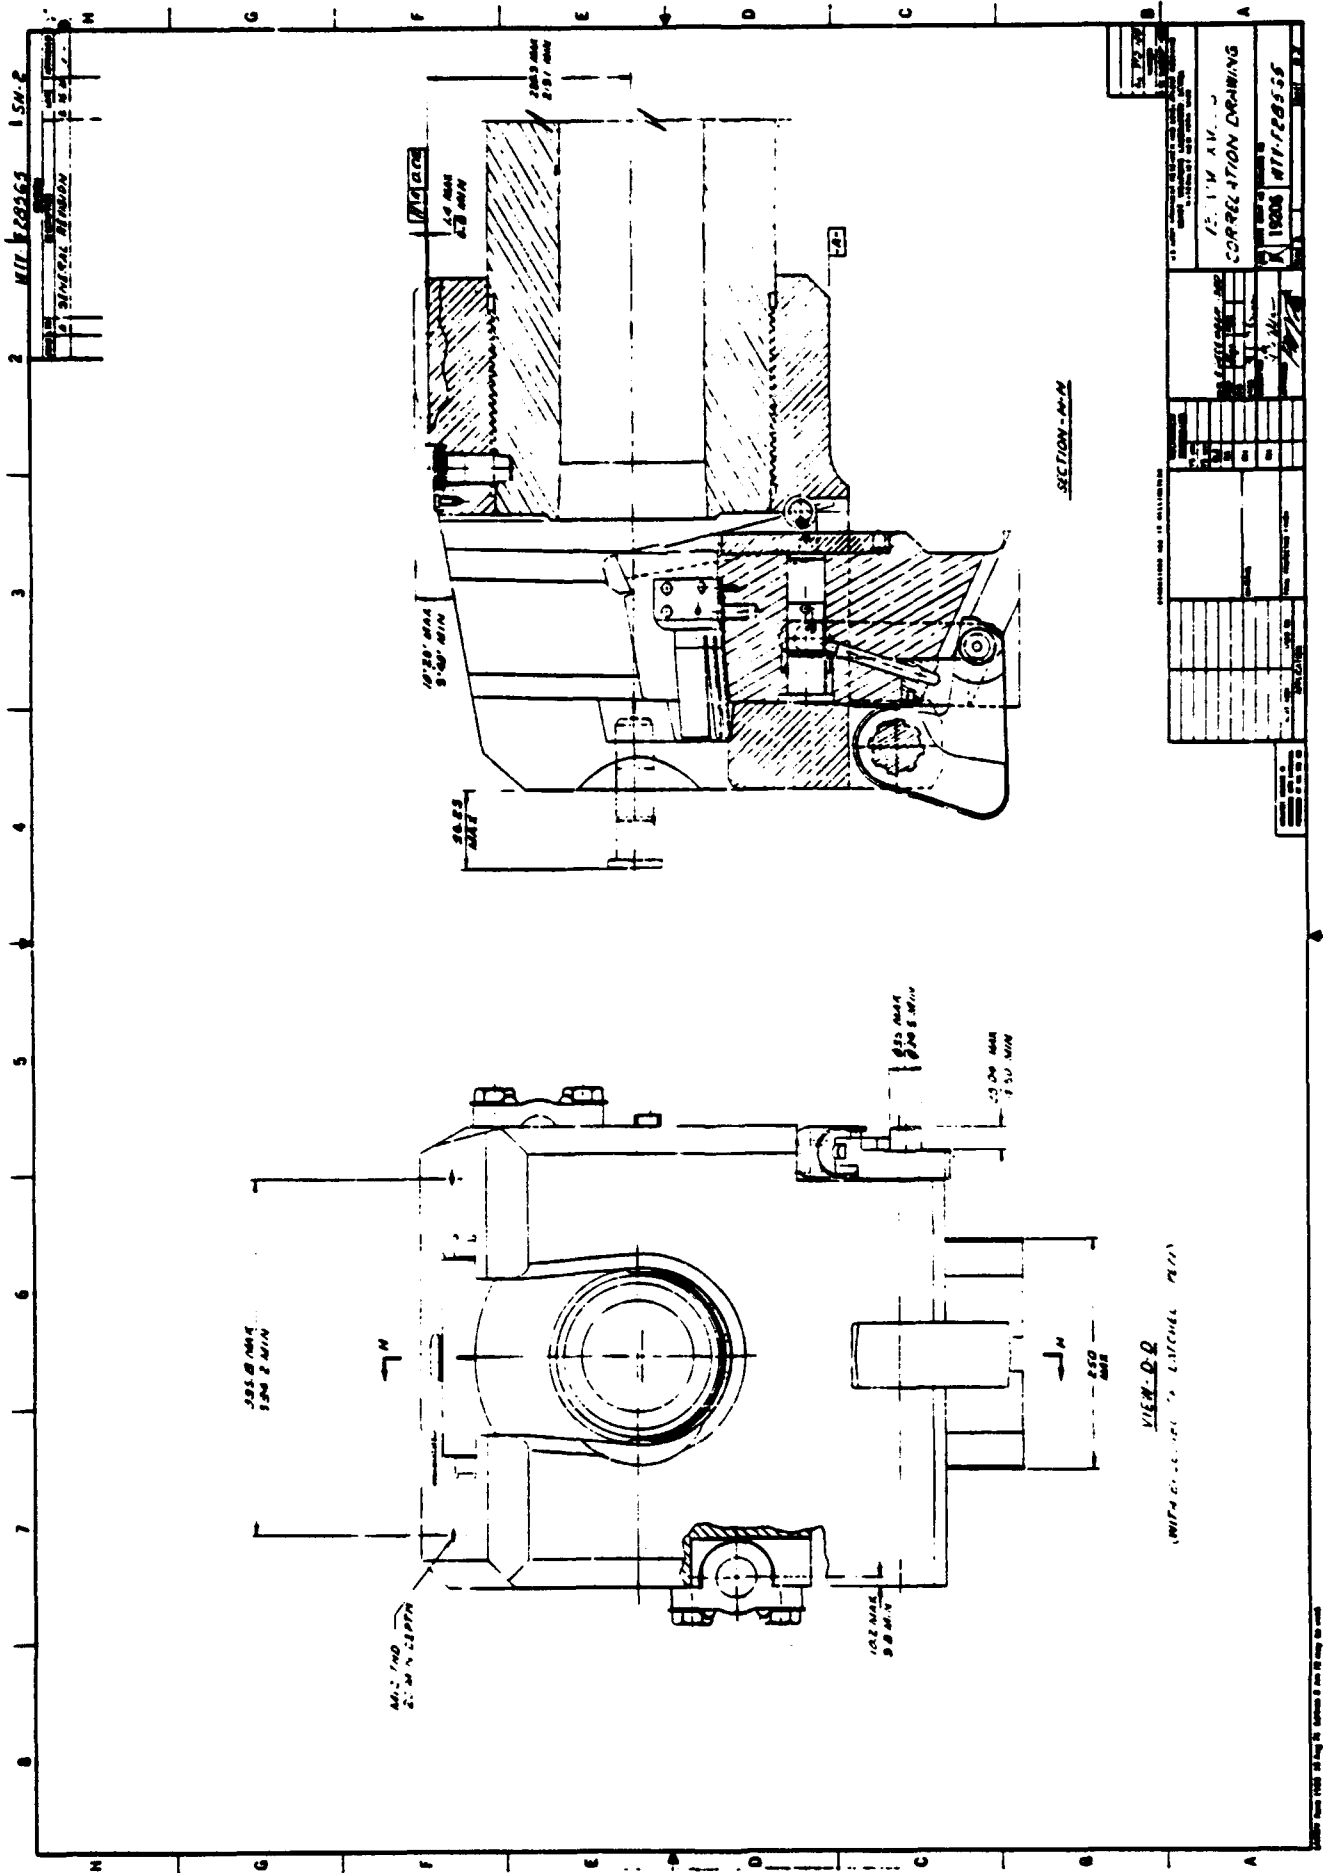
Figure 1. Drawing depicting the M256 breechblock as it is installed in the M256 breech ring assembly.

The M256 breech mechanism is a semi-automatic sliding wedge design, wherein the breechblock is designed to move upward within the breech recess and lock behind the rear face of the stub case of 120-mm ammunition cartridges following loading into the cannon tube chamber. Camming of the operating crank on counterrecoil or counterclockwise rotation of the separable breech opening handle rotates the operating shaft and causes the breechblock crank to lower the breechblock. When the breechblock nears the open-end position, the extractors cause ejection of the ammunition stub case simultaneously with the locking of the breechblock in the opened position until tripped by the loading of a round of ammunition. The location of the breechblock within the breech recess subjects it to compressive stresses from the cartridge case on one side and the restraining force of the breech ring on the opposite side. The breechblock contains the electrical contact firing mechanism and such circuitry as necessary to transmit the electrical signal to the probe, which comes in contact with the ammunition cartridge primer. The breechblock also causes retraction of the firing mechanism probe as the breechblock cycles from its closed (firing) position to the open position. To accomplish this, a driver is actuated by the breechblock crank, which actuates the cam in the firing mechanism assembly causing the probe to protrude through the faceplate of the breechblock and contact the rear face of the cartridge. The aforementioned components can be seen in Figure 1.

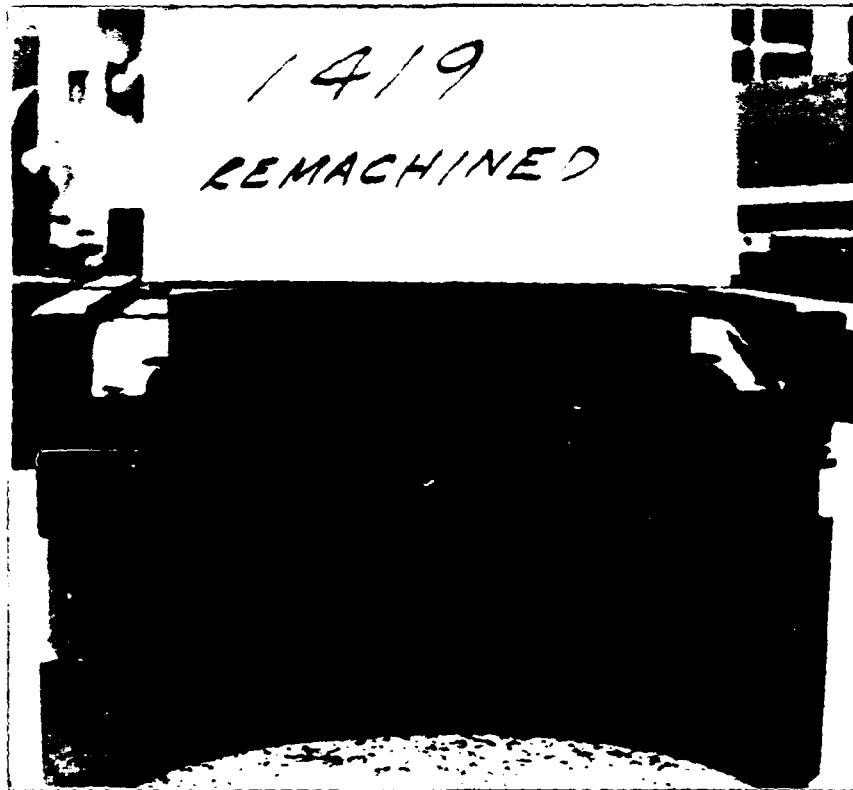
Figure 7. Photographs showing weld repair breechblock specimens (a) prior to and (b) after finish machining.

A preliminary weld repair procedure was created (SARWV Weld Repair Procedure No. 35, Appendix A), which requires weld application and remachining prior to ion nitriding. The maximum depth of weld permitted is 4.76 mm (3/16 inch). Two M256 breechblocks were selected to simulate tool gouges and other defects that represent 90 percent of the nonconforming material conditions reported. As a result, breechblock shop numbers 1419 and 2814 were machined, welded, remachined, and subsequently ion nitrided. These breechblocks were subsequently shipped to the New Mexico Institute of Mining Technology, TERA Group, Socorro, New Mexico, where they were installed in cannon assemblies and fired. Figures 5 through 8 show the appearance of breechblock shop number 1419 after weld repair and after finish machining in the areas of concern.

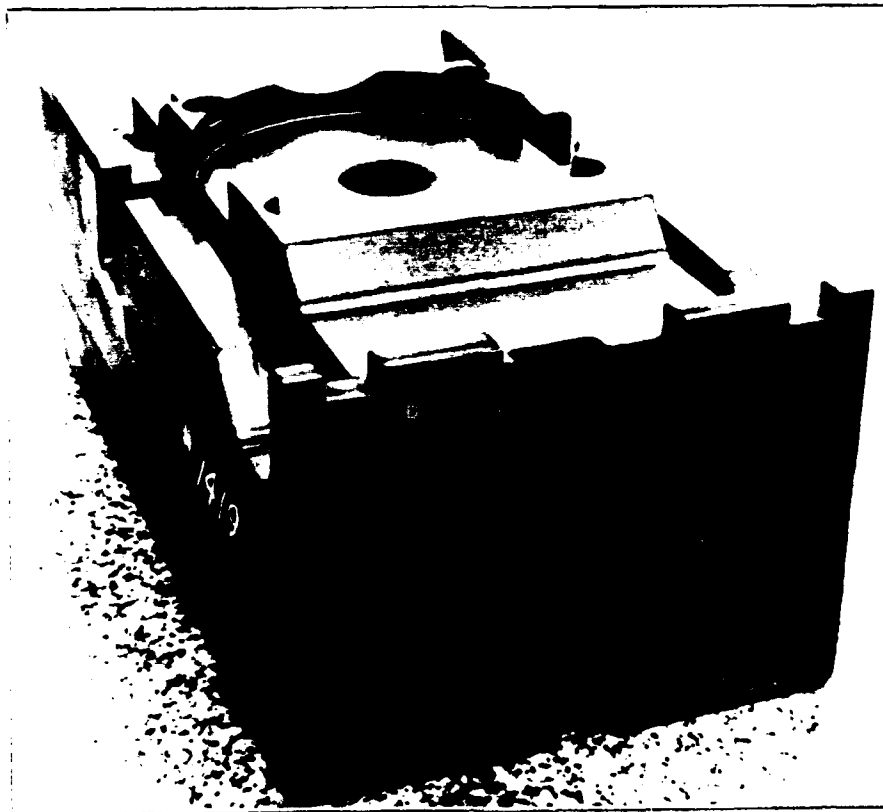
Figure 8. Photographs showing weld repair breechblock specimens (a) prior to and (b) after finish machining.
