# **Gravel Road Test Sections Insulated with Scrap Tire Chips Construction and First Year's Results**

Robert A. Eaton, Richard J. Roberts and Dana N. Humphrey    August 1994

**U.S. Army Corps  
of Engineers**  
Cold Regions Research &  
Engineering Laboratory

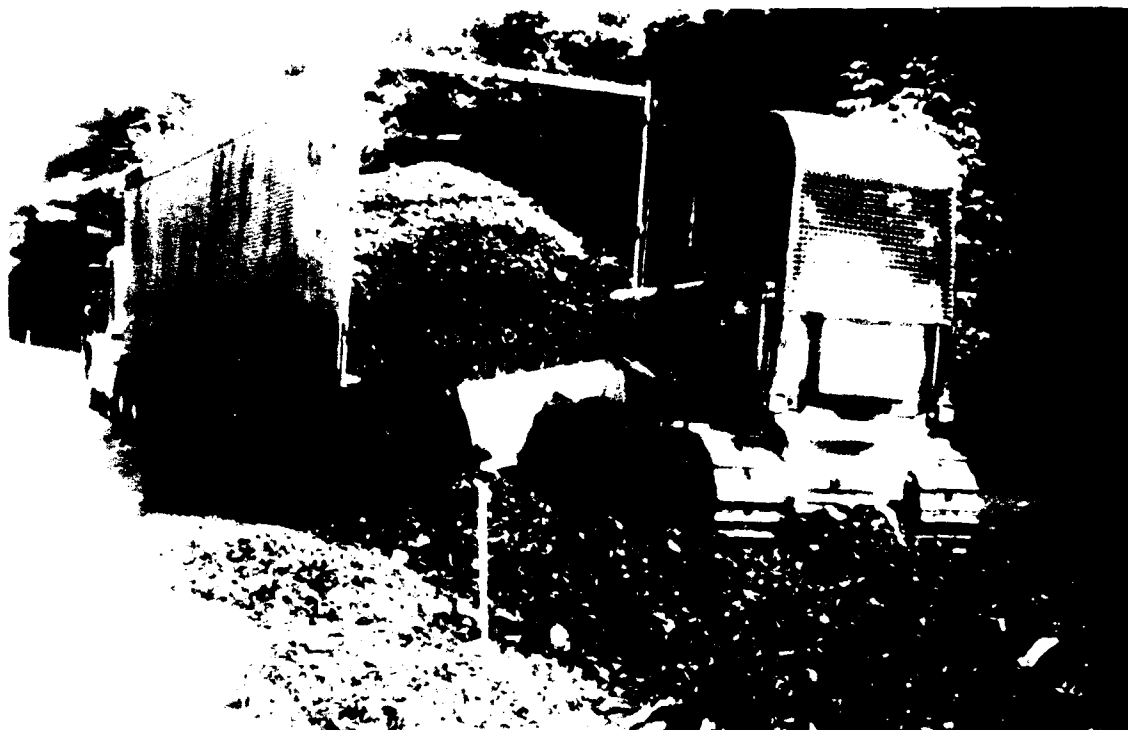
*Figure 7. Unloading tire chips from the semi-trailer and spreading them with the small bulldozer.*

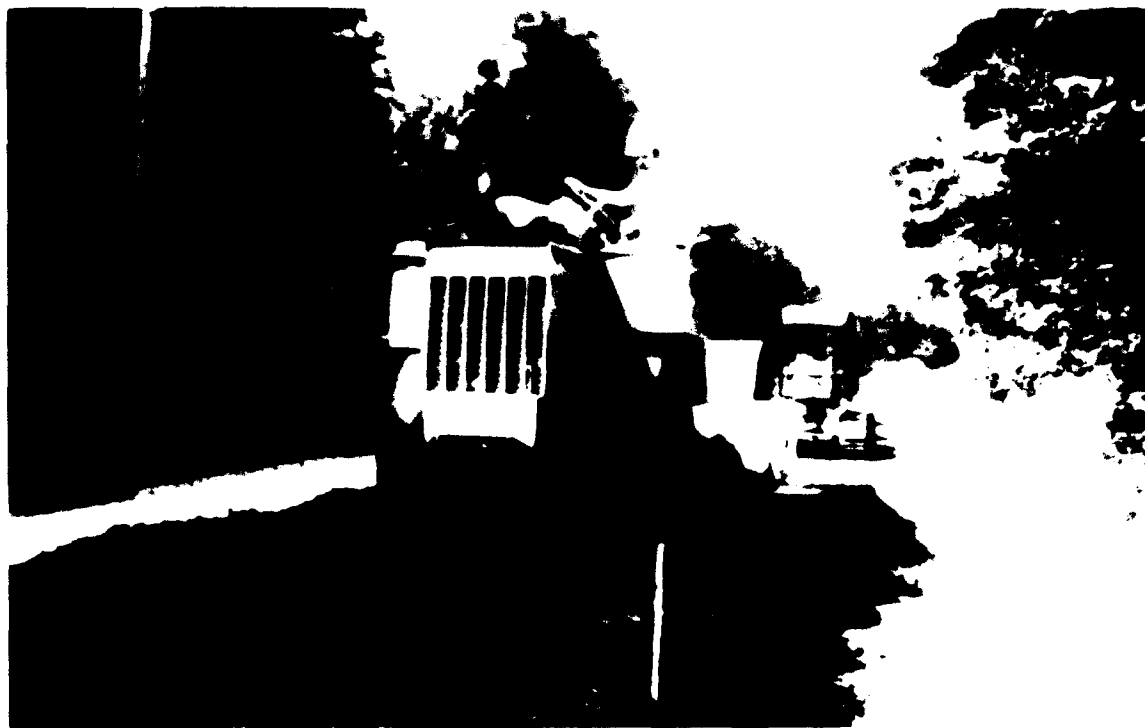
Figure 8. Compacting the tire chips with the vibratory roller.

row were hauled to the site in 15-yd<sup>3</sup>-capacity dump trucks, spread in a 12-in. maximum thickness lift by the small bulldozer, and then compacted with six passes of the roller.

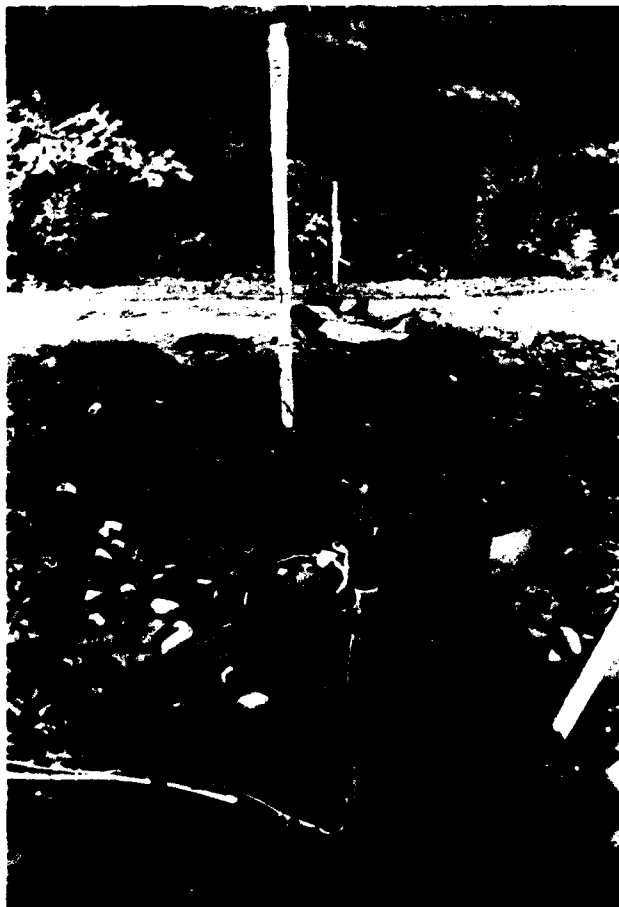
*Figure A8. Thermocouple string with three fliers to be placed in overlying gravel.*

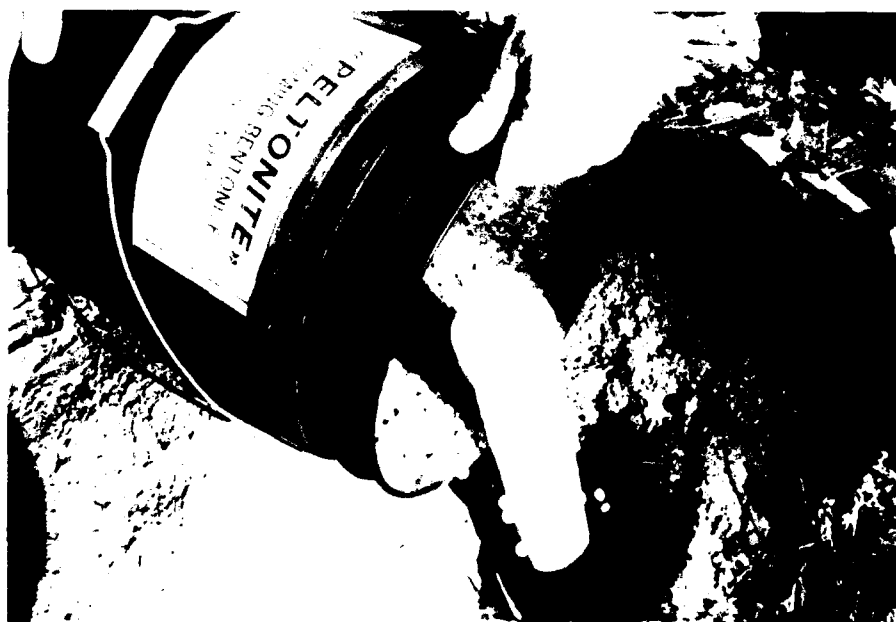
*Figure A10. Putting bentonite around water wells to seal against surface water infiltration.*
