DOT/FAA/CT-94/79

# Evaluation of Scanners for C-Scan Imaging for Nondestructive Inspection of Aircraft

Final Report

| 9. Performing Organization Name and Address<br>Sandia National Laboratories<br>Albuquerque New Mexico 87185 | | 10. Work Unit No. (TRAI) | |

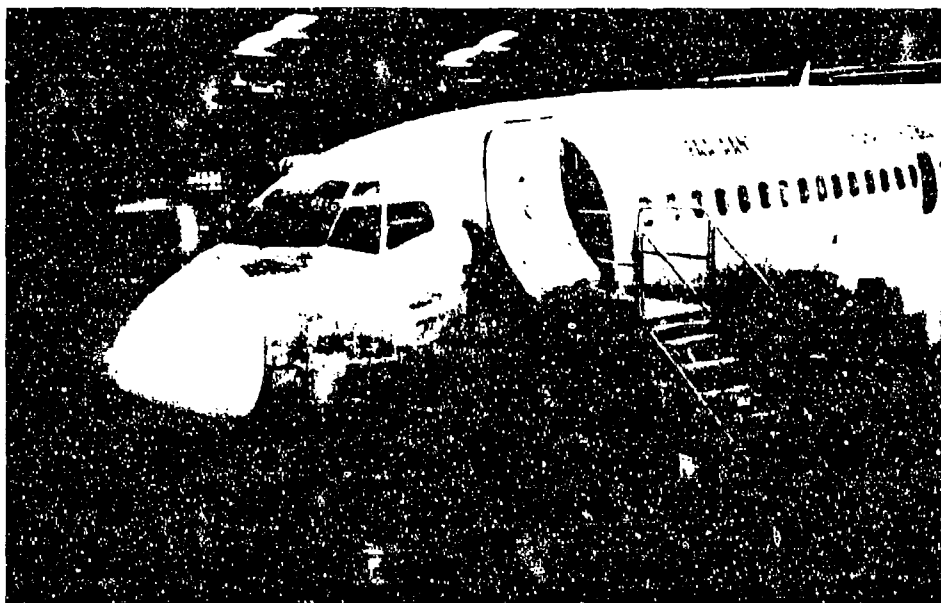
## 5. B737 Airplane Locations (AANC Test Specimen Library Number 100)

The full scale B737 aircraft was received by AANC on October 9, 1992. The aircraft is being used as a commercial transport aircraft test specimen that provides a means to assess human factors issues, accessibility issues, and hangar environment for evaluating NDI inspection requirements.

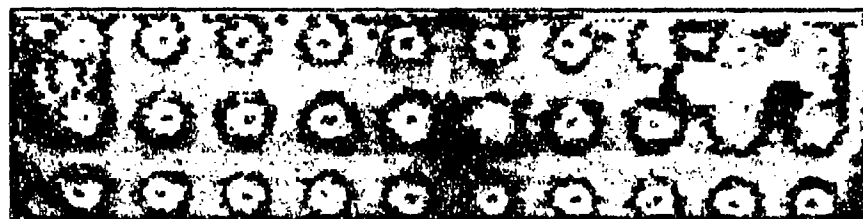
DuPont, CalData, Zetec automated scanner. Corrosion is shown in black and yellow

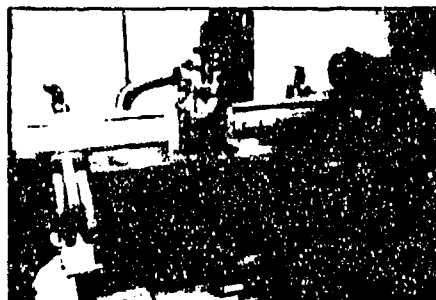
Panametrics portable scanner on a bench top. Shown is a scan of the Textron Specialty Materials boron/epoxy repair sample. A demonstration on the B737 was not made.
