NASA CR-159677  
PWA 5570-37

DESIGN, DURABILITY AND LOW-COST PROCESSING  
TECHNOLOGY FOR COMPOSITE FAN EXIT GUIDE VANES

UNITED TECHNOLOGIES CORPORATION  
Pratt & Whitney Aircraft Group  
Commercial Products Division

Prepared for  
National Aeronautics and Space Administration  
NASA Lewis Research Center  
Contract NAS3-21037

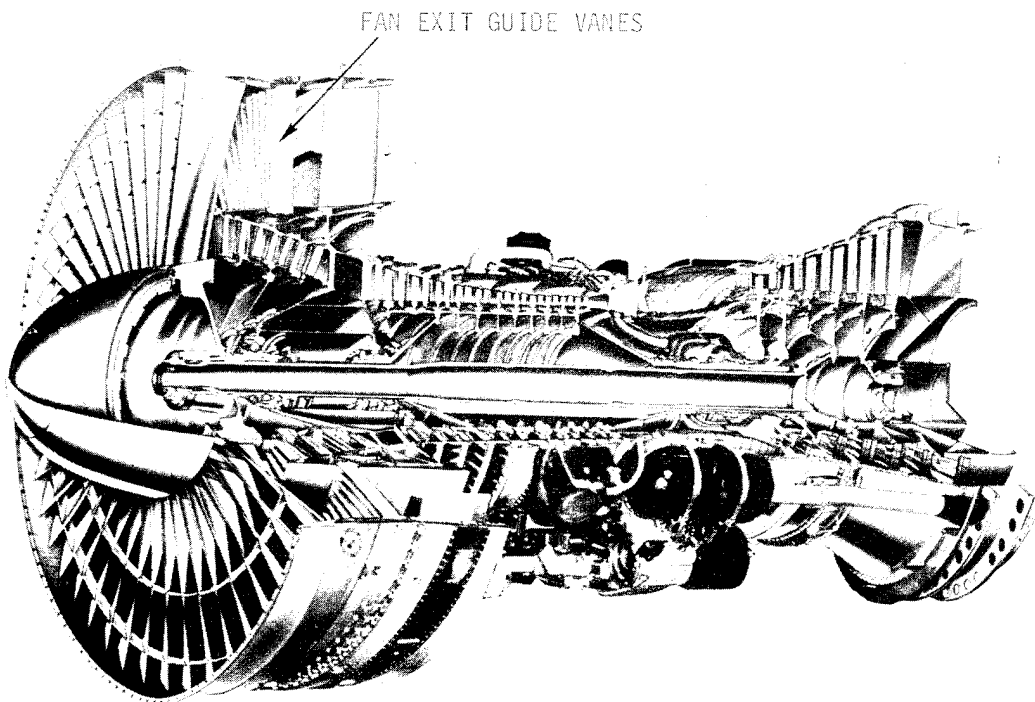
Figure 3-1 JT9D Turbofan Engine

Fan exit guide vanes in JT9D model engines are located downstream of the fan blades in the fan bypass duct (Figure 3-1). In this position, the vanes turn fan air in the axial direction to reduce aerodynamic drag and improve engine operating efficiency. The vanes are designed to withstand aerodynamic forces and experience no significant engine structural loads. Failure or loss of a vane during engine operation would have no effect on the reliability of engine operation. Individual vanes are positioned in cast aluminum platforms using polyurethane as a means of bonding the vane in position. Various JT9D engine models use from 84 to 108 vanes per engine. The quantity and size of vanes are determined by aerodynamic and noise requirements.

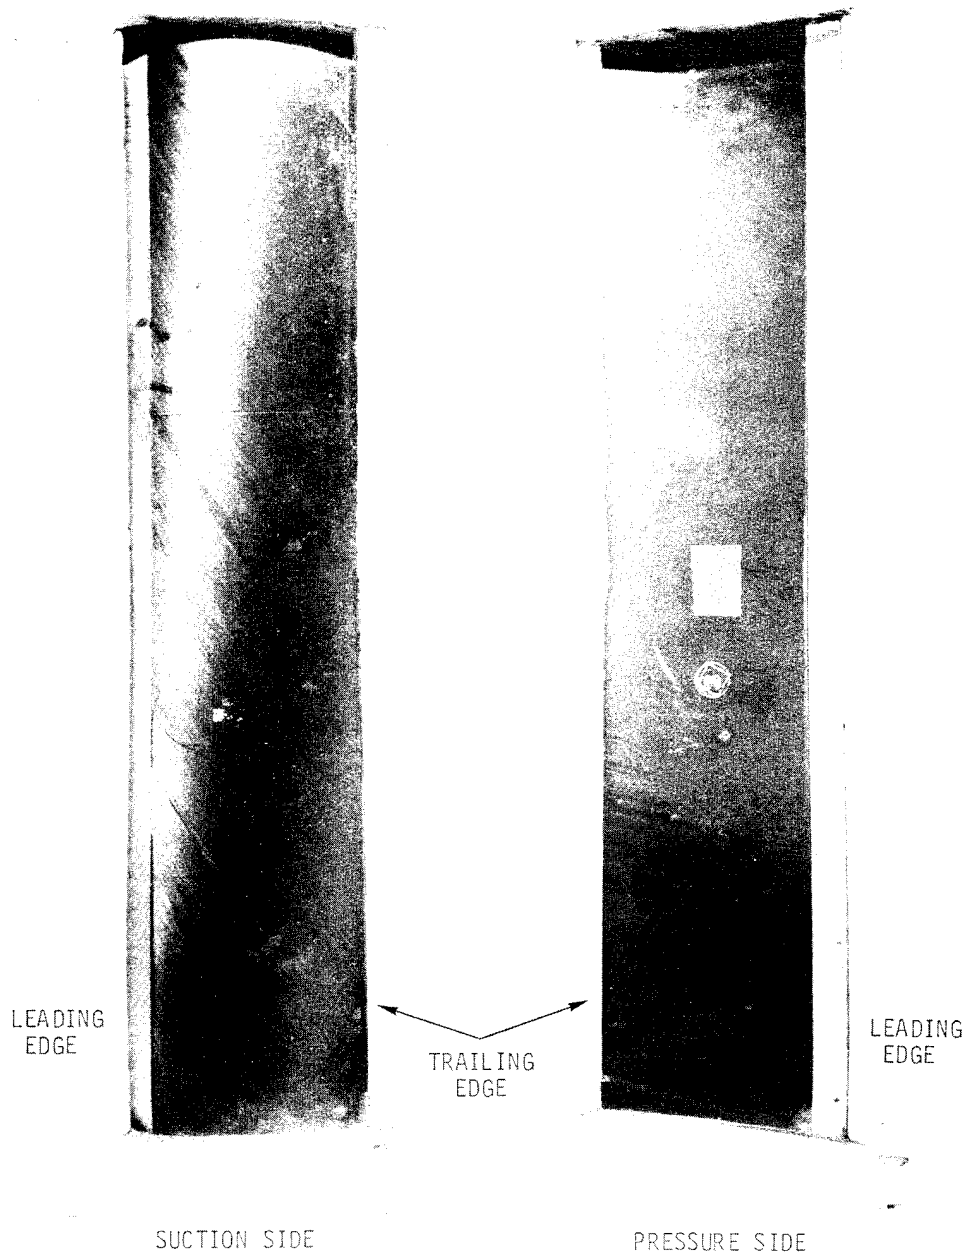
*Figure 3-2 Early Design Thin Trailing Edge Graphite/Epoxy Fan Exit Guide Vane After Long Term Endurance Test in Experimental Engine Environment*

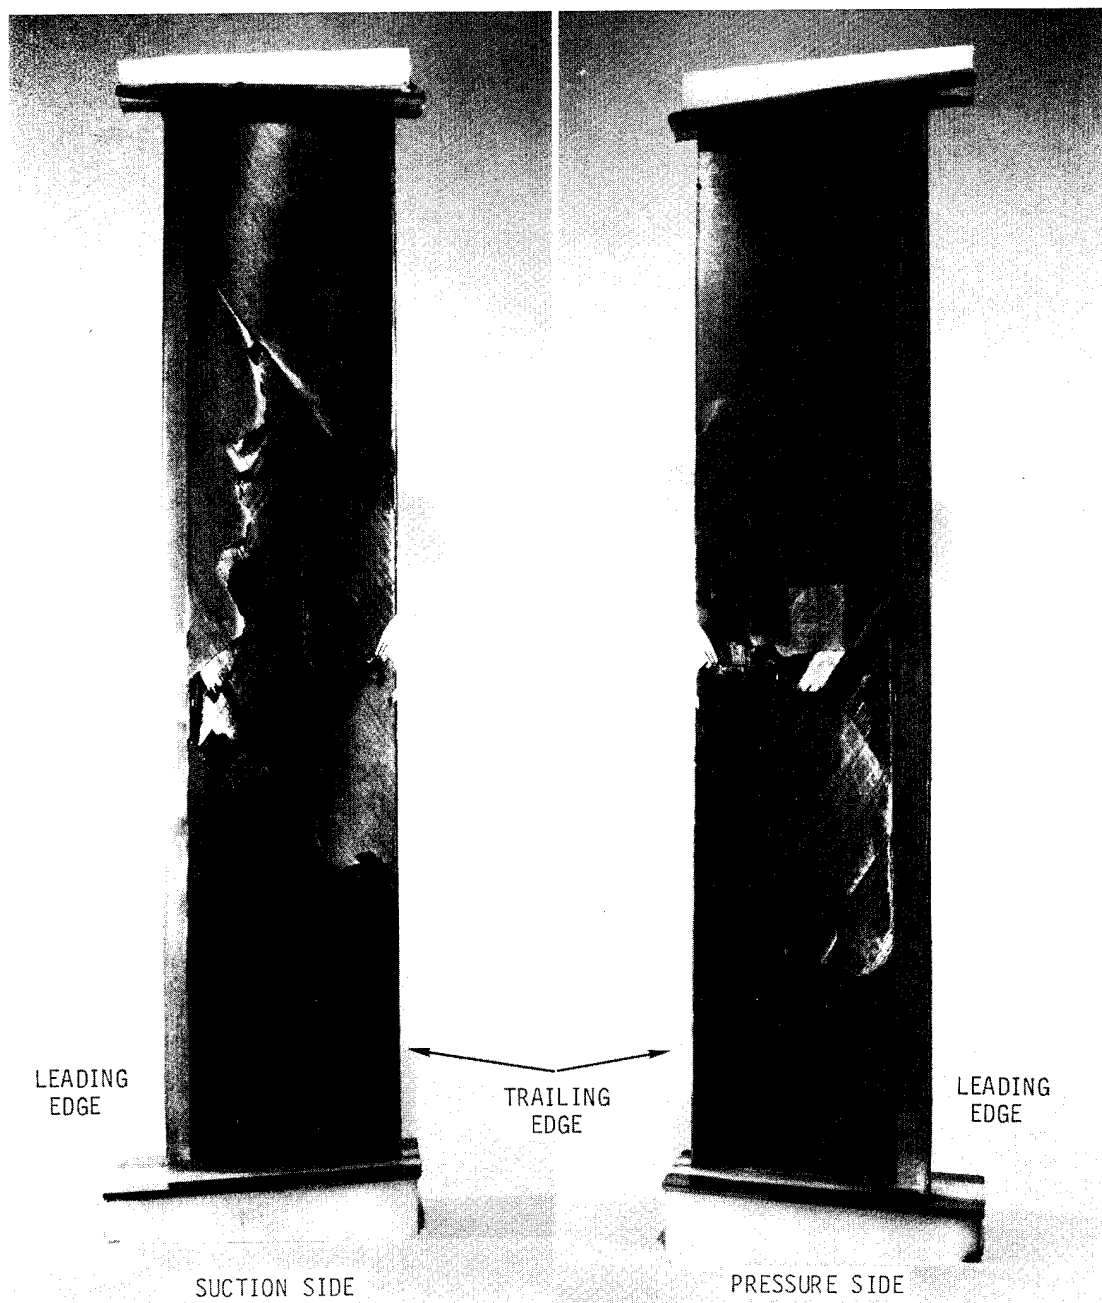
*Figure 3-3 Early Design Thin Trailing Edge Graphite/Epoxy Fan Exit Guide Vane Failure After Test in Fatigue Environment*

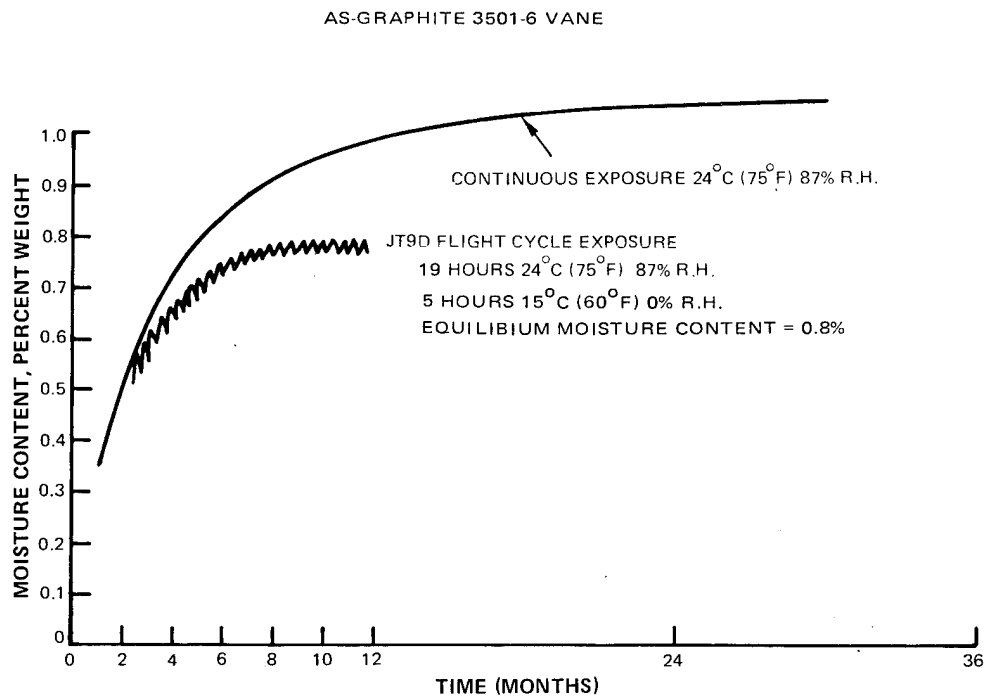
Figure 3-4 Composite Fan Exit Guide Vane Trailing Edge Moisture Content: Trailing Edge Thickness = 2.03 mm (0.080 in.)

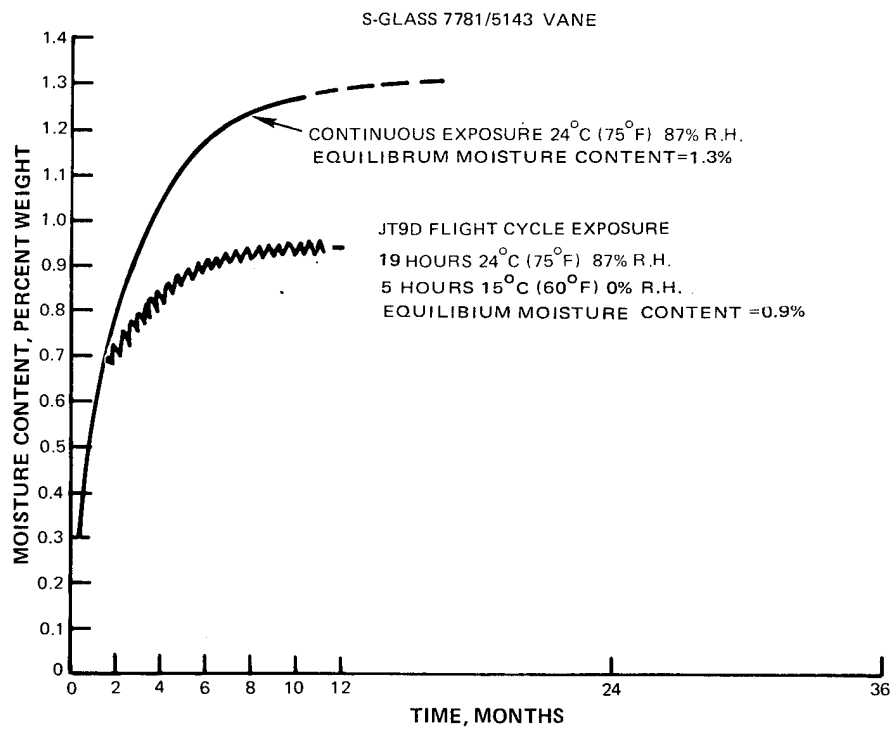
Figure 3-5 Composite Fan Exit Guide Vane Trailing Edge Moisture Content: Trailing Edge Thickness = 2.03 mm (0.080 in.)

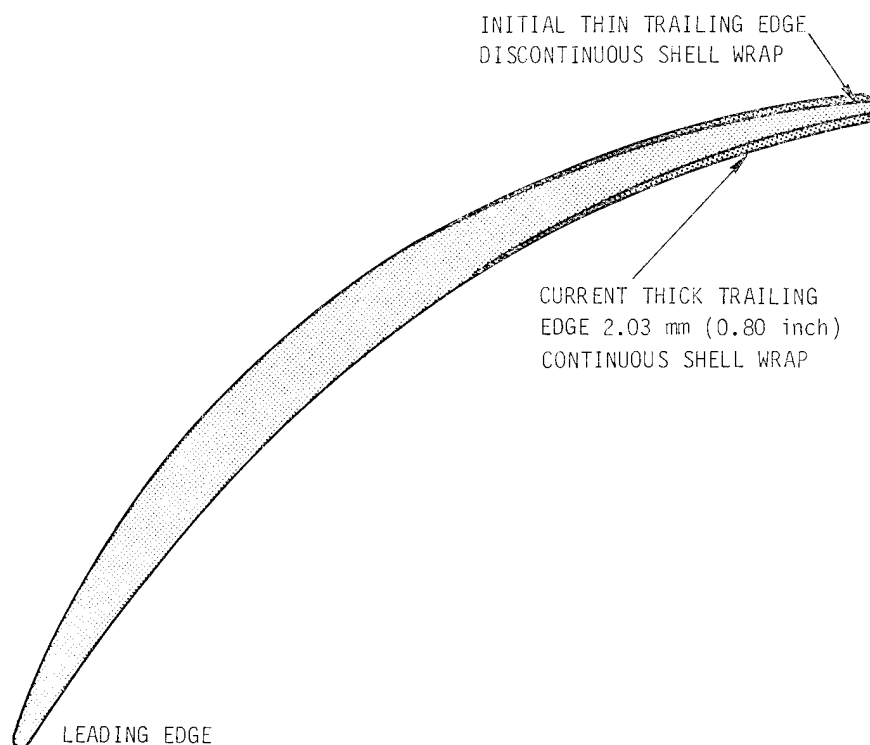
Figure 3-6 Initial and Current JT9D Composite Vane Cross Section

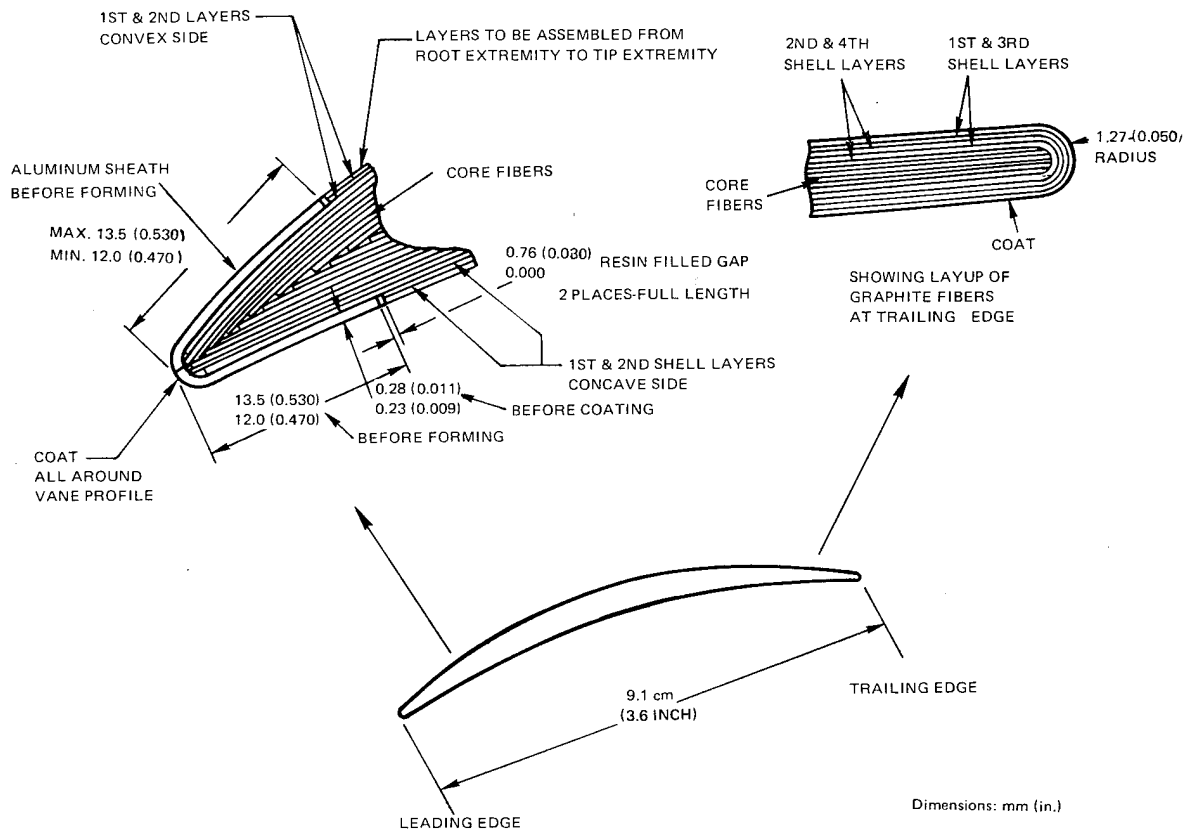
Figure 3-7 Thick Trailing Edge Composite Fan Exit Guide Vane

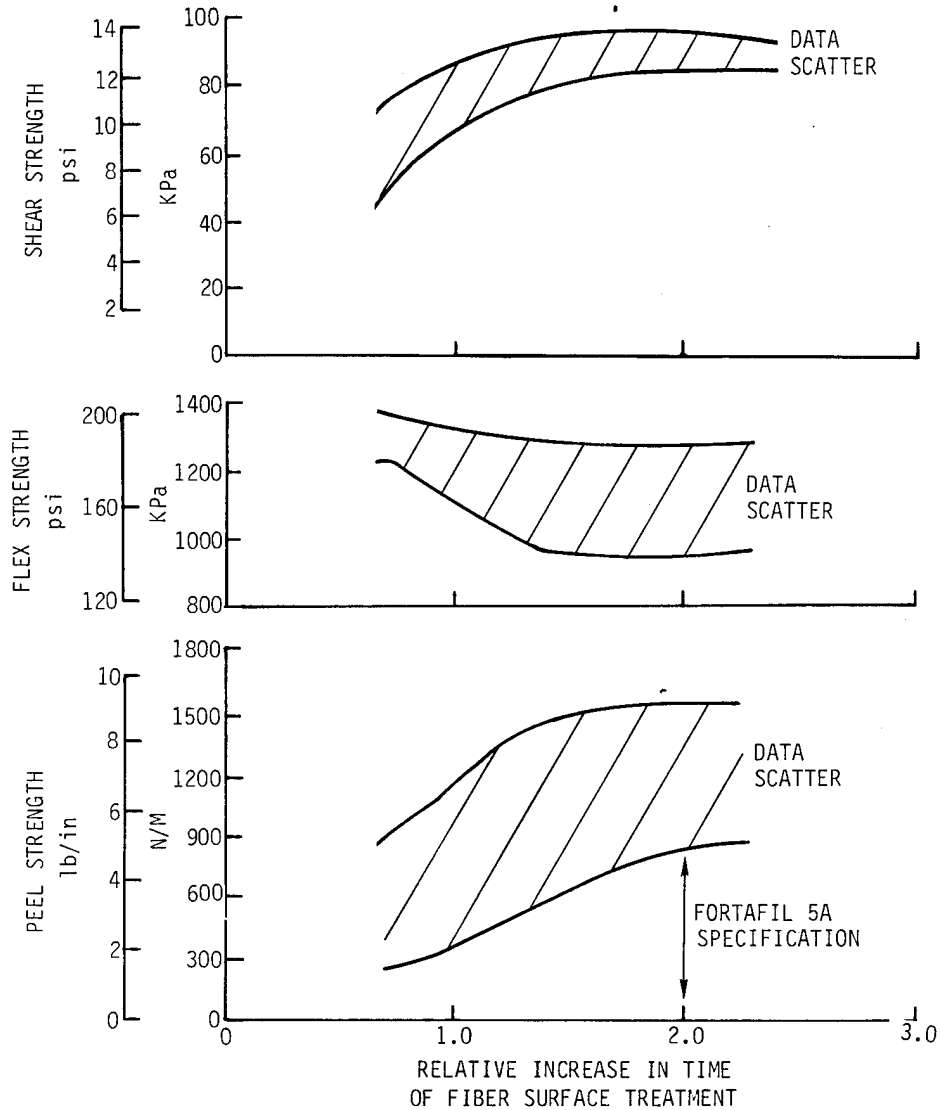
Figure 3-9 Composite Shear, Flexural and Polyurethane Peel Strength of Fortafil 5A Composites vs. Relative Degree of Fiber Surface Treatment

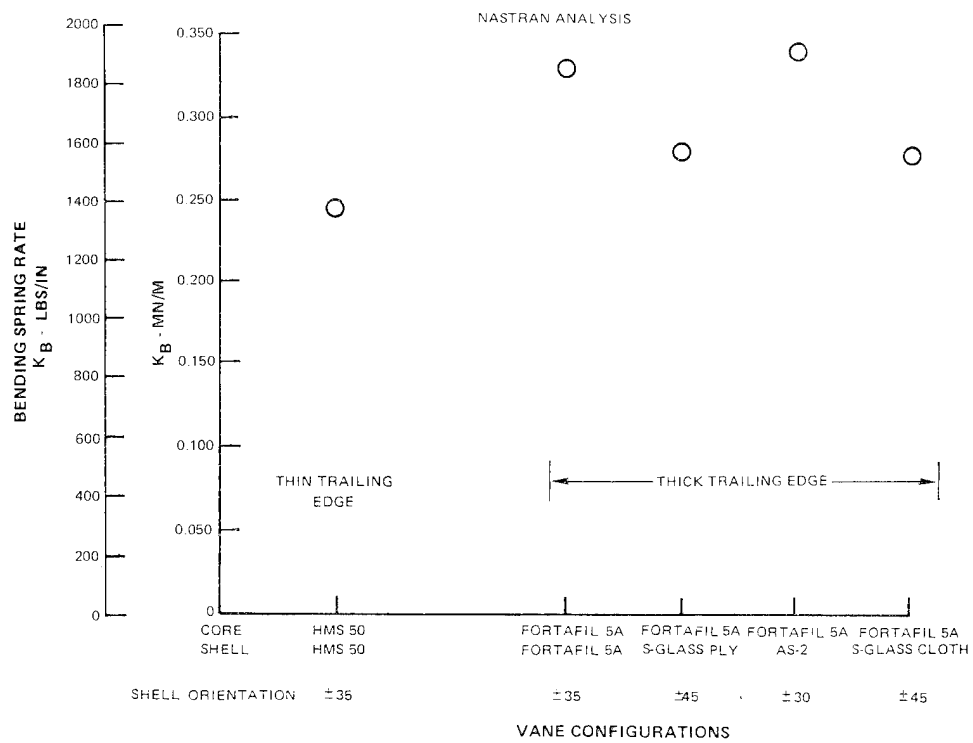
Figure 3-10 Composite Fan Exit Guide Vane Bending Stiffness

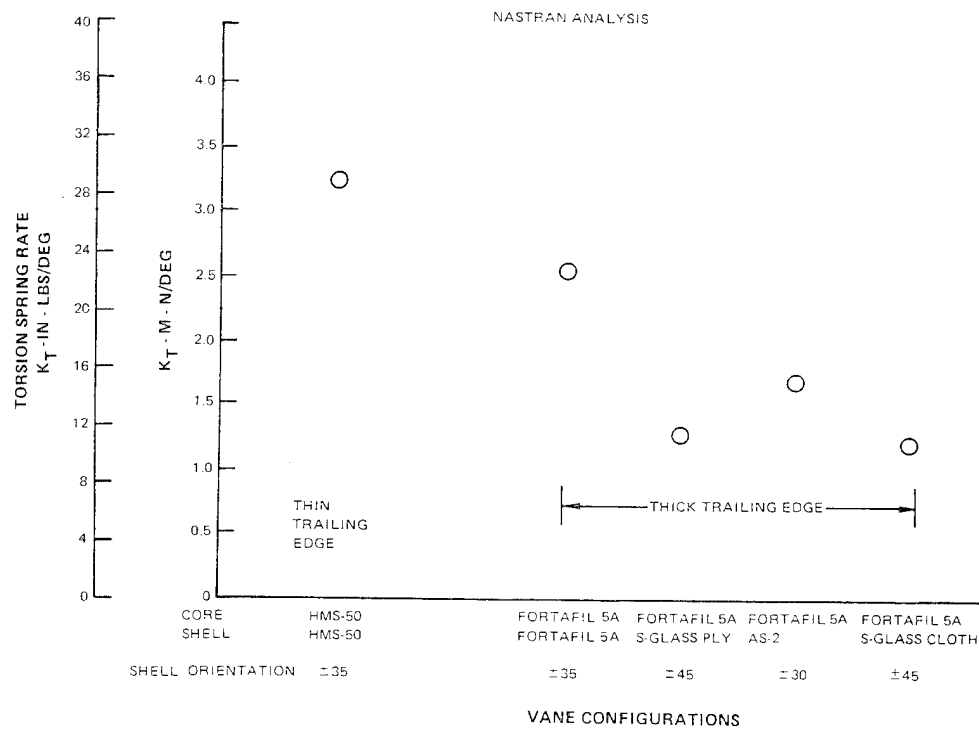
Figure 3-11 Composite Fan Exit Guide Vane Torsional Stiffness

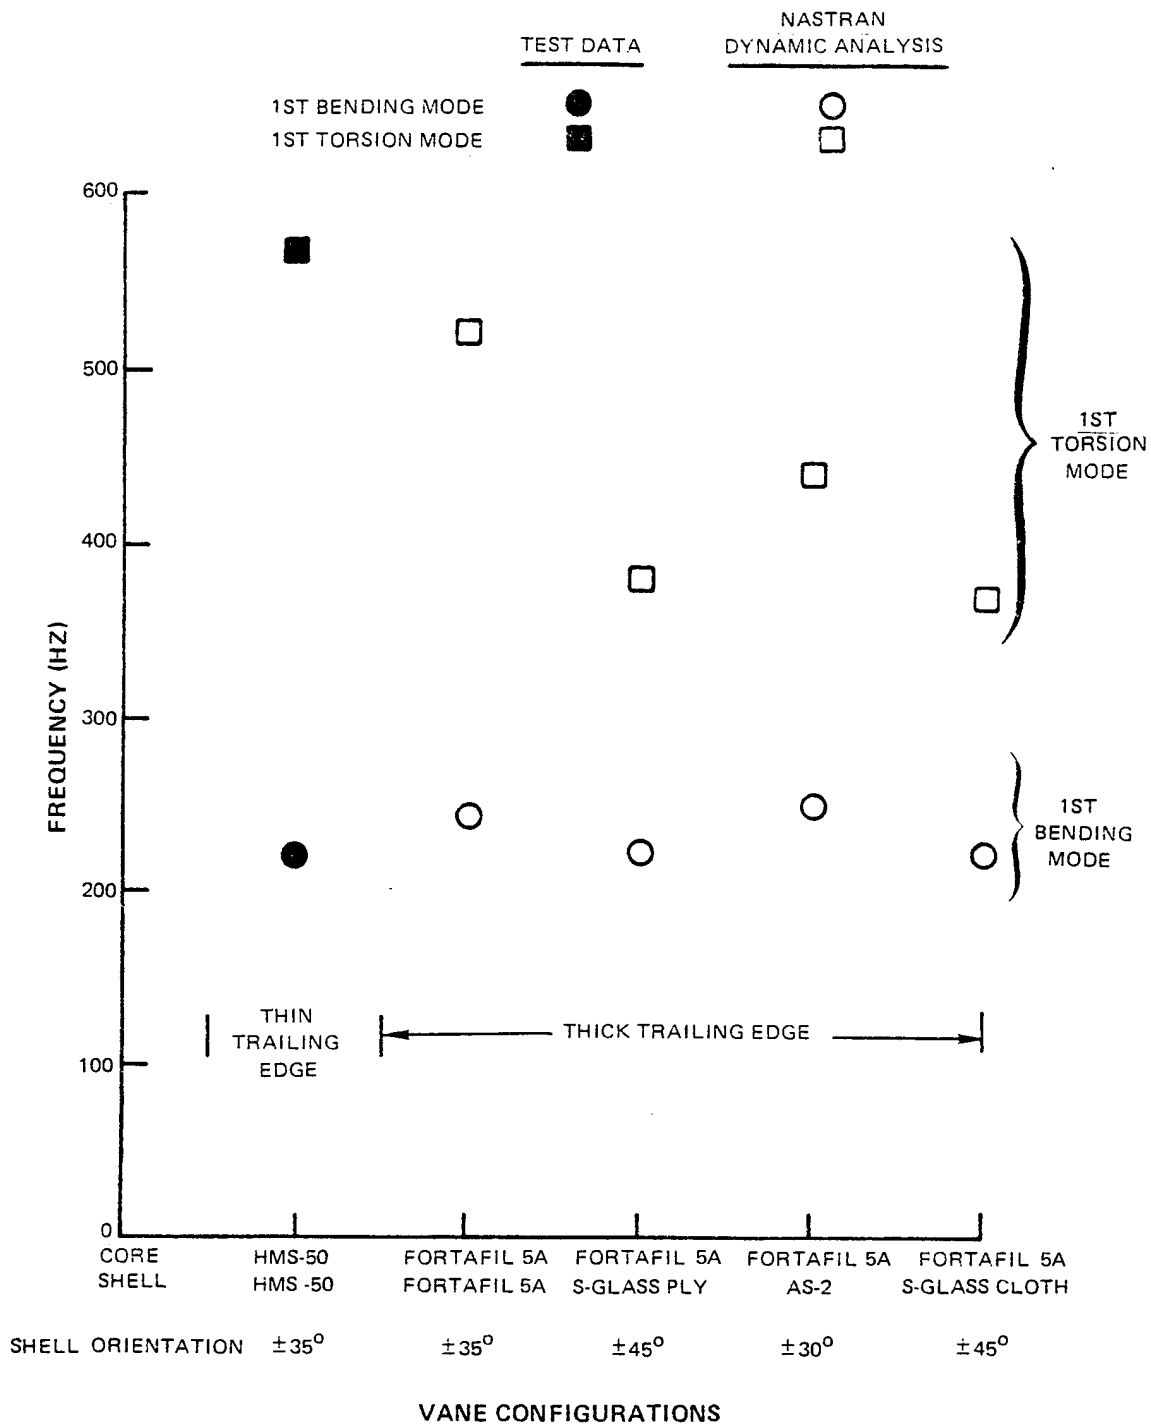
Figure 3-12 Composite Fan Exit Guide Vane Torsion and Bending Frequency

After static loads were stabilized, vibrational loading in the first bending mode was introduced (See Figure 3-12 for frequency ranges). When the test vane successfully completed  $10^7$  cycles at any one vibrational strain level, strain was progressively increased until a frequency loss indicated failure. The sequence for increasing strain increments on test vanes is presented in Figure 5-8. Strain at failure was considered quite conservative, since many vanes were tested at  $10^7$  cycles for up to six times before failure occurred. An Unholtz Dickie 42.4 KN (9500 lbs.) electrodynamic exciter was used to vibrate the part (Figure 5-9). The exciter frequency was varied until vane first bending resonant frequency was achieved. Exciter amplifier gain was adjusted to establish the required vane TE dynamic strain level. A telemicroscope was focused on the vane TE at midspan and the relationship between vane TE dynamic strain and vibratory amplitude was determined. The short life of strain gage instrumentation during dynamic testing forced reliance on the telemicroscope method for monitoring trailing edge strain.

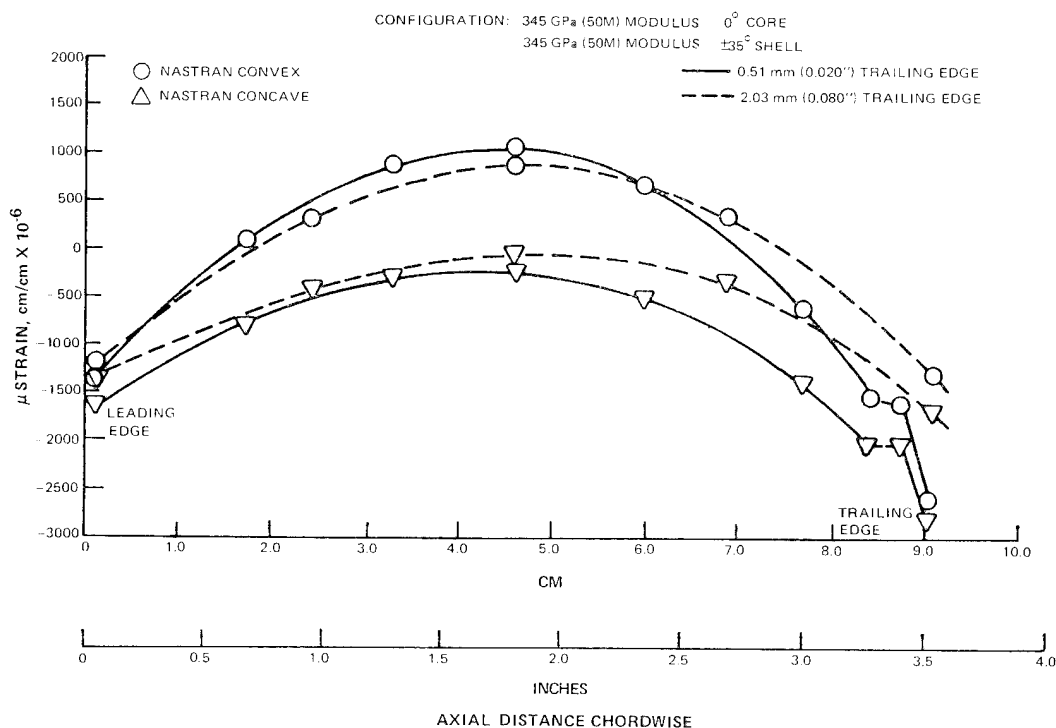
Figure 3-13 Composite Fan Exit Guide Vane Strain Distribution  
NASTRAN Static Pressure Load Analysis, 34 KPa (5 psi)

Chordwise distribution of radial strain was compared for both thick and thin trailing edge vanes of comparable material/ply orientation for maximum static load on the airfoil at the vane midspan (Figure 3-13). A thickening of the airfoil, starting at midchord and gradually continuing to the trailing edge, provided additional high modulus core fiber which decreased the average strain in the core from the 6.4 cm (2.5 in.) chord location to the trailing edge. The use of the trailing edge shell wrap-around concept in conjunction with the thick trailing edge permitted unidirectional core to move approximately 7.62 mm (0.30 in.) closer to the trailing edge outer surface which also contributed to increased bending stiffness. These additive effects of increasing core thickness and moving the core closer to the trailing edge resulted in decreased strain from  $-2800 \mu\epsilon$  to  $-1720 \mu\epsilon$ . Furthermore, the wrap around shell concept was expected to provide a two-fold benefit. One of these benefits was expected to be improved fiber/resin homogeneity which would reduce peak strains at the trailing edge. Another benefit expected was an improved shear tie in the shell around the trailing edge radius from the concave side of the airfoil to the convex side. The earlier vane was designed with concave and convex shell fibers terminating at the trailing edge.

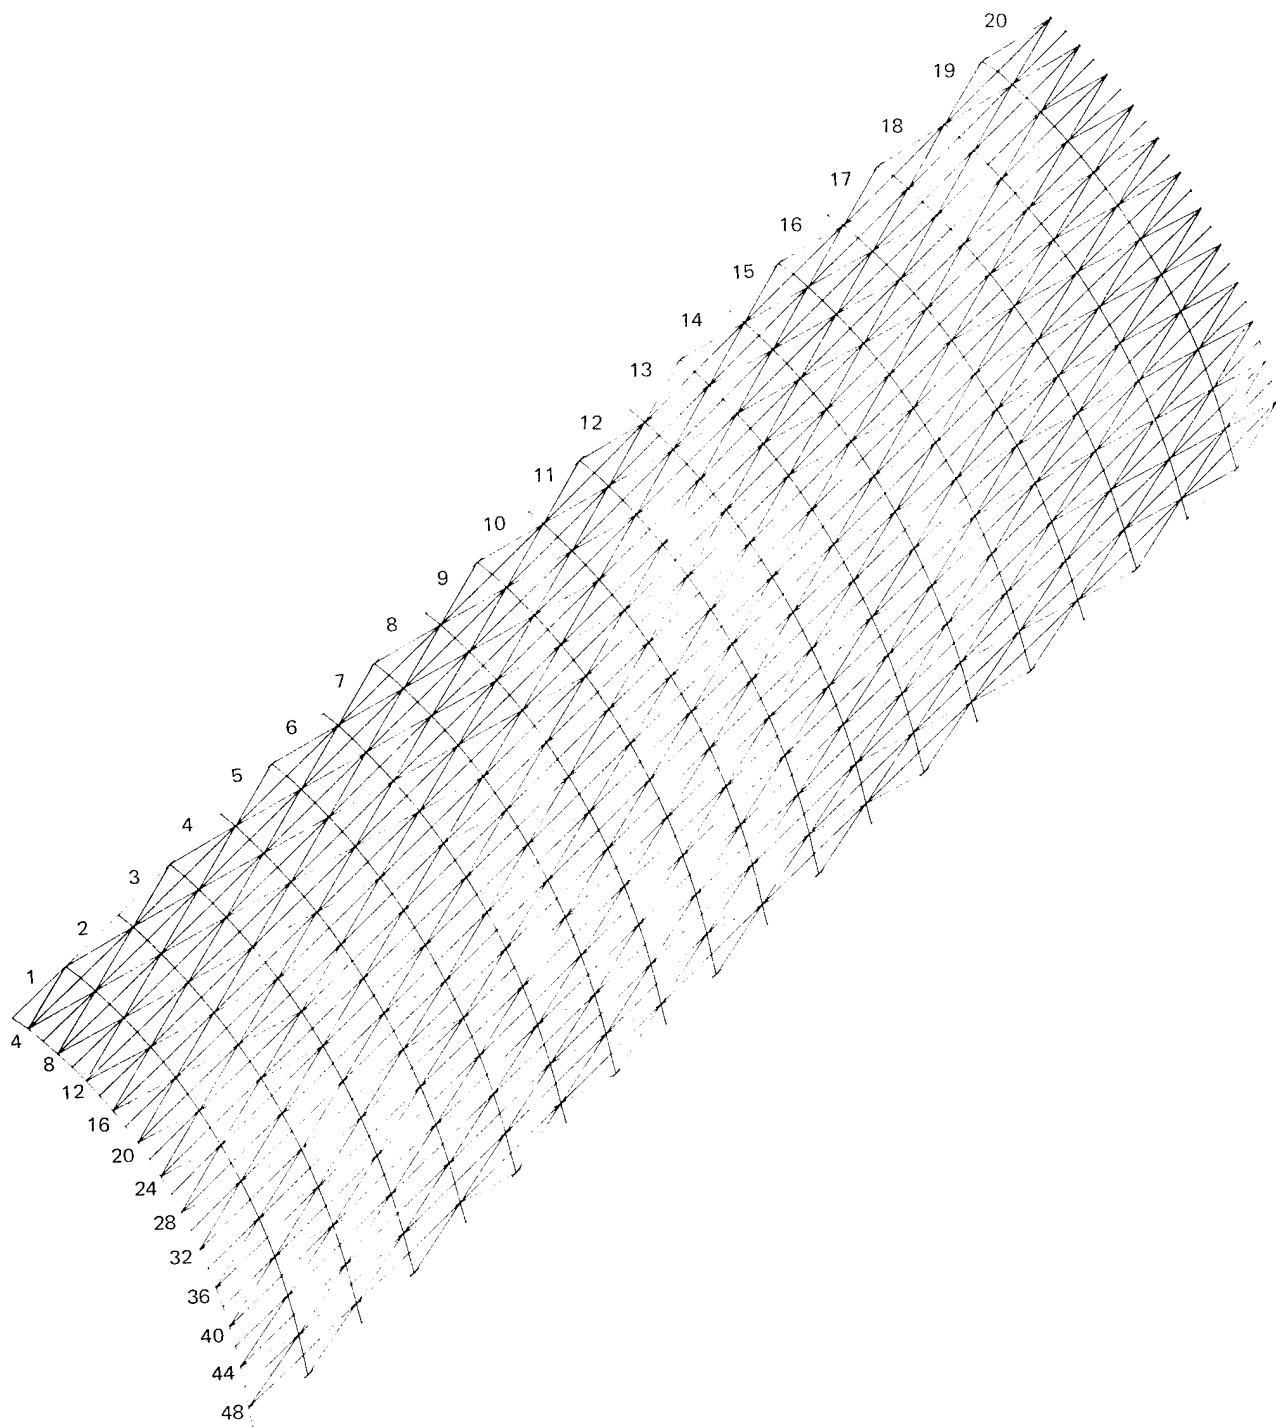
Figure 3-14 Fan Exit Guide Vane View of NASTRAN Plate Elements - 48  
Chordal Sections, 20 Spanwise Sections for Core and  
Shell

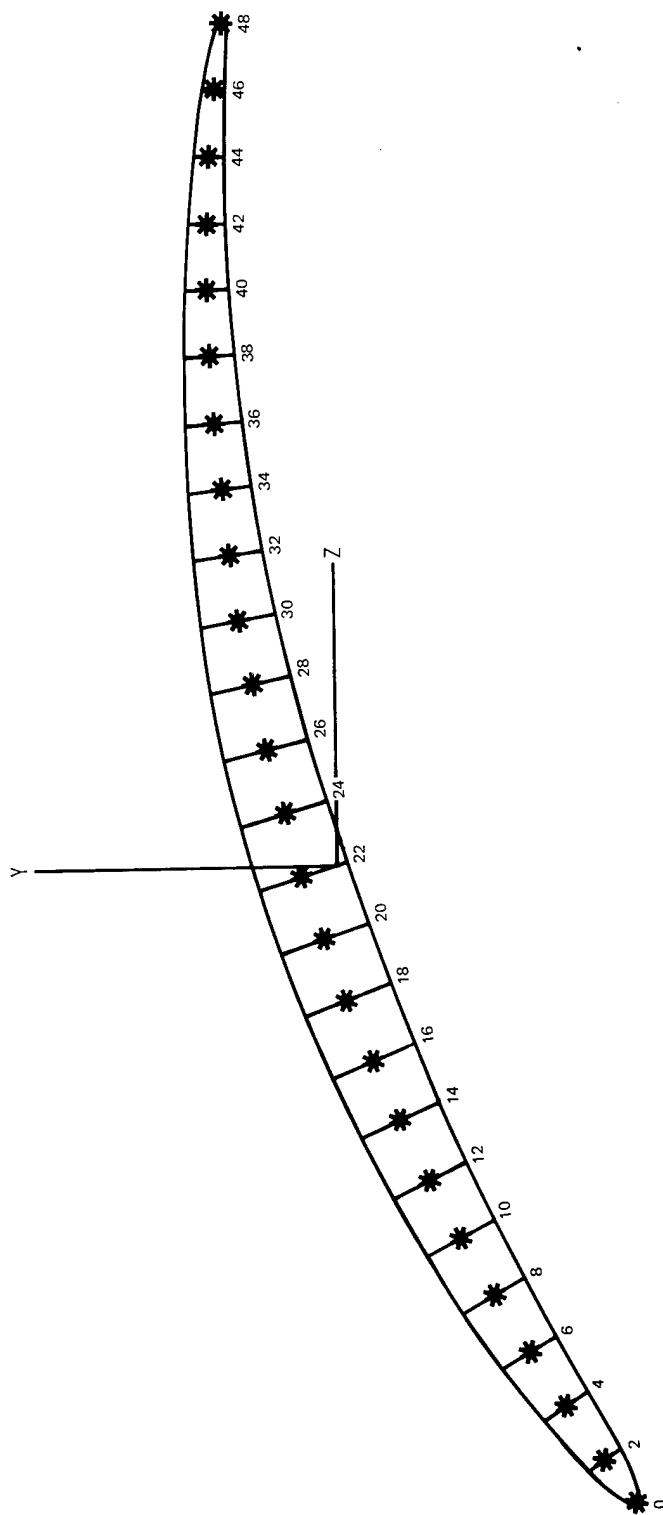
Figure 3-15 Fan Exit Guide Vane Airfoil Cross Section for NASTRAN Analysis at 15% Span - 48 Chordal Plate Elements for Core and Shell

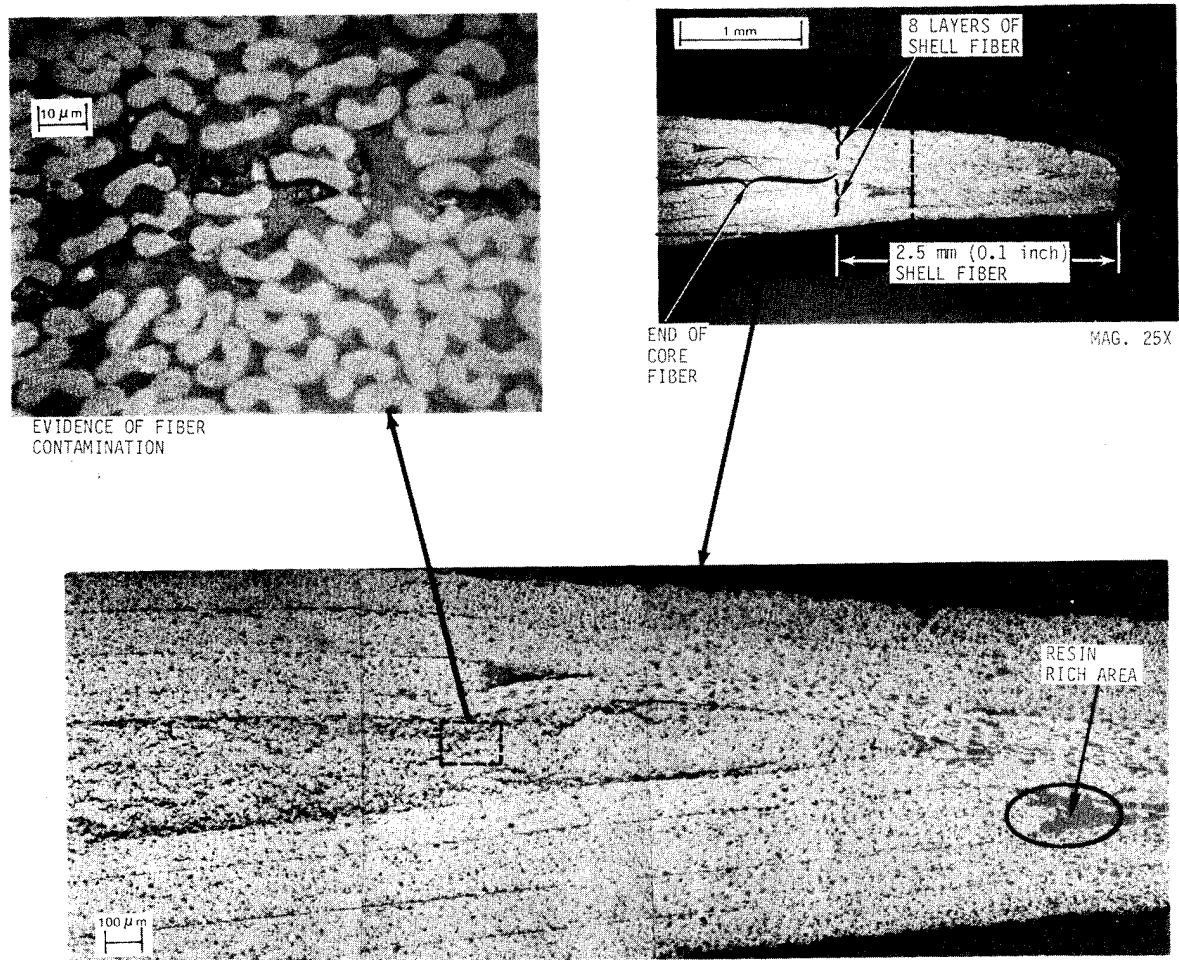
Figure 4-1 Photomicrograph of Typical Cross-Section of Contaminated Fiber 1975 Period Thin Trailing Edge Vane

During the 1975 program, a mechanical property correlation for panels fabricated with Fortafil 5 was found to exist between shear, flexure and polyurethane to composite peel strength. To achieve the best balance of all three properties and eliminate the fiber contamination problem, various fiber surface treatments were undertaken by Great Lakes Carbon. The results of those treatments indicated that significant improvements in shear strength and polyurethane peel strength were obtained when panels were fabricated from fiber which had twice the level of surface treatment previously received. This fiber surface conditioning which is proprietary to Great Lakes Carbon was agreed upon by all parties and the modified fiber was identified as Fortafil 5A and used in the subject program. The failure characteristics of low peel strength showed fiber pullout from the composite rather than adhesive failure between the composite and polyurethane film. Peel strength was also a good indication of proper polyurethane bonding conditions to the composite part. A typical example of the result of contaminated fiber on vane microstructure can be seen in Figure 4-1. Also apparent are resin rich areas at the vane trailing edge.

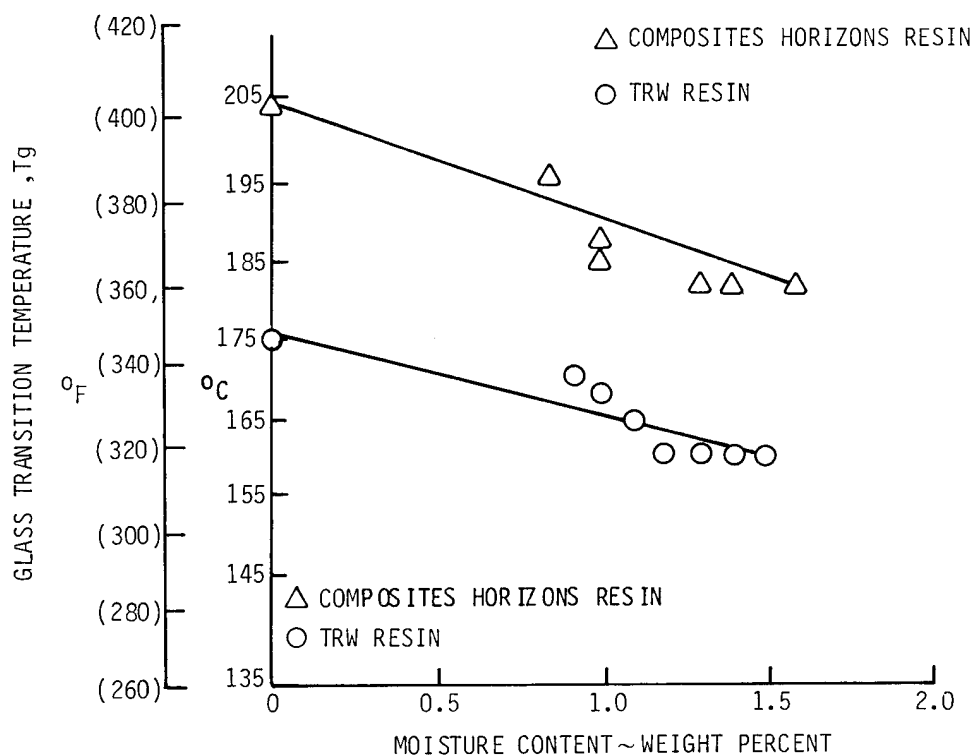
Figure 4-2

Effect of Moisture on Glass Transition Temperature  
 of Epoxy Novalac Resin Systems

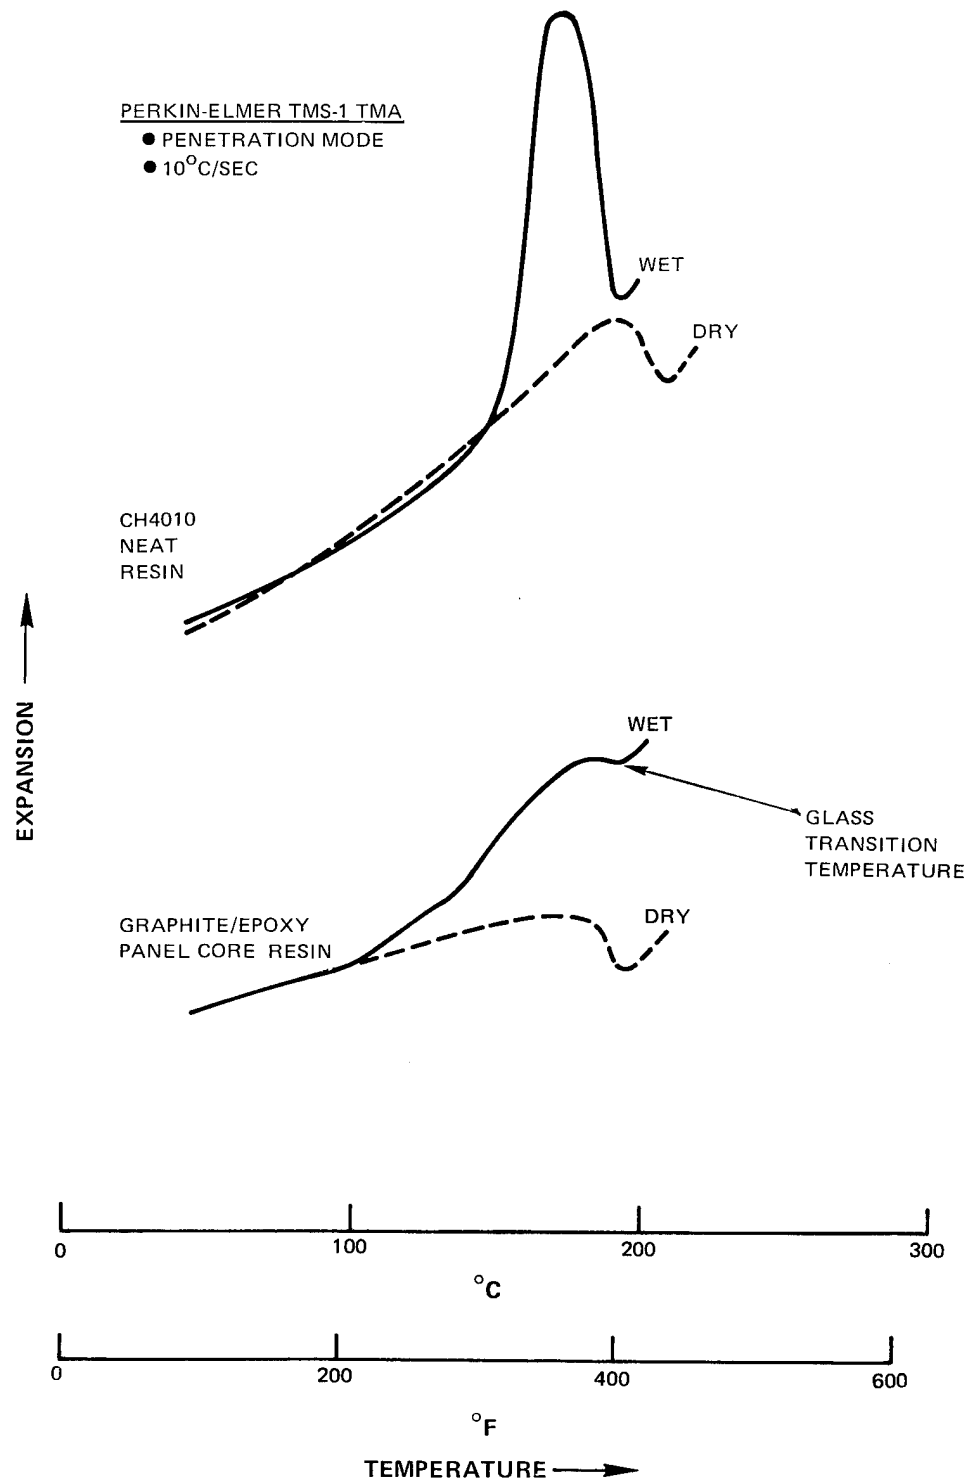
Figure 4-3 Thermomechanical Trace of Composite Horizons Neat Resin and Composite Panels

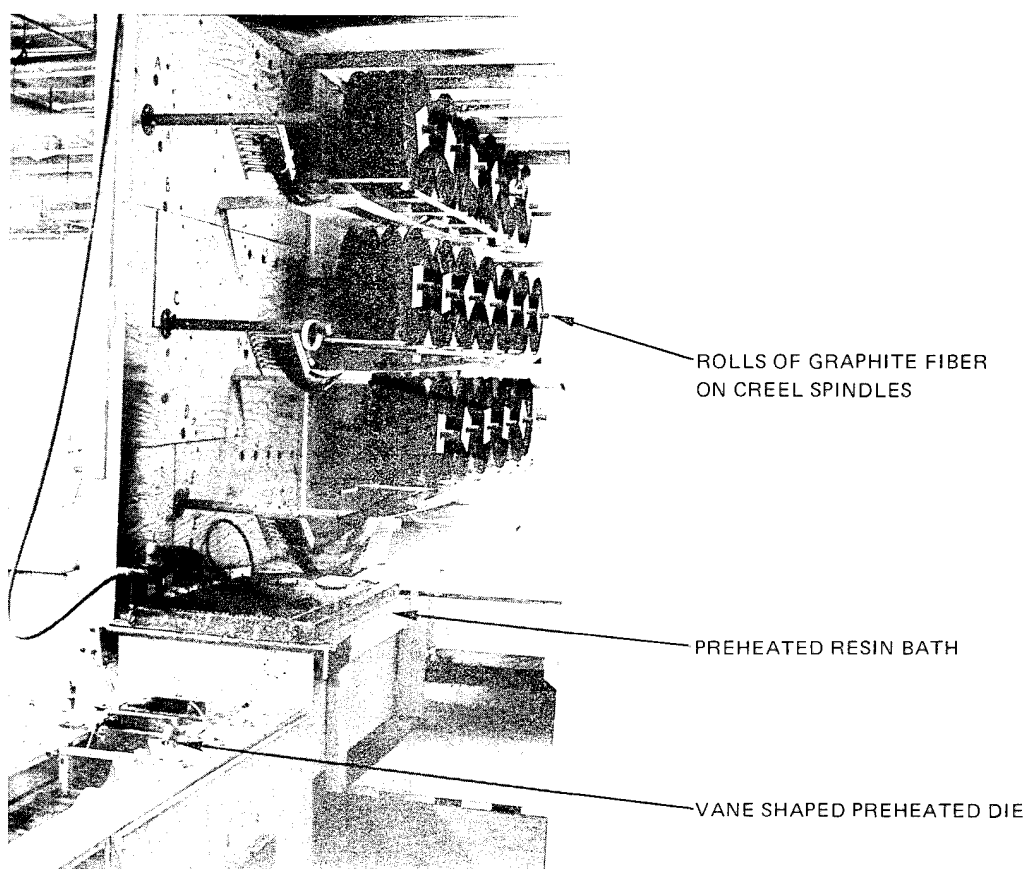
Figure 4-5 Composites Horizons Pultrusion Equipment

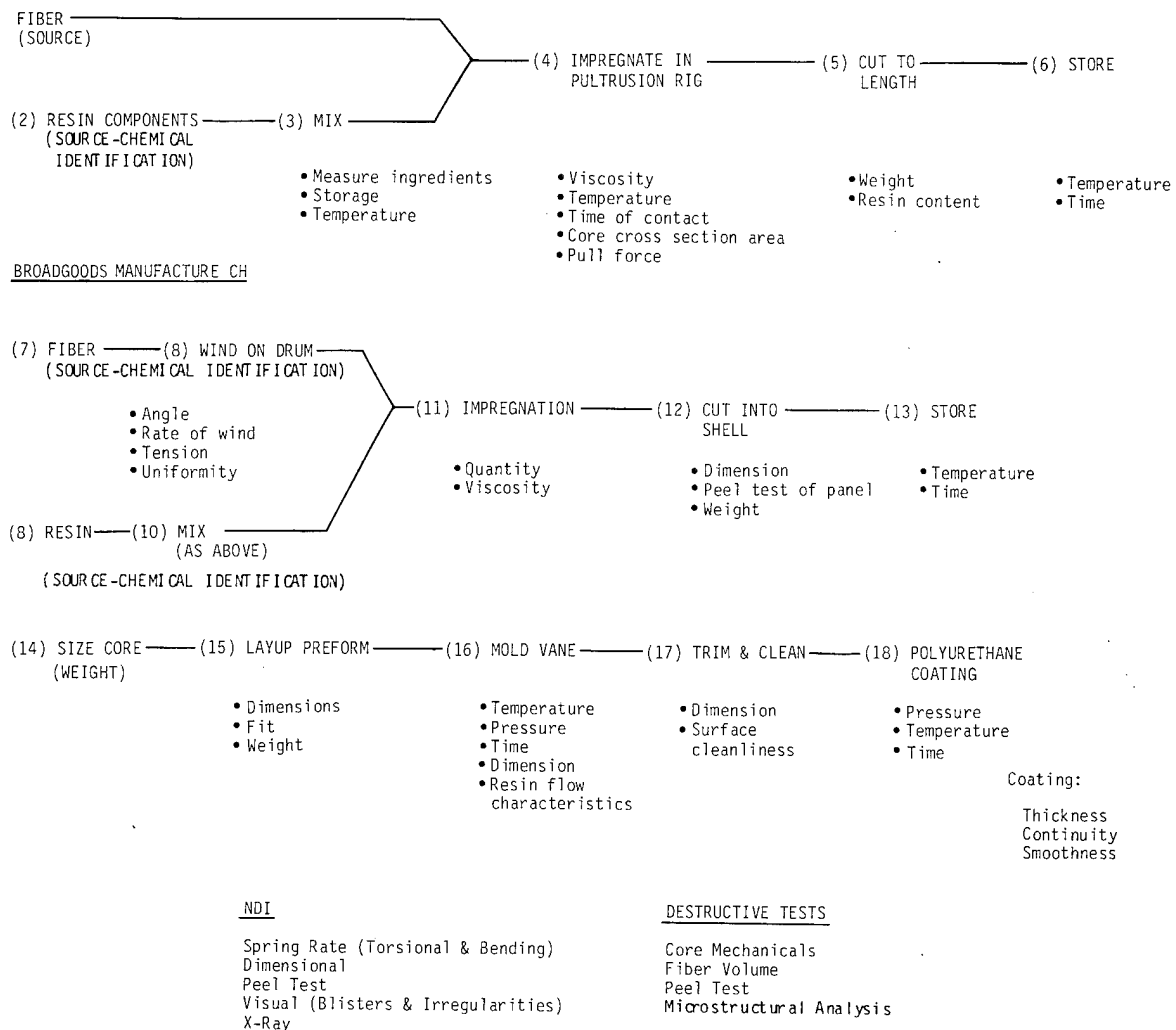
Figure 4-10 Composites Horizons Fan Exit Guide Vane Fabrication Sequence

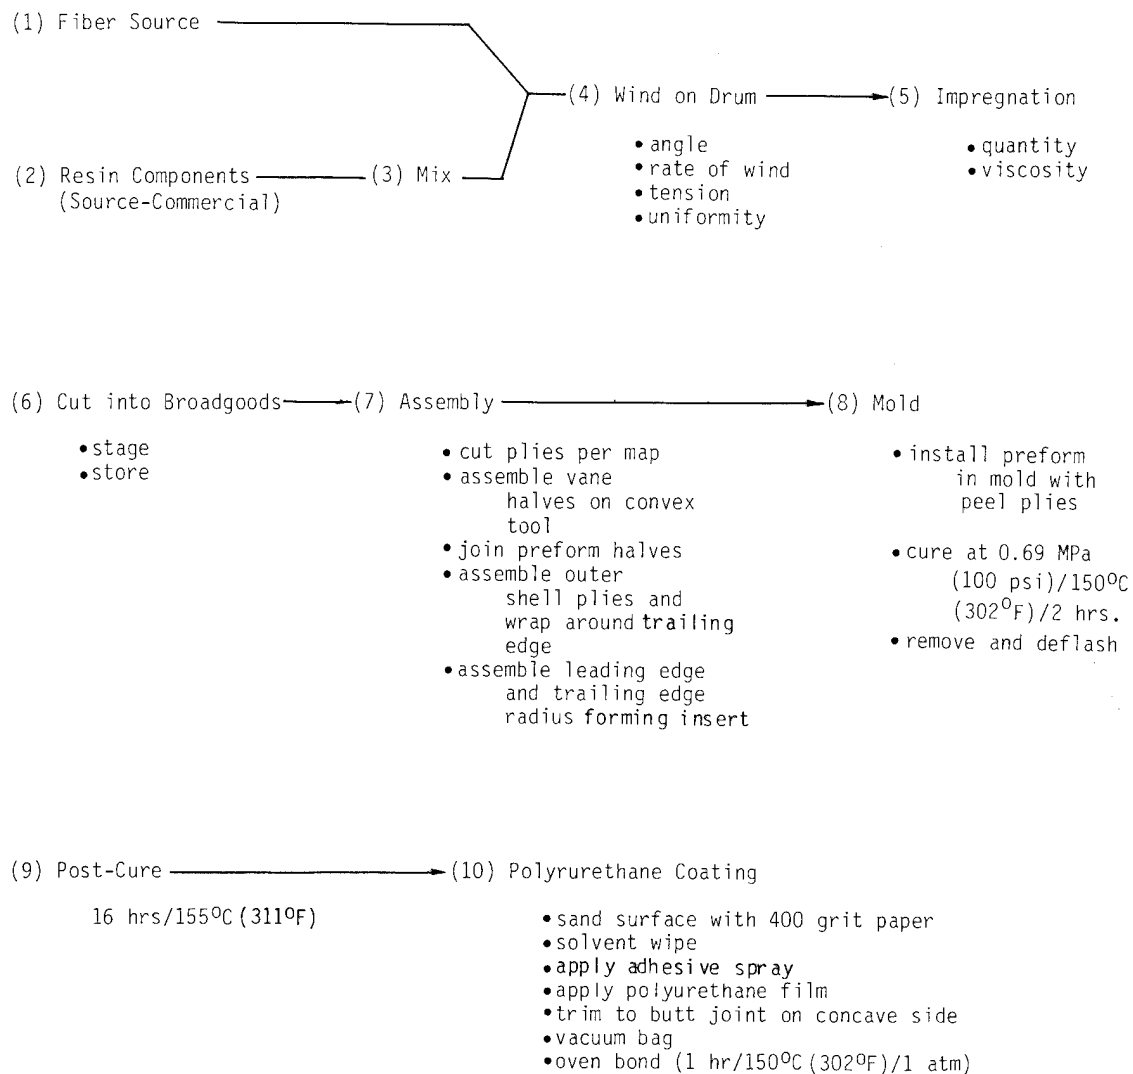
Figure 4-11 TRW Fan Exit Guide Vane Fabrication Sequence
