NASA CR-159677  
PWA 5570-37

DESIGN, DURABILITY AND LOW-COST PROCESSING  
TECHNOLOGY FOR COMPOSITE FAN EXIT GUIDE VANES

UNITED TECHNOLOGIES CORPORATION  
Pratt & Whitney Aircraft Group  
Commercial Products Division

Prepared for  
National Aeronautics and Space Administration  
NASA Lewis Research Center  
Contract NAS3-21037

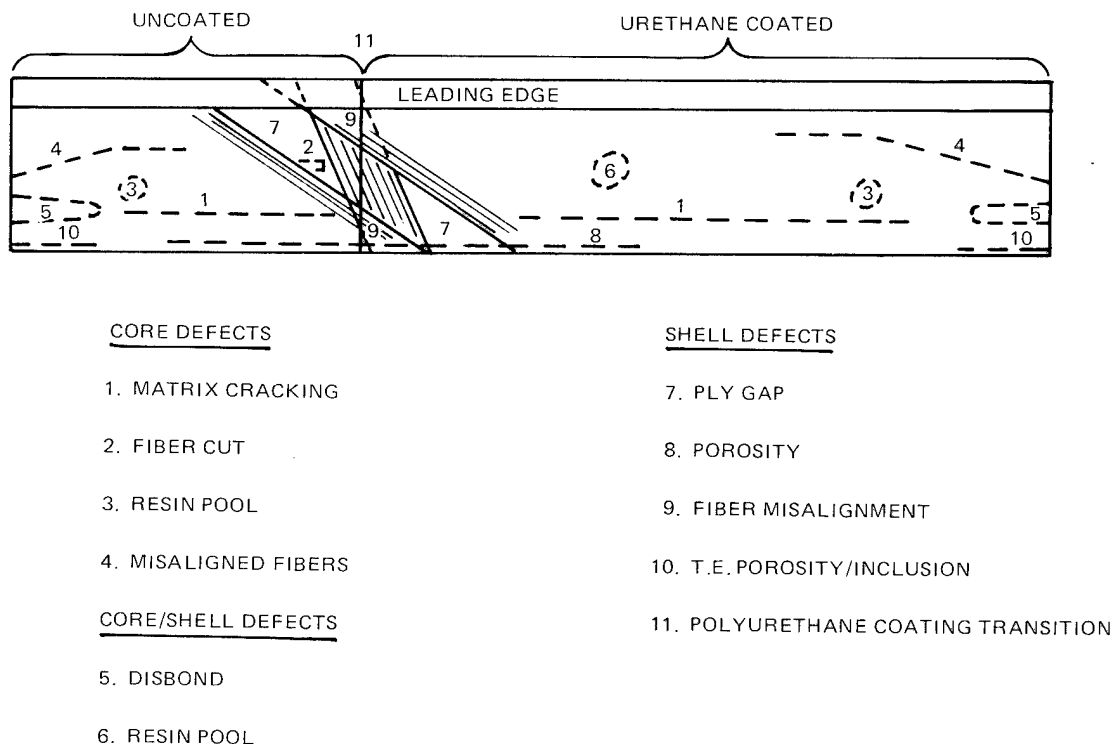
Figure 4-13                      Composites Horizons Defect Vane Flaw Location and Identification Map

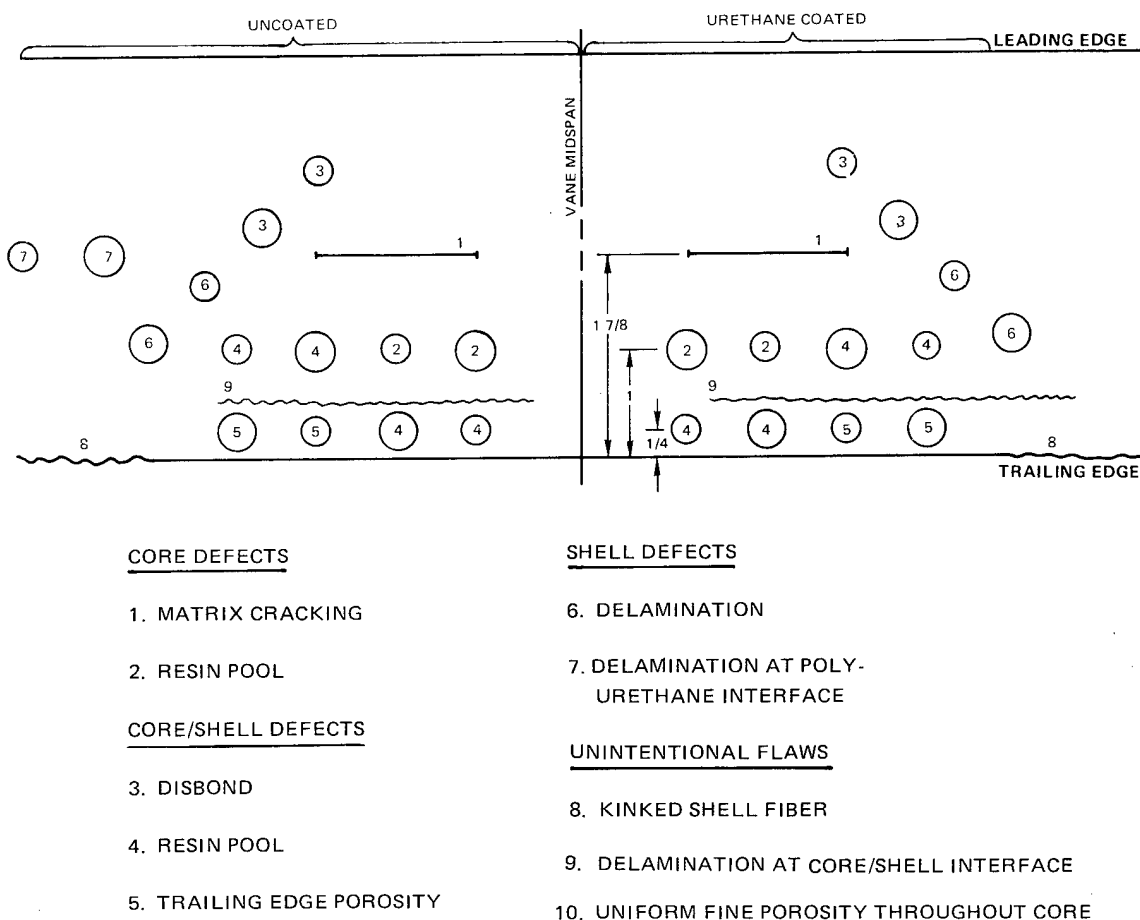
Figure 4-14 TRW Defect Vane Flaw Location and Identification Map

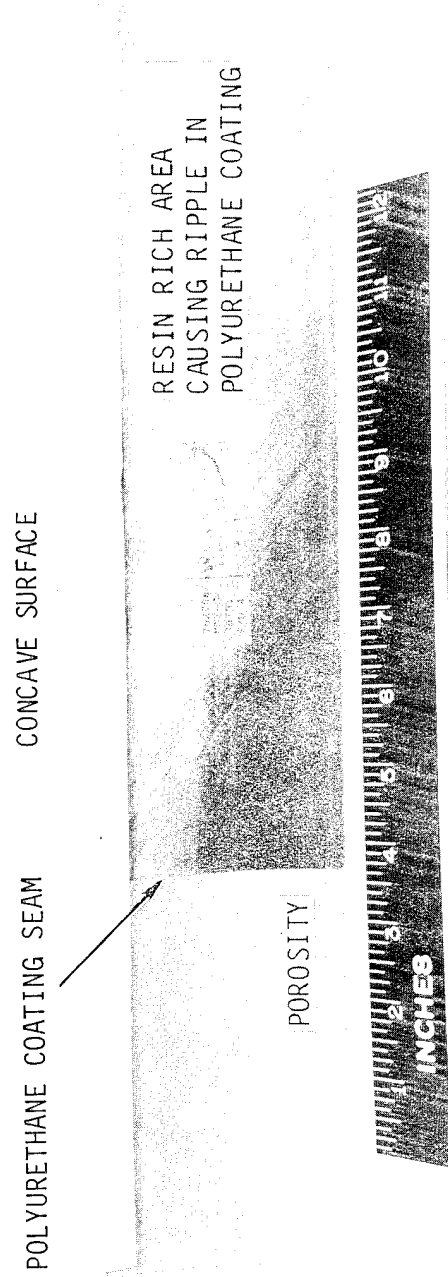
Figure 4-15 Photograph of Nondestructive Evaluation Standard Vane  
Graphite Shell Graphite Core/Epoxy Composites Horizons;  
S/N 4

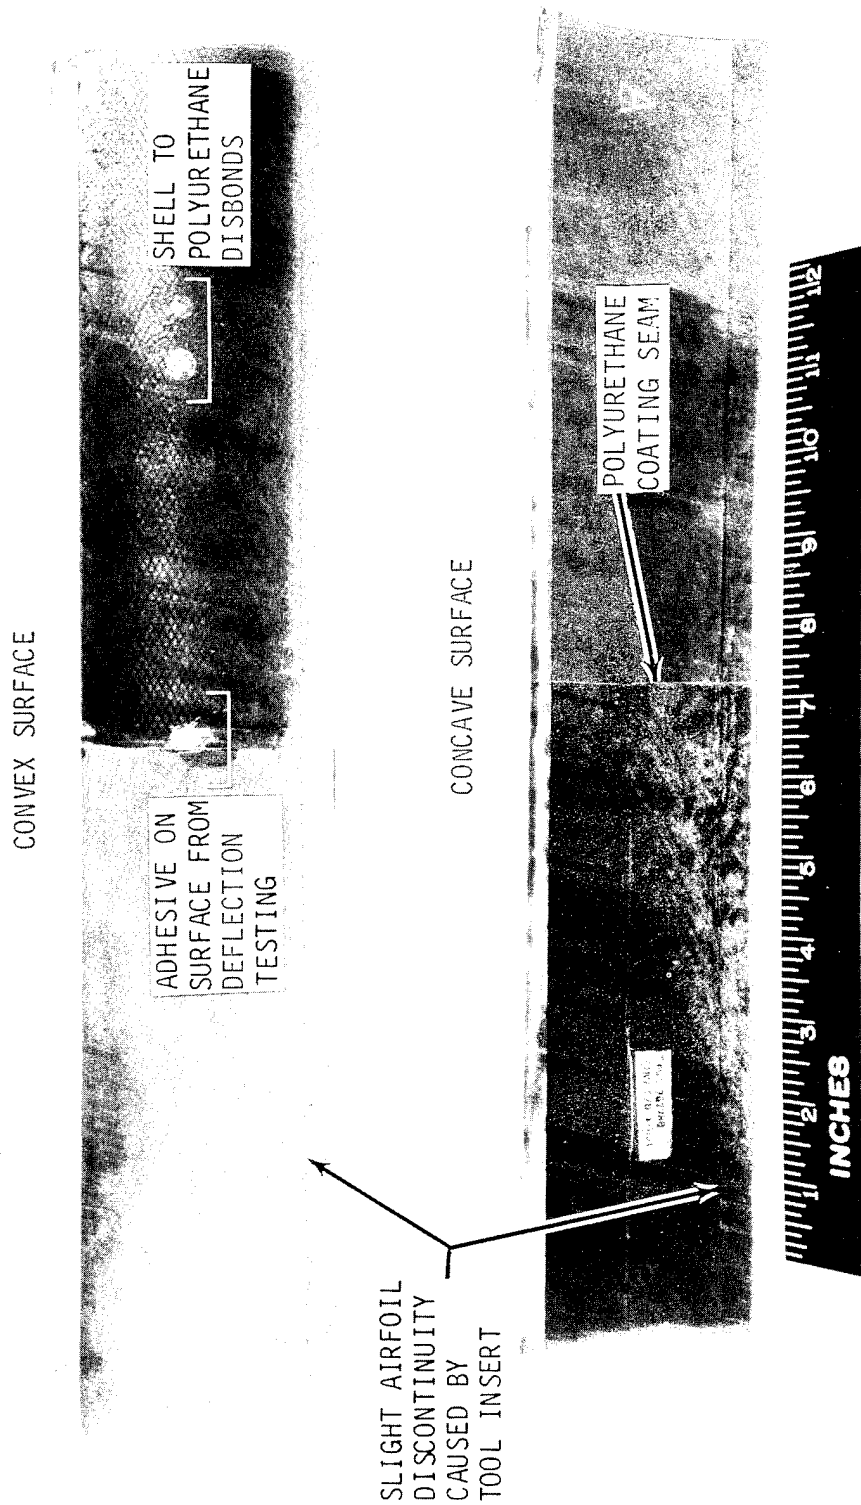
Figure 4-17 Photograph of Nondestructive Evaluation Standard Vane;  
Graphite Shell Graphite Core/Epoxy - TRW S/N 1-001

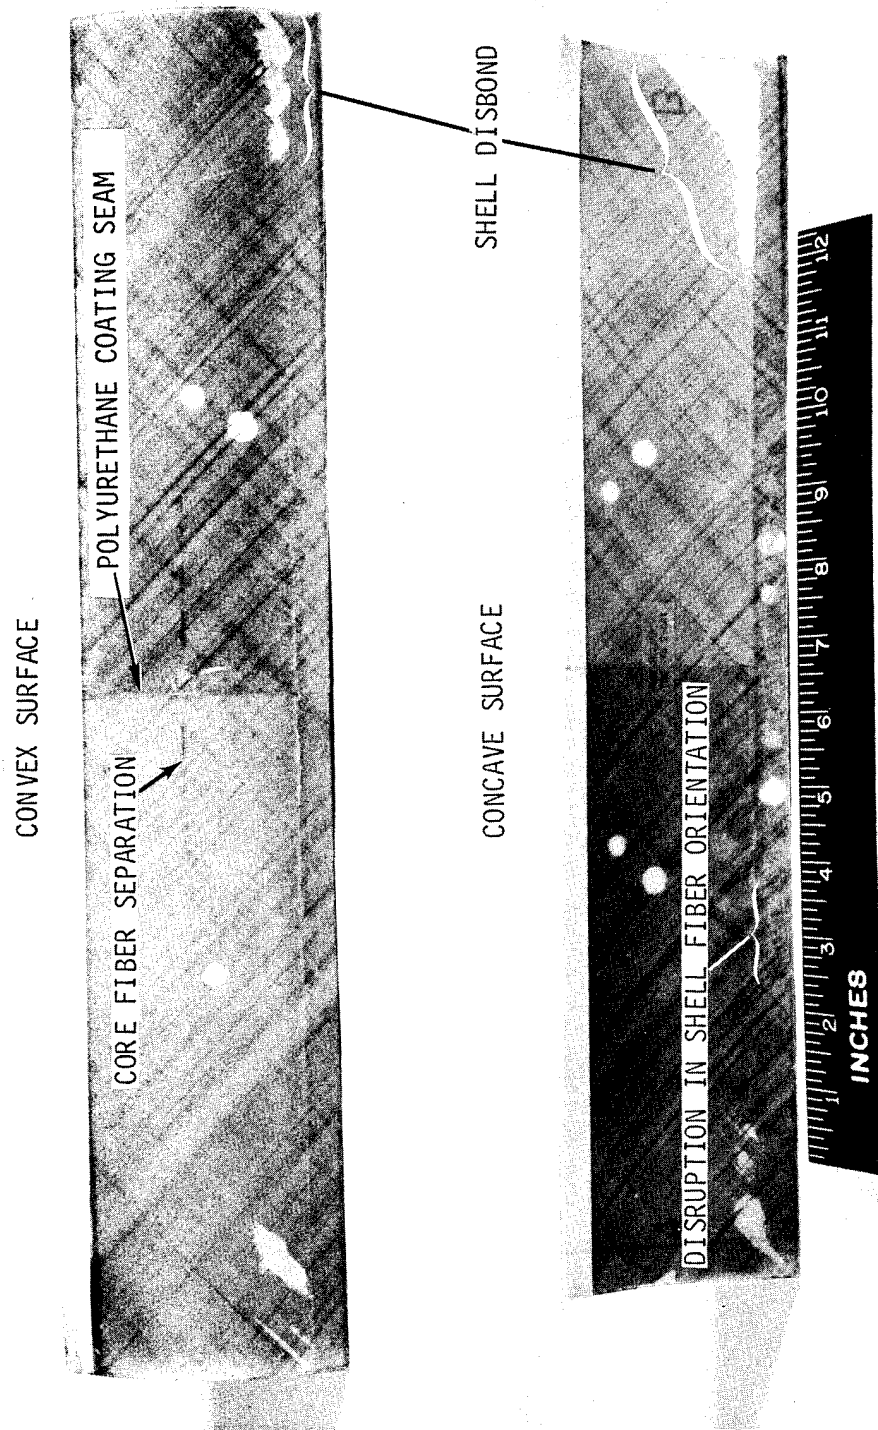
Figure 4-18 Photograph of Nondestructive Evaluation Standard Vane;  
Fiberglass Shell Graphite Core/Epoxy - TRW S/N 2-001

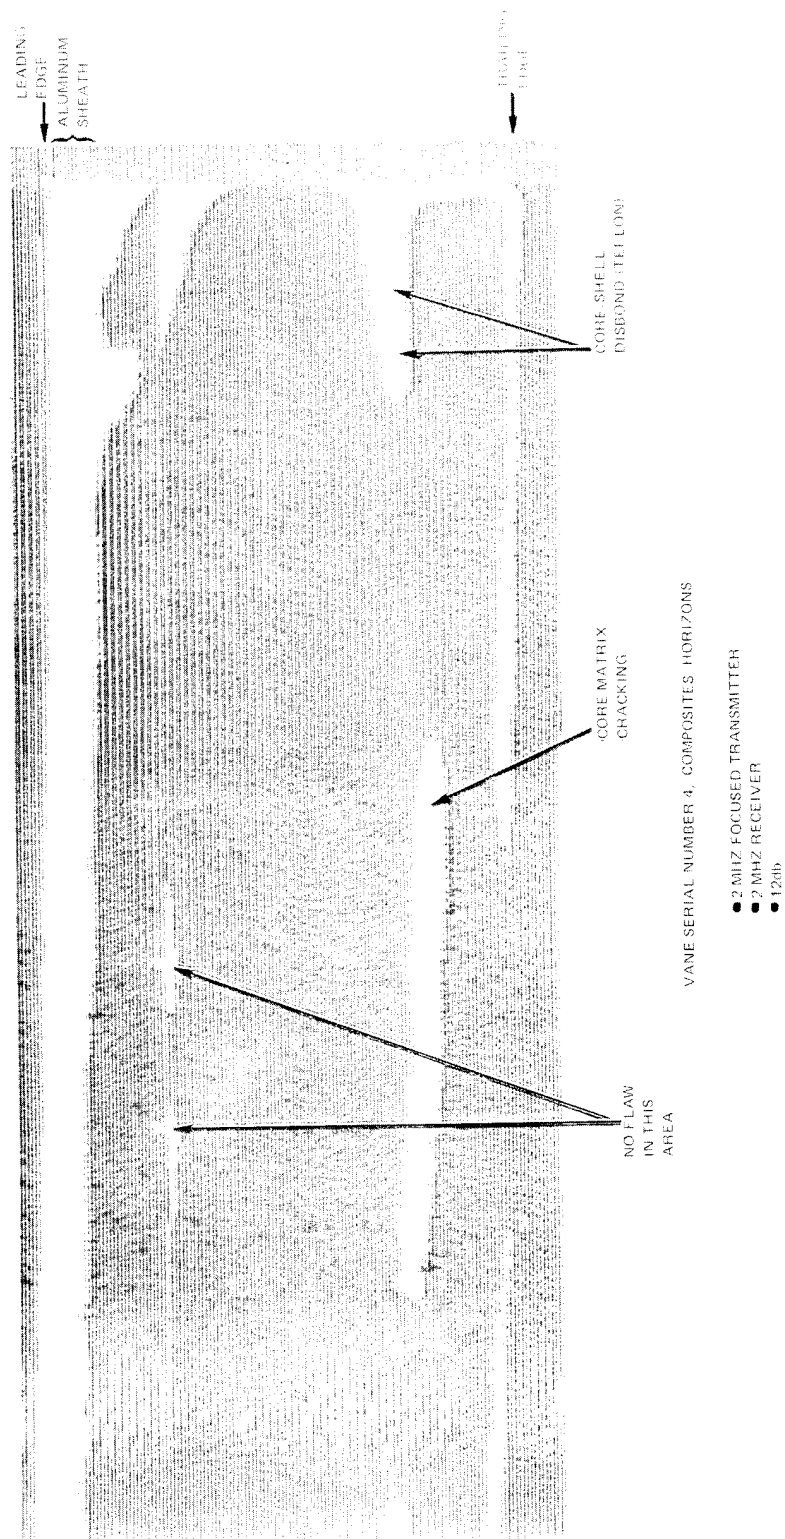
Figure 4-19 *Ultrasound "C" Scan of Graphite/Epoxy Intentionally Flawed Vane (Polyurethane Coated Section)*

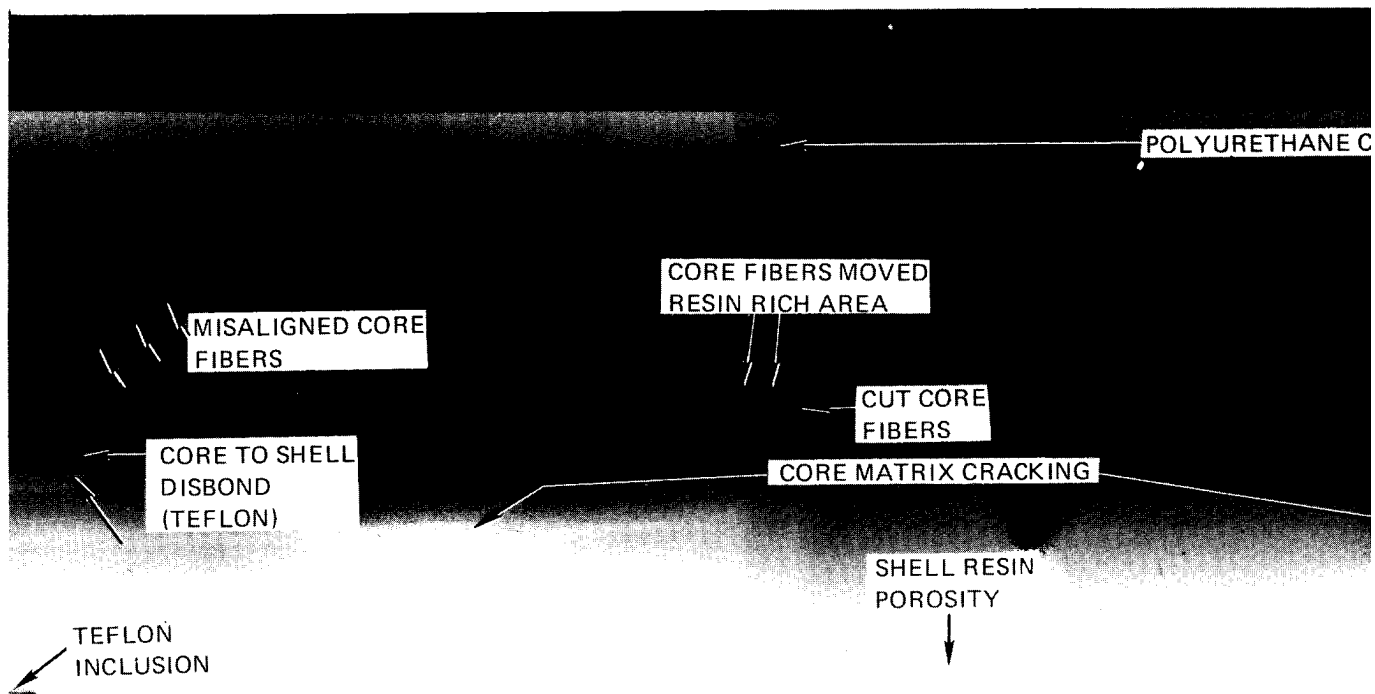
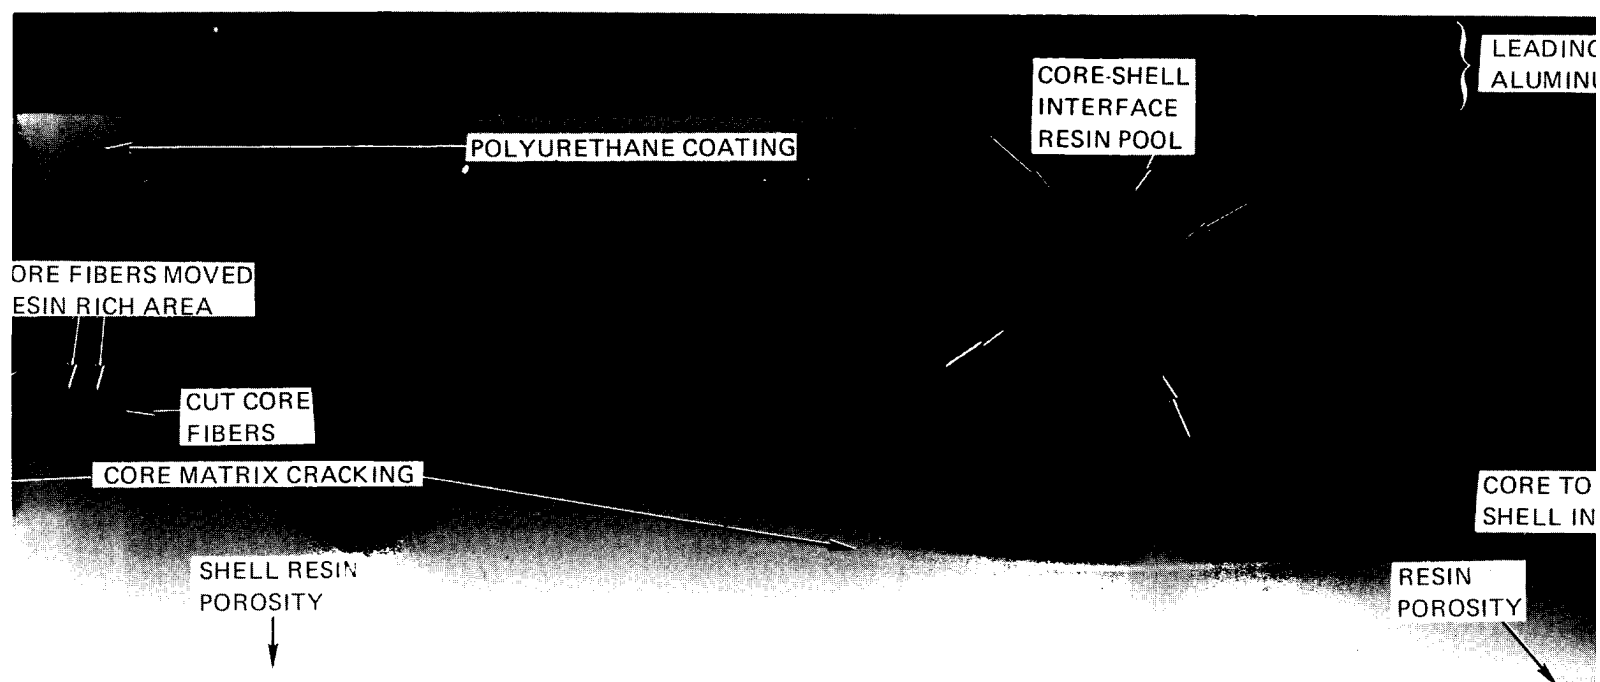
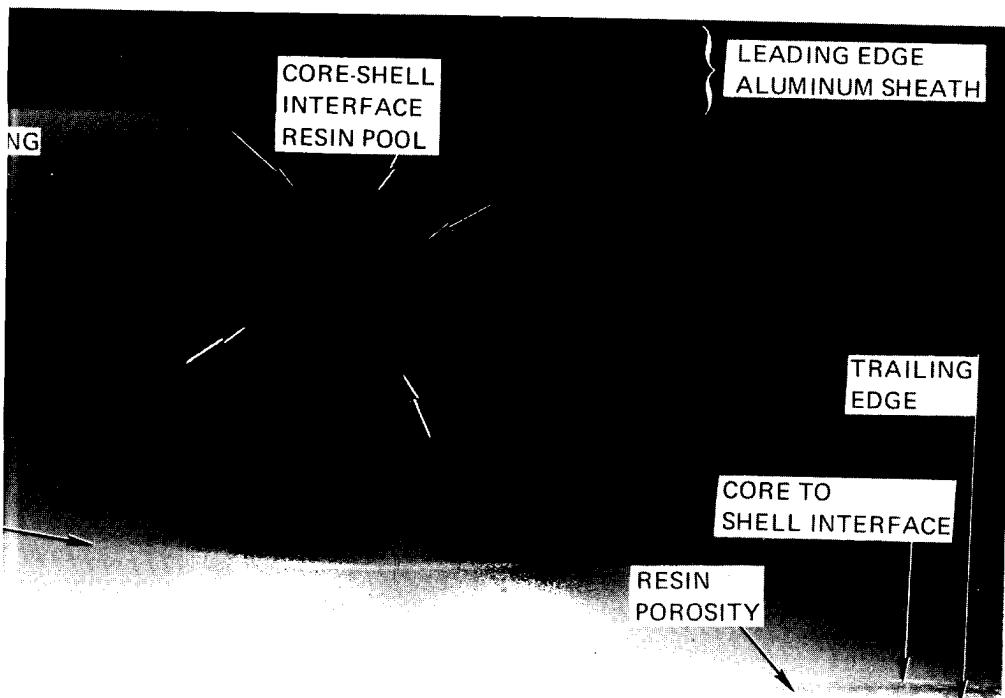
Figure 4-20 Print from Radiograph of Composites Horizons  
Intentionally Flawed Graphite/Epoxy NDE Vane (Vane No.  
4)

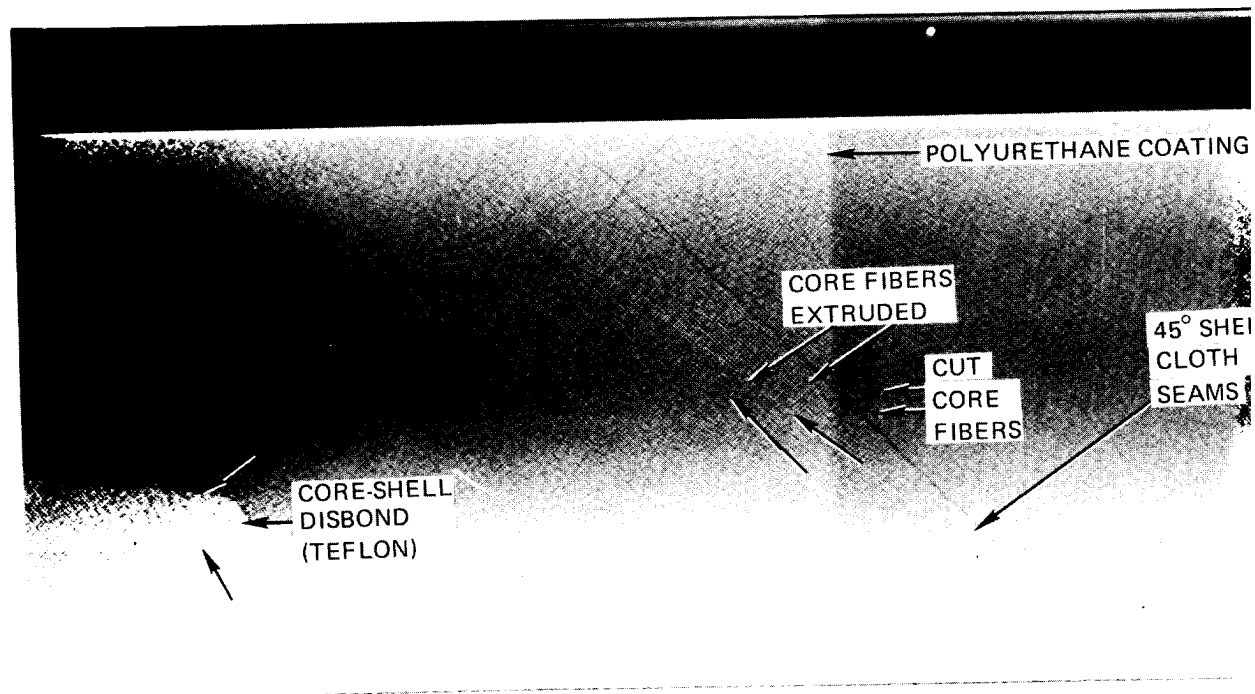
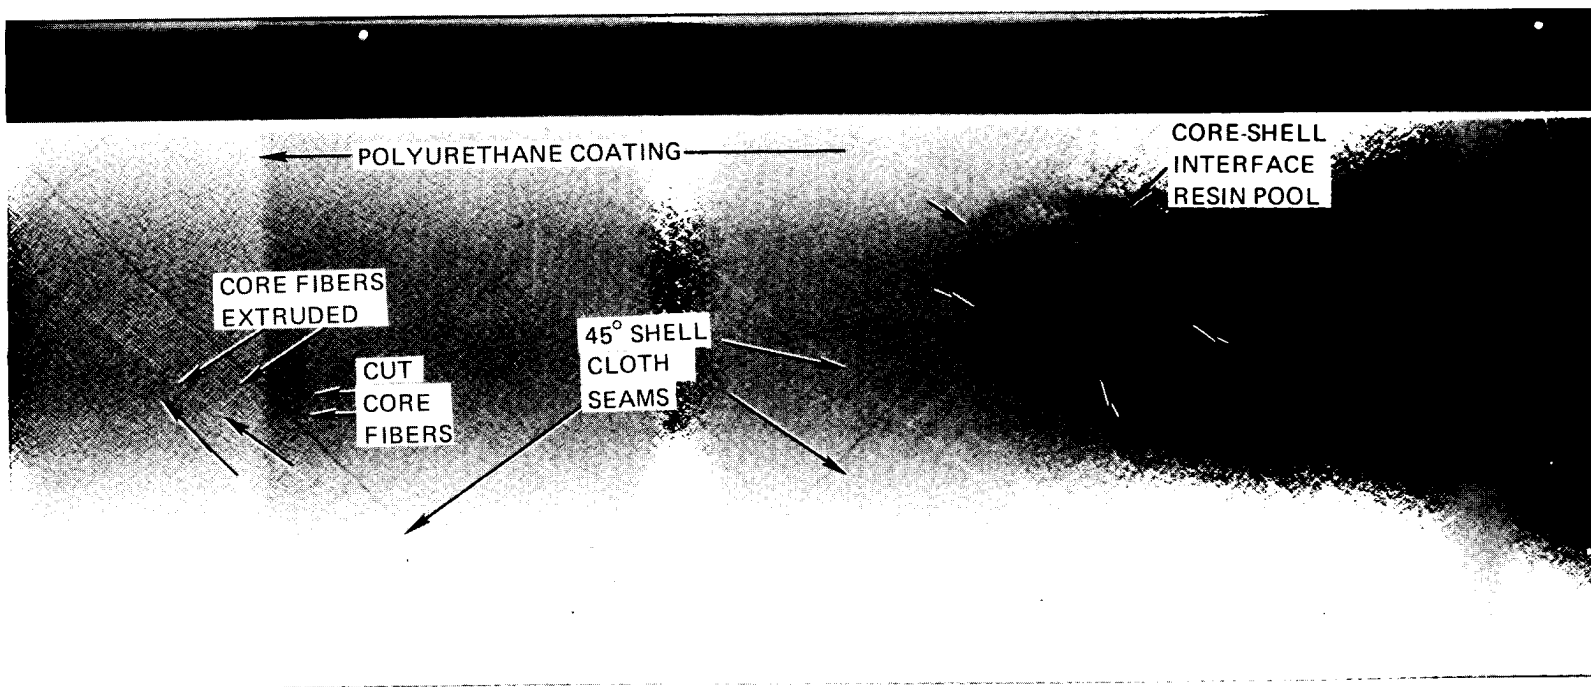
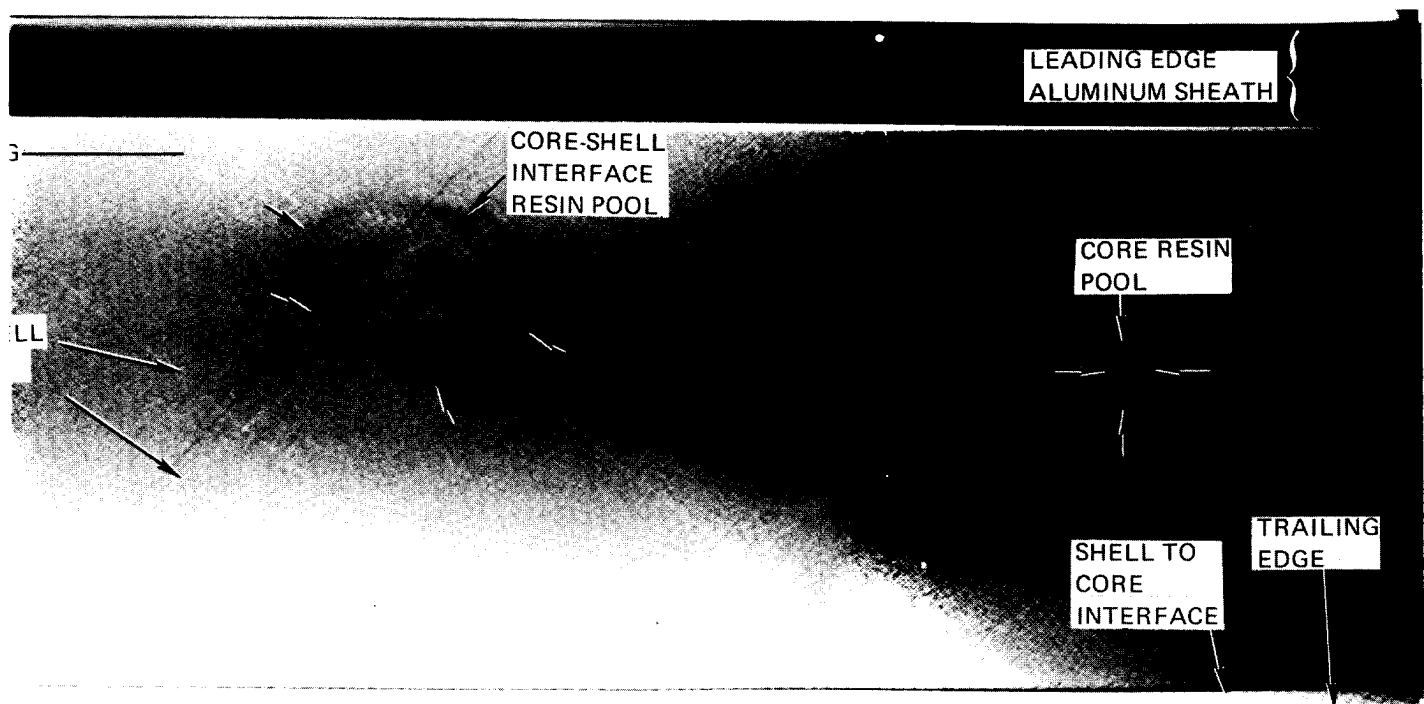
Figure 4-21      *Print from Radiograph of Composites Horizons  
Intentionally Flawed Hybrid Glass Shell Graphite  
Core/Epoxy NDE Vane (Vane No. 1)*

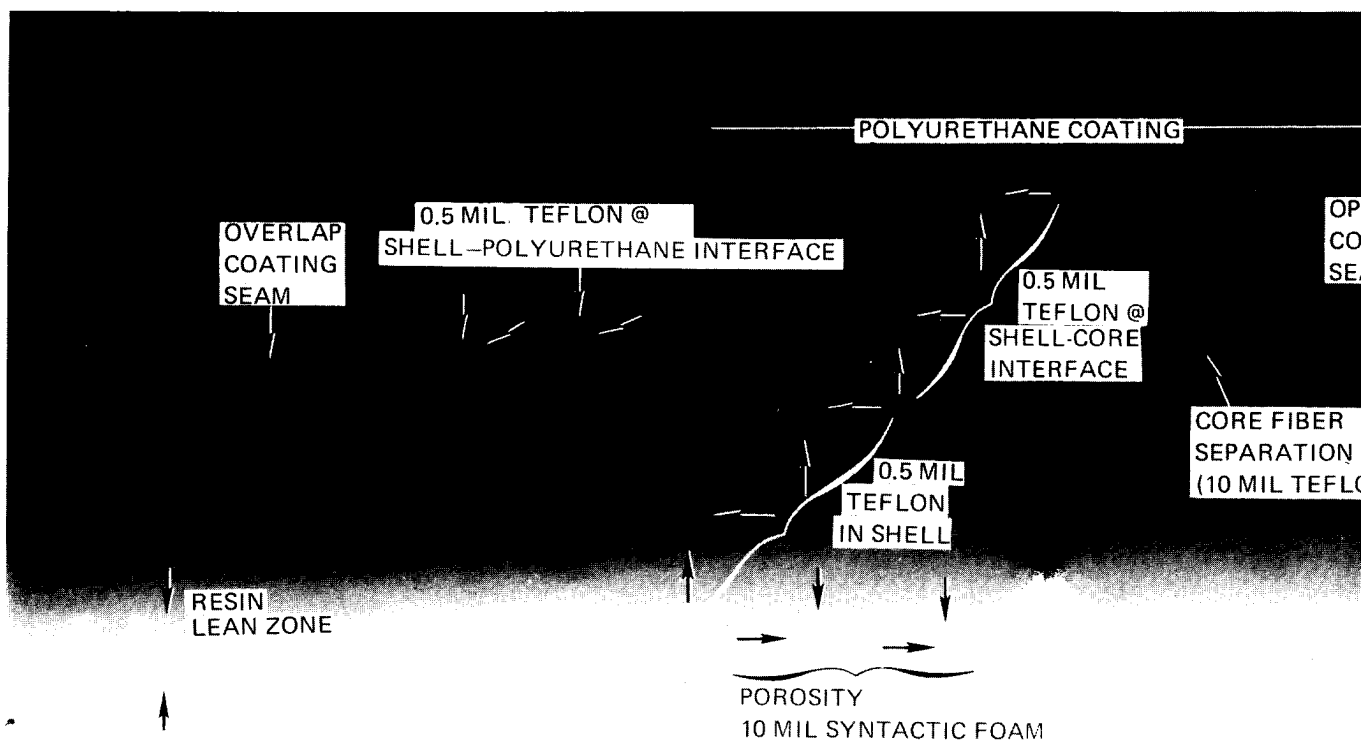
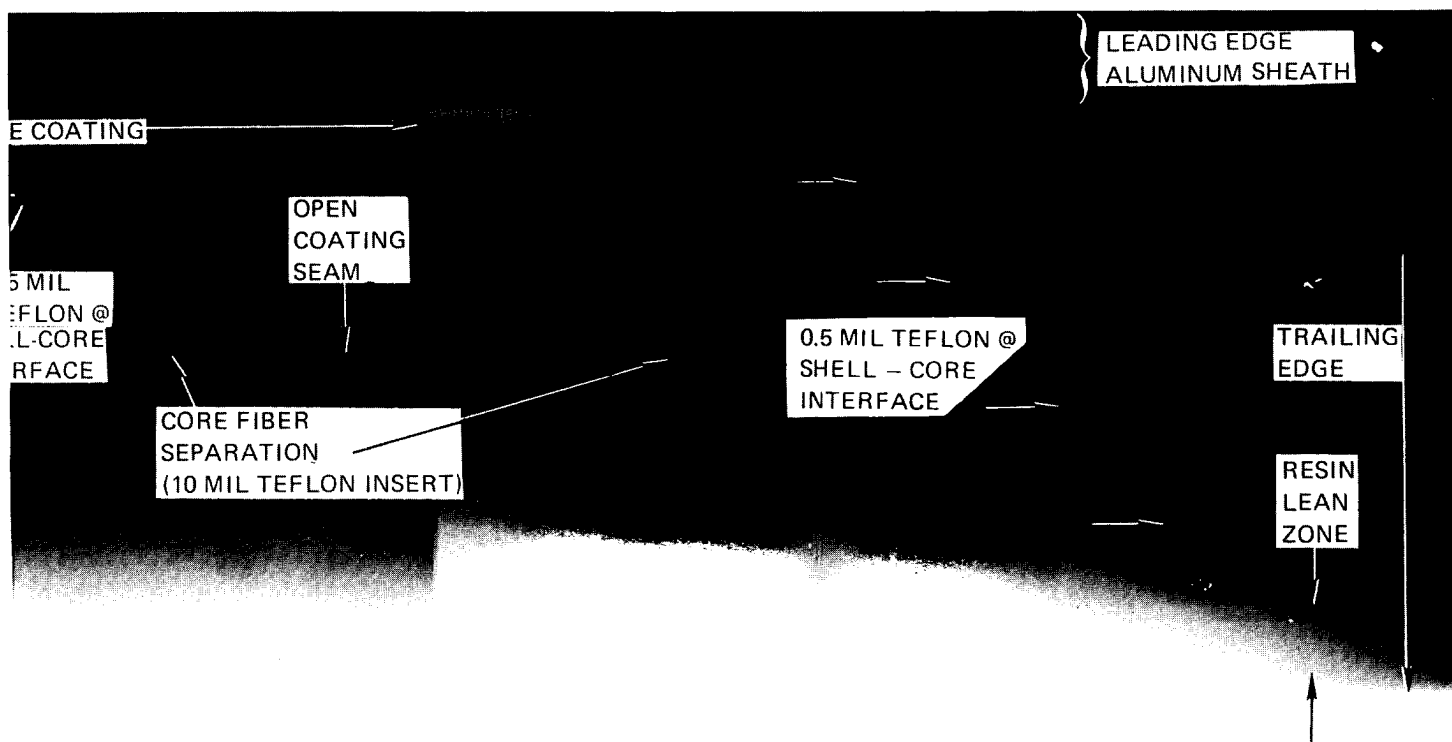
Figure 4-22

Print from Radiograph of TRW Intentionally Flawed Graphite/Epoxy NDI Vane (Vane No. 1-001)

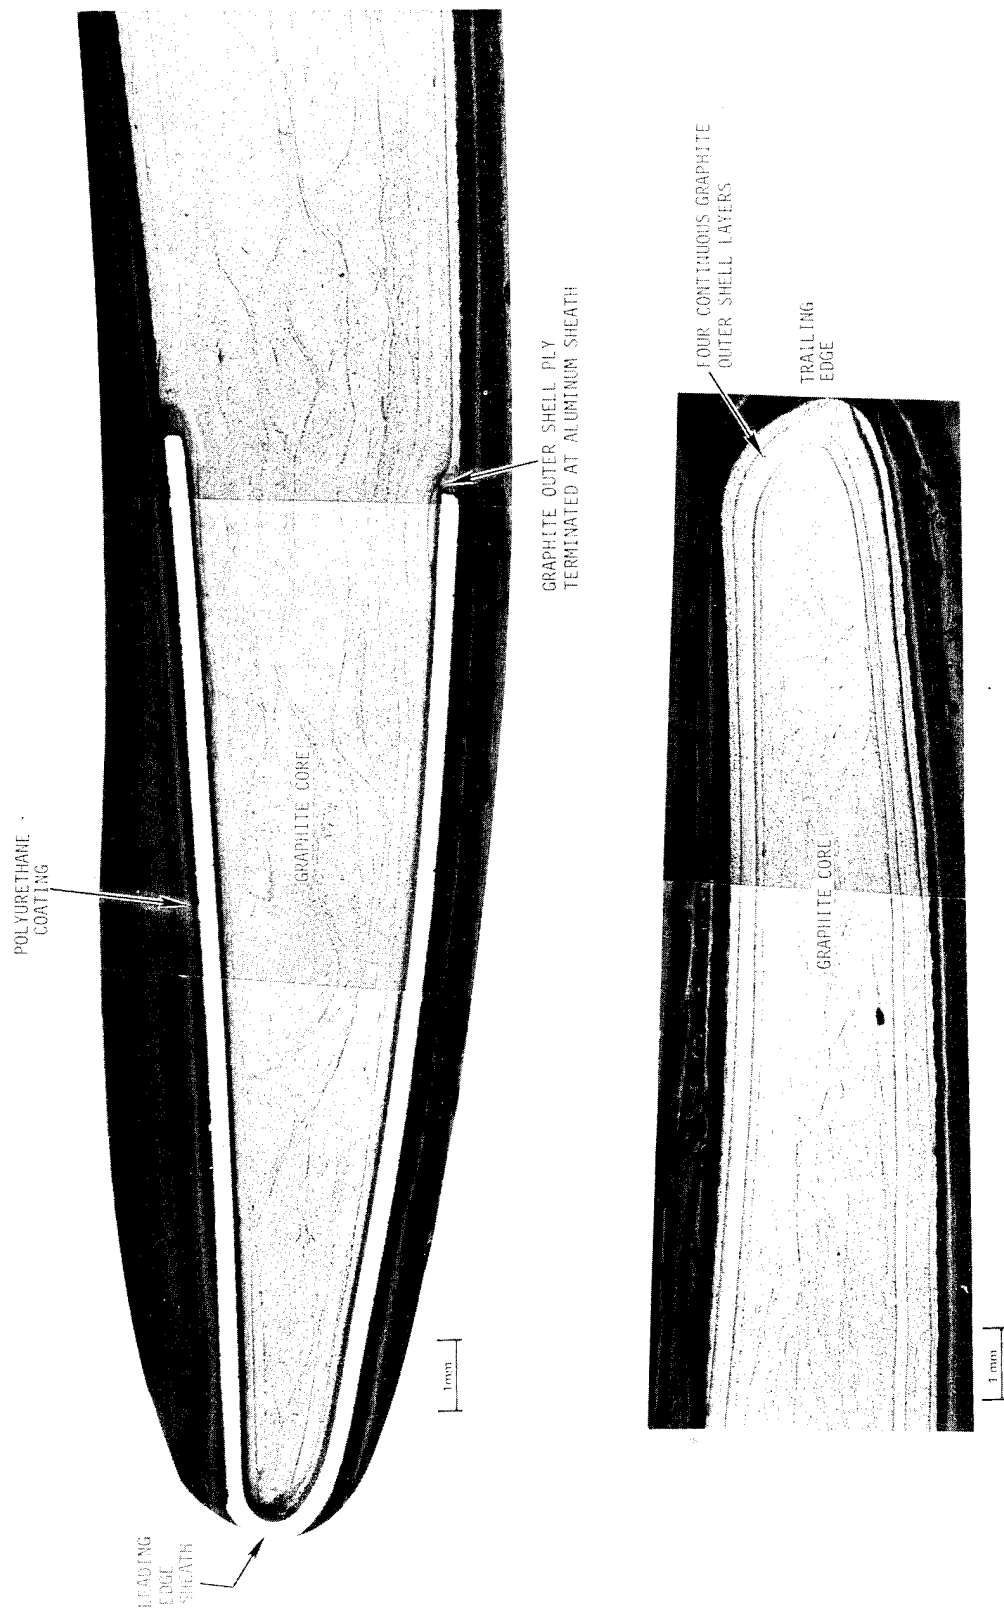
Figure 4-24 Photomicrograph of Typical Cross Section of Composites  
Horizons Fabricated Glass Shell Graphite Core/Epoxy Fan  
Exit Guide Vane

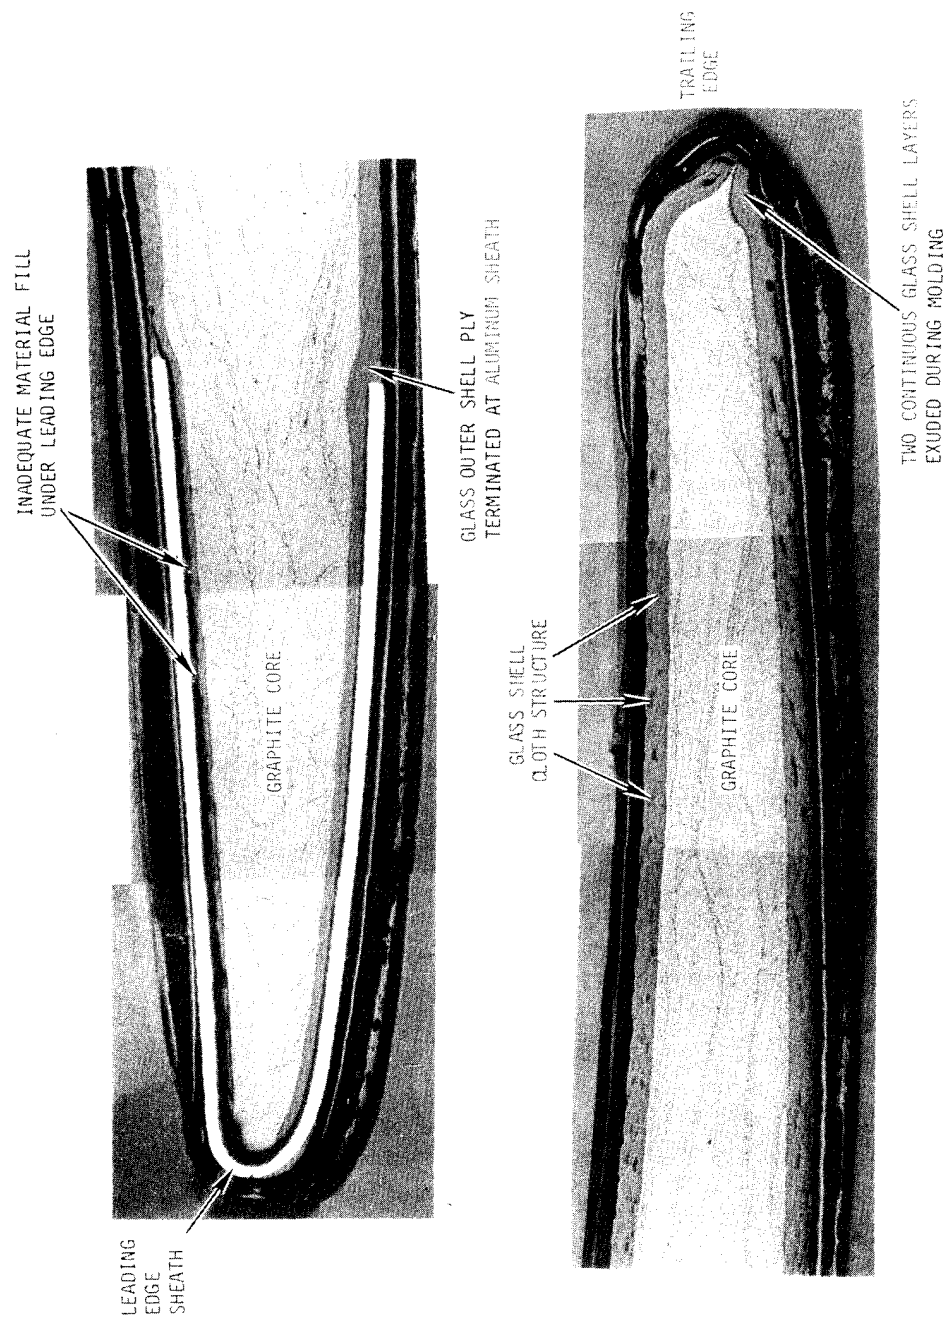
**Figure 4-25** Photomicrograph of Typical Cross Section of Composites  
Horizons Fabricated Glass Shell Graphite Core/Epoxy Fan  
Exit Guide Vane

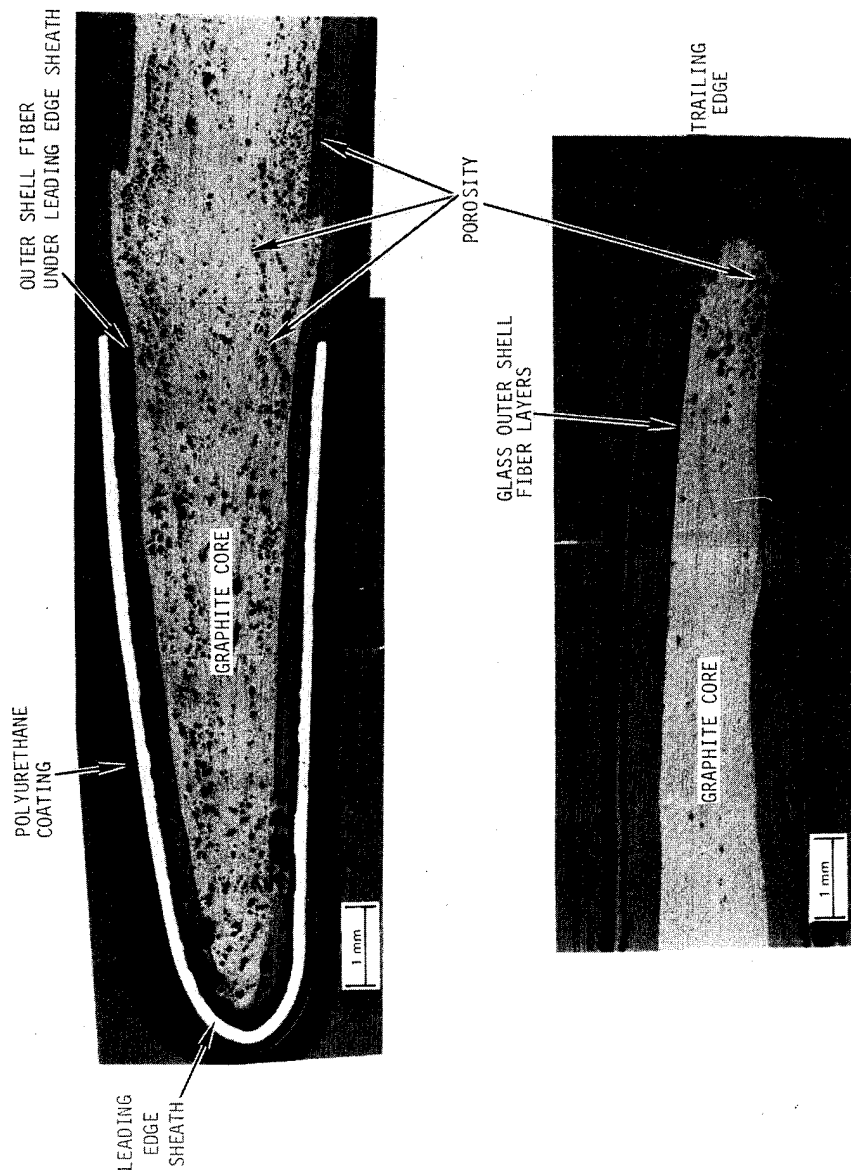
**Figure 4-27** Photomicrograph of Typical Cross Section of TRW  
Fabricated Glass Shell Graphite Core/Epoxy Fan Exit  
Guide Vane

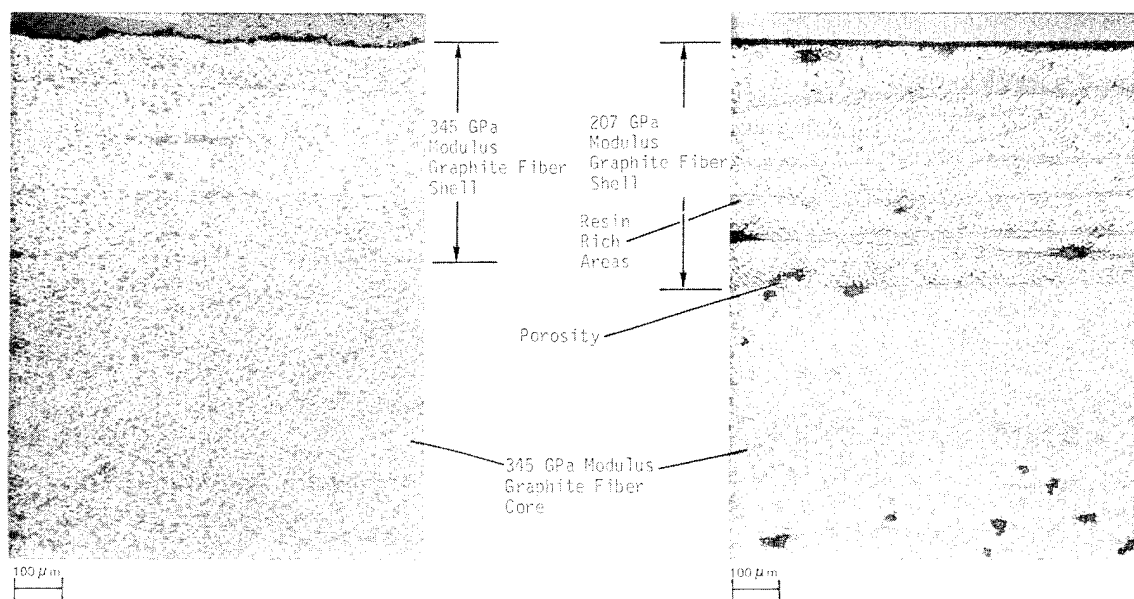
Figure 4-28 Photomicrographs of Graphite/Epoxy Fan Exit Guide Vanes. Comparison of Shell and Core Microstructure at Typical Transverse Cross-Section.

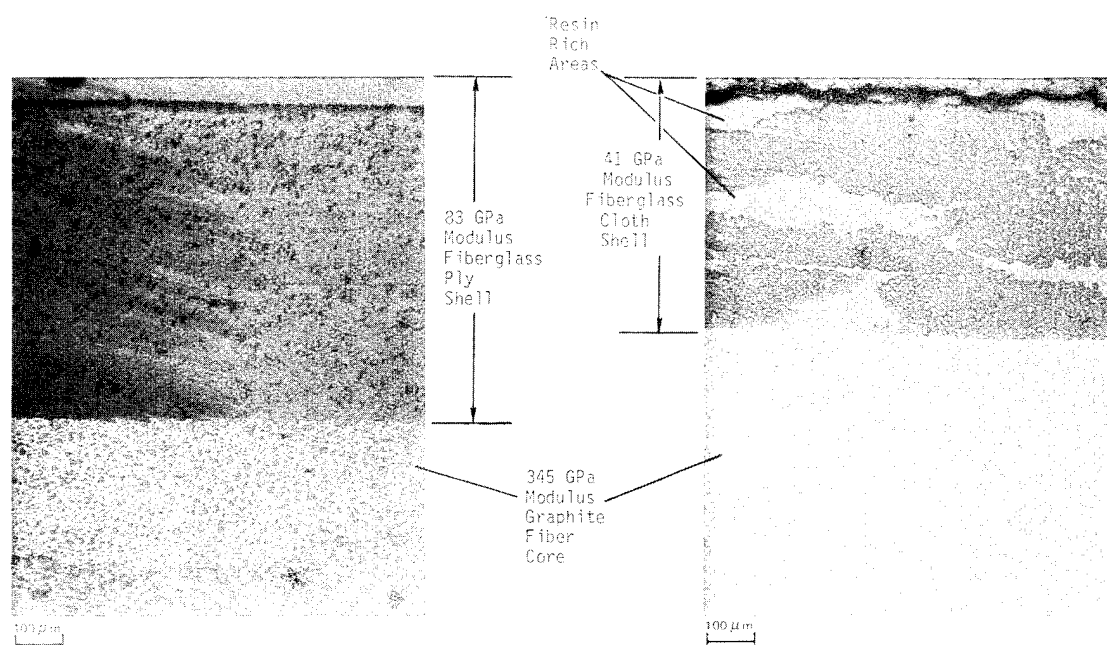
Figure 4-29 Photomicrographs of Fiberglass Shell-Graphite Core/Epoxy Fan Exit Guide Vane. Comparison of Shell and Core Microstructure at Typical Transverse Cross-Section.

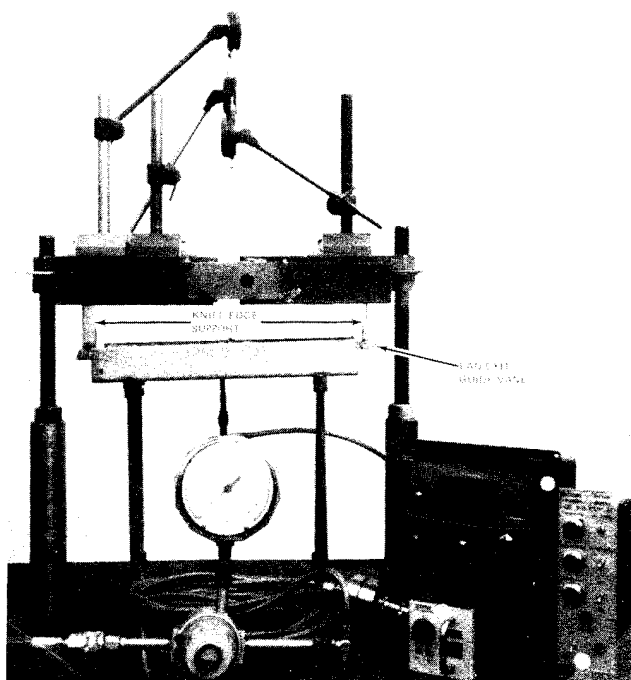
Figure 5-1 Vane Bending Spring Rate Fixture for Application of Bending Load to Vane.

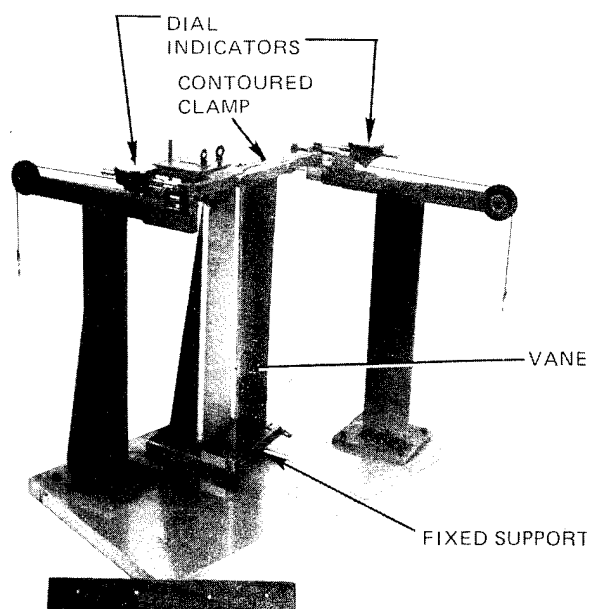
Figure 5-3      *Vane Torsion Spring Rate Fixture for Application of Torque Load to Vane*

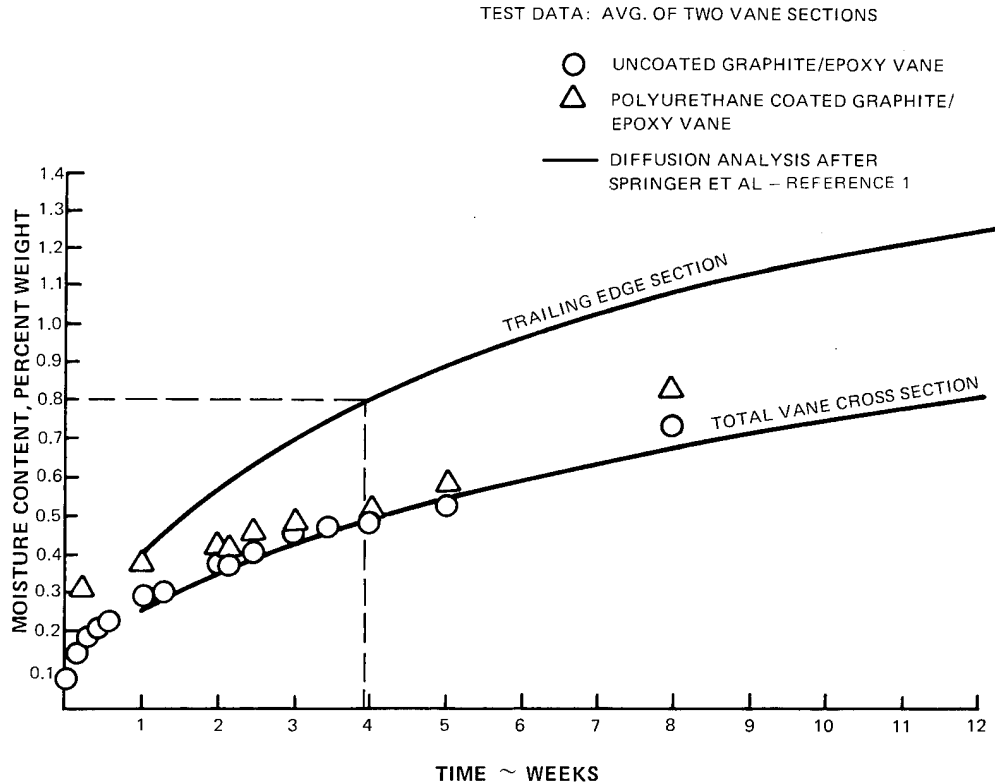
Figure 5-4 Fortafil 5A Graphite/Epoxy Shell and Core Fan Exit Guide Vane.

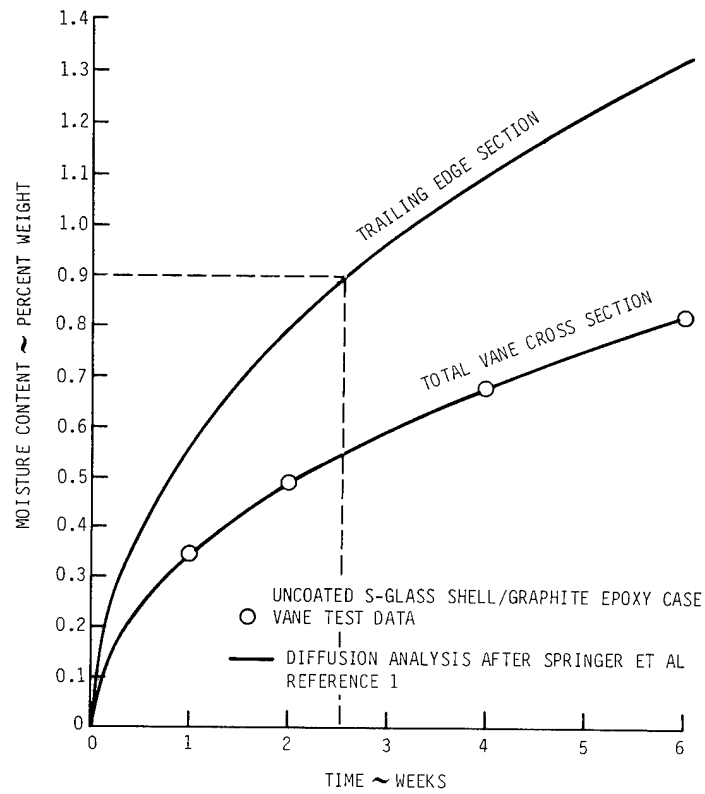
Figure 5-5 S-Glass Shell (7781/5143)/Graphite Epoxy Core Fan Exit Guide Vane
