NASA CR-159677  
PWA 5570-37

DESIGN, DURABILITY AND LOW-COST PROCESSING  
TECHNOLOGY FOR COMPOSITE FAN EXIT GUIDE VANES

UNITED TECHNOLOGIES CORPORATION  
Pratt & Whitney Aircraft Group  
Commercial Products Division

Prepared for  
National Aeronautics and Space Administration  
NASA Lewis Research Center  
Contract NAS3-21037

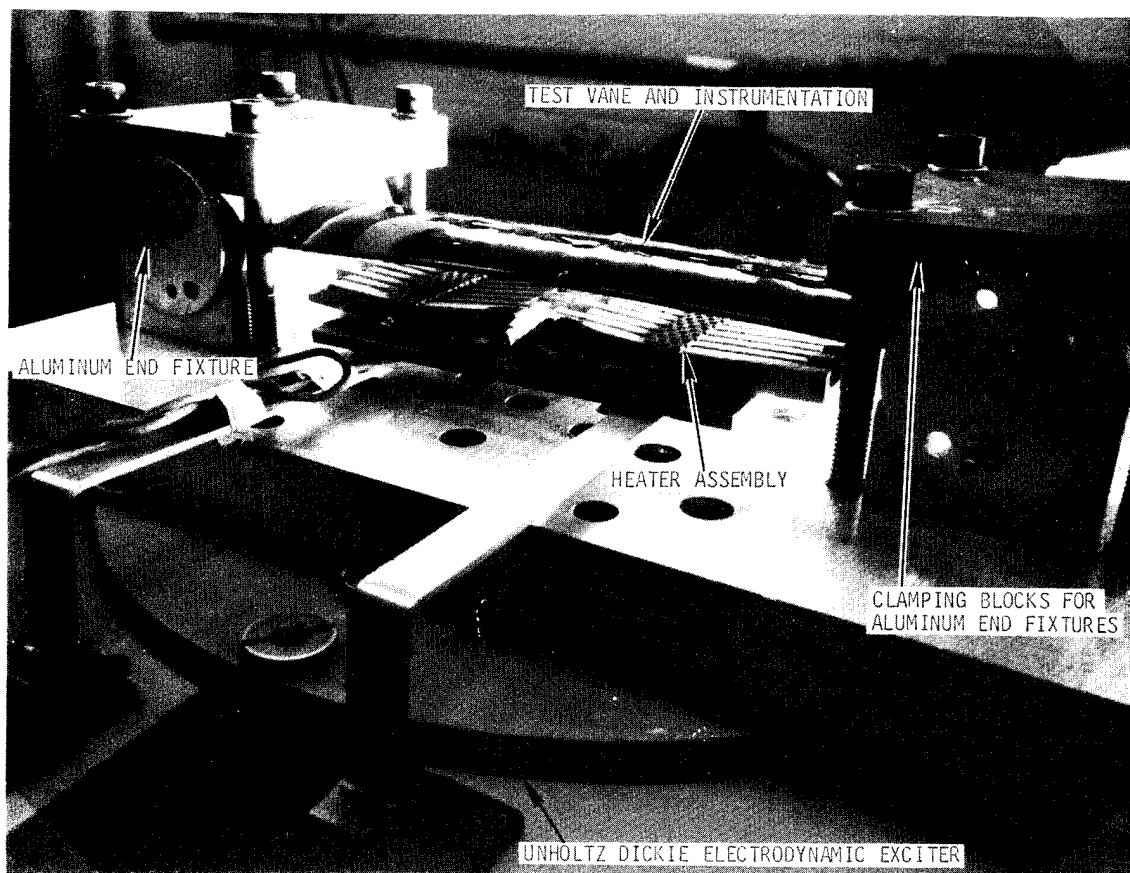
Figure 5-7      Fan Exit Guide Vane Fatigue Test Fixture and Heater Assembly

Prior to the application of vibratory loading, the aluminum end fixtures on the vane were turned to provide an airfoil static bending load which simulated the magnitude of aerodynamic loads experienced in the engine. Static loads were increased until the preselected trailing edge radial static strain of  $-1750\mu\epsilon$  was reached. Vane corner gages were checked to confirm uniform loading of the vane; adjustments were performed as necessary. The vane end fixtures were then locked in position for the duration of the test to maintain the static load. Vanes which were tested at  $60^{\circ}\text{C}$  ( $140^{\circ}\text{F}$ ) in the "wet" condition, were first heated to temperature before the static load was applied to the vane. A low power resistance heater provided convective heating (Figure 5-7). No provisions were made to control moisture content during fatigue testing. However, provisions were made to maintain these vanes in a 95 percent relative humidity environment to prevent loss of moisture whenever the vibration test was being recalibrated between increasing stress levels. This was accomplished by wrapping a wet towel over the vane at room temperature.

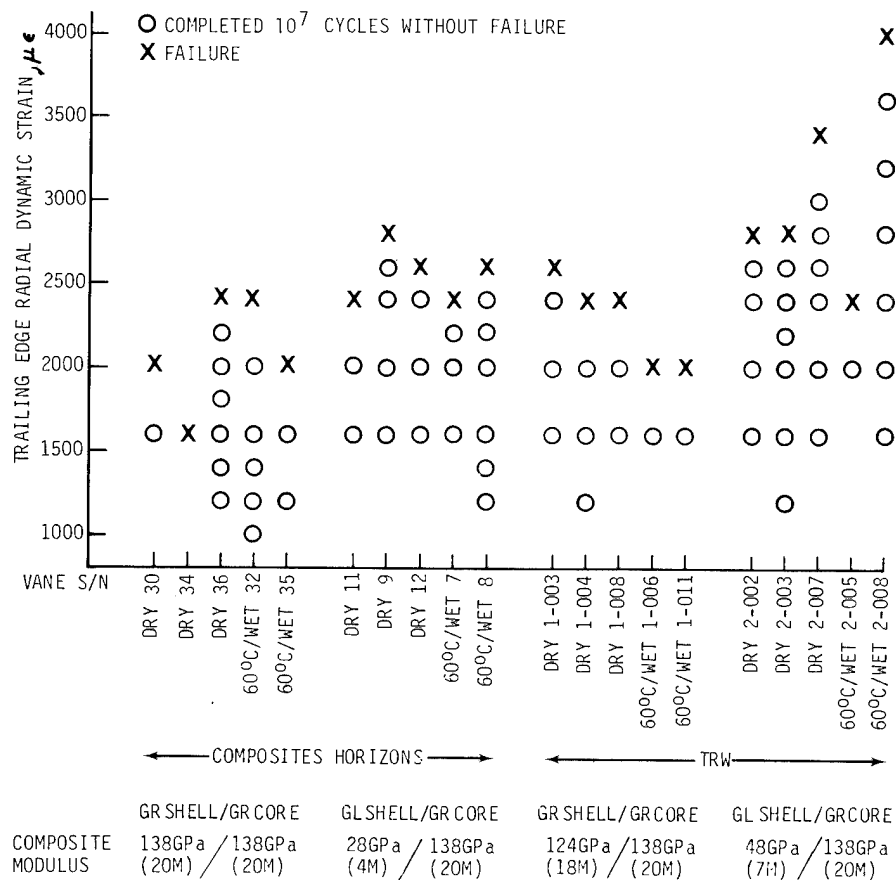
Figure 5-8 Summary of Fatigue Test Program Dynamic Loading Sequence - Composite Fan Exit Guide Vanes

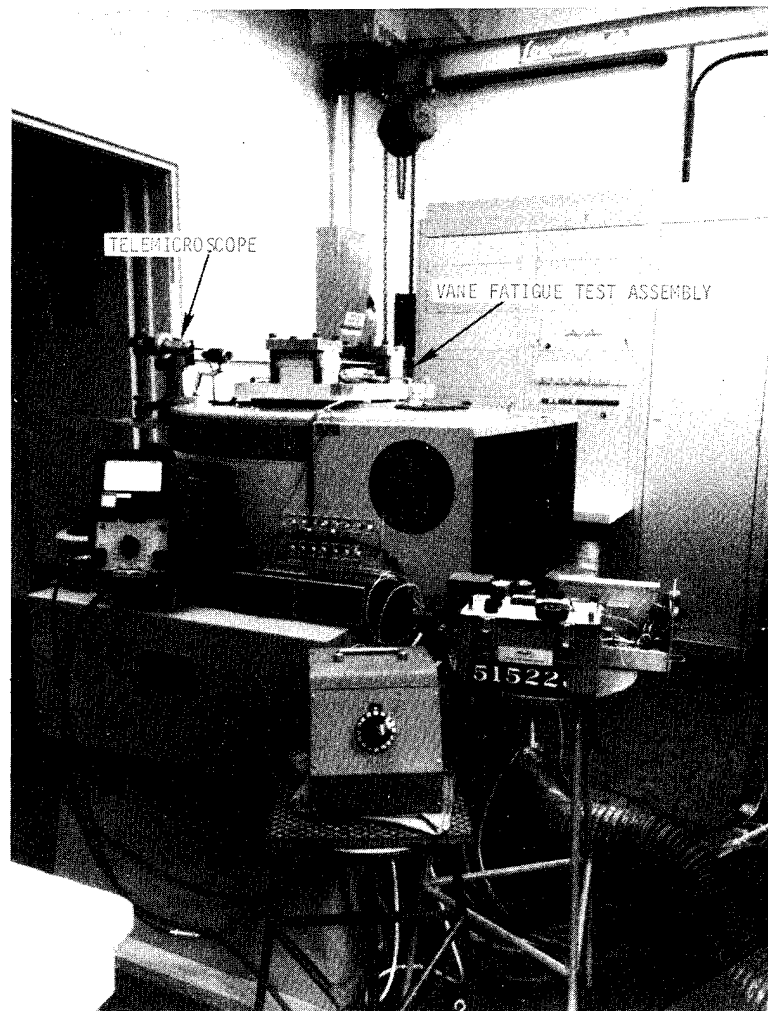
Figure 5-9 Unholtz-Dickie 42.4 KN (9500 lb) Electrodynamic Exciter

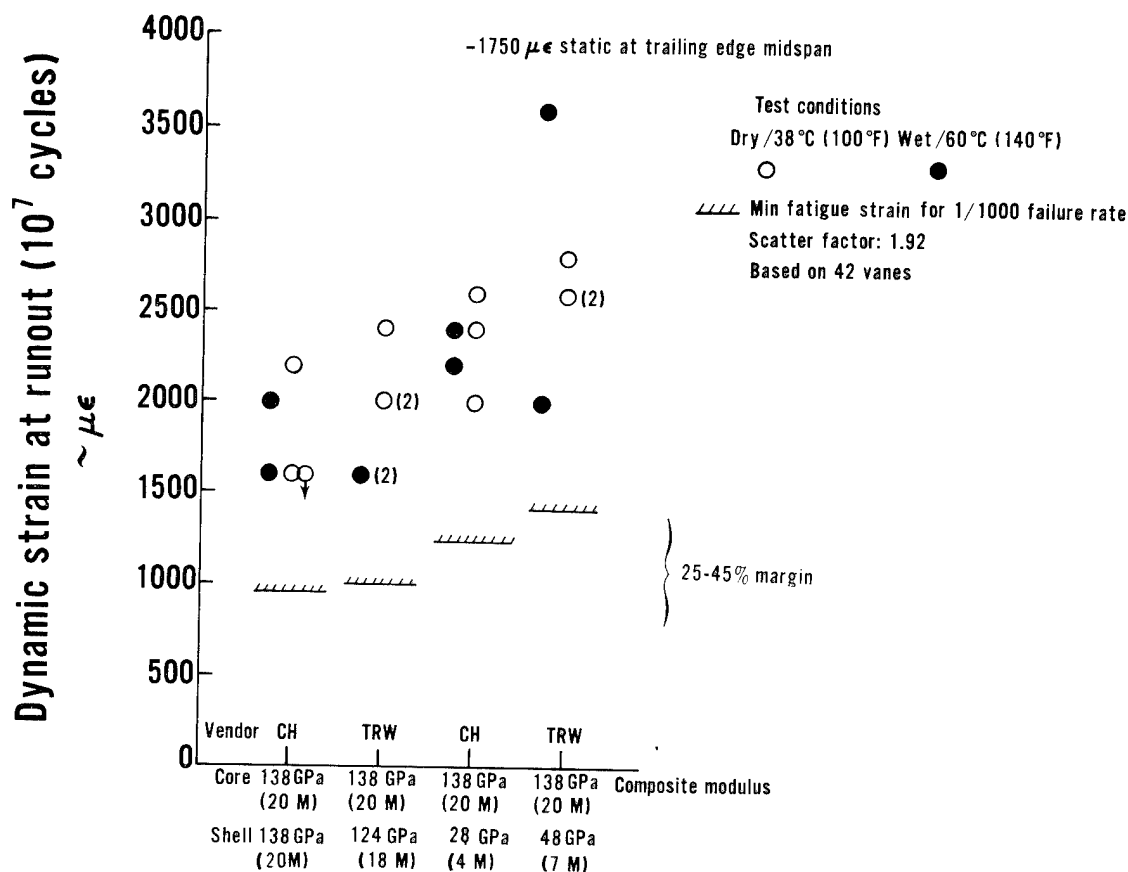
Figure 5-10 Composite Fan Exit Guide Vane Fatigue Strain Capability

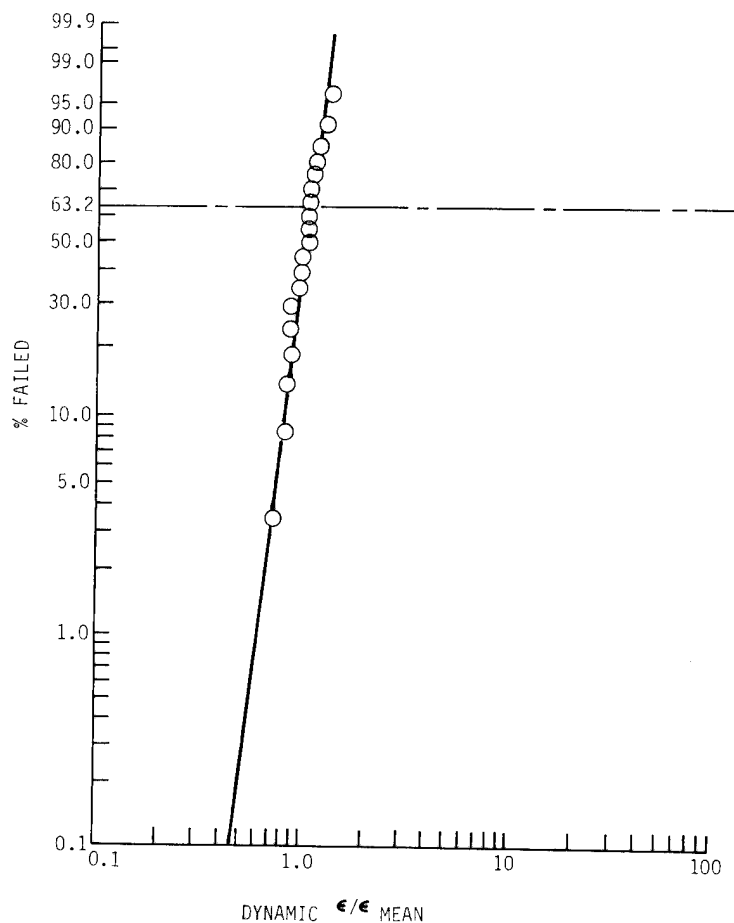
Figure 5-11 Weibull Plot Composite FEGV Fatigue Test Data-NASA Program

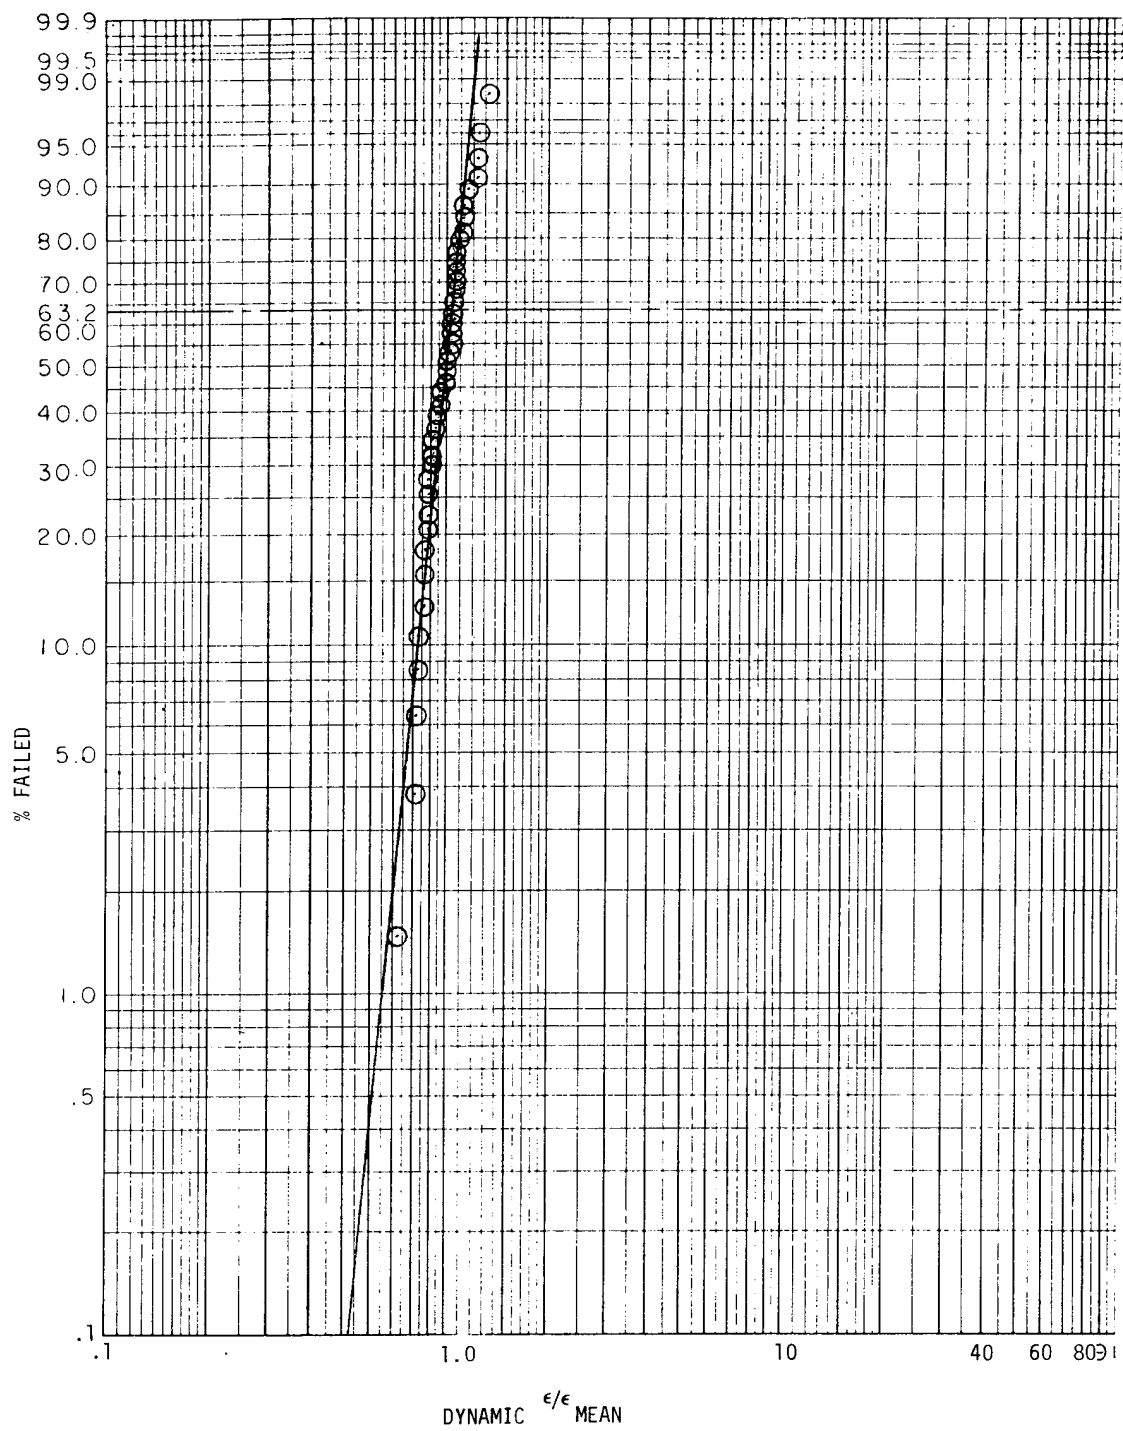
Figure 5-12 Weibull Plot Composite FEGV Fatigue Test Data - All Data

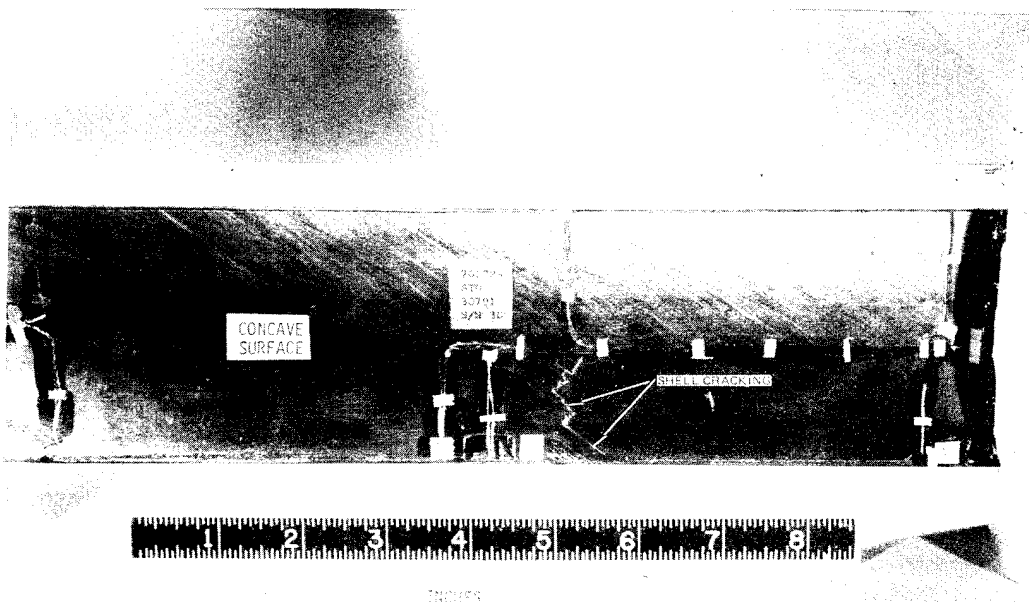
Figure 5-13      Photograph of Fatigue Tested Composites Horizons  
Graphite/Epoxy Vane

Several different failure modes were noted for the four material configurations. The patterns and locations for failures were essentially consistent within any one material configuration. Shell fiber modulus was most important in determining the torsional and uncamber stiffness of the airfoil and a relationship is apparent between failure location, mode and torsional stiffness. Differences in torsional stiffness between two all graphite configurations ranged from 2.38 M-N/deg (21 in. lb/deg.) to 1.77 M-N/deg. (16 in. lb/deg.). Failure location and mode were essentially identical for all of these ten vanes fabricated with graphite regardless of shell modulus material. Vanes failed under vibratory load at approximately the midspan location at the trailing edge (Figures 5-13, 5-14 and 5-15). A combination of different types of cracking was common to these vanes. Visually, shell cracking parallel and transverse to fibers was observed. In addition shell separation from the core section was apparent. Radiographic examination confirmed two additional types of cracking, transverse and longitudinal core cracks. These will be shown in Section 5.2.4. It can be speculated from microexamination performed after testing and reported in Section 5.2.6 that shell-to-core shear failure occurred first, followed by shell cracking, transverse cracking of core, and longitudinal core cracking. It is also possible, especially for the lower torsional stiffness graphite shell fiber vanes (124 GPa), that longitudinal core cracking may have occurred first, followed by shell deterioration.

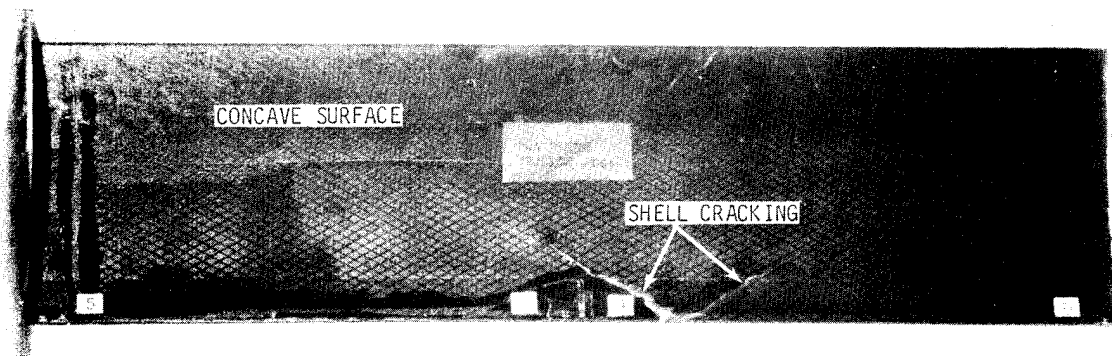
Figure 5-15      Photograph of Fatigue Tested TWG Graphite/Epoxy Vane

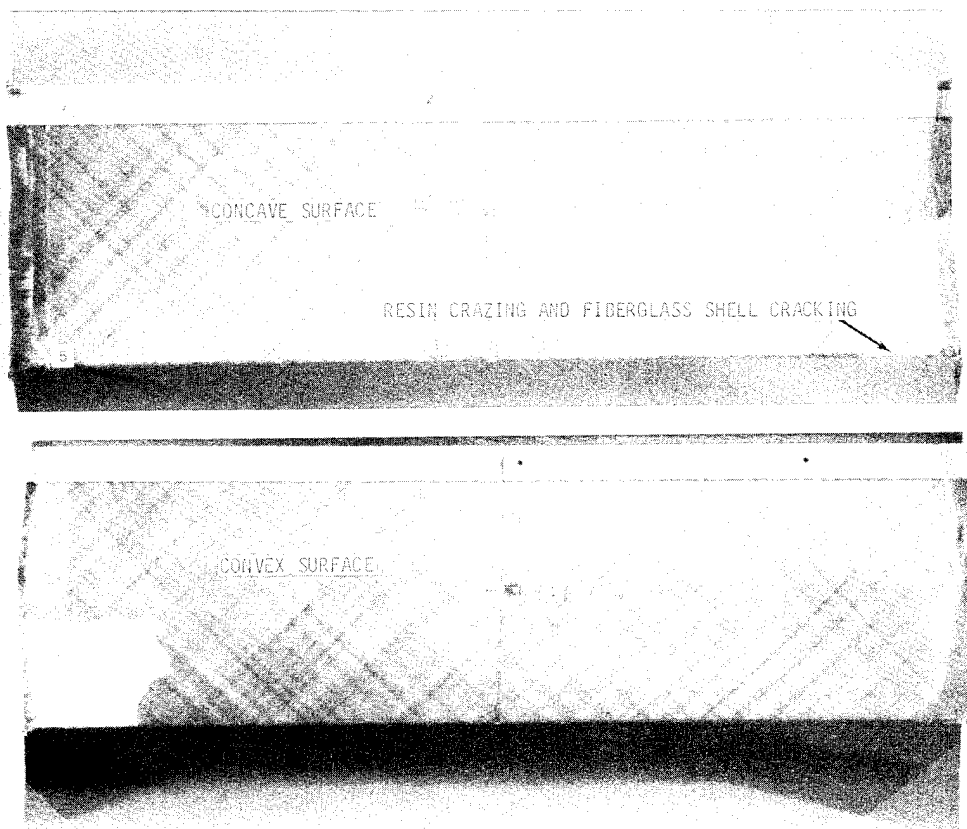
Figure 5-16      Photograph of Fatigue Tested TW Glass Shell - Graphite Core/Epoxy Vane

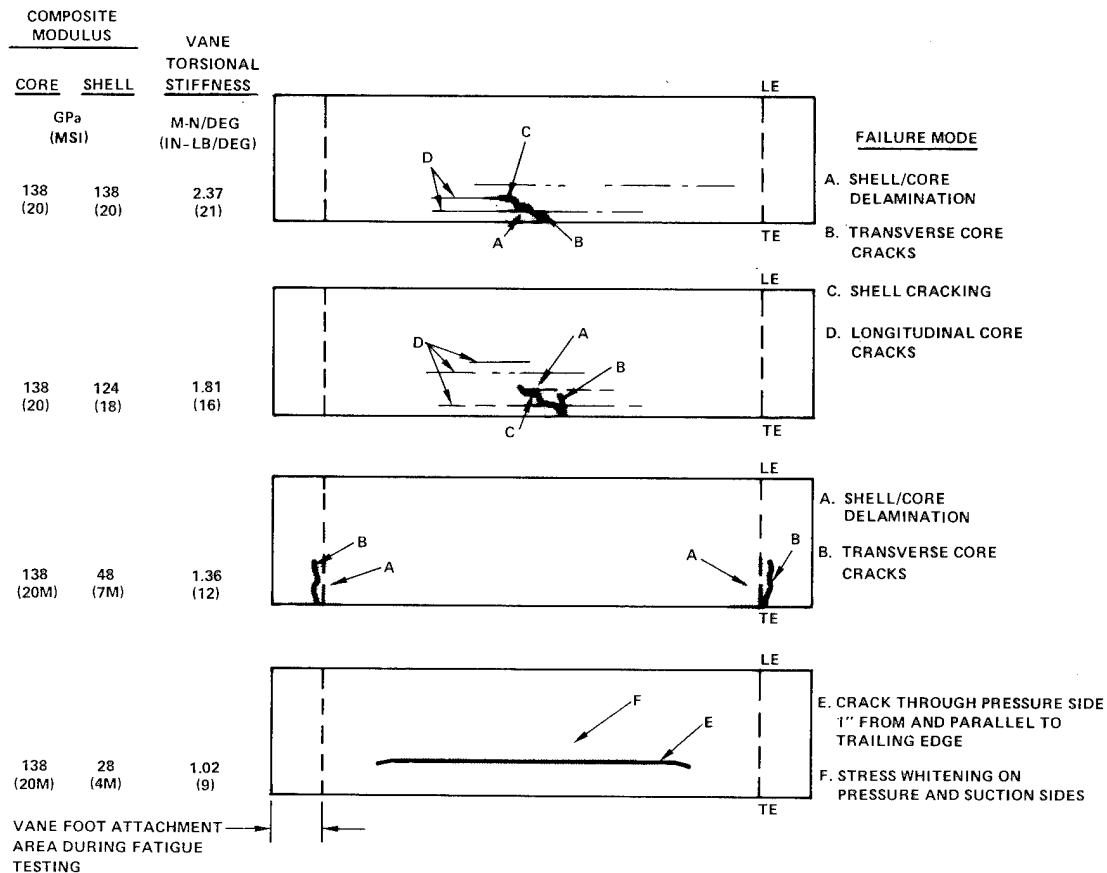
Figure 5-19 Composite Fan Exit Guide Vane Failure Mode Summary

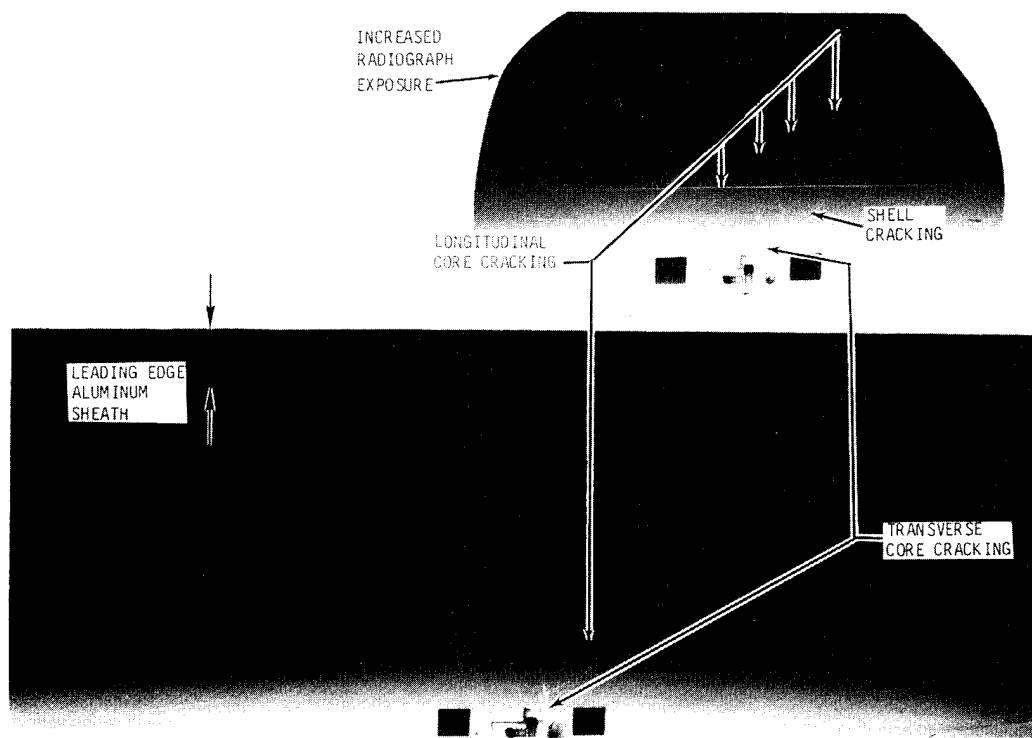
Figure 5-21 *Print from Radiograph of TRW Graphite/Epoxy Vane After Fatigue Test (Vane No. 1-011)*

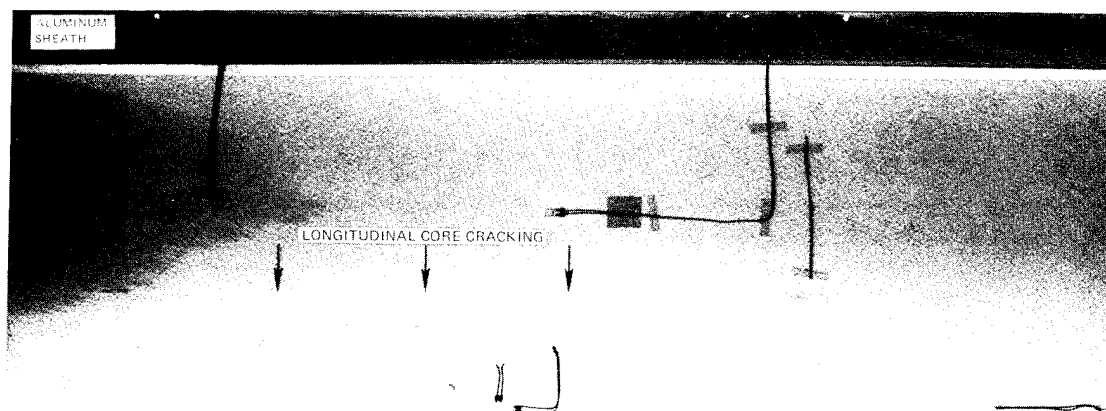
Figure 5-22      *Print from Radiograph of Composites Horizons Fiberglass Cloth Shell-Graphite Core/Epoxy Vane After Fatigue Test (Vane No. 9)*

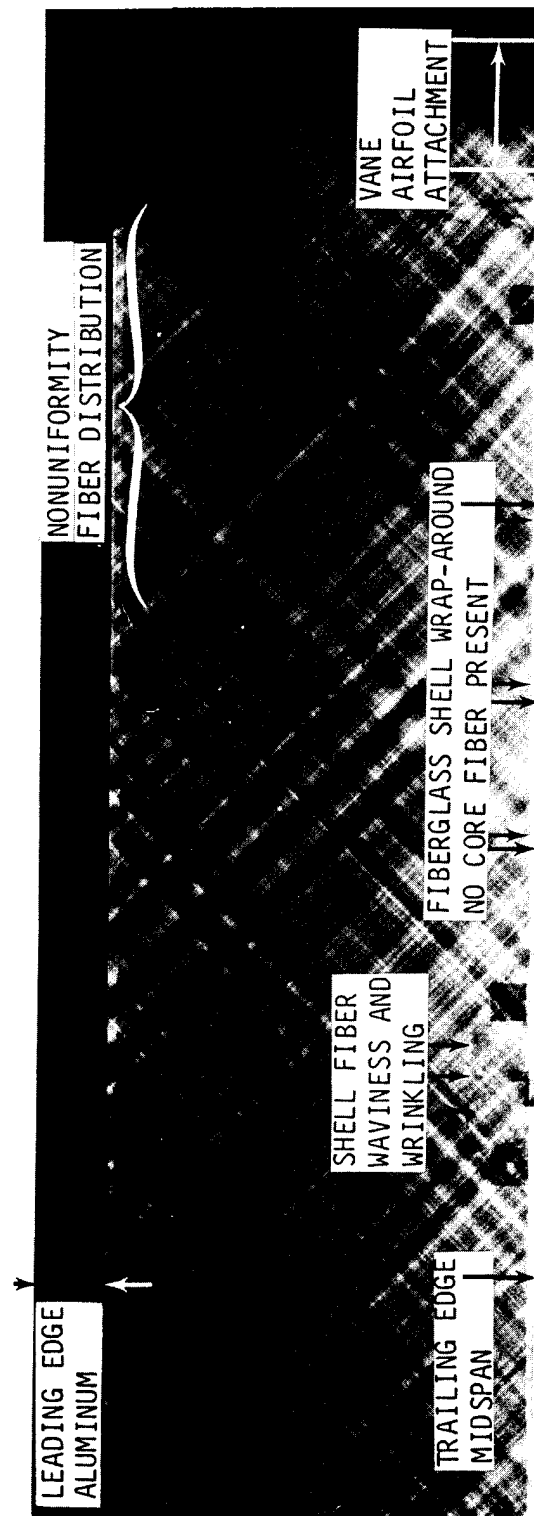
Figure 5-23 Print from Radiograph of TRW Fiberglass Shell-Graphite Core/Epoxy Vane After Fatigue Test (Vane No. 2-008)

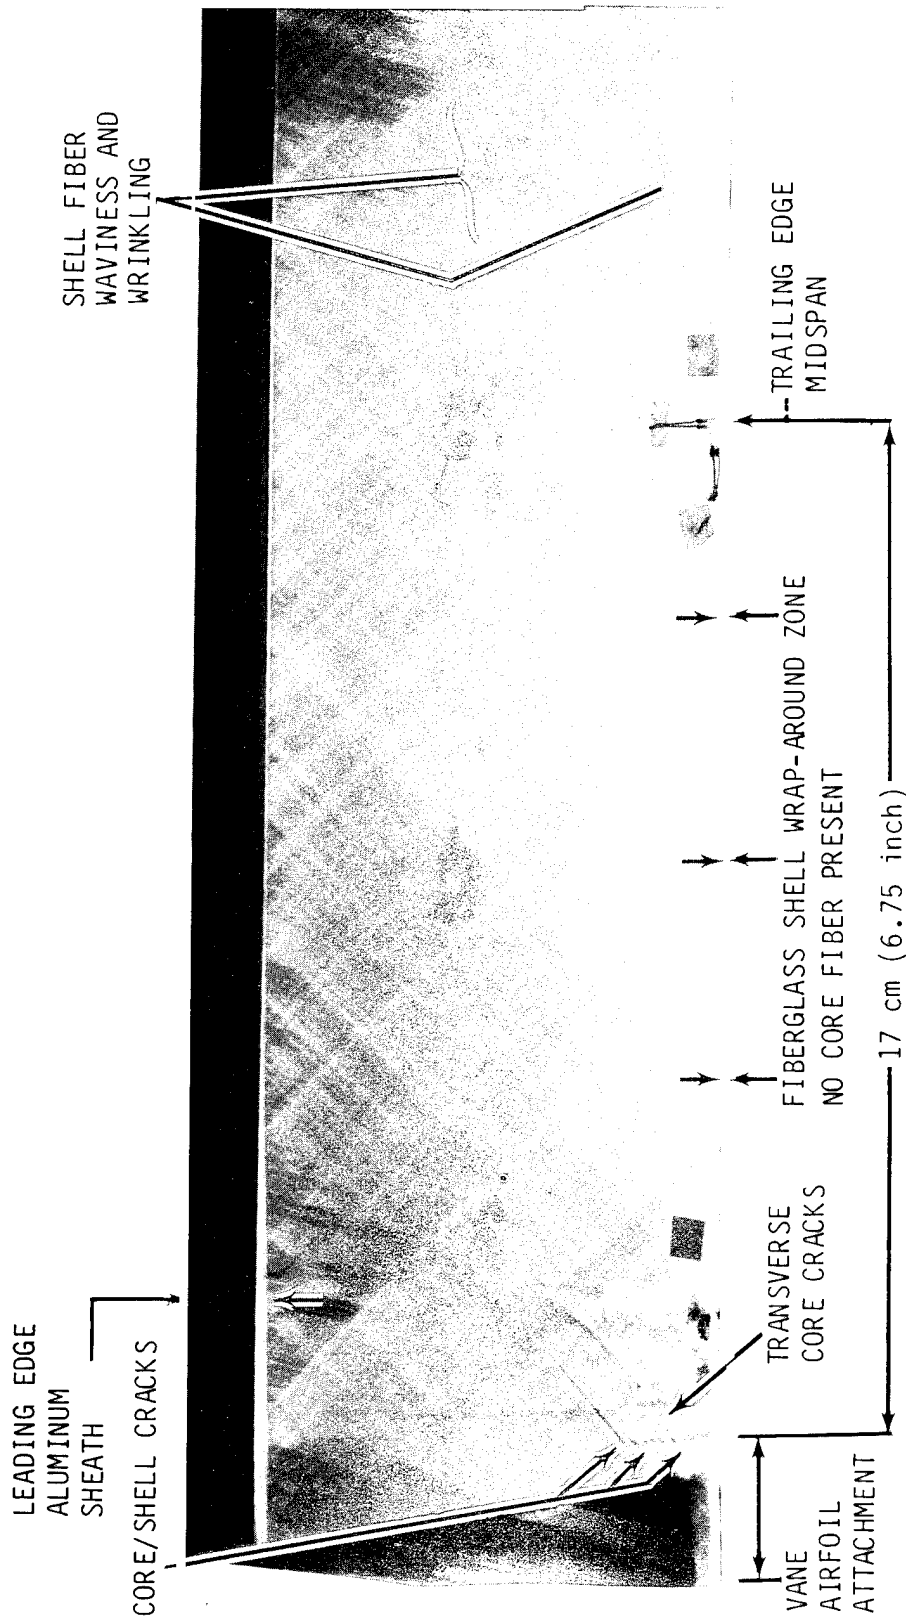
Figure 5-24 Print from Radiograph of TW Fiberglass Shell-Graphite  
Core/Epoxy Vane After Fatigue Test (Vane No. 2-005)

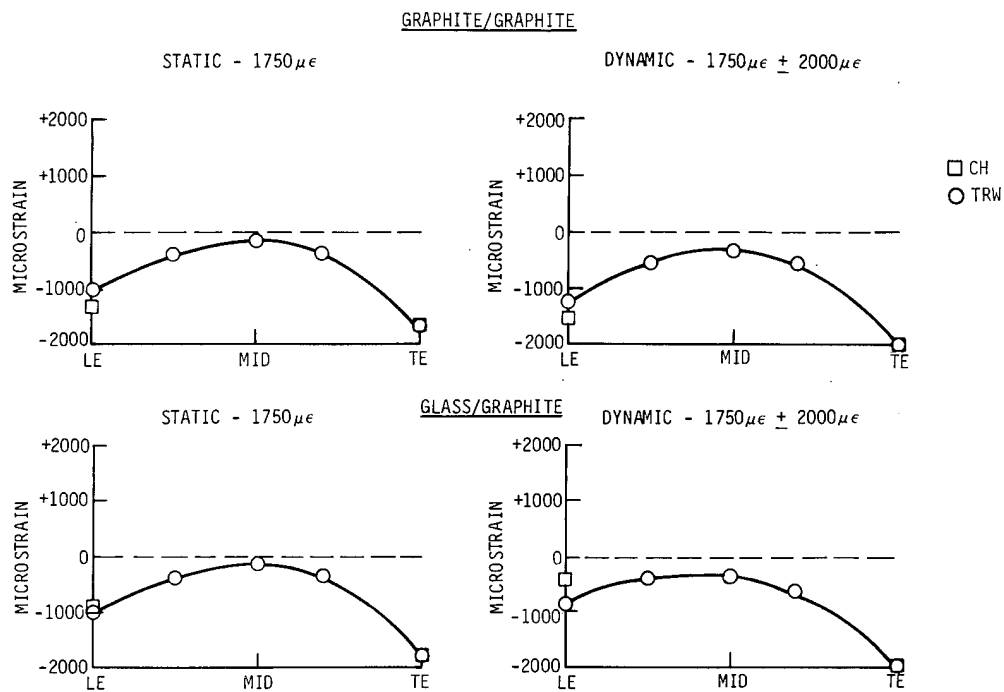
Figure 5-25 Chordwise Distribution of Radial Strain on Concave Surface for Graphite and Hybrid Vanes

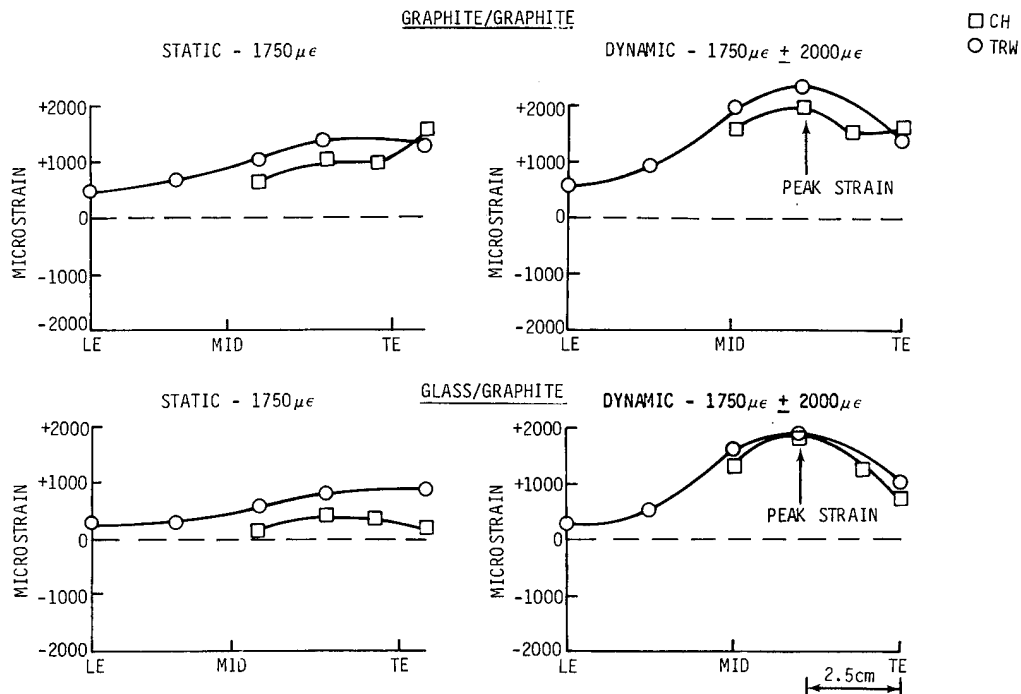
Figure 5-26 Chordwise Distribution of Chordwise Strain on Concave Surface for Graphite and Hybrid Vanes

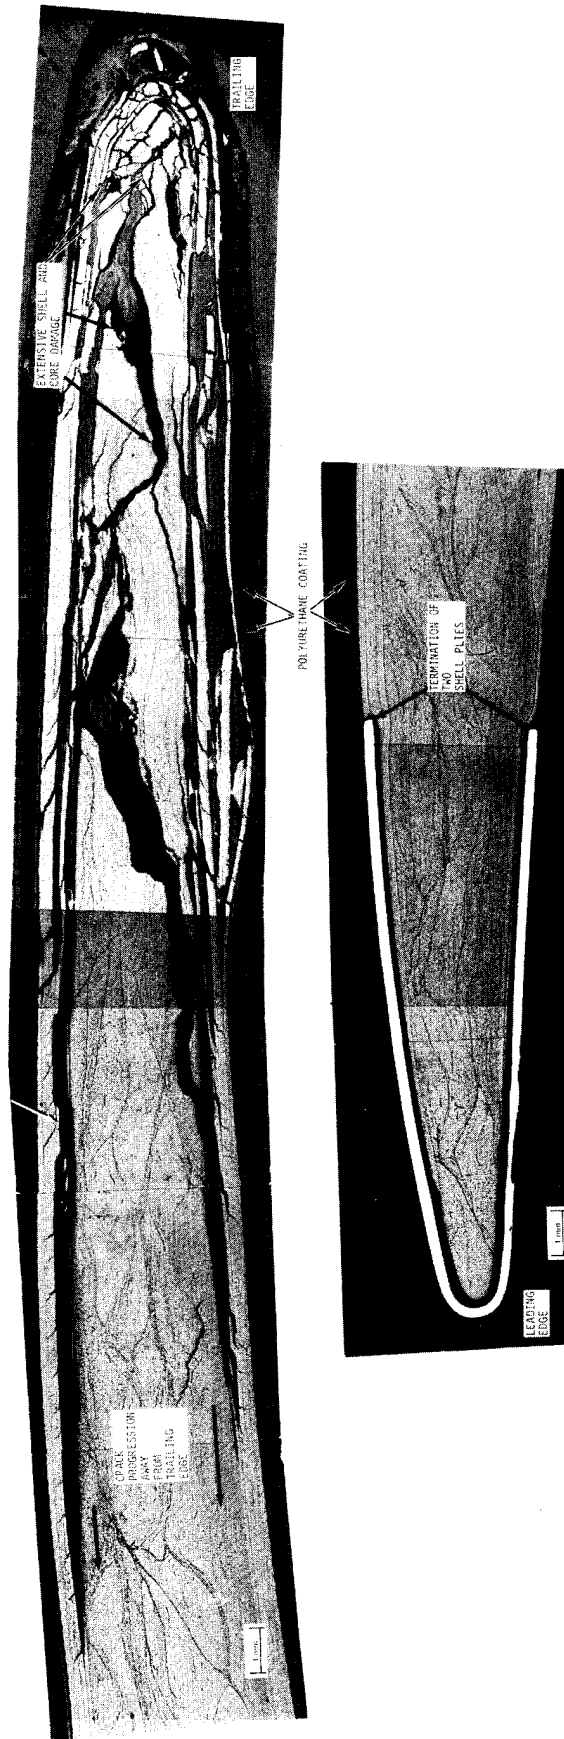
Figure 5-27 Photomicrograph of Graphite/Epoxy Fan Exit Guide Vane Fatigue Failure

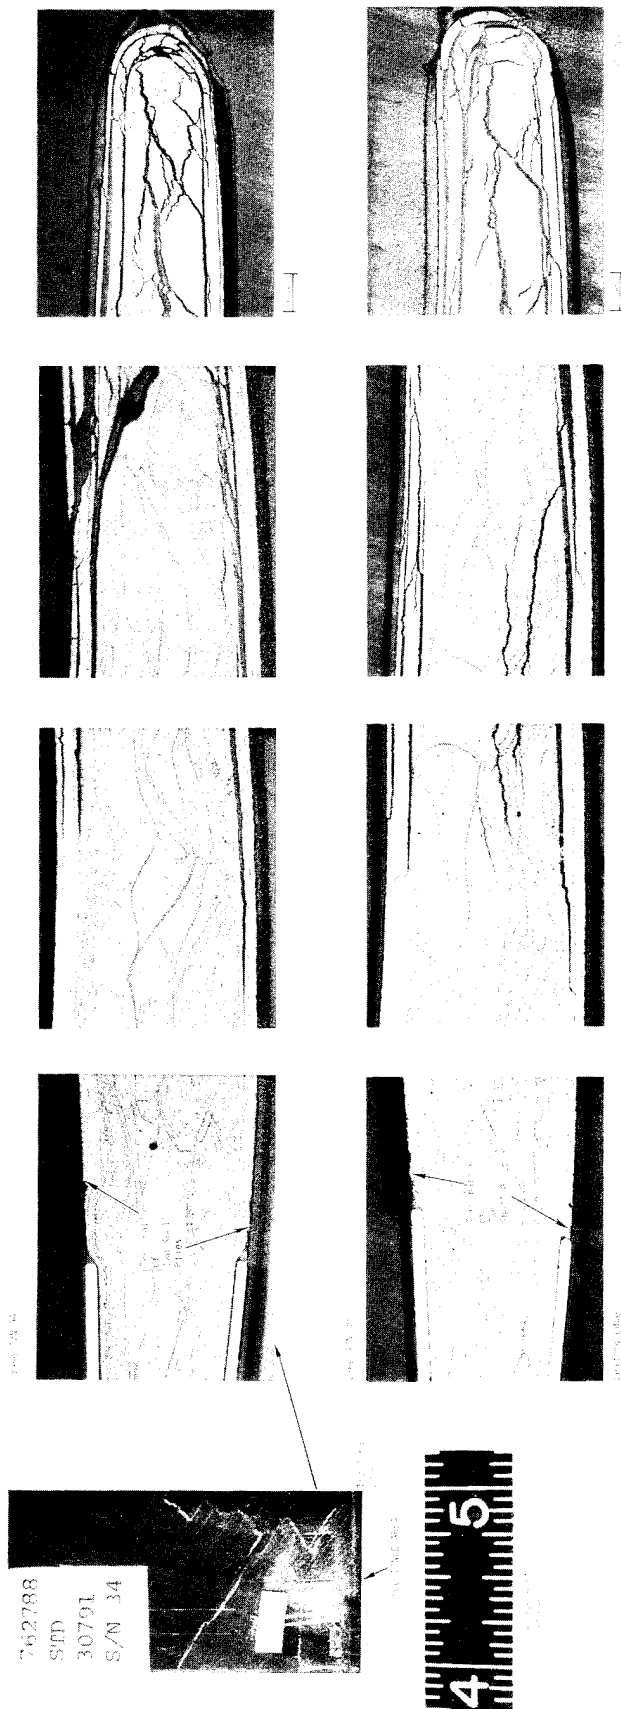
Figure 5-28 Photomicrograph of Graphite/Epoxy Fan Exit Guide Vane Fatigue Failure

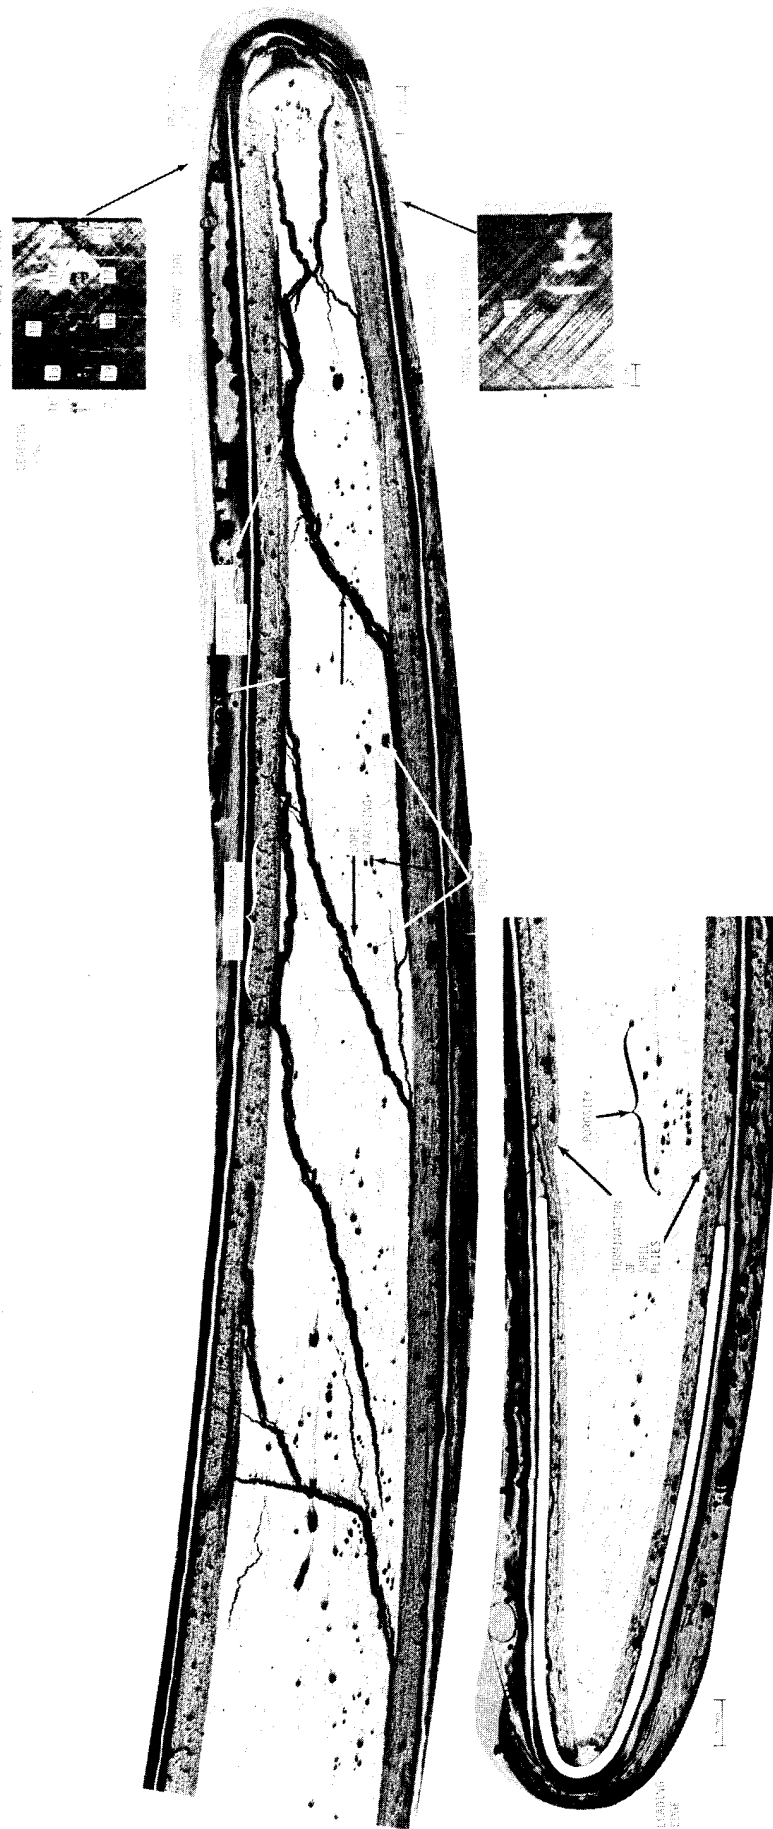
Figure 5-31 Photomicrograph of Hybrid Glass Shell-Graphite/Epoxy Core Fan Exit Guide Vane Fatigue Failure

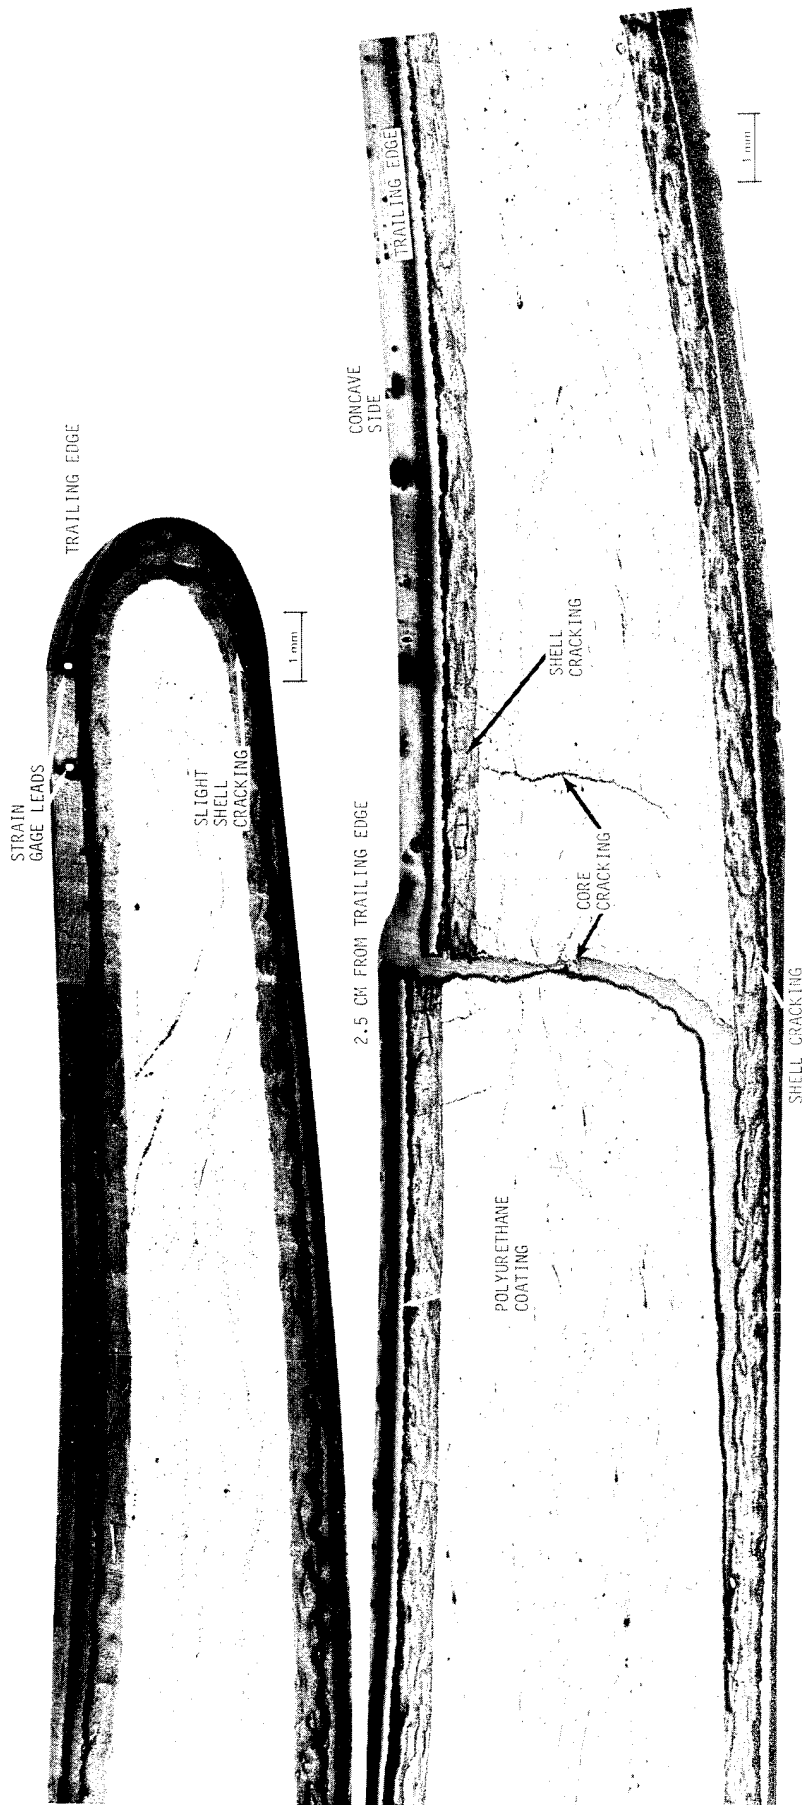
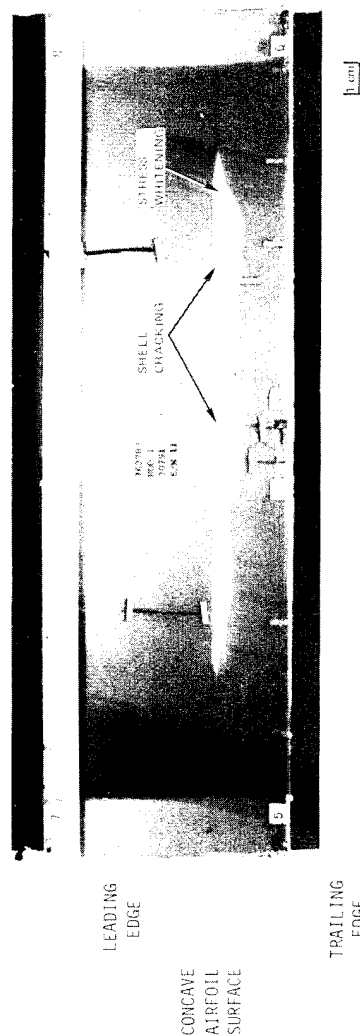
Figure 5-32 Photomicrograph of Hybrid Glass Cloth Shell-Graphite/ Epoxy Core Fan Exit Guide Vane Fatigue Failure
